Profile/Photo Observation Report

Date:	10/31/2021	Weather:		Coding:	PACP 7.0
Pipe Length (ft):	162.4	Owner:	City of Hobart	Pre Clean:	Heavy Cleaning
P.O.#:	YES502259	Surveyor:	S. Bucklin	PSR:	P-504-034-033
Customer:	City of Hobart	Clean Date:	10/27/2021	Shape:	C

Street:	West Home Avenue	Flow Control:	Not Controlled
City:	Hobart, IN	Year Renewed:	
Location:	Local rural streets with light traffic, t	Tape/Media #:	
Purpose:	Routine Assessment	Dia/Height:	12"
Use:	Sanitary Sewage Pipe	Material:	VCP
Drain Area:		Lining:	None
Category:	NA		
Comment:			
Location Details:		Direction of Survey:	Upstream
US MH:	M-504-033	DS MH:	M-504-034
		Total Length Surveyed (ft):	162.4

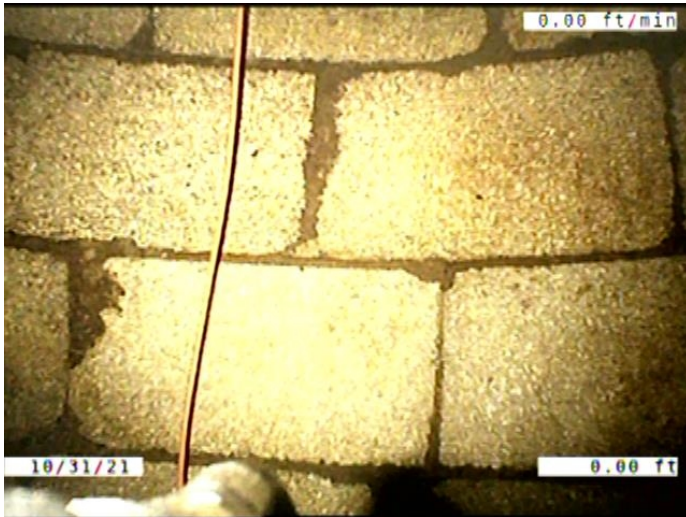
Code: **AMH**
 Description: **Manhole**

Distance (ft): **.0**
 Structural Grade: **0**
 O&M Grade: **0**
 Clock Start/From:
 Clock To:
 1st Value:
 2nd Value:
 Value Percent:
 Continuous Index:
 Within 8" of Joint: **NO**
 Remarks: **M-504-034**

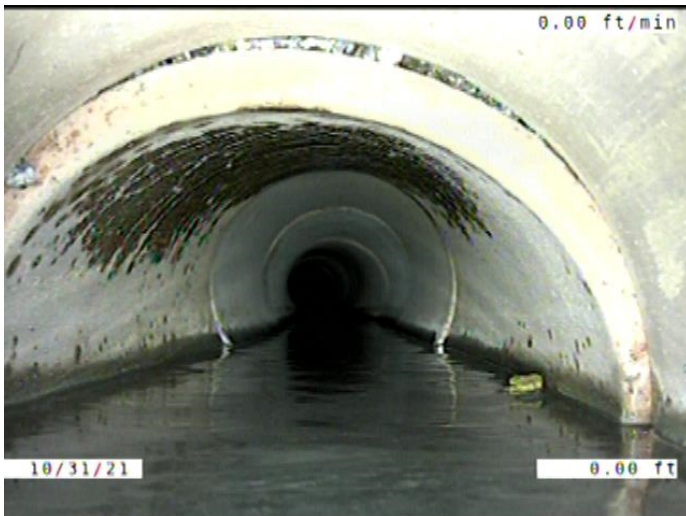
Code: **MWL**
 Description: **Miscellaneous Water Level**

Distance (ft): **.0**
 Structural Grade: **0**
 O&M Grade: **0**
 Clock Start/From:
 Clock To:
 1st Value:
 2nd Value:
 Value Percent: **15.000**
 Continuous Index:
 Within 8" of Joint: **NO**
 Remarks:

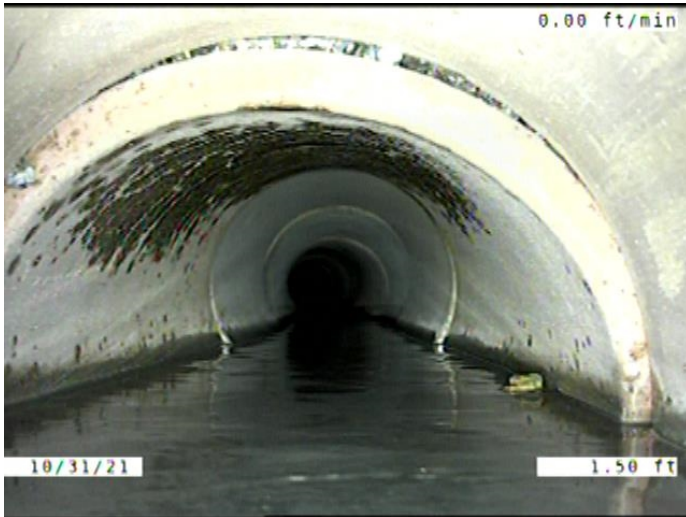
Code: **MGO**
 Description: **Miscellaneous General Observation**

Distance (ft): **1.5**
 Structural Grade: **0**
 O&M Grade: **0**
 Clock Start/From:
 Clock To:
 1st Value:
 2nd Value:
 Value Percent:
 Continuous Index:
 Within 8" of Joint: **NO**
 Remarks: **DROP INTO THE MANHOLE. HAD TO START IN THE PIPE.**

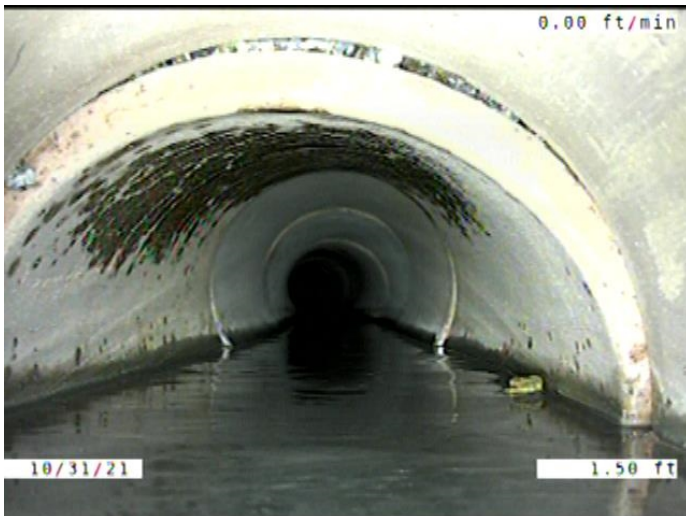
Code: **DSF**
 Description: **Deposits Settled Fine**

Distance (ft): **1.5**
 Structural Grade: **0**
 O&M Grade: **2**
 Clock Start/From: **5**
 Clock To: **7**
 1st Value:
 2nd Value:
 Value Percent: **10.000**
 Continuous Index: **S01**
 Within 8" of Joint: **YES**
 Remarks:

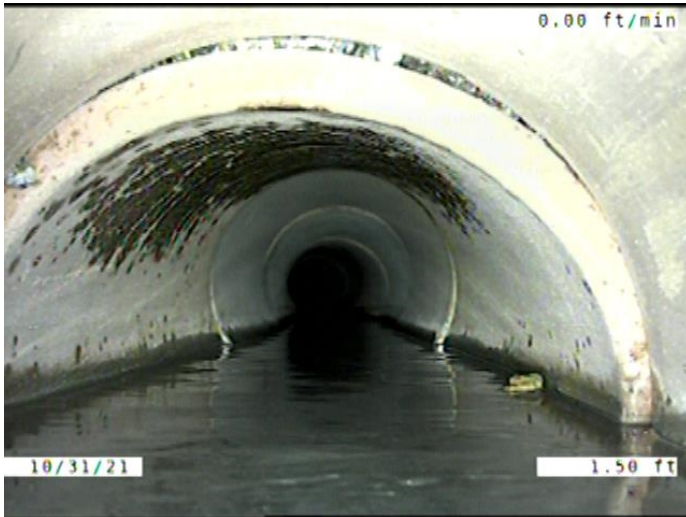
Code: **MGO**
 Description: **Miscellaneous General Observation**

Distance (ft): **1.5**
 Structural Grade: **0**
 O&M Grade: **0**
 Clock Start/From:
 Clock To:
 1st Value:
 2nd Value:
 Value Percent:
 Continuous Index:
 Within 8" of Joint: **NO**
 Remarks: **PIPE IS SHOWING A 13% NEGATIVE SLOPE AT THIS POINT**

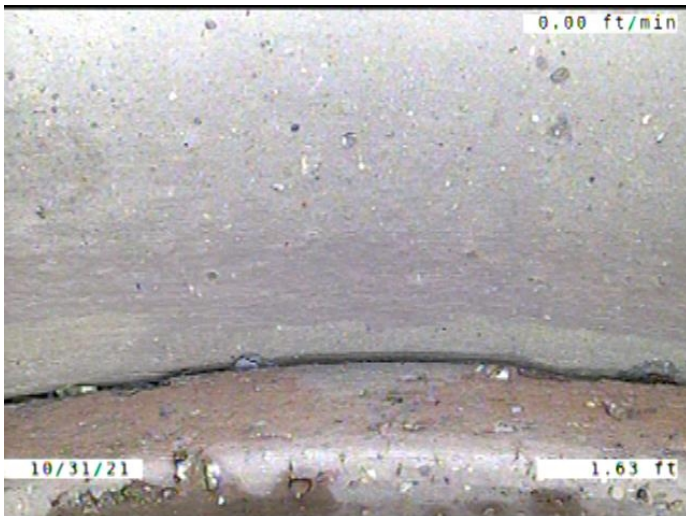
Code: **JOMD**
 Description: **Joint Offset Medium Defective**

Distance (ft): **1.6**
 Structural Grade: **3**
 O&M Grade: **0**
 Clock Start/From:
 Clock To:
 1st Value:
 2nd Value:
 Value Percent:
 Continuous Index:
 Within 8" of Joint: **NO**
 Remarks:

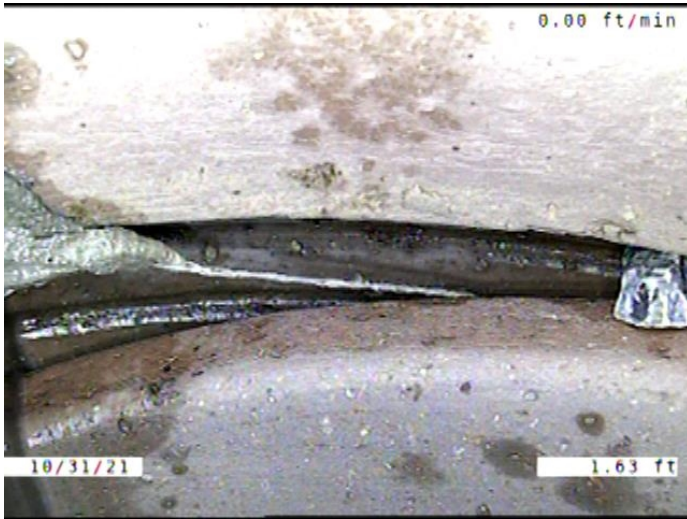
Code: **JAM**
Description: **Joint Angular Medium**

Distance (ft): **1.6**
Structural Grade: **3**
O&M Grade: **0**
Clock Start/From:
Clock To:
1st Value:
2nd Value:
Value Percent:
Continuous Index:
Within 8" of Joint: **NO**
Remarks:

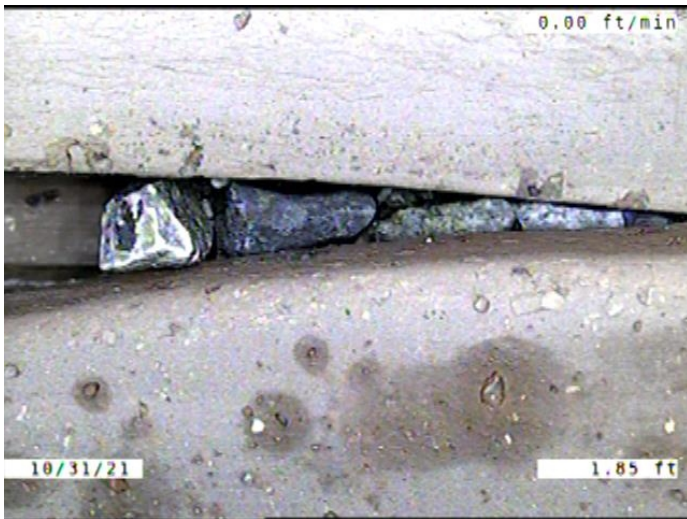
Code: **OBJ**
Description: **Obstruction Wedged In The Joint**

Distance (ft): **1.9**
Structural Grade: **0**
O&M Grade: **2**
Clock Start/From: **10**
Clock To: **11**
1st Value:
2nd Value:
Value Percent: **5.000**
Continuous Index:
Within 8" of Joint: **YES**
Remarks:

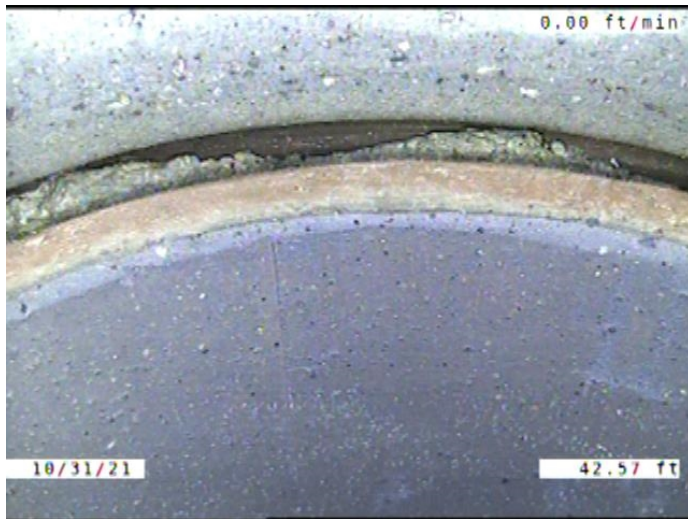
Code: **JOM**
 Description: **Joint Offset Medium**

Distance (ft): **42.6**
 Structural Grade: **3**
 O&M Grade: **0**
 Clock Start/From:
 Clock To:
 1st Value:
 2nd Value:
 Value Percent:
 Continuous Index:
 Within 8" of Joint: **NO**
 Remarks:

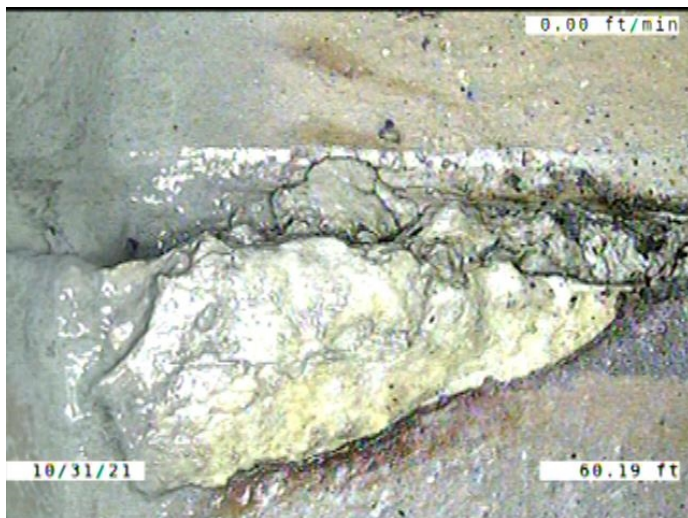
Code: **DAE**
 Description: **Deposits Attached Encrustation**

Distance (ft): **60.2**
 Structural Grade: **0**
 O&M Grade: **2**
 Clock Start/From: **3**
 Clock To: **4**
 1st Value:
 2nd Value:
 Value Percent: **5.000**
 Continuous Index:
 Within 8" of Joint: **YES**
 Remarks:

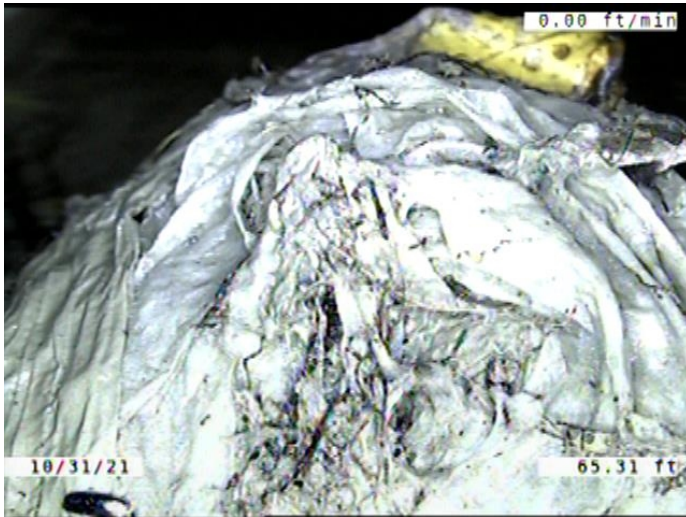
Code:	OBZ
Description:	Obstruction Other
Distance (ft):	65.3
Structural Grade:	0
O&M Grade:	2
Clock Start/From:	5
Clock To:	7
1st Value:	
2nd Value:	
Value Percent:	10.000
Continuous Index:	
Within 8" of Joint:	YES
Remarks:	ROOTS THAT HAVE BEEN CUT. RAGS HUG UP ON THEM

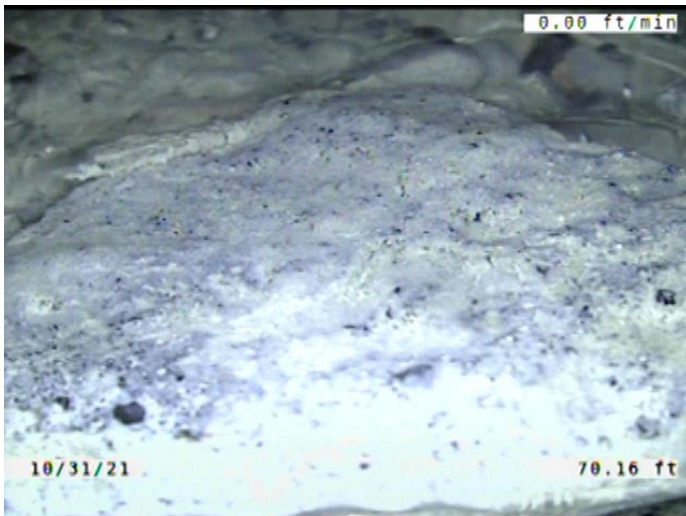
Code:	OBN
Description:	Obstruction Construction Debris
Distance (ft):	70.2
Structural Grade:	0
O&M Grade:	2
Clock Start/From:	5
Clock To:	7
1st Value:	
2nd Value:	
Value Percent:	5.000
Continuous Index:	
Within 8" of Joint:	YES
Remarks:

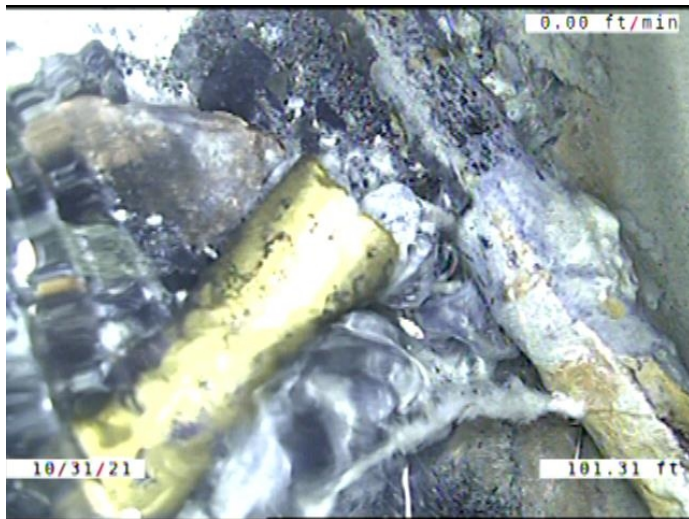
Code: **OBZ**
Description: **Obstruction Other**

Distance (ft): **101.3**
Structural Grade: **0**
O&M Grade: **2**
Clock Start/From: **5**
Clock To: **6**
1st Value:
2nd Value:
Value Percent: **5.000**
Continuous Index:
Within 8" of Joint: **NO**
Remarks: **BATTERY**

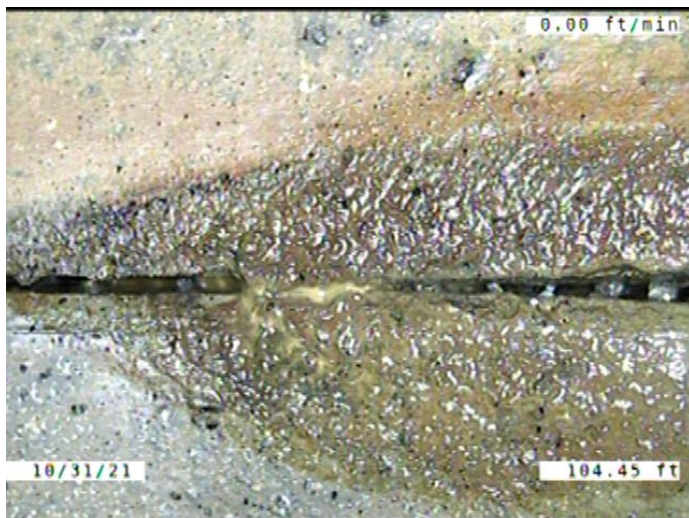
Code: **DAE**
Description: **Deposits Attached Encrustation**

Distance (ft): **104.4**
Structural Grade: **0**
O&M Grade: **2**
Clock Start/From: **2**
Clock To: **4**
1st Value:
2nd Value:
Value Percent: **5.000**
Continuous Index:
Within 8" of Joint: **YES**
Remarks:

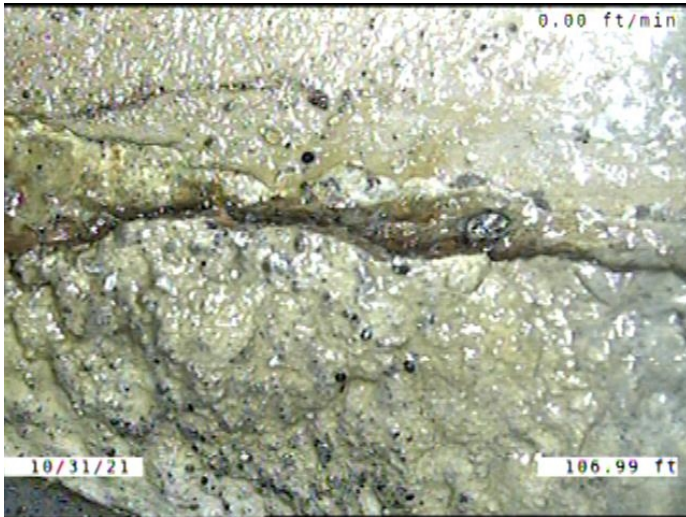
Code: **DAE**
Description: **Deposits Attached Encrustation**

Distance (ft): **107.0**
Structural Grade: **0**
O&M Grade: **2**
Clock Start/From: **2**
Clock To: **4**
1st Value:
2nd Value:
Value Percent: **5.000**
Continuous Index:
Within 8" of Joint: **YES**
Remarks:

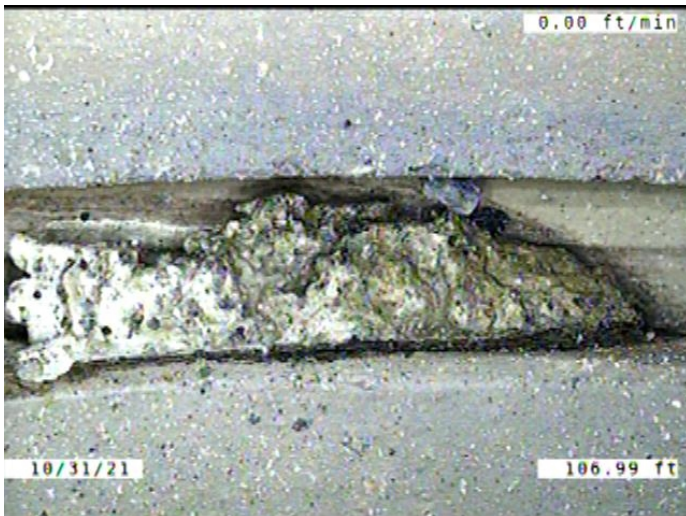
Code: **DAE**
Description: **Deposits Attached Encrustation**

Distance (ft): **107.0**
Structural Grade: **0**
O&M Grade: **2**
Clock Start/From: **10**
Clock To:
1st Value:
2nd Value:
Value Percent: **5.000**
Continuous Index:
Within 8" of Joint: **YES**
Remarks:

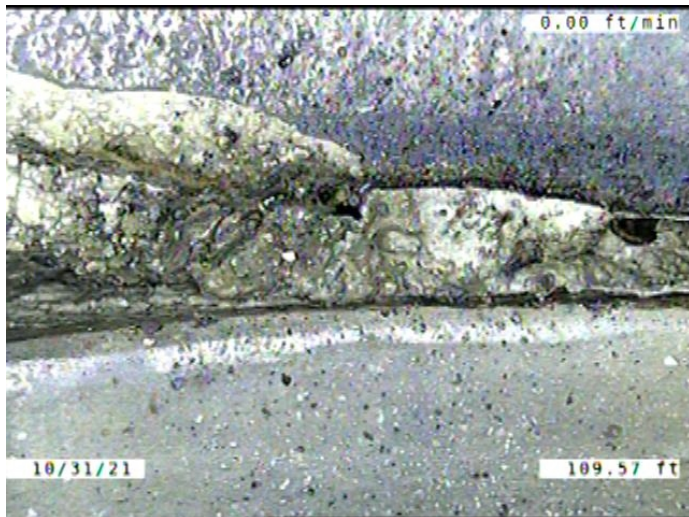
Code: **DAE**
 Description: **Deposits Attached Encrustation**

Distance (ft): **109.6**
 Structural Grade: **0**
 O&M Grade: **2**
 Clock Start/From: **8**
 Clock To: **11**
 1st Value:
 2nd Value:
 Value Percent: **5.000**
 Continuous Index:
 Within 8" of Joint: **YES**
 Remarks:

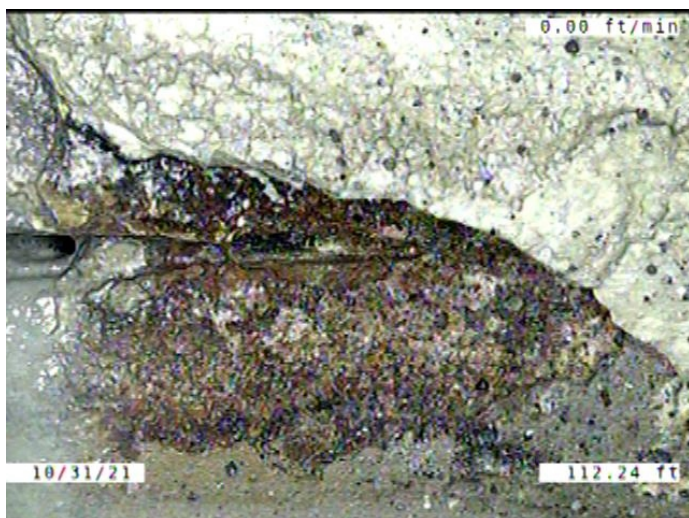
Code: **DAE**
 Description: **Deposits Attached Encrustation**

Distance (ft): **112.2**
 Structural Grade: **0**
 O&M Grade: **2**
 Clock Start/From: **8**
 Clock To: **4**
 1st Value:
 2nd Value:
 Value Percent: **5.000**
 Continuous Index: **S02**
 Within 8" of Joint: **YES**
 Remarks:

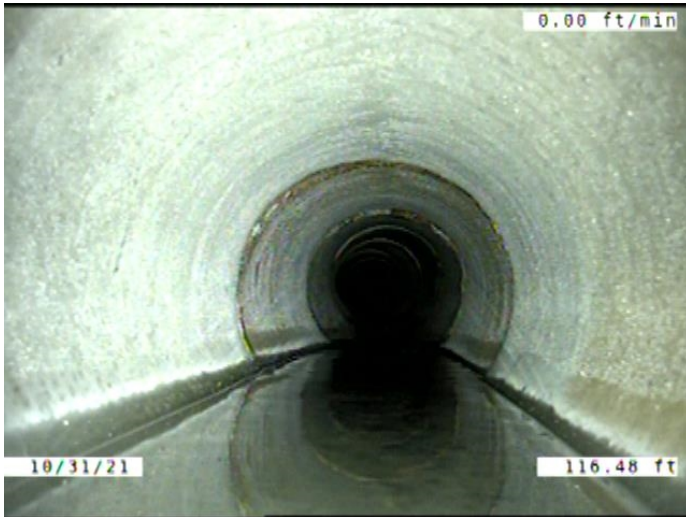
Code: **MWLS**
 Description: **Miscellaneous Water Level Sag**

Distance (ft): **116.5**
 Structural Grade: **2**
 O&M Grade: **0**
 Clock Start/From:
 Clock To:
 1st Value:
 2nd Value:
 Value Percent: **10.000**
 Continuous Index: **S03**
 Within 8" of Joint: **NO**
 Remarks:

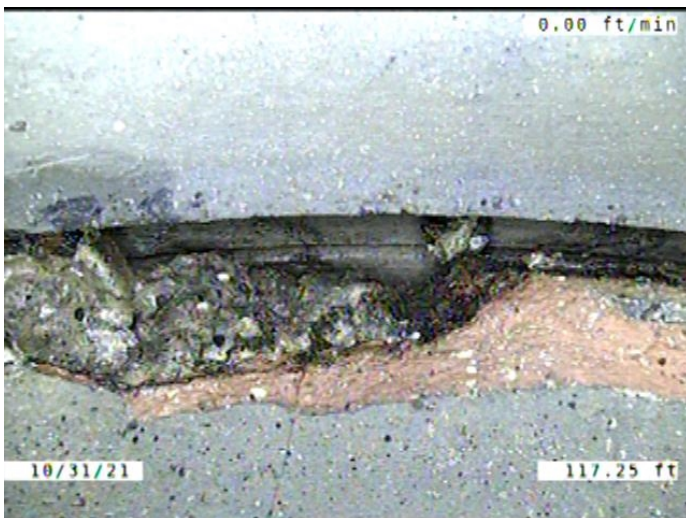
Code: **SMW**
 Description: **Surface Damage Missing Wall**

Distance (ft): **117.2**
 Structural Grade: **5**
 O&M Grade: **0**
 Clock Start/From: **10**
 Clock To: **11**
 1st Value:
 2nd Value:
 Value Percent:
 Continuous Index:
 Within 8" of Joint: **YES**
 Remarks: **INSIDE OF THE JOINT**

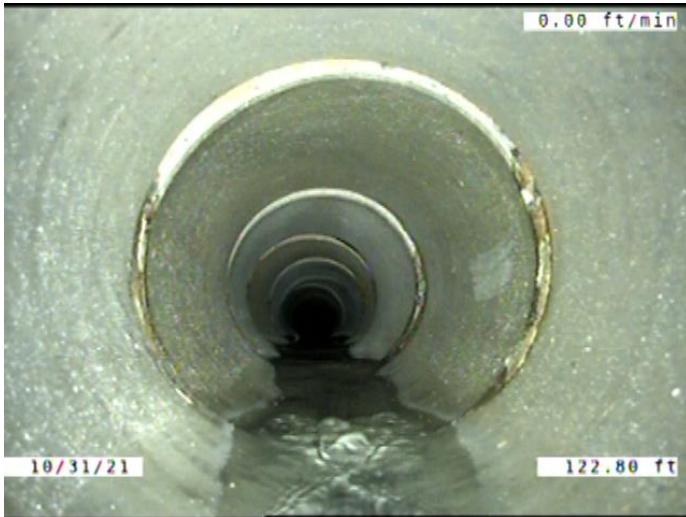
Code: **MWLS**
Description: **Miscellaneous Water Level Sag**

Distance (ft): **122.8**
Structural Grade: **2**
O&M Grade: **0**
Clock Start/From:
Clock To:
1st Value:
2nd Value:
Value Percent: **10.000**
Continuous Index: **F03**
Within 8" of Joint: **NO**
Remarks:

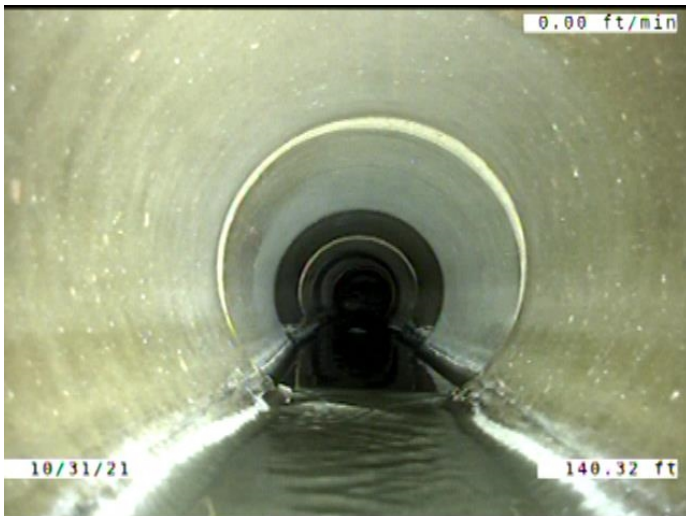
Code: **DAE**
Description: **Deposits Attached Encrustation**

Distance (ft): **140.3**
Structural Grade: **0**
O&M Grade: **2**
Clock Start/From: **8**
Clock To: **4**
1st Value:
2nd Value:
Value Percent: **5.000**
Continuous Index: **F02**
Within 8" of Joint: **YES**
Remarks:

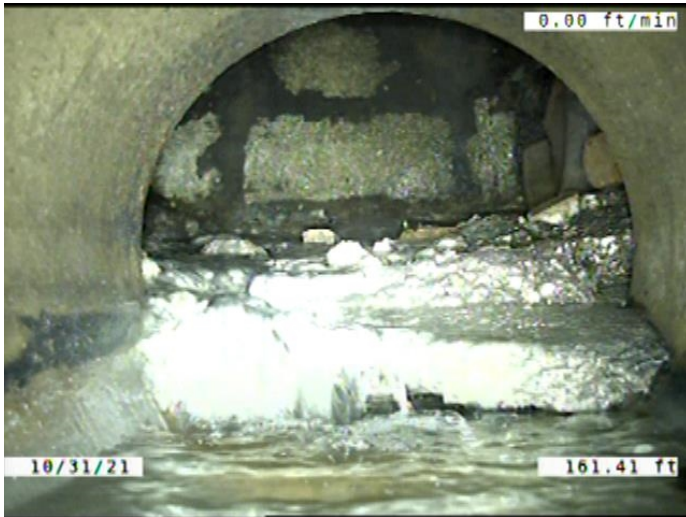
Code: **DSF**
 Description: **Deposits Settled Fine**

Distance (ft): **161.4**
 Structural Grade: **0**
 O&M Grade: **2**
 Clock Start/From: **5**
 Clock To: **7**
 1st Value:
 2nd Value:
 Value Percent: **10.000**
 Continuous Index: **F01**
 Within 8" of Joint: **YES**
 Remarks:

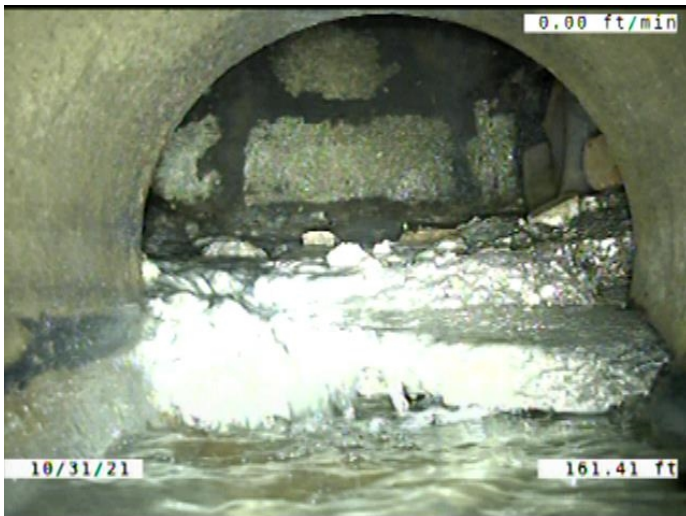
Code: **DSC**
 Description: **Deposits Settled Hard/Compacted**

Distance (ft): **161.4**
 Structural Grade: **0**
 O&M Grade: **2**
 Clock Start/From: **4**
 Clock To: **8**
 1st Value:
 2nd Value:
 Value Percent: **10.000**
 Continuous Index:
 Within 8" of Joint: **YES**
 Remarks:

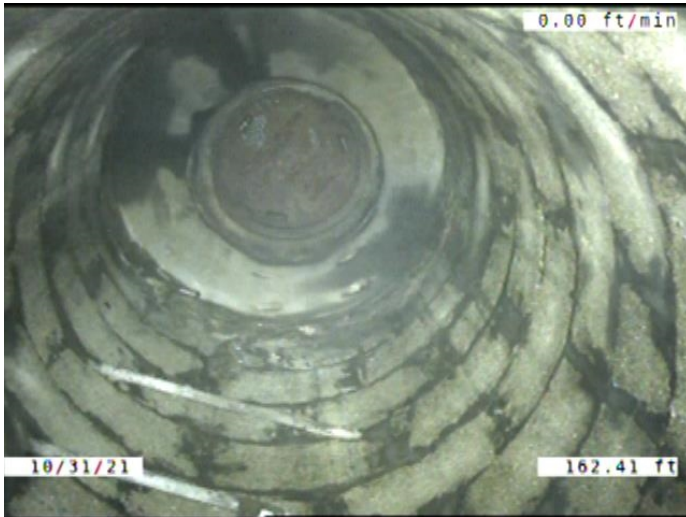
Code:	AMH
Description:	Manhole
Distance (ft):	162.4
Structural Grade:	0
O&M Grade:	0
Clock Start/From:	
Clock To:	
1st Value:	
2nd Value:	
Value Percent:	
Continuous Index:	
Within 8" of Joint:	NO
Remarks:	M-504-033
