Profile/Photo Observation Report

Date:	10/31/2021	Weather:		Coding:	PACP 7.0
Pipe Length (ft):	162.4	Owner:	City of Hobart	Pre Clean:	Heavy Cleaning
P.O.#:	YES502259	Surveyor:	S. Bucklin	PSR:	P-504-034-033
Customer:	City of Hobart	Clean Date:	10/27/2021	Shape:	C

Street:	West Home Avenue	Flow Control:	Not Controlled
City:	Hobart, IN	Year Renewed:	
Location:	Local rural streets with light traffic, t	Tape/Media #:	
Purpose:	Routine Assessment	Dia/Height:	12"
Use:	Sanitary Sewage Pipe	Material:	VCP
Drain Area:		Lining:	None
Category:	NA		
Comment:			
Location Details:		Direction of Survey:	Upstream
US MH:	M-504-033	DS MH:	M-504-034
		Total Length Surveyed (ft):	162.4

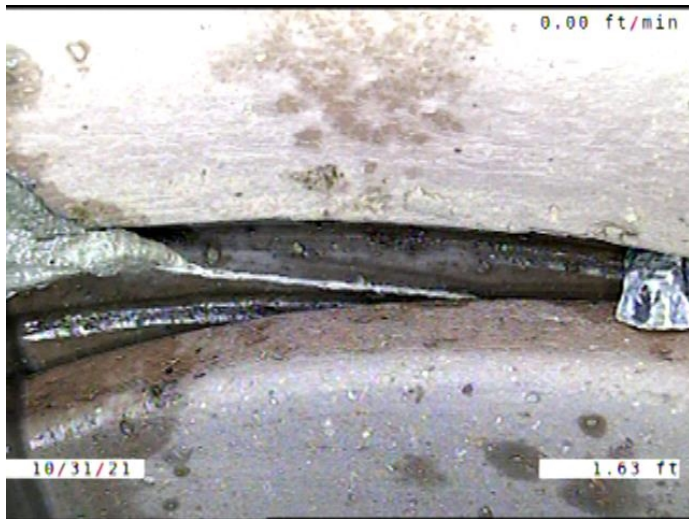
Code: **JAM**
Description: **Joint Angular Medium**

Distance (ft): **1.6**
Structural Grade: **3**
O&M Grade: **0**
Clock Start/From:
Clock To:
1st Value:
2nd Value:
Value Percent:
Continuous Index:
Within 8" of Joint: **NO**
Remarks:

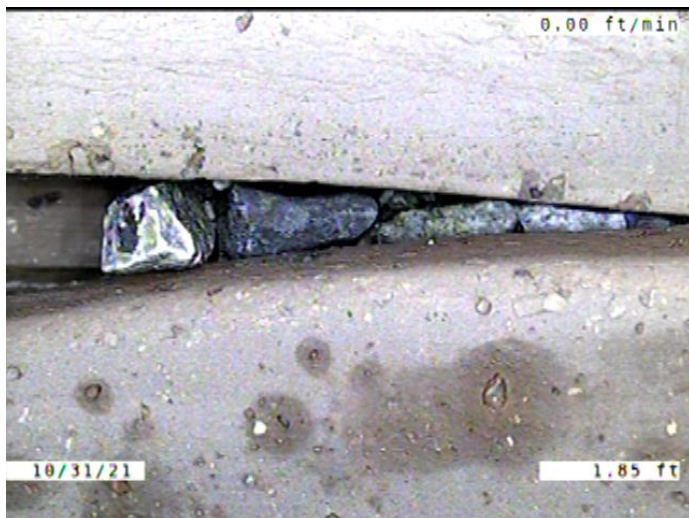
Code: **OBJ**
Description: **Obstruction Wedged In The Joint**

Distance (ft): **1.9**
Structural Grade: **0**
O&M Grade: **2**
Clock Start/From: **10**
Clock To: **11**
1st Value:
2nd Value:
Value Percent: **5.000**
Continuous Index:
Within 8" of Joint: **YES**
Remarks:

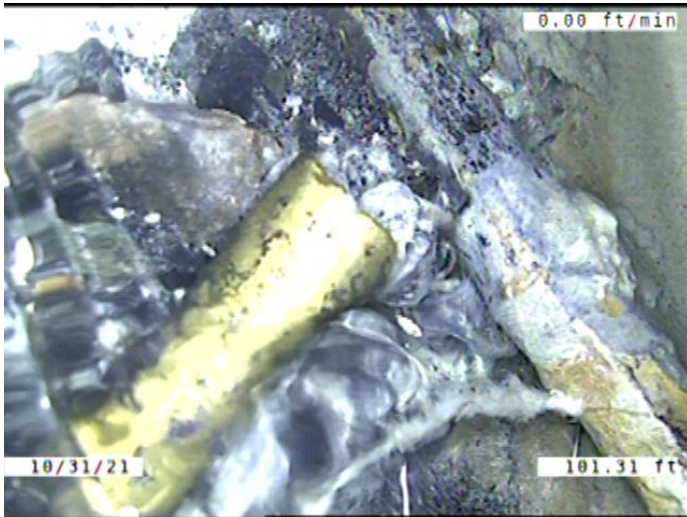
Code: **OBZ**
Description: **Obstruction Other**

Distance (ft): **101.3**
Structural Grade: **0**
O&M Grade: **2**
Clock Start/From: **5**
Clock To: **6**
1st Value:
2nd Value:
Value Percent: **5.000**
Continuous Index:
Within 8" of Joint: **NO**
Remarks: **BATTERY**

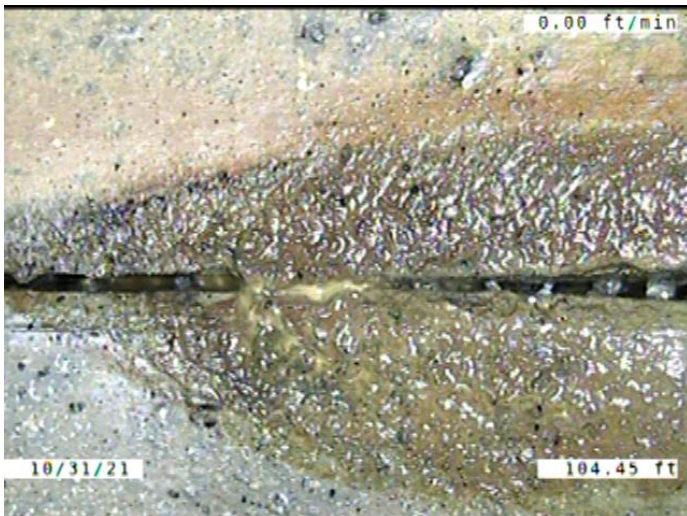
Code: **DAE**
Description: **Deposits Attached Encrustation**

Distance (ft): **104.4**
Structural Grade: **0**
O&M Grade: **2**
Clock Start/From: **2**
Clock To: **4**
1st Value:
2nd Value:
Value Percent: **5.000**
Continuous Index:
Within 8" of Joint: **YES**
Remarks:

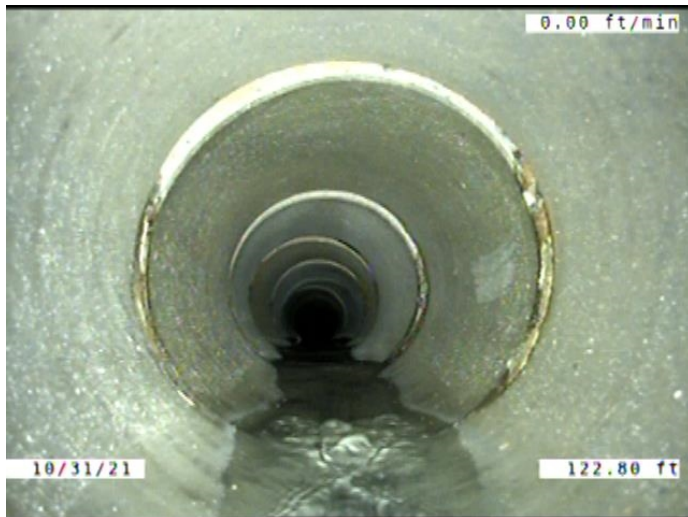
Code: **MWLS**
 Description: **Miscellaneous Water Level Sag**

Distance (ft): **122.8**
 Structural Grade: **2**
 O&M Grade: **0**
 Clock Start/From:
 Clock To:
 1st Value:
 2nd Value:
 Value Percent: **10.000**
 Continuous Index: **F03**
 Within 8" of Joint: **NO**
 Remarks:

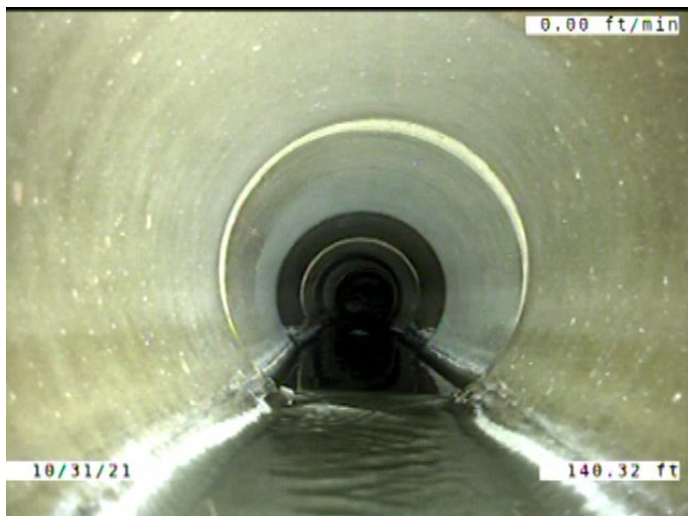
Code: **DAE**
 Description: **Deposits Attached Encrustation**

Distance (ft): **140.3**
 Structural Grade: **0**
 O&M Grade: **2**
 Clock Start/From: **8**
 Clock To: **4**
 1st Value:
 2nd Value:
 Value Percent: **5.000**
 Continuous Index: **F02**
 Within 8" of Joint: **YES**
 Remarks:
