## Profile/Photo Observation Report

Date:	<b>04/24/2018</b>	Weather:		Coding:	<b>PACP 6.0</b>
Pipe Length (ft):	<b>187.7</b>	Owner:	<b>NA</b>	Pre Clean:	<b>No Pre-Cleaning</b>
P.O.#:		Surveyor:	<b>Jen Costello</b>	PSR:	<b>P-504-045-033</b>
Customer:		Clean Date:	<b>01/01/1900</b>	Shape:	<b>C</b>

Street:	<b>W HOME AVE</b>	Flow Control:	<b>Not Controlled</b>
City:	<b>Hobart, IN</b>	Year Renewed:	
Location:	<b>Light Highway</b>	Tape/Media #:	
Purpose:	<b>Routine Assessment</b>	Dia/Height:	<b>12"</b>
Use:	<b>Sanitary</b>	Material:	<b>VCP</b>
Drain Area:	<b>NA</b>	Lining:	
Category:	<b>NA</b>		
Comment:	<b>P_C at 125 nothing visible . Flow direction wrong</b>		
Location Details:		Direction of Survey:	<b>Upstream</b>
US MH:	<b>M-504-033</b>	DS MH:	<b>M-504-045</b>
		Total Length Surveyed (ft):	<b>126.6</b>

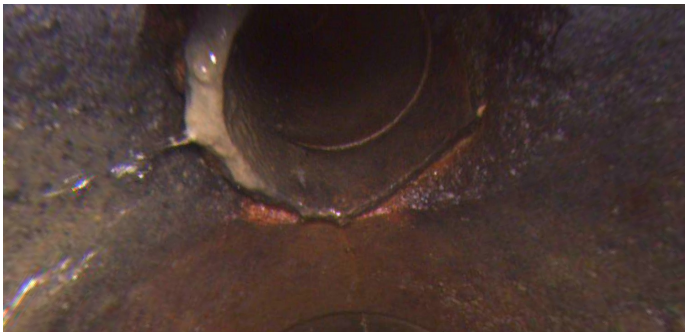
Code:	<b>TBI</b>
Description:	<b>Tap Break-in Intruding</b>

Distance (ft):	<b>11.0</b>
Structural Grade:	<b>0</b>
O&M Grade:	<b>2</b>
Clock Start/From:	<b>12</b>
Clock To:	
1st Value:	<b>4.000</b>
2nd Value:	<b>1.000</b>
Value Percent:	
Continuous Index:	
Within 8" of Joint:	
Remarks:

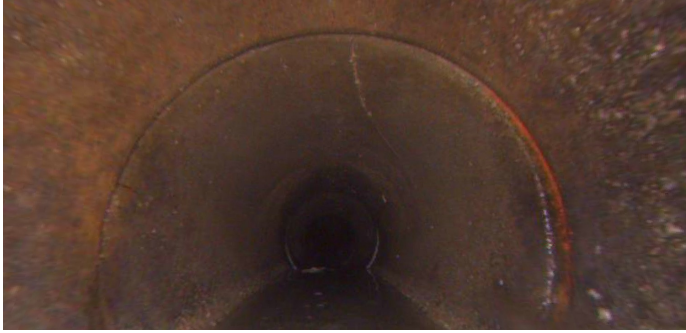
Code: **FM**  
Description: **Fracture Multiple**

Distance (ft): **11.3**  
Structural Grade: **4**  
O&M Grade: **0**  
Clock Start/From: **9**  
Clock To: **12**  
1st Value:  
2nd Value:  
Value Percent:  
Continuous Index:  
Within 8" of Joint: **YES**  
Remarks:

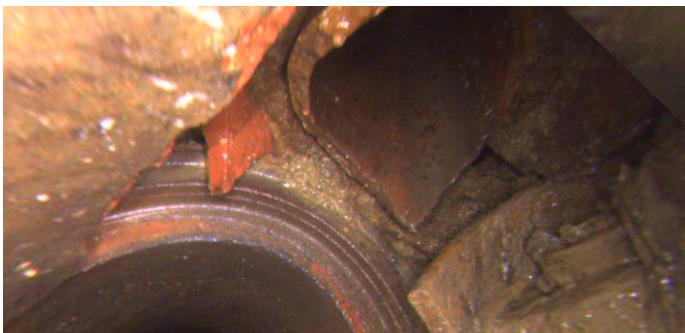
Code: **TBD**  
Description: **Tap Break-in Defective**

Distance (ft): **48.3**  
Structural Grade: **0**  
O&M Grade: **3**  
Clock Start/From: **2**  
Clock To:  
1st Value: **4.000**  
2nd Value:  
Value Percent:  
Continuous Index:  
Within 8" of Joint:  
Remarks: **BROKEN**

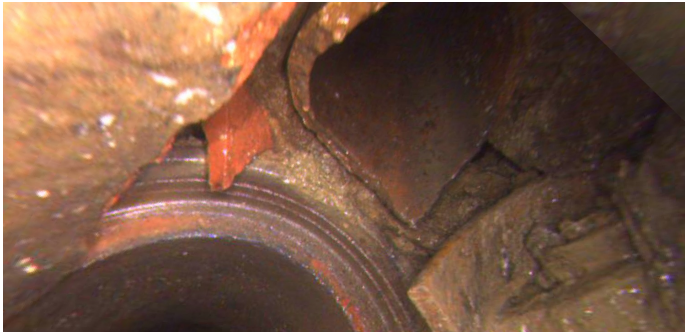
Code: **BSV**  
Description: **Broken Soil Visible**

Distance (ft): **48.3**  
Structural Grade: **5**  
O&M Grade: **0**  
Clock Start/From: **12**  
Clock To: **3**  
1st Value:  
2nd Value:  
Value Percent:  
Continuous Index:  
Within 8" of Joint: **YES**  
Remarks:

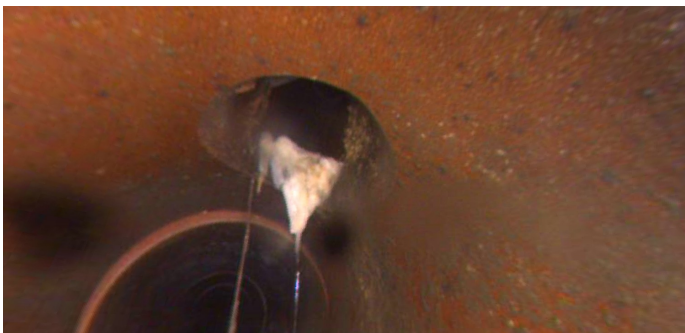
Code: **TFD**  
Description: **Tap Factory Defective**

Distance (ft): **68.8**  
Structural Grade: **0**  
O&M Grade: **2**  
Clock Start/From: **12**  
Clock To:  
1st Value: **4.000**  
2nd Value:  
Value Percent:  
Continuous Index:  
Within 8" of Joint:  
Remarks: **ROOTS**

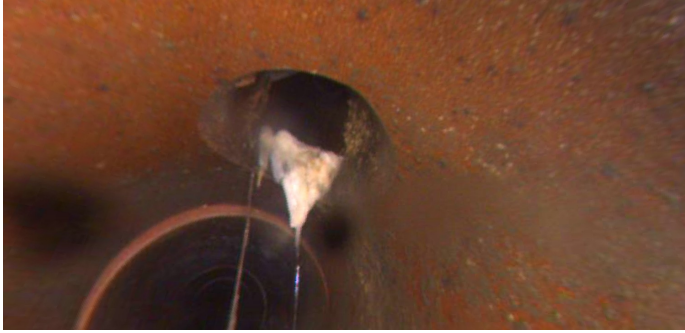
Code: **RFL**  
Description: **Roots Fine Lateral**

Distance (ft): **68.8**  
Structural Grade: **0**  
O&M Grade: **1**  
Clock Start/From: **12**  
Clock To:  
1st Value:  
2nd Value:  
Value Percent:  
Continuous Index:  
Within 8" of Joint: **NO**  
Remarks:

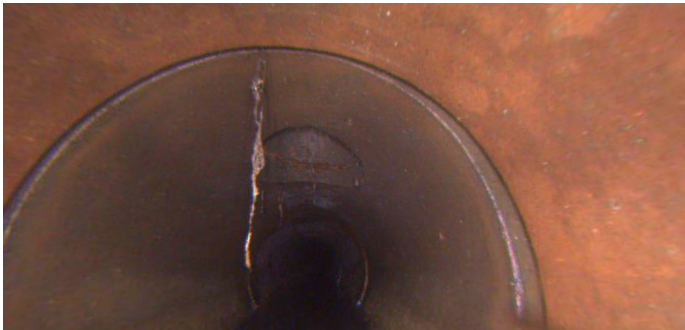
Code: **RFJ**  
Description: **Roots Fine Joint**

Distance (ft): **81.4**  
Structural Grade: **0**  
O&M Grade: **1**  
Clock Start/From: **12**  
Clock To:  
1st Value:  
2nd Value:  
Value Percent:  
Continuous Index:  
Within 8" of Joint: **YES**  
Remarks:

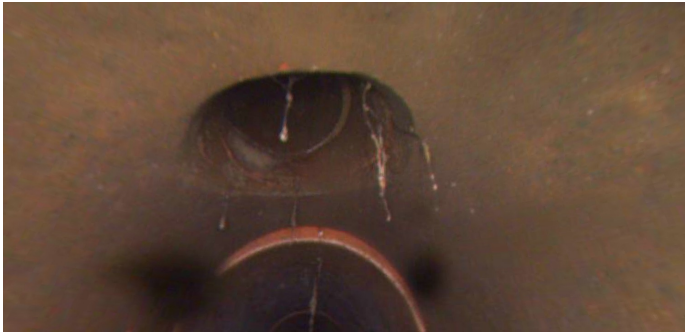
Code: **TFD**  
Description: **Tap Factory Defective**

Distance (ft): **83.5**  
Structural Grade: **0**  
O&M Grade: **2**  
Clock Start/From: **12**  
Clock To:  
1st Value: **4.000**  
2nd Value:  
Value Percent:  
Continuous Index:  
Within 8" of Joint:  
Remarks: **ROOTS**

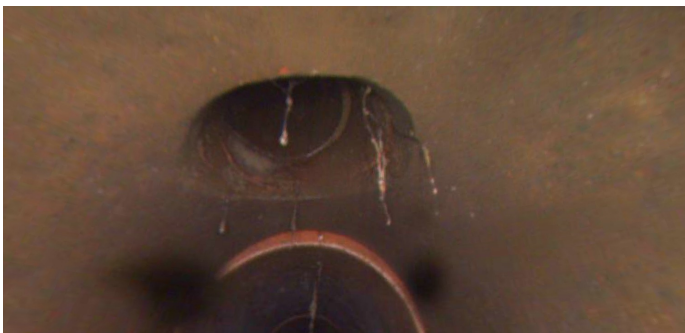
Code: **RFL**  
Description: **Roots Fine Lateral**

Distance (ft): **83.5**  
Structural Grade: **0**  
O&M Grade: **1**  
Clock Start/From: **12**  
Clock To:  
1st Value:  
2nd Value:  
Value Percent:  
Continuous Index:  
Within 8" of Joint: **NO**  
Remarks:

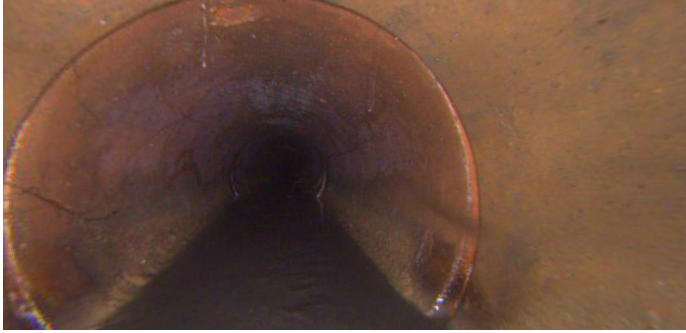
Code: **RFJ**  
Description: **Roots Fine Joint**

Distance (ft): **83.5**  
Structural Grade: **0**  
O&M Grade: **1**  
Clock Start/From: **9**  
Clock To: **12**  
1st Value:  
2nd Value:  
Value Percent:  
Continuous Index:  
Within 8" of Joint: **YES**  
Remarks:

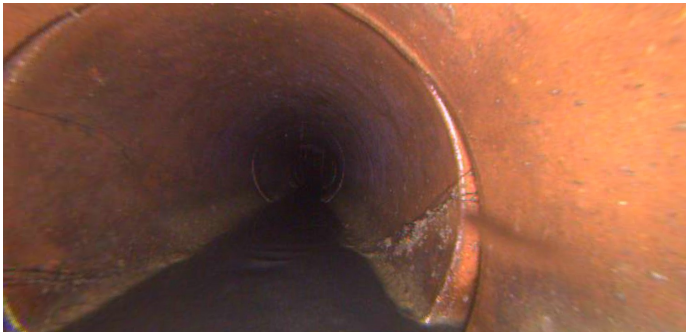
Code: **RFJ**  
Description: **Roots Fine Joint**

Distance (ft): **86.1**  
Structural Grade: **0**  
O&M Grade: **1**  
Clock Start/From: **8**  
Clock To: **4**  
1st Value:  
2nd Value:  
Value Percent:  
Continuous Index: **S01**  
Within 8" of Joint: **YES**  
Remarks:

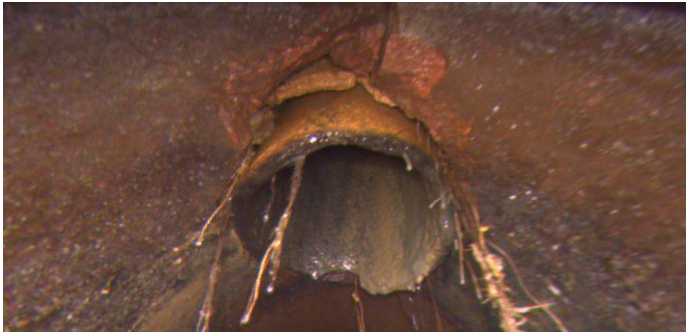
Code: **FL**  
Description: **Fracture Longitudinal**

Distance (ft): **91.8**  
Structural Grade: **3**  
O&M Grade: **0**  
Clock Start/From: **12**  
Clock To:  
1st Value:  
2nd Value:  
Value Percent:  
Continuous Index:  
Within 8" of Joint: **YES**  
Remarks:

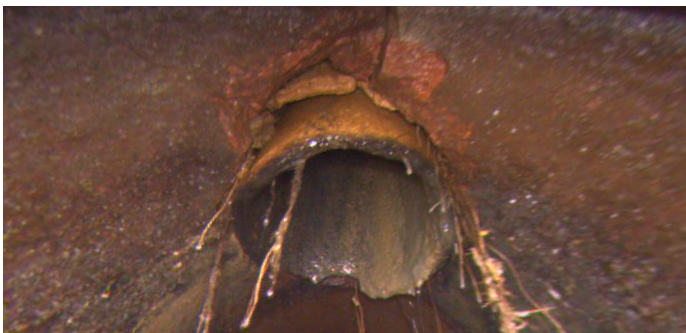
Code: **TBI**  
Description: **Tap Break-in Intruding**

Distance (ft): **91.8**  
Structural Grade: **0**  
O&M Grade: **2**  
Clock Start/From: **12**  
Clock To:  
1st Value: **4.000**  
2nd Value: **1.000**  
Value Percent:  
Continuous Index:  
Within 8" of Joint:  
Remarks:

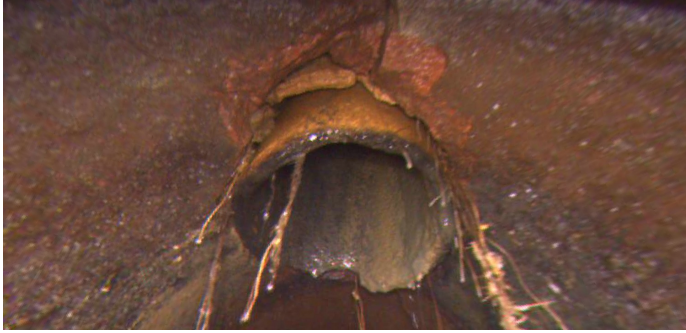
Code: **RFC**  
Description: **Roots Fine Connection**

Distance (ft): **91.8**  
Structural Grade: **0**  
O&M Grade: **1**  
Clock Start/From: **11**  
Clock To: **1**  
1st Value:  
2nd Value:  
Value Percent:  
Continuous Index:  
Within 8" of Joint: **NO**  
Remarks:

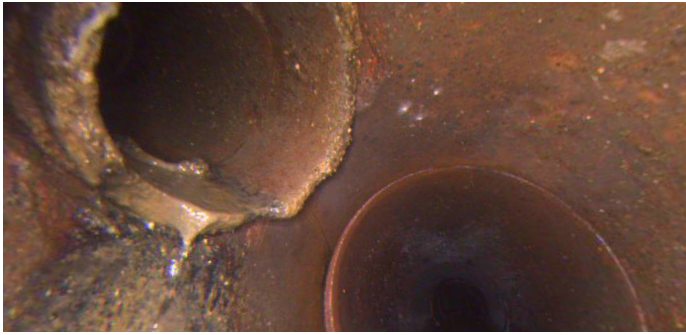
Code: **TBI**  
Description: **Tap Break-in Intruding**

Distance (ft): **121.0**  
Structural Grade: **0**  
O&M Grade: **2**  
Clock Start/From: **10**  
Clock To:  
1st Value: **4.000**  
2nd Value: **1.000**  
Value Percent:  
Continuous Index:  
Within 8" of Joint:  
Remarks:

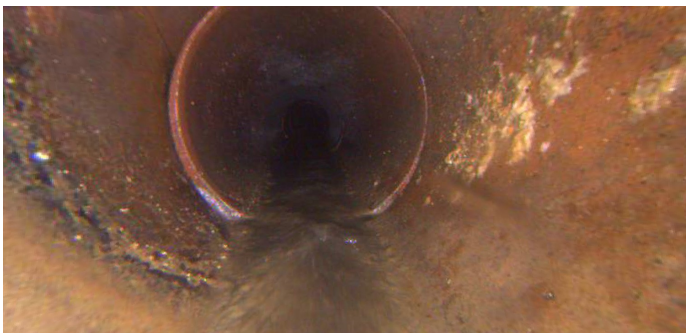
Code: **FC**  
Description: **Fracture Circumferential**

Distance (ft): **121.0**  
Structural Grade: **2**  
O&M Grade: **0**  
Clock Start/From: **7**  
Clock To: **9**  
1st Value:  
2nd Value:  
Value Percent:  
Continuous Index:  
Within 8" of Joint:  
Remarks:

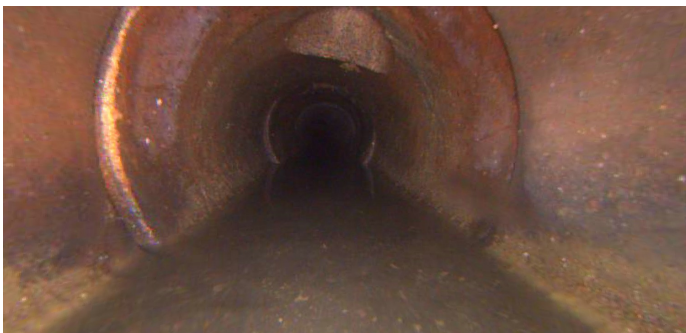
Code: **RFJ**  
Description: **Roots Fine Joint**

Distance (ft): **126.6**  
Structural Grade: **0**  
O&M Grade: **1**  
Clock Start/From: **8**  
Clock To: **4**  
1st Value:  
2nd Value:  
Value Percent:  
Continuous Index: **F01**  
Within 8" of Joint: **YES**  
Remarks:
