Profile/Photo Observation Report

Date:	04/24/2018	Weather:		Coding:	PACP 6.0
Pipe Length (ft):	187.7	Owner:	NA	Pre Clean:	No Pre-Cleaning
P.O.#:		Surveyor:	Jen Costello	PSR:	P-504-045-033
Customer:		Clean Date:	01/01/1900	Shape:	C

Street:	FOXCROFT STREET	Flow Control:	Not Controlled
City:	Hobart, IN	Year Renewed:	
Location:	Light Highway	Tape/Media #:	
Purpose:	Routine Assessment	Dia/Height:	12"
Use:	Sanitary	Material:	VCP
Drain Area:	NA	Lining:	
Category:	NA		
Comment:	P_C at 125 nothing visible . Flow direction wrong		
Location Details:		Direction of Survey:	Upstream
US MH:	M-504-033	DS MH:	M-504-045
		Total Length Surveyed (ft):	126.6

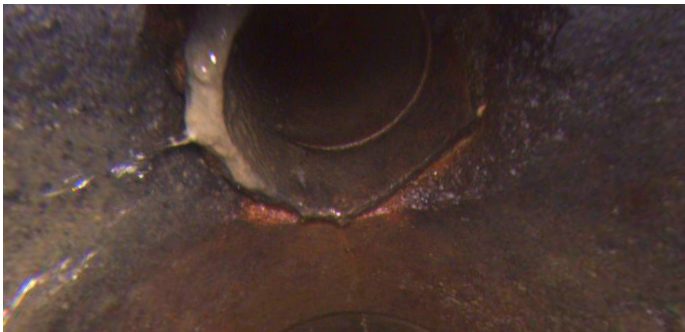
Code:	TBI
Description:	Tap Break-in Intruding

Distance (ft):	11.0
Structural Grade:	0
O&M Grade:	2
Clock Start/From:	12
Clock To:	
1st Value:	4.000
2nd Value:	1.000
Value Percent:	
Continuous Index:	
Within 8" of Joint:	
Remarks:

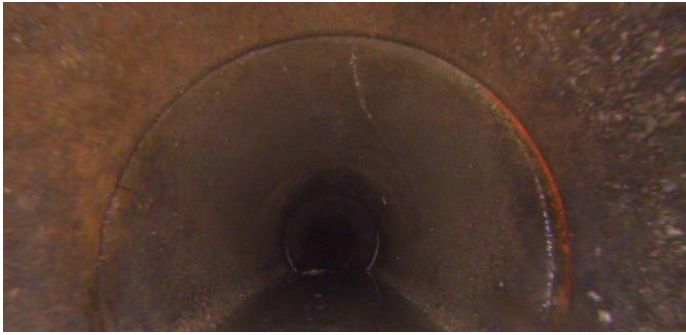
Code: **FM**
Description: **Fracture Multiple**

Distance (ft): **11.3**
Structural Grade: **4**
O&M Grade: **0**
Clock Start/From: **9**
Clock To: **12**
1st Value:
2nd Value:
Value Percent:
Continuous Index:
Within 8" of Joint: **YES**
Remarks:

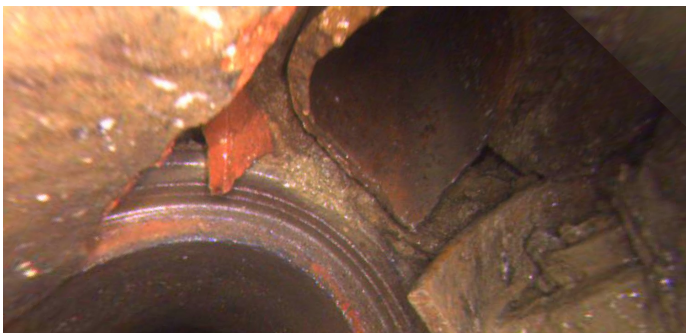
Code: **TBD**
Description: **Tap Break-in Defective**

Distance (ft): **48.3**
Structural Grade: **0**
O&M Grade: **3**
Clock Start/From: **2**
Clock To:
1st Value: **4.000**
2nd Value:
Value Percent:
Continuous Index:
Within 8" of Joint:
Remarks: **BROKEN**

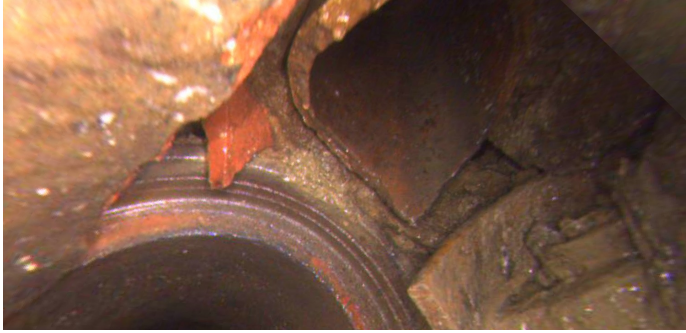
Code: **BSV**
Description: **Broken Soil Visible**

Distance (ft): **48.3**
Structural Grade: **5**
O&M Grade: **0**
Clock Start/From: **12**
Clock To: **3**
1st Value:
2nd Value:
Value Percent:
Continuous Index:
Within 8" of Joint: **YES**
Remarks:

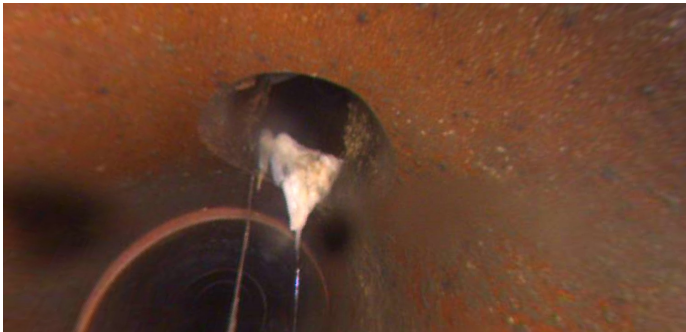
Code: **TFD**
Description: **Tap Factory Defective**

Distance (ft): **68.8**
Structural Grade: **0**
O&M Grade: **2**
Clock Start/From: **12**
Clock To:
1st Value: **4.000**
2nd Value:
Value Percent:
Continuous Index:
Within 8" of Joint:
Remarks: **ROOTS**

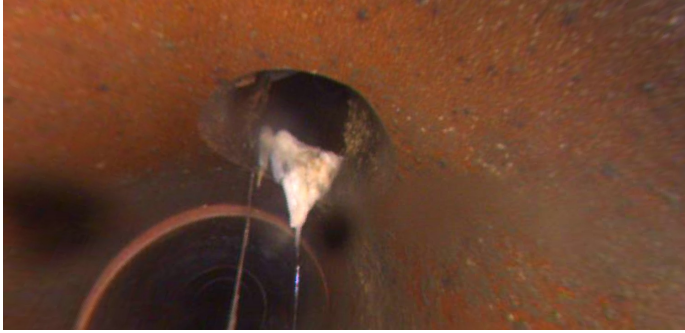
Code: **RFL**
Description: **Roots Fine Lateral**

Distance (ft): **68.8**
Structural Grade: **0**
O&M Grade: **1**
Clock Start/From: **12**
Clock To:
1st Value:
2nd Value:
Value Percent:
Continuous Index:
Within 8" of Joint: **NO**
Remarks:

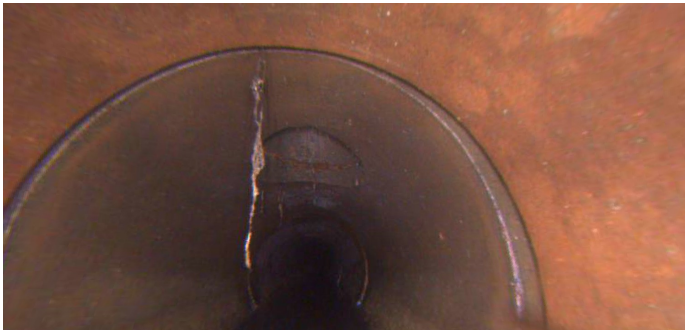
Code: **RFJ**
Description: **Roots Fine Joint**

Distance (ft): **81.4**
Structural Grade: **0**
O&M Grade: **1**
Clock Start/From: **12**
Clock To:
1st Value:
2nd Value:
Value Percent:
Continuous Index:
Within 8" of Joint: **YES**
Remarks:

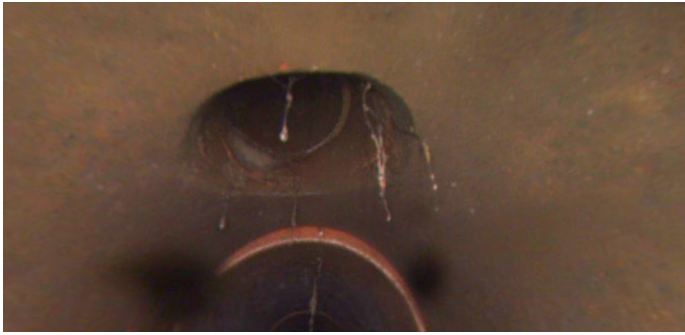
Code: **TFD**
Description: **Tap Factory Defective**

Distance (ft): **83.5**
Structural Grade: **0**
O&M Grade: **2**
Clock Start/From: **12**
Clock To:
1st Value: **4.000**
2nd Value:
Value Percent:
Continuous Index:
Within 8" of Joint:
Remarks: **ROOTS**

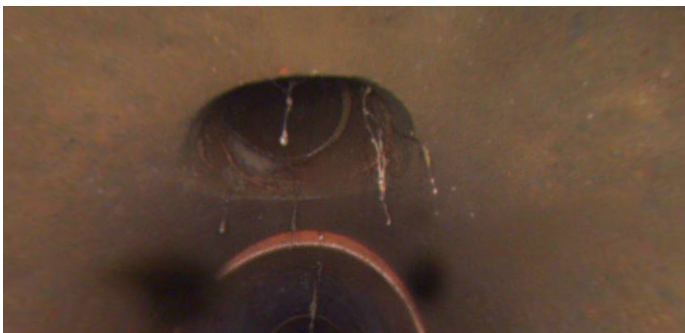
Code: **RFL**
Description: **Roots Fine Lateral**

Distance (ft): **83.5**
Structural Grade: **0**
O&M Grade: **1**
Clock Start/From: **12**
Clock To:
1st Value:
2nd Value:
Value Percent:
Continuous Index:
Within 8" of Joint: **NO**
Remarks:

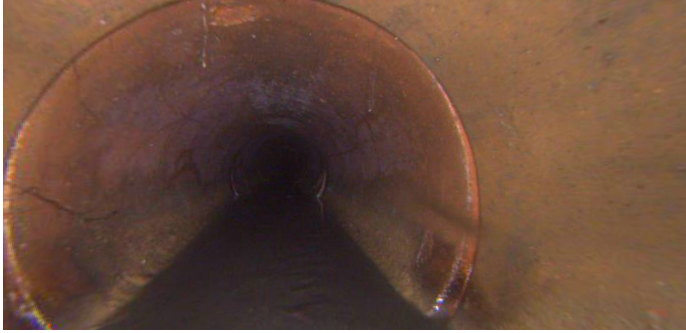
Code: **RFJ**
Description: **Roots Fine Joint**

Distance (ft): **83.5**
Structural Grade: **0**
O&M Grade: **1**
Clock Start/From: **9**
Clock To: **12**
1st Value:
2nd Value:
Value Percent:
Continuous Index:
Within 8" of Joint: **YES**
Remarks:

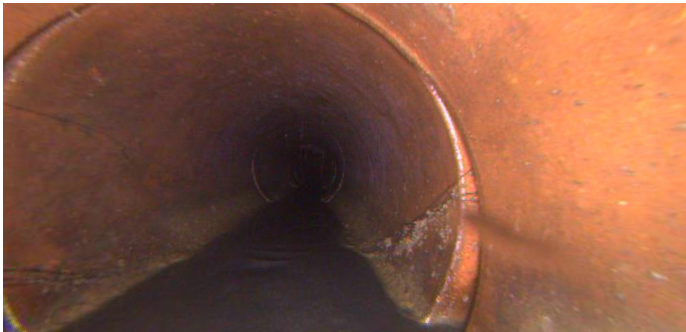
Code: **RFJ**
Description: **Roots Fine Joint**

Distance (ft): **86.1**
Structural Grade: **0**
O&M Grade: **1**
Clock Start/From: **8**
Clock To: **4**
1st Value:
2nd Value:
Value Percent:
Continuous Index: **S01**
Within 8" of Joint: **YES**
Remarks:

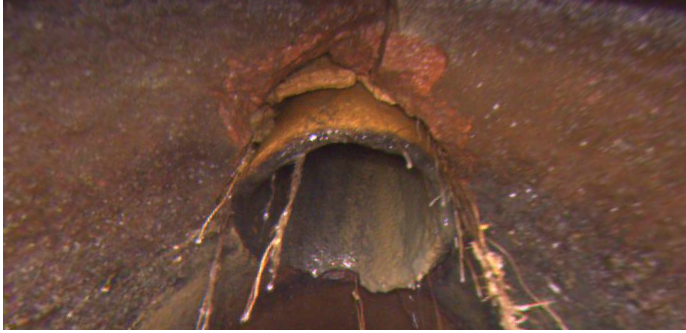
Code: **FL**
Description: **Fracture Longitudinal**

Distance (ft): **91.8**
Structural Grade: **3**
O&M Grade: **0**
Clock Start/From: **12**
Clock To:
1st Value:
2nd Value:
Value Percent:
Continuous Index:
Within 8" of Joint: **YES**
Remarks:

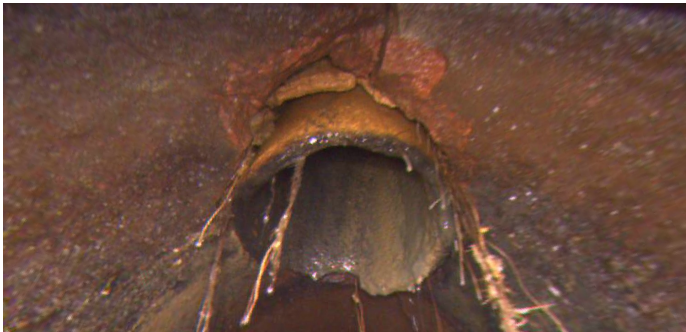
Code: **TBI**
Description: **Tap Break-in Intruding**

Distance (ft): **91.8**
Structural Grade: **0**
O&M Grade: **2**
Clock Start/From: **12**
Clock To:
1st Value: **4.000**
2nd Value: **1.000**
Value Percent:
Continuous Index:
Within 8" of Joint:
Remarks:

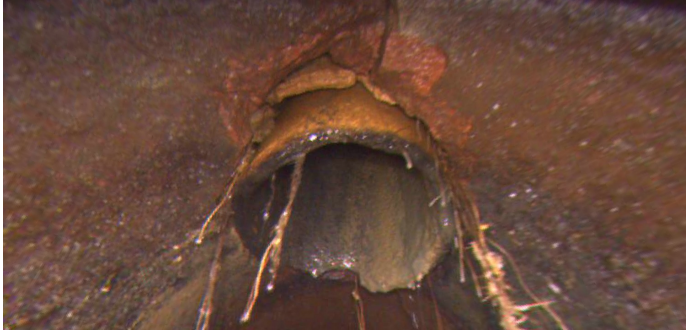
Code: **RFC**
Description: **Roots Fine Connection**

Distance (ft): **91.8**
Structural Grade: **0**
O&M Grade: **1**
Clock Start/From: **11**
Clock To: **1**
1st Value:
2nd Value:
Value Percent:
Continuous Index:
Within 8" of Joint: **NO**
Remarks:

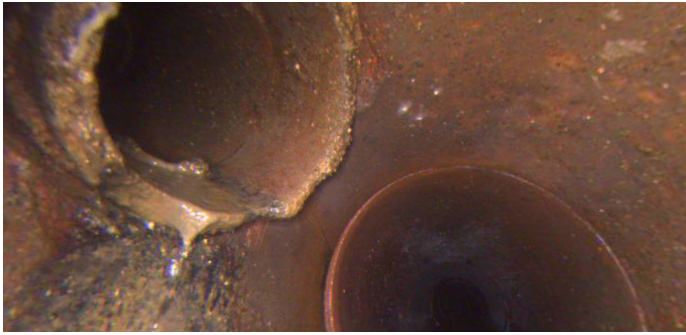
Code: **TBI**
Description: **Tap Break-in Intruding**

Distance (ft): **121.0**
Structural Grade: **0**
O&M Grade: **2**
Clock Start/From: **10**
Clock To:
1st Value: **4.000**
2nd Value: **1.000**
Value Percent:
Continuous Index:
Within 8" of Joint:
Remarks:

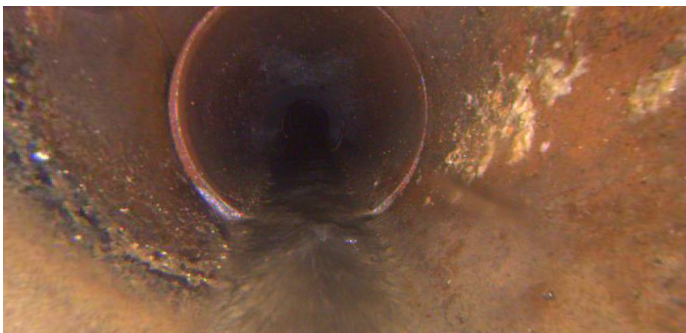
Code: **FC**
Description: **Fracture Circumferential**

Distance (ft): **121.0**
Structural Grade: **2**
O&M Grade: **0**
Clock Start/From: **7**
Clock To: **9**
1st Value:
2nd Value:
Value Percent:
Continuous Index:
Within 8" of Joint:
Remarks:

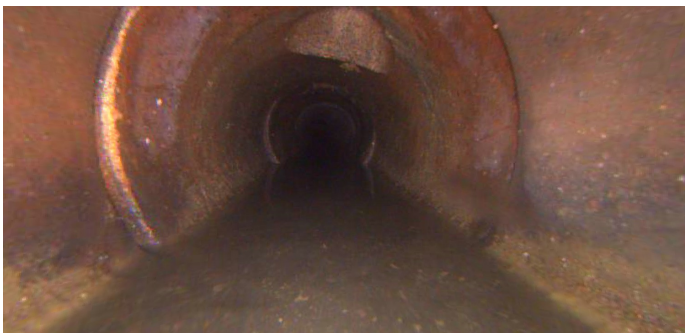
Code: **RFJ**
Description: **Roots Fine Joint**

Distance (ft): **126.6**
Structural Grade: **0**
O&M Grade: **1**
Clock Start/From: **8**
Clock To: **4**
1st Value:
2nd Value:
Value Percent:
Continuous Index: **F01**
Within 8" of Joint: **YES**
Remarks:
