Profile/Photo Observation Report

Date:	10/30/2021	Weather:		Coding:	PACP 7.0
Pipe Length (ft):	177.7	Owner:	City of Hobart	Pre Clean:	Heavy Cleaning
P.O.#:	YES502259	Surveyor:	S. Bucklin	PSR:	P-504-045-033
Customer:	City of Hobart	Clean Date:	10/26/2021	Shape:	C

Street:	North Colorado Street	Flow Control:	Not Controlled
City:	Hobart, IN	Year Renewed:	
Location:	Alley	Tape/Media #:	
Purpose:	Routine Assessment	Dia/Height:	12"
Use:	Sanitary Sewage Pipe	Material:	VCP
Drain Area:		Lining:	None
Category:	NA		
Comment:

Location Details:		Direction of Survey:	Downstream
US MH:	M-504-033	DS MH:	M-504-045
		Total Length Surveyed (ft):	177.7

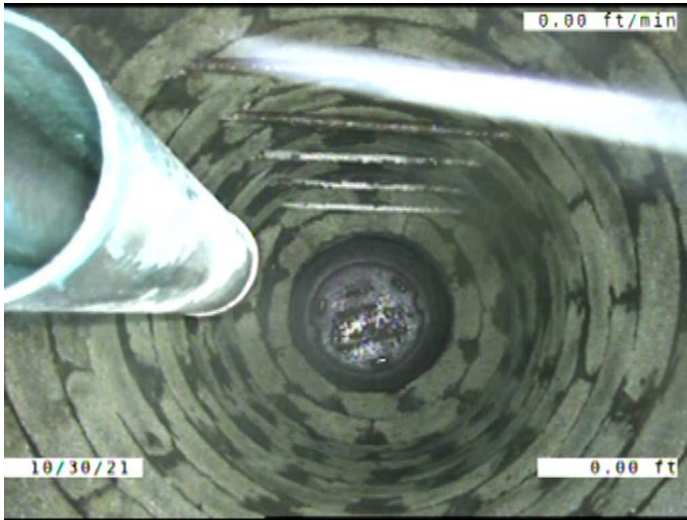
Code: **AMH**
Description: **Manhole**

Distance (ft): **.0**
Structural Grade: **0**
O&M Grade: **0**
Clock Start/From:
Clock To:
1st Value:
2nd Value:
Value Percent:
Continuous Index:
Within 8" of Joint: **NO**
Remarks: **M-504-033**

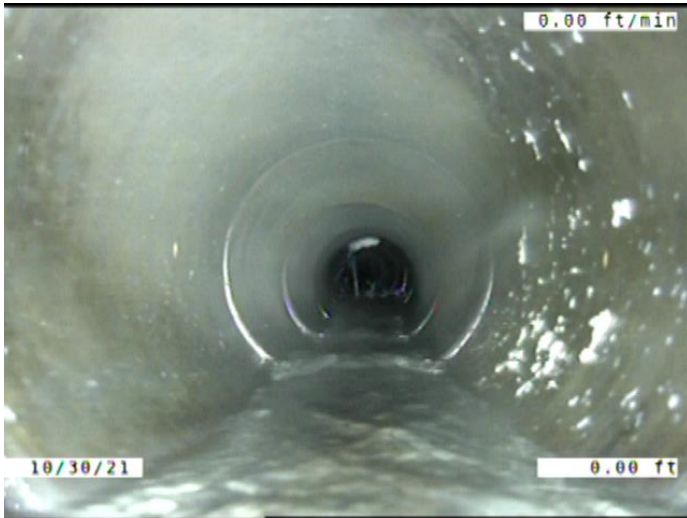
Code: **MWL**
Description: **Miscellaneous Water Level**

Distance (ft): **.0**
Structural Grade: **0**
O&M Grade: **0**
Clock Start/From:
Clock To:
1st Value:
2nd Value:
Value Percent: **5.000**
Continuous Index:
Within 8" of Joint: **NO**
Remarks:

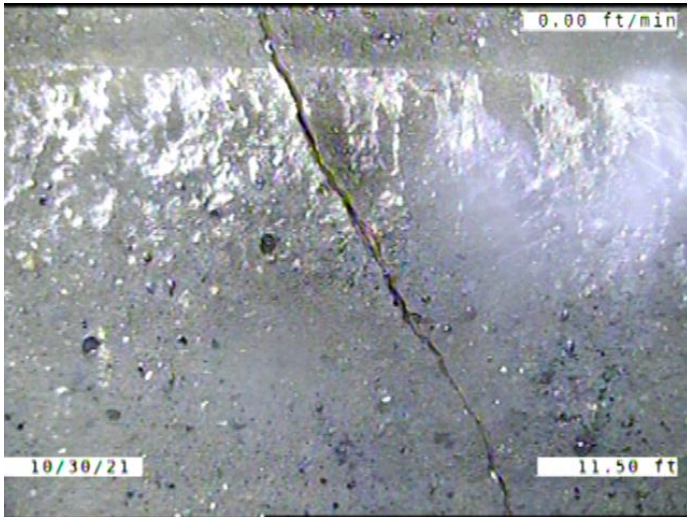
Code: **FM**
 Description: **Fracture Multiple**

Distance (ft): **11.5**
 Structural Grade: **4**
 O&M Grade: **0**
 Clock Start/From: **9**
 Clock To: **1**
 1st Value:
 2nd Value:
 Value Percent:
 Continuous Index:
 Within 8" of Joint: **YES**
 Remarks:

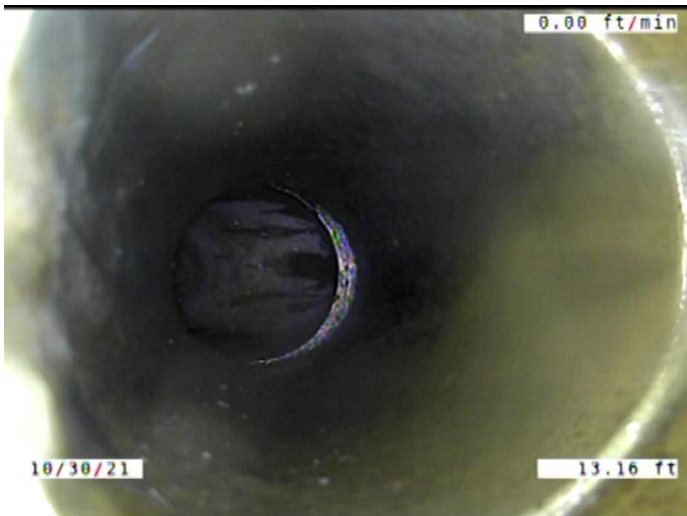
Code: **TBI**
 Description: **Tap Break-in Intruding**

Distance (ft): **13.2**
 Structural Grade: **0**
 O&M Grade: **2**
 Clock Start/From: **11**
 Clock To:
 1st Value: **4.000**
 2nd Value: **1.000**
 Value Percent:
 Continuous Index:
 Within 8" of Joint: **YES**
 Remarks: **CONSTANTLY RUNNING WATER**

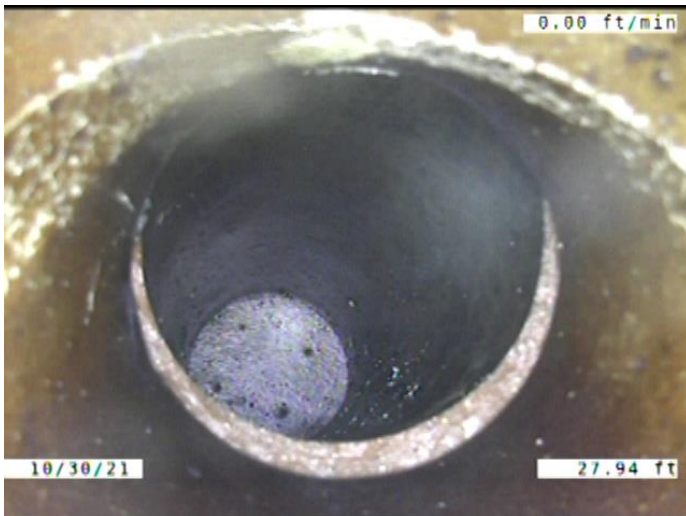
Code: **TFC**
 Description: **Tap Factory Capped**

Distance (ft): **27.9**
 Structural Grade: **0**
 O&M Grade: **0**
 Clock Start/From: **11**
 Clock To:
 1st Value: **4.000**
 2nd Value:
 Value Percent:
 Continuous Index:
 Within 8" of Joint: **YES**
 Remarks:

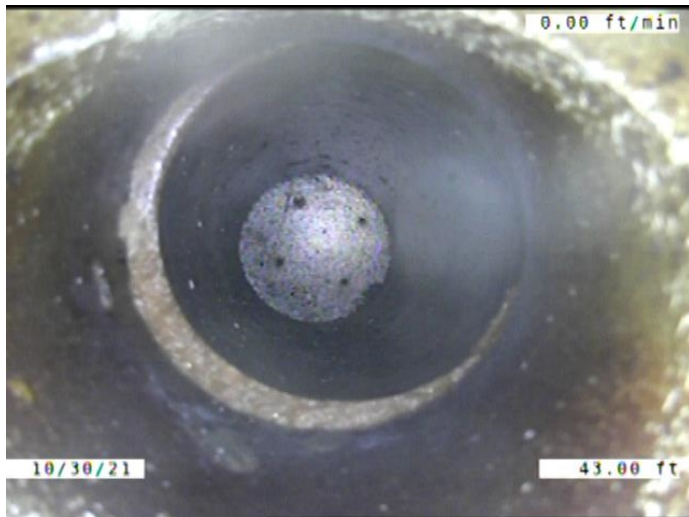
Code: **TFC**
 Description: **Tap Factory Capped**

Distance (ft): **43.0**
 Structural Grade: **0**
 O&M Grade: **0**
 Clock Start/From: **1**
 Clock To:
 1st Value: **4.000**
 2nd Value:
 Value Percent:
 Continuous Index:
 Within 8" of Joint: **YES**
 Remarks:

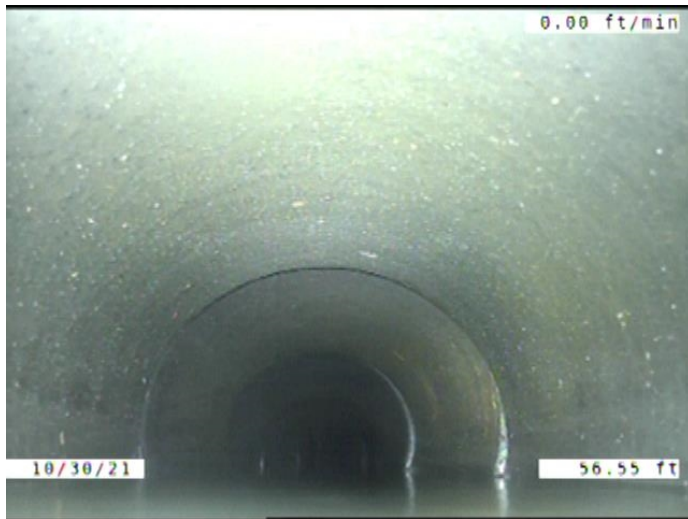
Code: **MWL**
 Description: **Miscellaneous Water Level**

Distance (ft): **56.5**
 Structural Grade: **0**
 O&M Grade: **0**
 Clock Start/From:
 Clock To:
 1st Value:
 2nd Value:
 Value Percent: **15.000**
 Continuous Index:
 Within 8" of Joint: **NO**
 Remarks:

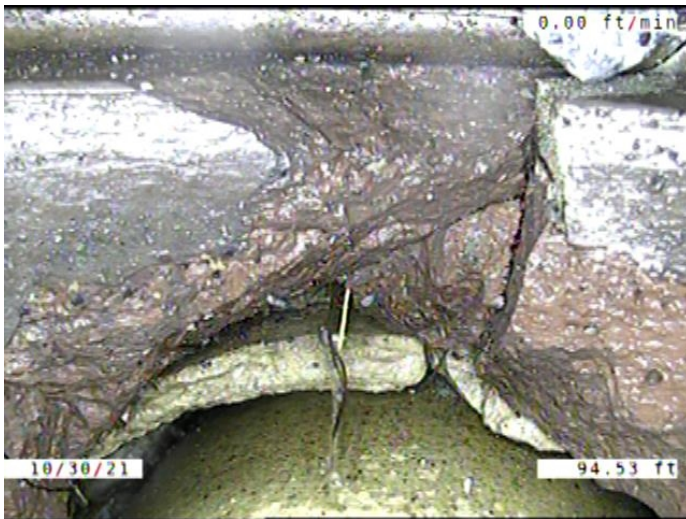
Code: **B**
 Description: **Broken**

Distance (ft): **94.5**
 Structural Grade: **4**
 O&M Grade: **0**
 Clock Start/From: **10**
 Clock To: **1**
 1st Value:
 2nd Value:
 Value Percent:
 Continuous Index:
 Within 8" of Joint: **YES**
 Remarks:

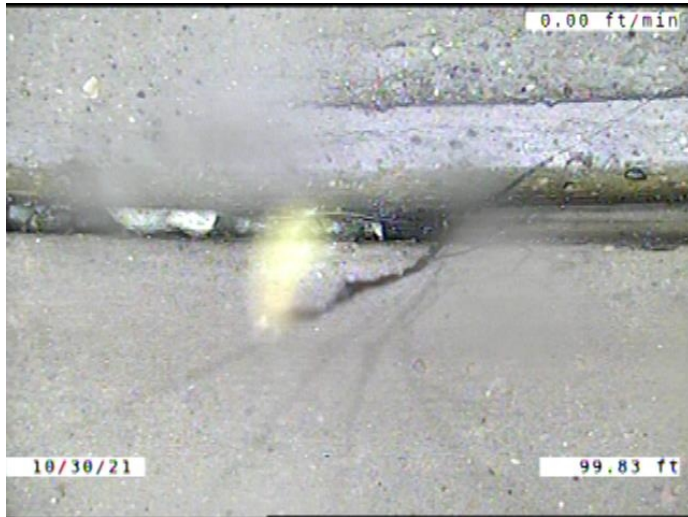
Code: **RFJ**
 Description: **Roots Fine Joint**

Distance (ft): **99.8**
 Structural Grade: **0**
 O&M Grade: **1**
 Clock Start/From: **10**
 Clock To: **12**
 1st Value:
 2nd Value:
 Value Percent:
 Continuous Index:
 Within 8" of Joint: **YES**
 Remarks:

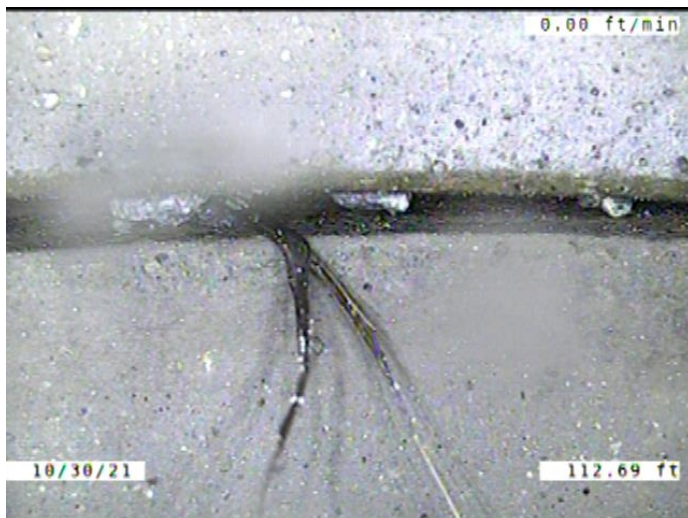
Code: **RFJ**
 Description: **Roots Fine Joint**

Distance (ft): **112.7**
 Structural Grade: **0**
 O&M Grade: **1**
 Clock Start/From: **11**
 Clock To: **12**
 1st Value:
 2nd Value:
 Value Percent:
 Continuous Index:
 Within 8" of Joint: **YES**
 Remarks:

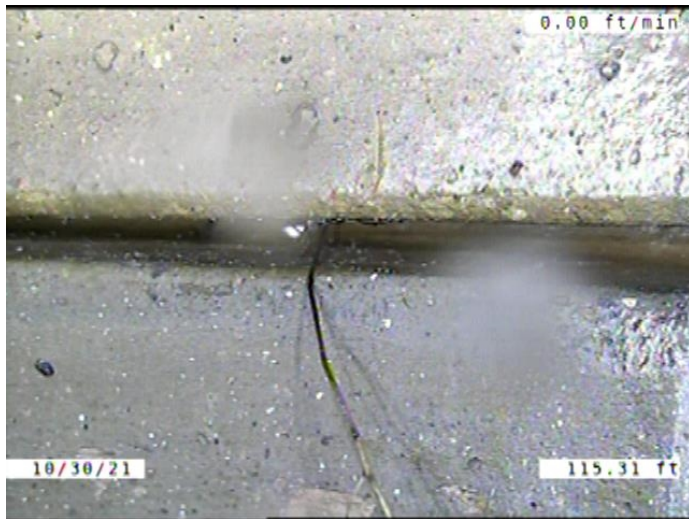
Code: **RFJ**
 Description: **Roots Fine Joint**

Distance (ft): **115.3**
 Structural Grade: **0**
 O&M Grade: **1**
 Clock Start/From: **1**
 Clock To: **3**
 1st Value:
 2nd Value:
 Value Percent:
 Continuous Index:
 Within 8" of Joint: **YES**
 Remarks:

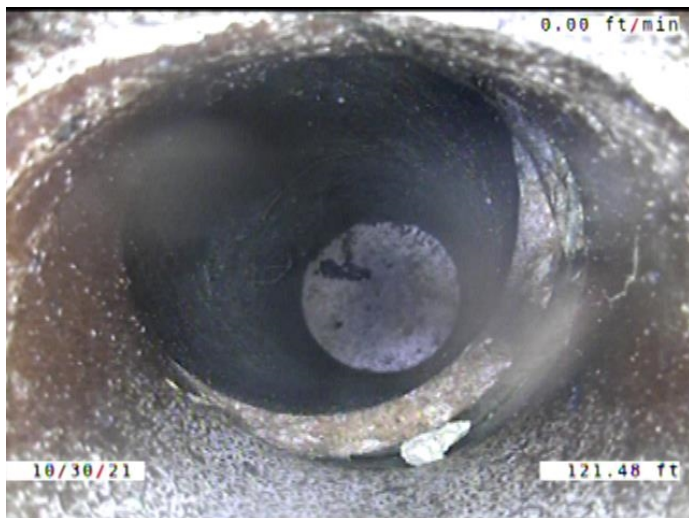
Code: **TFD**
 Description: **Tap Factory Defective**

Distance (ft): **121.5**
 Structural Grade: **0**
 O&M Grade: **3**
 Clock Start/From: **11**
 Clock To:
 1st Value: **4.000**
 2nd Value:
 Value Percent:
 Continuous Index:
 Within 8" of Joint: **YES**
 Remarks: **CAPPED. LARGE OFFSET. SOIL
 VISIBLE. ROOTS GROWING IN IT.**

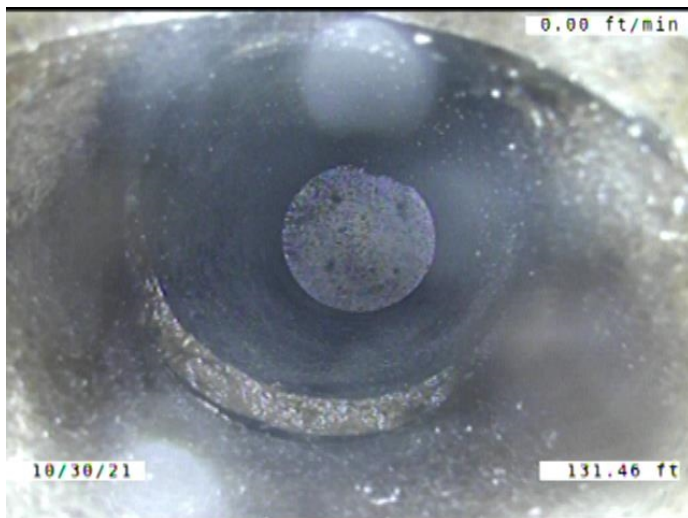
Code: **TFD**
 Description: **Tap Factory Defective**

Distance (ft): **131.5**
 Structural Grade: **0**
 O&M Grade: **3**
 Clock Start/From: **1**
 Clock To:
 1st Value: **4.000**
 2nd Value:
 Value Percent:
 Continuous Index:
 Within 8" of Joint: **YES**
 Remarks: **CAPPED. OFFSET**

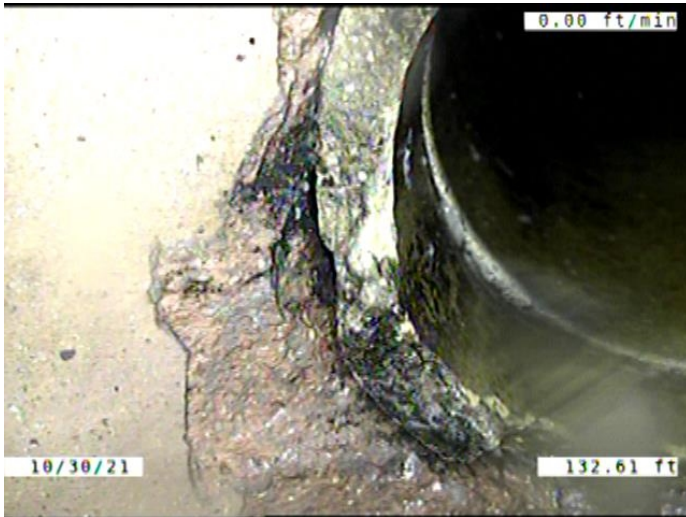
Code: **SSS**
Description: **Surface Damage Surface Spalling**

Distance (ft): **132.6**
Structural Grade: **2**
O&M Grade: **0**
Clock Start/From: **12**
Clock To: **2**
1st Value:
2nd Value:
Value Percent:
Continuous Index:
Within 8" of Joint: **YES**
Remarks:

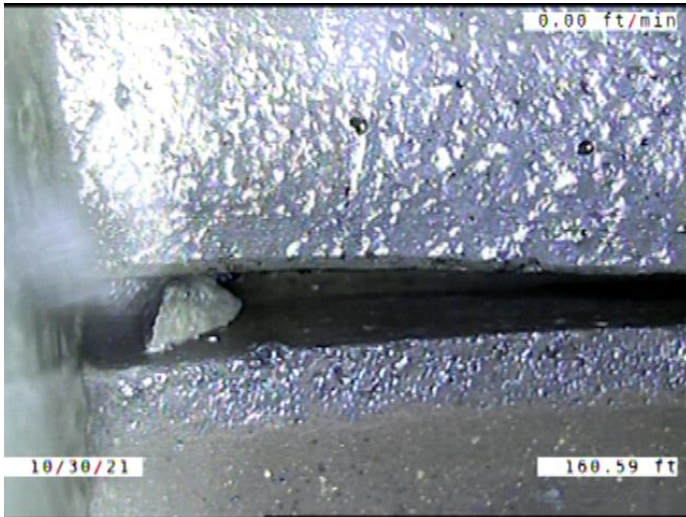
Code: **OBJ**
 Description: **Obstruction Wedged In The Joint**

Distance (ft): **160.6**
 Structural Grade: **0**
 O&M Grade: **2**
 Clock Start/From: **9**
 Clock To: **10**
 1st Value:
 2nd Value:
 Value Percent: **5.000**
 Continuous Index:
 Within 8" of Joint: **YES**
 Remarks:

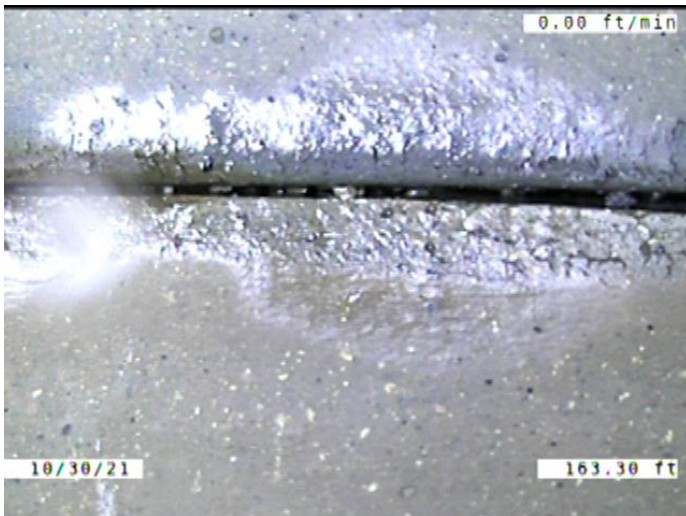
Code: **IWJ**
 Description: **Infiltration Weeper Joint**

Distance (ft): **163.3**
 Structural Grade: **0**
 O&M Grade: **2**
 Clock Start/From: **9**
 Clock To: **11**
 1st Value:
 2nd Value:
 Value Percent:
 Continuous Index:
 Within 8" of Joint: **YES**
 Remarks:

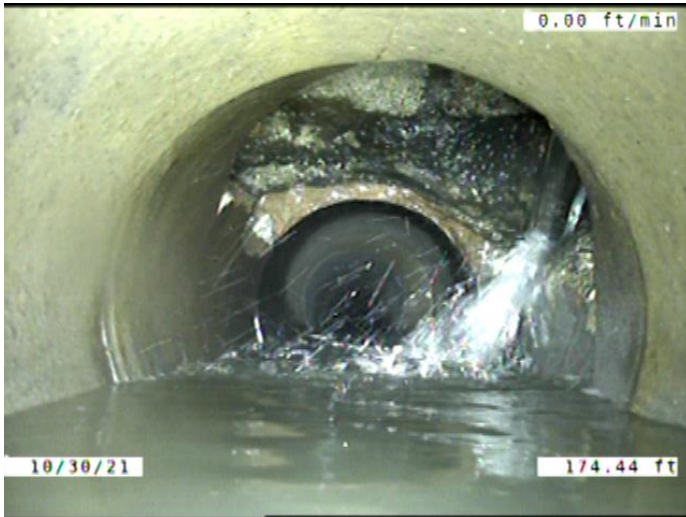
Code: **OBN**
 Description: **Obstruction Construction Debris**

Distance (ft): **174.4**
 Structural Grade: **0**
 O&M Grade: **2**
 Clock Start/From: **5**
 Clock To: **7**
 1st Value:
 2nd Value:
 Value Percent: **5.000**
 Continuous Index: **F01**
 Within 8" of Joint: **YES**
 Remarks:

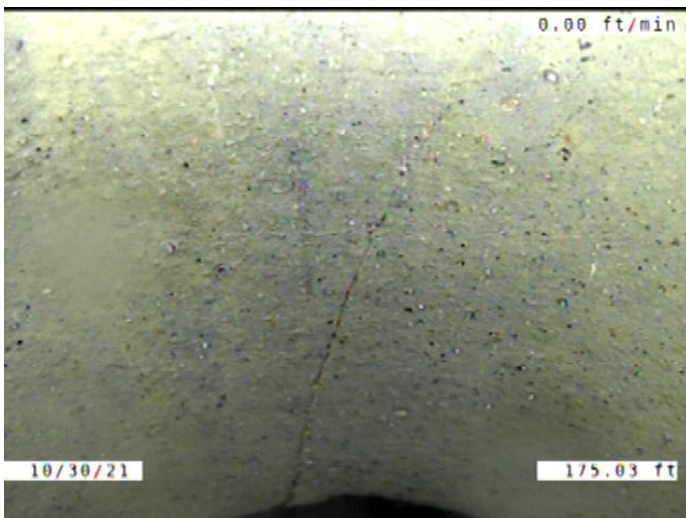
Code: **CM**
 Description: **Crack Multiple**

Distance (ft): **175.0**
 Structural Grade: **3**
 O&M Grade: **0**
 Clock Start/From: **12**
 Clock To: **3**
 1st Value:
 2nd Value:
 Value Percent:
 Continuous Index:
 Within 8" of Joint: **YES**
 Remarks:

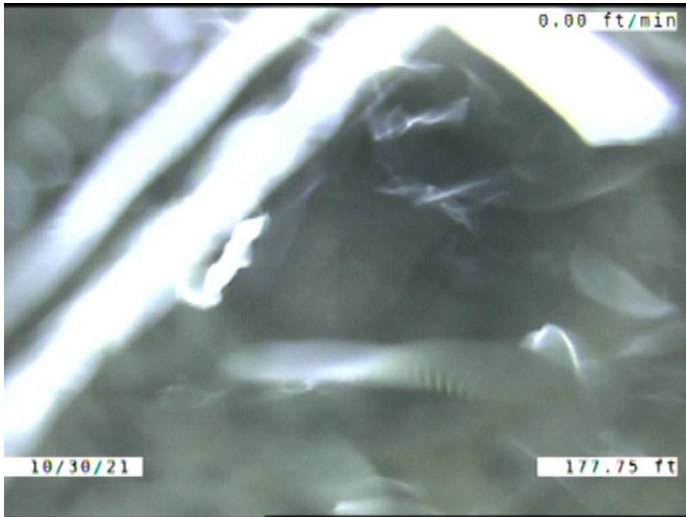
Code:	AMH
Description:	Manhole
Distance (ft):	177.7
Structural Grade:	0
O&M Grade:	0
Clock Start/From:	
Clock To:	
1st Value:	
2nd Value:	
Value Percent:	
Continuous Index:	
Within 8" of Joint:	NO
Remarks:	M-504-045
