## Profile/Photo Observation Report

Date:	<b>10/30/2021</b>	Weather:		Coding:	<b>PACP 7.0</b>
Pipe Length (ft):	<b>177.7</b>	Owner:	<b>City of Hobart</b>	Pre Clean:	<b>Heavy Cleaning</b>
P.O.#:	<b>YES502259</b>	Surveyor:	<b>S. Bucklin</b>	PSR:	<b>P-504-045-033</b>
Customer:	<b>City of Hobart</b>	Clean Date:	<b>10/26/2021</b>	Shape:	<b>C</b>

Street:	<b>North Colorado Street</b>	Flow Control:	<b>Not Controlled</b>
City:	<b>Hobart, IN</b>	Year Renewed:	
Location:	<b>Alley</b>	Tape/Media #:	
Purpose:	<b>Routine Assessment</b>	Dia/Height:	<b>12"</b>
Use:	<b>Sanitary Sewage Pipe</b>	Material:	<b>VCP</b>
Drain Area:		Lining:	<b>None</b>
Category:	<b>NA</b>		
Comment:

Location Details:		Direction of Survey:	<b>Downstream</b>
US MH:	<b>M-504-033</b>	DS MH:	<b>M-504-045</b>
		Total Length Surveyed (ft):	<b>177.7</b>

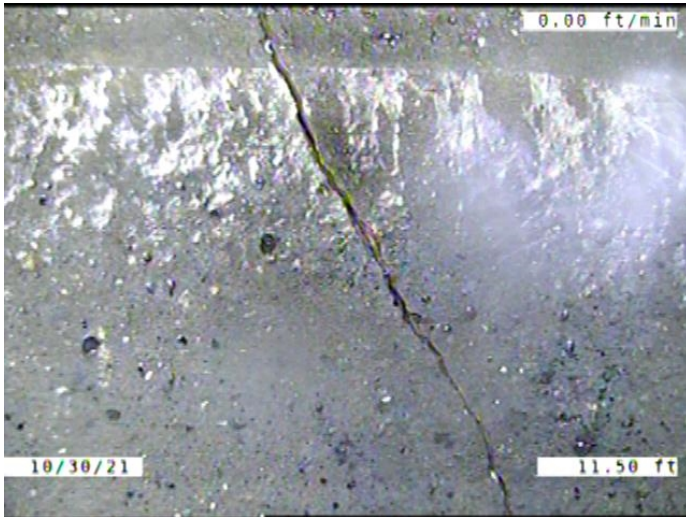
Code: **FM**  
 Description: **Fracture Multiple**

Distance (ft): **11.5**  
 Structural Grade: **4**  
 O&M Grade: **0**  
 Clock Start/From: **9**  
 Clock To: **1**  
 1st Value:  
 2nd Value:  
 Value Percent:  
 Continuous Index:  
 Within 8" of Joint: **YES**  
 Remarks:

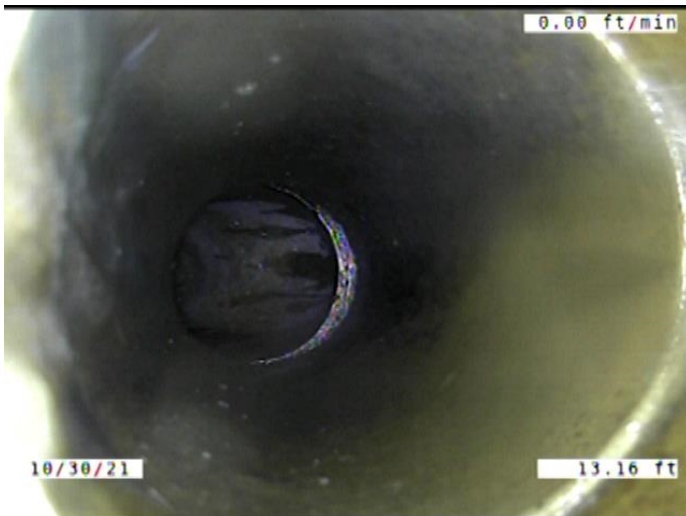
Code: **TBI**  
 Description: **Tap Break-in Intruding**

Distance (ft): **13.2**  
 Structural Grade: **0**  
 O&M Grade: **2**  
 Clock Start/From: **11**  
 Clock To:  
 1st Value: **4.000**  
 2nd Value: **1.000**  
 Value Percent:  
 Continuous Index:  
 Within 8" of Joint: **YES**  
 Remarks: **CONSTANTLY RUNNING WATER**

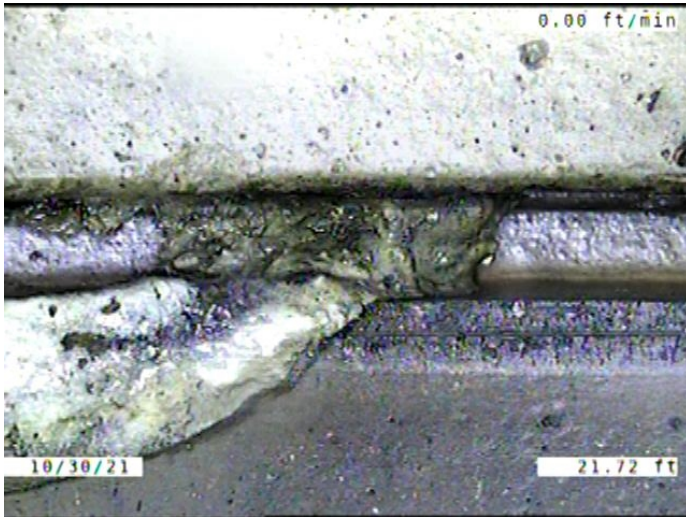
Code: **DAE**  
 Description: **Deposits Attached Encrustation**

Distance (ft): **21.7**  
 Structural Grade: **0**  
 O&M Grade: **2**  
 Clock Start/From: **8**  
 Clock To: **11**  
 1st Value:  
 2nd Value:  
 Value Percent: **5.000**  
 Continuous Index:  
 Within 8" of Joint: **YES**  
 Remarks:

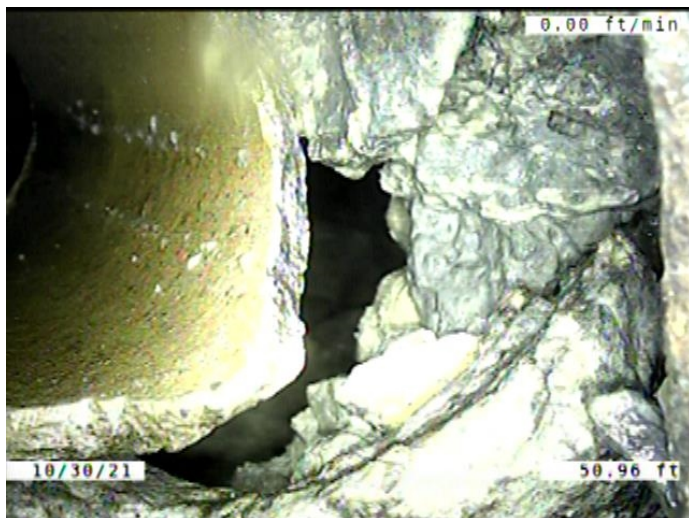
Code: **SMW**  
 Description: **Surface Damage Missing Wall**

Distance (ft): **51.0**  
 Structural Grade: **5**  
 O&M Grade: **0**  
 Clock Start/From: **11**  
 Clock To: **2**  
 1st Value:  
 2nd Value:  
 Value Percent:  
 Continuous Index:  
 Within 8" of Joint: **YES**  
 Remarks:

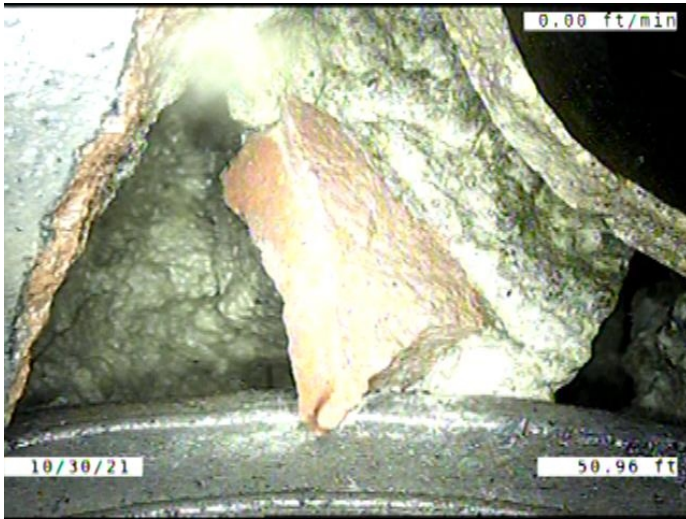
Code: **BVV**  
 Description: **Broken Void Visible**

Distance (ft): **51.0**  
 Structural Grade: **5**  
 O&M Grade: **0**  
 Clock Start/From: **11**  
 Clock To: **2**  
 1st Value:  
 2nd Value:  
 Value Percent:  
 Continuous Index:  
 Within 8" of Joint: **YES**  
 Remarks: **SOIL VISIBLE TOO.**

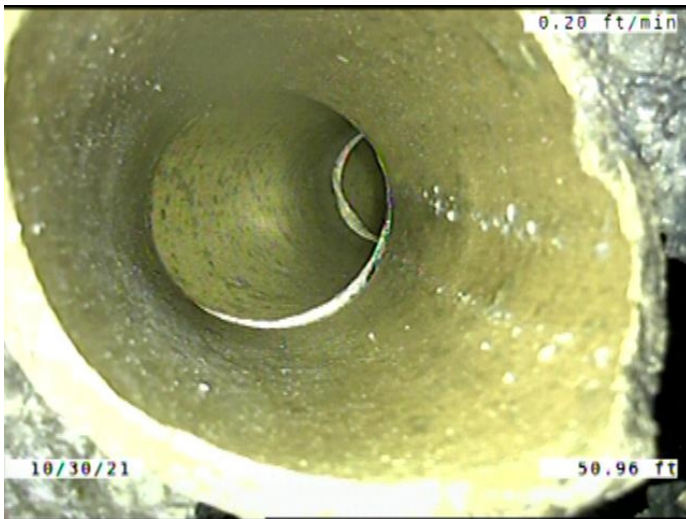
Code: **TBD**  
 Description: **Tap Break-in/Hammer Defective**

Distance (ft): **51.0**  
 Structural Grade: **0**  
 O&M Grade: **3**  
 Clock Start/From: **1**  
 Clock To:  
 1st Value: **4.000**  
 2nd Value:  
 Value Percent:  
 Continuous Index:  
 Within 8" of Joint: **YES**  
 Remarks: **Defective**

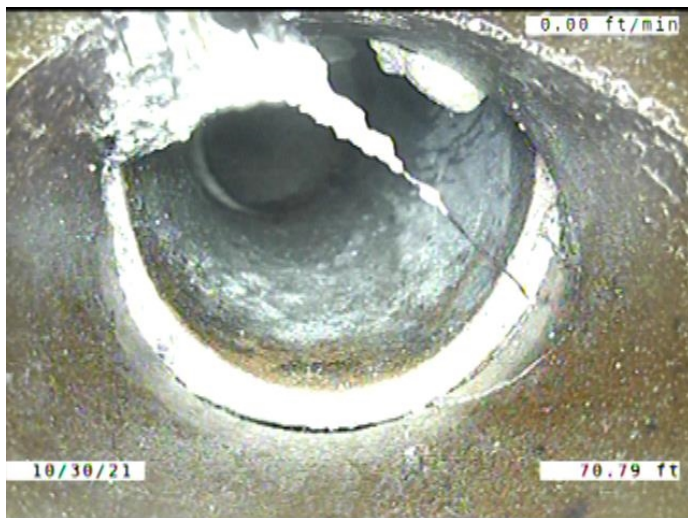
Code: **TFD**  
 Description: **Tap Factory Defective**

Distance (ft): **70.8**  
 Structural Grade: **0**  
 O&M Grade: **3**  
 Clock Start/From: **11**  
 Clock To:  
 1st Value: **4.000**  
 2nd Value:  
 Value Percent:  
 Continuous Index:  
 Within 8" of Joint: **YES**  
 Remarks: **OFFSET JOINT. ROOTS GROWING IN IT. CONSTANTLY DRIPPING WATER**

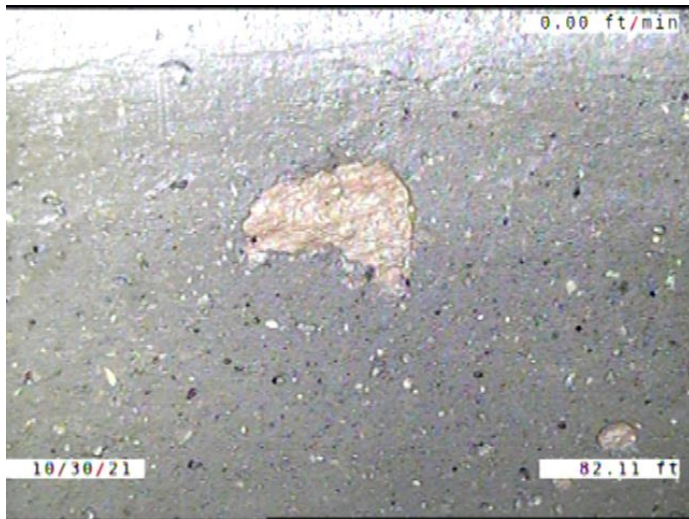
Code: **SSS**  
Description: **Surface Damage Surface Spalling**

Distance (ft): **82.1**  
Structural Grade: **2**  
O&M Grade: **0**  
Clock Start/From: **9**  
Clock To:  
1st Value:  
2nd Value:  
Value Percent:  
Continuous Index:  
Within 8" of Joint: **YES**  
Remarks:

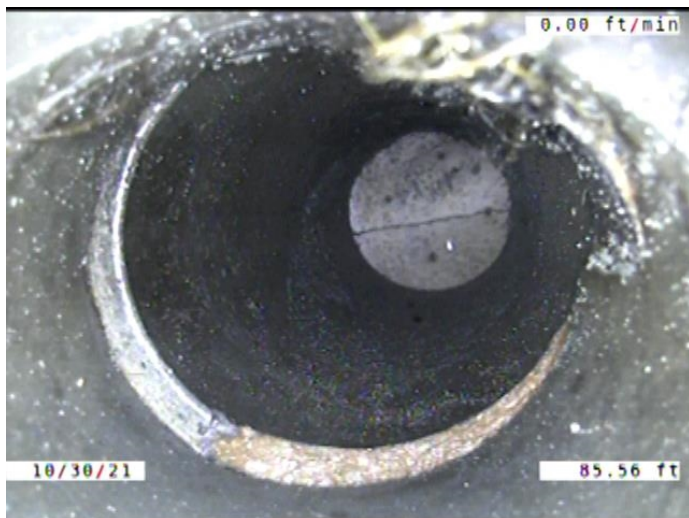
Code: **TFD**  
Description: **Tap Factory Defective**

Distance (ft): **85.6**  
Structural Grade: **0**  
O&M Grade: **3**  
Clock Start/From: **12**  
Clock To:  
1st Value: **4.000**  
2nd Value:  
Value Percent:  
Continuous Index:  
Within 8" of Joint: **YES**  
Remarks: **CAP BROKEN. ROOTS GROWING IN IT. TAP BROKEN**

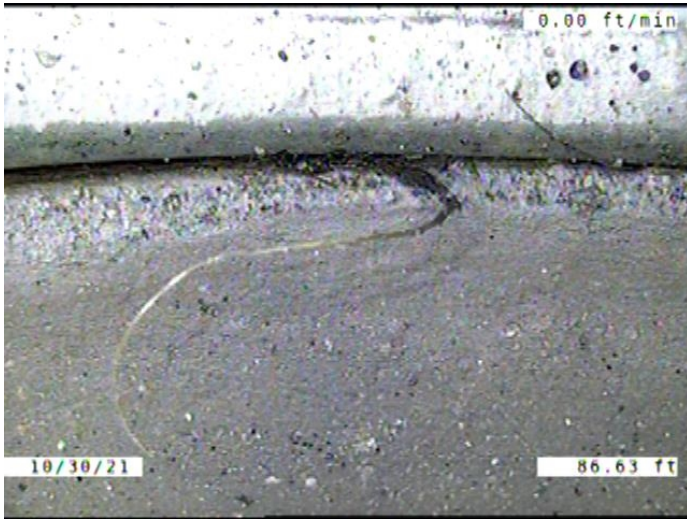
Code: **RFJ**  
 Description: **Roots Fine Joint**

Distance (ft): **86.6**  
 Structural Grade: **0**  
 O&M Grade: **1**  
 Clock Start/From: **10**  
 Clock To:  
 1st Value:  
 2nd Value:  
 Value Percent:  
 Continuous Index:  
 Within 8" of Joint: **YES**  
 Remarks:

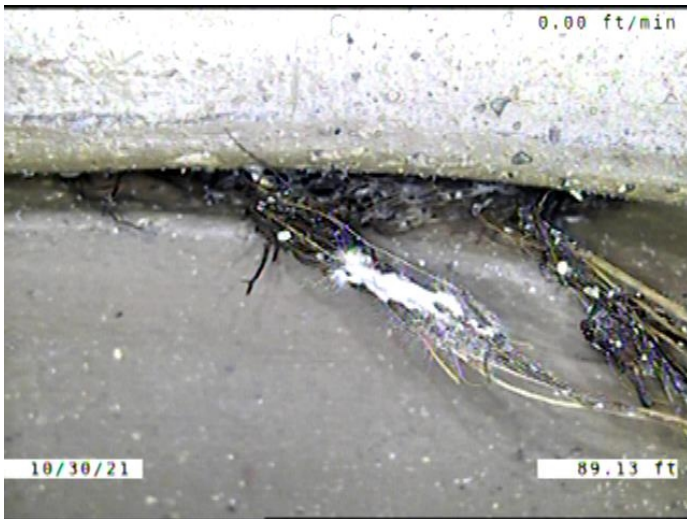
Code: **RFJ**  
 Description: **Roots Fine Joint**

Distance (ft): **89.1**  
 Structural Grade: **0**  
 O&M Grade: **1**  
 Clock Start/From: **1**  
 Clock To: **2**  
 1st Value:  
 2nd Value:  
 Value Percent:  
 Continuous Index:  
 Within 8" of Joint: **YES**  
 Remarks:

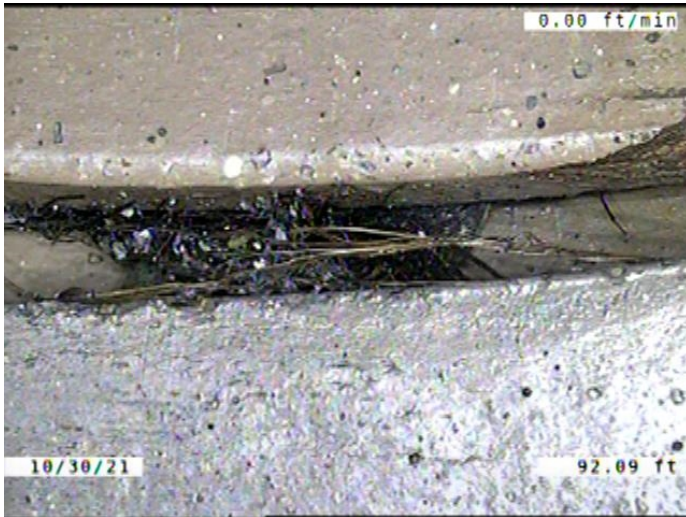
Code: **RFJ**  
 Description: **Roots Fine Joint**

Distance (ft): **92.1**  
 Structural Grade: **0**  
 O&M Grade: **1**  
 Clock Start/From: **9**  
 Clock To: **3**  
 1st Value:  
 2nd Value:  
 Value Percent:  
 Continuous Index:  
 Within 8" of Joint: **YES**  
 Remarks:

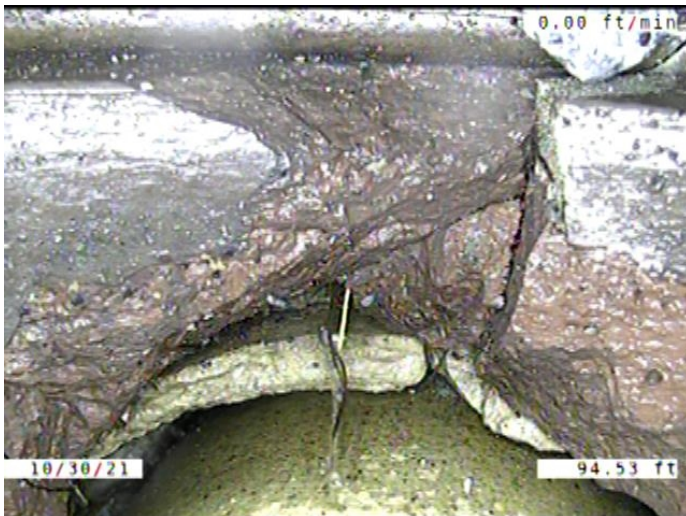
Code: **B**  
 Description: **Broken**

Distance (ft): **94.5**  
 Structural Grade: **4**  
 O&M Grade: **0**  
 Clock Start/From: **10**  
 Clock To: **1**  
 1st Value:  
 2nd Value:  
 Value Percent:  
 Continuous Index:  
 Within 8" of Joint: **YES**  
 Remarks:

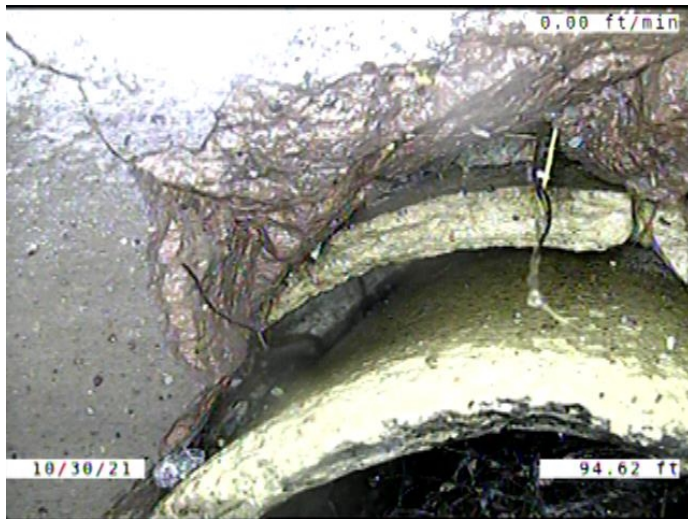
Code: **RFC**  
 Description: **Roots Fine Connection**

Distance (ft): **94.6**  
 Structural Grade: **0**  
 O&M Grade: **1**  
 Clock Start/From: **10**  
 Clock To: **1**  
 1st Value:  
 2nd Value:  
 Value Percent:  
 Continuous Index:  
 Within 8" of Joint: **NO**  
 Remarks:

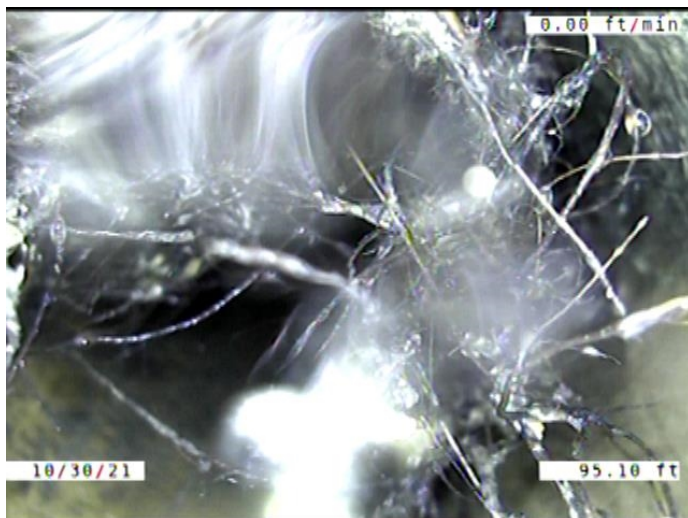
Code: **TBI**  
 Description: **Tap Break-in Intruding**

Distance (ft): **95.1**  
 Structural Grade: **0**  
 O&M Grade: **2**  
 Clock Start/From: **12**  
 Clock To:  
 1st Value: **4.000**  
 2nd Value: **1.000**  
 Value Percent:  
 Continuous Index:  
 Within 8" of Joint: **YES**  
 Remarks: **CONSTANTLY RUNNING WATER. ROOTS GROWING IN IT**

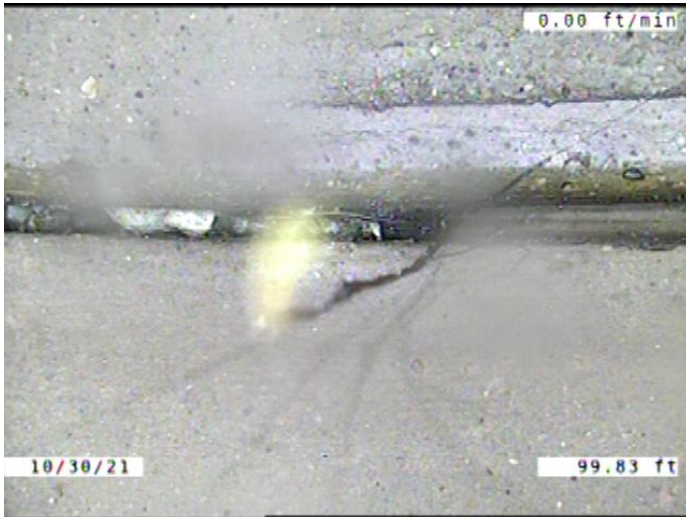
Code: **RFJ**  
 Description: **Roots Fine Joint**

Distance (ft): **99.8**  
 Structural Grade: **0**  
 O&M Grade: **1**  
 Clock Start/From: **10**  
 Clock To: **12**  
 1st Value:  
 2nd Value:  
 Value Percent:  
 Continuous Index:  
 Within 8" of Joint: **YES**  
 Remarks:

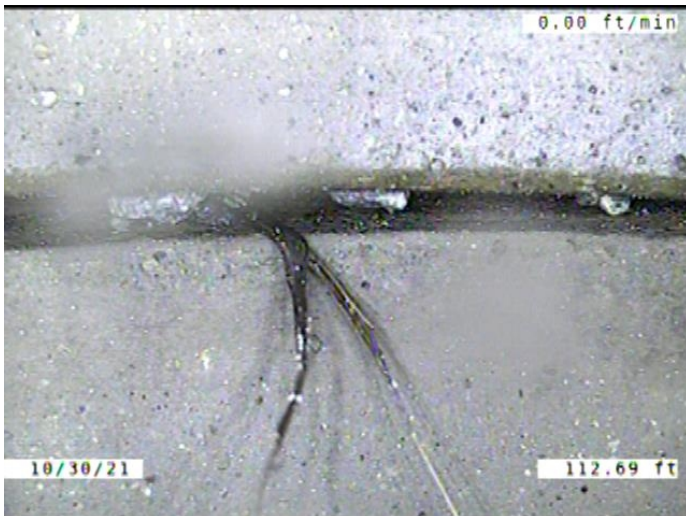
Code: **RFJ**  
 Description: **Roots Fine Joint**

Distance (ft): **112.7**  
 Structural Grade: **0**  
 O&M Grade: **1**  
 Clock Start/From: **11**  
 Clock To: **12**  
 1st Value:  
 2nd Value:  
 Value Percent:  
 Continuous Index:  
 Within 8" of Joint: **YES**  
 Remarks:

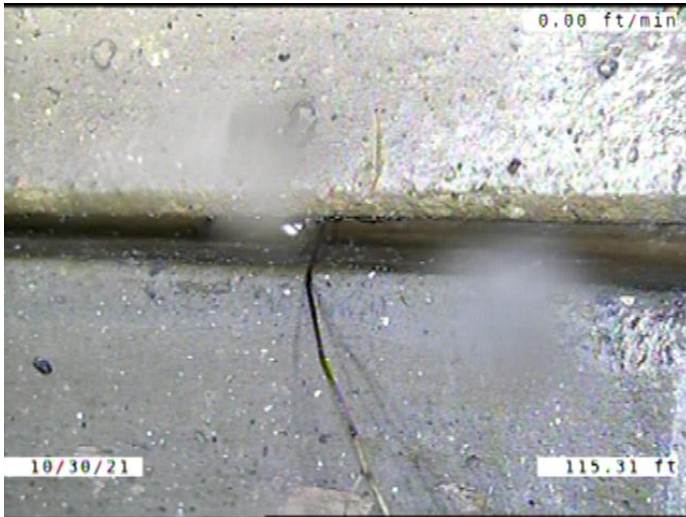
Code: **RFJ**  
 Description: **Roots Fine Joint**

Distance (ft): **115.3**  
 Structural Grade: **0**  
 O&M Grade: **1**  
 Clock Start/From: **1**  
 Clock To: **3**  
 1st Value:  
 2nd Value:  
 Value Percent:  
 Continuous Index:  
 Within 8" of Joint: **YES**  
 Remarks:

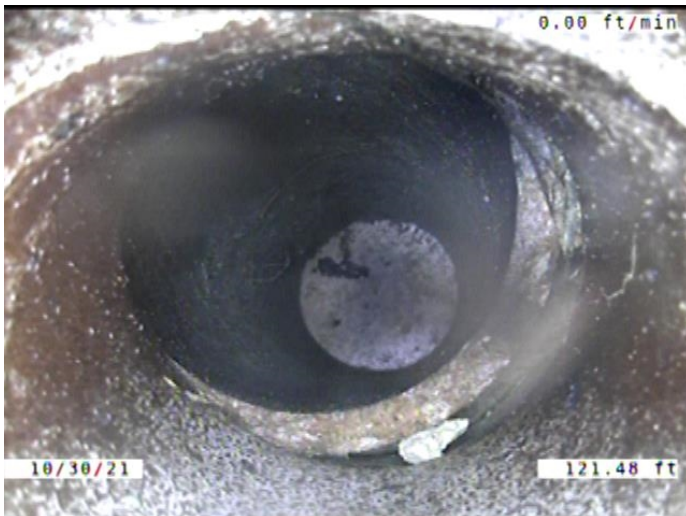
Code: **TFD**  
 Description: **Tap Factory Defective**

Distance (ft): **121.5**  
 Structural Grade: **0**  
 O&M Grade: **3**  
 Clock Start/From: **11**  
 Clock To:  
 1st Value: **4.000**  
 2nd Value:  
 Value Percent:  
 Continuous Index:  
 Within 8" of Joint: **YES**  
 Remarks: **CAPPED. LARGE OFFSET. SOIL  
 VISIBLE. ROOTS GROWING IN IT.**

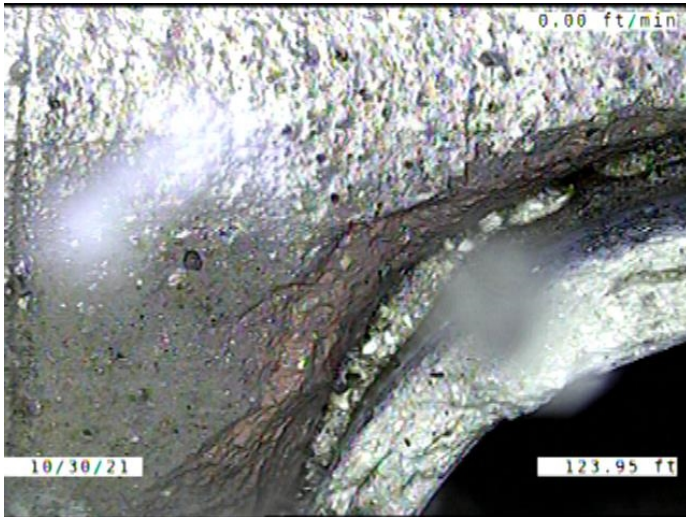
Code: **SSS**  
 Description: **Surface Damage Surface Spalling**

Distance (ft): **123.9**  
 Structural Grade: **2**  
 O&M Grade: **0**  
 Clock Start/From: **10**  
 Clock To: **12**  
 1st Value:  
 2nd Value:  
 Value Percent:  
 Continuous Index:  
 Within 8" of Joint: **YES**  
 Remarks:

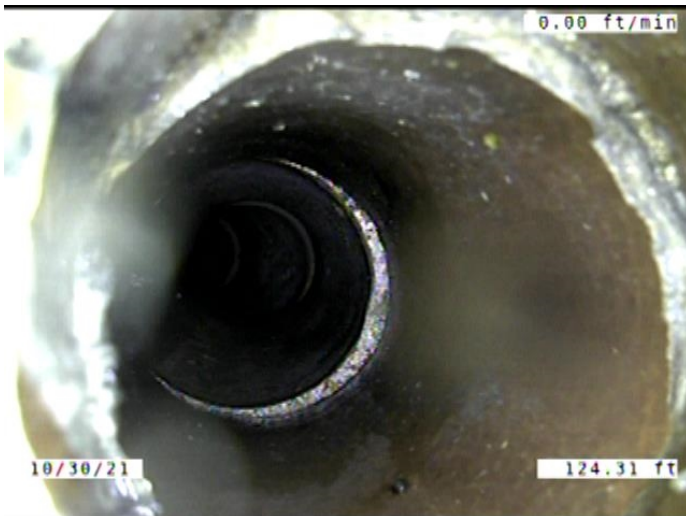
Code: **TBI**  
 Description: **Tap Break-in Intruding**

Distance (ft): **124.3**  
 Structural Grade: **0**  
 O&M Grade: **2**  
 Clock Start/From: **11**  
 Clock To:  
 1st Value: **4.000**  
 2nd Value: **1.000**  
 Value Percent:  
 Continuous Index:  
 Within 8" of Joint: **YES**  
 Remarks: **CONSTANTLY RUNNING WATER**

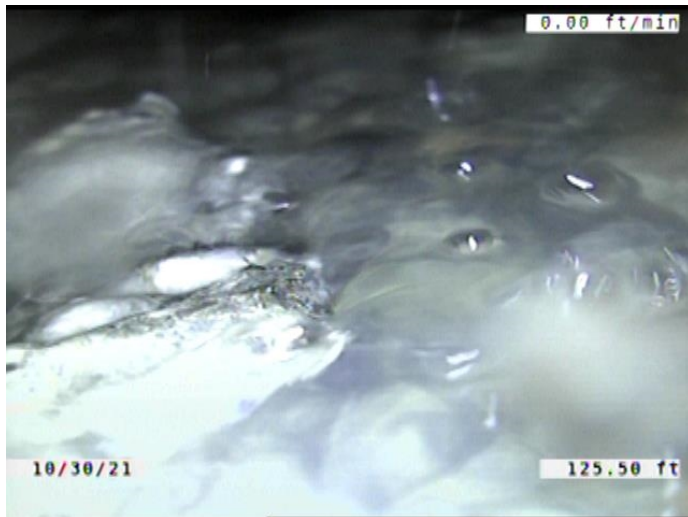
Code: **OBN**  
 Description: **Obstruction Construction Debris**

Distance (ft): **125.5**  
 Structural Grade: **0**  
 O&M Grade: **2**  
 Clock Start/From: **5**  
 Clock To: **7**  
 1st Value:  
 2nd Value:  
 Value Percent: **5.000**  
 Continuous Index: **S01**  
 Within 8" of Joint: **YES**  
 Remarks:

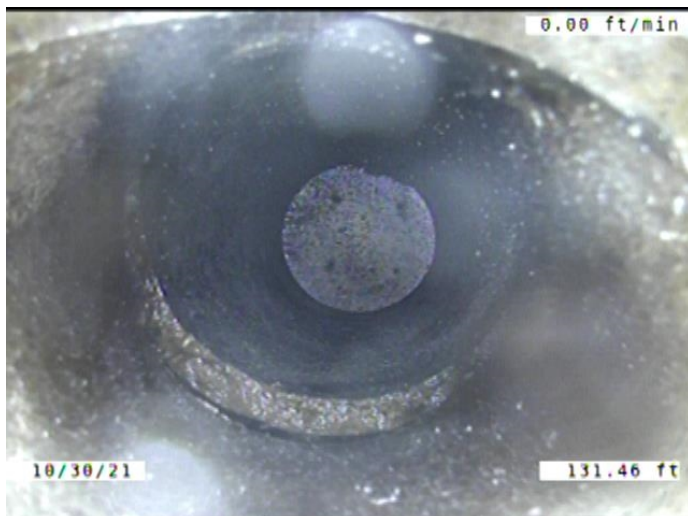
Code: **TFD**  
 Description: **Tap Factory Defective**

Distance (ft): **131.5**  
 Structural Grade: **0**  
 O&M Grade: **3**  
 Clock Start/From: **1**  
 Clock To:  
 1st Value: **4.000**  
 2nd Value:  
 Value Percent:  
 Continuous Index:  
 Within 8" of Joint: **YES**  
 Remarks: **CAPPED. OFFSET**

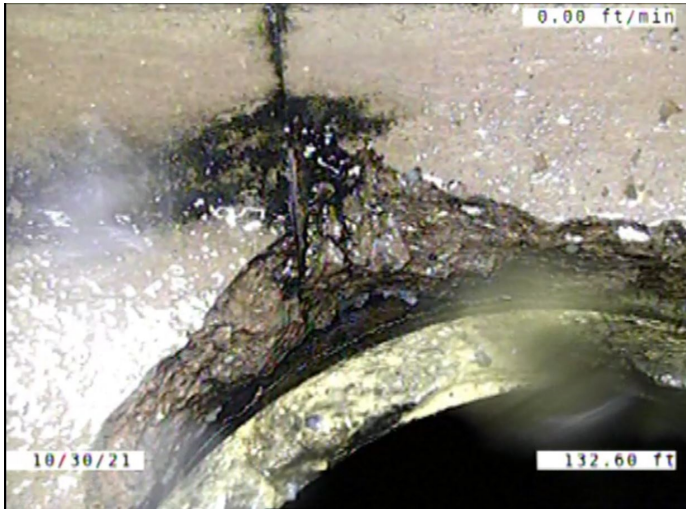
Code: **FL**  
 Description: **Fracture Longitudinal**

Distance (ft): **132.6**  
 Structural Grade: **3**  
 O&M Grade: **0**  
 Clock Start/From: **12**  
 Clock To:  
 1st Value:  
 2nd Value:  
 Value Percent:  
 Continuous Index:  
 Within 8" of Joint: **NO**  
 Remarks:

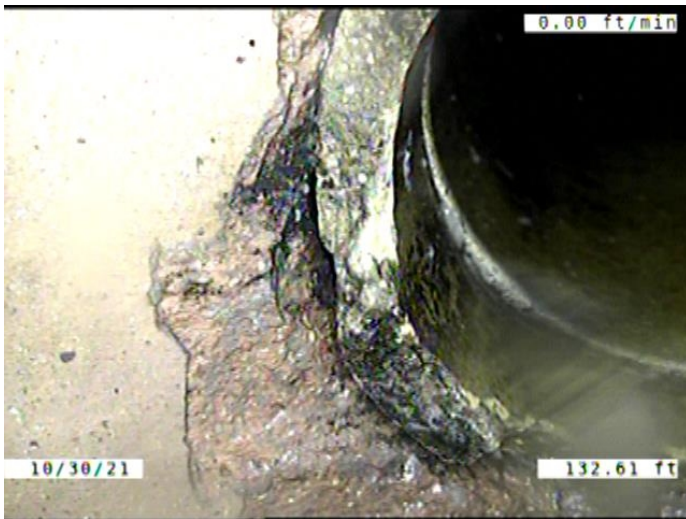
Code: **SSS**  
 Description: **Surface Damage Surface Spalling**

Distance (ft): **132.6**  
 Structural Grade: **2**  
 O&M Grade: **0**  
 Clock Start/From: **12**  
 Clock To: **2**  
 1st Value:  
 2nd Value:  
 Value Percent:  
 Continuous Index:  
 Within 8" of Joint: **YES**  
 Remarks:

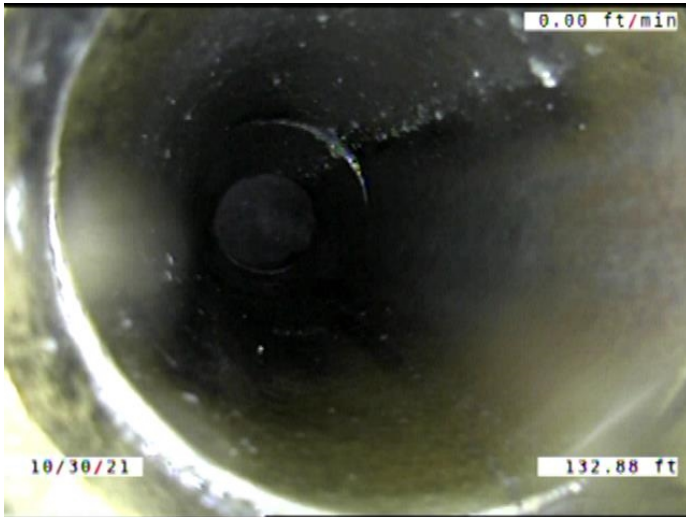
Code: **TBD**  
 Description: **Tap Break-in/Hammer Defective**

Distance (ft): **132.9**  
 Structural Grade: **0**  
 O&M Grade: **3**  
 Clock Start/From: **1**  
 Clock To:  
 1st Value: **4.000**  
 2nd Value:  
 Value Percent:  
 Continuous Index:  
 Within 8" of Joint: **YES**  
 Remarks: **CONSTANTLY RUNNING WATER**

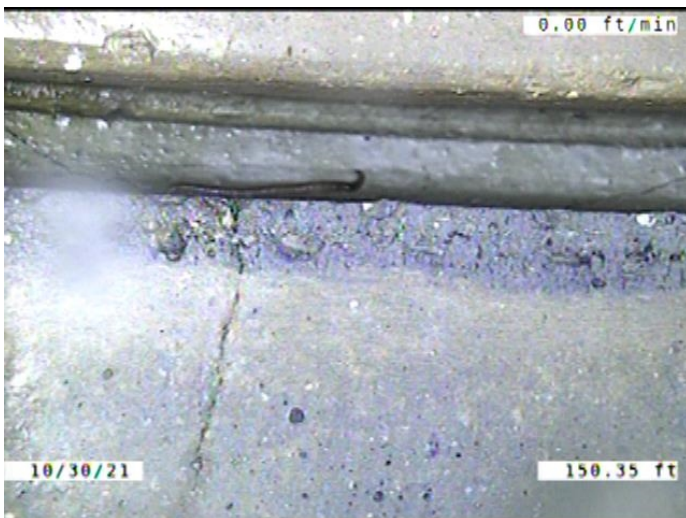
Code: **CM**  
 Description: **Crack Multiple**

Distance (ft): **150.4**  
 Structural Grade: **3**  
 O&M Grade: **0**  
 Clock Start/From: **9**  
 Clock To: **11**  
 1st Value:  
 2nd Value:  
 Value Percent:  
 Continuous Index:  
 Within 8" of Joint: **YES**  
 Remarks:

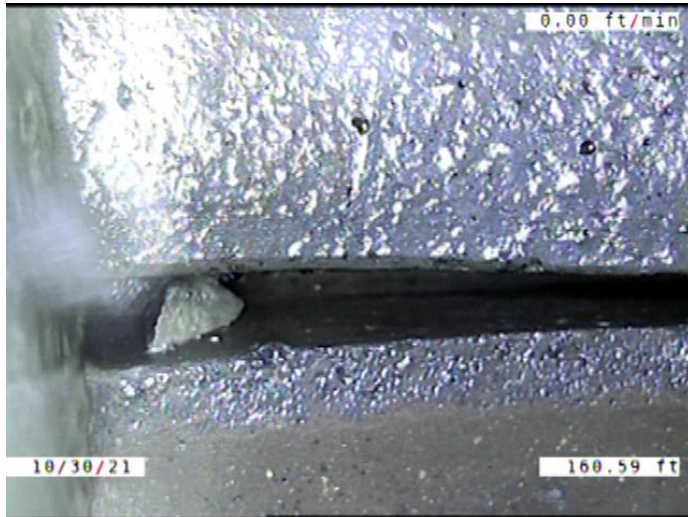
Code:	<b>OBJ</b>
Description:	<b>Obstruction Wedged In The Joint</b>
Distance (ft):	<b>160.6</b>
Structural Grade:	<b>0</b>
O&M Grade:	<b>2</b>
Clock Start/From:	<b>9</b>
Clock To:	<b>10</b>
1st Value:	
2nd Value:	
Value Percent:	<b>5.000</b>
Continuous Index:	
Within 8" of Joint:	<b>YES</b>
Remarks:

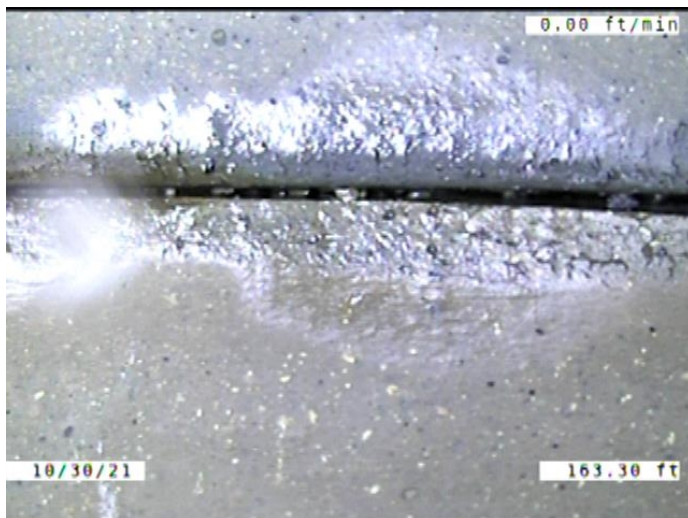
Code:	<b>IWJ</b>
Description:	<b>Infiltration Weeper Joint</b>
Distance (ft):	<b>163.3</b>
Structural Grade:	<b>0</b>
O&M Grade:	<b>2</b>
Clock Start/From:	<b>9</b>
Clock To:	<b>11</b>
1st Value:	
2nd Value:	
Value Percent:	
Continuous Index:	
Within 8" of Joint:	<b>YES</b>
Remarks:

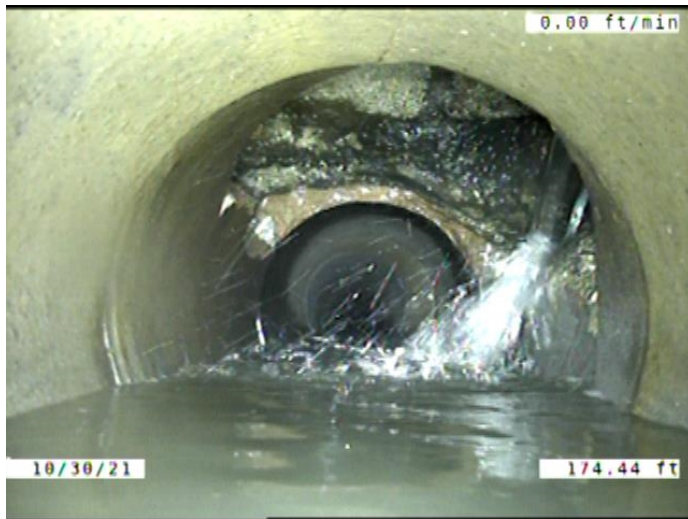
Code: **OBN**  
 Description: **Obstruction Construction Debris**

Distance (ft): **174.4**  
 Structural Grade: **0**  
 O&M Grade: **2**  
 Clock Start/From: **5**  
 Clock To: **7**  
 1st Value:  
 2nd Value:  
 Value Percent: **5.000**  
 Continuous Index: **F01**  
 Within 8" of Joint: **YES**  
 Remarks:

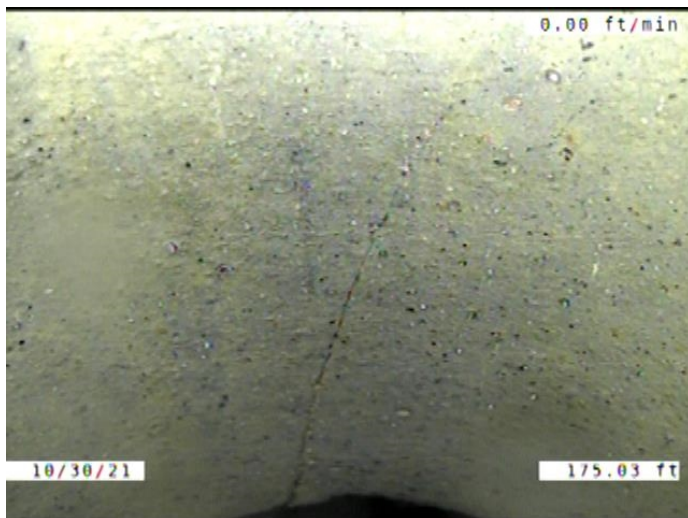
Code: **CM**  
 Description: **Crack Multiple**

Distance (ft): **175.0**  
 Structural Grade: **3**  
 O&M Grade: **0**  
 Clock Start/From: **12**  
 Clock To: **3**  
 1st Value:  
 2nd Value:  
 Value Percent:  
 Continuous Index:  
 Within 8" of Joint: **YES**  
 Remarks:
