Profile/Photo Observation Report

Street:	W HOME AVE & N COLORADO ST	Flow Control:	Not Controlled
City:	Hobart, IN	Year Renewed:	
Location:	Light Highway	Tape/Media #:	
Purpose:	Routine Assessment	Dia/Height:	10"
Use:	Sanitary	Material:	VCP
Drain Area:	NA	Lining:	
Category:	NA		
Comment:	P_C at 32 ft sludge . Flow direction wrong		
Location Details:		Direction of Survey:	Downstream
US MH:	M-504-034	DS MH:	M-504-035
		Total Length Surveyed (ft):	33.5

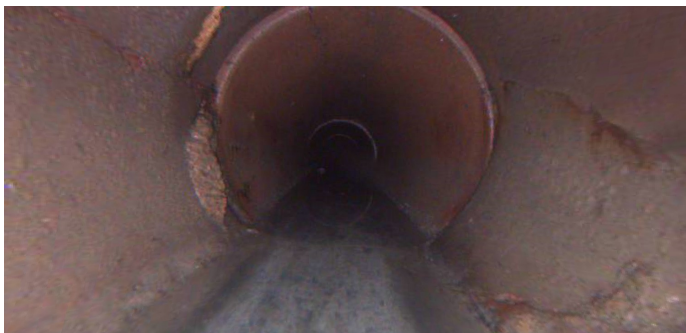
Code: **AMH**
Description: **Manhole**

Distance (ft): **.0**
Structural Grade: **0**
O&M Grade: **0**
Clock Start/From:
Clock To:
1st Value:
2nd Value:
Value Percent:
Continuous Index:
Within 8" of Joint: **NO**
Remarks: **M-504-034**

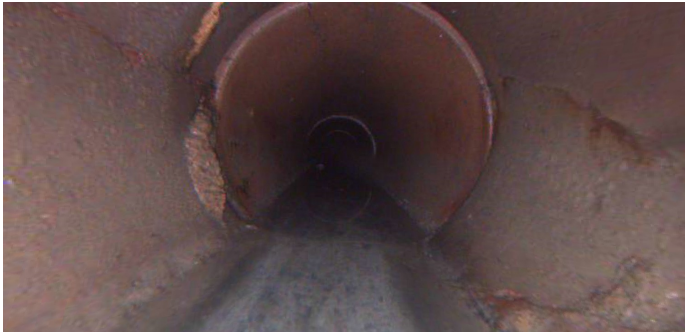
Code:	MWL
Description:	Water Level

Distance (ft):	.0
Structural Grade:	0
O&M Grade:	0
Clock Start/From:	
Clock To:	
1st Value:	
2nd Value:	
Value Percent:	5.000
Continuous Index:	
Within 8" of Joint:	NO
Remarks:

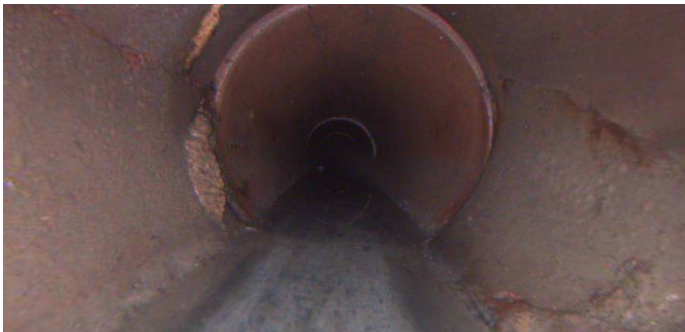
Code:	FM
Description:	Fracture Multiple

Distance (ft):	.0
Structural Grade:	4
O&M Grade:	0
Clock Start/From:	8
Clock To:	4
1st Value:	
2nd Value:	
Value Percent:	
Continuous Index:	
Within 8" of Joint:	YES
Remarks:

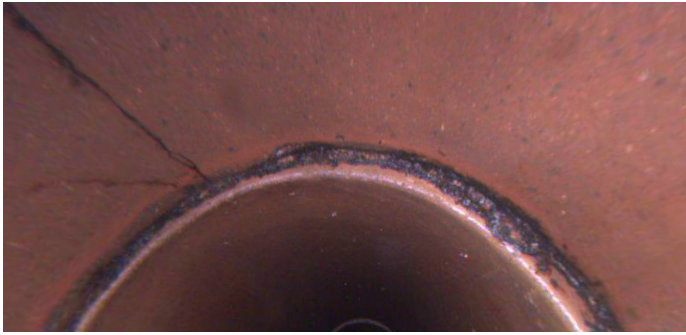
Code: **FL**
Description: **Fracture Longitudinal**

Distance (ft): **4.0**
Structural Grade: **3**
O&M Grade: **0**
Clock Start/From: **12**
Clock To:
1st Value:
2nd Value:
Value Percent:
Continuous Index:
Within 8" of Joint: **YES**
Remarks:

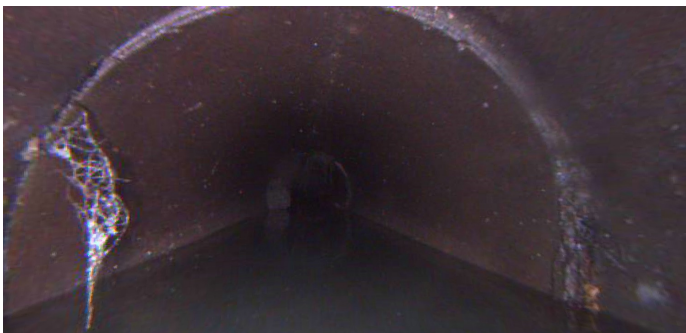
Code: **RFJ**
Description: **Roots Fine Joint**

Distance (ft): **33.1**
Structural Grade: **0**
O&M Grade: **1**
Clock Start/From: **8**
Clock To: **4**
1st Value:
2nd Value:
Value Percent:
Continuous Index:
Within 8" of Joint: **YES**
Remarks:

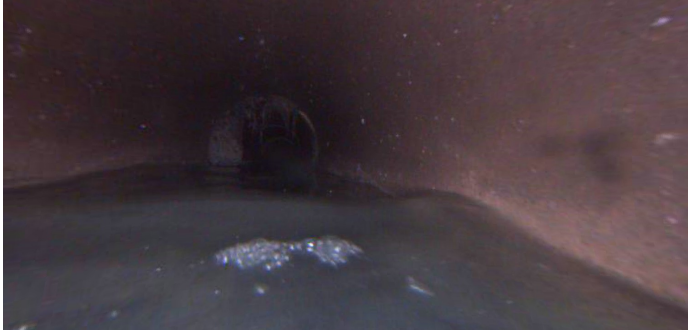
Code:	MSA
Description:	Abandoned Survey
Distance (ft):	33.5
Structural Grade:	0
O&M Grade:	0
Clock Start/From:	
Clock To:	
1st Value:	
2nd Value:	
Value Percent:	
Continuous Index:	
Within 8" of Joint:	NO
Remarks:	DEBRIS UNDER WATER
