## Profile/Photo Observation Report

Date:	<b>04/25/2018</b>	Weather:		Coding:	<b>PACP 6.0</b>
Pipe Length (ft):	<b>166.7</b>	Owner:	<b>NA</b>	Pre Clean:	<b>No Pre-Cleaning</b>
P.O.#:		Surveyor:	<b>Jen Costello</b>	PSR:	<b>P-504-035-034</b>
Customer:		Clean Date:	<b>01/01/1900</b>	Shape:	<b>C</b>

Street:	<b>FOXCROFT STREET</b>	Flow Control:	<b>Not Controlled</b>
City:	<b>Hobart, IN</b>	Year Renewed:	
Location:	<b>Light Highway</b>	Tape/Media #:	
Purpose:	<b>Routine Assessment</b>	Dia/Height:	<b>10"</b>
Use:	<b>Sanitary</b>	Material:	<b>VCP</b>
Drain Area:	<b>NA</b>	Lining:	
Category:	<b>NA</b>		
Comment:	<b>P_C at 32 ft sludge . Flow direction wrong</b>		
Location Details:		Direction of Survey:	<b>Downstream</b>
US MH:	<b>M-504-034</b>	DS MH:	<b>M-504-035</b>
		Total Length Surveyed (ft):	<b>33.5</b>

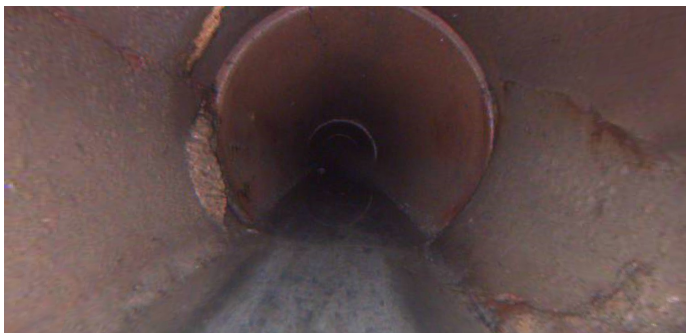
Code: **AMH**  
Description: **Manhole**

Distance (ft): **.0**  
Structural Grade: **0**  
O&M Grade: **0**  
Clock Start/From:  
Clock To:  
1st Value:  
2nd Value:  
Value Percent:  
Continuous Index:  
Within 8" of Joint: **NO**  
Remarks: **M-504-034**

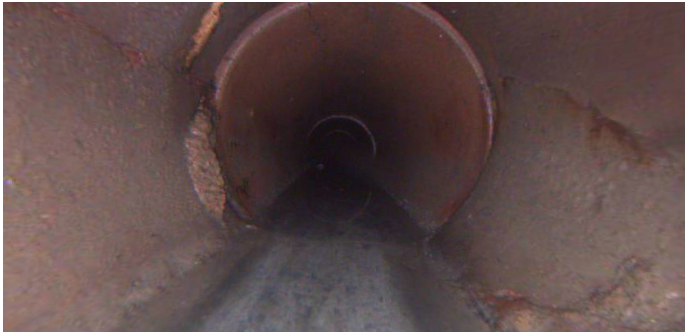
Code:	<b>MWL</b>
Description:	<b>Water Level</b>

Distance (ft):	<b>.0</b>
Structural Grade:	<b>0</b>
O&M Grade:	<b>0</b>
Clock Start/From:	
Clock To:	
1st Value:	
2nd Value:	
Value Percent:	<b>5.000</b>
Continuous Index:	
Within 8" of Joint:	<b>NO</b>
Remarks:

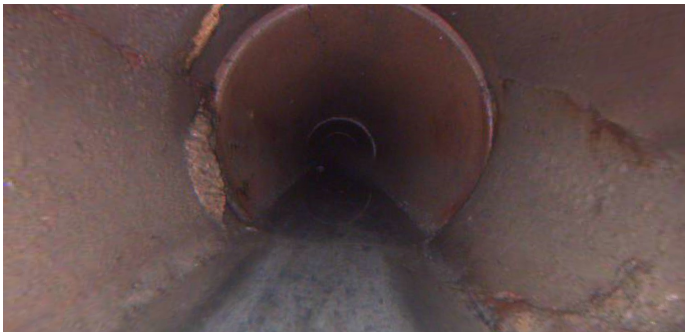
Code:	<b>FM</b>
Description:	<b>Fracture Multiple</b>

Distance (ft):	<b>.0</b>
Structural Grade:	<b>4</b>
O&M Grade:	<b>0</b>
Clock Start/From:	<b>8</b>
Clock To:	<b>4</b>
1st Value:	
2nd Value:	
Value Percent:	
Continuous Index:	
Within 8" of Joint:	<b>YES</b>
Remarks:

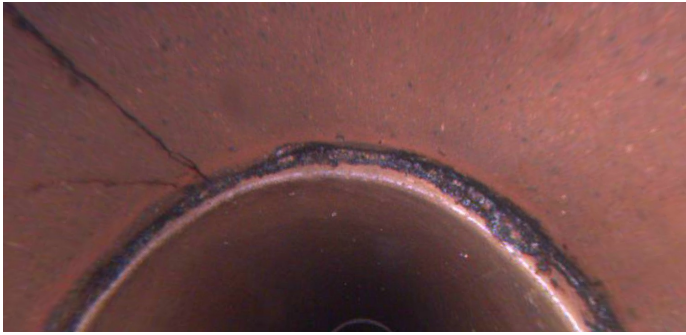
Code: **FL**  
Description: **Fracture Longitudinal**

Distance (ft): **4.0**  
Structural Grade: **3**  
O&M Grade: **0**  
Clock Start/From: **12**  
Clock To:  
1st Value:  
2nd Value:  
Value Percent:  
Continuous Index:  
Within 8" of Joint: **YES**  
Remarks:

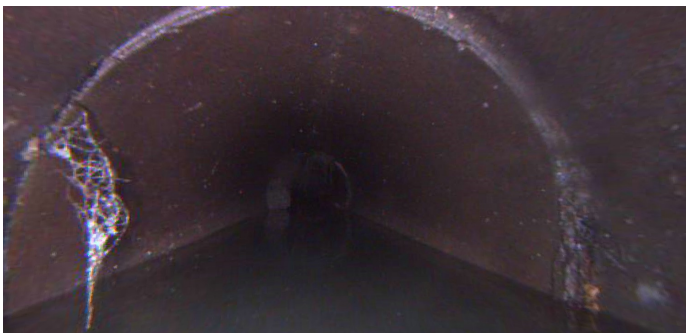
Code: **RFJ**  
Description: **Roots Fine Joint**

Distance (ft): **33.1**  
Structural Grade: **0**  
O&M Grade: **1**  
Clock Start/From: **8**  
Clock To: **4**  
1st Value:  
2nd Value:  
Value Percent:  
Continuous Index:  
Within 8" of Joint: **YES**  
Remarks:

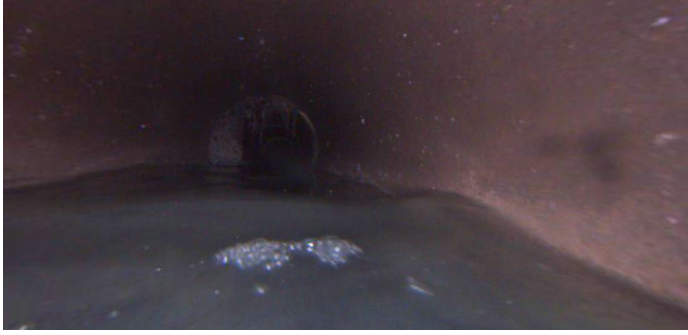
Code:	MSA
Description:	Abandoned Survey
Distance (ft):	33.5
Structural Grade:	0
O&M Grade:	0
Clock Start/From:	
Clock To:	
1st Value:	
2nd Value:	
Value Percent:	
Continuous Index:	
Within 8" of Joint:	NO
Remarks:	DEBRIS UNDER WATER
