Profile/Photo Observation Report

Street:	W HOME AVE & N COLORADO ST	Flow Control:	Not Controlled
City:	Hobart, IN	Year Renewed:	
Location:	Light Highway	Tape/Media #:	
Purpose:	Routine Assessment	Dia/Height:	10"
Use:	Sanitary	Material:	VCP
Drain Area:	NA	Lining:	
Category:	NA		
Comment:	P_C at 39 ft nothing visible. Flow direction wrong		
Location Details:		Direction of Survey:	Upstream
US MH:	M-504-034	DS MH:	M-504-035
		Total Length Surveyed (ft):	40.3

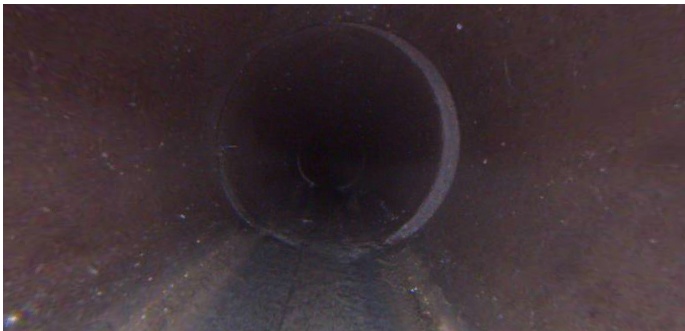
Code: **AMH**
Description: **Manhole**

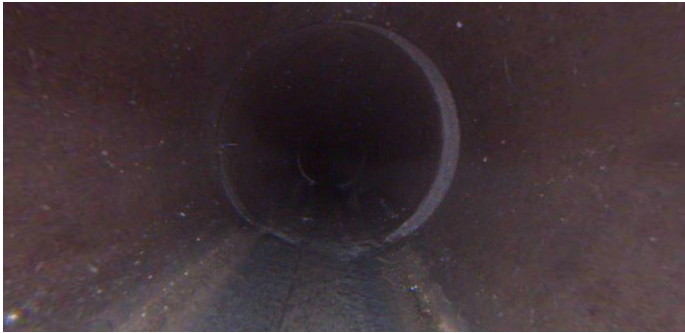
Code:	MWL
Description:	Water Level

Distance (ft):	.0
Structural Grade:	0
O&M Grade:	0
Clock Start/From:	
Clock To:	
1st Value:	
2nd Value:	
Value Percent:	5.000
Continuous Index:	
Within 8" of Joint:	NO
Remarks:

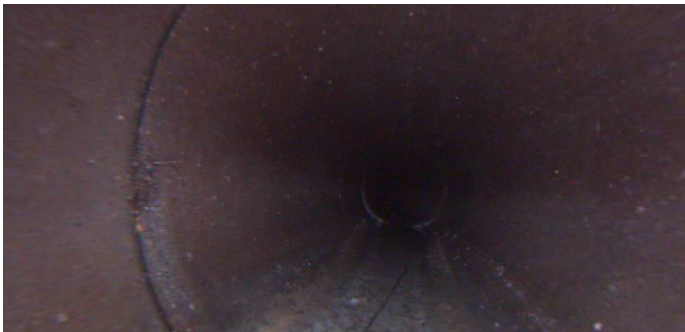
Code:	RFJ
Description:	Roots Fine Joint

Distance (ft):	1.6
Structural Grade:	0
O&M Grade:	1
Clock Start/From:	9
Clock To:	
1st Value:	
2nd Value:	
Value Percent:	
Continuous Index:	
Within 8" of Joint:	YES
Remarks:

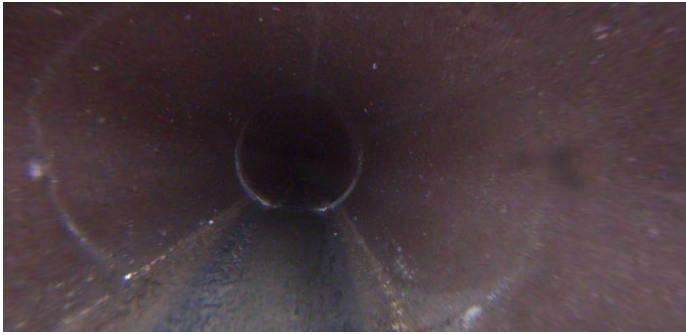
Code: **FC**
Description: **Fracture Circumferential**

Distance (ft): **3.1**
Structural Grade: **2**
O&M Grade: **0**
Clock Start/From: **8**
Clock To: **4**
1st Value:
2nd Value:
Value Percent:
Continuous Index:
Within 8" of Joint:
Remarks:

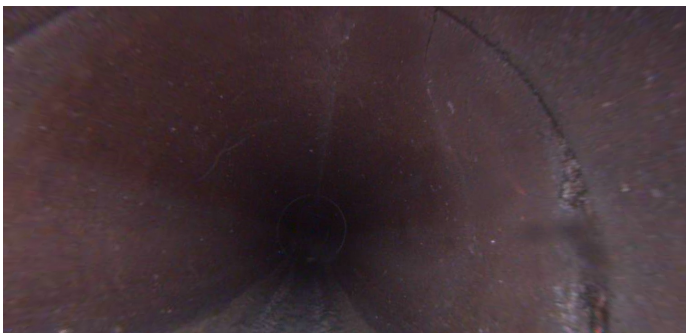
Code: **FC**
Description: **Fracture Circumferential**

Distance (ft): **4.4**
Structural Grade: **2**
O&M Grade: **0**
Clock Start/From: **1**
Clock To: **3**
1st Value:
2nd Value:
Value Percent:
Continuous Index:
Within 8" of Joint: **YES**
Remarks:

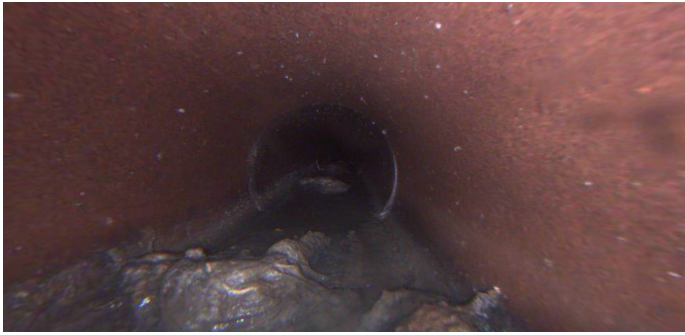
Code: **OBZ**
Description: **Obstacle Other**

Distance (ft): **16.0**
Structural Grade: **0**
O&M Grade: **2**
Clock Start/From: **5**
Clock To: **7**
1st Value:
2nd Value:
Value Percent: **10.000**
Continuous Index: **S01**
Within 8" of Joint: **NO**
Remarks: **misc**

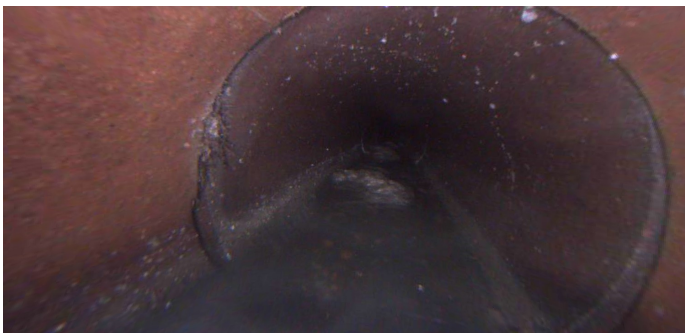
Code: **RFJ**
Description: **Roots Fine Joint**

Distance (ft): **16.8**
Structural Grade: **0**
O&M Grade: **1**
Clock Start/From: **9**
Clock To:
1st Value:
2nd Value:
Value Percent:
Continuous Index:
Within 8" of Joint: **YES**
Remarks:

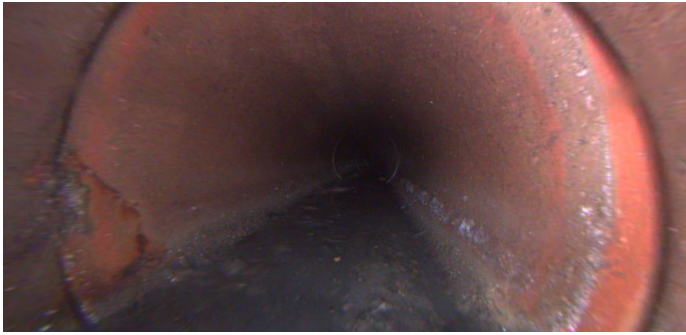
Code: **FS**
Description: **Fracture Spiral**

Distance (ft): **24.6**
Structural Grade: **3**
O&M Grade: **0**
Clock Start/From: **7**
Clock To: **9**
1st Value:
2nd Value:
Value Percent:
Continuous Index:
Within 8" of Joint: **YES**
Remarks:

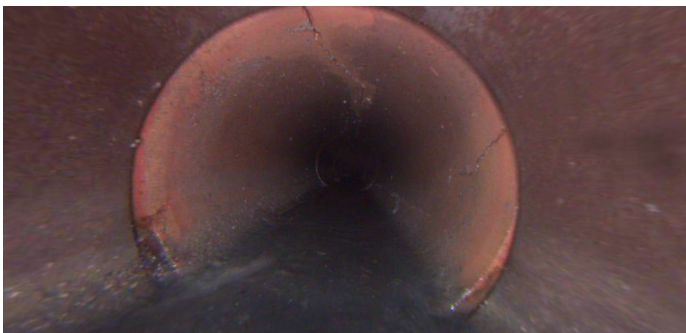
Code: **FM**
Description: **Fracture Multiple**

Distance (ft): **29.4**
Structural Grade: **4**
O&M Grade: **0**
Clock Start/From: **8**
Clock To: **4**
1st Value:
2nd Value:
Value Percent:
Continuous Index:
Within 8" of Joint: **YES**
Remarks:

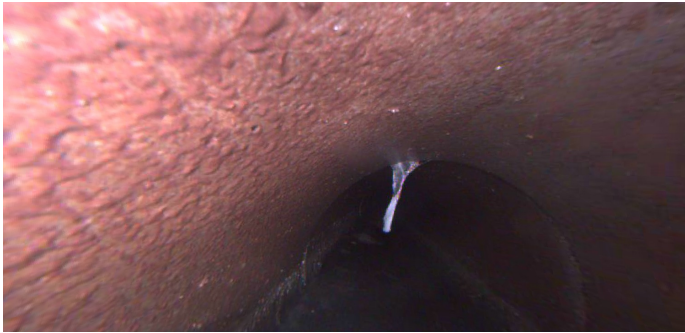
Code: **OBZ**
Description: **Obstacle Other**

Distance (ft): **40.3**
Structural Grade: **0**
O&M Grade: **2**
Clock Start/From: **5**
Clock To: **7**
1st Value:
2nd Value:
Value Percent: **10.000**
Continuous Index: **F01**
Within 8" of Joint: **NO**
Remarks: **misc**

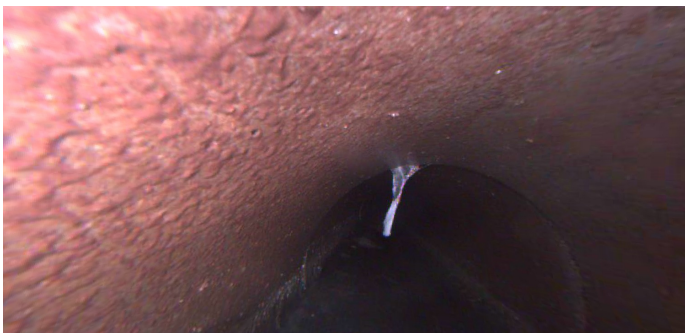
Code: **MSA**
Description: **Abandoned Survey**

Distance (ft): **40.3**
Structural Grade: **0**
O&M Grade: **0**
Clock Start/From:
Clock To:
1st Value:
2nd Value:
Value Percent:
Continuous Index:
Within 8" of Joint: **NO**
Remarks: **overturned**
