Profile/Photo Observation Report

| Street: | FOXCROFT STREET | Flow Control: | Not Controlled |
| City: | Hobart, IN | Year Renewed: | |
| US MH: | M-504-034 | DS MH: | M-504-035 |

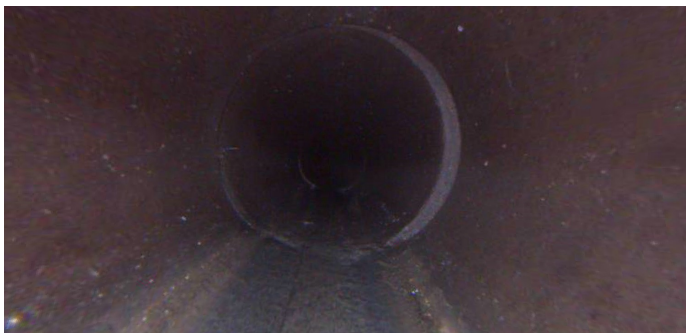
Code: **AMH**
Description: **Manhole**

Distance (ft): **.0**
Structural Grade: **0**
O&M Grade: **0**
Clock Start/From:
Clock To:
1st Value:
2nd Value:
Value Percent:
Continuous Index:
Within 8" of Joint: **NO**
Remarks: **M-504-035**

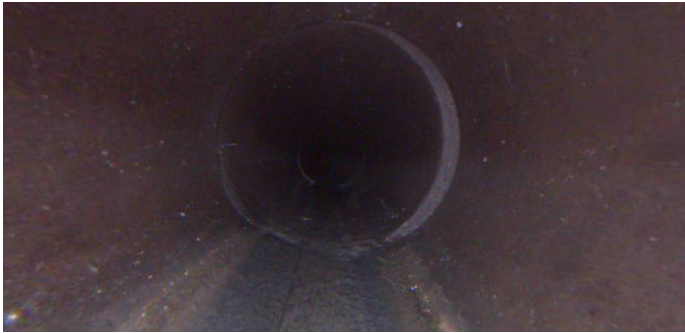
| Code: | MWL |
| Description: | Water Level |

| Value Percent: | 5.000 |

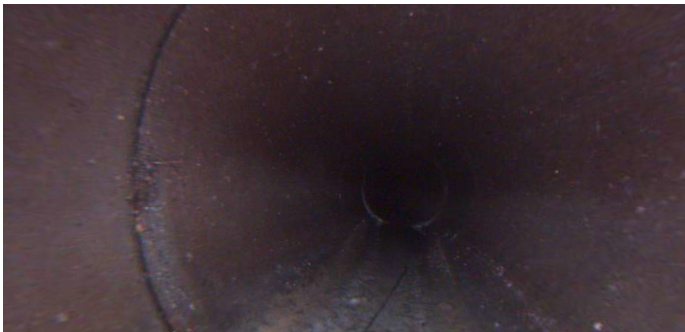
| Code: | RFJ |
| Description: | Roots Fine Joint |

| Distance (ft): | 1.6 |
| O&M Grade: | 1 |
| Clock Start/From: | 9 |
| Within 8" of Joint: | YES |

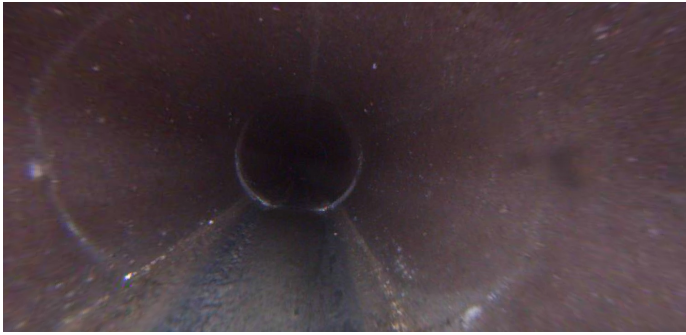
Code: **FC**
Description: **Fracture Circumferential**

Distance (ft): **3.1**
Structural Grade: **2**
O&M Grade: **0**
Clock Start/From: **8**
Clock To: **4**
1st Value:
2nd Value:
Value Percent:
Continuous Index:
Within 8" of Joint:
Remarks:

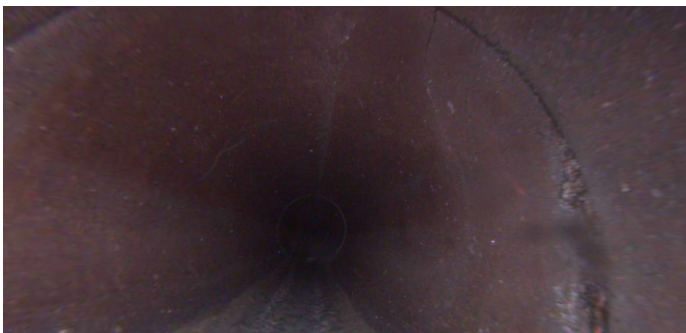
Code: **FC**
Description: **Fracture Circumferential**

Distance (ft): **4.4**
Structural Grade: **2**
O&M Grade: **0**
Clock Start/From: **1**
Clock To: **3**
1st Value:
2nd Value:
Value Percent:
Continuous Index:
Within 8" of Joint: **YES**
Remarks:

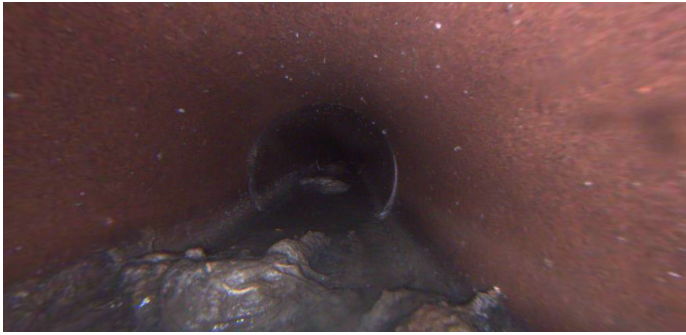
Code: **OBZ**
Description: **Obstacle Other**

Distance (ft): **16.0**
Structural Grade: **0**
O&M Grade: **2**
Clock Start/From: **5**
Clock To: **7**
1st Value:
2nd Value:
Value Percent: **10.000**
Continuous Index: **S01**
Within 8" of Joint: **NO**
Remarks: **misc**

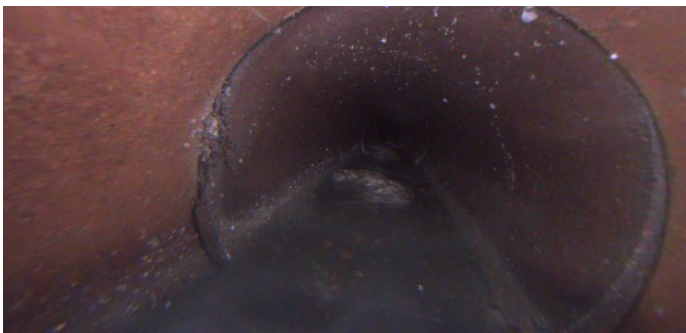
Code: **RFJ**
Description: **Roots Fine Joint**

Distance (ft): **16.8**
Structural Grade: **0**
O&M Grade: **1**
Clock Start/From: **9**
Clock To:
1st Value:
2nd Value:
Value Percent:
Continuous Index:
Within 8" of Joint: **YES**
Remarks:

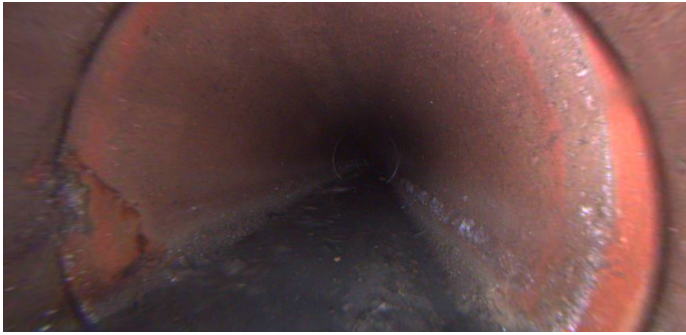
Code: **FS**
Description: **Fracture Spiral**

Distance (ft): **24.6**
Structural Grade: **3**
O&M Grade: **0**
Clock Start/From: **7**
Clock To: **9**
1st Value:
2nd Value:
Value Percent:
Continuous Index:
Within 8" of Joint: **YES**
Remarks:

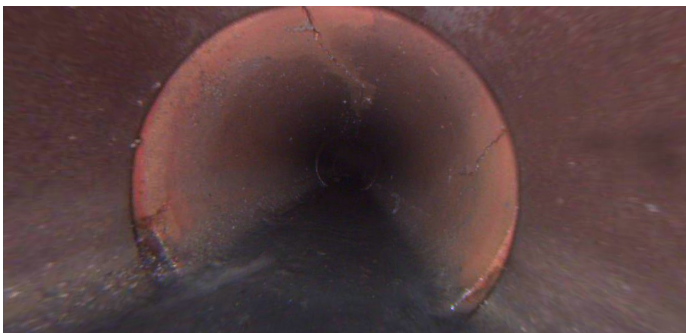
Code: **FM**
Description: **Fracture Multiple**

Distance (ft): **29.4**
Structural Grade: **4**
O&M Grade: **0**
Clock Start/From: **8**
Clock To: **4**
1st Value:
2nd Value:
Value Percent:
Continuous Index:
Within 8" of Joint: **YES**
Remarks:

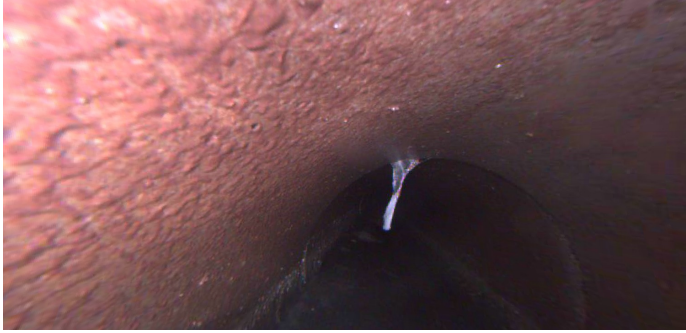
Code: **OBZ**
Description: **Obstacle Other**

Distance (ft): **40.3**
Structural Grade: **0**
O&M Grade: **2**
Clock Start/From: **5**
Clock To: **7**
1st Value:
2nd Value:
Value Percent: **10.000**
Continuous Index: **F01**
Within 8" of Joint: **NO**
Remarks: **misc**

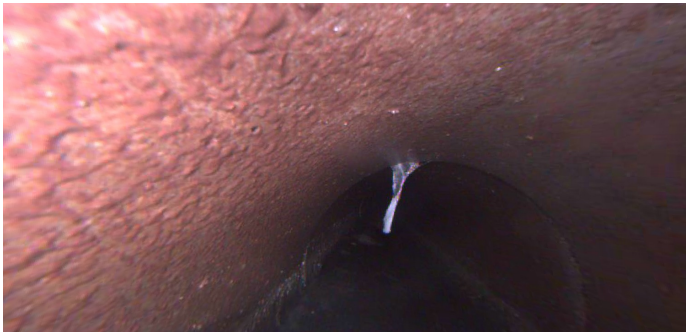
Code: **MSA**
Description: **Abandoned Survey**

Distance (ft): **40.3**
Structural Grade: **0**
O&M Grade: **0**
Clock Start/From:
Clock To:
1st Value:
2nd Value:
Value Percent:
Continuous Index:
Within 8" of Joint: **NO**
Remarks: **overturned**
