# Profile/Photo Observation Report

Date:	<b>10/31/2021</b>	Weather:		Coding:	<b>PACP 7.0</b>
Pipe Length (ft):	<b>163.8</b>	Owner:	<b>City of Hobart</b>	Pre Clean:	<b>Heavy Cleaning</b>
P.O.#:	<b>YES502259</b>	Surveyor:	<b>S. Bucklin</b>	PSR:	<b>P-504-035-034</b>
Customer:	<b>City of Hobart</b>	Clean Date:	<b>10/27/2021</b>	Shape:	<b>C</b>

Street:	<b>North Colorado Street</b>	Flow Control:	<b>Not Controlled</b>
City:	<b>Hobart, IN</b>	Year Renewed:	
Location:	<b>Local rural streets with light traffic, t</b>	Tape/Media #:	
Purpose:	<b>Routine Assessment</b>	Dia/Height:	<b>10"</b>
Use:	<b>Sanitary Sewage Pipe</b>	Material:	<b>VCP</b>
Drain Area:		Lining:	<b>None</b>
Category:	<b>NA</b>		
Comment:			
Location Details:		Direction of Survey:	<b>Upstream</b>
US MH:	<b>M-504-034</b>	DS MH:	<b>M-504-035</b>
		Total Length Surveyed (ft):	<b>163.8</b>

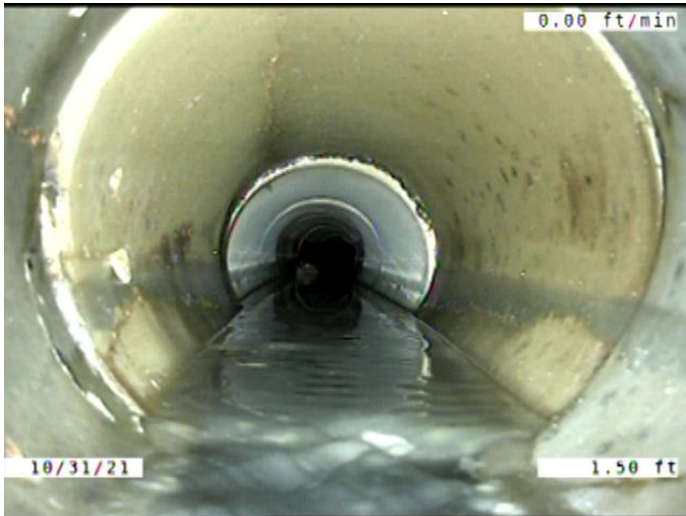
Code: **MGO**  
Description: **Miscellaneous General Observation**

Distance (ft): **1.5**  
Structural Grade: **0**  
O&M Grade: **0**  
Clock Start/From:  
Clock To:  
1st Value:  
2nd Value:  
Value Percent:  
Continuous Index:  
Within 8" of Joint: **NO**  
Remarks: **DROP INTO THE MANHOLE. HAD TO START IN THE PIPE.**

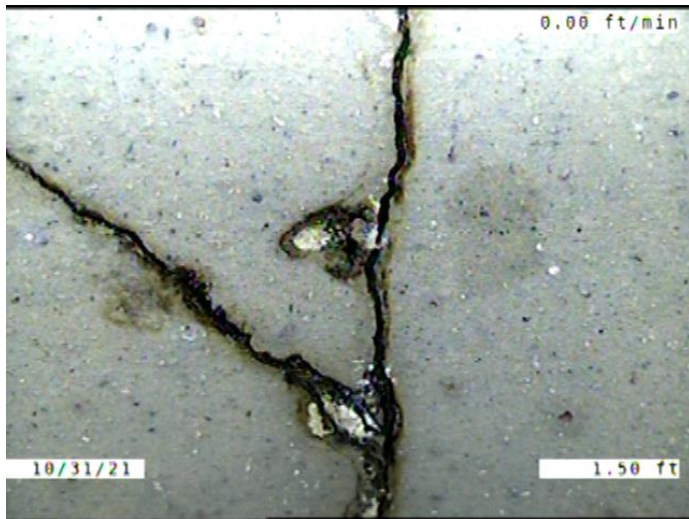
Code: **FM**  
 Description: **Fracture Multiple**

Distance (ft): **1.5**  
 Structural Grade: **4**  
 O&M Grade: **0**  
 Clock Start/From: **12**  
 Clock To: **12**  
 1st Value:  
 2nd Value:  
 Value Percent:  
 Continuous Index: **S01**  
 Within 8" of Joint: **YES**  
 Remarks:

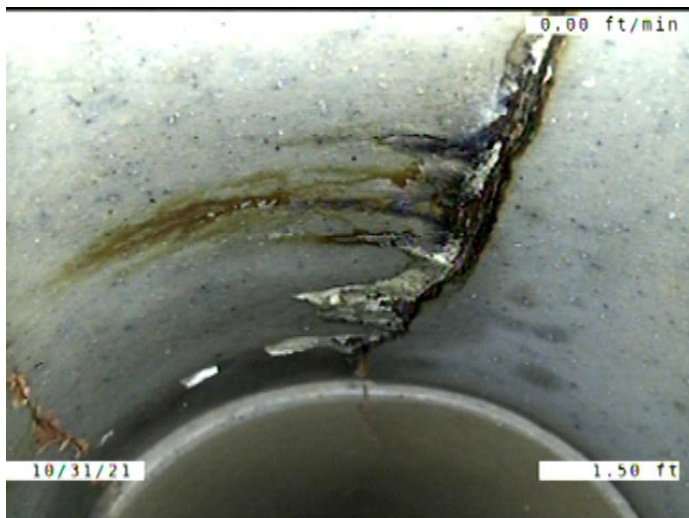
Code: **ISB**  
 Description: **Infiltration Stain Barrel**

Distance (ft): **1.5**  
 Structural Grade: **0**  
 O&M Grade: **1**  
 Clock Start/From: **7**  
 Clock To: **5**  
 1st Value:  
 2nd Value:  
 Value Percent:  
 Continuous Index:  
 Within 8" of Joint: **YES**  
 Remarks:

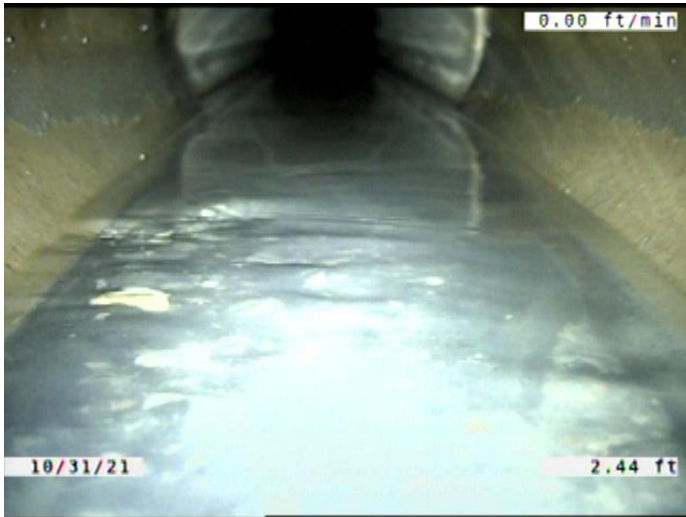
Code: **DSF**  
 Description: **Deposits Settled Fine**

Distance (ft): **2.4**  
 Structural Grade: **0**  
 O&M Grade: **2**  
 Clock Start/From: **5**  
 Clock To: **7**  
 1st Value:  
 2nd Value:  
 Value Percent: **5.000**  
 Continuous Index: **S02**  
 Within 8" of Joint: **YES**  
 Remarks:

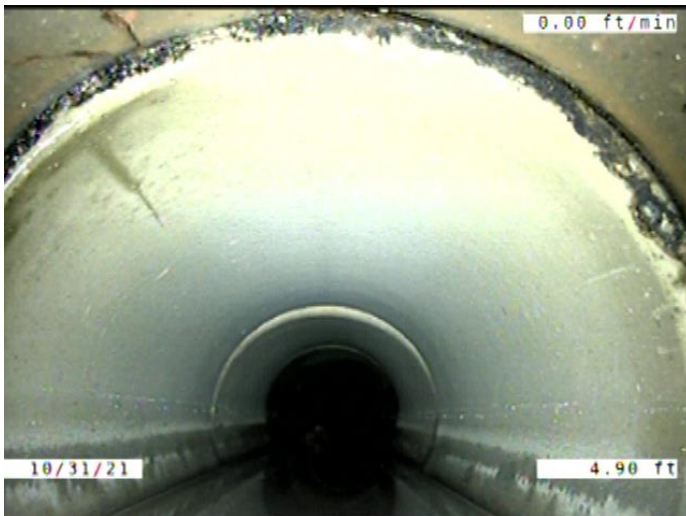
Code: **JOMD**  
 Description: **Joint Offset Medium Defective**

Distance (ft): **4.9**  
 Structural Grade: **3**  
 O&M Grade: **0**  
 Clock Start/From:  
 Clock To:  
 1st Value:  
 2nd Value:  
 Value Percent:  
 Continuous Index:  
 Within 8" of Joint: **NO**  
 Remarks:

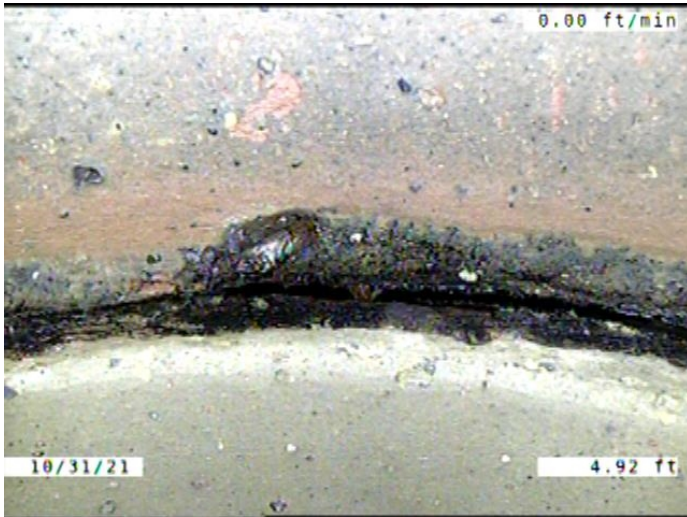
Code: **DAE**  
Description: **Deposits Attached Encrustation**

Distance (ft): **4.9**  
Structural Grade: **0**  
O&M Grade: **2**  
Clock Start/From: **9**  
Clock To: **3**  
1st Value:  
2nd Value:  
Value Percent: **5.000**  
Continuous Index:  
Within 8" of Joint: **YES**  
Remarks:

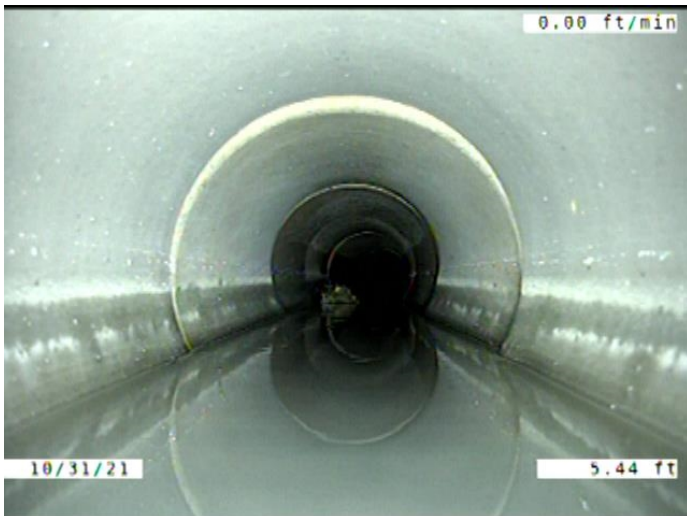
Code: **FM**  
Description: **Fracture Multiple**

Distance (ft): **5.4**  
Structural Grade: **4**  
O&M Grade: **0**  
Clock Start/From: **12**  
Clock To: **12**  
1st Value:  
2nd Value:  
Value Percent:  
Continuous Index: **F01**  
Within 8" of Joint: **YES**  
Remarks:

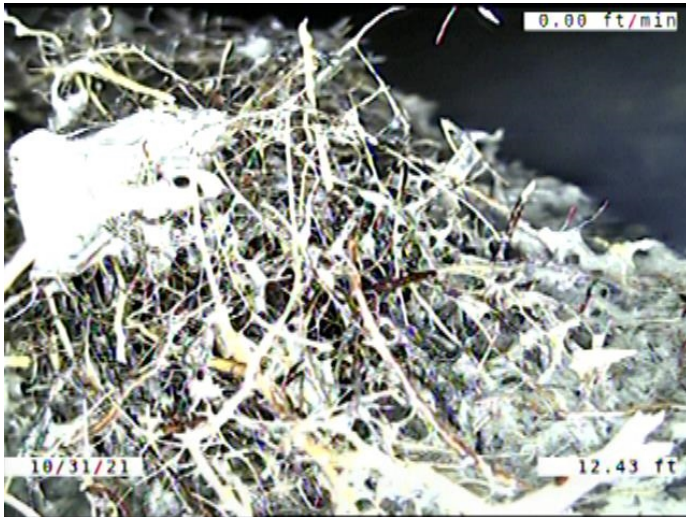
Code: **OBZ**  
 Description: **Obstruction Other**

Distance (ft): **12.4**  
 Structural Grade: **0**  
 O&M Grade: **2**  
 Clock Start/From: **6**  
 Clock To: **8**  
 1st Value:  
 2nd Value:  
 Value Percent: **5.000**  
 Continuous Index:  
 Within 8" of Joint: **YES**  
 Remarks: **ROOTS THAT HAVE BEEN CUT**

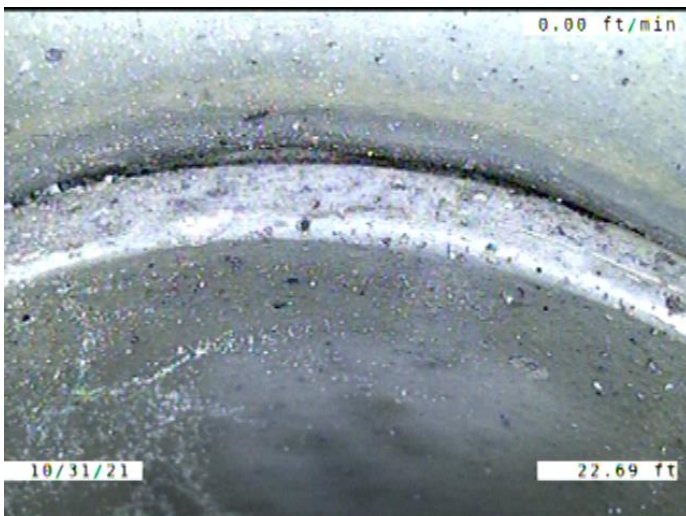
Code: **JOM**  
 Description: **Joint Offset Medium**

Distance (ft): **22.7**  
 Structural Grade: **3**  
 O&M Grade: **0**  
 Clock Start/From:  
 Clock To:  
 1st Value:  
 2nd Value:  
 Value Percent:  
 Continuous Index:  
 Within 8" of Joint: **NO**  
 Remarks:

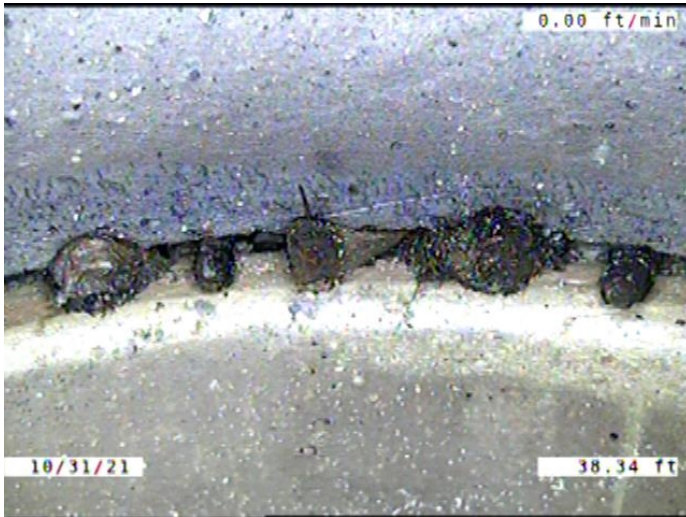
Code: **RFJ**  
 Description: **Roots Fine Joint**

Distance (ft): **38.3**  
 Structural Grade: **0**  
 O&M Grade: **1**  
 Clock Start/From: **10**  
 Clock To: **12**  
 1st Value:  
 2nd Value:  
 Value Percent:  
 Continuous Index:  
 Within 8" of Joint: **YES**  
 Remarks:

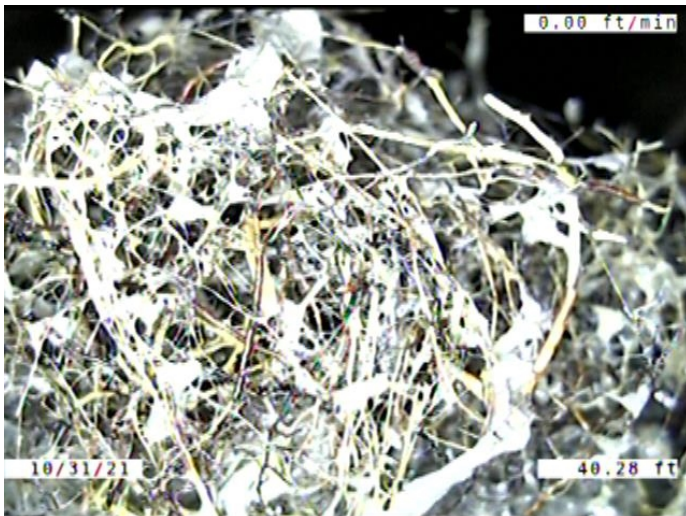
Code: **OBZ**  
 Description: **Obstruction Other**

Distance (ft): **40.3**  
 Structural Grade: **0**  
 O&M Grade: **2**  
 Clock Start/From: **5**  
 Clock To: **7**  
 1st Value:  
 2nd Value:  
 Value Percent: **5.000**  
 Continuous Index:  
 Within 8" of Joint: **YES**  
 Remarks: **ROOTS THAT HAVE BEEN CUT**

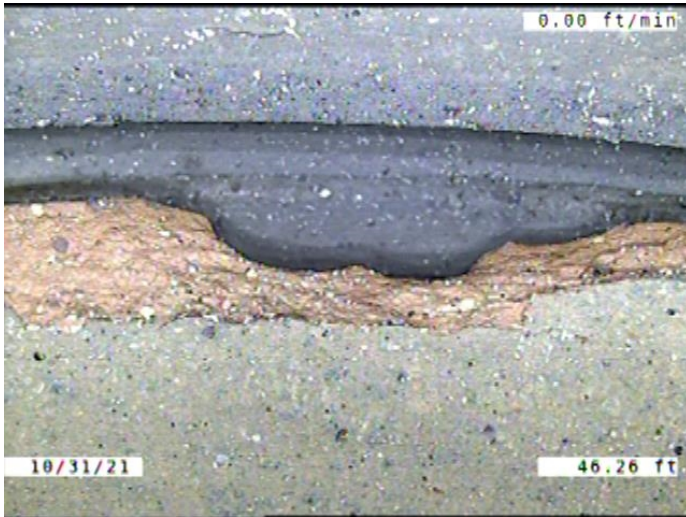
Code:	<b>SZ</b>
Description:	<b>Surface Damage Other</b>
Distance (ft):	<b>46.3</b>
Structural Grade:	<b>0</b>
O&M Grade:	<b>0</b>
Clock Start/From:	<b>12</b>
Clock To:	<b>2</b>
1st Value:	
2nd Value:	
Value Percent:	
Continuous Index:	
Within 8" of Joint:	<b>YES</b>
Remarks:	<b>A PIECE CHIPPED AWAY FROM THE JOINT</b>

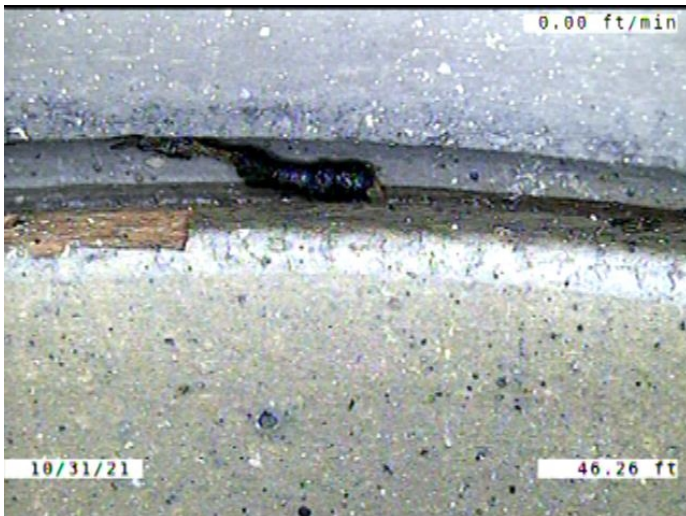
Code:	<b>RFJ</b>
Description:	<b>Roots Fine Joint</b>
Distance (ft):	<b>46.3</b>
Structural Grade:	<b>0</b>
O&M Grade:	<b>1</b>
Clock Start/From:	<b>2</b>
Clock To:	<b>3</b>
1st Value:	
2nd Value:	
Value Percent:	
Continuous Index:	
Within 8" of Joint:	<b>YES</b>
Remarks:

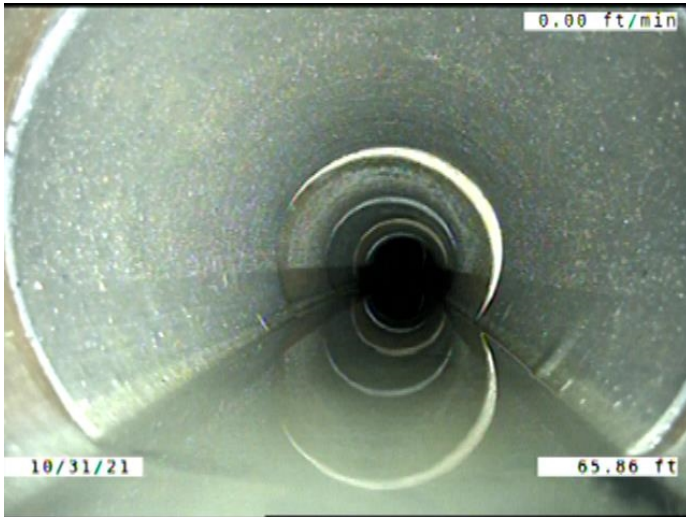
Code: **MWLS**  
Description: **Miscellaneous Water Level Sag**

Distance (ft): **65.9**  
Structural Grade: **2**  
O&M Grade: **0**  
Clock Start/From:  
Clock To:  
1st Value:  
2nd Value:  
Value Percent: **10.000**  
Continuous Index: **S03**  
Within 8" of Joint: **NO**  
Remarks:

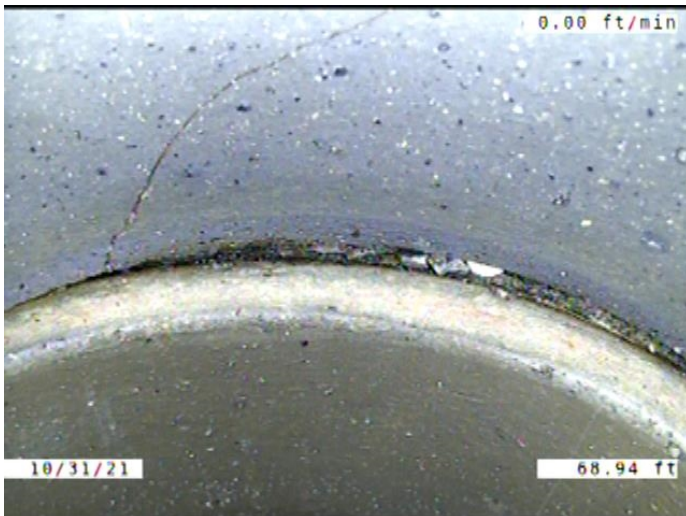
Code: **JOM**  
Description: **Joint Offset Medium**

Distance (ft): **68.9**  
Structural Grade: **3**  
O&M Grade: **0**  
Clock Start/From:  
Clock To:  
1st Value:  
2nd Value:  
Value Percent:  
Continuous Index:  
Within 8" of Joint: **NO**  
Remarks:

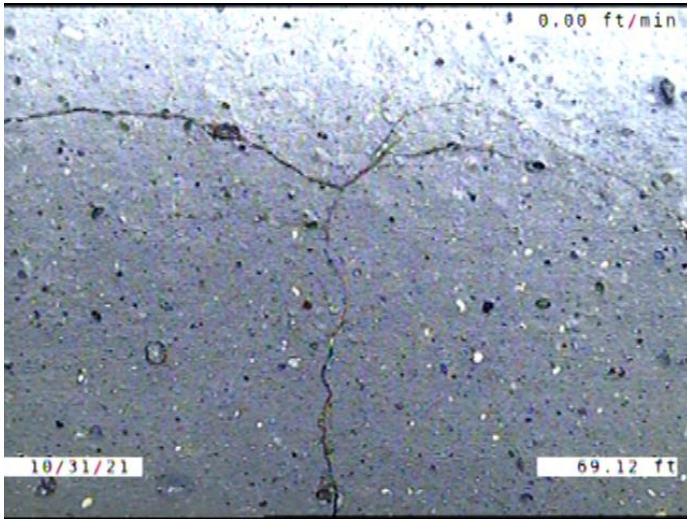
Code: **CM**  
Description: **Crack Multiple**

Distance (ft): **69.1**  
Structural Grade: **3**  
O&M Grade: **0**  
Clock Start/From: **12**  
Clock To: **4**  
1st Value:  
2nd Value:  
Value Percent:  
Continuous Index:  
Within 8" of Joint: **YES**  
Remarks:

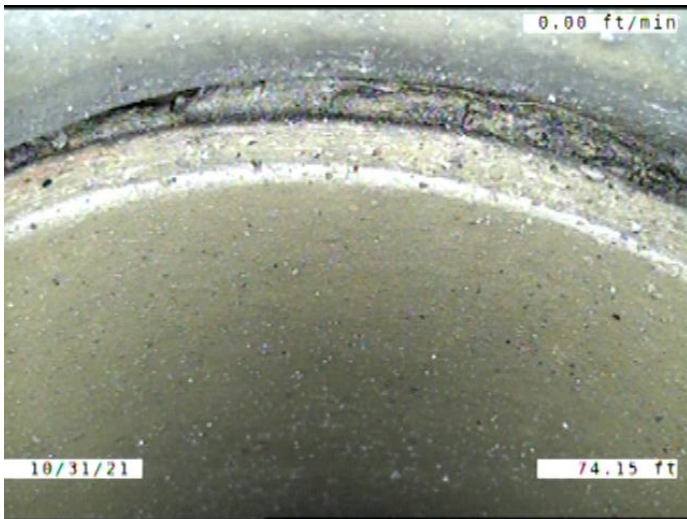
Code: **JOMD**  
Description: **Joint Offset Medium Defective**

Distance (ft): **74.2**  
Structural Grade: **3**  
O&M Grade: **0**  
Clock Start/From:  
Clock To:  
1st Value:  
2nd Value:  
Value Percent:  
Continuous Index:  
Within 8" of Joint: **NO**  
Remarks:

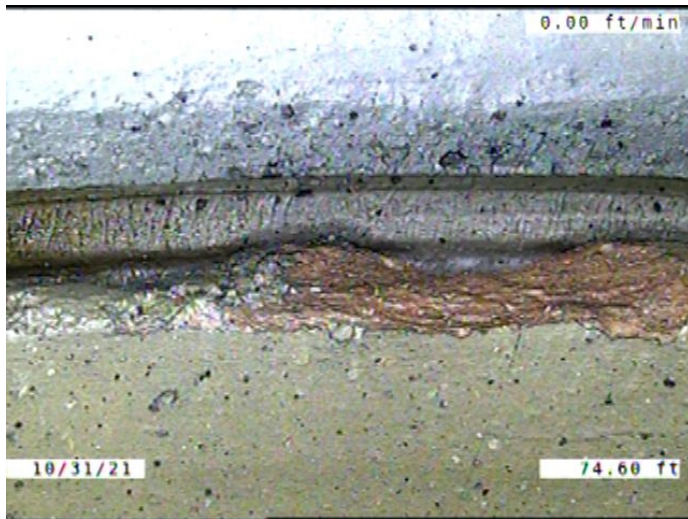
Code: **SZ**  
Description: **Surface Damage Other**

Distance (ft): **74.6**  
Structural Grade: **0**  
O&M Grade: **0**  
Clock Start/From: **8**  
Clock To: **10**  
1st Value:  
2nd Value:  
Value Percent:  
Continuous Index:  
Within 8" of Joint: **YES**  
Remarks: **A PIECE CHIPPED AWAY FROM THE JOINT**

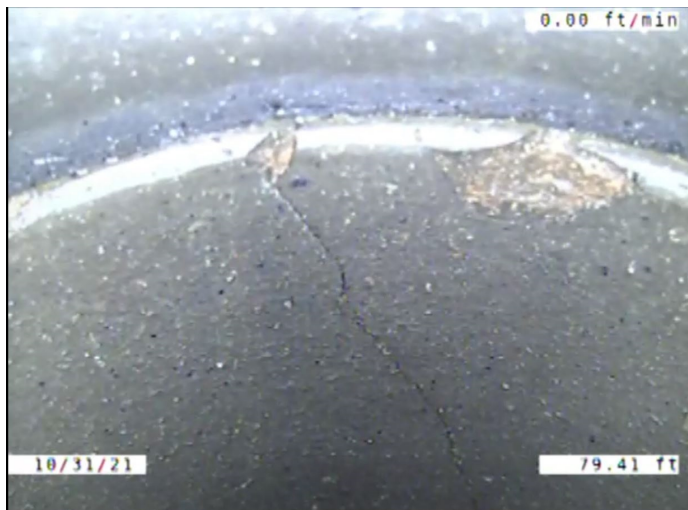
Code: **SSS**  
Description: **Surface Damage Surface Spalling**

Distance (ft): **79.4**  
Structural Grade: **2**  
O&M Grade: **0**  
Clock Start/From: **11**  
Clock To:  
1st Value:  
2nd Value:  
Value Percent:  
Continuous Index:  
Within 8" of Joint: **YES**  
Remarks:

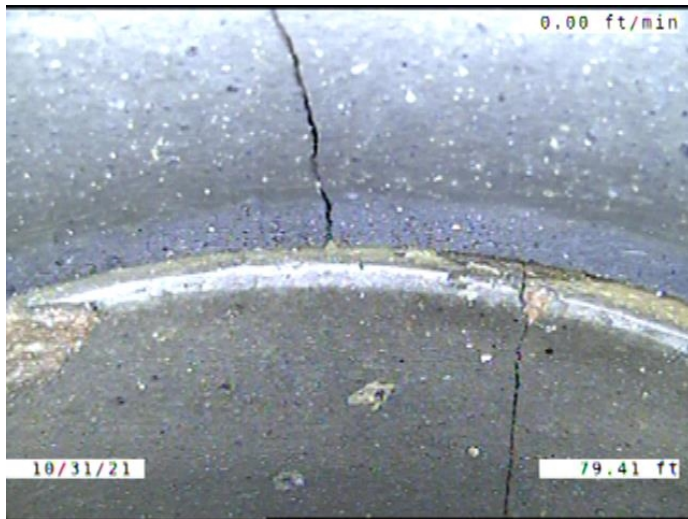
Code: **FM**  
Description: **Fracture Multiple**

Distance (ft): **79.4**  
Structural Grade: **4**  
O&M Grade: **0**  
Clock Start/From: **10**  
Clock To: **1**  
1st Value:  
2nd Value:  
Value Percent:  
Continuous Index: **S04**  
Within 8" of Joint: **YES**  
Remarks:

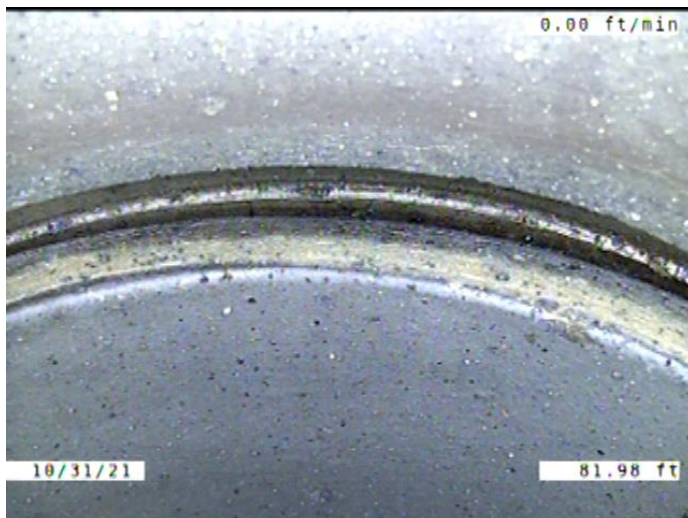
Code: **JOM**  
Description: **Joint Offset Medium**

Distance (ft): **82.0**  
Structural Grade: **3**  
O&M Grade: **0**  
Clock Start/From:  
Clock To:  
1st Value:  
2nd Value:  
Value Percent:  
Continuous Index:  
Within 8" of Joint: **NO**  
Remarks:

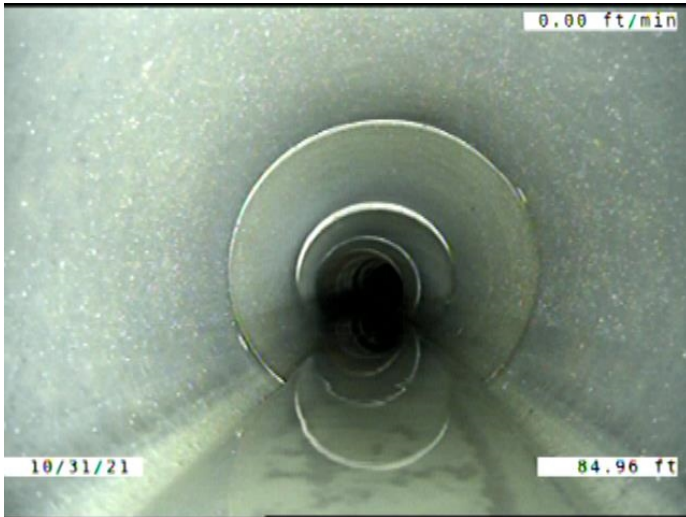
Code: **FM**  
Description: **Fracture Multiple**

Distance (ft): **85.0**  
Structural Grade: **4**  
O&M Grade: **0**  
Clock Start/From: **10**  
Clock To: **1**  
1st Value:  
2nd Value:  
Value Percent:  
Continuous Index: **F04**  
Within 8" of Joint: **YES**  
Remarks:

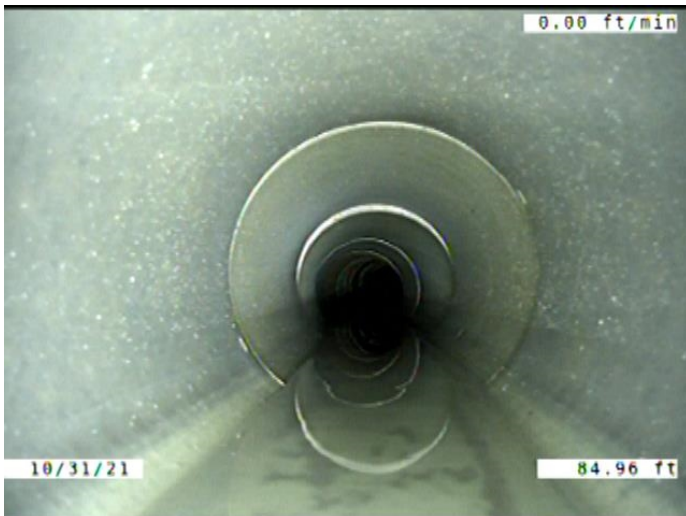
Code: **MWLS**  
Description: **Miscellaneous Water Level Sag**

Distance (ft): **85.0**  
Structural Grade: **2**  
O&M Grade: **0**  
Clock Start/From:  
Clock To:  
1st Value:  
2nd Value:  
Value Percent: **10.000**  
Continuous Index: **F03**  
Within 8" of Joint: **NO**  
Remarks:

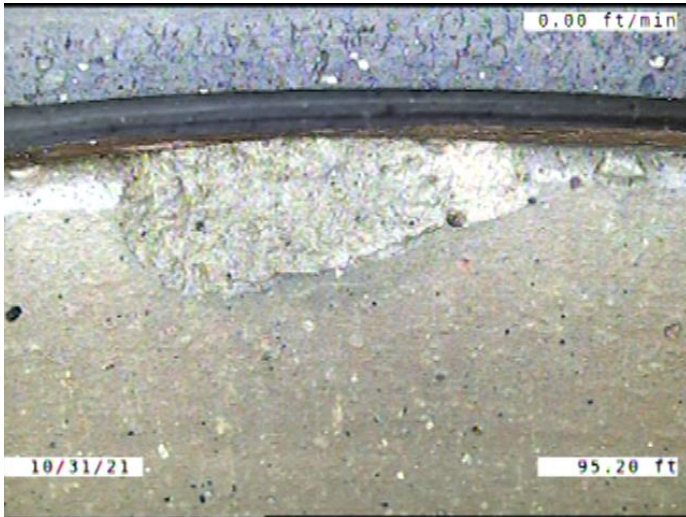
Code: **SZ**  
 Description: **Surface Damage Other**

Distance (ft): **95.2**  
 Structural Grade: **0**  
 O&M Grade: **0**  
 Clock Start/From: **11**  
 Clock To: **2**

**YES**  
**A COUPLE PIECES CHIPPED AWAY FROM THE JOINT**

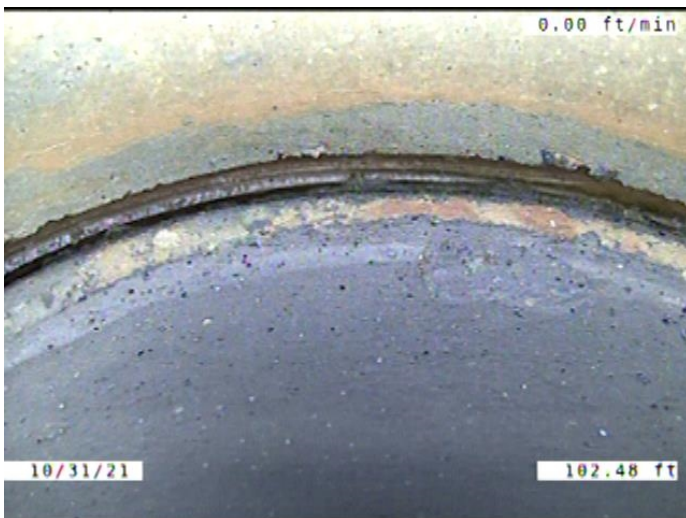
Code: **JOM**  
 Description: **Joint Offset Medium**

Distance (ft): **102.5**  
 Structural Grade: **3**  
 O&M Grade: **0**  
 Clock Start/From:  
 Clock To:

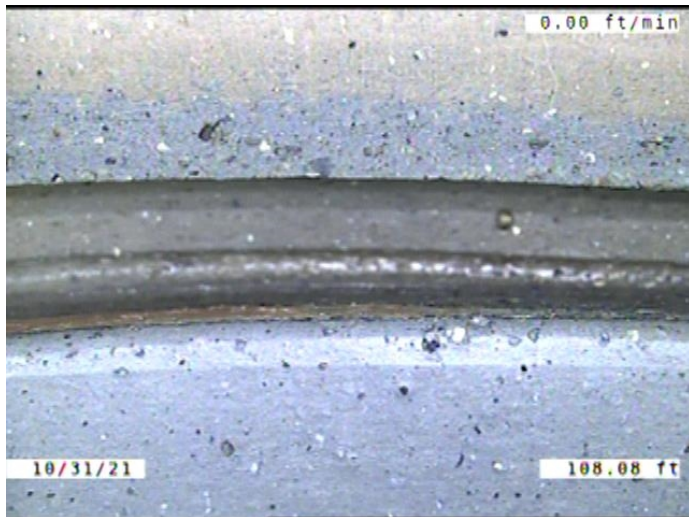
Code: **JAM**  
 Description: **Joint Angular Medium**

Distance (ft): **108.1**  
 Structural Grade: **3**  
 O&M Grade: **0**  
 Clock Start/From:  
 Clock To:  
 1st Value:  
 2nd Value:  
 Value Percent:  
 Continuous Index:  
 Within 8" of Joint: **NO**  
 Remarks:

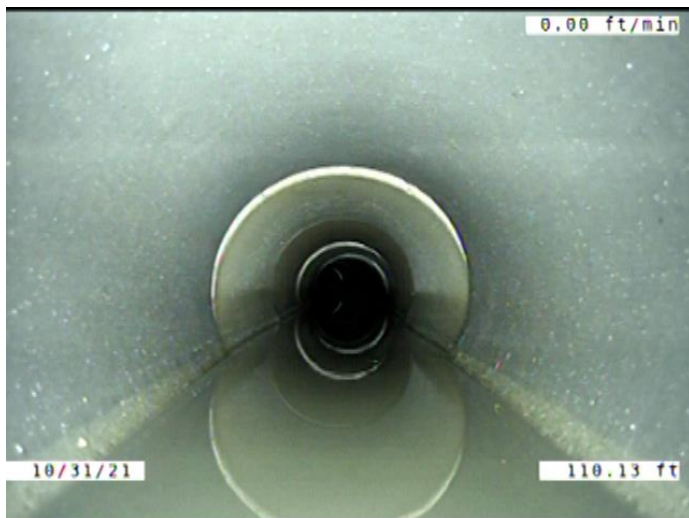
Code: **MWLS**  
 Description: **Miscellaneous Water Level Sag**

Distance (ft): **110.1**  
 Structural Grade: **2**  
 O&M Grade: **0**  
 Clock Start/From:  
 Clock To:  
 1st Value:  
 2nd Value:  
 Value Percent: **10.000**  
 Continuous Index: **S05**  
 Within 8" of Joint: **NO**  
 Remarks:

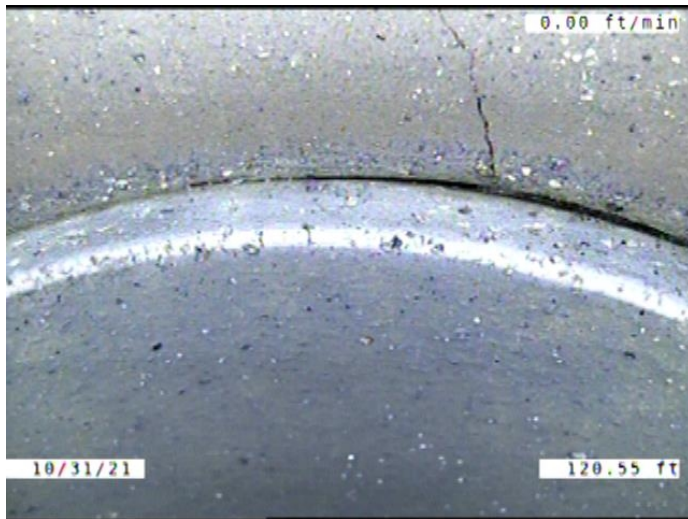
Code: **JOM**  
Description: **Joint Offset Medium**

Distance (ft): **120.6**  
Structural Grade: **3**  
O&M Grade: **0**  
Clock Start/From:  
Clock To:  
1st Value:  
2nd Value:  
Value Percent:  
Continuous Index:  
Within 8" of Joint: **NO**  
Remarks:

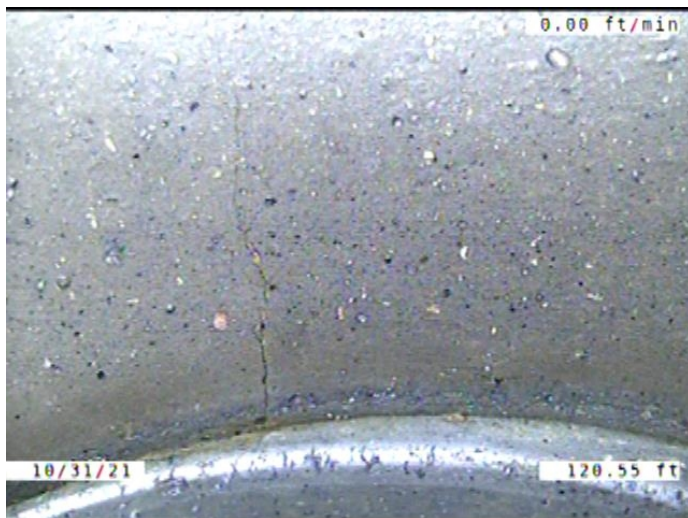
Code: **CM**  
Description: **Crack Multiple**

Distance (ft): **120.6**  
Structural Grade: **3**  
O&M Grade: **0**  
Clock Start/From: **10**  
Clock To: **1**  
1st Value:  
2nd Value:  
Value Percent:  
Continuous Index:  
Within 8" of Joint: **YES**  
Remarks:

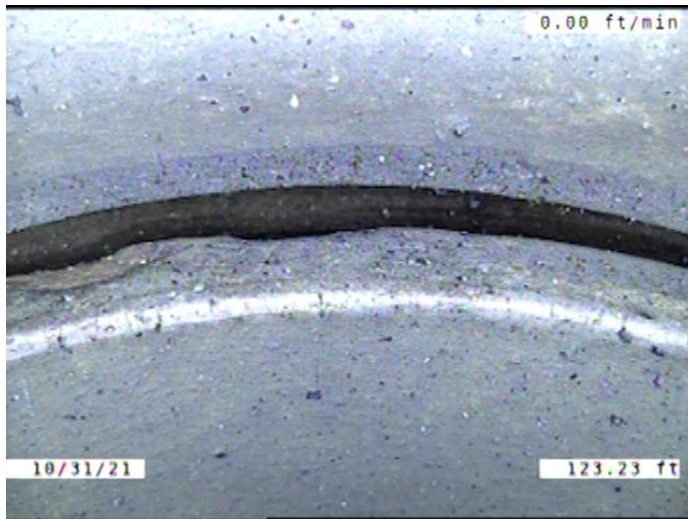
Code: **JOM**  
Description: **Joint Offset Medium**

Distance (ft): **123.2**  
Structural Grade: **3**  
O&M Grade: **0**  
Clock Start/From:  
Clock To:  
1st Value:  
2nd Value:  
Value Percent:  
Continuous Index:  
Within 8" of Joint: **NO**  
Remarks:

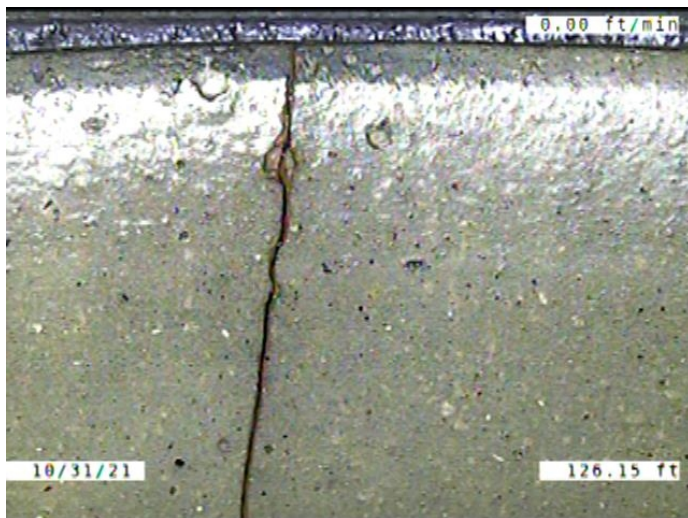
Code: **FM**  
Description: **Fracture Multiple**

Distance (ft): **126.2**  
Structural Grade: **4**  
O&M Grade: **0**  
Clock Start/From: **9**  
Clock To: **2**  
1st Value:  
2nd Value:  
Value Percent:  
Continuous Index: **S06**  
Within 8" of Joint: **YES**  
Remarks:

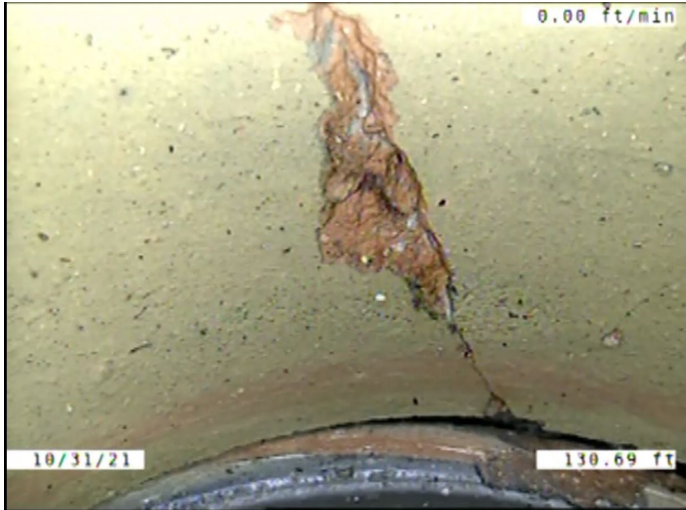
Code: **SSS**  
Description: **Surface Damage Surface Spalling**

Distance (ft): **130.7**  
Structural Grade: **2**  
O&M Grade: **0**  
Clock Start/From: **11**  
Clock To:  
1st Value:  
2nd Value:  
Value Percent:  
Continuous Index:  
Within 8" of Joint: **YES**  
Remarks:

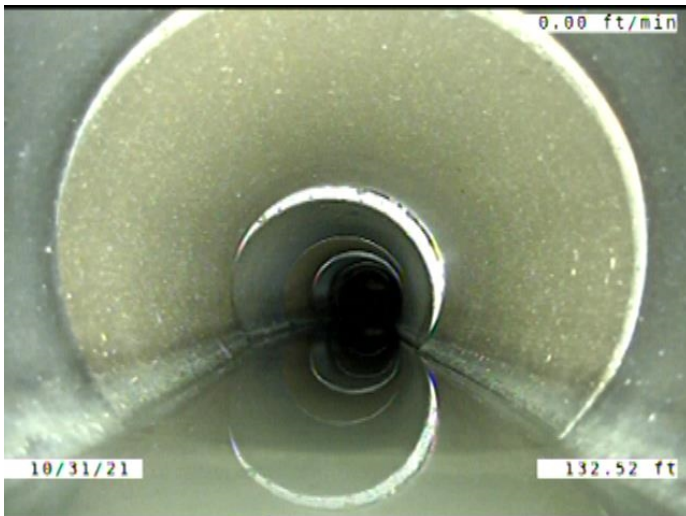
Code: **FM**  
Description: **Fracture Multiple**

Distance (ft): **132.5**  
Structural Grade: **4**  
O&M Grade: **0**  
Clock Start/From: **9**  
Clock To: **2**  
1st Value:  
2nd Value:  
Value Percent:  
Continuous Index: **F06**  
Within 8" of Joint: **YES**  
Remarks:

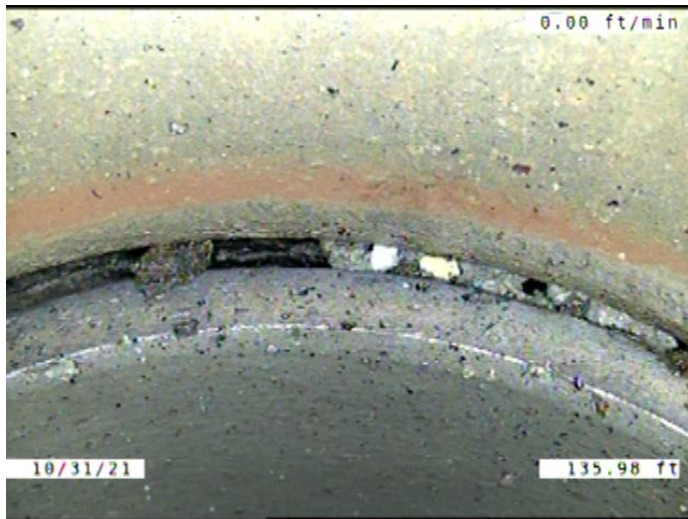
Code: **JOMD**  
 Description: **Joint Offset Medium Defective**

Distance (ft): **136.0**  
 Structural Grade: **3**  
 O&M Grade: **0**  
 Clock Start/From:  
 Clock To:  
 1st Value:  
 2nd Value:  
 Value Percent:  
 Continuous Index:  
 Within 8" of Joint: **NO**  
 Remarks:

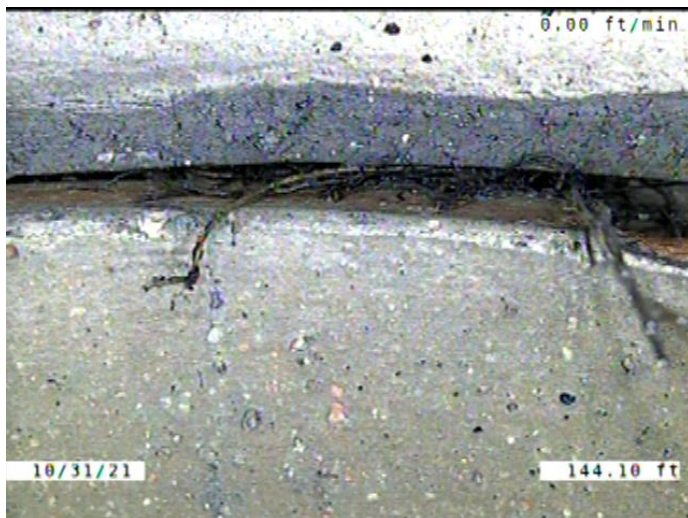
Code: **RFJ**  
 Description: **Roots Fine Joint**

Distance (ft): **144.1**  
 Structural Grade: **0**  
 O&M Grade: **1**  
 Clock Start/From: **1**  
 Clock To: **3**  
 1st Value:  
 2nd Value:  
 Value Percent:  
 Continuous Index:  
 Within 8" of Joint: **YES**  
 Remarks:

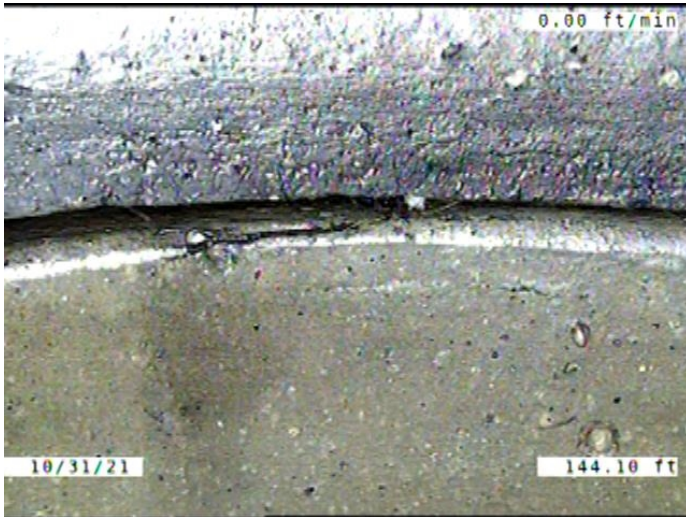
Code: **RFJ**  
 Description: **Roots Fine Joint**

Distance (ft): **144.1**  
 Structural Grade: **0**  
 O&M Grade: **1**  
 Clock Start/From: **9**  
 Clock To: **10**  
 1st Value:  
 2nd Value:  
 Value Percent:  
 Continuous Index:  
 Within 8" of Joint: **YES**  
 Remarks:

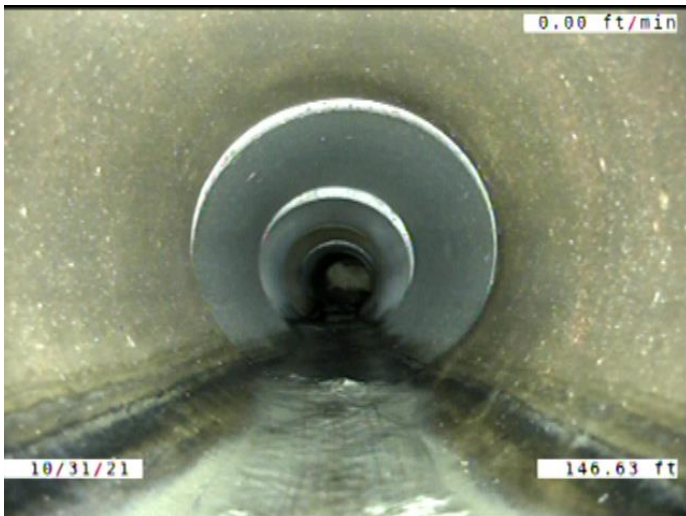
Code: **MWLS**  
 Description: **Miscellaneous Water Level Sag**

Distance (ft): **146.6**  
 Structural Grade: **2**  
 O&M Grade: **0**  
 Clock Start/From:  
 Clock To:  
 1st Value:  
 2nd Value:  
 Value Percent: **10.000**  
 Continuous Index: **F05**  
 Within 8" of Joint: **NO**  
 Remarks:

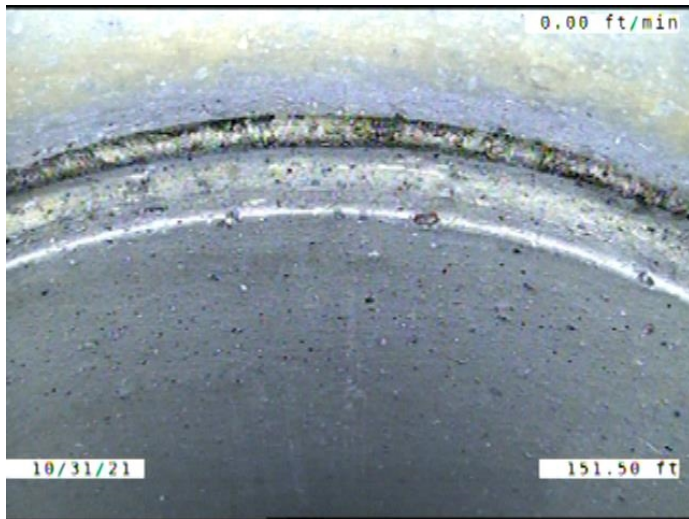
Code: **JOM**  
 Description: **Joint Offset Medium**

Distance (ft): **151.5**  
 Structural Grade: **3**  
 O&M Grade: **0**  
 Clock Start/From:  
 Clock To:  
 1st Value:  
 2nd Value:  
 Value Percent:  
 Continuous Index:  
 Within 8" of Joint: **NO**  
 Remarks:

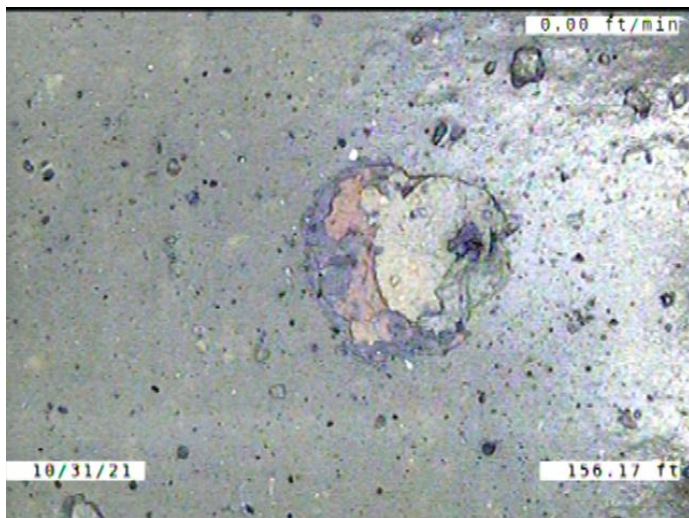
Code: **SSS**  
 Description: **Surface Damage Surface Spalling**

Distance (ft): **156.2**  
 Structural Grade: **2**  
 O&M Grade: **0**  
 Clock Start/From: **8**  
 Clock To:  
 1st Value:  
 2nd Value:  
 Value Percent:  
 Continuous Index:  
 Within 8" of Joint: **YES**  
 Remarks:

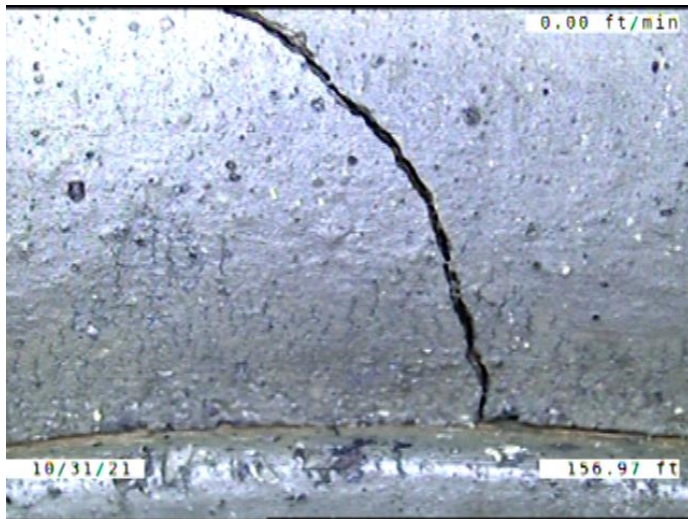
Code: **B**  
Description: **Broken**

Distance (ft): **157.0**  
Structural Grade: **4**  
O&M Grade: **0**  
Clock Start/From: **11**  
Clock To: **1**  
1st Value:  
2nd Value:  
Value Percent:  
Continuous Index:  
Within 8" of Joint: **YES**  
Remarks:

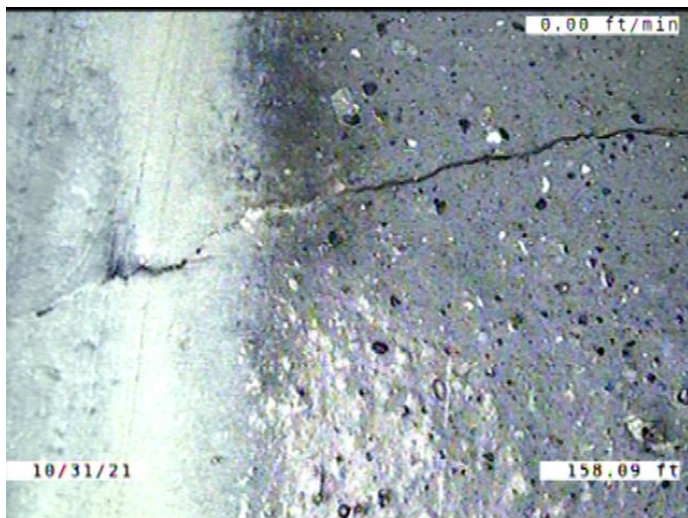
Code: **FC**  
Description: **Fracture Circumferential**

Distance (ft): **158.1**  
Structural Grade: **2**  
O&M Grade: **0**  
Clock Start/From: **12**  
Clock To: **12**  
1st Value:  
2nd Value:  
Value Percent:  
Continuous Index:  
Within 8" of Joint: **NO**  
Remarks:

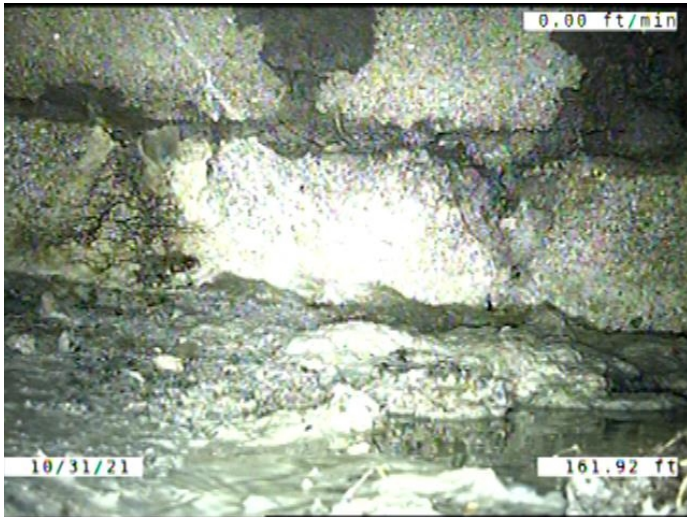
Code: **DSF**  
 Description: **Deposits Settled Fine**

Distance (ft): **161.9**  
 Structural Grade: **0**  
 O&M Grade: **2**  
 Clock Start/From: **5**  
 Clock To: **7**  
 1st Value:  
 2nd Value:  
 Value Percent: **5.000**  
 Continuous Index: **F02**  
 Within 8" of Joint: **YES**  
 Remarks:
