# Profile/Photo Observation Report

Date:	10/31/2021	Weather:		Coding:	PACP 7.0
Pipe Length (ft):	163.8	Owner:	City of Hobart	Pre Clean:	Heavy Cleaning
P.O.#:	YES502259	Surveyor:	S. Bucklin	PSR:	P-504-035-034
Customer:	City of Hobart	Clean Date:	10/27/2021	Shape:	C

Street:	North Colorado Street	Flow Control:	Not Controlled
City:	Hobart, IN	Year Renewed:	
Location:	Local rural streets with light traffic, t	Tape/Media #:	
Purpose:	Routine Assessment	Dia/Height:	10"
Use:	Sanitary Sewage Pipe	Material:	VCP
Drain Area:		Lining:	None
Category:	NA		
Comment:			
Location Details:		Direction of Survey:	Upstream
US MH:	M-504-034	DS MH:	M-504-035
		Total Length Surveyed (ft):	163.8

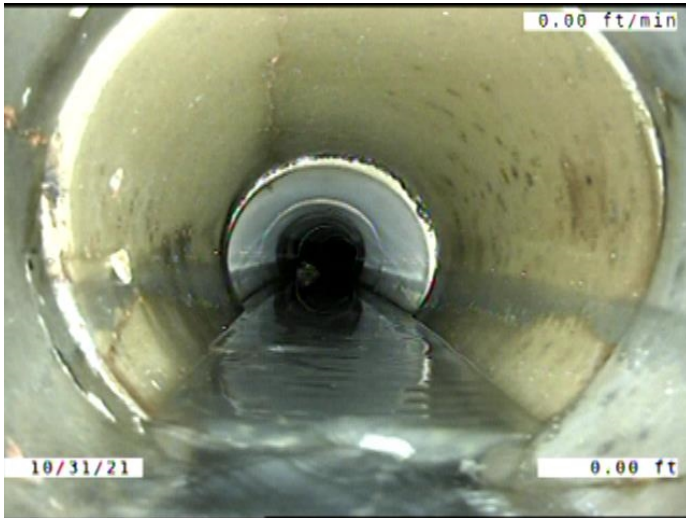
Code: **MWL**  
Description: **Miscellaneous Water Level**

Distance (ft): **.0**  
Structural Grade: **0**  
O&M Grade: **0**  
Clock Start/From:  
Clock To:  
1st Value:  
2nd Value:  
Value Percent: **5.000**  
Continuous Index:  
Within 8" of Joint: **NO**  
Remarks:

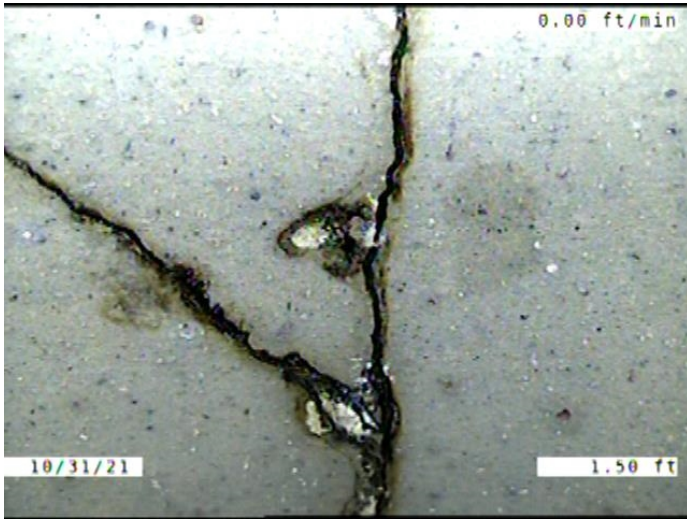
Code: **FM**  
Description: **Fracture Multiple**

Distance (ft): **1.5**  
Structural Grade: **4**  
O&M Grade: **0**  
Clock Start/From: **12**  
Clock To: **12**  
1st Value:  
2nd Value:  
Value Percent:  
Continuous Index: **S01**  
Within 8" of Joint: **YES**  
Remarks:

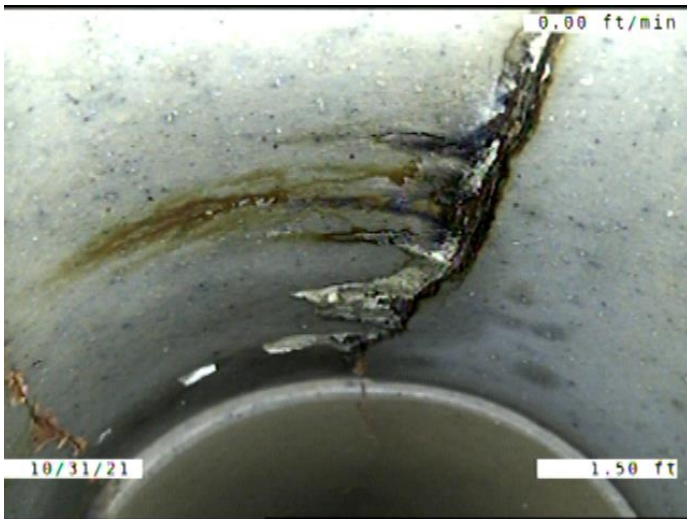
Code: **ISB**  
Description: **Infiltration Stain Barrel**

Distance (ft): **1.5**  
Structural Grade: **0**  
O&M Grade: **1**  
Clock Start/From: **7**  
Clock To: **5**  
1st Value:  
2nd Value:  
Value Percent:  
Continuous Index:  
Within 8" of Joint: **YES**  
Remarks:

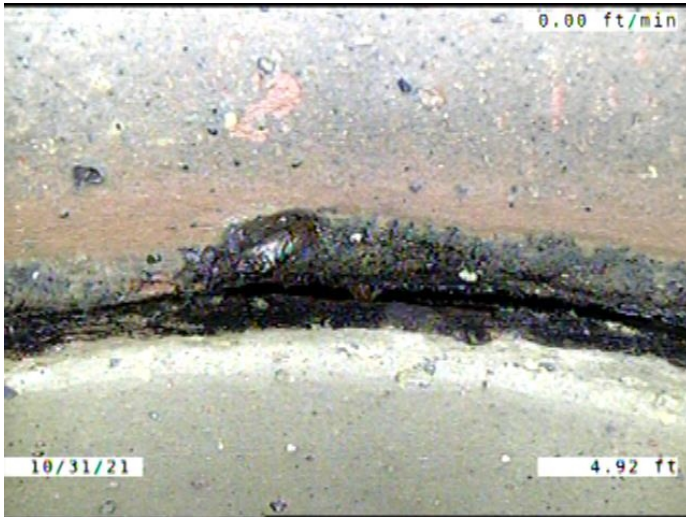
Code: **DAE**  
Description: **Deposits Attached Encrustation**

Distance (ft): **4.9**  
Structural Grade: **0**  
O&M Grade: **2**  
Clock Start/From: **9**  
Clock To: **3**  
1st Value:  
2nd Value:  
Value Percent: **5.000**  
Continuous Index:  
Within 8" of Joint: **YES**  
Remarks:

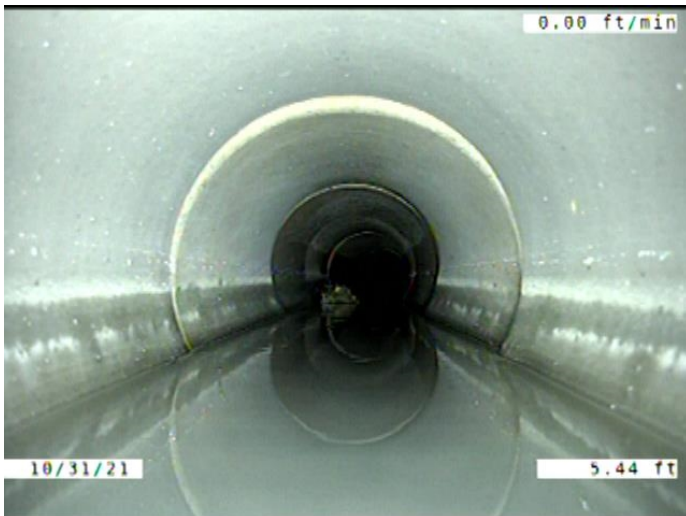
Code: **FM**  
Description: **Fracture Multiple**

Distance (ft): **5.4**  
Structural Grade: **4**  
O&M Grade: **0**  
Clock Start/From: **12**  
Clock To: **12**  
1st Value:  
2nd Value:  
Value Percent:  
Continuous Index: **F01**  
Within 8" of Joint: **YES**  
Remarks:

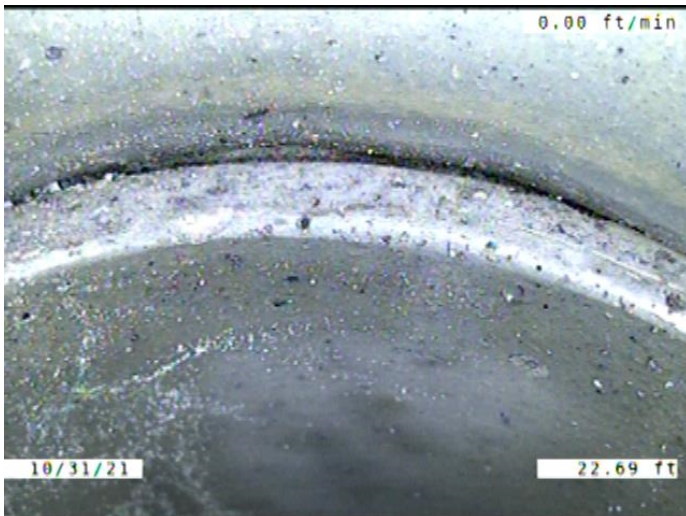
Code: **JOM**  
 Description: **Joint Offset Medium**

Distance (ft): **22.7**  
 Structural Grade: **3**  
 O&M Grade: **0**  
 Clock Start/From:  
 Clock To:  
 1st Value:  
 2nd Value:  
 Value Percent:  
 Continuous Index:  
 Within 8" of Joint: **NO**  
 Remarks:

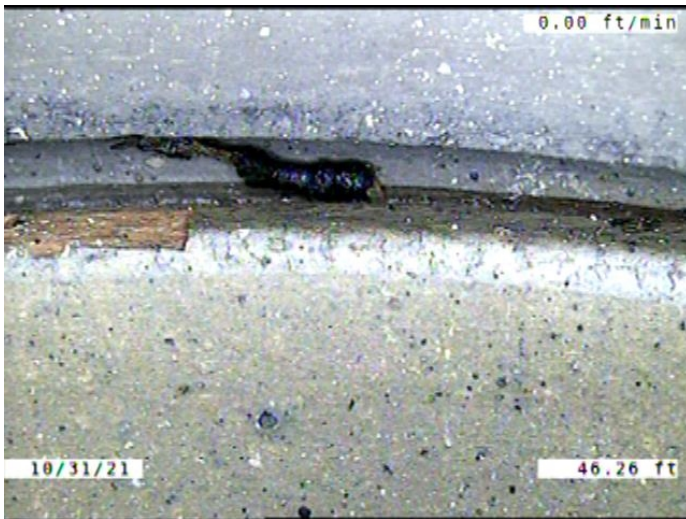
Code:	<b>RFJ</b>
Description:	<b>Roots Fine Joint</b>
Distance (ft):	<b>46.3</b>
Structural Grade:	<b>0</b>
O&M Grade:	<b>1</b>
Clock Start/From:	<b>2</b>
Clock To:	<b>3</b>
1st Value:	
2nd Value:	
Value Percent:	
Continuous Index:	
Within 8" of Joint:	<b>YES</b>
Remarks:

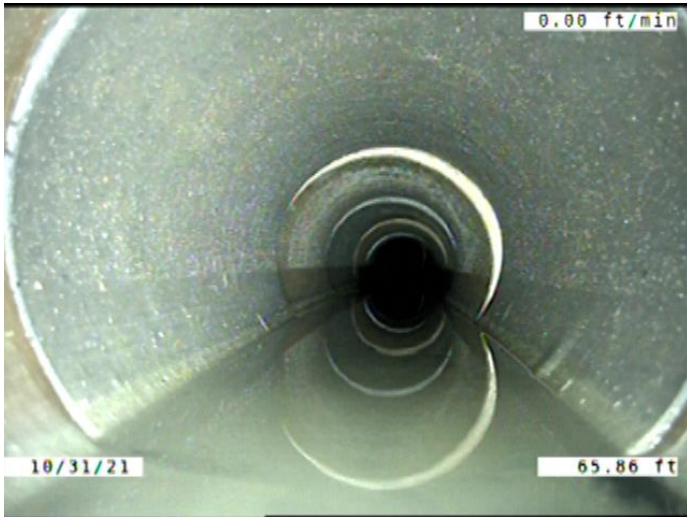
Code: **MWLS**  
 Description: **Miscellaneous Water Level Sag**

Distance (ft): **65.9**  
 Structural Grade: **2**  
 O&M Grade: **0**  
 Clock Start/From:  
 Clock To:  
 1st Value:  
 2nd Value:  
 Value Percent: **10.000**  
 Continuous Index: **S03**  
 Within 8" of Joint: **NO**  
 Remarks:

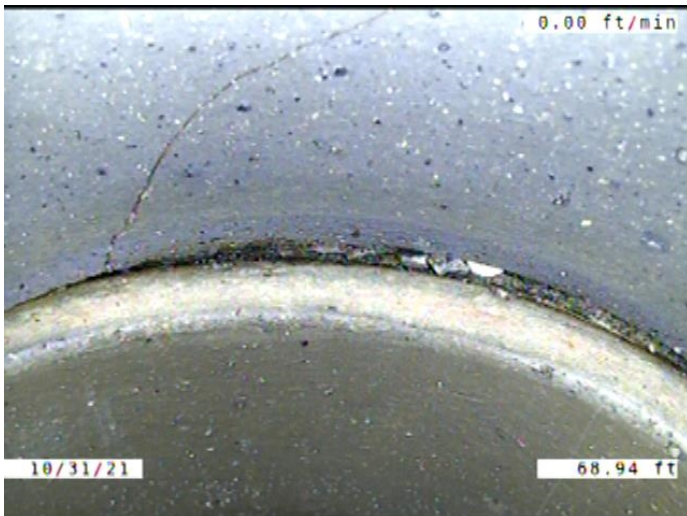
Code: **JOM**  
 Description: **Joint Offset Medium**

Distance (ft): **68.9**  
 Structural Grade: **3**  
 O&M Grade: **0**  
 Clock Start/From:  
 Clock To:  
 1st Value:  
 2nd Value:  
 Value Percent:  
 Continuous Index:  
 Within 8" of Joint: **NO**  
 Remarks:

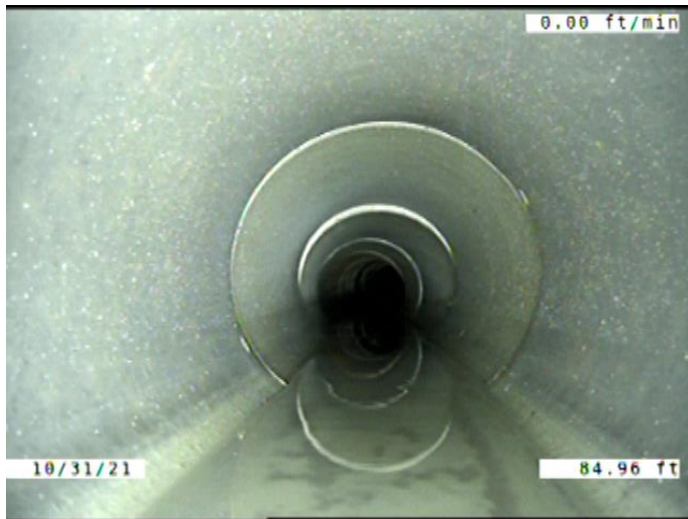
Code: **FM**  
Description: **Fracture Multiple**

Distance (ft): **85.0**  
Structural Grade: **4**  
O&M Grade: **0**  
Clock Start/From: **10**  
Clock To: **1**  
1st Value:  
2nd Value:  
Value Percent:  
Continuous Index: **F04**  
Within 8" of Joint: **YES**  
Remarks:

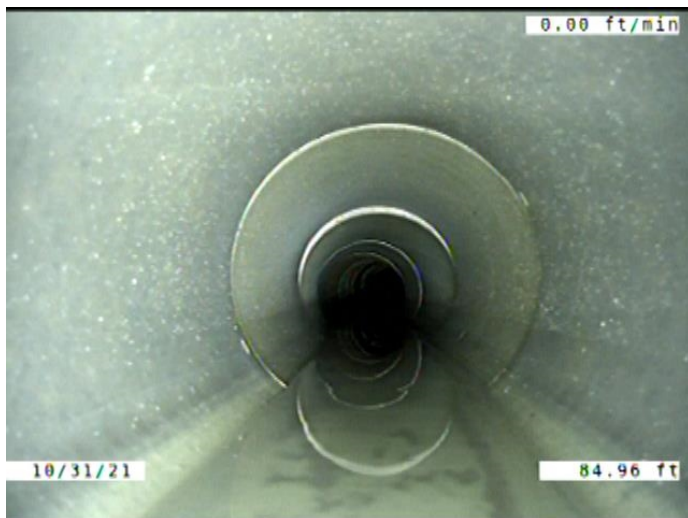
Code: **MWLS**  
Description: **Miscellaneous Water Level Sag**

Distance (ft): **85.0**  
Structural Grade: **2**  
O&M Grade: **0**  
Clock Start/From:  
Clock To:  
1st Value:  
2nd Value:  
Value Percent: **10.000**  
Continuous Index: **F03**  
Within 8" of Joint: **NO**  
Remarks:

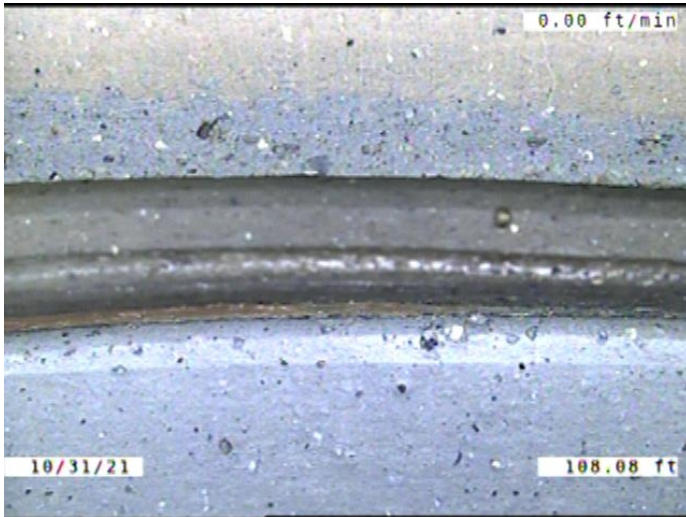
Code: **JAM**  
Description: **Joint Angular Medium**

Distance (ft): **108.1**  
Structural Grade: **3**  
O&M Grade: **0**  
Clock Start/From:  
Clock To:  
1st Value:  
2nd Value:  
Value Percent:  
Continuous Index:  
Within 8" of Joint: **NO**  
Remarks:

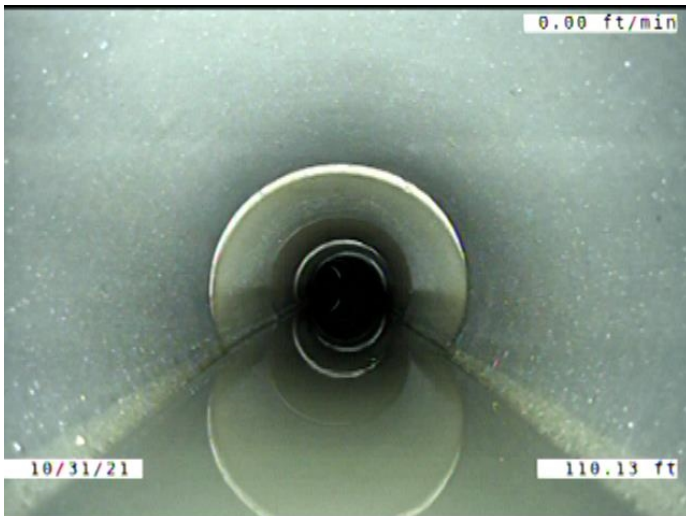
Code: **MWLS**  
Description: **Miscellaneous Water Level Sag**

Distance (ft): **110.1**  
Structural Grade: **2**  
O&M Grade: **0**  
Clock Start/From:  
Clock To:  
1st Value:  
2nd Value:  
Value Percent: **10.000**  
Continuous Index: **S05**  
Within 8" of Joint: **NO**  
Remarks:

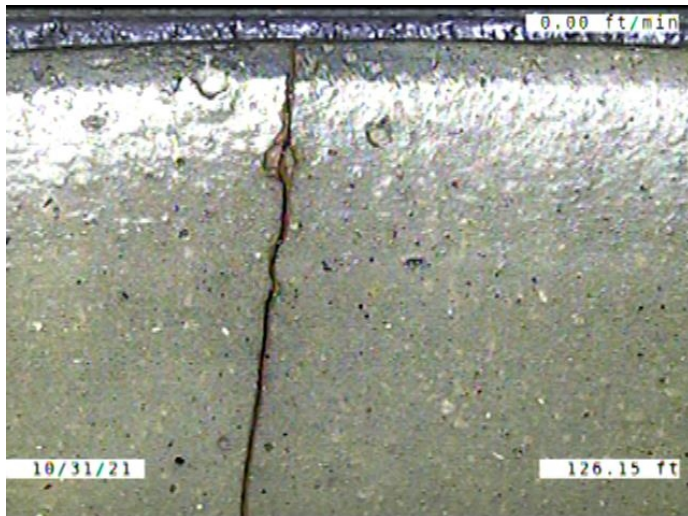
Code: **FM**  
 Description: **Fracture Multiple**

Distance (ft): **126.2**  
 Structural Grade: **4**  
 O&M Grade: **0**  
 Clock Start/From: **9**  
 Clock To: **2**  
 1st Value:  
 2nd Value:  
 Value Percent:  
 Continuous Index: **S06**  
 Within 8" of Joint: **YES**  
 Remarks:

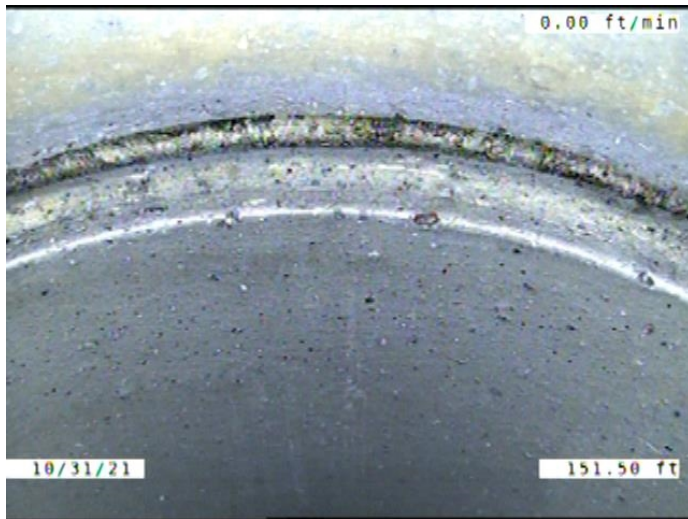
Code: **JOM**  
 Description: **Joint Offset Medium**

Distance (ft): **151.5**  
 Structural Grade: **3**  
 O&M Grade: **0**  
 Clock Start/From:  
 Clock To:  
 1st Value:  
 2nd Value:  
 Value Percent:  
 Continuous Index:  
 Within 8" of Joint: **NO**  
 Remarks:

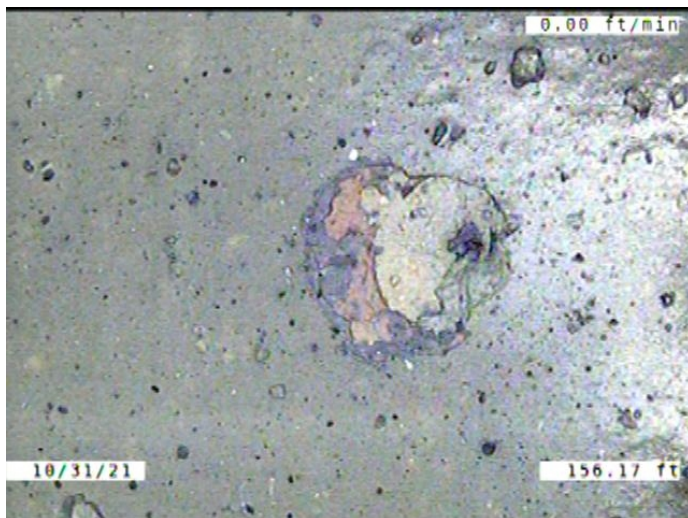
Code: **SSS**  
 Description: **Surface Damage Surface Spalling**

Distance (ft): **156.2**  
 Structural Grade: **2**  
 O&M Grade: **0**  
 Clock Start/From: **8**  
 Clock To:  
 1st Value:  
 2nd Value:  
 Value Percent:  
 Continuous Index:  
 Within 8" of Joint: **YES**  
 Remarks:

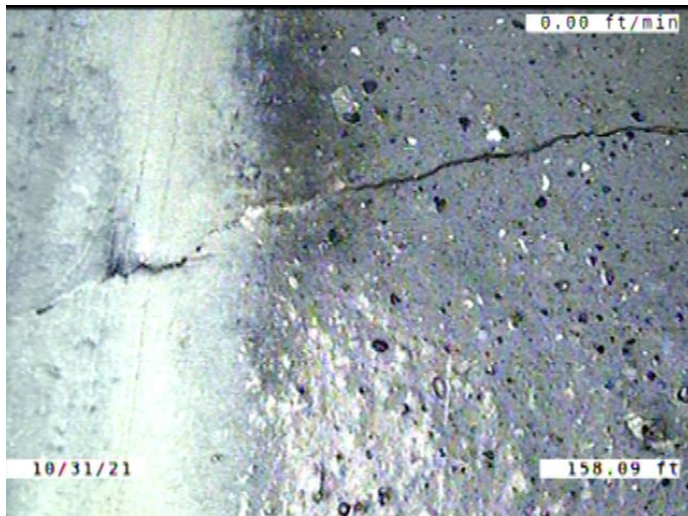
Code: **FC**  
 Description: **Fracture Circumferential**

Distance (ft): **158.1**  
 Structural Grade: **2**  
 O&M Grade: **0**  
 Clock Start/From: **12**  
 Clock To: **12**  
 1st Value:  
 2nd Value:  
 Value Percent:  
 Continuous Index:  
 Within 8" of Joint: **NO**  
 Remarks:

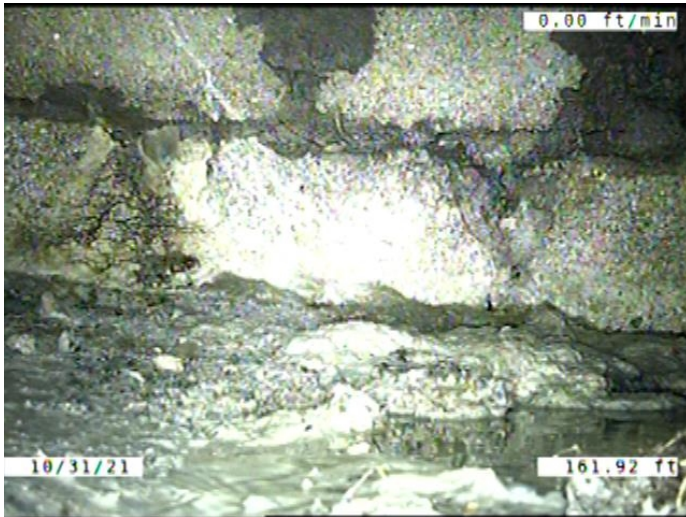
Code: **DSF**  
 Description: **Deposits Settled Fine**

Distance (ft): **161.9**  
 Structural Grade: **0**  
 O&M Grade: **2**  
 Clock Start/From: **5**  
 Clock To: **7**  
 1st Value:  
 2nd Value:  
 Value Percent: **5.000**  
 Continuous Index: **F02**  
 Within 8" of Joint: **YES**  
 Remarks:
