Profile/Photo Observation Report

Street:	W CLEVELAND AVE & N CAVENDER S	Flow Control:	Not Controlled
City:	Hobart, IN	Year Renewed:	
Location:	Light Highway	Tape/Media #:	
Purpose:	Routine Assessment	Dia/Height:	10"
Use:	Sanitary	Material:	VCP
Drain Area:	NA	Lining:	
Category:	NA		
Comment:	F_S_P_C at 4 ft debris . Flow direction wrong		
Location Details:		Direction of Survey:	Downstream
US MH:	M-504-034	DS MH:	M-504-041
		Total Length Surveyed (ft):	5.5

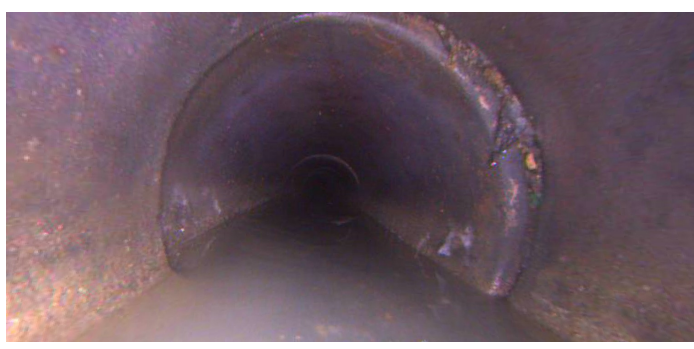
Code: **AMH**
Description: **Manhole**

Distance (ft): **.0**
Structural Grade: **0**
O&M Grade: **0**
Clock Start/From:
Clock To:
1st Value:
2nd Value:
Value Percent:
Continuous Index:
Within 8" of Joint: **NO**
Remarks: **M-504-034**

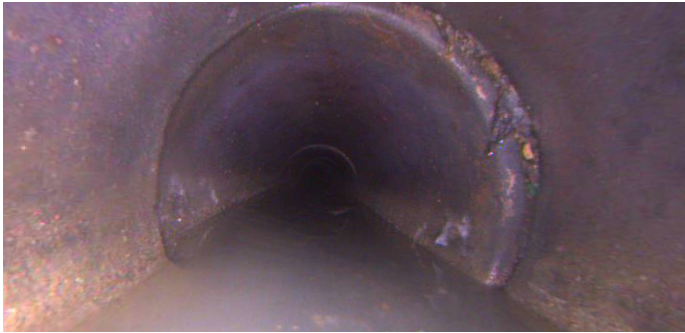
Code:	MWL
Description:	Water Level

Distance (ft):	.0
Structural Grade:	0
O&M Grade:	0
Clock Start/From:	
Clock To:	
1st Value:	
2nd Value:	
Value Percent:	20.000
Continuous Index:	
Within 8" of Joint:	NO
Remarks:

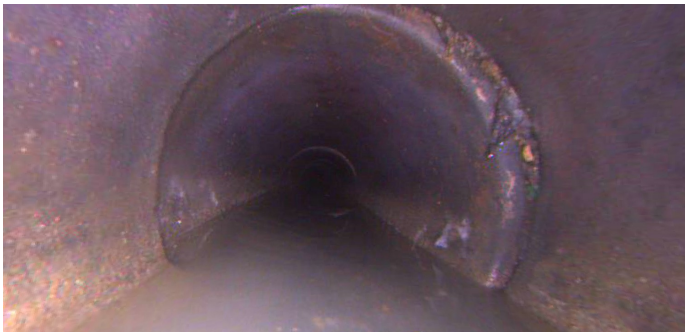
Code:	RFJ
Description:	Roots Fine Joint

Distance (ft):	.0
Structural Grade:	0
O&M Grade:	1
Clock Start/From:	8
Clock To:	4
1st Value:	
2nd Value:	
Value Percent:	
Continuous Index:	
Within 8" of Joint:	YES
Remarks:

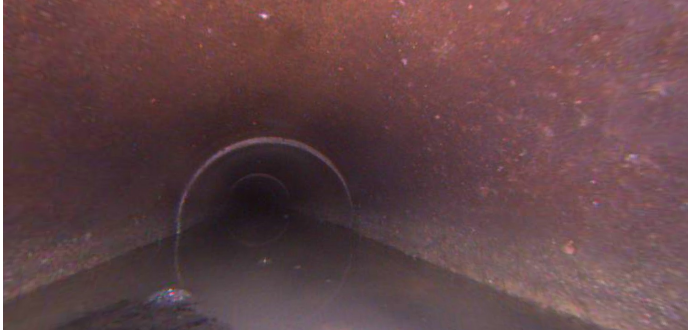
Code:	MSA
Description:	Abandoned Survey
Distance (ft):	5.5
Structural Grade:	0
O&M Grade:	0
Clock Start/From:	
Clock To:	
1st Value:	
2nd Value:	
Value Percent:	
Continuous Index:	
Within 8" of Joint:	NO
Remarks:	debris under water
