## Profile/Photo Observation Report

Street:	<b>FOXCROFT STREET</b>	Flow Control:	<b>Not Controlled</b>
City:	<b>Hobart, IN</b>	Year Renewed:	
Location:	<b>Light Highway</b>	Tape/Media #:	
Purpose:	<b>Routine Assessment</b>	Dia/Height:	<b>10"</b>
Use:	<b>Sanitary</b>	Material:	<b>VCP</b>
Drain Area:	<b>NA</b>	Lining:	
Category:	<b>NA</b>		
Comment:	<b>F_S_P_C at 4 ft debris . Flow direction wrong</b>		
Location Details:		Direction of Survey:	<b>Downstream</b>
US MH:	<b>M-504-034</b>	DS MH:	<b>M-504-041</b>
		Total Length Surveyed (ft):	<b>5.5</b>

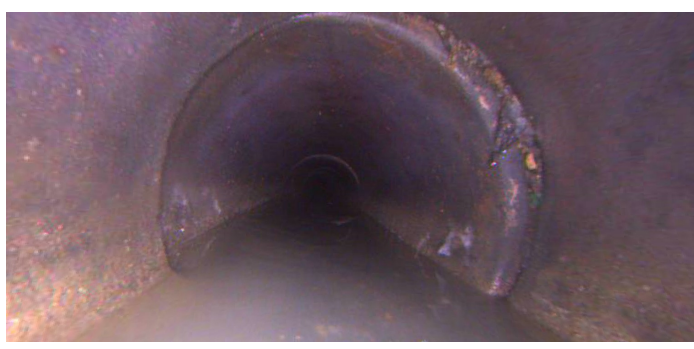
Code: **AMH**  
Description: **Manhole**

Distance (ft): **.0**  
Structural Grade: **0**  
O&M Grade: **0**  
Clock Start/From:  
Clock To:  
1st Value:  
2nd Value:  
Value Percent:  
Continuous Index:  
Within 8" of Joint: **NO**  
Remarks: **M-504-034**

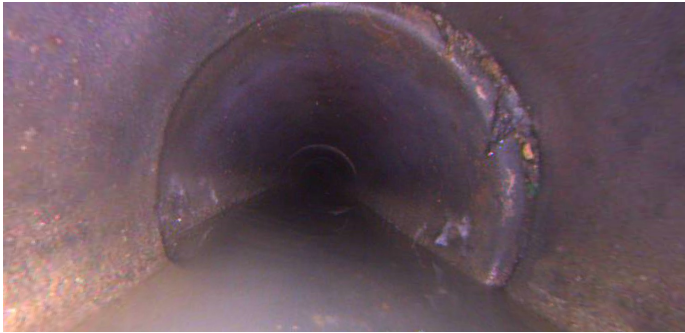
Code:	<b>MWL</b>
Description:	<b>Water Level</b>

Distance (ft):	<b>.0</b>
Structural Grade:	<b>0</b>
O&M Grade:	<b>0</b>
Clock Start/From:	
Clock To:	
1st Value:	
2nd Value:	
Value Percent:	<b>20.000</b>
Continuous Index:	
Within 8" of Joint:	<b>NO</b>
Remarks:

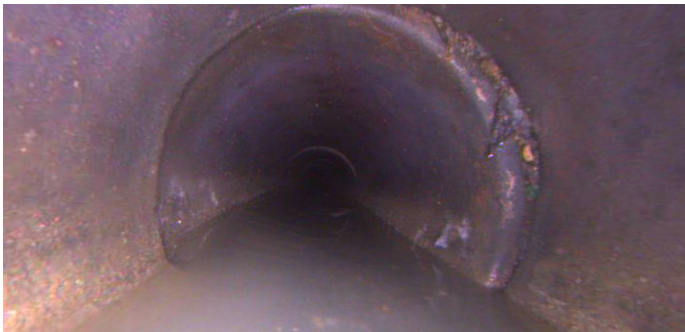
Code:	<b>RFJ</b>
Description:	<b>Roots Fine Joint</b>

Distance (ft):	<b>.0</b>
Structural Grade:	<b>0</b>
O&M Grade:	<b>1</b>
Clock Start/From:	<b>8</b>
Clock To:	<b>4</b>
1st Value:	
2nd Value:	
Value Percent:	
Continuous Index:	
Within 8" of Joint:	<b>YES</b>
Remarks:

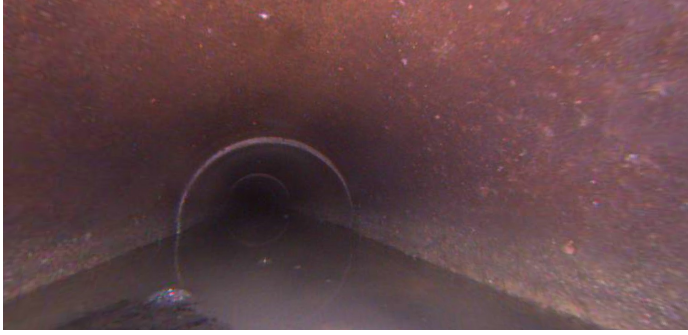
Code:	<b>MSA</b>
Description:	<b>Abandoned Survey</b>
Distance (ft):	<b>5.5</b>
Structural Grade:	<b>0</b>
O&M Grade:	<b>0</b>
Clock Start/From:	
Clock To:	
1st Value:	
2nd Value:	
Value Percent:	
Continuous Index:	
Within 8" of Joint:	<b>NO</b>
Remarks:	<b>debris under water</b>
