RedZone[®]
ROBOTICS

Street:	North Colorado Street		Flow Control:	Not Controlled	
City:	Hobart, IN		Year Renewed:		
Location:	Local rural streets with light traffic, t		Tape/Media #:		
Purpose:	Routine Assessment		Dia/Height:	10"	
Use:	Sanitary Sewage Pipe		Material:	VCP	
Drain Area:			Lining:	None	
Category:	NA				
Comment:					
Location Details:			Direction of Survey:	Upstream	
US MH:	M-504-034	DS MH:	M-504-041	Total Length Surveyed (ft):	161.8

Tuesday, April 25, 2023

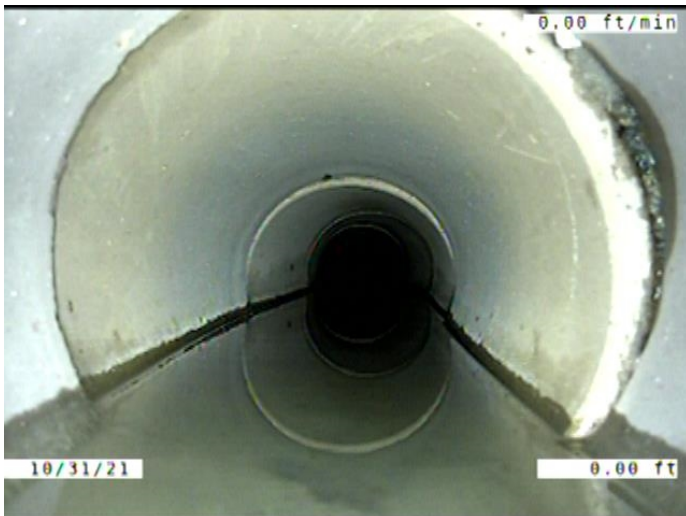
Code: **MWL**
Description: **Miscellaneous Water Level**

Distance (ft): **.0**
Structural Grade: **0**
O&M Grade: **0**
Clock Start/From:
Clock To:
1st Value:
2nd Value:
Value Percent: **10.000**
Continuous Index:
Within 8" of Joint: **NO**
Remarks:

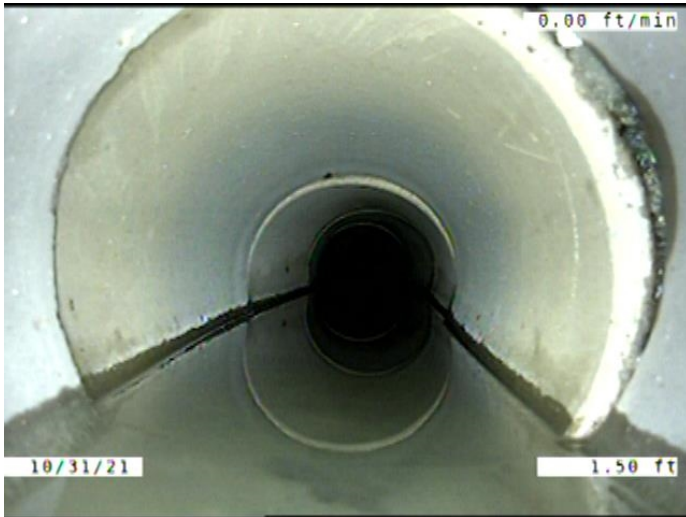
Code: **MGO**
 Description: **Miscellaneous General Observation**

Distance (ft): **1.5**
 Structural Grade: **0**
 O&M Grade: **0**
 Clock Start/From:
 Clock To:
 1st Value:
 2nd Value:
 Value Percent:
 Continuous Index:
 Within 8" of Joint: **NO**
 Remarks: **DROP INTO THE MANHOLE. HAD TO START IN THE PIPE.**

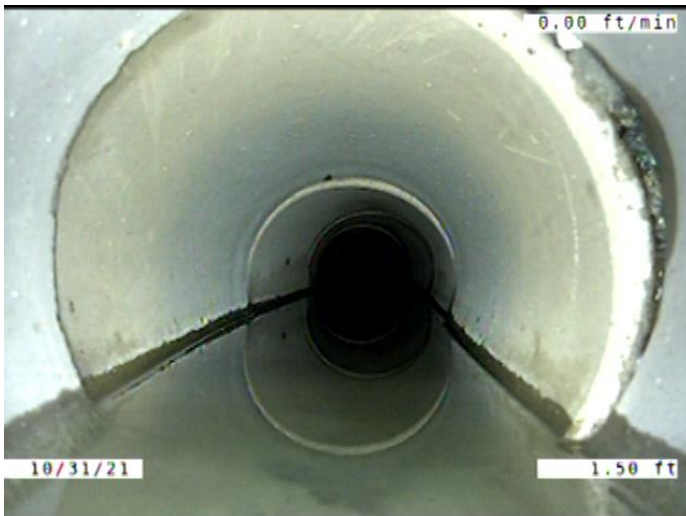
Code: **MWLS**
 Description: **Miscellaneous Water Level Sag**

Distance (ft): **1.5**
 Structural Grade: **2**
 O&M Grade: **0**
 Clock Start/From:
 Clock To:
 1st Value:
 2nd Value:
 Value Percent: **10.000**
 Continuous Index: **S01**
 Within 8" of Joint: **NO**
 Remarks:

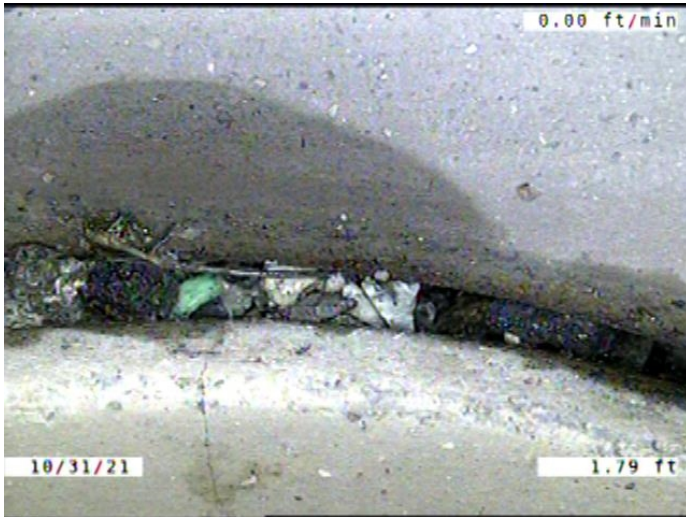
Code: **RFJ**
Description: **Roots Fine Joint**

Distance (ft): **1.8**
Structural Grade: **0**
O&M Grade: **1**
Clock Start/From: **2**
Clock To:
1st Value:
2nd Value:
Value Percent:
Continuous Index:
Within 8" of Joint: **YES**
Remarks:

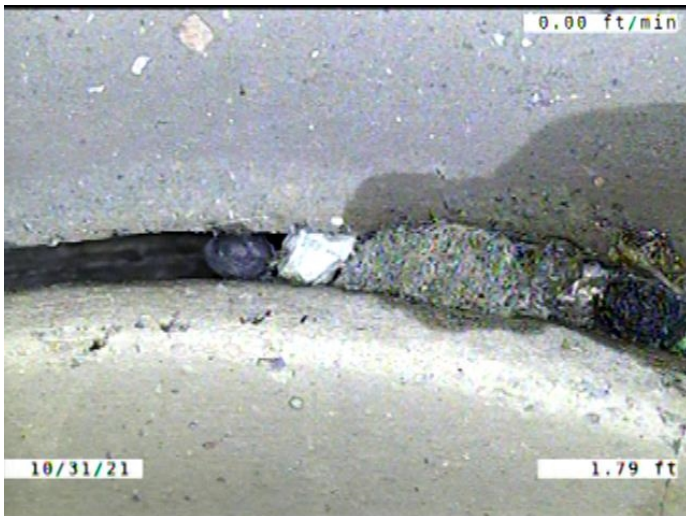
Code: **JOMD**
Description: **Joint Offset Medium Defective**

Distance (ft): **1.8**
Structural Grade: **3**
O&M Grade: **0**
Clock Start/From:
Clock To:
1st Value:
2nd Value:
Value Percent:
Continuous Index:
Within 8" of Joint: **NO**
Remarks: **LOOKS TO BE LEAKING WATER**

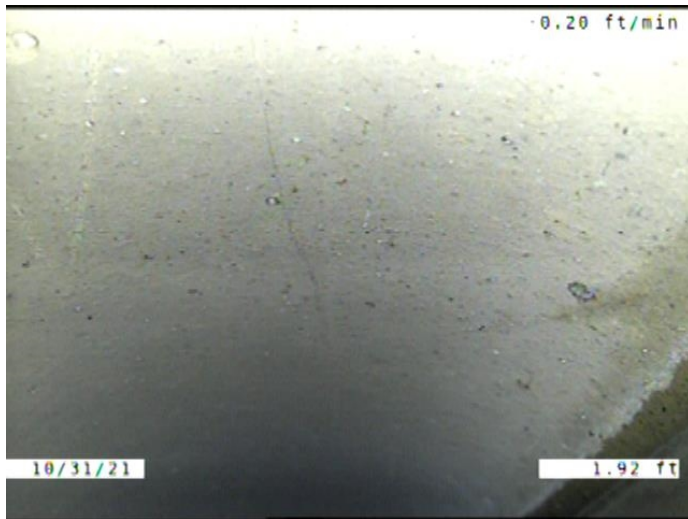
Code: **CM**
Description: **Crack Multiple**

Distance (ft): **1.9**
Structural Grade: **3**
O&M Grade: **0**
Clock Start/From: **2**
Clock To: **4**
1st Value:
2nd Value:
Value Percent:
Continuous Index:
Within 8" of Joint: **YES**
Remarks:

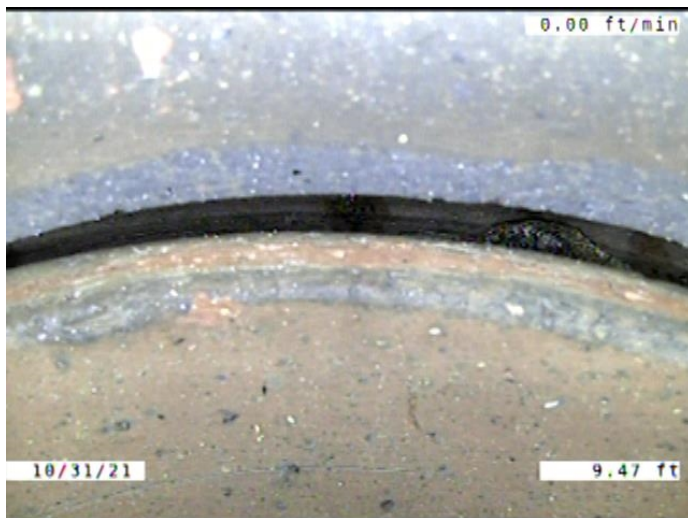
Code: **JOM**
Description: **Joint Offset Medium**

Distance (ft): **9.5**
Structural Grade: **3**
O&M Grade: **0**
Clock Start/From:
Clock To:
1st Value:
2nd Value:
Value Percent:
Continuous Index:
Within 8" of Joint: **NO**
Remarks:

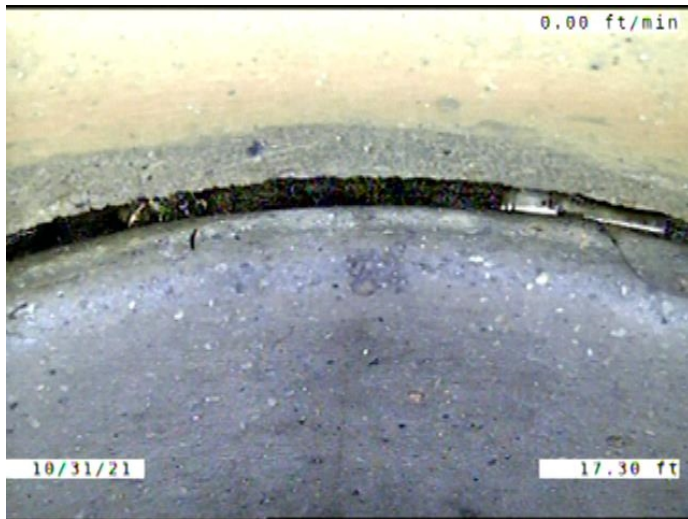
Code: **JOM**
 Description: **Joint Offset Medium**

Distance (ft): **17.3**
 Structural Grade: **3**
 O&M Grade: **0**
 Clock Start/From:
 Clock To:
 1st Value:
 2nd Value:
 Value Percent:
 Continuous Index:
 Within 8" of Joint: **NO**
 Remarks:

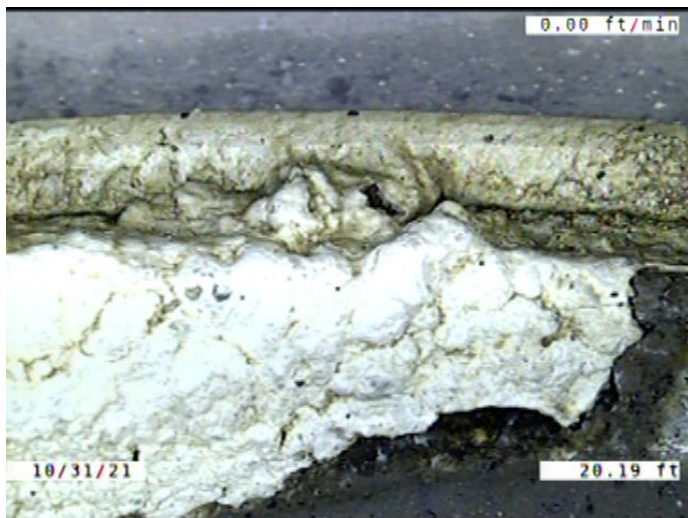
Code: **DAE**
 Description: **Deposits Attached Encrustation**

Distance (ft): **20.2**
 Structural Grade: **0**
 O&M Grade: **2**
 Clock Start/From: **9**
 Clock To: **3**
 1st Value:
 2nd Value:
 Value Percent: **5.000**
 Continuous Index:
 Within 8" of Joint: **YES**
 Remarks:

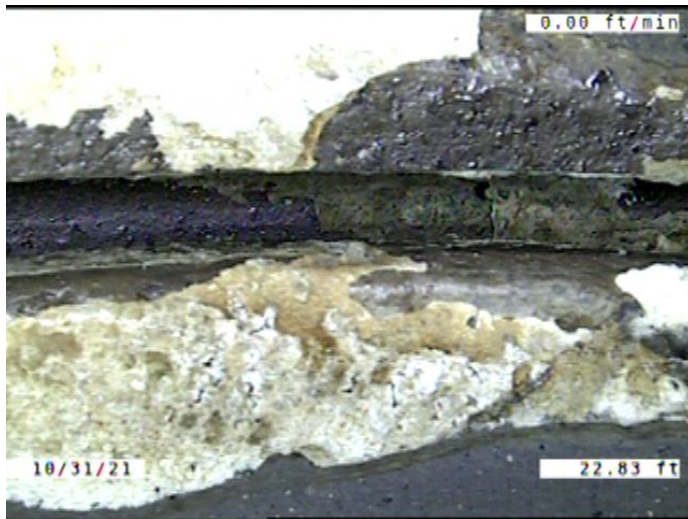
Code: **DAE**
Description: **Deposits Attached Encrustation**

Distance (ft): **22.8**
Structural Grade: **0**
O&M Grade: **2**
Clock Start/From: **9**
Clock To: **2**
1st Value:
2nd Value:
Value Percent: **5.000**
Continuous Index:
Within 8" of Joint: **YES**
Remarks:

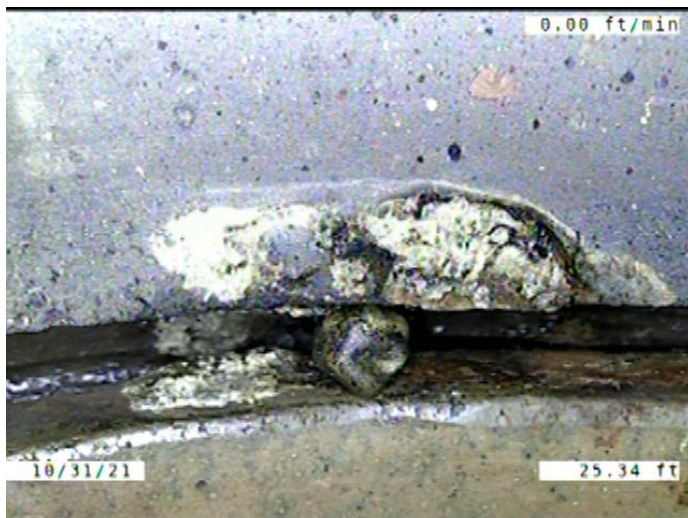
Code: **DAE**
Description: **Deposits Attached Encrustation**

Distance (ft): **25.3**
Structural Grade: **0**
O&M Grade: **2**
Clock Start/From: **7**
Clock To: **5**
1st Value:
2nd Value:
Value Percent: **5.000**
Continuous Index: **S02**
Within 8" of Joint: **YES**
Remarks:

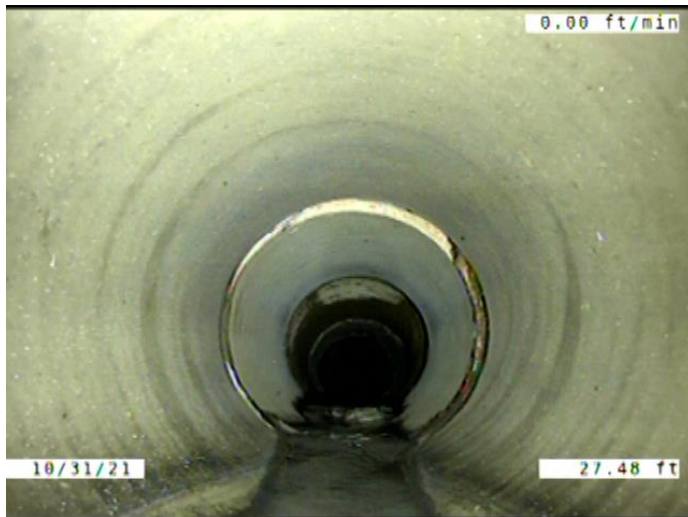
Code: **MWLS**
 Description: **Miscellaneous Water Level Sag**

Distance (ft): **27.5**
 Structural Grade: **2**
 O&M Grade: **0**
 Clock Start/From:
 Clock To:
 1st Value:
 2nd Value:
 Value Percent: **10.000**
 Continuous Index: **F01**
 Within 8" of Joint: **NO**
 Remarks:

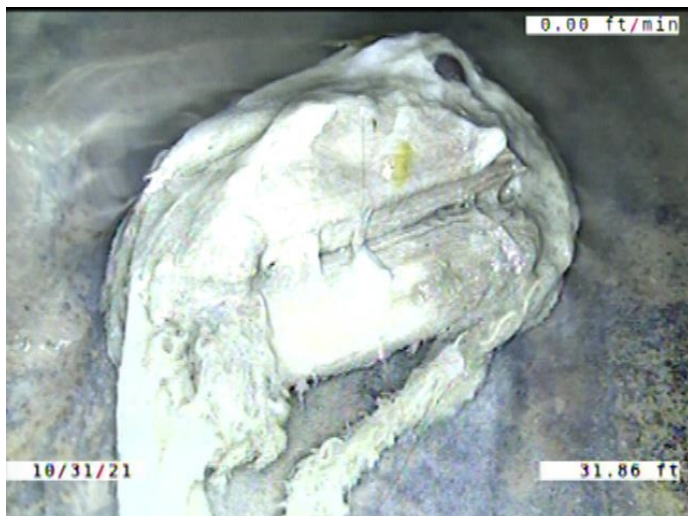
Code: **OBM**
 Description: **Obstruction Pipe Material in Invert**

Distance (ft): **31.9**
 Structural Grade: **0**
 O&M Grade: **2**
 Clock Start/From: **6**
 Clock To:
 1st Value:
 2nd Value:
 Value Percent: **5.000**
 Continuous Index:
 Within 8" of Joint: **YES**
 Remarks:

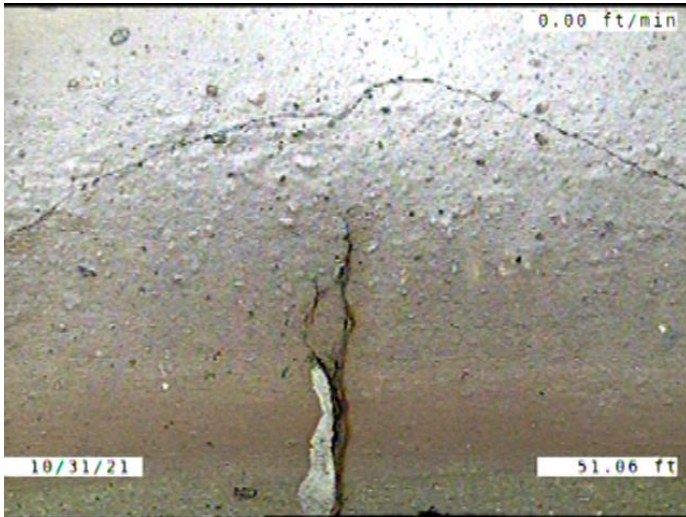
Code: **CM**
 Description: **Crack Multiple**

Distance (ft): **51.1**
 Structural Grade: **3**
 O&M Grade: **0**
 Clock Start/From: **9**
 Clock To: **1**
 1st Value:
 2nd Value:
 Value Percent:
 Continuous Index:
 Within 8" of Joint: **YES**
 Remarks:

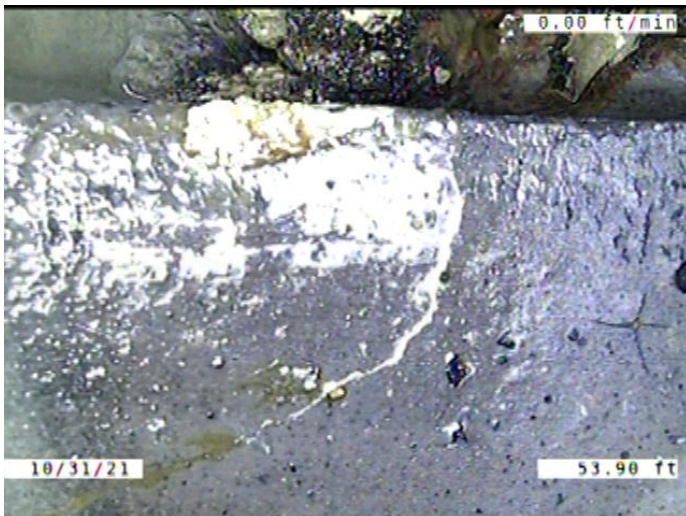
Code: **CM**
 Description: **Crack Multiple**

Distance (ft): **53.9**
 Structural Grade: **3**
 O&M Grade: **0**
 Clock Start/From: **3**
 Clock To: **4**
 1st Value:
 2nd Value:
 Value Percent:
 Continuous Index:
 Within 8" of Joint: **YES**
 Remarks:

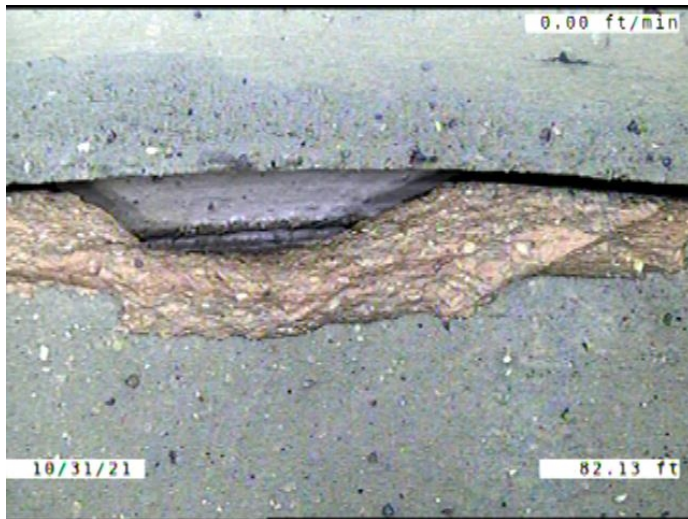
Code:	SZ
Description:	Surface Damage Other
Distance (ft):	82.1
Structural Grade:	0
O&M Grade:	0
Clock Start/From:	10
Clock To:	12
1st Value:	
2nd Value:	
Value Percent:	
Continuous Index:	
Within 8" of Joint:	YES
Remarks:	A PIECE CHIPPED AWAY FROM THE JOINT

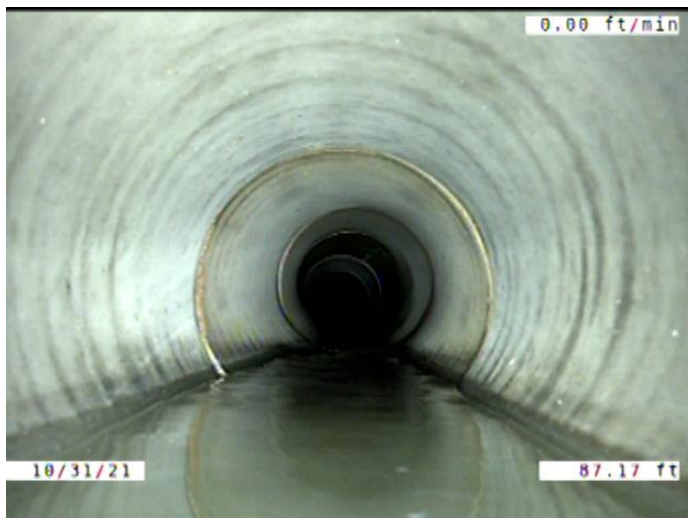
Code:	MWLS
Description:	Miscellaneous Water Level Sag
Distance (ft):	87.2
Structural Grade:	2
O&M Grade:	0
Clock Start/From:	
Clock To:	
1st Value:	
2nd Value:	
Value Percent:	10.000
Continuous Index:	S03
Within 8" of Joint:	NO
Remarks:

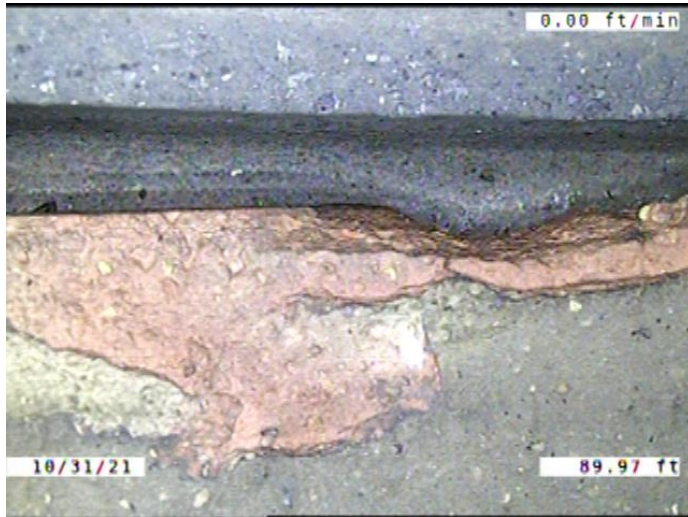
Code:	SZ
Description:	Surface Damage Other
Distance (ft):	90.0
Structural Grade:	0
O&M Grade:	0
Clock Start/From:	9
Clock To:	10
1st Value:	
2nd Value:	
Value Percent:	
Continuous Index:	
Within 8" of Joint:	YES
Remarks:	A PIECE CHIPPED AWAY FROM THE JOINT

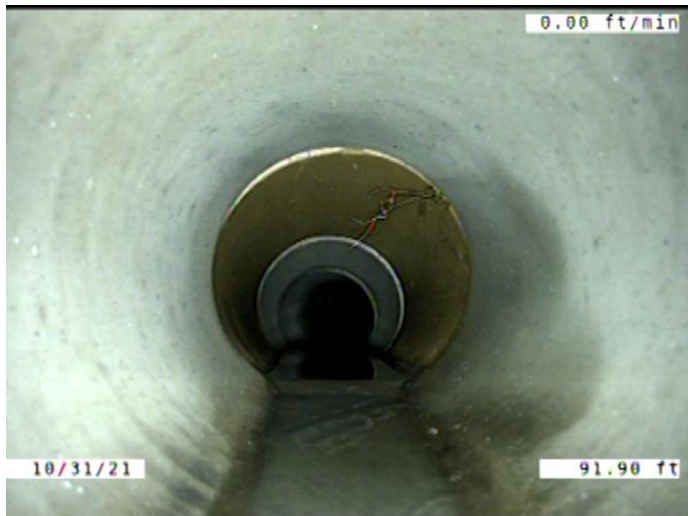
91.9	MWLS(F03)	Miscellaneous Water Level Sag	1018	S 2
94.9	RFJ	Roots Fine Joint	1049	M 1
94.9	CL	Crack Longitudinal	1077	S 2
95.0	FS	Fracture Spiral	1112	S 3

Code:	MWLS
Description:	Miscellaneous Water Level Sag
Distance (ft):	91.9
Structural Grade:	2
O&M Grade:	0
Clock Start/From:	
Clock To:	
1st Value:	
2nd Value:	
Value Percent:	10.000
Continuous Index:	F03
Within 8" of Joint:	NO
Remarks:

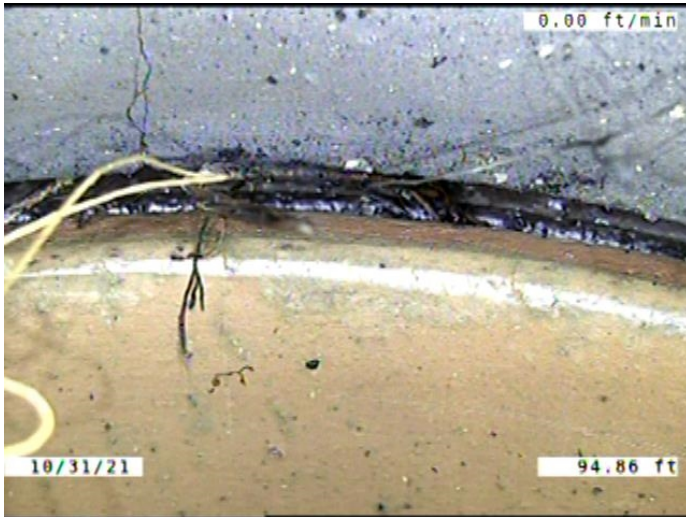
Code: **RFJ**
 Description: **Roots Fine Joint**

Distance (ft): **94.9**
 Structural Grade: **0**
 O&M Grade: **1**
 Clock Start/From: **1**
 Clock To: **2**
 1st Value:
 2nd Value:
 Value Percent:
 Continuous Index:
 Within 8" of Joint: **YES**
 Remarks:

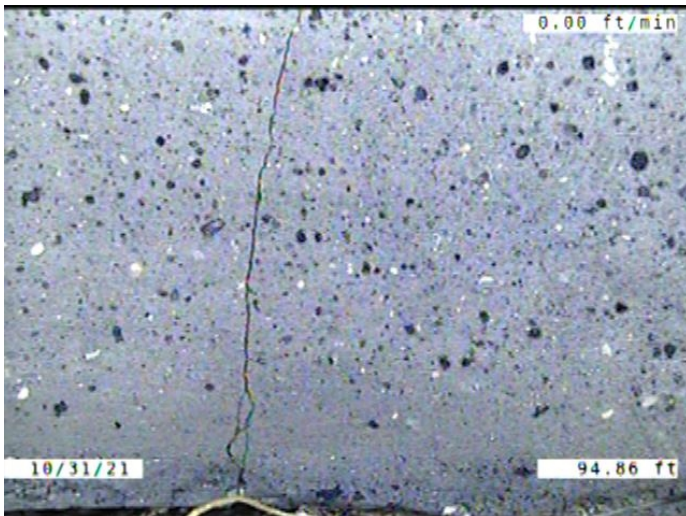
Code: **CL**
 Description: **Crack Longitudinal**

Distance (ft): **94.9**
 Structural Grade: **2**
 O&M Grade: **0**
 Clock Start/From: **1**
 Clock To:
 1st Value:
 2nd Value:
 Value Percent:
 Continuous Index:
 Within 8" of Joint: **YES**
 Remarks:

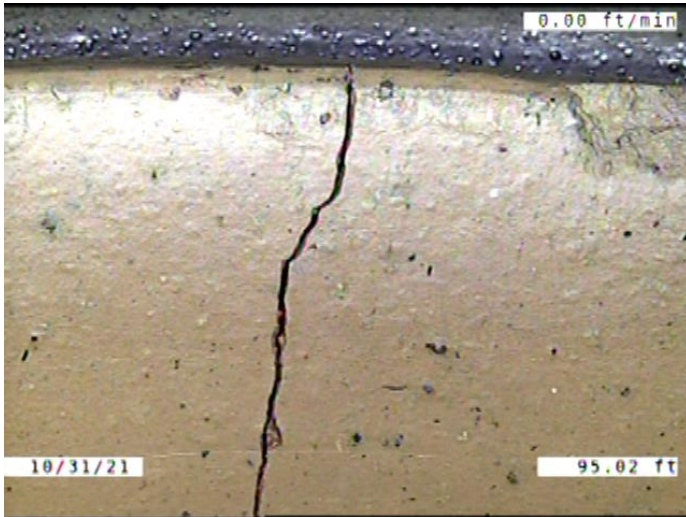
Code: **FS**
 Description: **Fracture Spiral**

Distance (ft): **95.0**
 Structural Grade: **3**
 O&M Grade: **0**
 Clock Start/From: **11**
 Clock To: **12**
 1st Value:
 2nd Value:
 Value Percent:
 Continuous Index:
 Within 8" of Joint: **YES**
 Remarks:

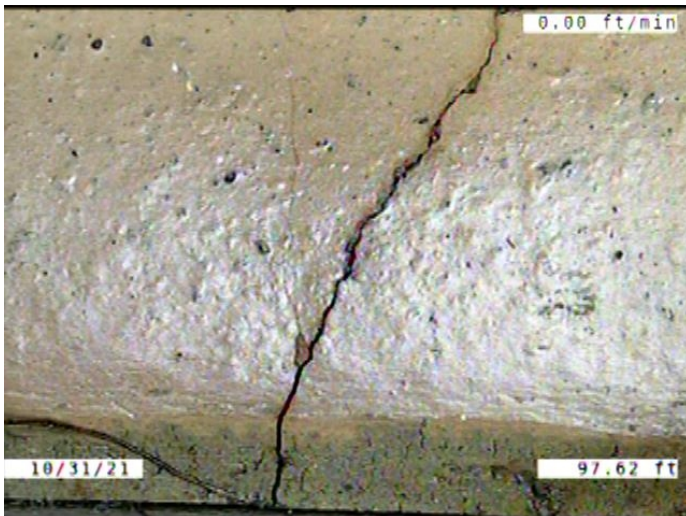
Code: **FM**
 Description: **Fracture Multiple**

Distance (ft): **97.6**
 Structural Grade: **4**
 O&M Grade: **0**
 Clock Start/From: **3**
 Clock To: **4**
 1st Value:
 2nd Value:
 Value Percent:
 Continuous Index:
 Within 8" of Joint: **YES**
 Remarks:

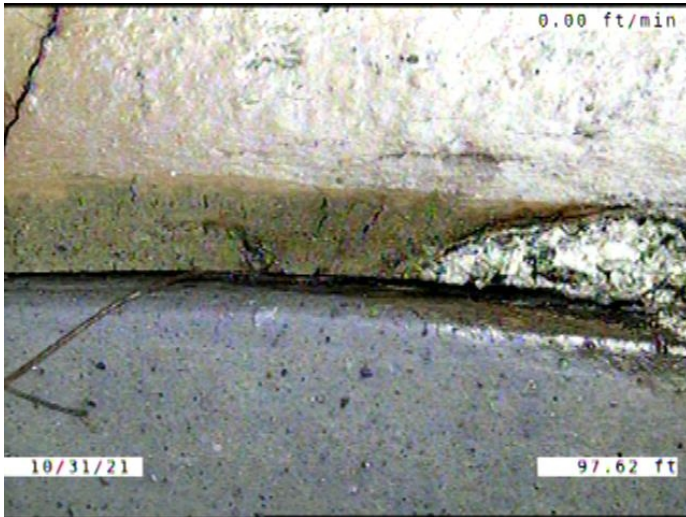
Code: **RFJ**
Description: **Roots Fine Joint**

Distance (ft): **97.6**
Structural Grade: **0**
O&M Grade: **1**
Clock Start/From: **2**
Clock To: **4**
1st Value:
2nd Value:
Value Percent:
Continuous Index:
Within 8" of Joint: **YES**
Remarks:

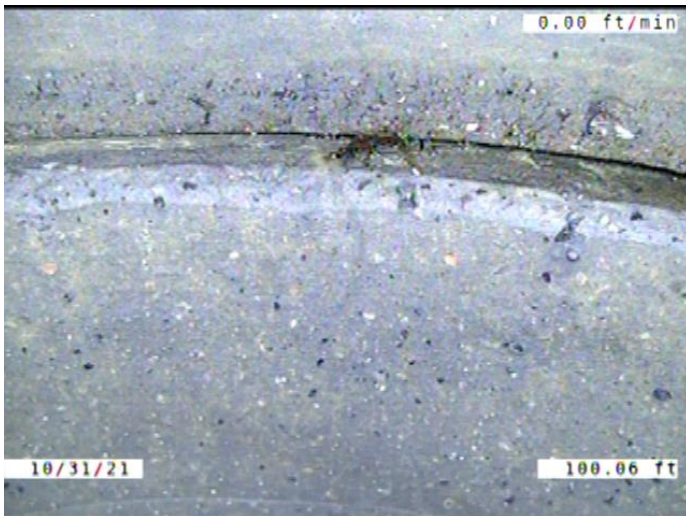
Code: **RFJ**
Description: **Roots Fine Joint**

Distance (ft): **100.1**
Structural Grade: **0**
O&M Grade: **1**
Clock Start/From: **2**
Clock To:
1st Value:
2nd Value:
Value Percent:
Continuous Index:
Within 8" of Joint: **YES**
Remarks:

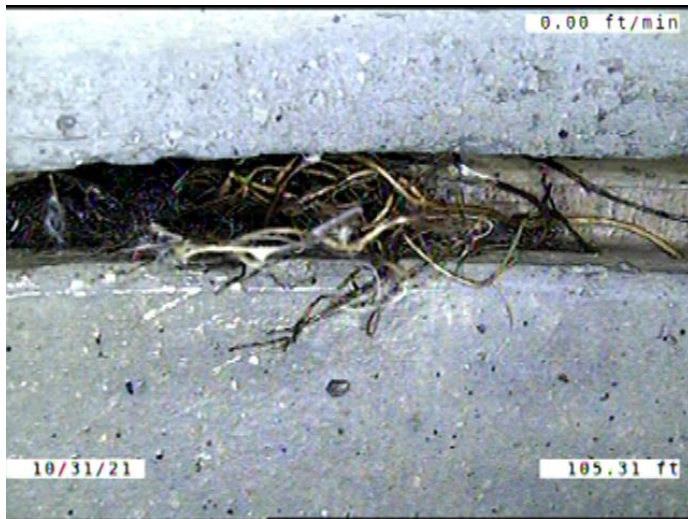
Code: **RFJ**
Description: **Roots Fine Joint**

Distance (ft): **105.3**
Structural Grade: **0**
O&M Grade: **1**
Clock Start/From: **9**
Clock To: **11**
1st Value:
2nd Value:
Value Percent:
Continuous Index:
Within 8" of Joint: **YES**
Remarks:

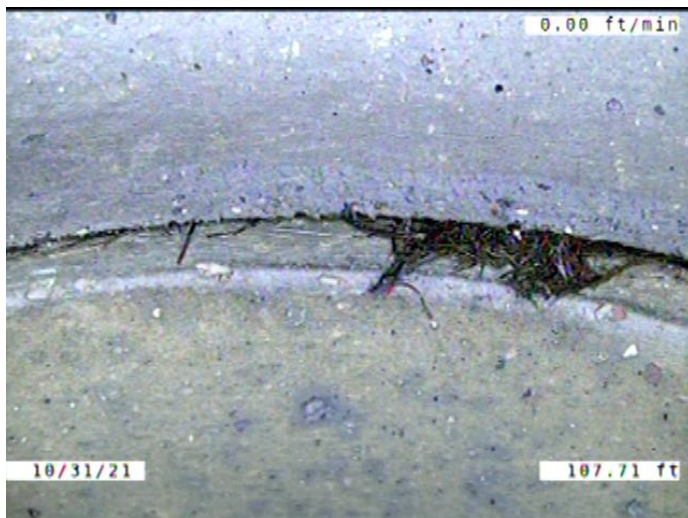
Code: **RFJ**
Description: **Roots Fine Joint**

Distance (ft): **107.7**
Structural Grade: **0**
O&M Grade: **1**
Clock Start/From: **11**
Clock To: **12**
1st Value:
2nd Value:
Value Percent:
Continuous Index:
Within 8" of Joint: **YES**
Remarks:

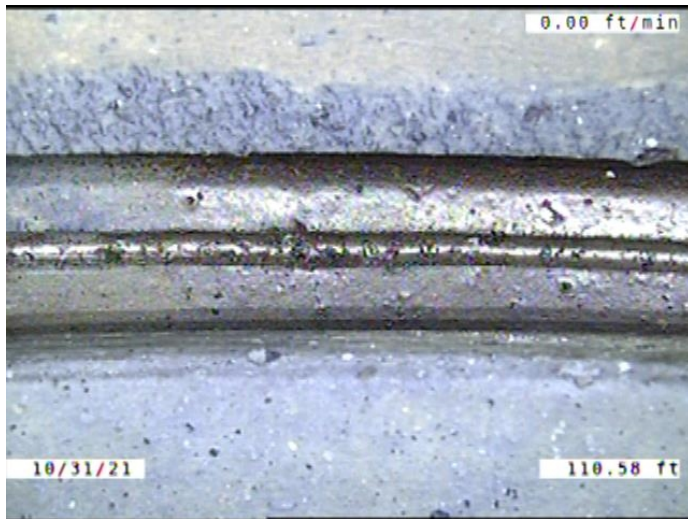
Code: **JAM**
 Description: **Joint Angular Medium**

Distance (ft): **110.6**
 Structural Grade: **3**
 O&M Grade: **0**
 Clock Start/From:
 Clock To:
 1st Value:
 2nd Value:
 Value Percent:
 Continuous Index:
 Within 8" of Joint: **NO**
 Remarks:

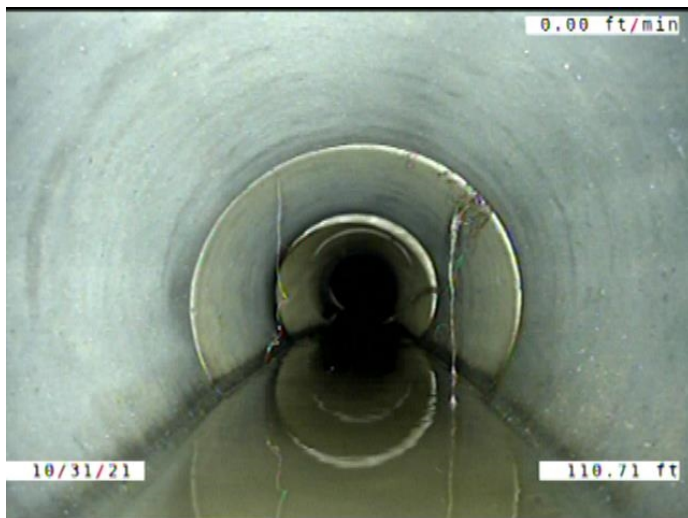
Code: **MWLS**
 Description: **Miscellaneous Water Level Sag**

Distance (ft): **110.7**
 Structural Grade: **2**
 O&M Grade: **0**
 Clock Start/From:
 Clock To:
 1st Value:
 2nd Value:
 Value Percent: **10.000**
 Continuous Index: **S04**
 Within 8" of Joint: **NO**
 Remarks:

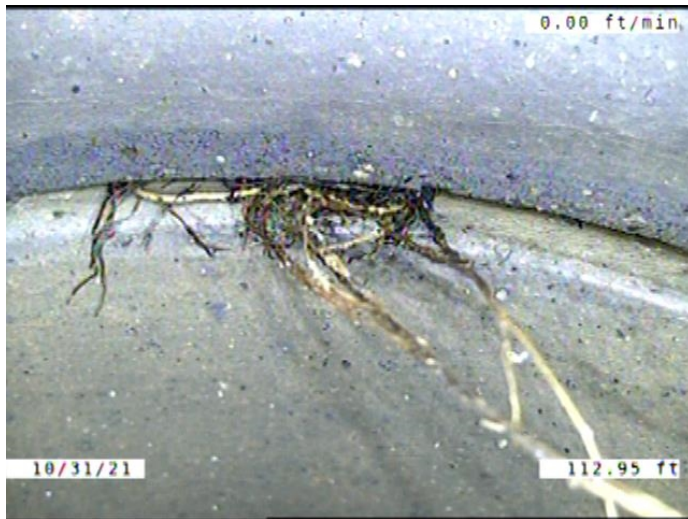
Code: **RFJ**
 Description: **Roots Fine Joint**

Distance (ft): **112.9**
 Structural Grade: **0**
 O&M Grade: **1**
 Clock Start/From: **11**
 Clock To: **2**
 1st Value:
 2nd Value:
 Value Percent:
 Continuous Index:
 Within 8" of Joint: **YES**
 Remarks:

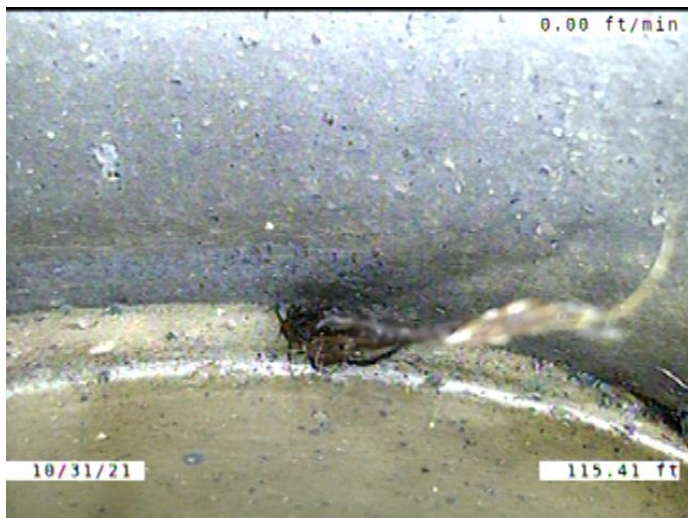
Code: **RFJ**
 Description: **Roots Fine Joint**

Distance (ft): **115.4**
 Structural Grade: **0**
 O&M Grade: **1**
 Clock Start/From: **11**
 Clock To: **3**
 1st Value:
 2nd Value:
 Value Percent:
 Continuous Index:
 Within 8" of Joint: **YES**
 Remarks:

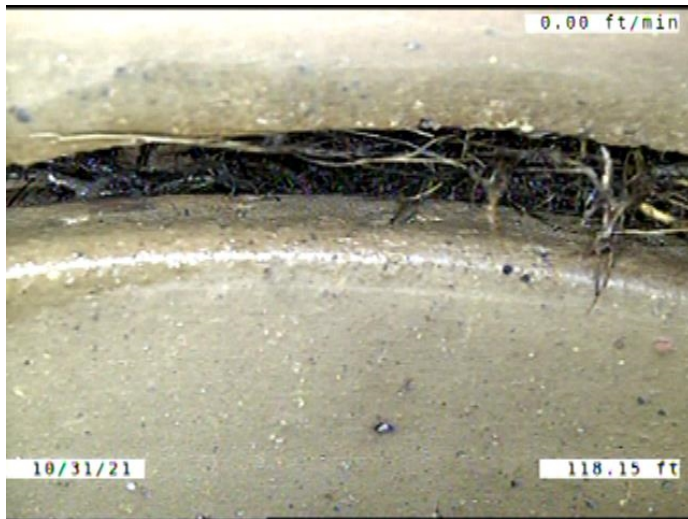
Code: **RFJ**
 Description: **Roots Fine Joint**

Distance (ft): **118.1**
 Structural Grade: **0**
 O&M Grade: **1**
 Clock Start/From: **9**
 Clock To: **2**
 1st Value:
 2nd Value:
 Value Percent:
 Continuous Index:
 Within 8" of Joint: **YES**
 Remarks:

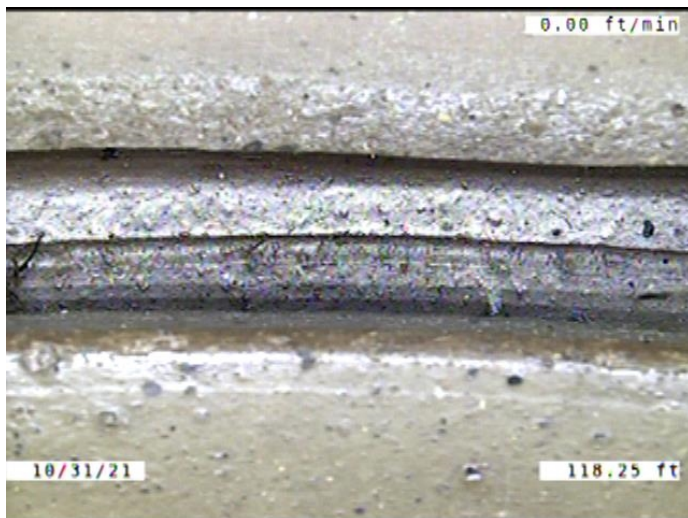
Code: **JAM**
 Description: **Joint Angular Medium**

Distance (ft): **118.2**
 Structural Grade: **3**
 O&M Grade: **0**
 Clock Start/From:
 Clock To:
 1st Value:
 2nd Value:
 Value Percent:
 Continuous Index:
 Within 8" of Joint: **NO**
 Remarks:

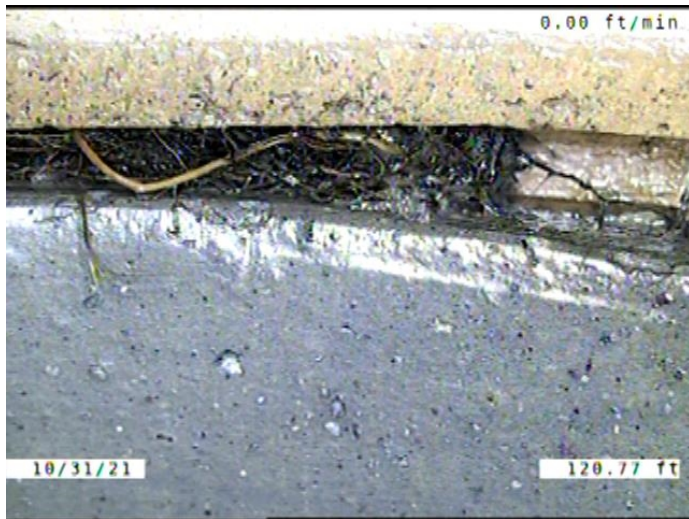
Code: **RFJ**
 Description: **Roots Fine Joint**

Distance (ft): **120.8**
 Structural Grade: **0**
 O&M Grade: **1**
 Clock Start/From: **9**
 Clock To: **3**
 1st Value:
 2nd Value:
 Value Percent:
 Continuous Index:
 Within 8" of Joint: **YES**
 Remarks:

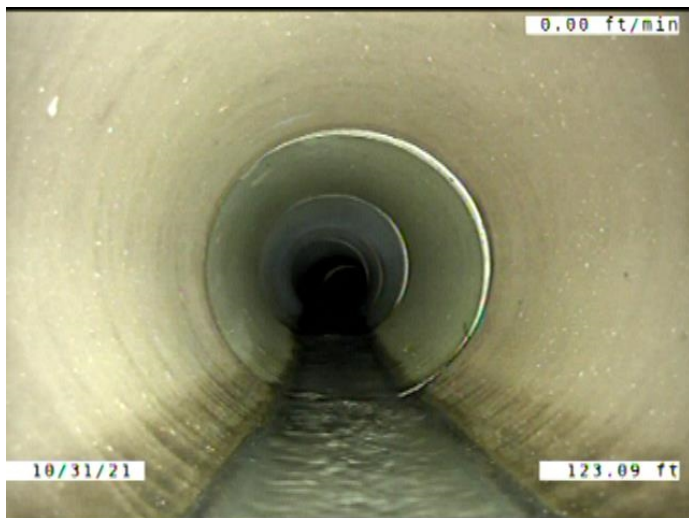
Code: **MWLS**
 Description: **Miscellaneous Water Level Sag**

Distance (ft): **123.1**
 Structural Grade: **2**
 O&M Grade: **0**
 Clock Start/From:
 Clock To:
 1st Value:
 2nd Value:
 Value Percent: **10.000**
 Continuous Index: **F04**
 Within 8" of Joint: **NO**
 Remarks:

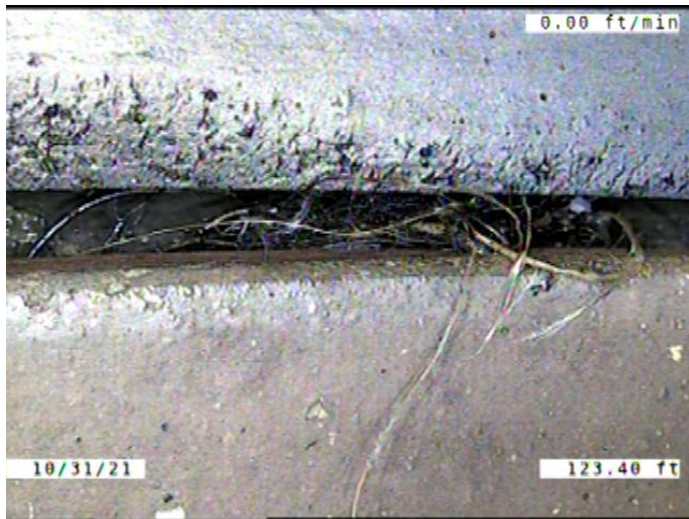
Code: **RFJ**
 Description: **Roots Fine Joint**

Distance (ft): **123.4**
 Structural Grade: **0**
 O&M Grade: **1**
 Clock Start/From: **9**
 Clock To:
 1st Value:
 2nd Value:
 Value Percent:
 Continuous Index:
 Within 8" of Joint: **YES**
 Remarks:

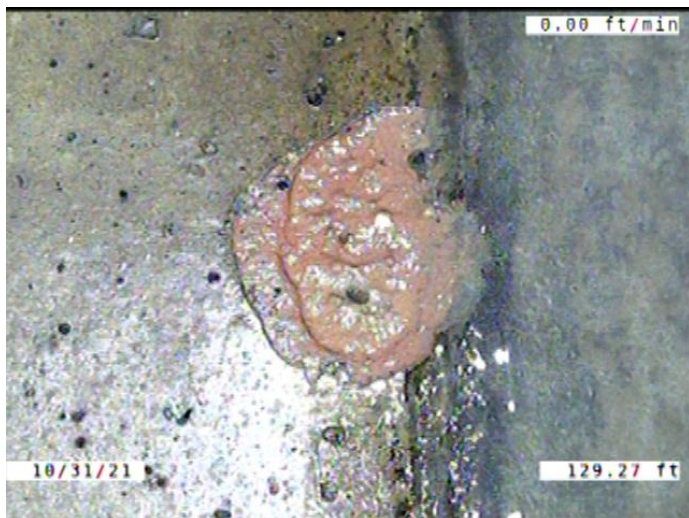
Code: **SSS**
 Description: **Surface Damage Surface Spalling**

Distance (ft): **129.3**
 Structural Grade: **2**
 O&M Grade: **0**
 Clock Start/From: **7**
 Clock To:
 1st Value:
 2nd Value:
 Value Percent:
 Continuous Index:
 Within 8" of Joint: **NO**
 Remarks:

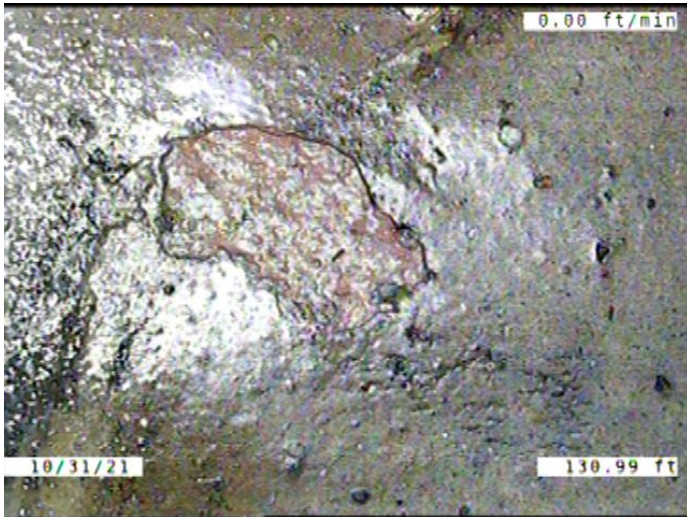
Code: **SSS**
 Description: **Surface Damage Surface Spalling**

Distance (ft): **131.0**
 Structural Grade: **2**
 O&M Grade: **0**
 Clock Start/From: **4**
 Clock To:
 1st Value:
 2nd Value:
 Value Percent:
 Continuous Index:
 Within 8" of Joint: **YES**
 Remarks:

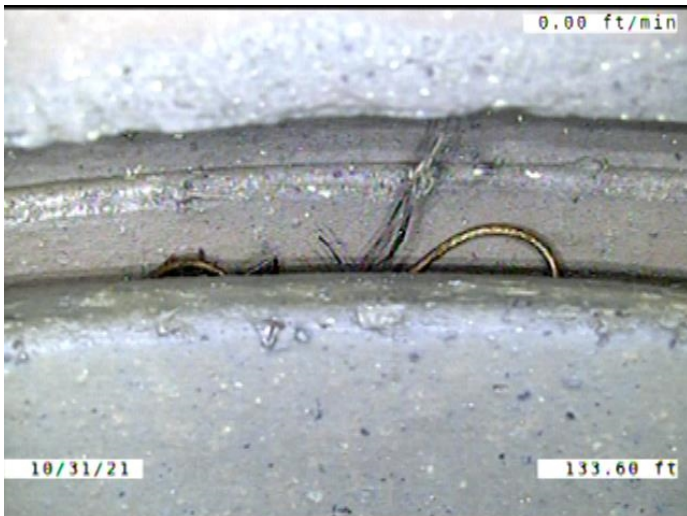
Code: **RFJ**
 Description: **Roots Fine Joint**

Distance (ft): **133.6**
 Structural Grade: **0**
 O&M Grade: **1**
 Clock Start/From: **10**
 Clock To:
 1st Value:
 2nd Value:
 Value Percent:
 Continuous Index:
 Within 8" of Joint: **YES**
 Remarks:

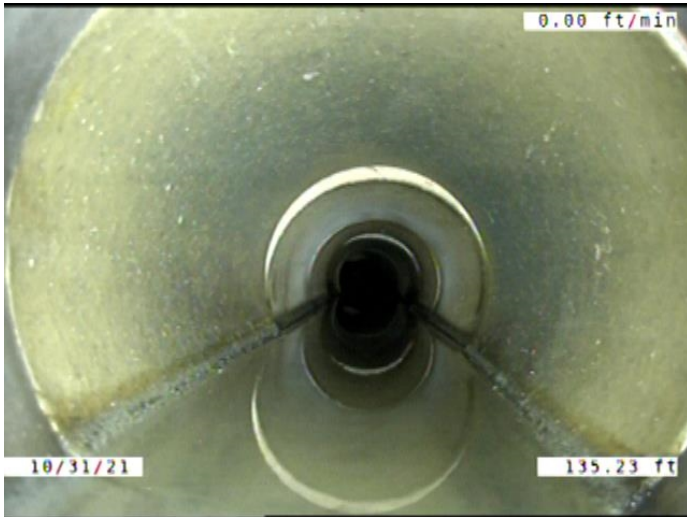
Code: **MWLS**
Description: **Miscellaneous Water Level Sag**

Distance (ft): **135.2**
Structural Grade: **2**
O&M Grade: **0**
Clock Start/From:
Clock To:
1st Value:
2nd Value:
Value Percent: **10.000**
Continuous Index: **S05**
Within 8" of Joint: **NO**
Remarks:

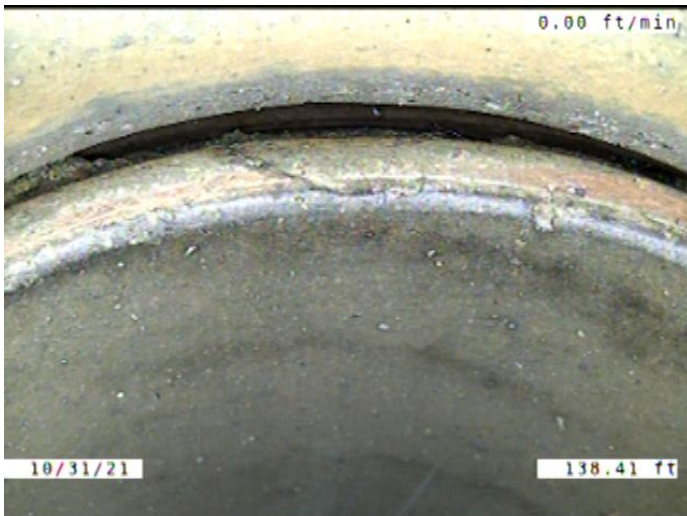
Code: **JOM**
Description: **Joint Offset Medium**

Distance (ft): **138.4**
Structural Grade: **3**
O&M Grade: **0**
Clock Start/From:
Clock To:
1st Value:
2nd Value:
Value Percent:
Continuous Index:
Within 8" of Joint: **NO**
Remarks:

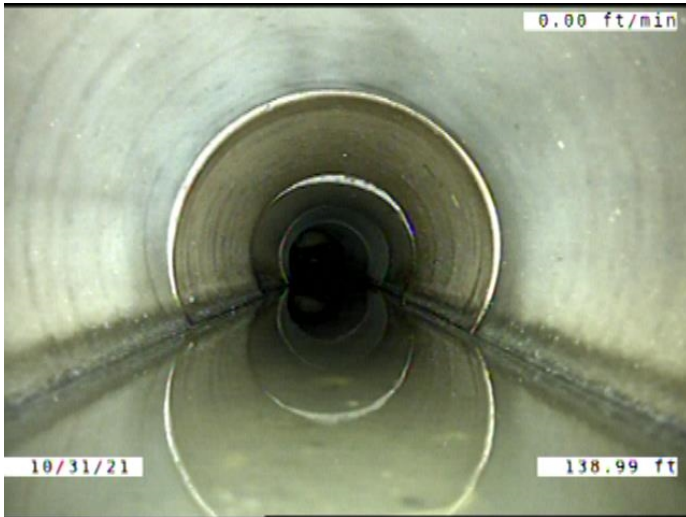
Code: **DSF**
Description: **Deposits Settled Fine**

Distance (ft): **139.0**
Structural Grade: **0**
O&M Grade: **2**
Clock Start/From: **5**
Clock To: **7**
1st Value:
2nd Value:
Value Percent: **5.000**
Continuous Index:
Within 8" of Joint: **YES**
Remarks:

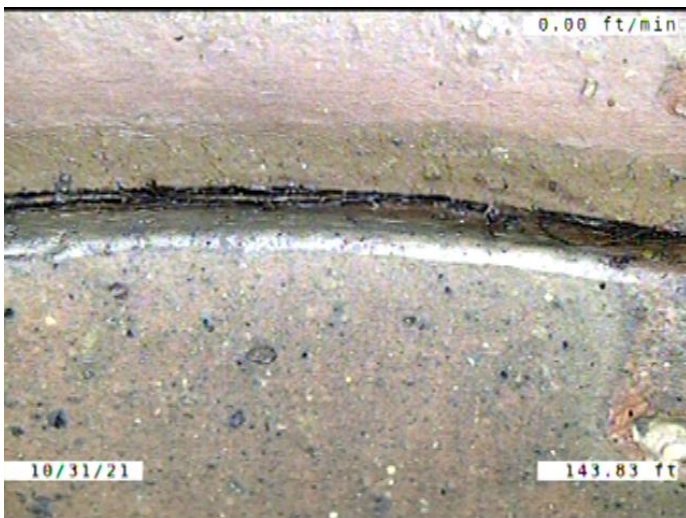
Code: **RFJ**
Description: **Roots Fine Joint**

Distance (ft): **143.8**
Structural Grade: **0**
O&M Grade: **1**
Clock Start/From: **12**
Clock To: **2**
1st Value:
2nd Value:
Value Percent:
Continuous Index:
Within 8" of Joint: **YES**
Remarks:

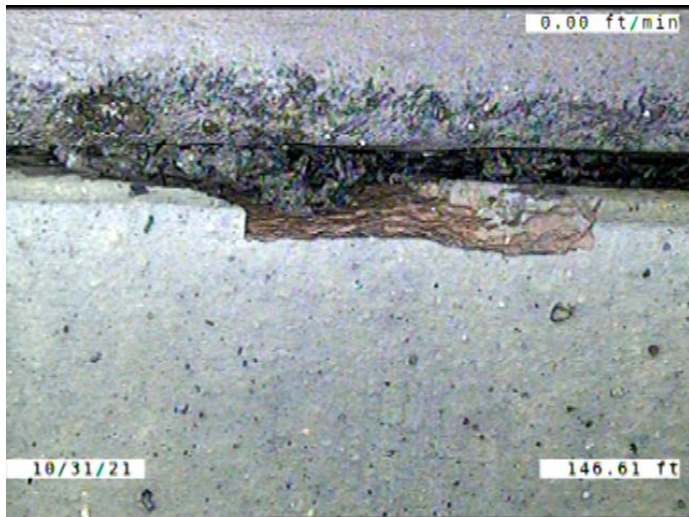
Code:	SZ
Description:	Surface Damage Other
Distance (ft):	146.6
Structural Grade:	0
O&M Grade:	0
Clock Start/From:	10
Clock To:	11
1st Value:	
2nd Value:	
Value Percent:	
Continuous Index:	
Within 8" of Joint:	YES
Remarks:	A PIECE CHIPPED AWAY FROM THE JOINT

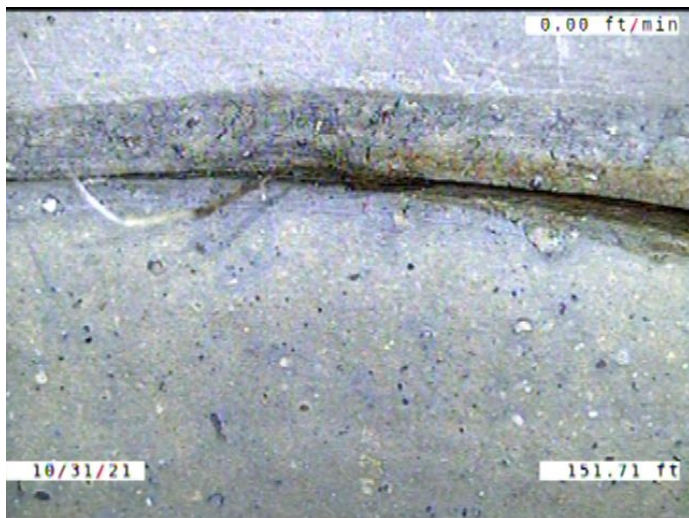
Code:	RFJ
Description:	Roots Fine Joint
Distance (ft):	151.7
Structural Grade:	0
O&M Grade:	1
Clock Start/From:	1
Clock To:	
1st Value:	
2nd Value:	
Value Percent:	
Continuous Index:	
Within 8" of Joint:	YES
Remarks:

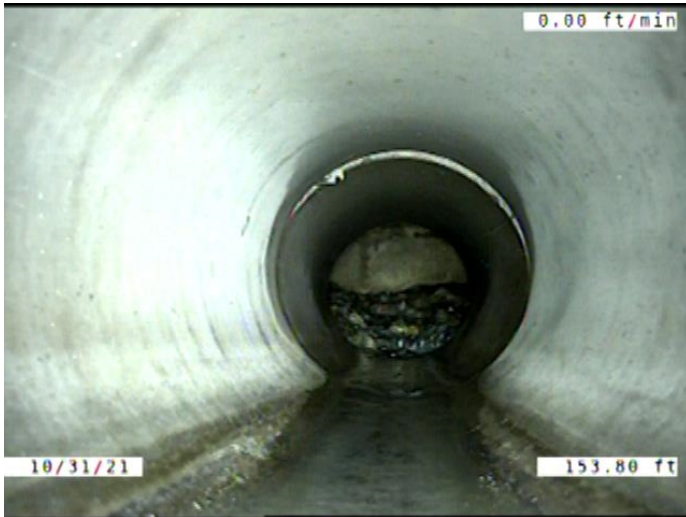
Code: **MWLS**
Description: **Miscellaneous Water Level Sag**

Distance (ft): **153.8**
Structural Grade: **2**
O&M Grade: **0**
Clock Start/From:
Clock To:
1st Value:
2nd Value:
Value Percent: **10.000**
Continuous Index: **F05**
Within 8" of Joint: **NO**
Remarks:

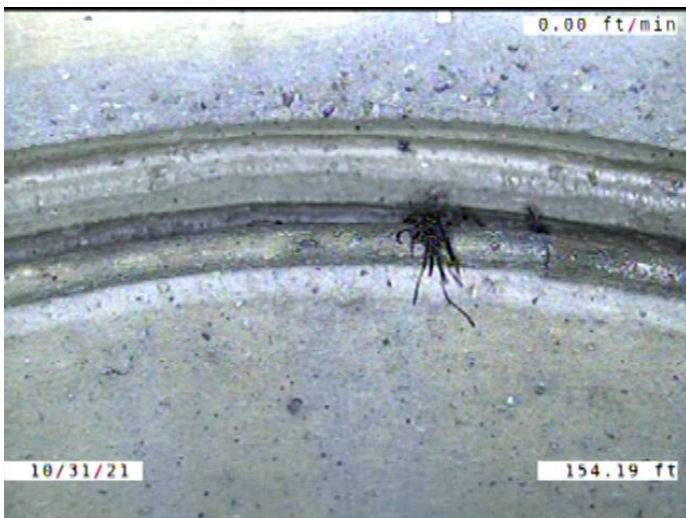
Code: **RFJ**
Description: **Roots Fine Joint**

Distance (ft): **154.2**
Structural Grade: **0**
O&M Grade: **1**
Clock Start/From: **11**
Clock To: **12**
1st Value:
2nd Value:
Value Percent:
Continuous Index:
Within 8" of Joint: **YES**
Remarks:

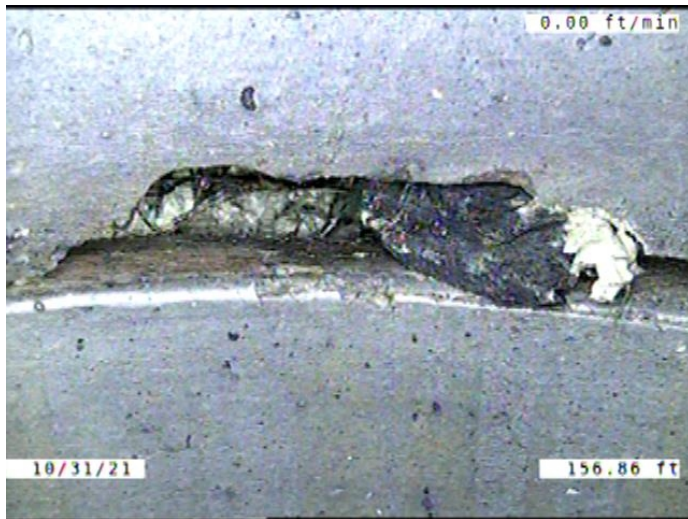
Code:	SZ
Description:	Surface Damage Other
Distance (ft):	156.9
Structural Grade:	0
O&M Grade:	0
Clock Start/From:	10
Clock To:	11
1st Value:	
2nd Value:	
Value Percent:	
Continuous Index:	
Within 8" of Joint:	YES
Remarks:	A PIECE CHIPPED AWAY FROM THE JOINT

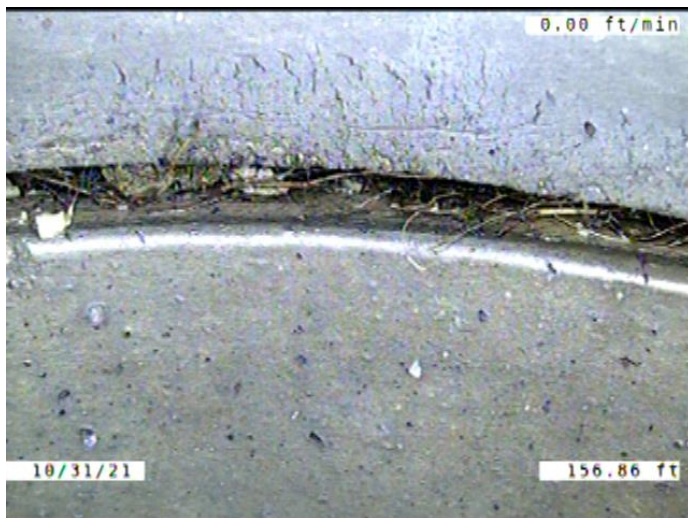
Code:	RFJ
Description:	Roots Fine Joint
Distance (ft):	156.9
Structural Grade:	0
O&M Grade:	1
Clock Start/From:	1
Clock To:	3
1st Value:	
2nd Value:	
Value Percent:	
Continuous Index:	
Within 8" of Joint:	YES
Remarks:

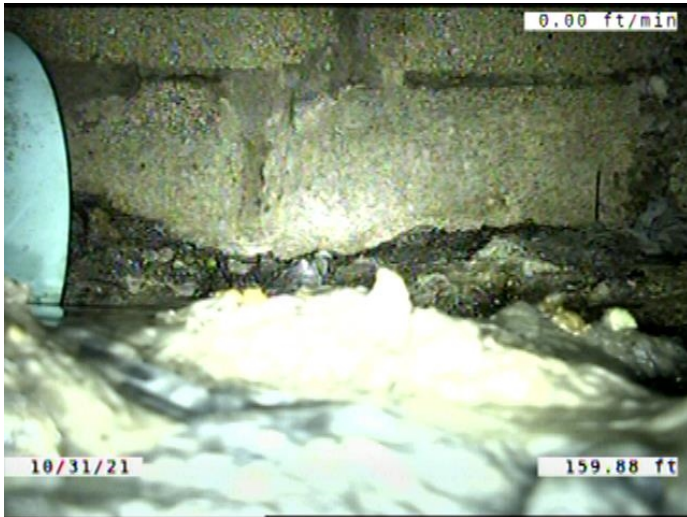
Code: **DAE**
 Description: **Deposits Attached Encrustation**

Distance (ft): **159.9**
 Structural Grade: **0**
 O&M Grade: **2**
 Clock Start/From: **7**
 Clock To: **5**
 1st Value:
 2nd Value:
 Value Percent: **5.000**
 Continuous Index: **F02**
 Within 8" of Joint: **YES**
 Remarks:
