## **Profile/Photo Observation Report**

Date: 10/31/2021 Weather: **PACP 7.0** Coding: Pipe Length (ft): 161.8 Owner: **City of Hobart** Pre Clean: **Heavy Cleaning** P.O.#: YES502259 S. Bucklin PSR: P-504-041-034 Surveyor:

Street: North Colorado Street Flow Control: Not Controlled

US MH: M-504-034 DS MH: M-504-041 Total Length Surveyed (ft): 161.8

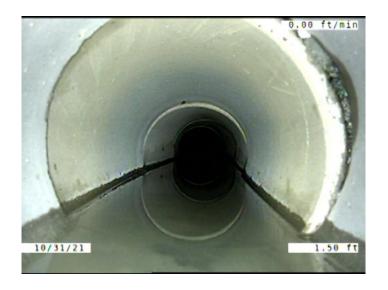
Description: **Miscellaneous General Observation**

Distance (ft): 1.5 Structural Grade: 0 0 O&M Grade:

Remarks: DROP INTO THE MANHOLE. HAD TO

START IN THE PIPE.

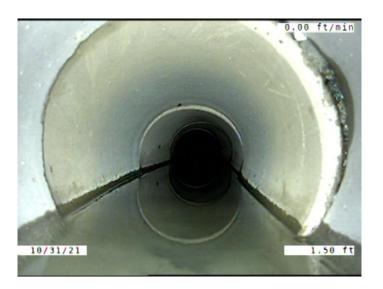
Description: **Miscellaneous Water Level Sag**

Distance (ft): 1.5 Structural Grade: 2 O&M Grade: 0

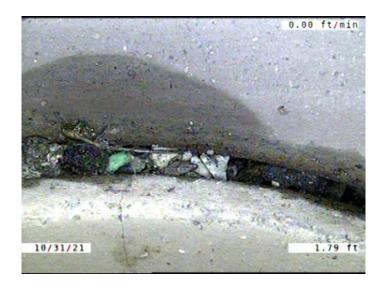
Description: Roots Fine Joint

Distance (ft): 1.8
Structural Grade: 0
O&M Grade: 1
Clock Start/From: 2

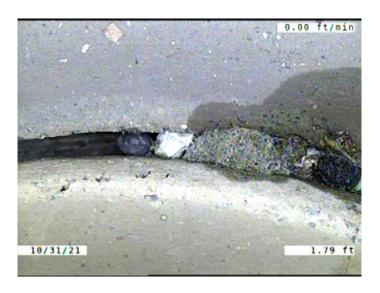
Description: Joint Offset Medium Defective

Distance (ft): 1.8
Structural Grade: 3
O&M Grade: 0

Remarks: LOOKS TO BE LEAKING WATER

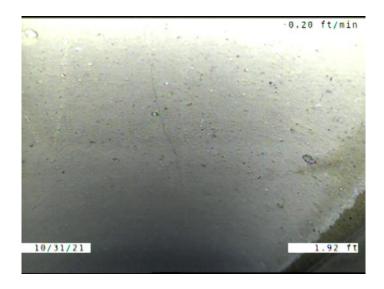
Code: CM
Description: Crack Multiple

Distance (ft): 1.9
Structural Grade: 3
O&M Grade: 0
Clock Start/From: 2
Clock To: 4
1st Value:
2nd Value:
Value Percent:
Continuous Index:

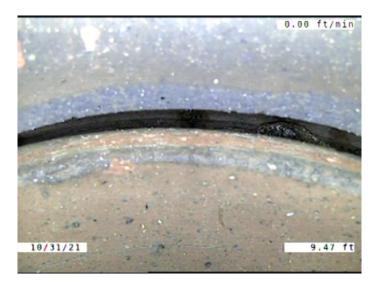
Description: Joint Offset Medium

Distance (ft): 9.5
Structural Grade: 3
O&M Grade: 0

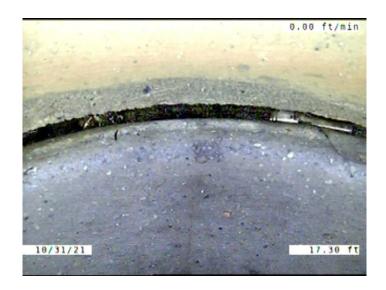
Description: **Joint Offset Medium**

Distance (ft): 17.3 Structural Grade: 3 0 O&M Grade:

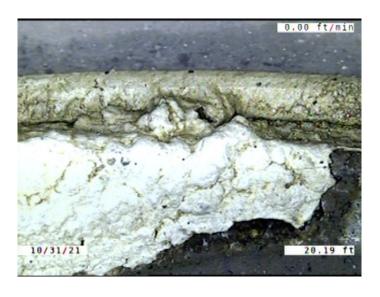
Description: **Deposits Attached Encrustation**

Distance (ft): 20.2 Structural Grade: 0 O&M Grade: 2 Clock Start/From: 9 3 Clock To: 1st Value: 2nd Value:

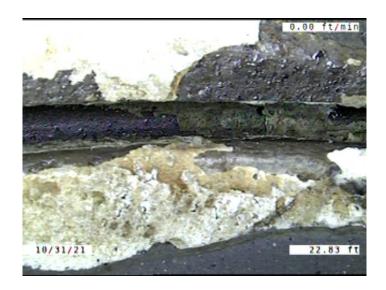
Description: **Deposits Attached Encrustation**

Distance (ft): 22.8 Structural Grade: 0 2 O&M Grade: Clock Start/From: 9 Clock To: 2

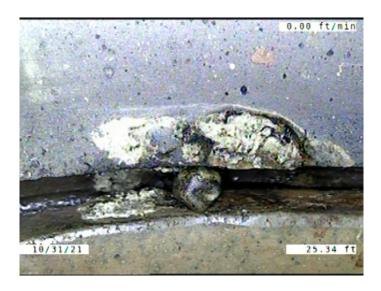
Description: **Deposits Attached Encrustation**

Distance (ft): 25.3 Structural Grade: 0 O&M Grade: 2 Clock Start/From: 7 5 Clock To: 1st Value:

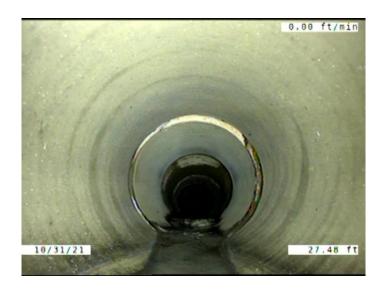
Description: Miscellaneous Water Level Sag

Distance (ft): 27.5
Structural Grade: 2
O&M Grade: 0

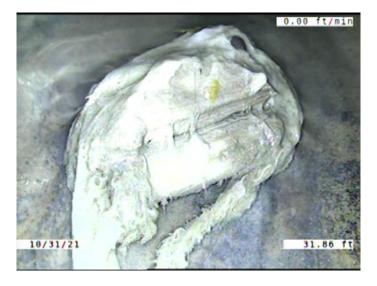
Description: Obstruction Pipe Material in Invert

Distance (ft): 31.9
Structural Grade: 0
O&M Grade: 2
Clock Start/From: 6
Clock To:

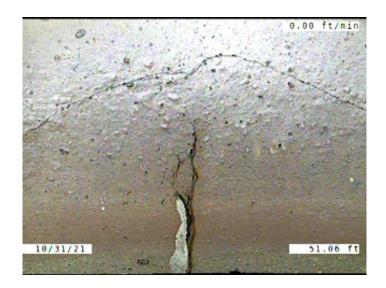
Code: CM Description: **Crack Multiple**

Distance (ft): 51.1 Structural Grade: 3 0 O&M Grade: Clock Start/From: 9 Clock To: 1 1st Value: 2nd Value: Value Percent: Continuous Index:

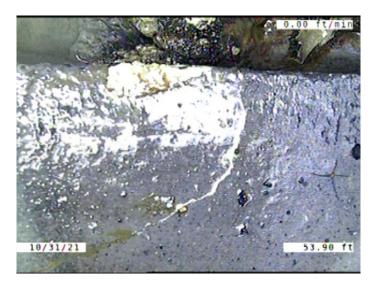
Description: **Crack Multiple**

Distance (ft): 53.9 Structural Grade: 3 O&M Grade: 0 Clock Start/From: 3 Clock To: 1st Value: 2nd Value: Value Percent: Continuous Index: Within 8" of Joint: YES

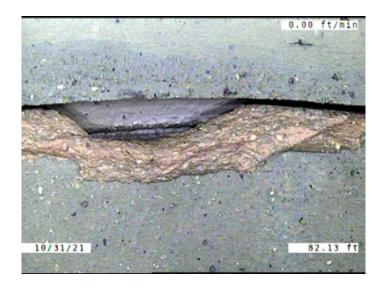
Description: Surface Damage Other

Distance (ft): 82.1
Structural Grade: 0

Remarks: A PIECE CHIPPED AWAY FROM THE

**JOINT**

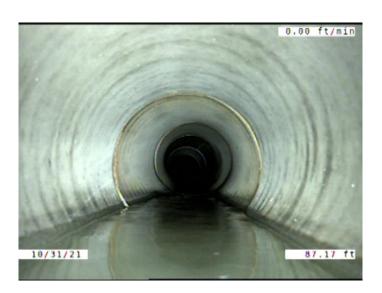
Description: Miscellaneous Water Level Sag

Distance (ft): 87.2
Structural Grade: 2
O&M Grade: 0

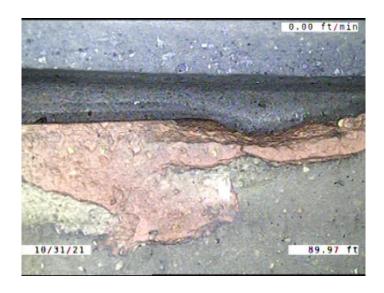
Description: Surface Damage Other

Distance (ft): 90.0
Structural Grade: 0
O&M Grade: 0
Clock Start/From: 9
Clock To: 10

Remarks: A PIECE CHIPPED AWAY FROM THE

**JOINT**

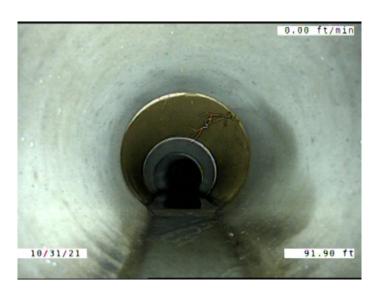
Description: Miscellaneous Water Level Sag

Distance (ft): 91.9
Structural Grade: 2
O&M Grade: 0

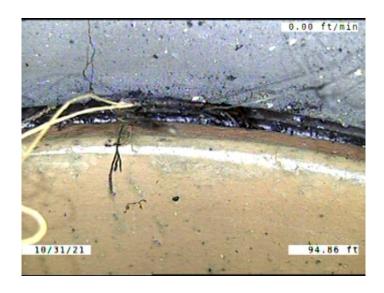
Description: Roots Fine Joint

Distance (ft): 94.9
Structural Grade: 0
O&M Grade: 1
Clock Start/From: 1
Clock To: 2

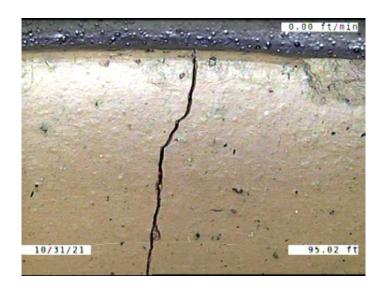
Description: Fracture Spiral

Distance (ft): 95.0
Structural Grade: 3
O&M Grade: 0
Clock Start/From: 11
Clock To: 12

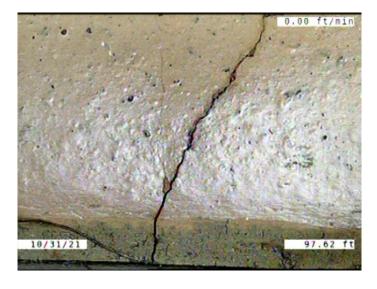
Description: Fracture Multiple

Distance (ft): 97.6
Structural Grade: 4

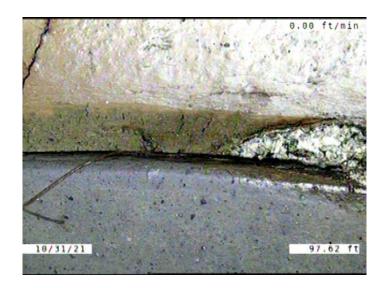
Code: RFJ
Description: Roots Fine Joint

Distance (ft): 97.6 Structural Grade: 0 O&M Grade: 1 Clock Start/From: 2 Clock To: 4 1st Value: 2nd Value: Value Percent: Continuous Index: Within 8" of Joint: YES

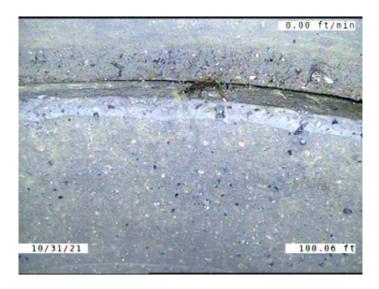
Description: Roots Fine Joint

Distance (ft): 100.1
Structural Grade: 0

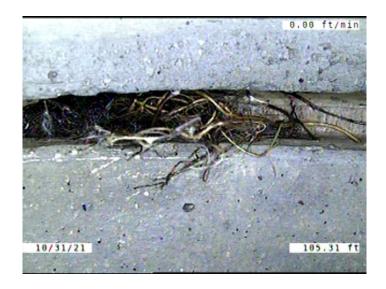
Description: Roots Fine Joint

Distance (ft): 105.3
Structural Grade: 0
O&M Grade: 1
Clock Start/From: 9
Clock To: 11

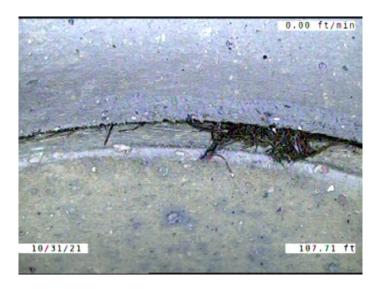
Description: Roots Fine Joint

Distance (ft): 107.7
Structural Grade: 0
O&M Grade: 1
Clock Start/From: 11
Clock To: 12
1st Value:
2nd Value:
Value Percent:

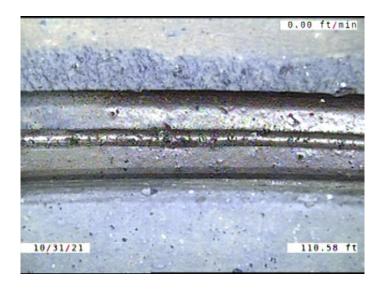
Description: Joint Angular Medium

Distance (ft): 110.6 Structural Grade: 3 0 O&M Grade:

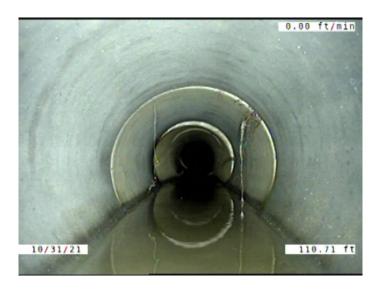
Description: **Miscellaneous Water Level Sag**

Distance (ft): 110.7 Structural Grade: 2 O&M Grade: 0

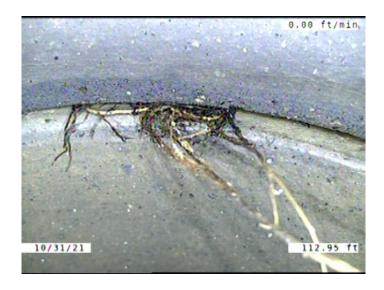
Description: Roots Fine Joint

Distance (ft): 112.9
Structural Grade: 0
O&M Grade: 1
Clock Start/From: 11
Clock To: 2

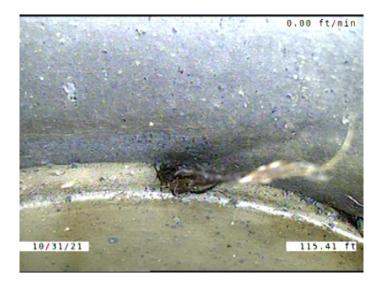
Description: Roots Fine Joint

Distance (ft): 115.4
Structural Grade: 0
O&M Grade: 1
Clock Start/From: 11
Clock To: 3
1st Value:
2nd Value:

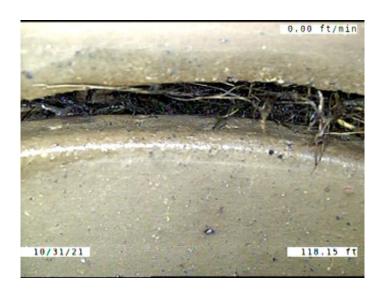
Description: Roots Fine Joint

Distance (ft): 118.1
Structural Grade: 0

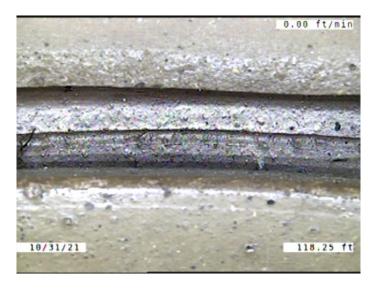
Description: Joint Angular Medium

Distance (ft): **118.2**

Structural Grade: **3**O&M Grade: **0**

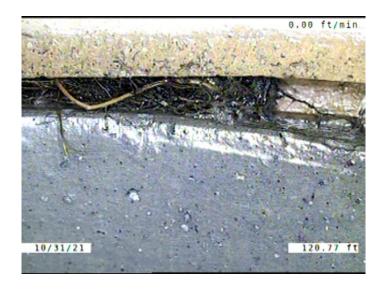
Description: Roots Fine Joint

Distance (ft): 120.8
Structural Grade: 0
O&M Grade: 1

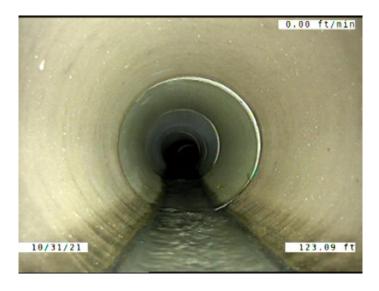
Description: Miscellaneous Water Level Sag

Distance (ft): 123.1
Structural Grade: 2
O&M Grade: 0

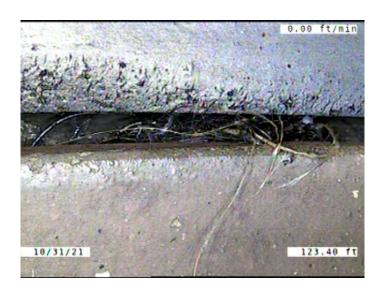
Description: Roots Fine Joint

Distance (ft): 123.4
Structural Grade: 0
O&M Grade: 1
Clock Start/From: 9

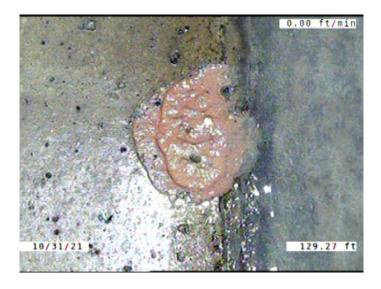
Description: Surface Damage Surface Spalling

Distance (ft): 129.3
Structural Grade: 2
O&M Grade: 0
Clock Start/From: 7

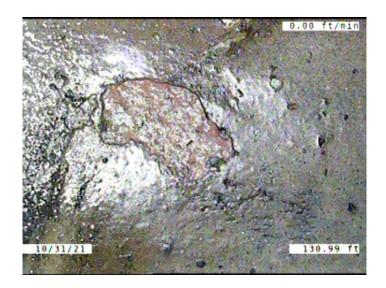
Description: Surface Damage Surface Spalling

Distance (ft): 131.0
Structural Grade: 2
O&M Grade: 0
Clock Start/From: 4

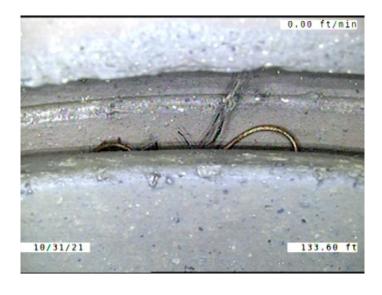
Description: Roots Fine Joint

Distance (ft): 133.6
Structural Grade: 0
O&M Grade: 1
Clock Start/From: 10

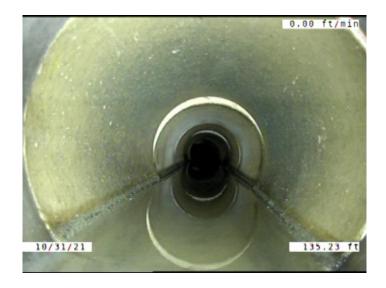
Description: Miscellaneous Water Level Sag

Distance (ft): 135.2
Structural Grade: 2
O&M Grade: 0

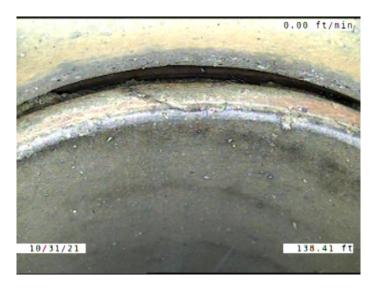
Description: Joint Offset Medium

Distance (ft): 138.4
Structural Grade: 3
O&M Grade: 0

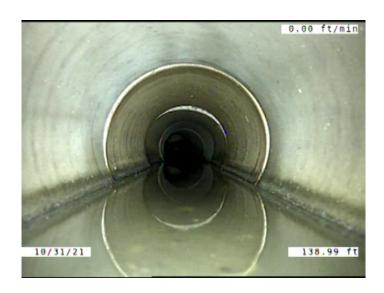
Description: Deposits Settled Fine

Distance (ft): 139.0
Structural Grade: 0
O&M Grade: 2
Clock Start/From: 5
Clock To: 7

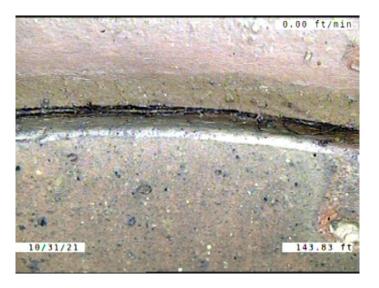
Description: Roots Fine Joint

Distance (ft): 143.8
Structural Grade: 0
O&M Grade: 1
Clock Start/From: 12
Clock To: 2
1st Value: 2nd Value:

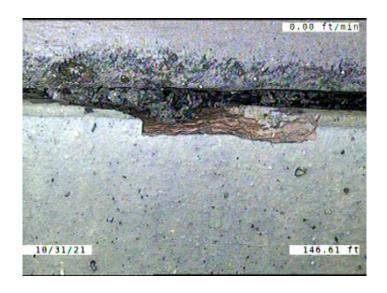
Description: Surface Damage Other

Distance (ft): 146.6
Structural Grade: 0

Remarks: A PIECE CHIPPED AWAY FROM THE

**JOINT**

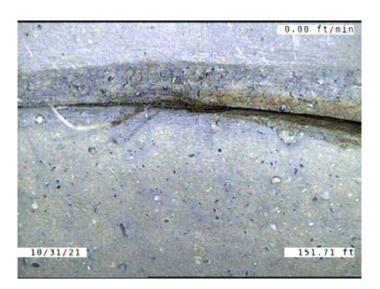
Description: Roots Fine Joint

Distance (ft): 151.7
Structural Grade: 0
O&M Grade: 1
Clock Start/From: 1

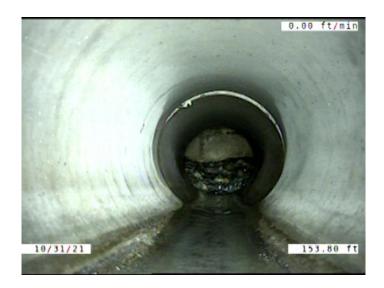
Description: Miscellaneous Water Level Sag

Distance (ft): 153.8
Structural Grade: 2
O&M Grade: 0

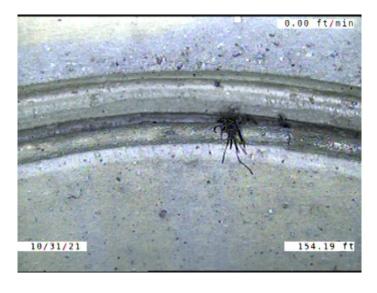
Description: Roots Fine Joint

Distance (ft): 154.2
Structural Grade: 0
O&M Grade: 1
Clock Start/From: 11
Clock To: 12
1st Value:
2nd Value:

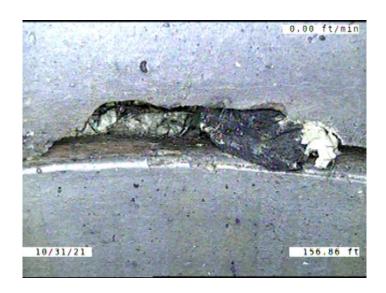
Description: Surface Damage Other

Distance (ft): 156.9
Structural Grade: 0
O&M Grade: 0
Clock Start/From: 10
Clock To: 11

Remarks: A PIECE CHIPPED AWAY FROM THE

**JOINT**

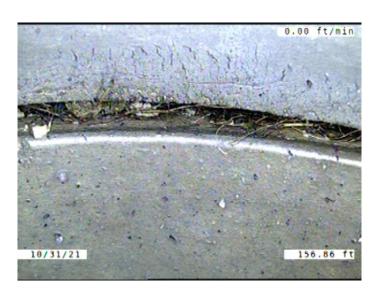
Description: Roots Fine Joint

Distance (ft): 156.9
Structural Grade: 0
O&M Grade: 1
Clock Start/From: 1
Clock To: 3
1st Value:
2nd Value:
Value Percent:
Continuous Index:

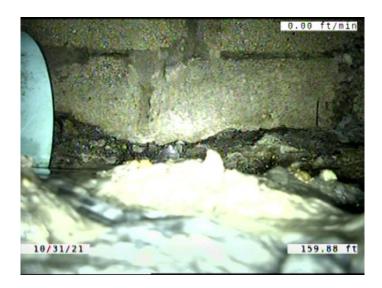
Description: Deposits Attached Encrustation

Distance (ft): 159.9
Structural Grade: 0
O&M Grade: 2
Clock Start/From: 7
Clock To: 5
