Profile/Photo Observation Report

Date:	04/25/2018	Weather:		Coding:	PACP 6.0
Pipe Length (ft):	215.7	Owner:	NA	Pre Clean:	No Pre-Cleaning
P.O.#:		Surveyor:	Jen Costello	PSR:	P-504-036-035
Customer:		Clean Date:	01/01/1900	Shape:	C

Street:	N COLORADO ST	Flow Control:	Not Controlled
City:	Hobart, IN	Year Renewed:	
Location:	Light Highway	Tape/Media #:	
Purpose:	Routine Assessment	Dia/Height:	10"
Use:	Sanitary	Material:	VCP
Drain Area:	NA	Lining:	
Category:	NA		
Comment:	P_C at 23 ft grit . Flow direction wrong		
Location Details:		Direction of Survey:	Downstream
US MH:	M-504-035	DS MH:	M-504-036
		Total Length Surveyed (ft):	24.9

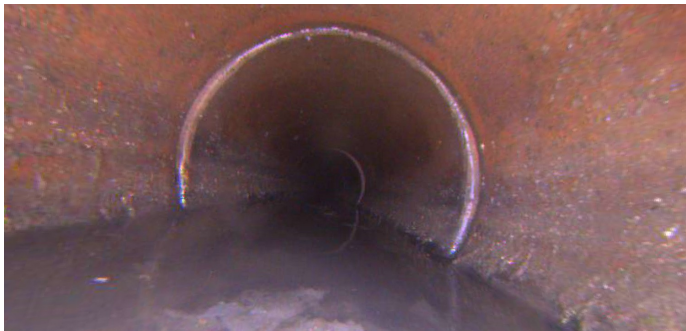
Code: **AMH**
Description: **Manhole**

Distance (ft): **.0**
Structural Grade: **0**
O&M Grade: **0**
Clock Start/From:
Clock To:
1st Value:
2nd Value:
Value Percent:
Continuous Index:
Within 8" of Joint: **NO**
Remarks: **M-504-035**

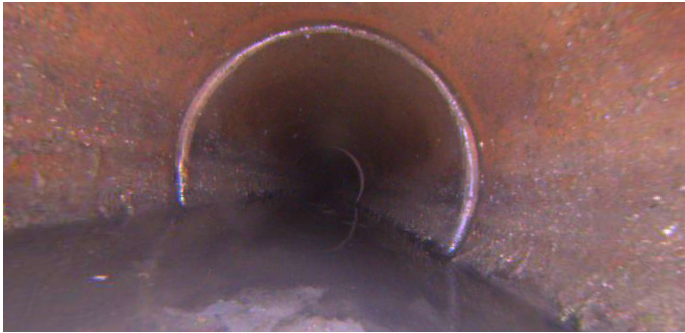
Code:	MWL
Description:	Water Level

Distance (ft):	.0
Structural Grade:	0
O&M Grade:	0
Clock Start/From:	
Clock To:	
1st Value:	
2nd Value:	
Value Percent:	30.000
Continuous Index:	
Within 8" of Joint:	NO
Remarks:

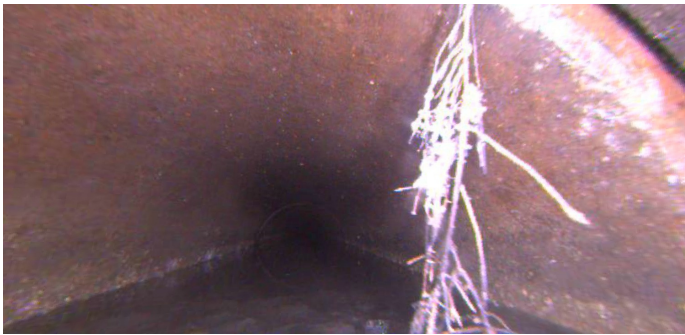
Code:	RFJ
Description:	Roots Fine Joint

Distance (ft):	19.9
Structural Grade:	0
O&M Grade:	1
Clock Start/From:	1
Clock To:	
1st Value:	
2nd Value:	
Value Percent:	
Continuous Index:	
Within 8" of Joint:	YES
Remarks:

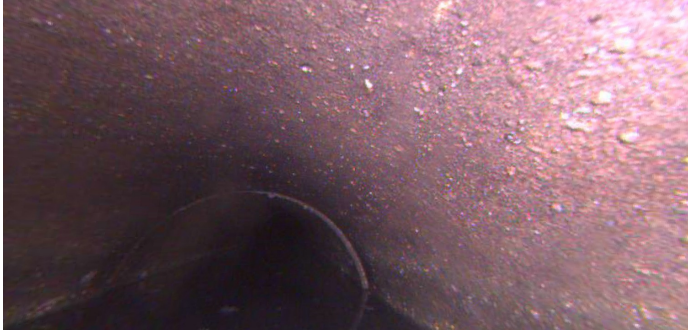
Code:	MSA
Description:	Abandoned Survey
Distance (ft):	24.9
Structural Grade:	0
O&M Grade:	0
Clock Start/From:	
Clock To:	
1st Value:	
2nd Value:	
Value Percent:	
Continuous Index:	
Within 8" of Joint:	NO
Remarks:	debris under water
