Profile/Photo Observation Report

Street:	FOXCROFT STREET	Flow Control:	Not Controlled
City:	Hobart, IN	Year Renewed:	
Location:	Light Highway	Tape/Media #:	
Purpose:	Routine Assessment	Dia/Height:	10"
Use:	Sanitary	Material:	VCP
Drain Area:	NA	Lining:	
Category:	NA		
Comment:	P_C at 23 ft grit . Flow direction wrong		
Location Details:		Direction of Survey:	Downstream
US MH:	M-504-035	DS MH:	M-504-036
		Total Length Surveyed (ft):	24.9

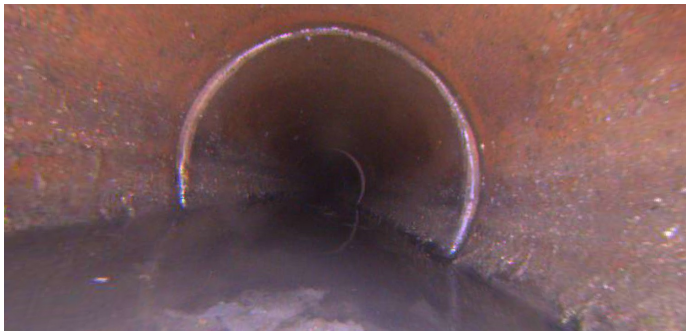
Code: **AMH**
Description: **Manhole**

Distance (ft): **.0**
Structural Grade: **0**
O&M Grade: **0**
Clock Start/From:
Clock To:
1st Value:
2nd Value:
Value Percent:
Continuous Index:
Within 8" of Joint: **NO**
Remarks: **M-504-035**

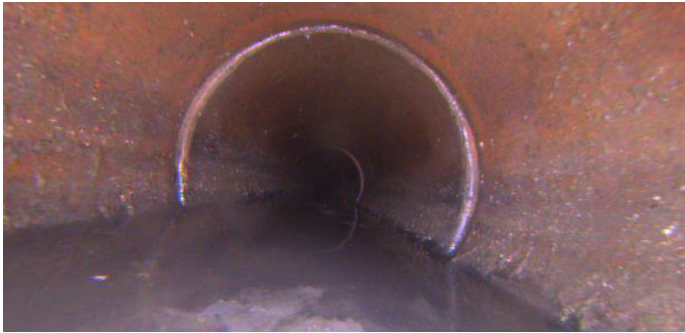
Code:	MWL
Description:	Water Level

Distance (ft):	.0
Structural Grade:	0
O&M Grade:	0
Clock Start/From:	
Clock To:	
1st Value:	
2nd Value:	
Value Percent:	30.000
Continuous Index:	
Within 8" of Joint:	NO
Remarks:

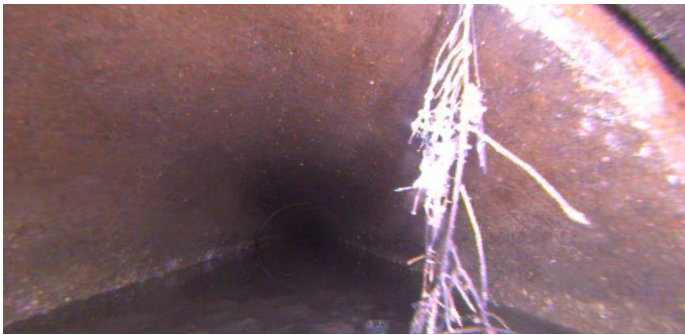
Code:	RFJ
Description:	Roots Fine Joint

Distance (ft):	19.9
Structural Grade:	0
O&M Grade:	1
Clock Start/From:	1
Clock To:	
1st Value:	
2nd Value:	
Value Percent:	
Continuous Index:	
Within 8" of Joint:	YES
Remarks:

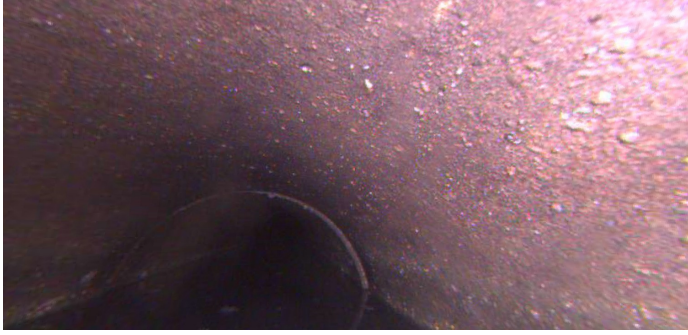
Code:	MSA
Description:	Abandoned Survey
Distance (ft):	24.9
Structural Grade:	0
O&M Grade:	0
Clock Start/From:	
Clock To:	
1st Value:	
2nd Value:	
Value Percent:	
Continuous Index:	
Within 8" of Joint:	NO
Remarks:	debris under water
