Profile/Photo Observation Report

Date:	10/31/2021	Weather:		Coding:	PACP 7.0
Pipe Length (ft):	210.2	Owner:	City of Hobart	Pre Clean:	Heavy Cleaning
P.O.#:	YES502259	Surveyor:	S. Bucklin	PSR:	P-504-036-035
Customer:	City of Hobart	Clean Date:	10/27/2021	Shape:	C

Street:	North Colorado Street	Flow Control:	Not Controlled
City:	Hobart, IN	Year Renewed:	
Location:	Alley	Tape/Media #:	
Purpose:	Routine Assessment	Dia/Height:	10"
Use:	Sanitary Sewage Pipe	Material:	VCP
Drain Area:		Lining:	None
Category:	NA		
Comment:			
Location Details:		Direction of Survey:	Downstream
US MH:	M-504-035	DS MH:	M-504-036
		Total Length Surveyed (ft):	210.2

O&M Index:	1.73	O&M Quick:	362B	O&M Rating:	64.00
Structural Index:	2.67	Structural Quick:	5546	Structural Rating:	112.00
Overall Index:	2.23	Overall Quick:	5546	Overall Rating:	176.00

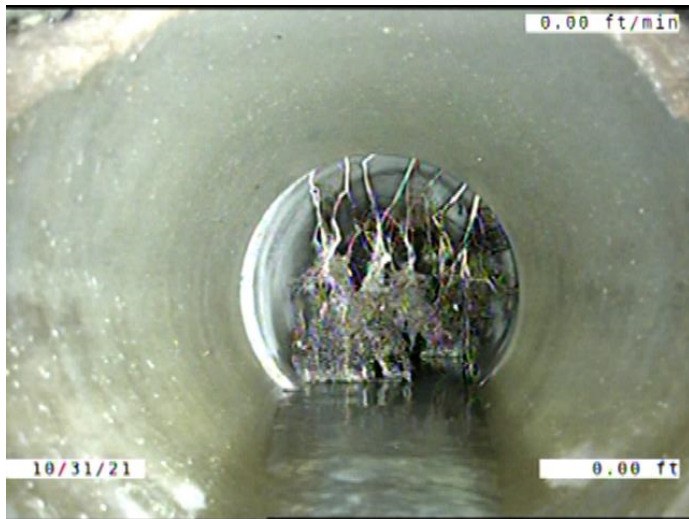
Code: **MWL**
 Description: **Miscellaneous Water Level**

Distance (ft): **.0**
 Structural Grade: **0**
 O&M Grade: **0**
 Clock Start/From:
 Clock To:
 1st Value:
 2nd Value:
 Value Percent: **5.000**
 Continuous Index:
 Within 8" of Joint: **NO**
 Remarks:

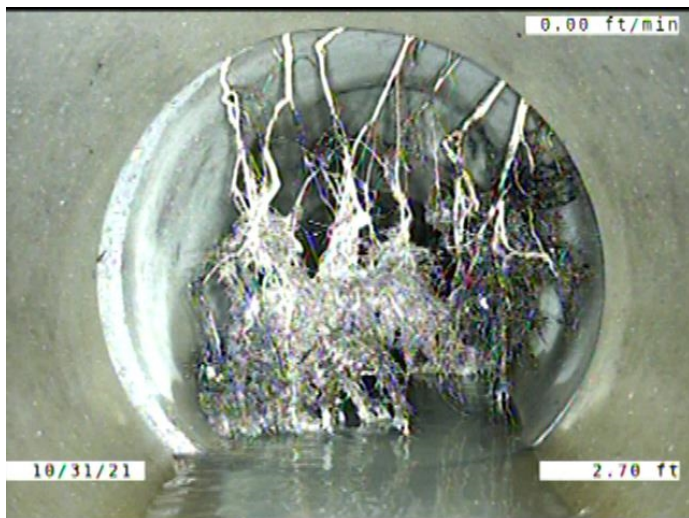
Code: **RMJ**
 Description: **Roots Medium Joint**

Distance (ft): **2.7**
 Structural Grade: **0**
 O&M Grade: **3**
 Clock Start/From: **11**
 Clock To: **2**
 1st Value:
 2nd Value:
 Value Percent: **40.000**
 Continuous Index:
 Within 8" of Joint: **YES**
 Remarks:

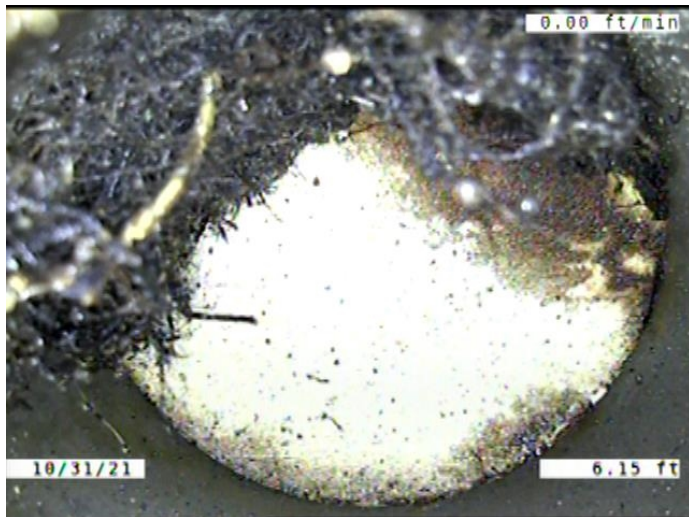
Code: **TFD**
 Description: **Tap Factory Defective**

Distance (ft): **6.2**
 Structural Grade: **0**
 O&M Grade: **3**
 Clock Start/From: **11**
 Clock To:
 1st Value: **4.000**
 2nd Value:
 Value Percent:
 Continuous Index:
 Within 8" of Joint: **YES**
 Remarks: **CAPPED. ROOTS GROWING AROUND THE CAP AND INTO THE MAIN**

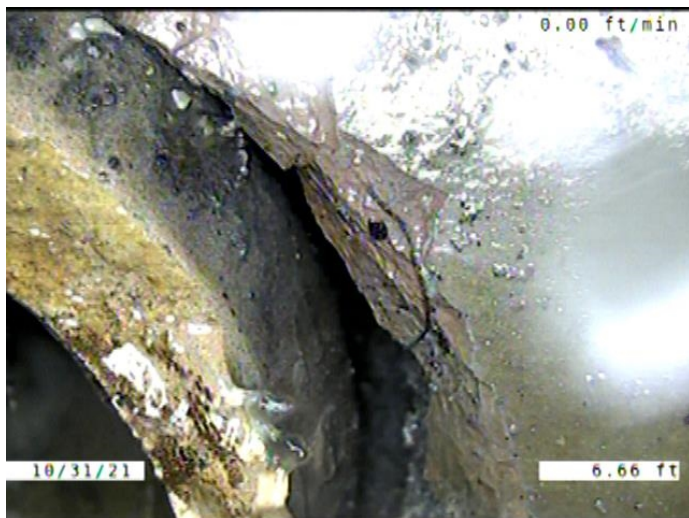
Code: **BVV**
 Description: **Broken Void Visible**

Distance (ft): **6.7**
 Structural Grade: **5**
 O&M Grade: **0**
 Clock Start/From: **11**
 Clock To: **1**
 1st Value:
 2nd Value:
 Value Percent:
 Continuous Index:
 Within 8" of Joint: **YES**
 Remarks:

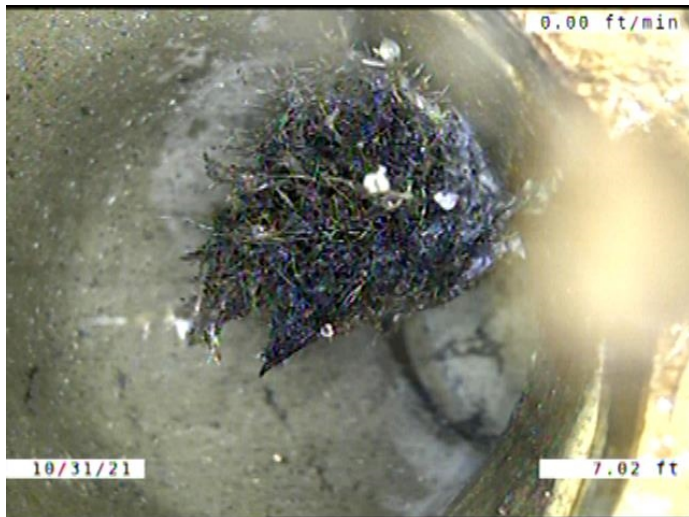
Code:	TBI
Description:	Tap Break-in Intruding
Distance (ft):	7.0
Structural Grade:	0
O&M Grade:	2
Clock Start/From:	1
Clock To:	
1st Value:	4.000
2nd Value:	1.000
Value Percent:	
Continuous Index:	
Within 8" of Joint:	YES
Remarks:	CONSTANTLY RUNNING WATER. ROOTS GROWING OUT OF IT

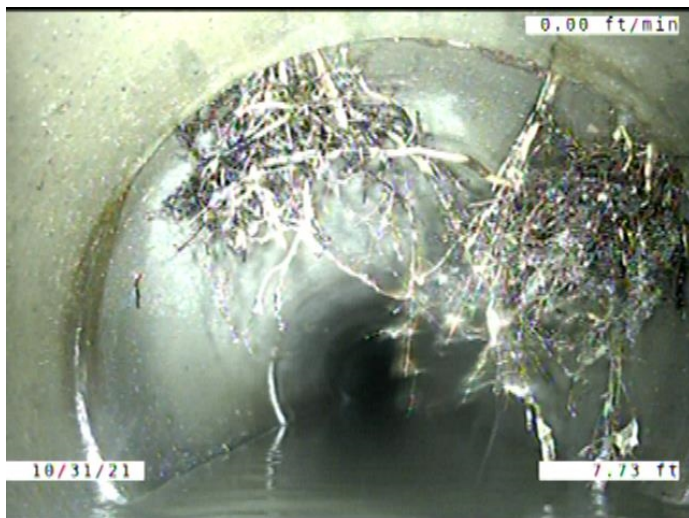
Code:	RMJ
Description:	Roots Medium Joint
Distance (ft):	7.7
Structural Grade:	0
O&M Grade:	3
Clock Start/From:	10
Clock To:	2
1st Value:	
2nd Value:	
Value Percent:	10.000
Continuous Index:	
Within 8" of Joint:	YES
Remarks:

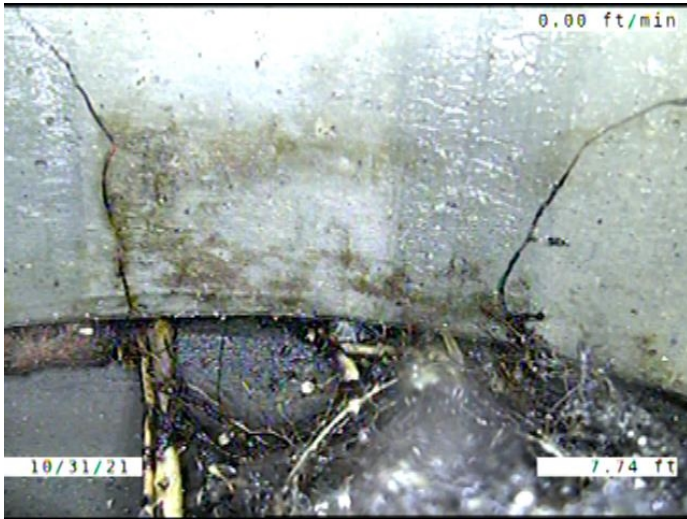
Code: **ISJ**
 Description: **Infiltration Stain Joint**

Distance (ft): **7.7**
 Structural Grade: **0**
 O&M Grade: **1**
 Clock Start/From: **12**
 Clock To: **2**
 1st Value:
 2nd Value:
 Value Percent:
 Continuous Index:
 Within 8" of Joint: **YES**
 Remarks:

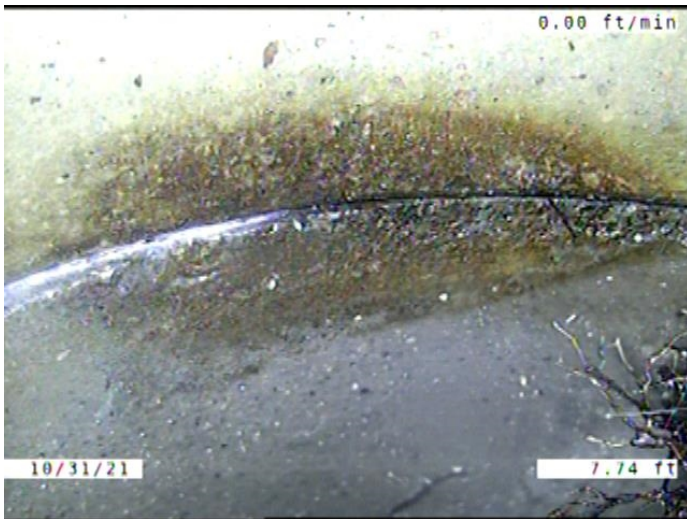
Code: **ISJ**
 Description: **Infiltration Stain Joint**

Distance (ft): **7.7**
 Structural Grade: **0**
 O&M Grade: **1**
 Clock Start/From: **9**
 Clock To: **10**
 1st Value:
 2nd Value:
 Value Percent:
 Continuous Index:
 Within 8" of Joint: **YES**
 Remarks:

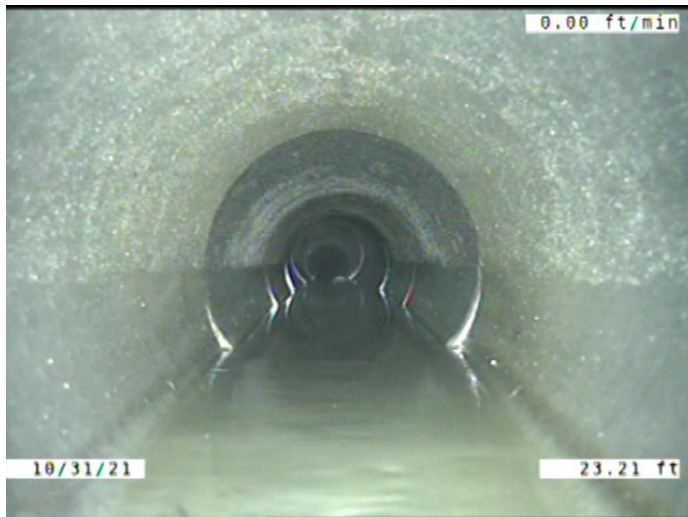
Code: **MWLS**
 Description: **Miscellaneous Water Level Sag**

Distance (ft): **23.2**
 Structural Grade: **2**
 O&M Grade: **0**
 Clock Start/From:
 Clock To:
 1st Value:
 2nd Value:
 Value Percent: **10.000**
 Continuous Index: **S01**
 Within 8" of Joint: **NO**
 Remarks:

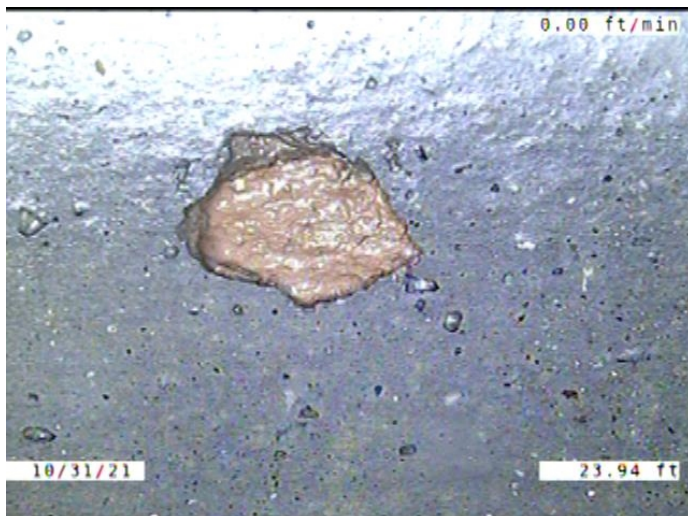
Code: **SSS**
 Description: **Surface Damage Surface Spalling**

Distance (ft): **23.9**
 Structural Grade: **2**
 O&M Grade: **0**
 Clock Start/From: **8**
 Clock To:
 1st Value:
 2nd Value:
 Value Percent:
 Continuous Index:
 Within 8" of Joint: **YES**
 Remarks:

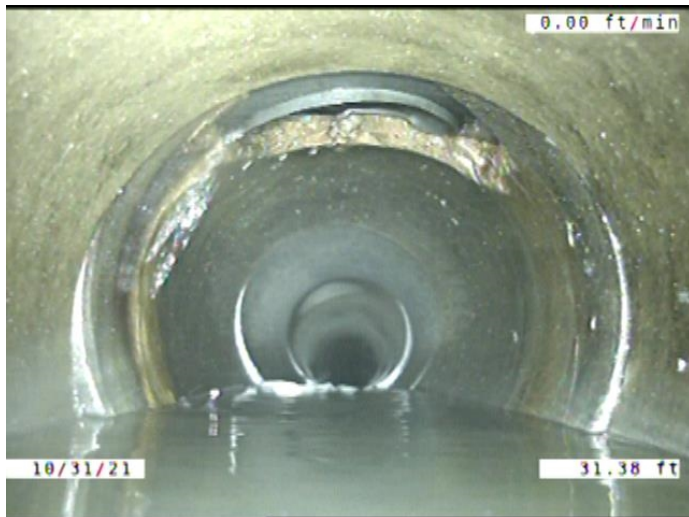
Code: **FM**
 Description: **Fracture Multiple**

Distance (ft): **31.4**
 Structural Grade: **4**
 O&M Grade: **0**
 Clock Start/From: **10**
 Clock To: **4**
 1st Value:
 2nd Value:
 Value Percent:
 Continuous Index:
 Within 8" of Joint: **YES**
 Remarks:

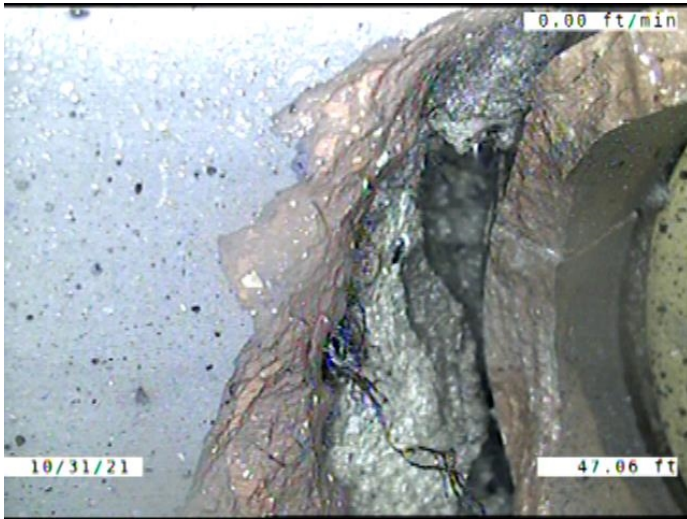
Code: **SMW**
 Description: **Surface Damage Missing Wall**

Distance (ft): **47.1**
 Structural Grade: **5**
 O&M Grade: **0**
 Clock Start/From: **11**
 Clock To: **2**
 1st Value:
 2nd Value:
 Value Percent:
 Continuous Index:
 Within 8" of Joint: **YES**
 Remarks:

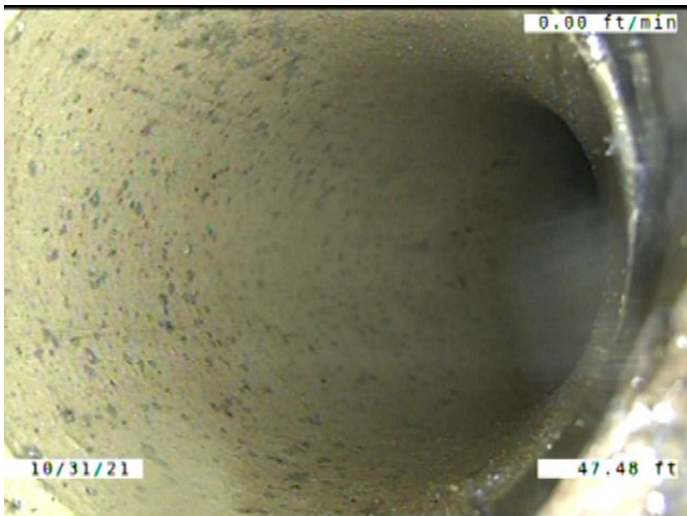
Code: **TBI**
 Description: **Tap Break-in Intruding**

Distance (ft): **47.5**
 Structural Grade: **0**
 O&M Grade: **2**
 Clock Start/From: **1**
 Clock To:
 1st Value: **4.000**
 2nd Value: **1.000**
 Value Percent:
 Continuous Index:
 Within 8" of Joint: **YES**
 Remarks: **CONSTANTLY RUNNING WATER.**

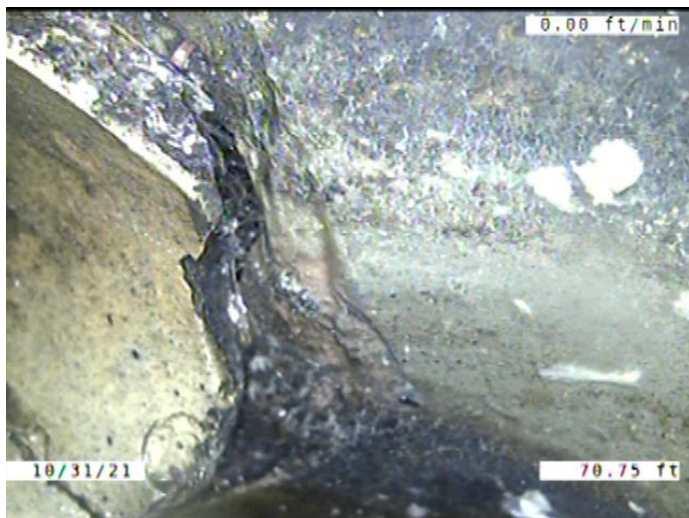
Code: **SSS**
 Description: **Surface Damage Surface Spalling**

Distance (ft): **70.8**
 Structural Grade: **2**
 O&M Grade: **0**
 Clock Start/From: **11**
 Clock To: **2**
 1st Value:
 2nd Value:
 Value Percent:
 Continuous Index:
 Within 8" of Joint: **YES**
 Remarks:

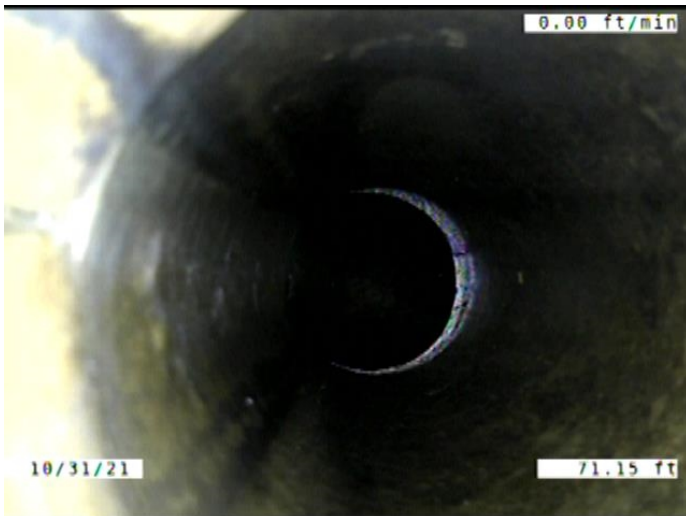
Code: **TBI**
 Description: **Tap Break-in Intruding**

Distance (ft): **71.1**
 Structural Grade: **0**
 O&M Grade: **2**
 Clock Start/From: **11**
 Clock To:
 1st Value: **4.000**
 2nd Value: **1.000**
 Value Percent:
 Continuous Index:
 Within 8" of Joint: **YES**
 Remarks: **CONSTANTLY RUNNING WATER.**

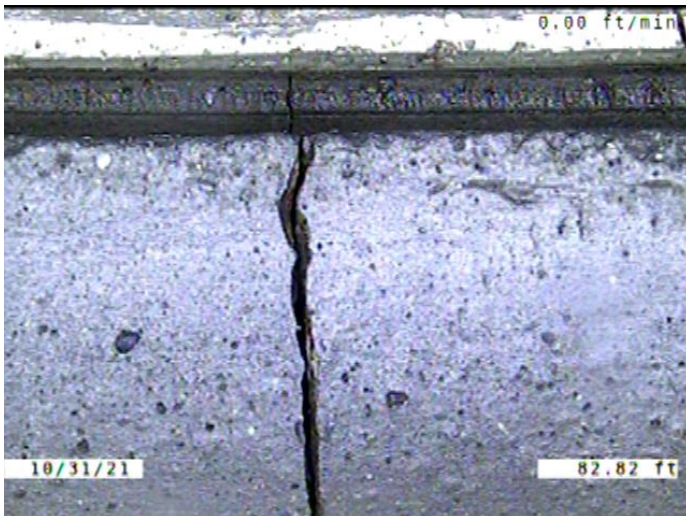
Code: **FL**
 Description: **Fracture Longitudinal**

Distance (ft): **82.8**
 Structural Grade: **3**
 O&M Grade: **0**
 Clock Start/From: **12**
 Clock To:
 1st Value:
 2nd Value:
 Value Percent:
 Continuous Index:
 Within 8" of Joint: **YES**
 Remarks:

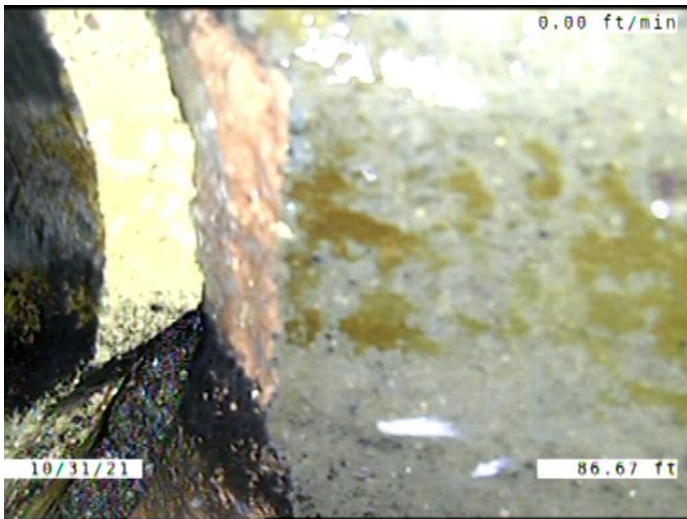
Code: **B**
Description: **Broken**

Distance (ft): **86.7**
Structural Grade: **4**
O&M Grade: **0**
Clock Start/From: **11**
Clock To: **3**
1st Value:
2nd Value:
Value Percent:
Continuous Index:
Within 8" of Joint: **YES**
Remarks:

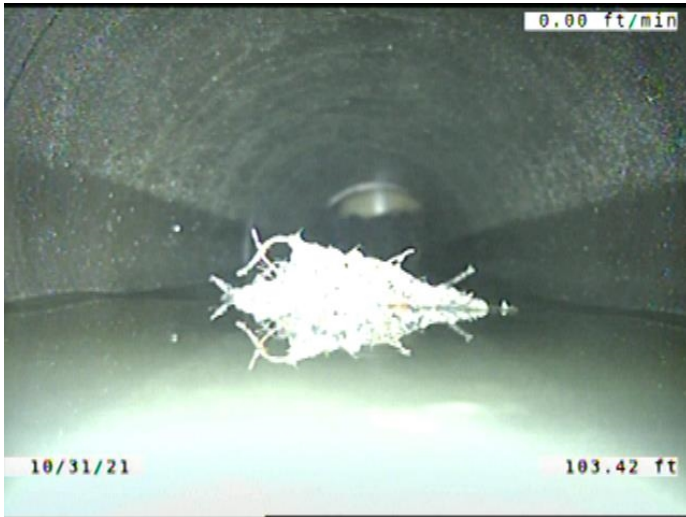
Code: **OBZ**
 Description: **Obstruction Other**

Distance (ft): **103.4**
 Structural Grade: **0**
 O&M Grade: **2**
 Clock Start/From: **5**
 Clock To: **7**
 1st Value:
 2nd Value:
 Value Percent: **5.000**
 Continuous Index:
 Within 8" of Joint: **YES**
 Remarks: **ROOTS THAT HAVE BEEN CUT OUT**

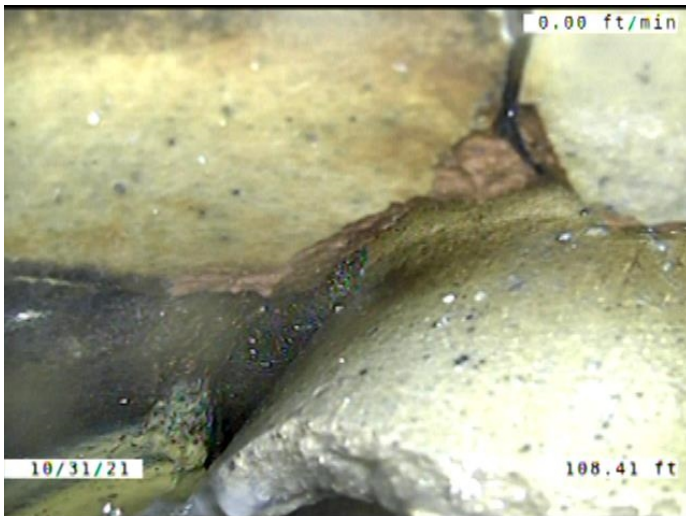
Code: **BSV**
 Description: **Broken Soil Visible**

Distance (ft): **108.4**
 Structural Grade: **5**
 O&M Grade: **0**
 Clock Start/From: **9**
 Clock To: **4**
 1st Value:
 2nd Value:
 Value Percent:
 Continuous Index:
 Within 8" of Joint: **YES**
 Remarks:

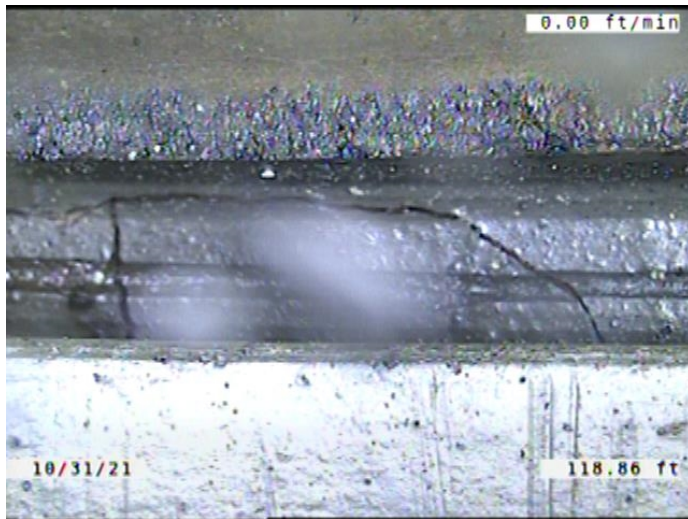
Code: **FM**
 Description: **Fracture Multiple**

Distance (ft): **118.9**
 Structural Grade: **4**
 O&M Grade: **0**
 Clock Start/From: **10**
 Clock To: **2**
 1st Value:
 2nd Value:
 Value Percent:
 Continuous Index:
 Within 8" of Joint: **YES**
 Remarks:

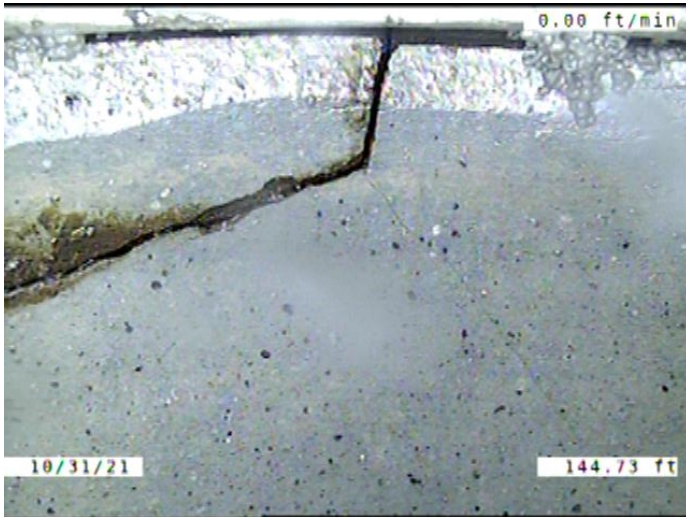
Code: **B**
Description: **Broken**

Distance (ft): **144.7**
Structural Grade: **4**
O&M Grade: **0**
Clock Start/From: **8**
Clock To: **4**
1st Value:
2nd Value:
Value Percent:
Continuous Index:
Within 8" of Joint: **YES**
Remarks:

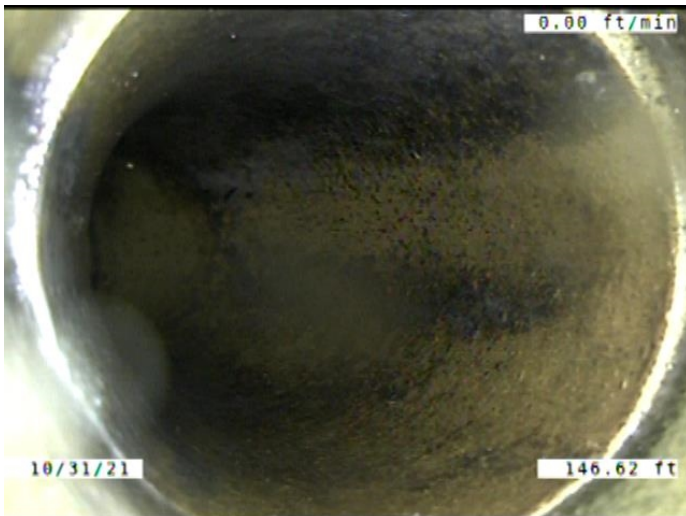
Code: **TBI**
Description: **Tap Break-in Intruding**

Distance (ft): **146.6**
Structural Grade: **0**
O&M Grade: **2**
Clock Start/From: **12**
Clock To:
1st Value: **4.000**
2nd Value: **2.000**
Value Percent:
Continuous Index:
Within 8" of Joint: **YES**
Remarks: **CONSTANTLY RUNNING WATER.**

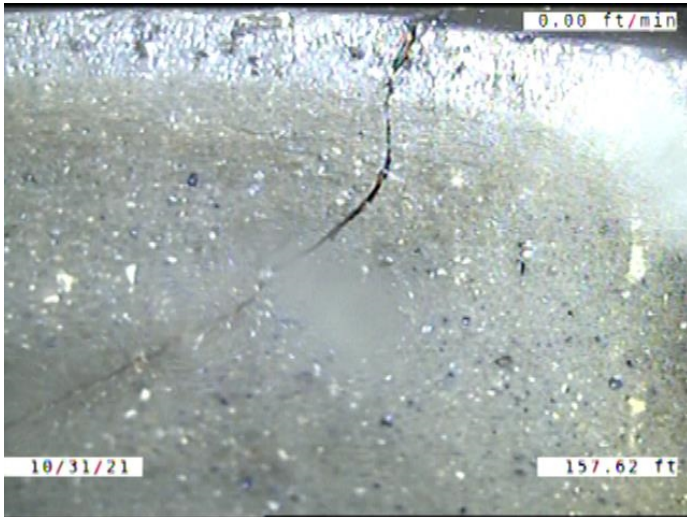
Code: **FM**
 Description: **Fracture Multiple**

Distance (ft): **157.6**
 Structural Grade: **4**
 O&M Grade: **0**
 Clock Start/From: **10**
 Clock To: **4**
 1st Value:
 2nd Value:
 Value Percent:
 Continuous Index:
 Within 8" of Joint: **YES**
 Remarks:

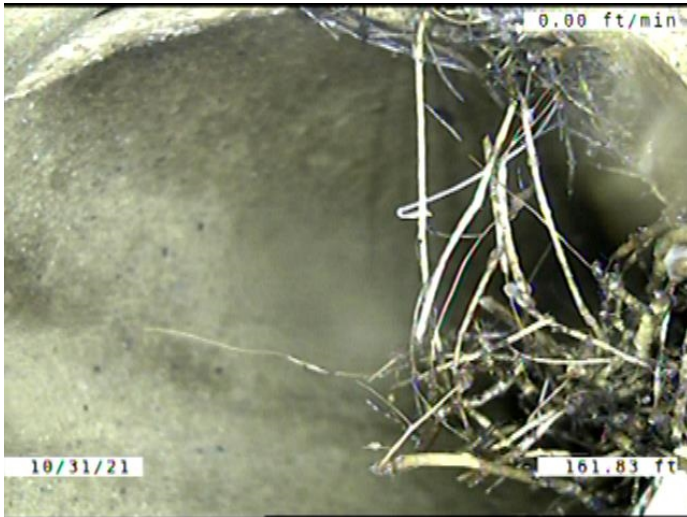
Code: **TBI**
 Description: **Tap Break-in Intruding**

Distance (ft): **161.8**
 Structural Grade: **0**
 O&M Grade: **2**
 Clock Start/From: **1**
 Clock To:
 1st Value: **4.000**
 2nd Value: **1.000**
 Value Percent:
 Continuous Index:
 Within 8" of Joint: **YES**
 Remarks: **ROOTS GROWING IN THE TAP**
