# Profile/Photo Observation Report

Date:	10/31/2021	Weather:		Coding:	PACP 7.0
Pipe Length (ft):	210.2	Owner:	City of Hobart	Pre Clean:	Heavy Cleaning
P.O.#:	YES502259	Surveyor:	S. Bucklin	PSR:	P-504-036-035
Customer:	City of Hobart	Clean Date:	10/27/2021	Shape:	C

Street:	North Colorado Street	Flow Control:	Not Controlled
City:	Hobart, IN	Year Renewed:	
Location:	Alley	Tape/Media #:	
Purpose:	Routine Assessment	Dia/Height:	10"
Use:	Sanitary Sewage Pipe	Material:	VCP
Drain Area:		Lining:	None
Category:	NA		
Comment:			
Location Details:		Direction of Survey:	Downstream
US MH:	M-504-035	DS MH:	M-504-036
		Total Length Surveyed (ft):	210.2

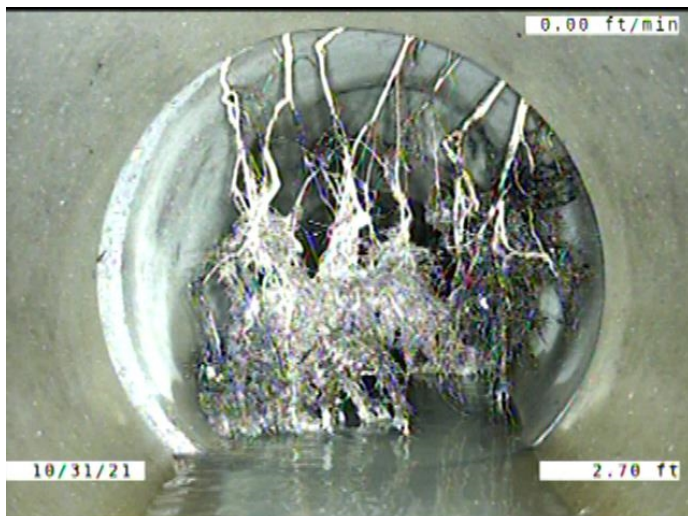
Code: **RMJ**  
 Description: **Roots Medium Joint**

Distance (ft): **2.7**  
 Structural Grade: **0**  
 O&M Grade: **3**  
 Clock Start/From: **11**  
 Clock To: **2**  
 1st Value:  
 2nd Value:  
 Value Percent: **40.000**  
 Continuous Index:  
 Within 8" of Joint: **YES**  
 Remarks:

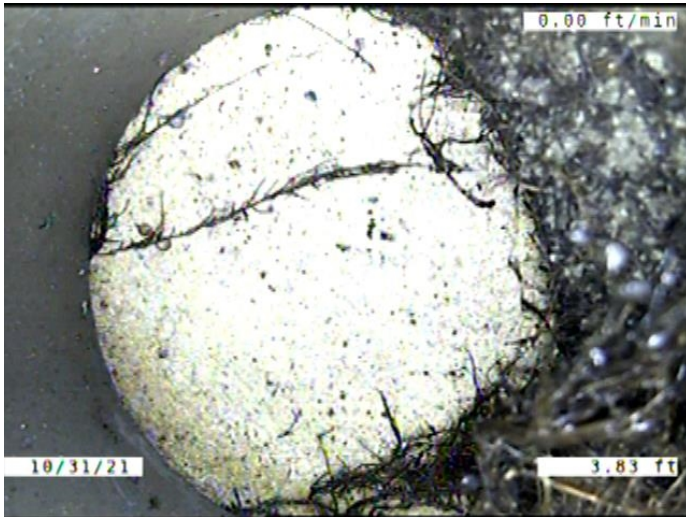
Code:	<b>TFC</b>
Description:	<b>Tap Factory Capped</b>
Distance (ft):	<b>3.8</b>
Structural Grade:	<b>0</b>
O&M Grade:	<b>0</b>
Clock Start/From:	<b>1</b>
Clock To:	
1st Value:	<b>4.000</b>
2nd Value:	
Value Percent:	
Continuous Index:	
Within 8" of Joint:	<b>YES</b>
Remarks:	<b>ROOTS GROWING AROUND THE CAP</b>

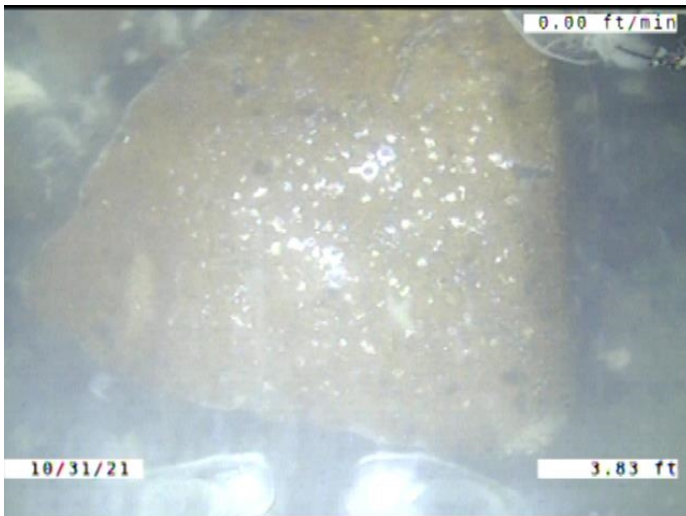
Code:	<b>OBM</b>
Description:	<b>Obstruction Pipe Material in Invert</b>
Distance (ft):	<b>3.8</b>
Structural Grade:	<b>0</b>
O&M Grade:	<b>2</b>
Clock Start/From:	<b>6</b>
Clock To:	
1st Value:	
2nd Value:	
Value Percent:	<b>5.000</b>
Continuous Index:	
Within 8" of Joint:	<b>YES</b>
Remarks:

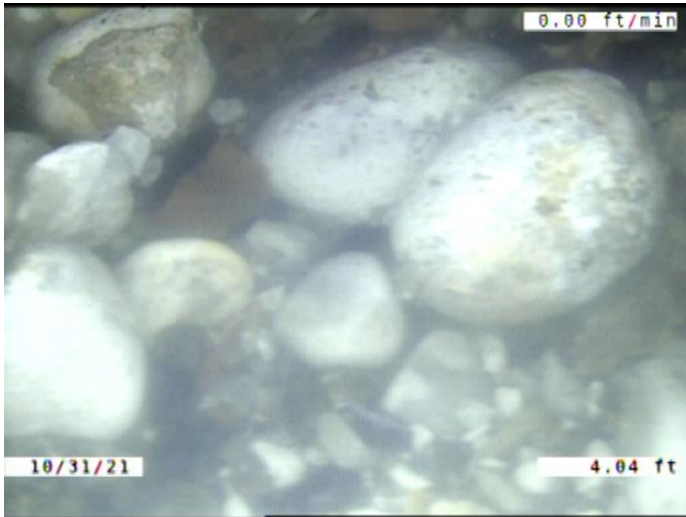
Code: **DSGV**  
 Description: **Deposits Settled Gravel**

Distance (ft): **4.0**  
 Structural Grade: **0**  
 O&M Grade: **2**  
 Clock Start/From: **5**  
 Clock To: **7**  
 1st Value:  
 2nd Value:  
 Value Percent: **5.000**  
 Continuous Index:  
 Within 8" of Joint: **YES**  
 Remarks:

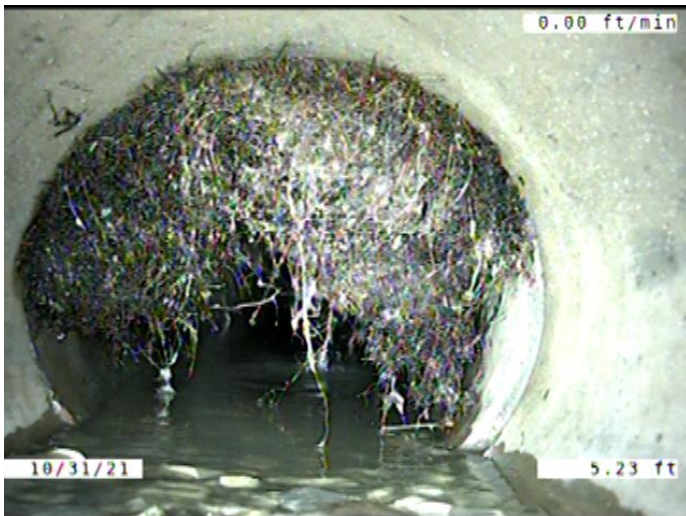
Code: **RMJ**  
 Description: **Roots Medium Joint**

Distance (ft): **5.2**  
 Structural Grade: **0**  
 O&M Grade: **3**  
 Clock Start/From: **9**  
 Clock To: **3**  
 1st Value:  
 2nd Value:  
 Value Percent: **50.000**  
 Continuous Index:  
 Within 8" of Joint: **YES**  
 Remarks:

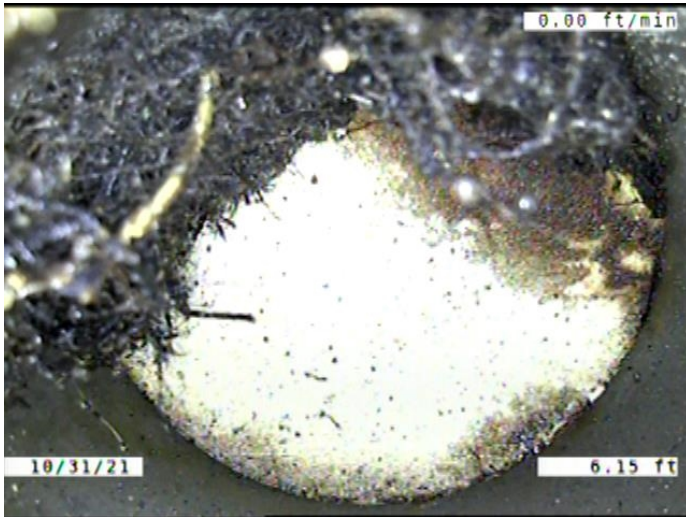
Code: **TFD**  
 Description: **Tap Factory Defective**

Distance (ft): **6.2**  
 Structural Grade: **0**  
 O&M Grade: **3**  
 Clock Start/From: **11**  
 Clock To:  
 1st Value: **4.000**  
 2nd Value:  
 Value Percent:  
 Continuous Index:  
 Within 8" of Joint: **YES**  
 Remarks: **CAPPED. ROOTS GROWING AROUND THE CAP AND INTO THE MAIN**

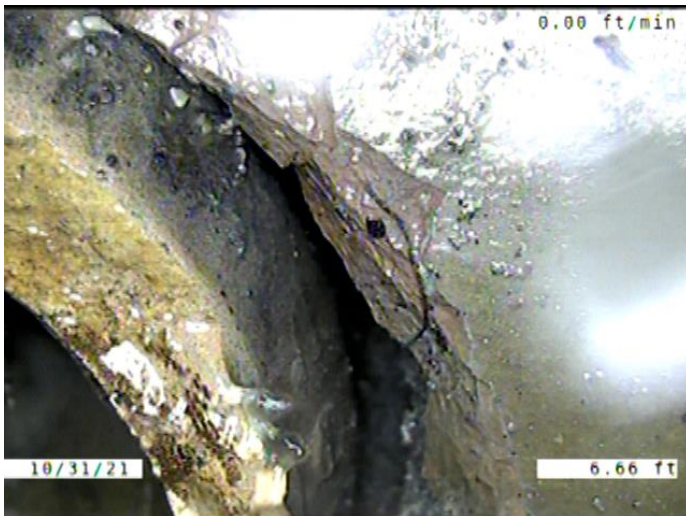
Code: **BVV**  
 Description: **Broken Void Visible**

Distance (ft): **6.7**  
 Structural Grade: **5**  
 O&M Grade: **0**  
 Clock Start/From: **11**  
 Clock To: **1**  
 1st Value:  
 2nd Value:  
 Value Percent:  
 Continuous Index:  
 Within 8" of Joint: **YES**  
 Remarks:

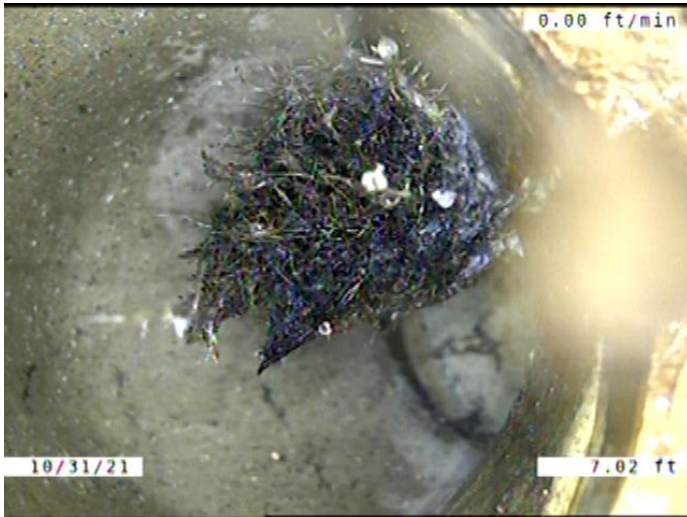
Code:	<b>TBI</b>
Description:	<b>Tap Break-in Intruding</b>
Distance (ft):	<b>7.0</b>
Structural Grade:	<b>0</b>
O&M Grade:	<b>2</b>
Clock Start/From:	<b>1</b>
Clock To:	
1st Value:	<b>4.000</b>
2nd Value:	<b>1.000</b>
Value Percent:	
Continuous Index:	
Within 8" of Joint:	<b>YES</b>
Remarks:	<b>CONSTANTLY RUNNING WATER. ROOTS GROWING OUT OF IT</b>

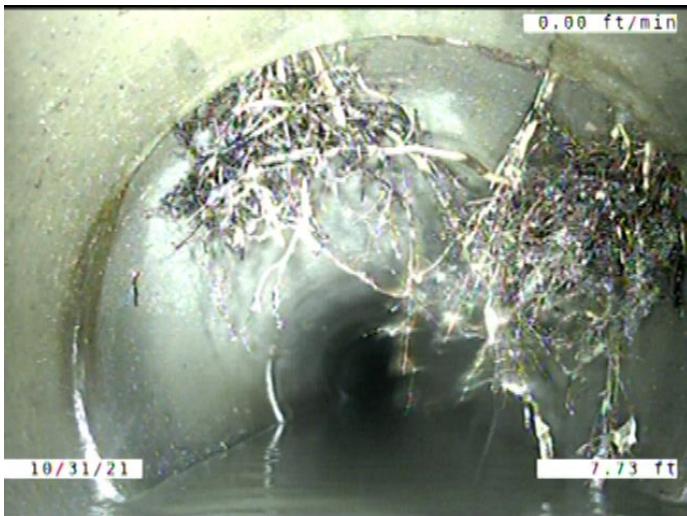
Code:	<b>RMJ</b>
Description:	<b>Roots Medium Joint</b>
Distance (ft):	<b>7.7</b>
Structural Grade:	<b>0</b>
O&M Grade:	<b>3</b>
Clock Start/From:	<b>10</b>
Clock To:	<b>2</b>
1st Value:	
2nd Value:	
Value Percent:	<b>10.000</b>
Continuous Index:	
Within 8" of Joint:	<b>YES</b>
Remarks:

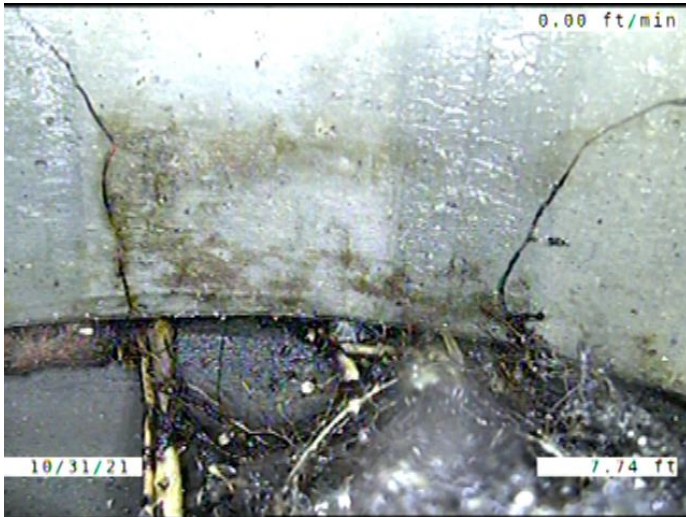
Code: **ISJ**  
 Description: **Infiltration Stain Joint**

Distance (ft): **7.7**  
 Structural Grade: **0**  
 O&M Grade: **1**  
 Clock Start/From: **12**  
 Clock To: **2**  
 1st Value:  
 2nd Value:  
 Value Percent:  
 Continuous Index:  
 Within 8" of Joint: **YES**  
 Remarks:

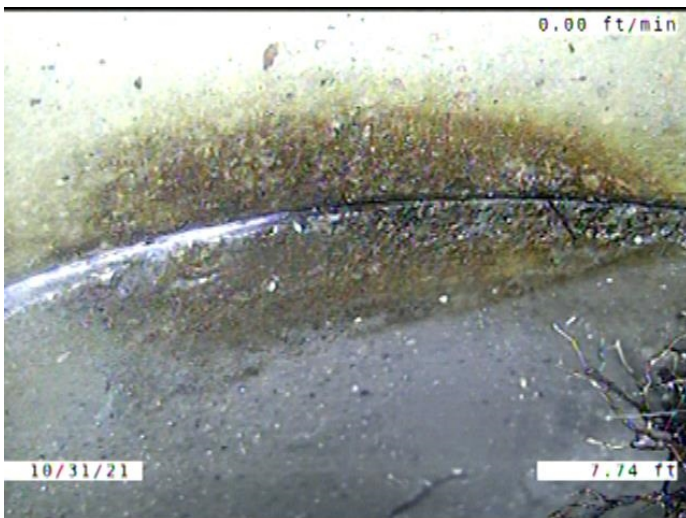
Code: **ISJ**  
 Description: **Infiltration Stain Joint**

Distance (ft): **7.7**  
 Structural Grade: **0**  
 O&M Grade: **1**  
 Clock Start/From: **9**  
 Clock To: **10**  
 1st Value:  
 2nd Value:  
 Value Percent:  
 Continuous Index:  
 Within 8" of Joint: **YES**  
 Remarks:

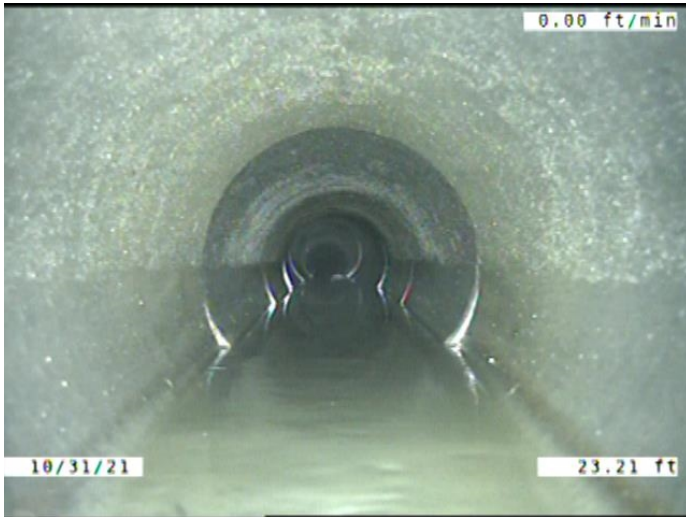
Code: **MWLS**  
 Description: **Miscellaneous Water Level Sag**

Distance (ft): **23.2**  
 Structural Grade: **2**  
 O&M Grade: **0**  
 Clock Start/From:  
 Clock To:  
 1st Value:  
 2nd Value:  
 Value Percent: **10.000**  
 Continuous Index: **S01**  
 Within 8" of Joint: **NO**  
 Remarks:

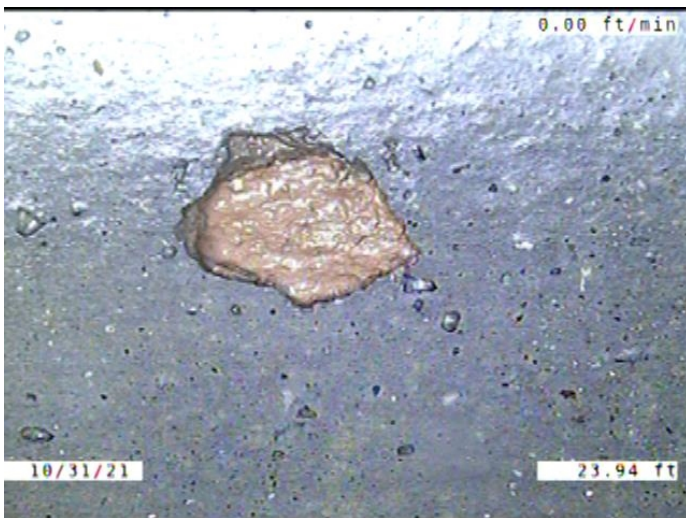
Code: **SSS**  
 Description: **Surface Damage Surface Spalling**

Distance (ft): **23.9**  
 Structural Grade: **2**  
 O&M Grade: **0**  
 Clock Start/From: **8**  
 Clock To:  
 1st Value:  
 2nd Value:  
 Value Percent:  
 Continuous Index:  
 Within 8" of Joint: **YES**  
 Remarks:

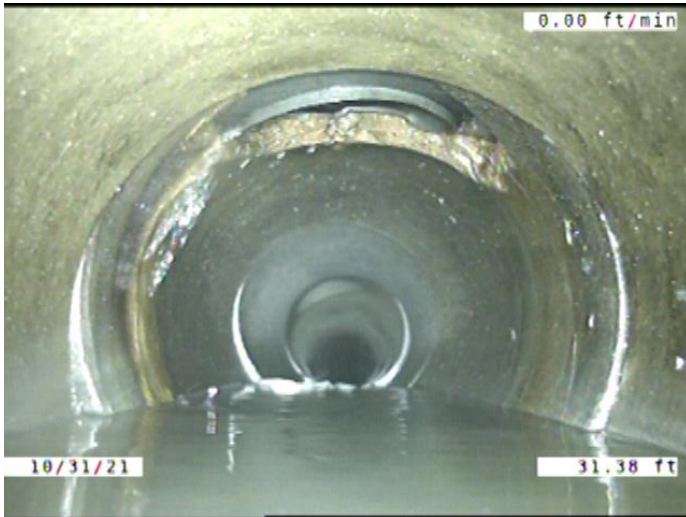
Code: **FM**  
 Description: **Fracture Multiple**

Distance (ft): **31.4**  
 Structural Grade: **4**  
 O&M Grade: **0**  
 Clock Start/From: **10**  
 Clock To: **4**  
 1st Value:  
 2nd Value:  
 Value Percent:  
 Continuous Index:  
 Within 8" of Joint: **YES**  
 Remarks:

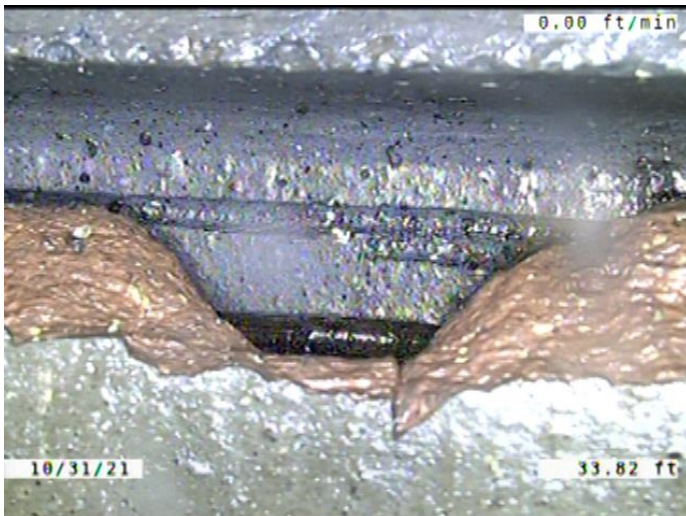
Code: **SMW**  
 Description: **Surface Damage Missing Wall**

Distance (ft): **33.8**  
 Structural Grade: **5**  
 O&M Grade: **0**  
 Clock Start/From: **8**  
 Clock To: **10**  
 1st Value:  
 2nd Value:  
 Value Percent:  
 Continuous Index:  
 Within 8" of Joint: **YES**  
 Remarks: **INSIDE OF THE JOINT**

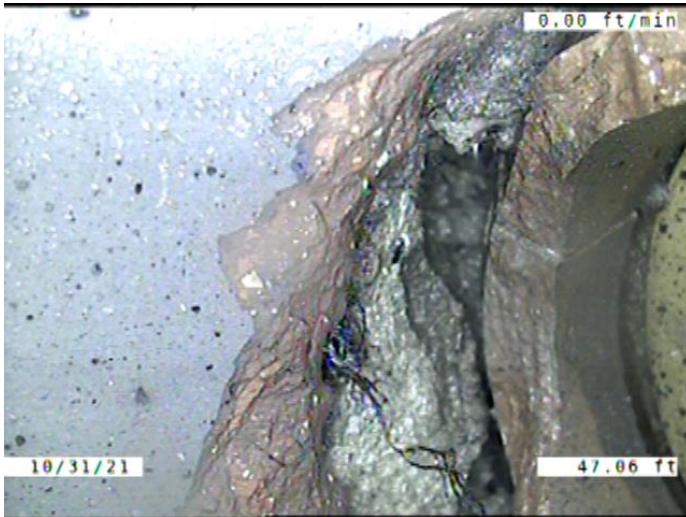
Code: **SMW**  
 Description: **Surface Damage Missing Wall**

Distance (ft): **47.1**  
 Structural Grade: **5**  
 O&M Grade: **0**  
 Clock Start/From: **11**  
 Clock To: **2**  
 1st Value:  
 2nd Value:  
 Value Percent:  
 Continuous Index:  
 Within 8" of Joint: **YES**  
 Remarks:

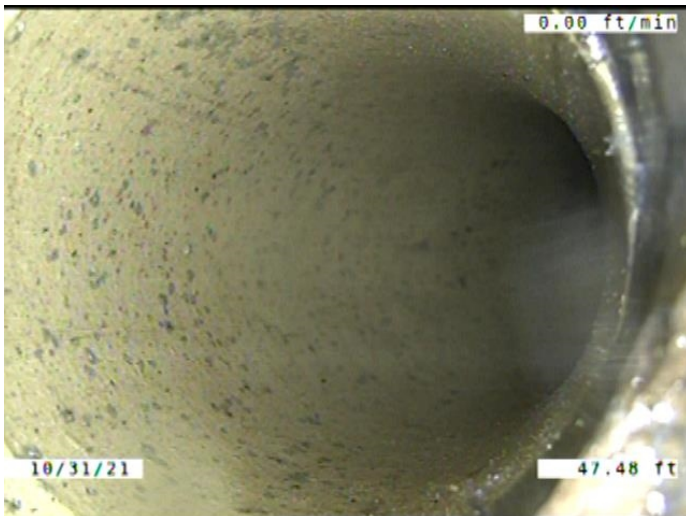
Code: **TBI**  
 Description: **Tap Break-in Intruding**

Distance (ft): **47.5**  
 Structural Grade: **0**  
 O&M Grade: **2**  
 Clock Start/From: **1**  
 Clock To:  
 1st Value: **4.000**  
 2nd Value: **1.000**  
 Value Percent:  
 Continuous Index:  
 Within 8" of Joint: **YES**  
 Remarks: **CONSTANTLY RUNNING WATER.**

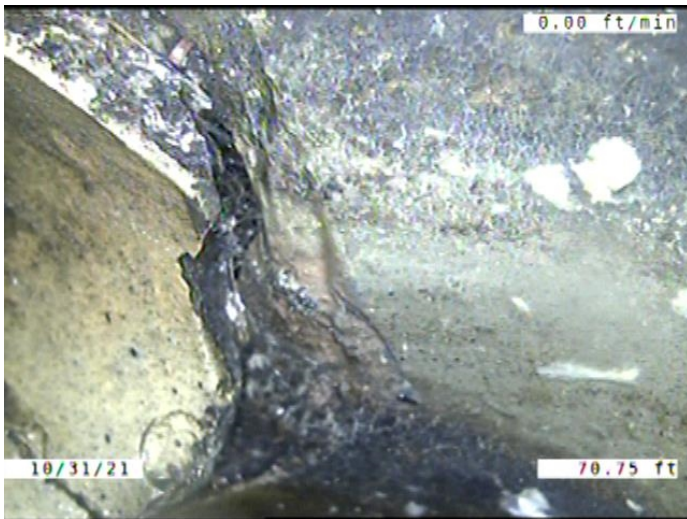
Code: **SSS**  
Description: **Surface Damage Surface Spalling**

Distance (ft): **70.8**  
Structural Grade: **2**  
O&M Grade: **0**  
Clock Start/From: **11**  
Clock To: **2**  
1st Value:  
2nd Value:  
Value Percent:  
Continuous Index:  
Within 8" of Joint: **YES**  
Remarks:

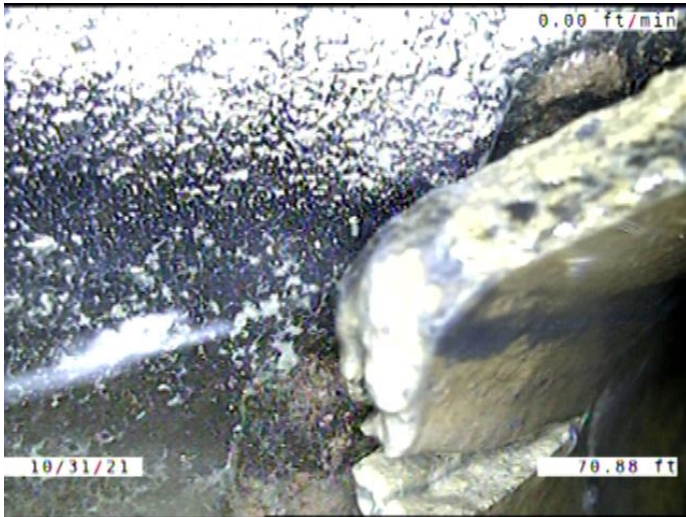
Code: **IDC**  
 Description: **Infiltration Dripper Connection**

Distance (ft): **70.9**  
 Structural Grade: **0**  
 O&M Grade: **3**  
 Clock Start/From: **1**  
 Clock To:  
 1st Value:  
 2nd Value:  
 Value Percent:  
 Continuous Index:  
 Within 8" of Joint: **YES**  
 Remarks:

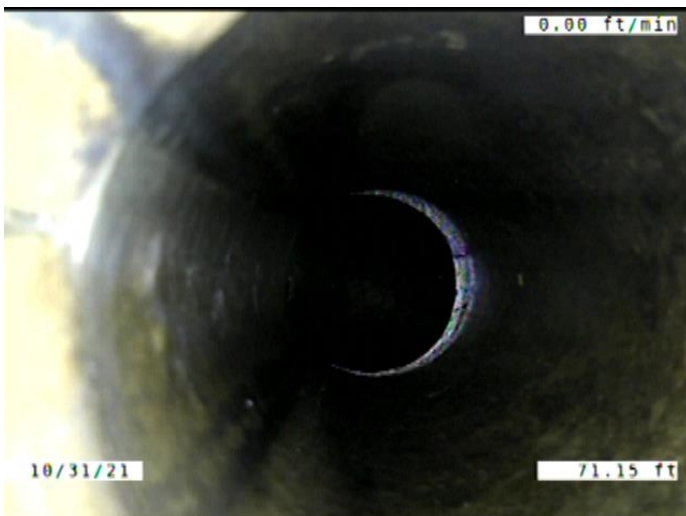
Code: **TBI**  
 Description: **Tap Break-in Intruding**

Distance (ft): **71.1**  
 Structural Grade: **0**  
 O&M Grade: **2**  
 Clock Start/From: **11**  
 Clock To:  
 1st Value: **4.000**  
 2nd Value: **1.000**  
 Value Percent:  
 Continuous Index:  
 Within 8" of Joint: **YES**  
 Remarks: **CONSTANTLY RUNNING WATER.**

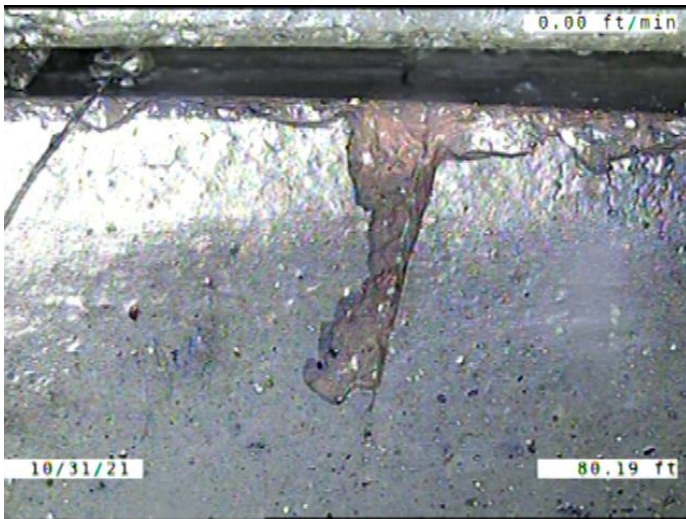
Code: **FM**  
Description: **Fracture Multiple**

Distance (ft): **80.2**  
Structural Grade: **4**  
O&M Grade: **0**  
Clock Start/From: **8**  
Clock To: **4**  
1st Value:  
2nd Value:  
Value Percent:  
Continuous Index:  
Within 8" of Joint: **YES**  
Remarks:

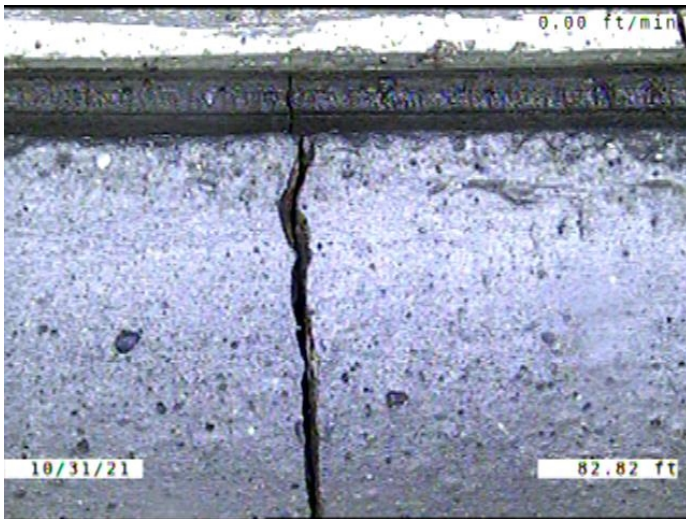
Code: **FL**  
 Description: **Fracture Longitudinal**

Distance (ft): **82.8**  
 Structural Grade: **3**  
 O&M Grade: **0**  
 Clock Start/From: **12**  
 Clock To:  
 1st Value:  
 2nd Value:  
 Value Percent:  
 Continuous Index:  
 Within 8" of Joint: **YES**  
 Remarks:

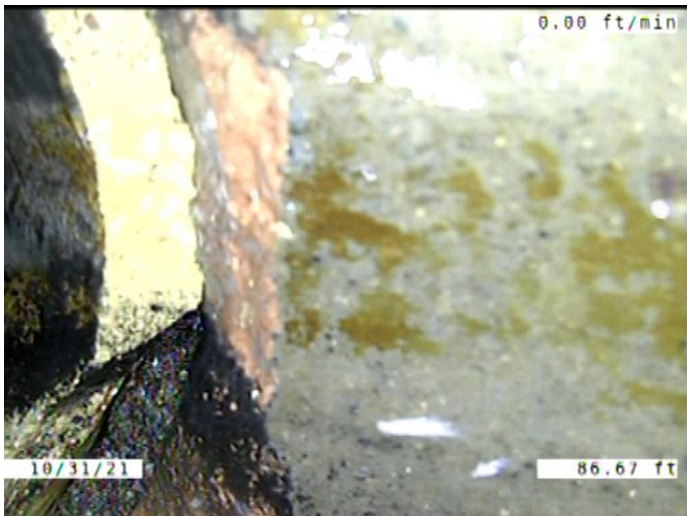
Code: **B**  
 Description: **Broken**

Distance (ft): **86.7**  
 Structural Grade: **4**  
 O&M Grade: **0**  
 Clock Start/From: **11**  
 Clock To: **3**  
 1st Value:  
 2nd Value:  
 Value Percent:  
 Continuous Index:  
 Within 8" of Joint: **YES**  
 Remarks:

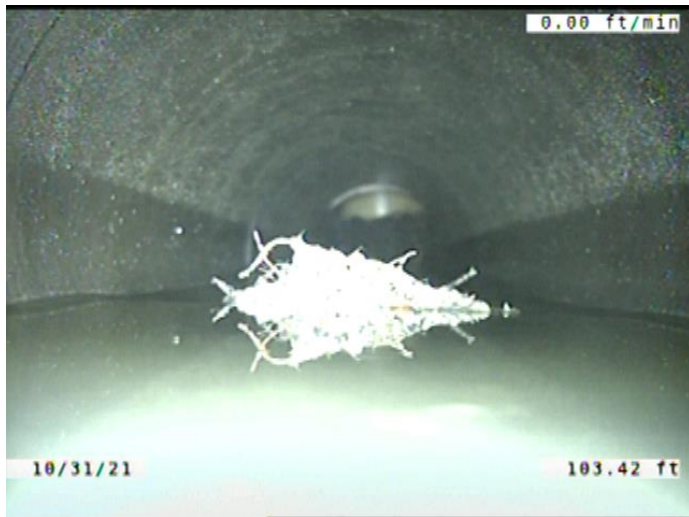
Code:	<b>OBZ</b>
Description:	<b>Obstruction Other</b>
Distance (ft):	<b>103.4</b>
Structural Grade:	<b>0</b>
O&M Grade:	<b>2</b>
Clock Start/From:	<b>5</b>
Clock To:	<b>7</b>
1st Value:	
2nd Value:	
Value Percent:	<b>5.000</b>
Continuous Index:	
Within 8" of Joint:	<b>YES</b>
Remarks:	<b>ROOTS THAT HAVE BEEN CUT OUT</b>

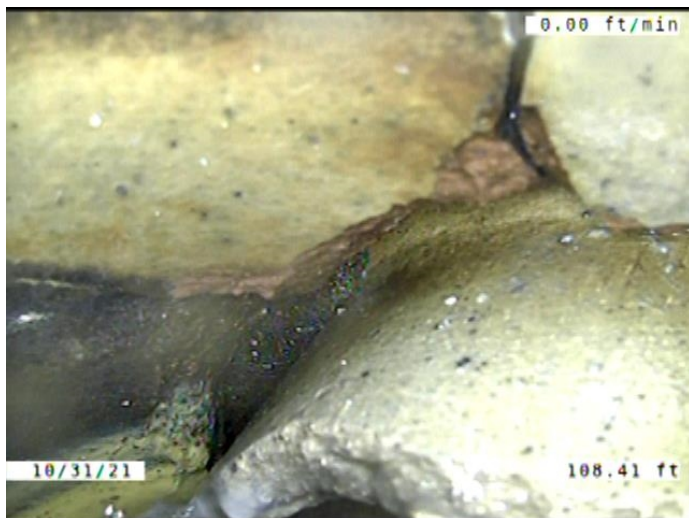
Code:	<b>BSV</b>
Description:	<b>Broken Soil Visible</b>
Distance (ft):	<b>108.4</b>
Structural Grade:	<b>5</b>
O&M Grade:	<b>0</b>
Clock Start/From:	<b>9</b>
Clock To:	<b>4</b>
1st Value:	
2nd Value:	
Value Percent:	
Continuous Index:	
Within 8" of Joint:	<b>YES</b>
Remarks:

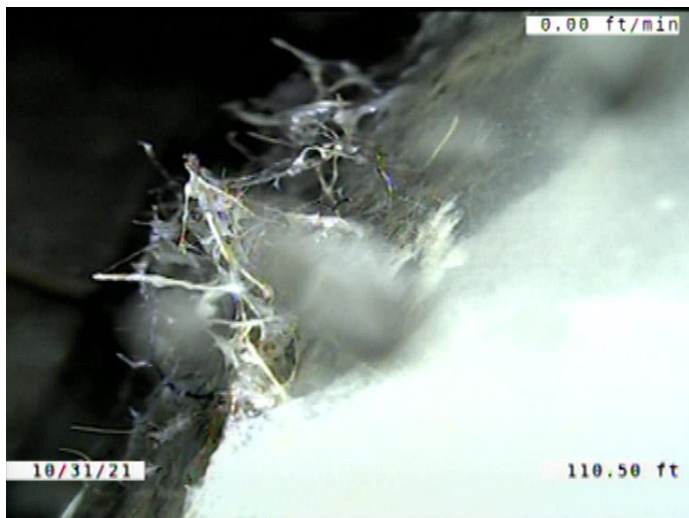
Code: **OBZ**  
Description: **Obstruction Other**

Distance (ft): **110.5**  
Structural Grade: **0**  
O&M Grade: **2**  
Clock Start/From: **6**  
Clock To: **8**  
1st Value:  
2nd Value:  
Value Percent: **5.000**  
Continuous Index:  
Within 8" of Joint: **YES**  
Remarks: **ROOTS WE CUT OUT**

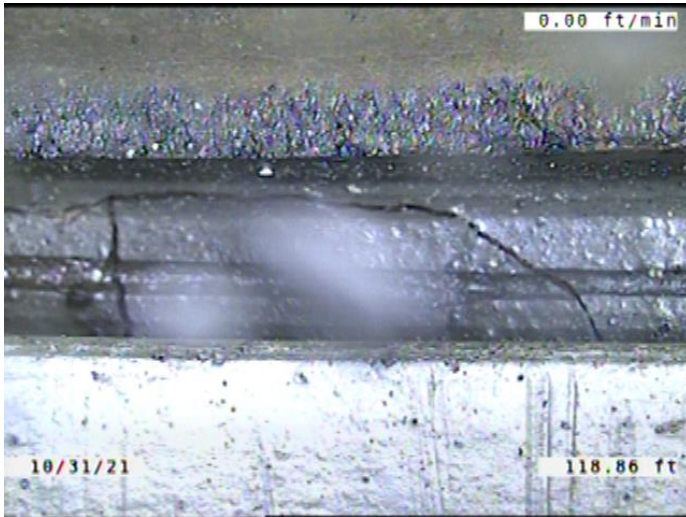
Code: **FM**  
 Description: **Fracture Multiple**

Distance (ft): **118.9**  
 Structural Grade: **4**  
 O&M Grade: **0**  
 Clock Start/From: **10**  
 Clock To: **2**  
 1st Value:  
 2nd Value:  
 Value Percent:  
 Continuous Index:  
 Within 8" of Joint: **YES**  
 Remarks:

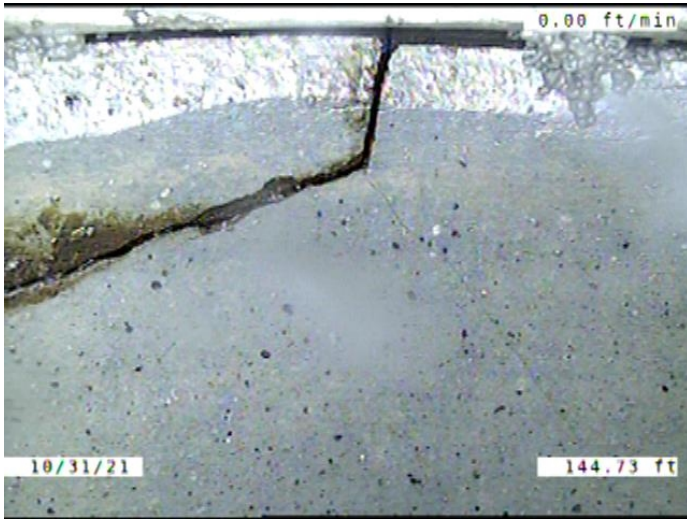
Code: **B**  
 Description: **Broken**

Distance (ft): **144.7**  
 Structural Grade: **4**  
 O&M Grade: **0**  
 Clock Start/From: **8**  
 Clock To: **4**  
 1st Value:  
 2nd Value:  
 Value Percent:  
 Continuous Index:  
 Within 8" of Joint: **YES**  
 Remarks:

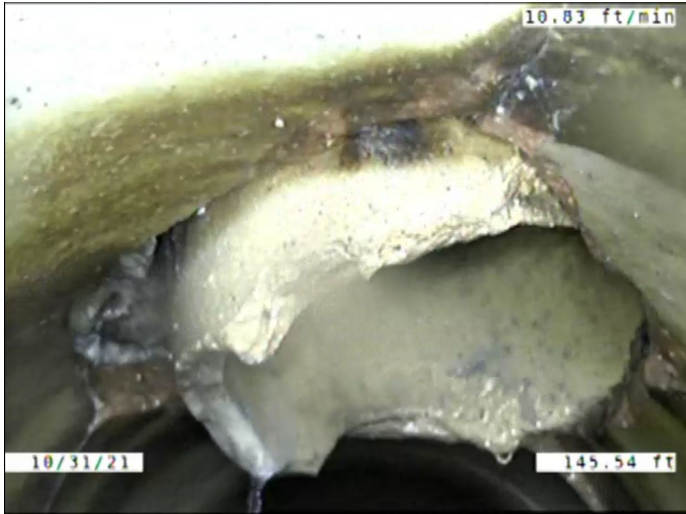
Code: **SMW**  
Description: **Surface Damage Missing Wall**

Distance (ft): **145.5**  
Structural Grade: **5**  
O&M Grade: **0**  
Clock Start/From: **11**  
Clock To:  
1st Value:  
2nd Value:  
Value Percent:  
Continuous Index:  
Within 8" of Joint: **NO**  
Remarks:

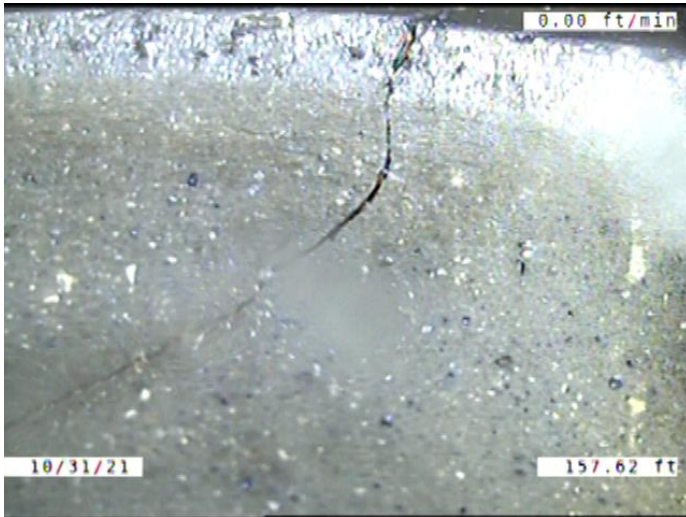
Code: **FM**  
Description: **Fracture Multiple**

Distance (ft): **157.6**  
Structural Grade: **4**  
O&M Grade: **0**  
Clock Start/From: **10**  
Clock To: **4**  
1st Value:  
2nd Value:  
Value Percent:  
Continuous Index:  
Within 8" of Joint: **YES**  
Remarks:

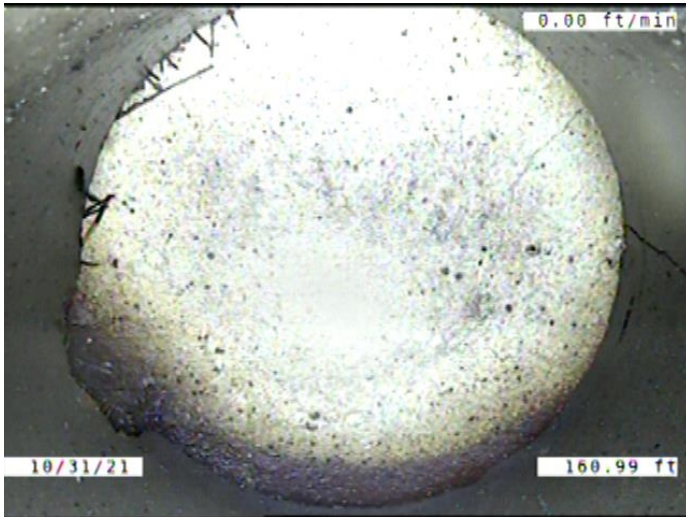
Code:	TFD
Description:	Tap Factory Defective
Distance (ft):	161.0
Structural Grade:	0
O&M Grade:	3
Clock Start/From:	11
Clock To:	
1st Value:	4.000
2nd Value:	
Value Percent:	
Continuous Index:	
Within 8" of Joint:	YES
Remarks:	A PIECE CHIPPED OUT TAP CRACKED. ROOTS GROWING AROUND THE CAP
