Profile/Photo Observation Report

Date:	10/31/2021	Weather:		Coding:	PACP 7.0
Pipe Length (ft):	197.3	Owner:	City of Hobart	Pre Clean:	Heavy Cleaning
P.O.#:	YES502259	Surveyor:	S. Bucklin	PSR:	P-504-037-036
Customer:	City of Hobart	Clean Date:	10/26/2021	Shape:	C

Street:	North Cavender Street	Flow Control:	Not Controlled
City:	Hobart, IN	Year Renewed:	
Location:	Alley	Tape/Media #:	
Purpose:	Routine Assessment	Dia/Height:	10"
Use:	Sanitary Sewage Pipe	Material:	VCP
Drain Area:		Lining:	None
Category:	NA		
Comment:			
Location Details:		Direction of Survey:	Downstream
US MH:	M-504-036	DS MH:	M-504-037
		Total Length Surveyed (ft):	197.3

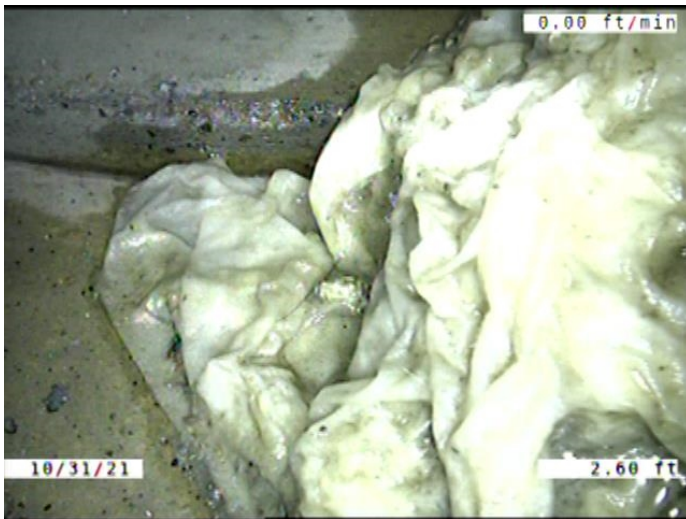
Code: **DAR**
 Description: **Deposits Attached Ragging**

Distance (ft): **2.6**
 Structural Grade: **0**
 O&M Grade: **2**
 Clock Start/From: **5**
 Clock To: **8**
 1st Value:
 2nd Value:
 Value Percent: **5.000**
 Continuous Index:
 Within 8" of Joint: **YES**
 Remarks:

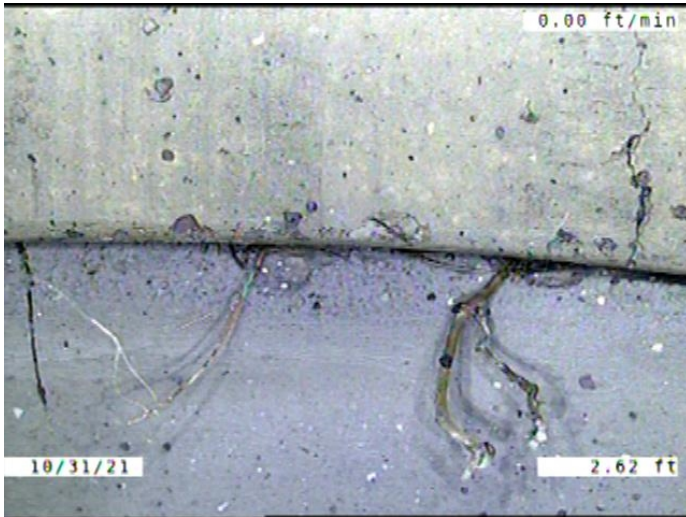
Code: **RFJ**
Description: **Roots Fine Joint**

Distance (ft): **2.6**
Structural Grade: **0**
O&M Grade: **1**
Clock Start/From: **1**
Clock To: **2**
1st Value:
2nd Value:
Value Percent:
Continuous Index:
Within 8" of Joint: **YES**
Remarks:

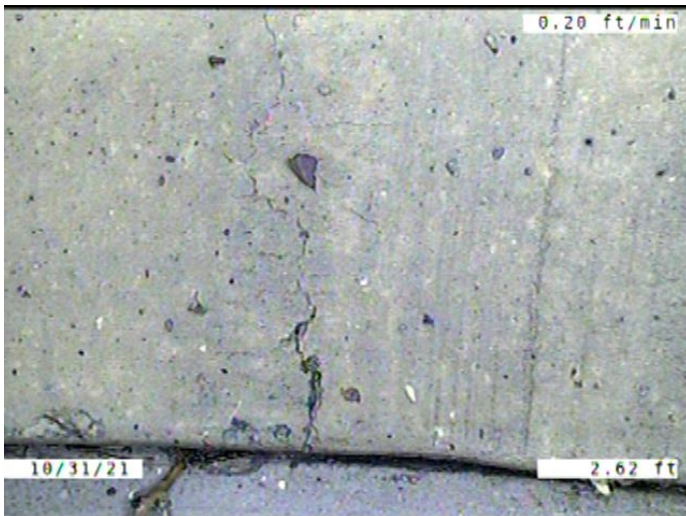
Code: **CL**
Description: **Crack Longitudinal**

Distance (ft): **2.6**
Structural Grade: **2**
O&M Grade: **0**
Clock Start/From: **2**
Clock To:
1st Value:
2nd Value:
Value Percent:
Continuous Index:
Within 8" of Joint: **YES**
Remarks:

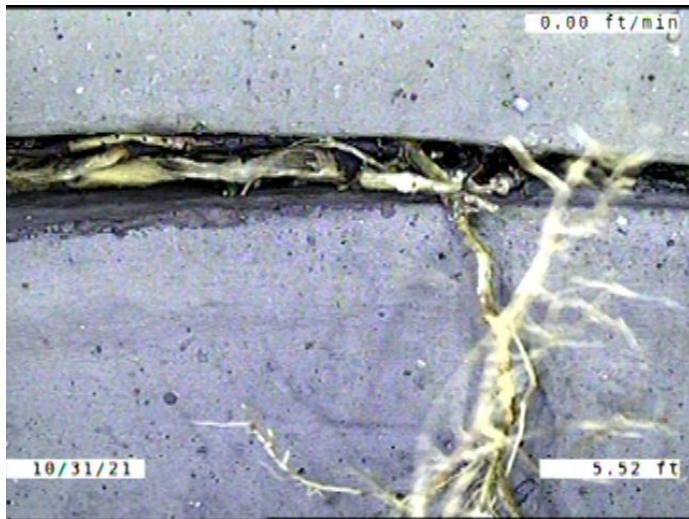
Code: **RFJ**
Description: **Roots Fine Joint**

Distance (ft): **5.5**
Structural Grade: **0**
O&M Grade: **1**
Clock Start/From: **12**
Clock To: **3**
1st Value:
2nd Value:
Value Percent:
Continuous Index:
Within 8" of Joint: **YES**
Remarks:

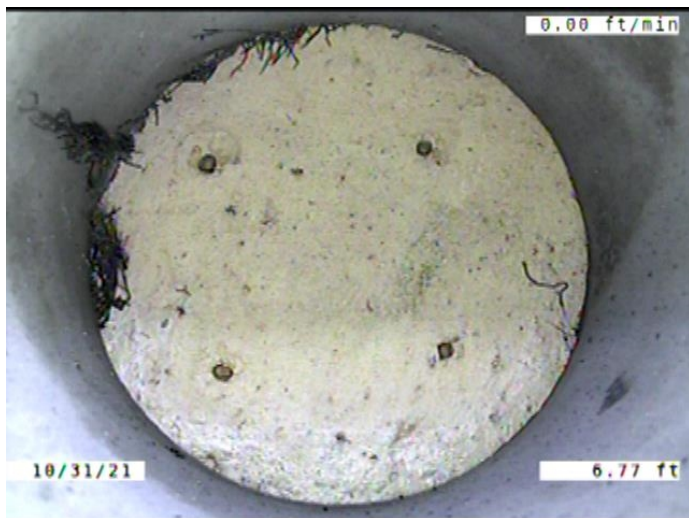
Code: **TFC**
Description: **Tap Factory Capped**

Distance (ft): **6.8**
Structural Grade: **0**
O&M Grade: **0**
Clock Start/From: **11**
Clock To:
1st Value: **4.000**
2nd Value:
Value Percent:
Continuous Index:
Within 8" of Joint: **YES**
Remarks: **ROOTS COMING AROUND THE CAP**

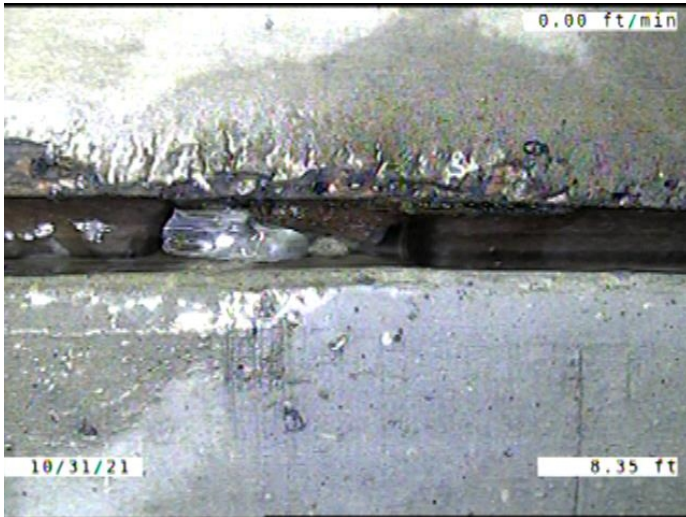
Code: **IRJ**
 Description: **Infiltration Runner Joint**

Distance (ft): **8.3**
 Structural Grade: **0**
 O&M Grade: **4**
 Clock Start/From: **3**
 Clock To: **4**
 1st Value:
 2nd Value:
 Value Percent:
 Continuous Index:
 Within 8" of Joint: **YES**
 Remarks:

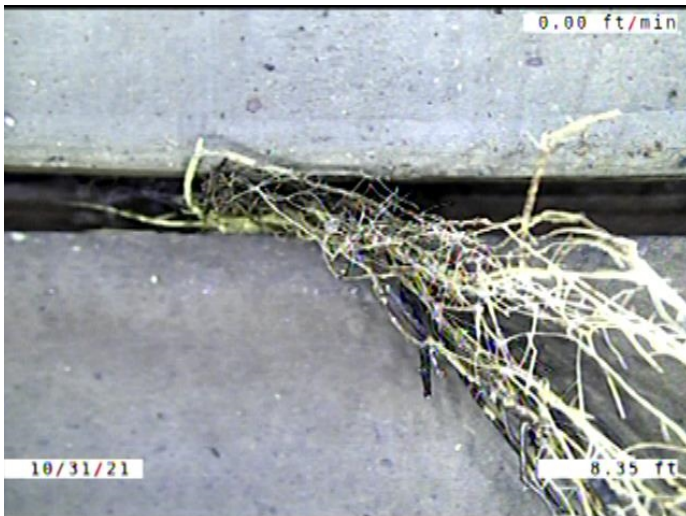
Code: **RFJ**
 Description: **Roots Fine Joint**

Distance (ft): **8.3**
 Structural Grade: **0**
 O&M Grade: **1**
 Clock Start/From: **10**
 Clock To: **3**
 1st Value:
 2nd Value:
 Value Percent:
 Continuous Index:
 Within 8" of Joint: **YES**
 Remarks:

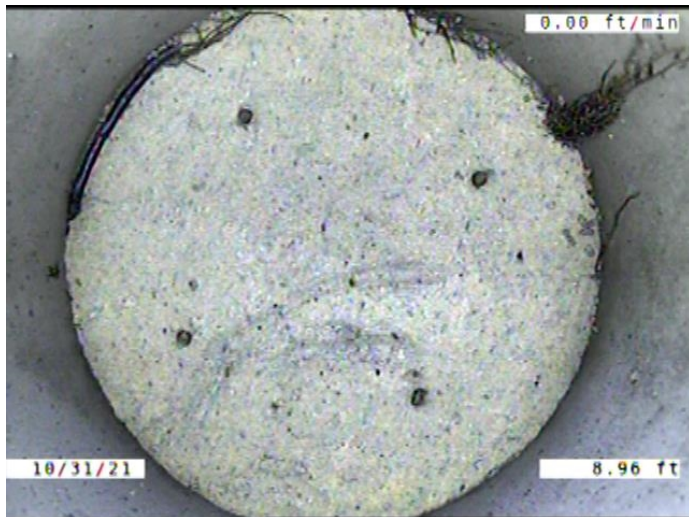
Code: **TFC**
Description: **Tap Factory Capped**

Distance (ft): **9.0**
Structural Grade: **0**
O&M Grade: **0**
Clock Start/From: **1**
Clock To:
1st Value: **4.000**
2nd Value:
Value Percent:
Continuous Index:
Within 8" of Joint: **YES**
Remarks: **ROOTS GROWING AROUND THE CAP**

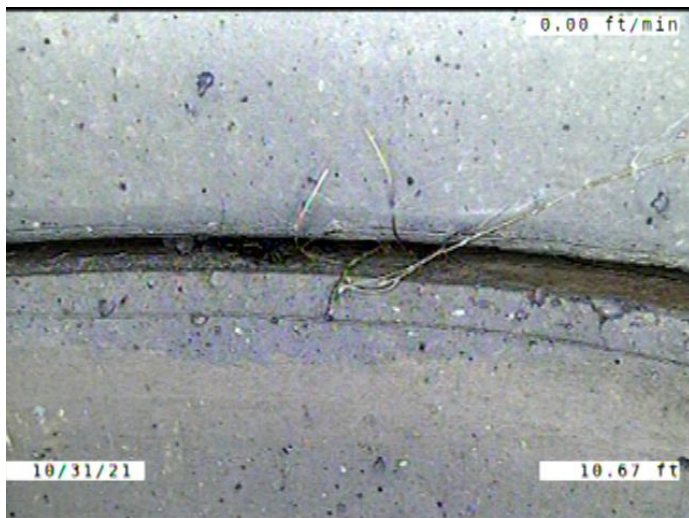
Code: **RFJ**
Description: **Roots Fine Joint**

Distance (ft): **10.7**
Structural Grade: **0**
O&M Grade: **1**
Clock Start/From: **2**
Clock To:
1st Value:
2nd Value:
Value Percent:
Continuous Index:
Within 8" of Joint: **YES**
Remarks:

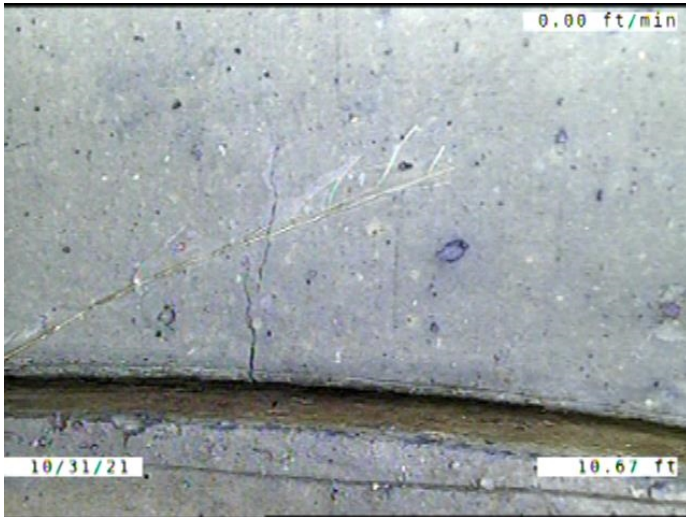
Code: **CL**
 Description: **Crack Longitudinal**

Distance (ft): **10.7**
 Structural Grade: **2**
 O&M Grade: **0**
 Clock Start/From: **2**
 Clock To:
 1st Value:
 2nd Value:
 Value Percent:
 Continuous Index:
 Within 8" of Joint: **YES**
 Remarks:

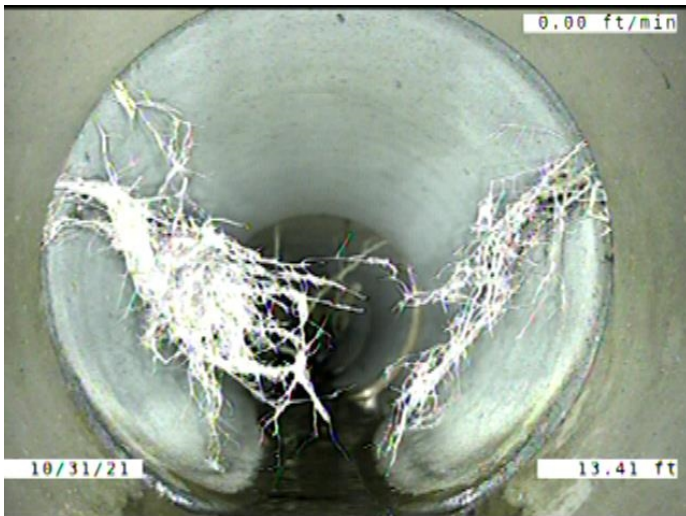
Code: **RMJ**
 Description: **Roots Medium Joint**

Distance (ft): **13.4**
 Structural Grade: **0**
 O&M Grade: **3**
 Clock Start/From: **9**
 Clock To: **3**
 1st Value:
 2nd Value:
 Value Percent: **5.000**
 Continuous Index:
 Within 8" of Joint: **YES**
 Remarks:

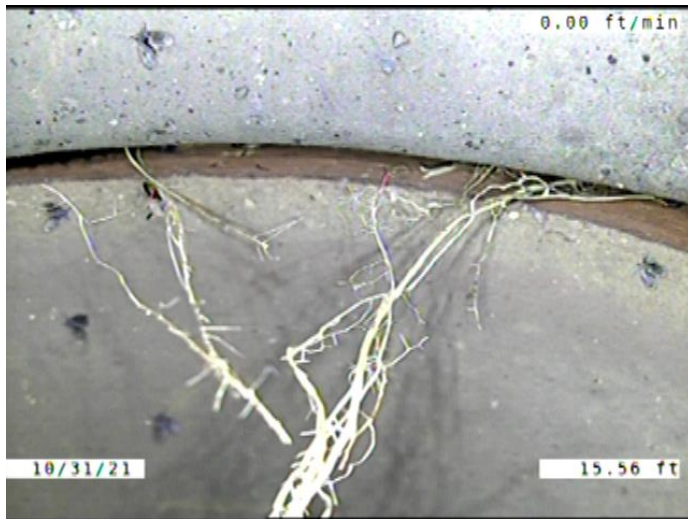
Code: **RFJ**
 Description: **Roots Fine Joint**

Distance (ft): **15.6**
 Structural Grade: **0**
 O&M Grade: **1**
 Clock Start/From: **9**
 Clock To: **2**
 1st Value:
 2nd Value:
 Value Percent:
 Continuous Index:
 Within 8" of Joint: **YES**
 Remarks:

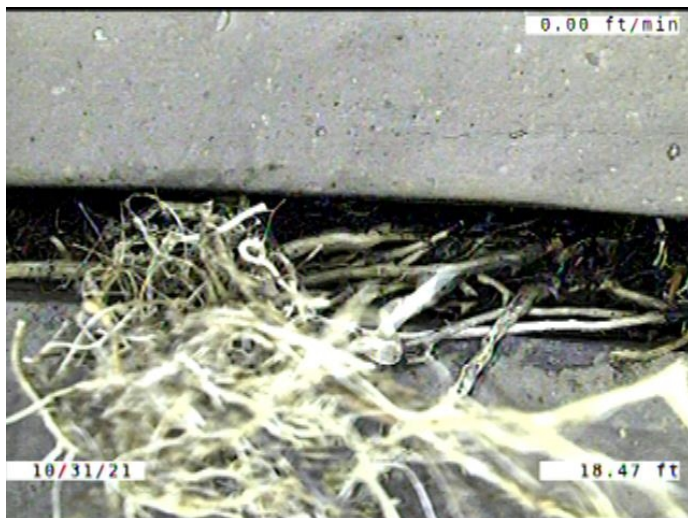
Code: **RFJ**
 Description: **Roots Fine Joint**

Distance (ft): **18.5**
 Structural Grade: **0**
 O&M Grade: **1**
 Clock Start/From: **9**
 Clock To: **3**
 1st Value:
 2nd Value:
 Value Percent:
 Continuous Index:
 Within 8" of Joint: **YES**
 Remarks:

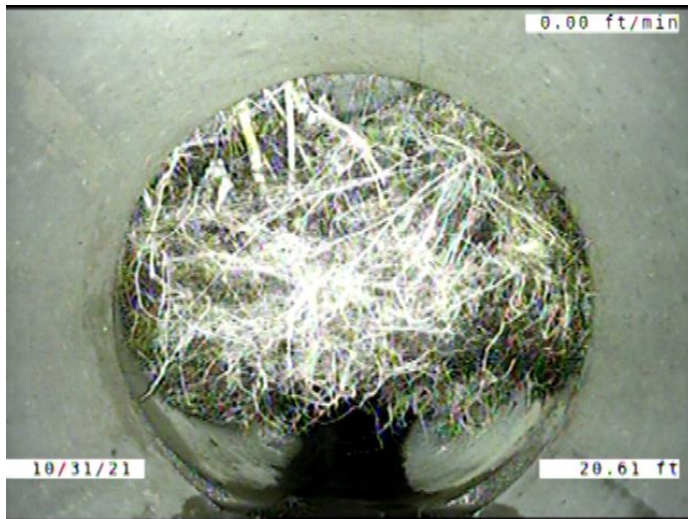
Code: **RBJ**
 Description: **Roots Ball Joint**

Distance (ft): **20.6**
 Structural Grade: **0**
 O&M Grade: **4**
 Clock Start/From: **8**
 Clock To: **4**
 1st Value:
 2nd Value:
 Value Percent: **80.000**
 Continuous Index:
 Within 8" of Joint: **YES**
 Remarks:

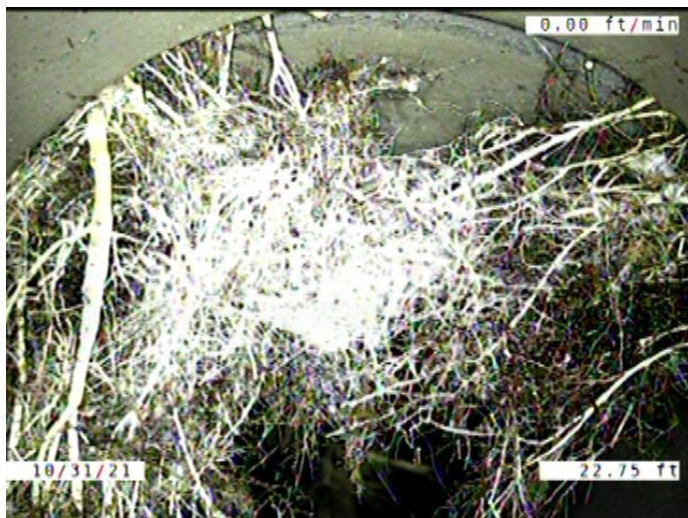
Code: **RMJ**
 Description: **Roots Medium Joint**

Distance (ft): **22.7**
 Structural Grade: **0**
 O&M Grade: **3**
 Clock Start/From: **8**
 Clock To: **2**
 1st Value:
 2nd Value:
 Value Percent: **15.000**
 Continuous Index:
 Within 8" of Joint: **YES**
 Remarks:

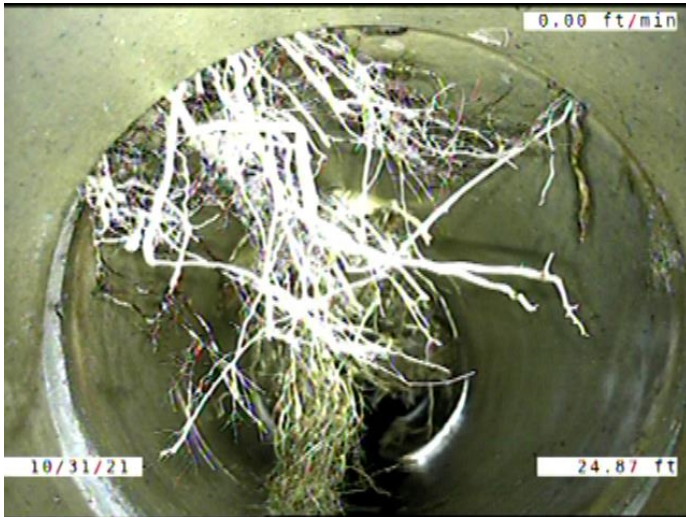
Code: **RMJ**
 Description: **Roots Medium Joint**

Distance (ft): **24.9**
 Structural Grade: **0**
 O&M Grade: **3**
 Clock Start/From: **10**
 Clock To: **1**
 1st Value:
 2nd Value:
 Value Percent: **5.000**
 Continuous Index:
 Within 8" of Joint: **YES**
 Remarks:

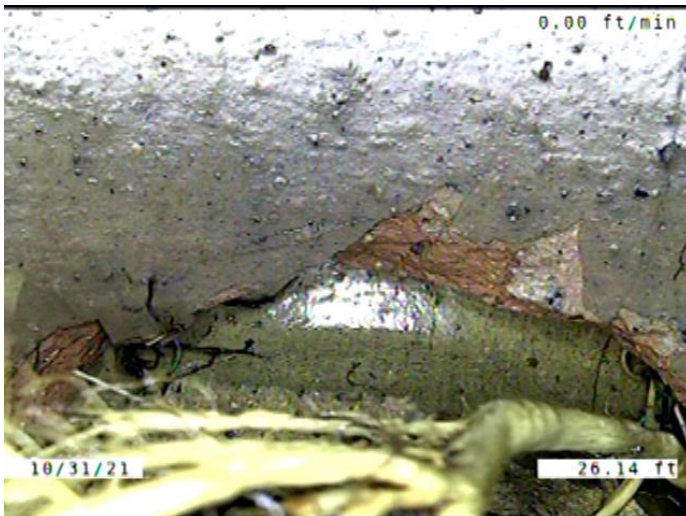
Code: **SSS**
 Description: **Surface Damage Surface Spalling**

Distance (ft): **26.1**
 Structural Grade: **2**
 O&M Grade: **0**
 Clock Start/From: **10**
 Clock To: **1**
 1st Value:
 2nd Value:
 Value Percent:
 Continuous Index:
 Within 8" of Joint: **YES**
 Remarks:

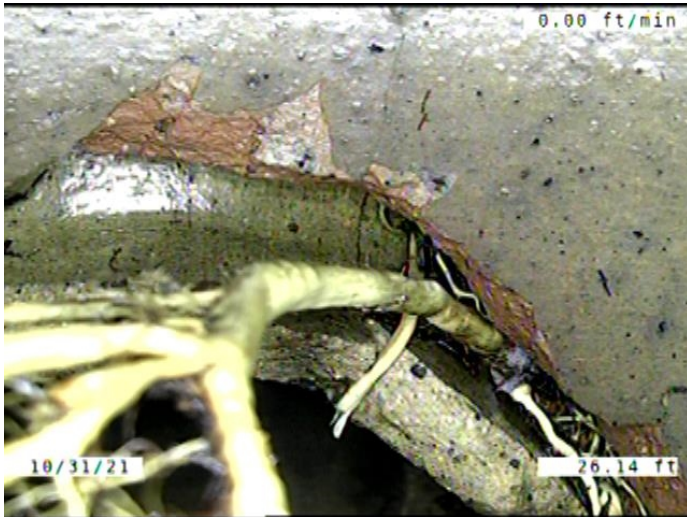
Code: **RMC**
Description: **Roots Medium Connection**

Distance (ft): **26.1**
Structural Grade: **0**
O&M Grade: **3**
Clock Start/From: **10**
Clock To: **1**
1st Value:
2nd Value:
Value Percent: **15.000**
Continuous Index:
Within 8" of Joint: **NO**
Remarks:

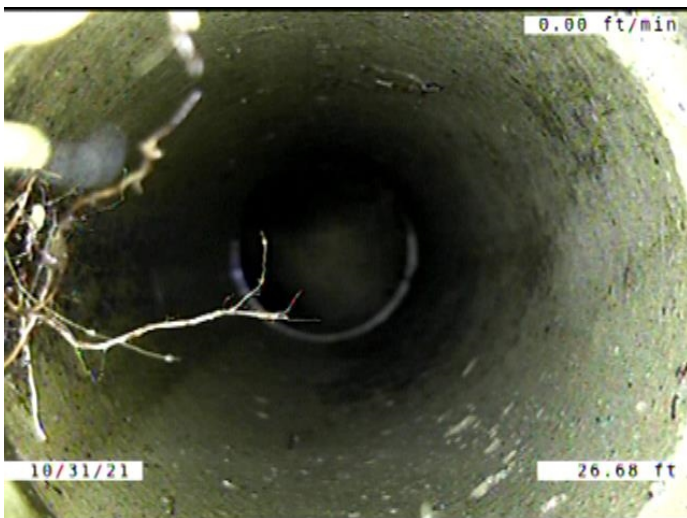
Code: **TBI**
Description: **Tap Break-in Intruding**

Distance (ft): **26.7**
Structural Grade: **0**
O&M Grade: **2**
Clock Start/From: **11**
Clock To:
1st Value: **4.000**
2nd Value: **1.000**
Value Percent:
Continuous Index:
Within 8" of Joint: **YES**
Remarks: **CONSTANTLY RUNNING WATER.
ROOTS GROWING INSIDE AND OUTS**

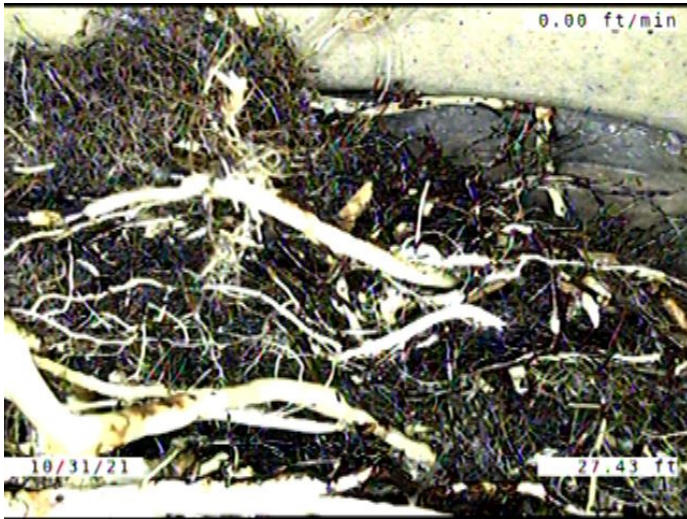
Code: **RMJ**
 Description: **Roots Medium Joint**

Distance (ft): **27.4**
 Structural Grade: **0**
 O&M Grade: **3**
 Clock Start/From: **8**
 Clock To: **3**
 1st Value:
 2nd Value:
 Value Percent: **50.000**
 Continuous Index:
 Within 8" of Joint: **YES**
 Remarks:

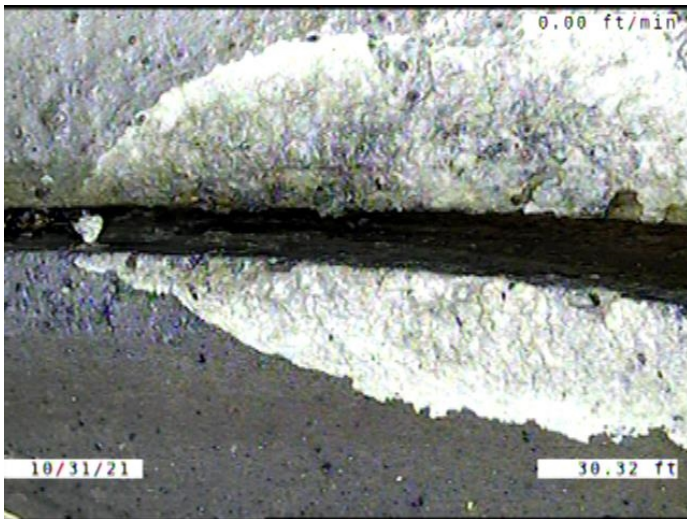
Code: **DAE**
 Description: **Deposits Attached Encrustation**

Distance (ft): **30.3**
 Structural Grade: **0**
 O&M Grade: **2**
 Clock Start/From: **2**
 Clock To: **4**
 1st Value:
 2nd Value:
 Value Percent: **5.000**
 Continuous Index:
 Within 8" of Joint: **YES**
 Remarks:

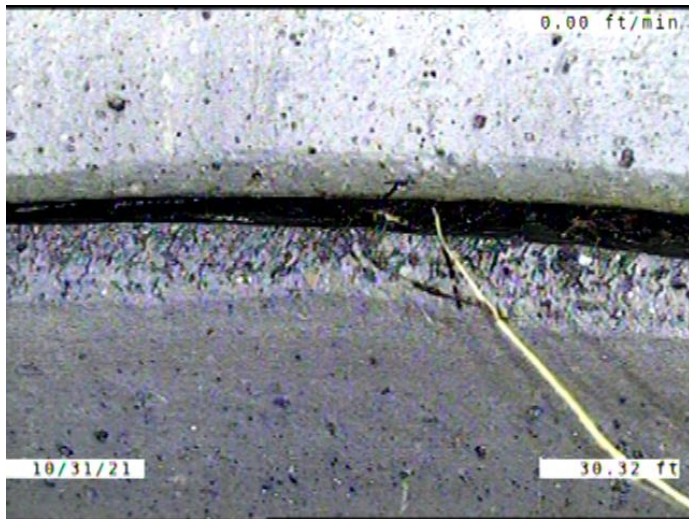
Code: **RFJ**
 Description: **Roots Fine Joint**

Distance (ft): **30.3**
 Structural Grade: **0**
 O&M Grade: **1**
 Clock Start/From: **12**
 Clock To: **2**
 1st Value:
 2nd Value:
 Value Percent:
 Continuous Index:
 Within 8" of Joint: **YES**
 Remarks:

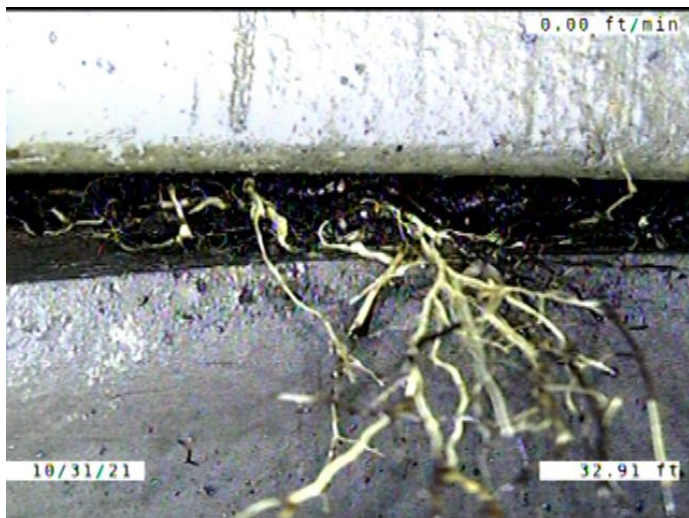
Code: **RFJ**
 Description: **Roots Fine Joint**

Distance (ft): **32.9**
 Structural Grade: **0**
 O&M Grade: **1**
 Clock Start/From: **9**
 Clock To: **12**
 1st Value:
 2nd Value:
 Value Percent:
 Continuous Index:
 Within 8" of Joint: **YES**
 Remarks:

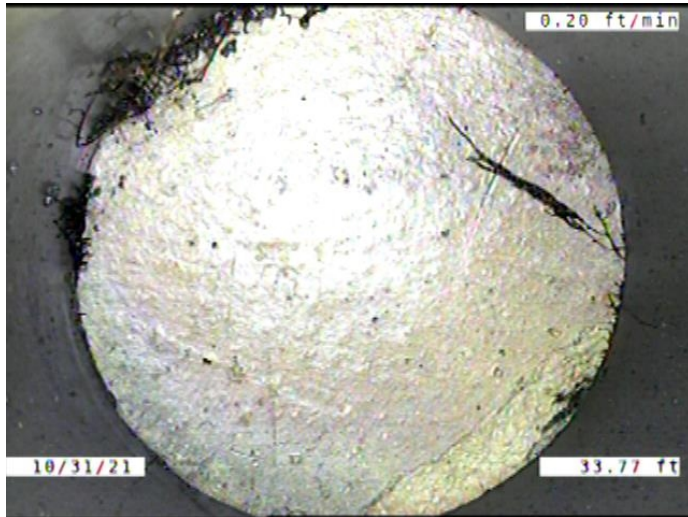
Code: **TFC**
Description: **Tap Factory Capped**

Distance (ft): **33.8**
Structural Grade: **0**
O&M Grade: **0**
Clock Start/From: **11**
Clock To:
1st Value: **4.000**
2nd Value:
Value Percent:
Continuous Index:
Within 8" of Joint: **YES**
Remarks: **ROOTS GROWING AROUND THE CAP**

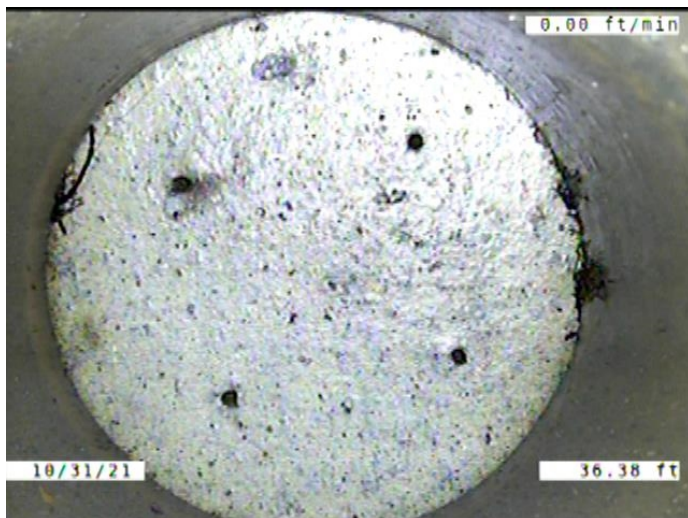
Code: **TFC**
Description: **Tap Factory Capped**

Distance (ft): **36.4**
Structural Grade: **0**
O&M Grade: **0**
Clock Start/From: **1**
Clock To:
1st Value: **4.000**
2nd Value:
Value Percent:
Continuous Index:
Within 8" of Joint: **YES**
Remarks: **ROOTS GROWING AROUND THE CAP**

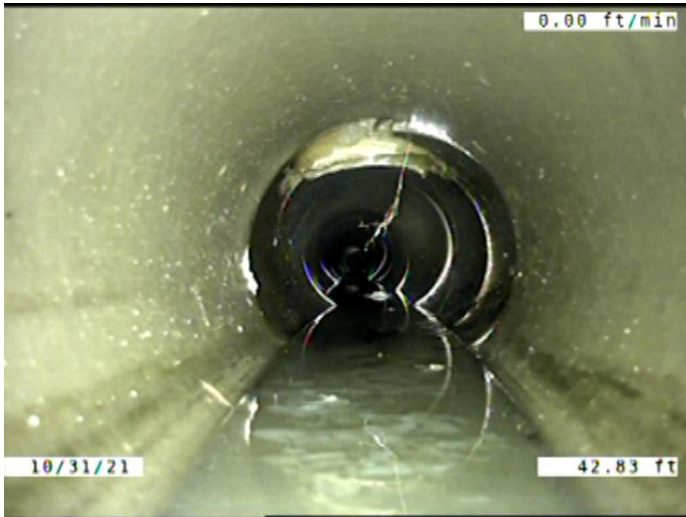
Code: **MWLS**
 Description: **Miscellaneous Water Level Sag**

Distance (ft): **42.8**
 Structural Grade: **2**
 O&M Grade: **0**
 Clock Start/From:
 Clock To:
 1st Value:
 2nd Value:
 Value Percent: **5.000**
 Continuous Index:
 Within 8" of Joint: **NO**
 Remarks:

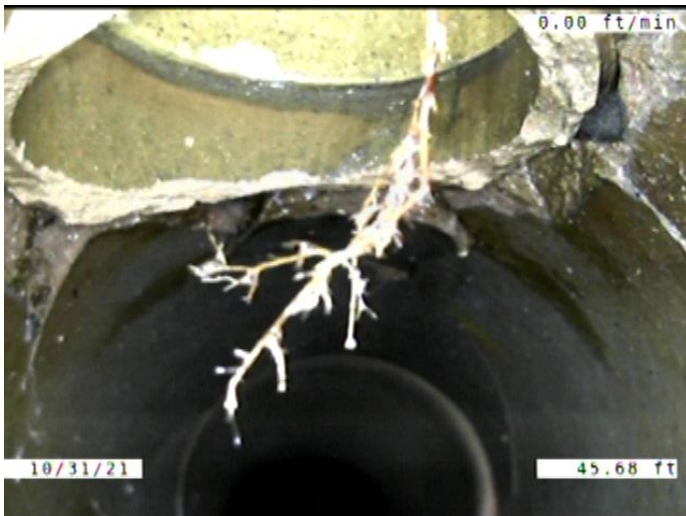
Code: **BSV**
 Description: **Broken Soil Visible**

Distance (ft): **45.7**
 Structural Grade: **5**
 O&M Grade: **0**
 Clock Start/From: **12**
 Clock To: **12**
 1st Value:
 2nd Value:
 Value Percent:
 Continuous Index:
 Within 8" of Joint: **YES**
 Remarks:

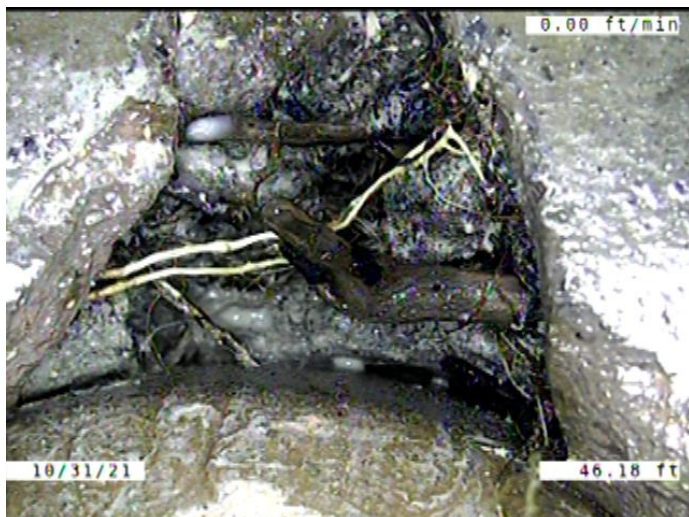
Code: **RFB**
 Description: **Roots Fine Barrel**

Distance (ft): **46.2**
 Structural Grade: **0**
 O&M Grade: **2**
 Clock Start/From: **11**
 Clock To: **1**
 1st Value:
 2nd Value:
 Value Percent:
 Continuous Index:
 Within 8" of Joint: **NO**
 Remarks:

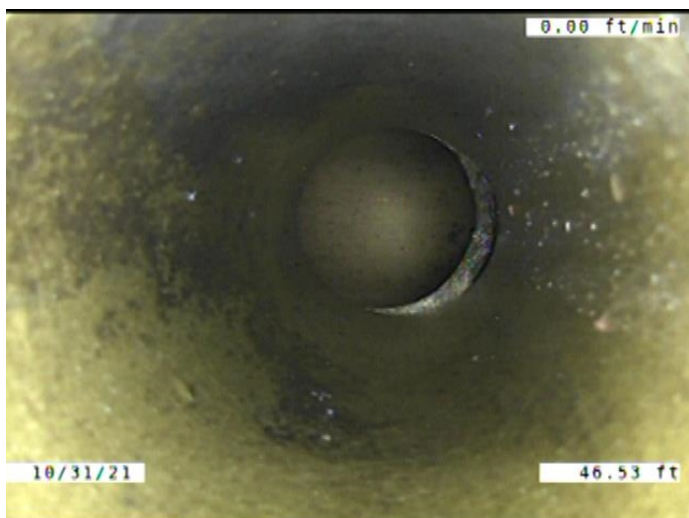
Code: **TBI**
 Description: **Tap Break-in Intruding**

Distance (ft): **46.5**
 Structural Grade: **0**
 O&M Grade: **2**
 Clock Start/From: **12**
 Clock To:
 1st Value: **4.000**
 2nd Value: **1.000**
 Value Percent:
 Continuous Index:
 Within 8" of Joint: **YES**
 Remarks:

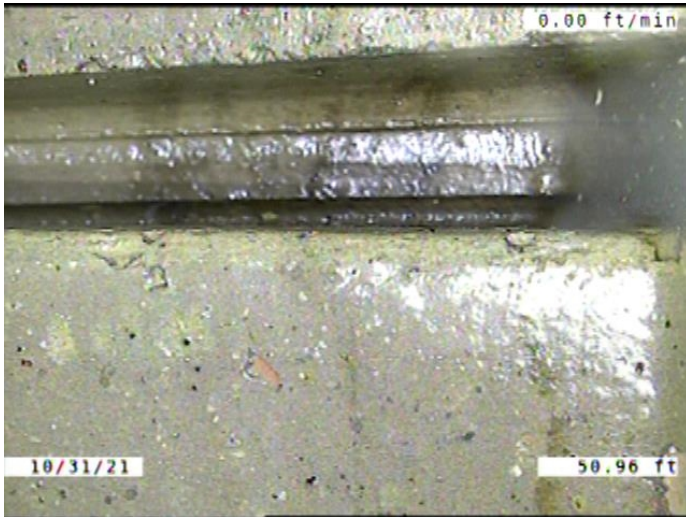
Code: **JAM**
 Description: **Joint Angular Medium**

Distance (ft): **51.0**
 Structural Grade: **3**
 O&M Grade: **0**
 Clock Start/From:
 Clock To:
 1st Value:
 2nd Value:
 Value Percent:
 Continuous Index:
 Within 8" of Joint: **NO**
 Remarks:

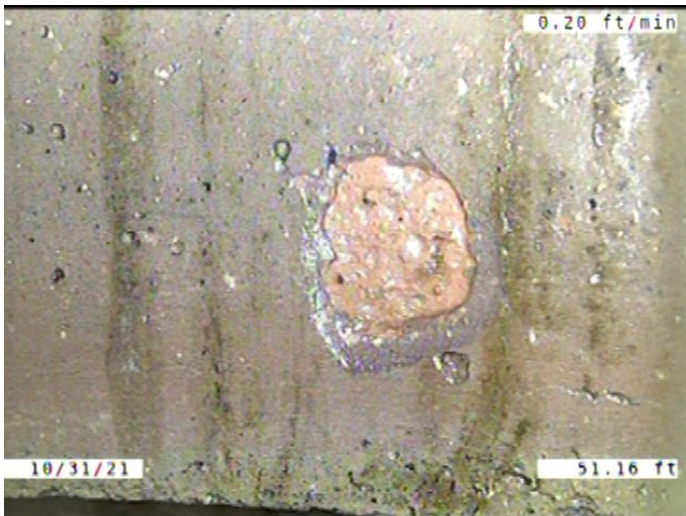
Code: **SSS**
 Description: **Surface Damage Surface Spalling**

Distance (ft): **51.2**
 Structural Grade: **2**
 O&M Grade: **0**
 Clock Start/From: **8**
 Clock To: **9**
 1st Value:
 2nd Value:
 Value Percent:
 Continuous Index:
 Within 8" of Joint: **YES**
 Remarks:

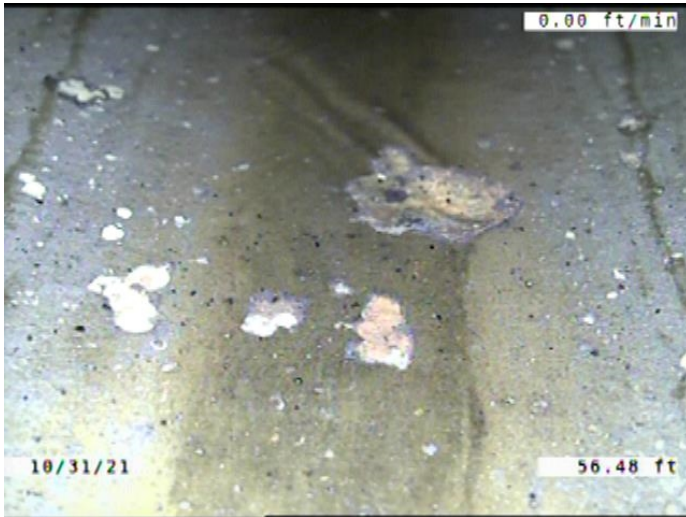
Code: **SSS**
Description: **Surface Damage Surface Spalling**

Distance (ft): **56.5**
Structural Grade: **2**
O&M Grade: **0**
Clock Start/From: **6**
Clock To:
1st Value:
2nd Value:
Value Percent:
Continuous Index:
Within 8" of Joint: **YES**
Remarks:

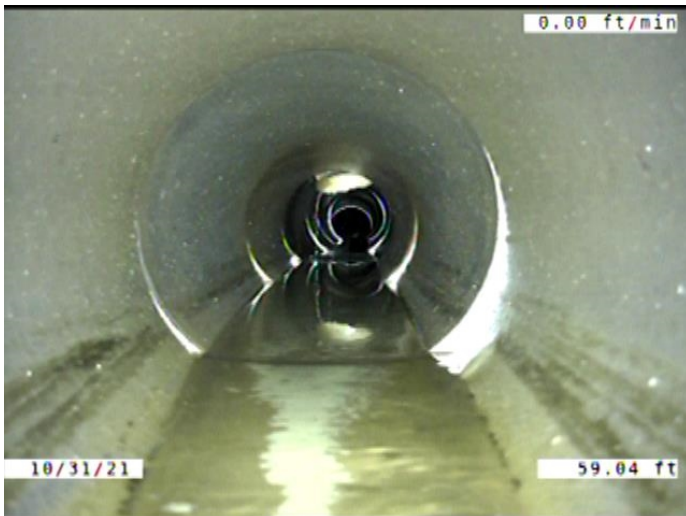
Code: **MWLS**
Description: **Miscellaneous Water Level Sag**

Distance (ft): **59.0**
Structural Grade: **2**
O&M Grade: **0**
Clock Start/From:
Clock To:
1st Value:
2nd Value:
Value Percent: **5.000**
Continuous Index: **S01**
Within 8" of Joint: **NO**
Remarks:

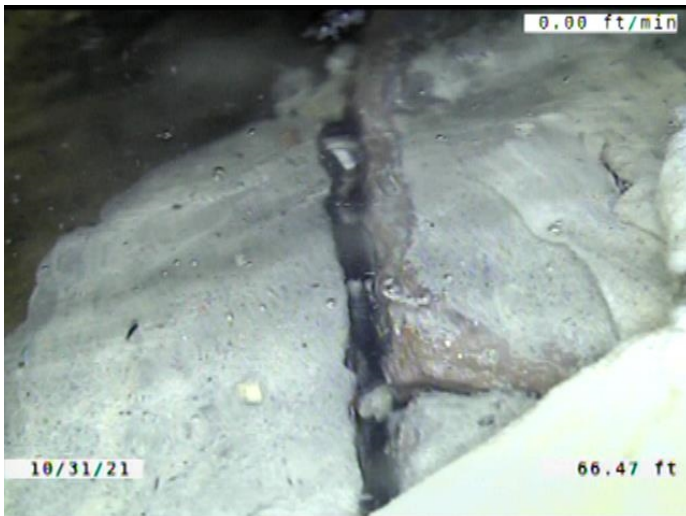
Code: **BSV**
 Description: **Broken Soil Visible**

Distance (ft): **66.5**
 Structural Grade: **5**
 O&M Grade: **0**
 Clock Start/From: **12**
 Clock To: **12**
 1st Value:
 2nd Value:
 Value Percent:
 Continuous Index:
 Within 8" of Joint: **YES**
 Remarks:

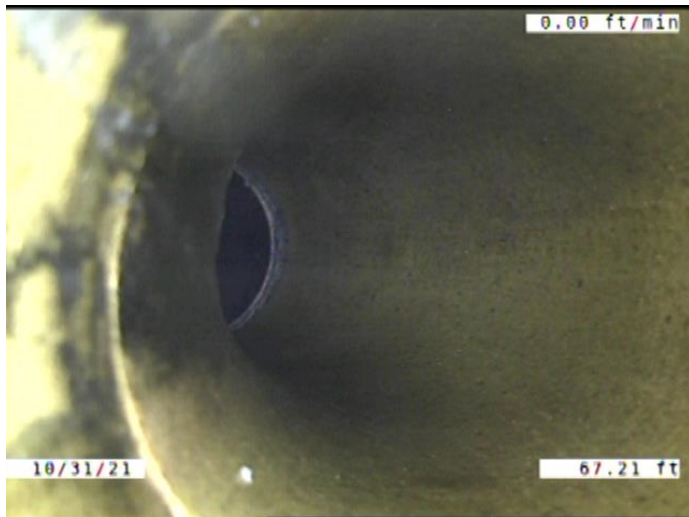
Code: **TBI**
Description: **Tap Break-in Intruding**

Distance (ft): **67.2**
Structural Grade: **0**
O&M Grade: **2**
Clock Start/From: **11**
Clock To:
1st Value: **4.000**
2nd Value: **1.000**
Value Percent:
Continuous Index:
Within 8" of Joint: **YES**
Remarks: **CONSTANTLY RUNNING WATER.**

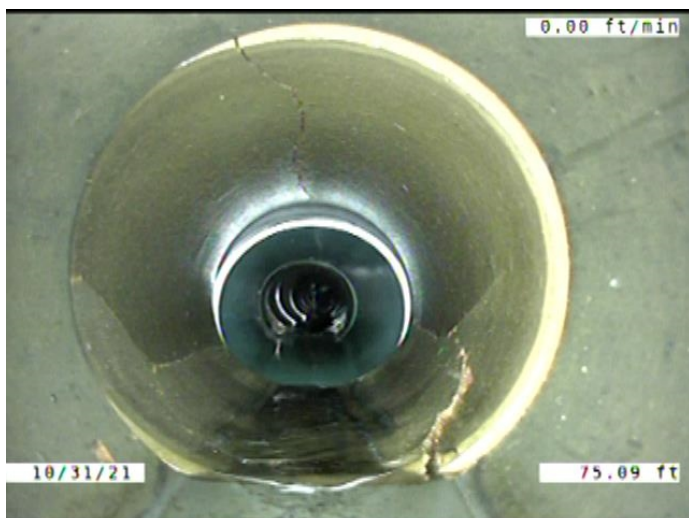
Code: **MWLS**
 Description: **Miscellaneous Water Level Sag**

Distance (ft): **75.1**
 Structural Grade: **2**
 O&M Grade: **0**
 Clock Start/From:
 Clock To:
 1st Value:
 2nd Value:
 Value Percent: **5.000**
 Continuous Index: **F01**
 Within 8" of Joint: **NO**
 Remarks:

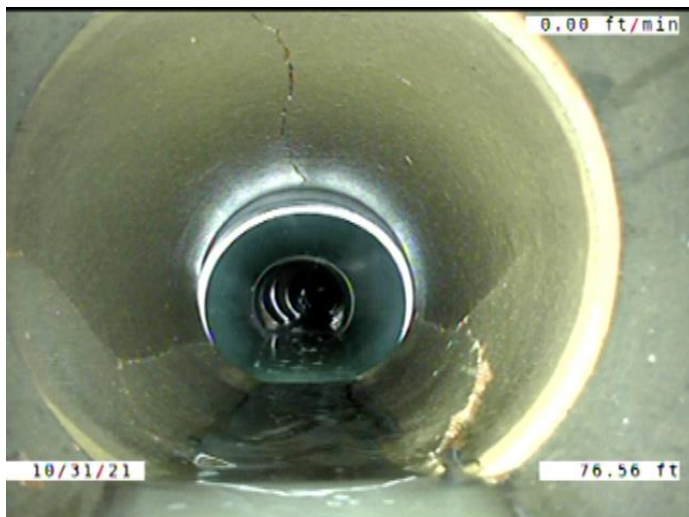
Code: **B**
 Description: **Broken**

Distance (ft): **76.6**
 Structural Grade: **4**
 O&M Grade: **0**
 Clock Start/From: **12**
 Clock To: **12**
 1st Value:
 2nd Value:
 Value Percent:
 Continuous Index:
 Within 8" of Joint: **YES**
 Remarks:

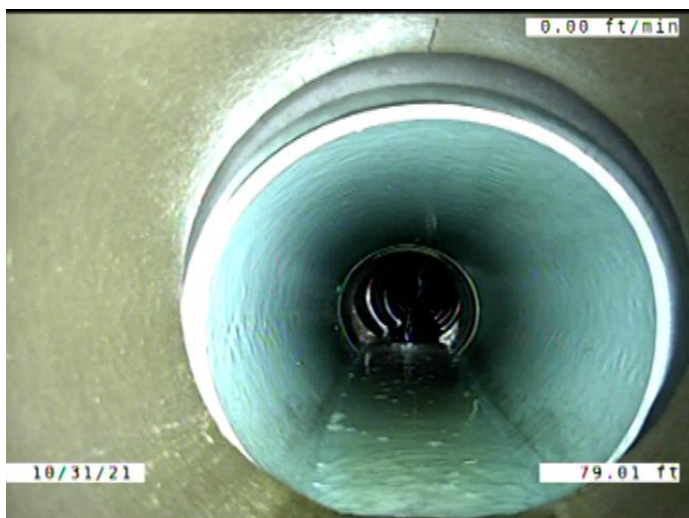
Code: **JOL**
 Description: **Joint Offset Large**

Distance (ft): **79.0**
 Structural Grade: **4**
 O&M Grade: **0**
 Clock Start/From:
 Clock To:
 1st Value: **1.000**
 2nd Value:
 Value Percent:
 Continuous Index:
 Within 8" of Joint: **NO**
 Remarks:

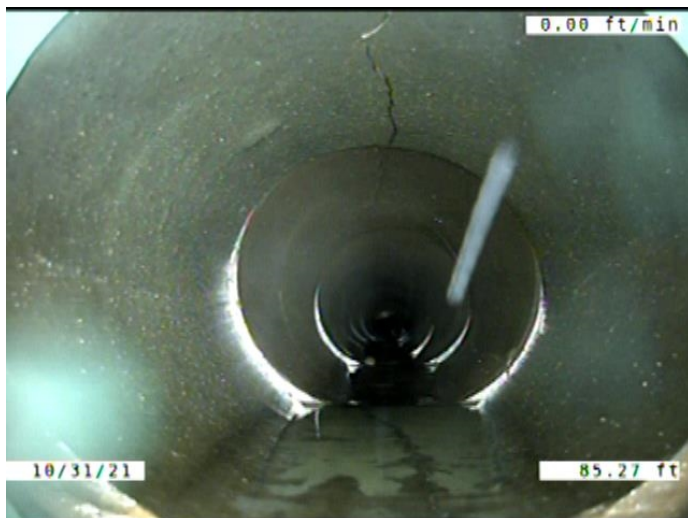
Code: **B**
 Description: **Broken**

Distance (ft): **85.3**
 Structural Grade: **4**
 O&M Grade: **0**
 Clock Start/From: **12**
 Clock To: **12**
 1st Value:
 2nd Value:
 Value Percent:
 Continuous Index: **S02**
 Within 8" of Joint: **YES**
 Remarks:

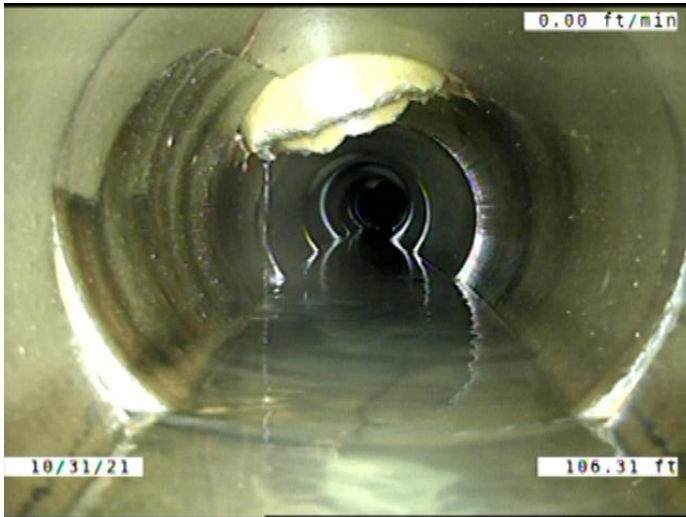
Code: **MWLS**
Description: **Miscellaneous Water Level Sag**

Distance (ft): **106.3**
Structural Grade: **2**
O&M Grade: **0**
Clock Start/From:
Clock To:
1st Value:
2nd Value:
Value Percent: **10.000**
Continuous Index: **S03**
Within 8" of Joint: **NO**
Remarks:

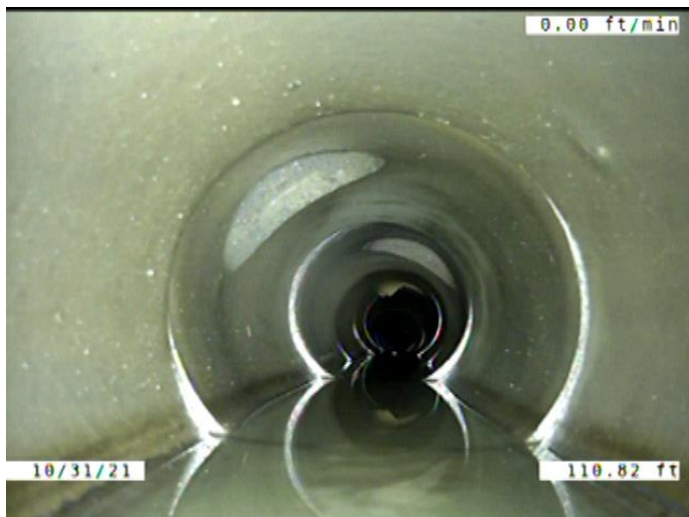
Code: **B**
 Description: **Broken**

Distance (ft): **110.8**
 Structural Grade: **4**
 O&M Grade: **0**
 Clock Start/From: **12**
 Clock To: **12**
 1st Value:
 2nd Value:
 Value Percent:
 Continuous Index: **F02**
 Within 8" of Joint: **YES**
 Remarks:

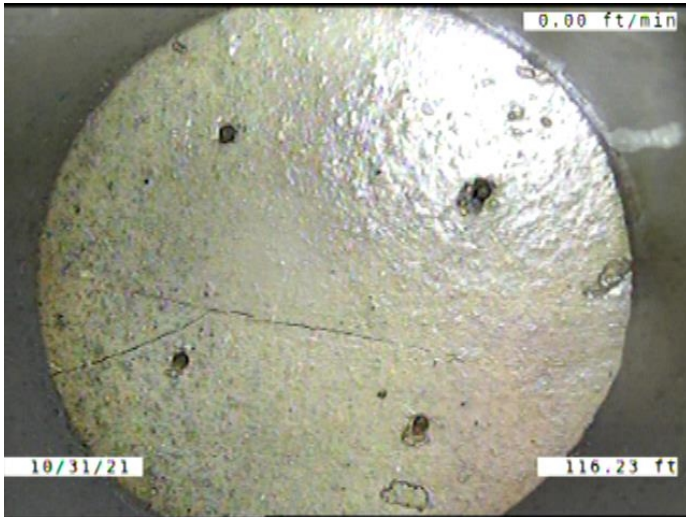
Code: **TFC**
Description: **Tap Factory Capped**

Distance (ft): **116.2**
Structural Grade: **0**
O&M Grade: **0**
Clock Start/From: **1**
Clock To:
1st Value: **4.000**
2nd Value:
Value Percent:
Continuous Index:
Within 8" of Joint: **YES**
Remarks: **CAP CRACKED**

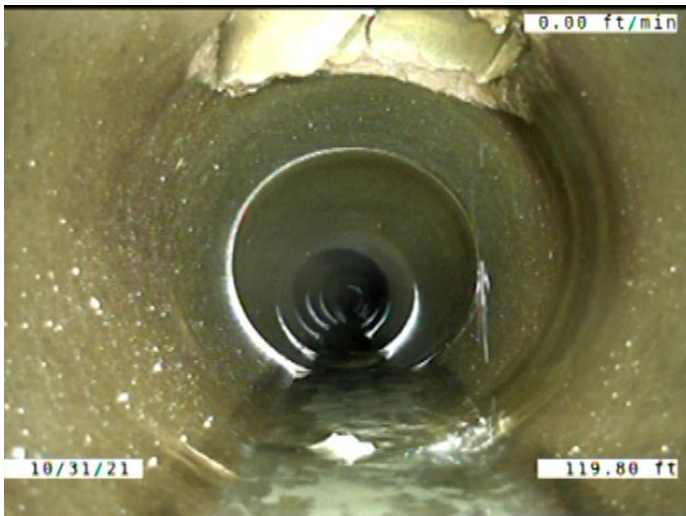
Code: **MWLS**
Description: **Miscellaneous Water Level Sag**

Distance (ft): **119.8**
Structural Grade: **2**
O&M Grade: **0**
Clock Start/From:
Clock To:
1st Value:
2nd Value:
Value Percent: **10.000**
Continuous Index: **F03**
Within 8" of Joint: **NO**
Remarks:

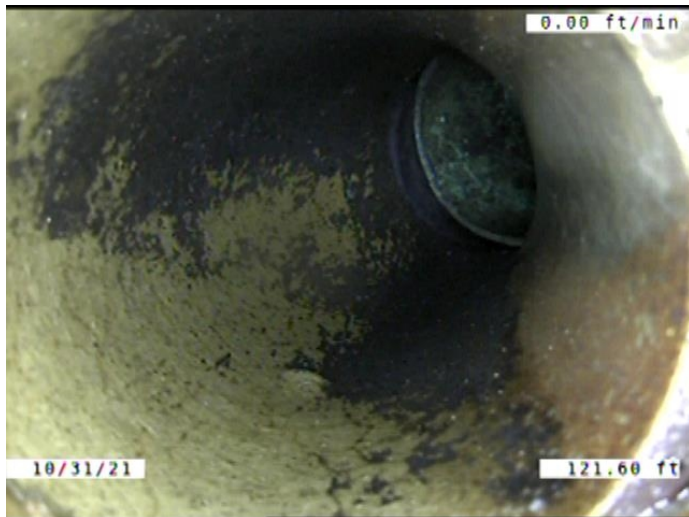
Code: **TBI**
Description: **Tap Break-in Intruding**

Distance (ft): **121.6**
Structural Grade: **0**
O&M Grade: **2**
Clock Start/From: **12**
Clock To:
1st Value: **4.000**
2nd Value: **2.000**
Value Percent:
Continuous Index:
Within 8" of Joint: **YES**
Remarks: **CONSTANTLY RUNNING WATER.**

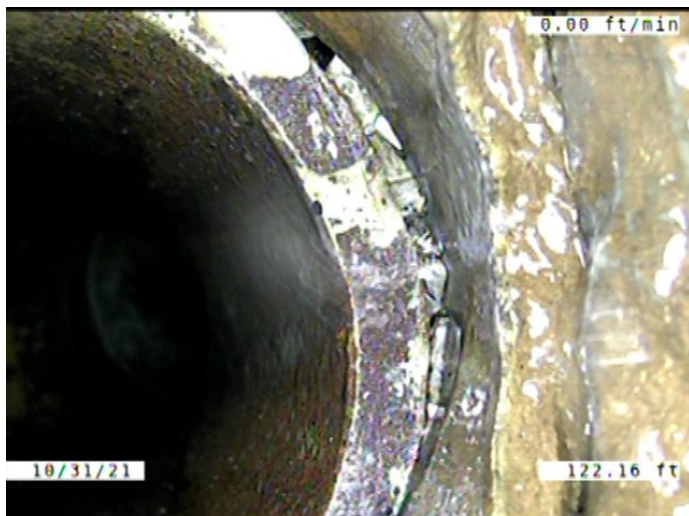
Code: **IRC**
Description: **Infiltration Runner Connection**

Distance (ft): **122.2**
Structural Grade: **0**
O&M Grade: **4**
Clock Start/From: **12**
Clock To: **1**
1st Value:
2nd Value:
Value Percent:
Continuous Index:
Within 8" of Joint: **YES**
Remarks:

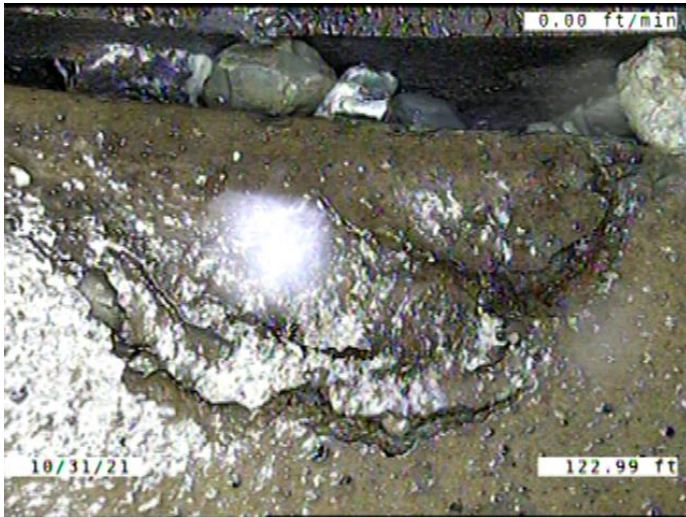
Code: **CM**
 Description: **Crack Multiple**

Distance (ft): **123.0**
 Structural Grade: **3**
 O&M Grade: **0**
 Clock Start/From: **3**
 Clock To: **4**
 1st Value:
 2nd Value:
 Value Percent:
 Continuous Index:
 Within 8" of Joint: **YES**
 Remarks:

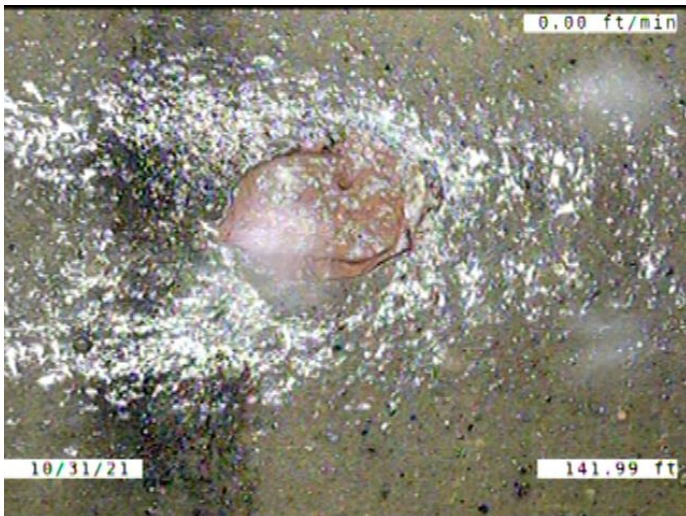
Code: **SSS**
 Description: **Surface Damage Surface Spalling**

Distance (ft): **142.0**
 Structural Grade: **2**
 O&M Grade: **0**
 Clock Start/From: **4**
 Clock To: **5**
 1st Value:
 2nd Value:
 Value Percent:
 Continuous Index:
 Within 8" of Joint: **NO**
 Remarks:

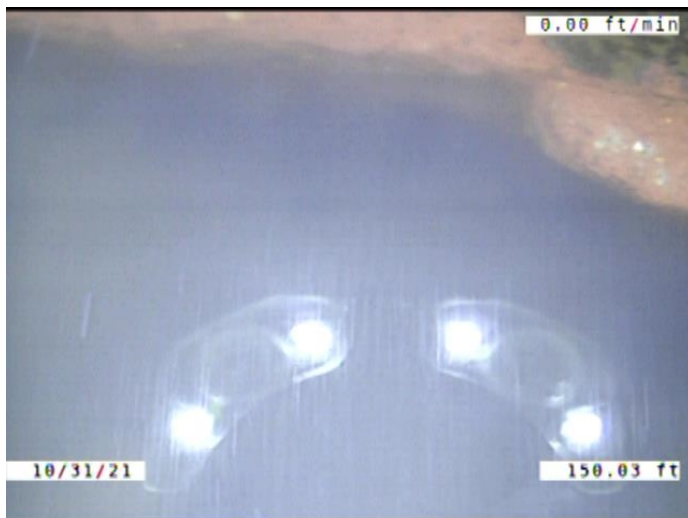
Code:	H
Description:	Hole
Distance (ft):	150.0
Structural Grade:	5
O&M Grade:	0
Clock Start/From:	5
Clock To:	8
1st Value:	
2nd Value:	
Value Percent:	
Continuous Index:	
Within 8" of Joint:	YES
Remarks:

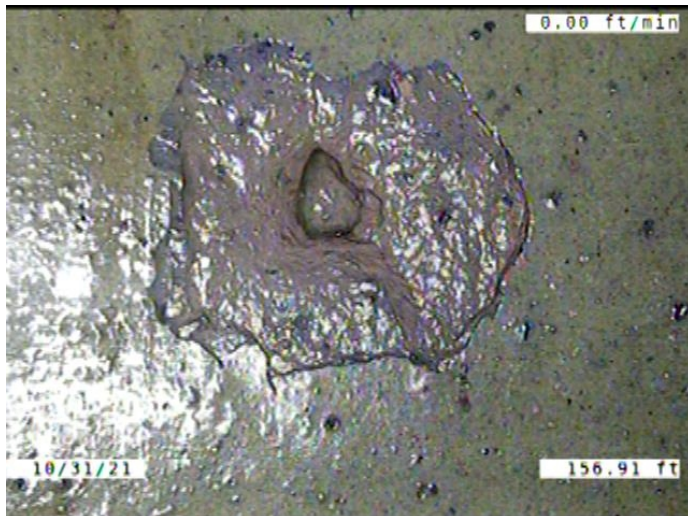
Code: **SSS**
 Description: **Surface Damage Surface Spalling**

Distance (ft): **156.9**
 Structural Grade: **2**
 O&M Grade: **0**
 Clock Start/From: **3**
 Clock To: **4**
 1st Value:
 2nd Value:
 Value Percent:
 Continuous Index:
 Within 8" of Joint: **YES**
 Remarks:

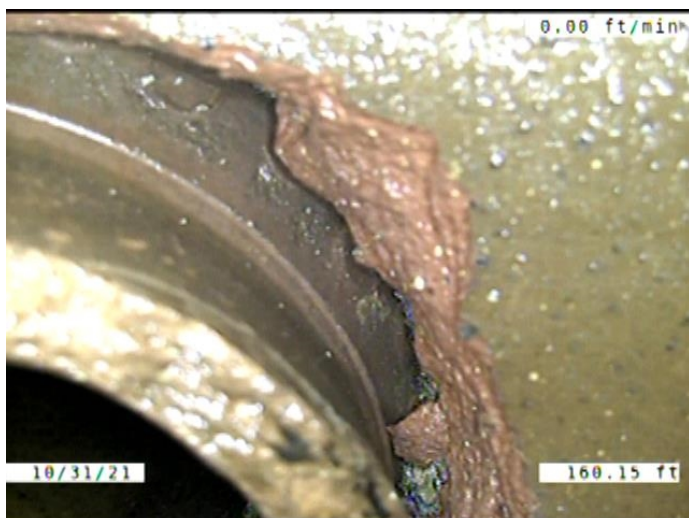
Code: **SSS**
 Description: **Surface Damage Surface Spalling**

Distance (ft): **160.2**
 Structural Grade: **2**
 O&M Grade: **0**
 Clock Start/From: **11**
 Clock To: **2**
 1st Value:
 2nd Value:
 Value Percent:
 Continuous Index:
 Within 8" of Joint: **YES**
 Remarks:

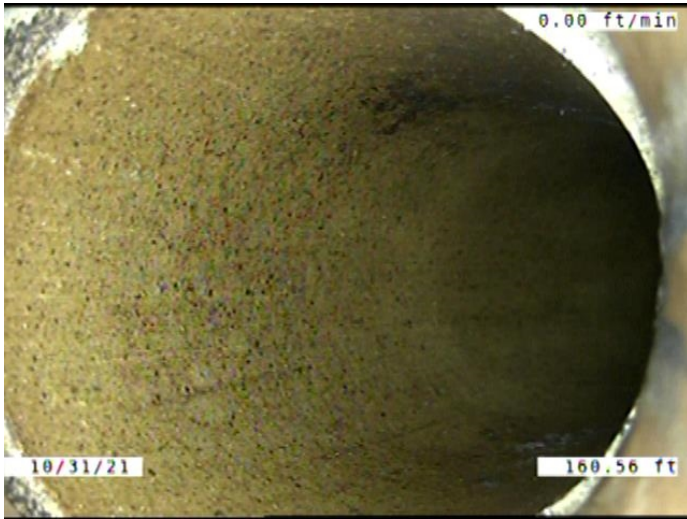
Code: **TBI**
 Description: **Tap Break-in Intruding**

Distance (ft): **160.6**
 Structural Grade: **0**
 O&M Grade: **2**
 Clock Start/From: **1**
 Clock To:
 1st Value: **4.000**
 2nd Value: **1.000**
 Value Percent:
 Continuous Index:
 Within 8" of Joint: **YES**
 Remarks:

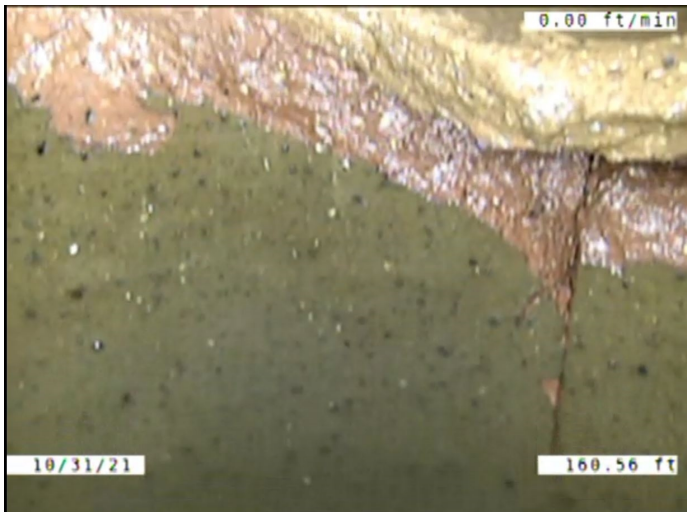
Code: **FL**
 Description: **Fracture Longitudinal**

Distance (ft): **160.6**
 Structural Grade: **3**
 O&M Grade: **0**
 Clock Start/From: **1**
 Clock To:
 1st Value:
 2nd Value:
 Value Percent:
 Continuous Index:
 Within 8" of Joint: **NO**
 Remarks:

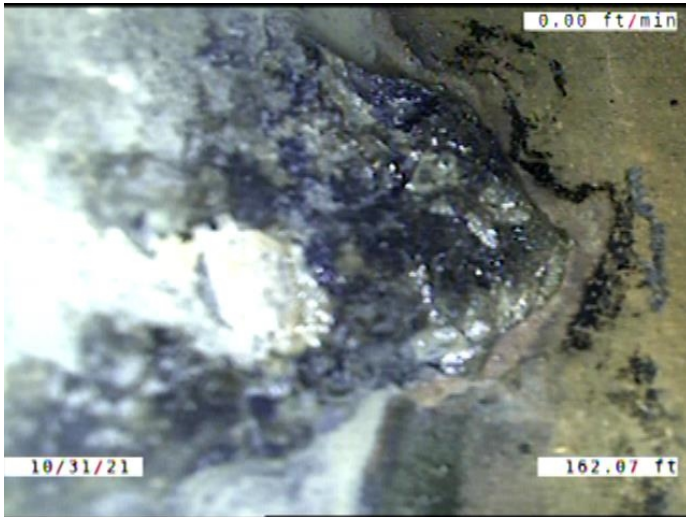
Code: **DAE**
Description: **Deposits Attached Encrustation**

Distance (ft): **162.1**
Structural Grade: **0**
O&M Grade: **2**
Clock Start/From: **4**
Clock To: **8**
1st Value:
2nd Value:
Value Percent: **5.000**
Continuous Index:
Within 8" of Joint: **NO**
Remarks:
