Profile/Photo Observation Report

Date:	10/31/2021	Weather:		Coding:	PACP 7.0
Pipe Length (ft):	197.3	Owner:	City of Hobart	Pre Clean:	Heavy Cleaning
P.O.#:	YES502259	Surveyor:	S. Bucklin	PSR:	P-504-037-036
Customer:	City of Hobart	Clean Date:	10/26/2021	Shape:	C

Street:	North Cavender Street	Flow Control:	Not Controlled
City:	Hobart, IN	Year Renewed:	
Location:	Alley	Tape/Media #:	
Purpose:	Routine Assessment	Dia/Height:	10"
Use:	Sanitary Sewage Pipe	Material:	VCP
Drain Area:		Lining:	None
Category:	NA		
Comment:			
Location Details:		Direction of Survey:	Downstream
US MH:	M-504-036	DS MH:	M-504-037
		Total Length Surveyed (ft):	197.3

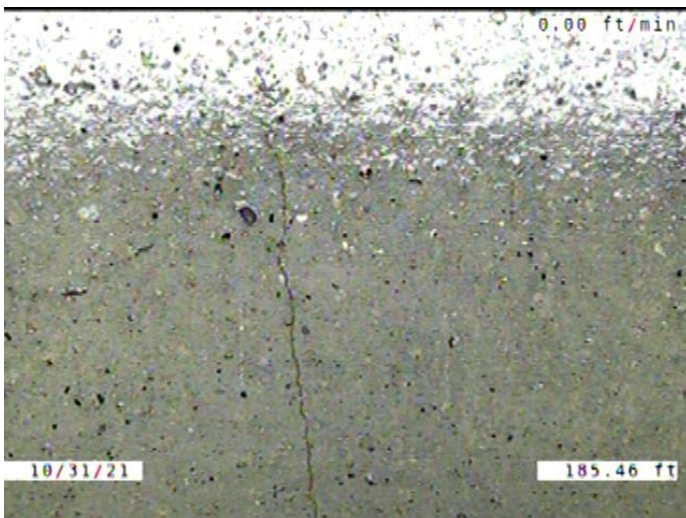
Code: **CL**
Description: **Crack Longitudinal**

Distance (ft): **185.5**
Structural Grade: **2**
O&M Grade: **0**
Clock Start/From: **12**
Clock To:
1st Value:
2nd Value:
Value Percent:
Continuous Index:
Within 8" of Joint: **YES**
Remarks:

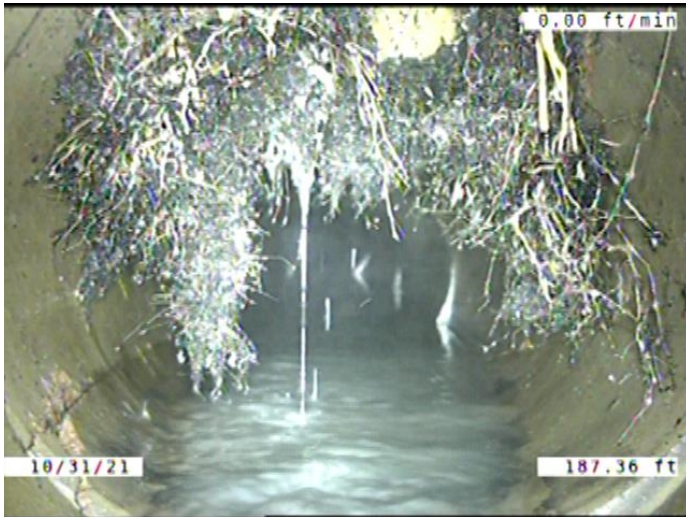
Code: **B**
 Description: **Broken**

Distance (ft): **187.4**
 Structural Grade: **4**
 O&M Grade: **0**
 Clock Start/From: **12**
 Clock To: **12**
 1st Value:
 2nd Value:
 Value Percent:
 Continuous Index:
 Within 8" of Joint: **YES**
 Remarks:

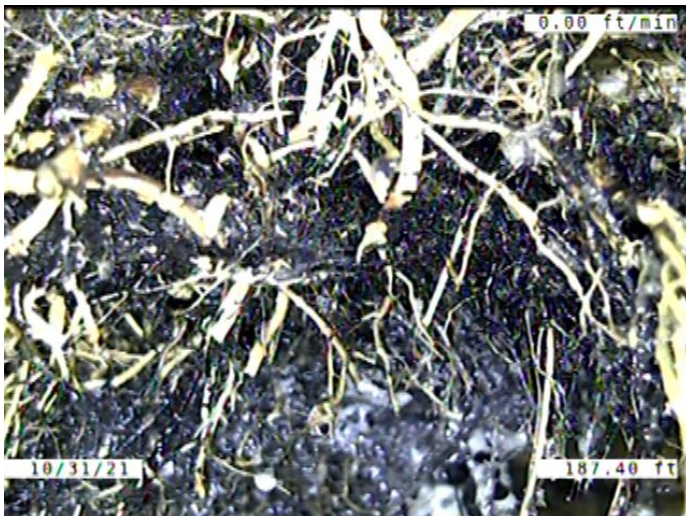
Code: **RMC**
 Description: **Roots Medium Connection**

Distance (ft): **187.4**
 Structural Grade: **0**
 O&M Grade: **3**
 Clock Start/From: **9**
 Clock To: **3**
 1st Value:
 2nd Value:
 Value Percent: **30.000**
 Continuous Index:
 Within 8" of Joint: **NO**
 Remarks:

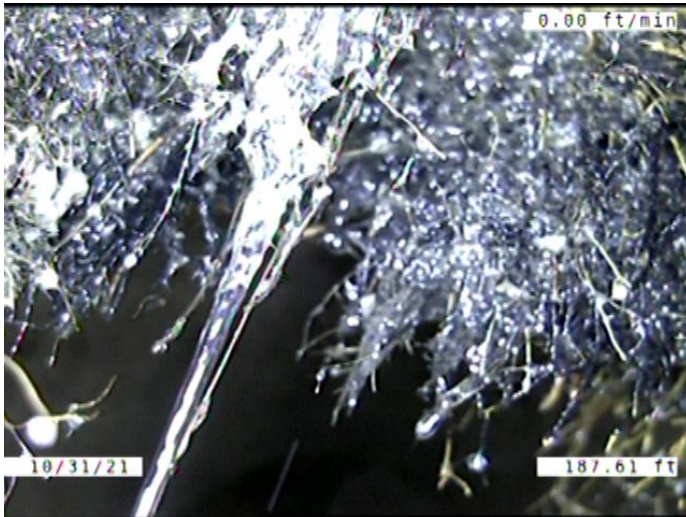
Code: **IRC**
 Description: **Infiltration Runner Connection**

Distance (ft): **187.6**
 Structural Grade: **0**
 O&M Grade: **4**
 Clock Start/From: **11**
 Clock To: **1**
 1st Value:
 2nd Value:
 Value Percent:
 Continuous Index:
 Within 8" of Joint: **YES**
 Remarks:

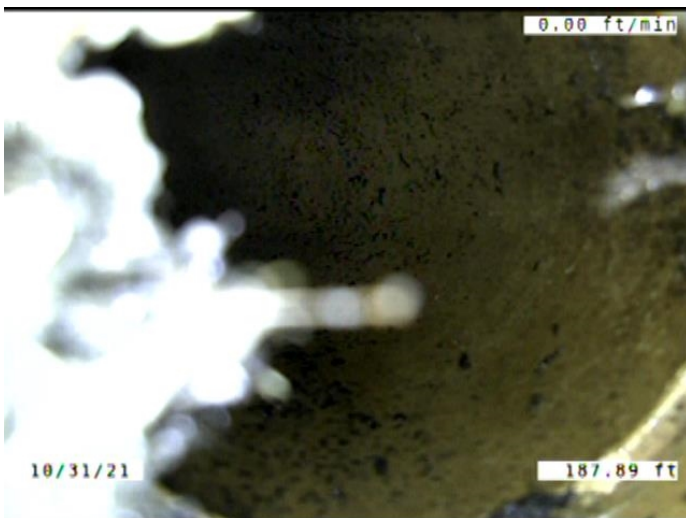
Code: **TBI**
 Description: **Tap Break-in Intruding**

Distance (ft): **187.9**
 Structural Grade: **0**
 O&M Grade: **2**
 Clock Start/From: **12**
 Clock To:
 1st Value: **4.000**
 2nd Value: **1.000**
 Value Percent:
 Continuous Index:
 Within 8" of Joint: **YES**
 Remarks: **CONSTANTLY RUNNING WATER.
 ROOTS GROWING AROUND THE TAP**

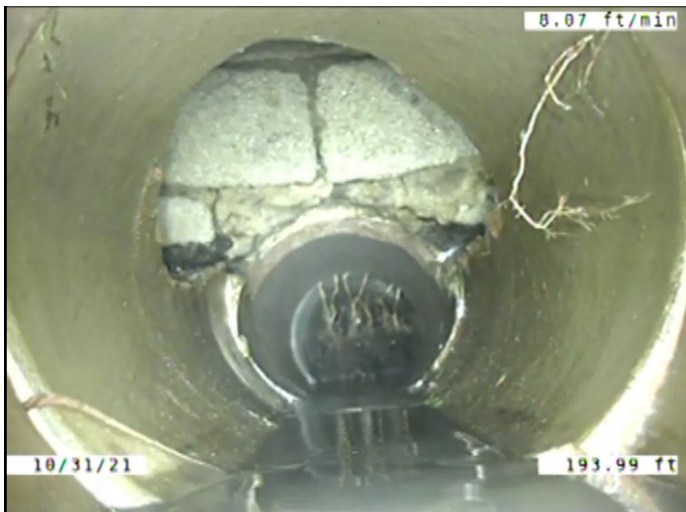
Code: **B**
 Description: **Broken**

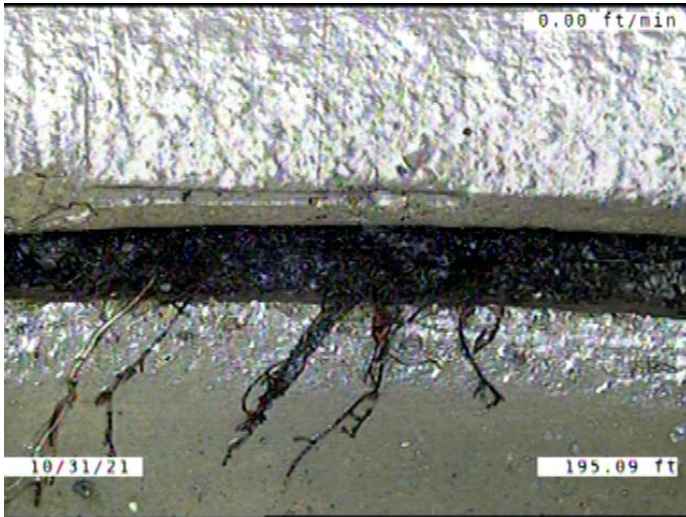
Code: **RFJ**
 Description: **Roots Fine Joint**
