# Profile/Photo Observation Report

Date:	<b>10/31/2021</b>	Weather:		Coding:	<b>PACP 7.0</b>
Pipe Length (ft):	<b>197.3</b>	Owner:	<b>City of Hobart</b>	Pre Clean:	<b>Heavy Cleaning</b>
P.O.#:	<b>YES502259</b>	Surveyor:	<b>S. Bucklin</b>	PSR:	<b>P-504-037-036</b>
Customer:	<b>City of Hobart</b>	Clean Date:	<b>10/26/2021</b>	Shape:	<b>C</b>

Street:	<b>North Cavender Street</b>	Flow Control:	<b>Not Controlled</b>
City:	<b>Hobart, IN</b>	Year Renewed:	
Location:	<b>Alley</b>	Tape/Media #:	
Purpose:	<b>Routine Assessment</b>	Dia/Height:	<b>10"</b>
Use:	<b>Sanitary Sewage Pipe</b>	Material:	<b>VCP</b>
Drain Area:		Lining:	<b>None</b>
Category:	<b>NA</b>		
Comment:			
Location Details:		Direction of Survey:	<b>Downstream</b>
US MH:	<b>M-504-036</b>	DS MH:	<b>M-504-037</b>
		Total Length Surveyed (ft):	<b>197.3</b>

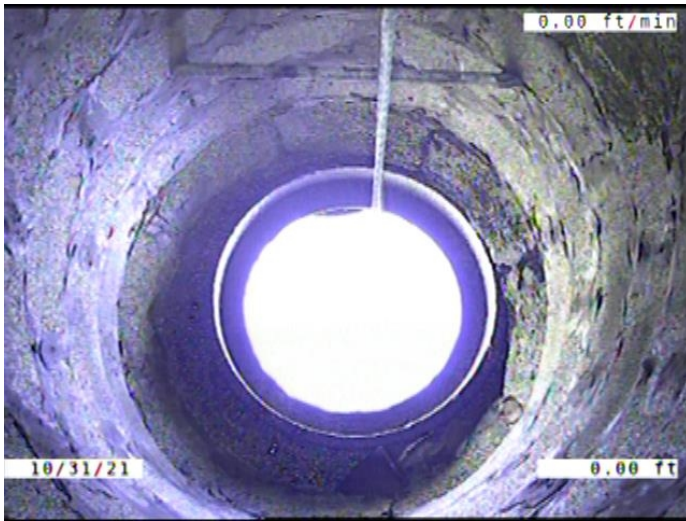
Code: **AMH**  
Description: **Manhole**

Distance (ft): **.0**  
Structural Grade: **0**  
O&M Grade: **0**  
Clock Start/From:  
Clock To:  
1st Value:  
2nd Value:  
Value Percent:  
Continuous Index:  
Within 8" of Joint: **NO**  
Remarks: **M-504-036**

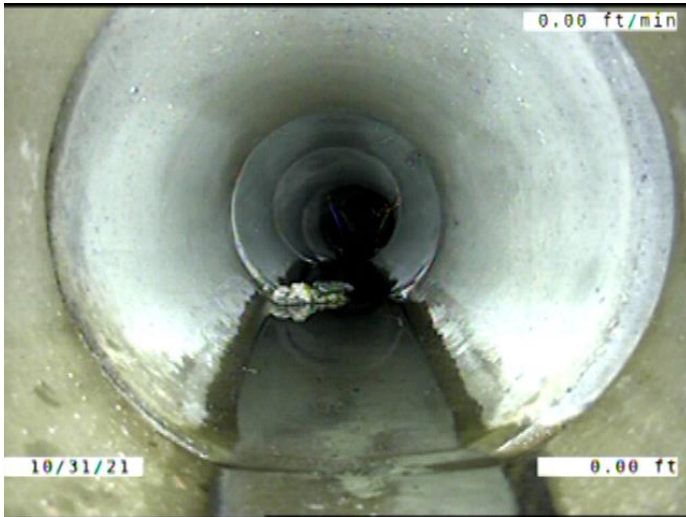
Code: **MWL**  
 Description: **Miscellaneous Water Level**

Distance (ft): **.0**  
 Structural Grade: **0**  
 O&M Grade: **0**  
 Clock Start/From:  
 Clock To:  
 1st Value:  
 2nd Value:  
 Value Percent: **5.000**  
 Continuous Index:  
 Within 8" of Joint: **NO**  
 Remarks:

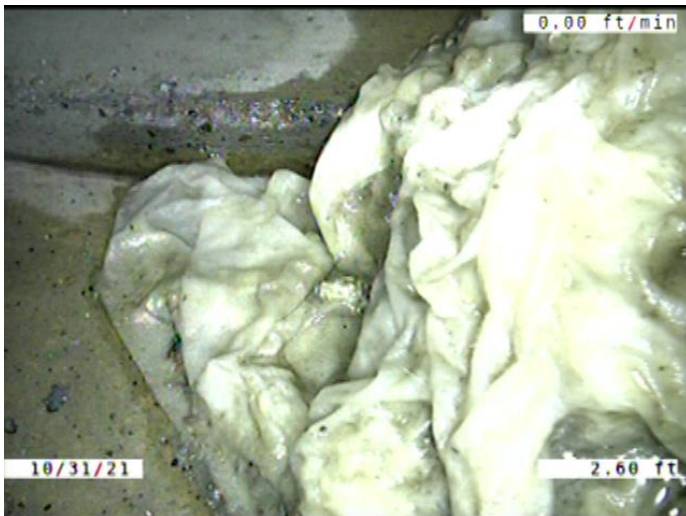
Code: **DAR**  
 Description: **Deposits Attached Ragging**

Distance (ft): **2.6**  
 Structural Grade: **0**  
 O&M Grade: **2**  
 Clock Start/From: **5**  
 Clock To: **8**  
 1st Value:  
 2nd Value:  
 Value Percent: **5.000**  
 Continuous Index:  
 Within 8" of Joint: **YES**  
 Remarks:

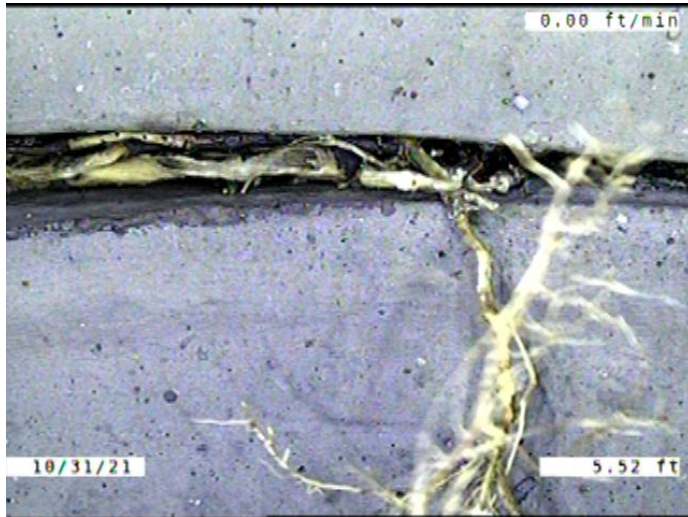
Code: **RFJ**  
 Description: **Roots Fine Joint**

Distance (ft): **5.5**  
 Structural Grade: **0**  
 O&M Grade: **1**  
 Clock Start/From: **12**  
 Clock To: **3**  
 1st Value:  
 2nd Value:  
 Value Percent:  
 Continuous Index:  
 Within 8" of Joint: **YES**  
 Remarks:

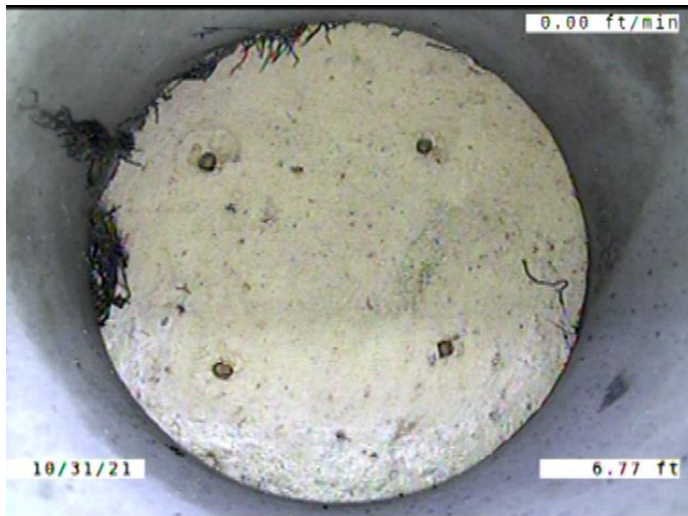
Code: **TFC**  
 Description: **Tap Factory Capped**

Distance (ft): **6.8**  
 Structural Grade: **0**  
 O&M Grade: **0**  
 Clock Start/From: **11**  
 Clock To:  
 1st Value: **4.000**  
 2nd Value:  
 Value Percent:  
 Continuous Index:  
 Within 8" of Joint: **YES**  
 Remarks: **ROOTS COMING AROUND THE CAP**

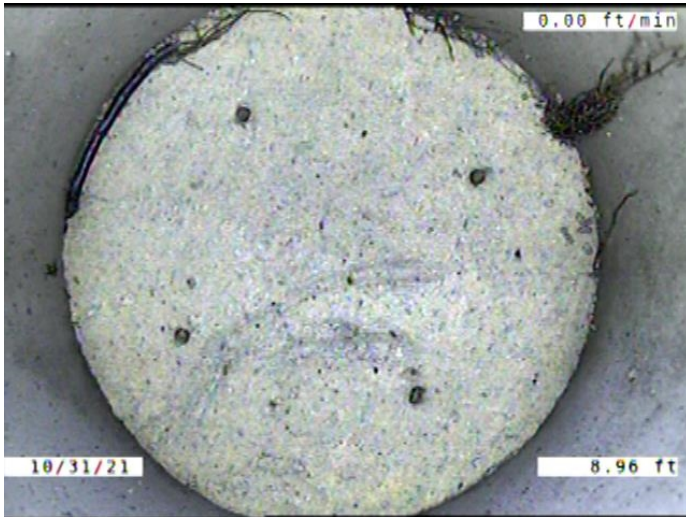
Code: **TFC**  
Description: **Tap Factory Capped**

Distance (ft): **9.0**  
Structural Grade: **0**  
O&M Grade: **0**  
Clock Start/From: **1**  
Clock To:  
1st Value: **4.000**  
2nd Value:  
Value Percent:  
Continuous Index:  
Within 8" of Joint: **YES**  
Remarks: **ROOTS GROWING AROUND THE CAP**

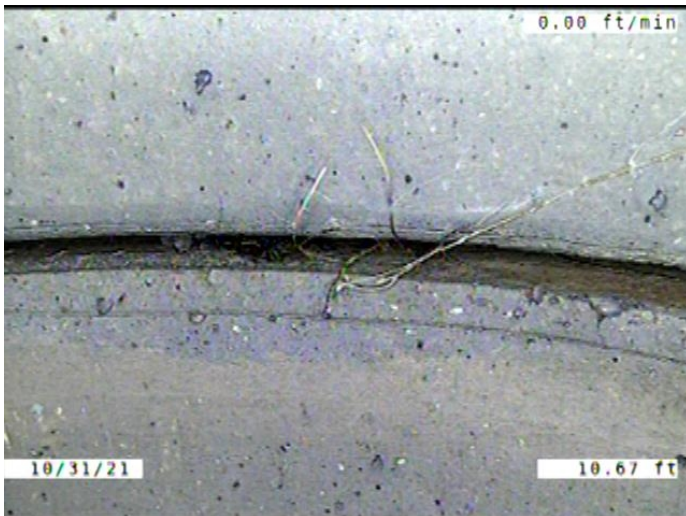
Code: **RFJ**  
Description: **Roots Fine Joint**

Distance (ft): **10.7**  
Structural Grade: **0**  
O&M Grade: **1**  
Clock Start/From: **2**  
Clock To:  
1st Value:  
2nd Value:  
Value Percent:  
Continuous Index:  
Within 8" of Joint: **YES**  
Remarks:

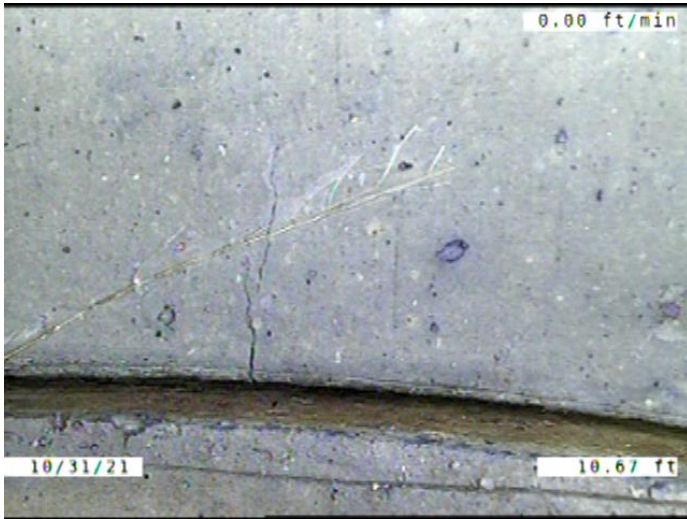
Code: **CL**  
 Description: **Crack Longitudinal**

Distance (ft): **10.7**  
 Structural Grade: **2**  
 O&M Grade: **0**  
 Clock Start/From: **2**  
 Clock To:  
 1st Value:  
 2nd Value:  
 Value Percent:  
 Continuous Index:  
 Within 8" of Joint: **YES**  
 Remarks:

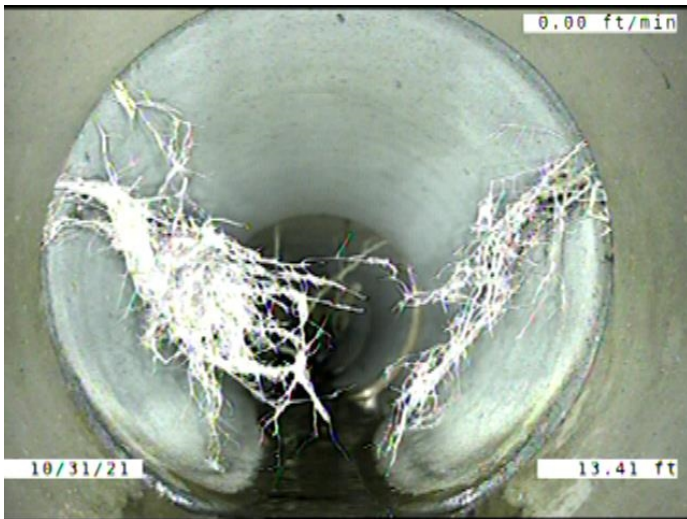
Code: **RMJ**  
 Description: **Roots Medium Joint**

Distance (ft): **13.4**  
 Structural Grade: **0**  
 O&M Grade: **3**  
 Clock Start/From: **9**  
 Clock To: **3**  
 1st Value:  
 2nd Value:  
 Value Percent: **5.000**  
 Continuous Index:  
 Within 8" of Joint: **YES**  
 Remarks:

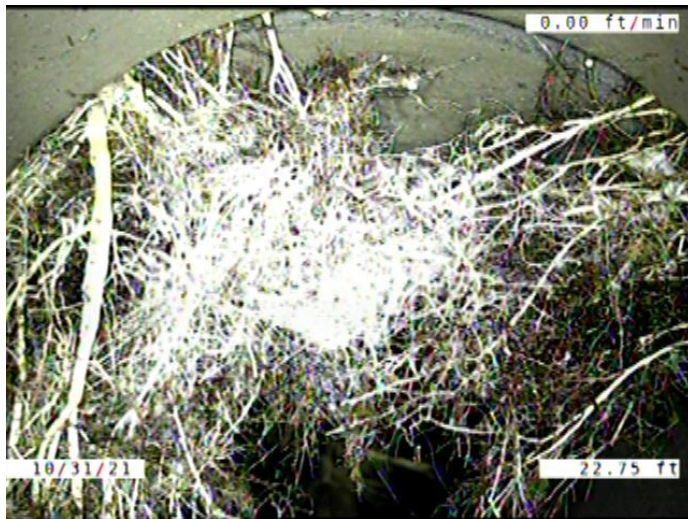
Code: **RMJ**  
 Description: **Roots Medium Joint**

Distance (ft): **22.7**  
 Structural Grade: **0**  
 O&M Grade: **3**  
 Clock Start/From: **8**  
 Clock To: **2**  
 1st Value:  
 2nd Value:  
 Value Percent: **15.000**  
 Continuous Index:  
 Within 8" of Joint: **YES**  
 Remarks:

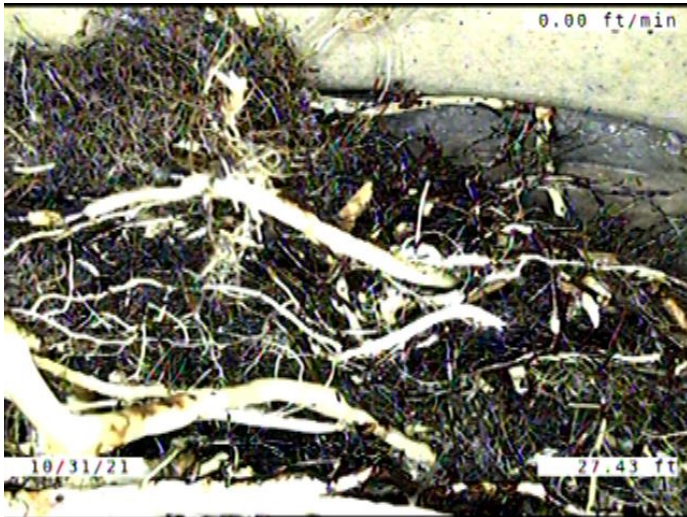
Code: **RMJ**  
 Description: **Roots Medium Joint**

Distance (ft): **27.4**  
 Structural Grade: **0**  
 O&M Grade: **3**  
 Clock Start/From: **8**  
 Clock To: **3**  
 1st Value:  
 2nd Value:  
 Value Percent: **50.000**  
 Continuous Index:  
 Within 8" of Joint: **YES**  
 Remarks:

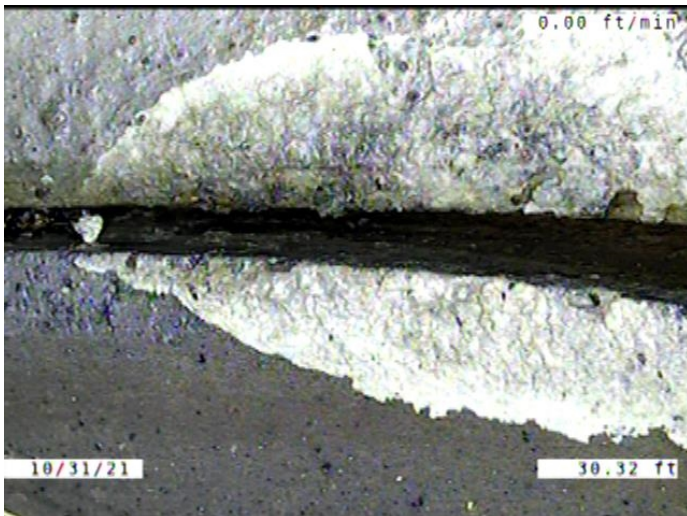
Code: **DAE**  
 Description: **Deposits Attached Encrustation**

Distance (ft): **30.3**  
 Structural Grade: **0**  
 O&M Grade: **2**  
 Clock Start/From: **2**  
 Clock To: **4**  
 1st Value:  
 2nd Value:  
 Value Percent: **5.000**  
 Continuous Index:  
 Within 8" of Joint: **YES**  
 Remarks:

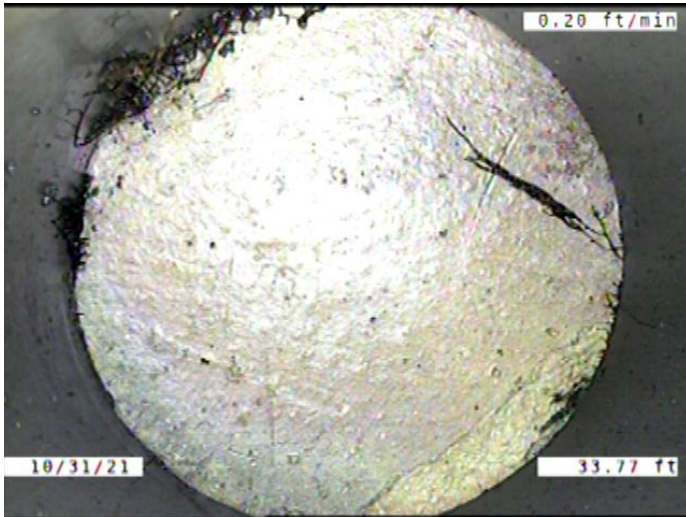
Code: **TFC**  
Description: **Tap Factory Capped**

Distance (ft): **33.8**  
Structural Grade: **0**  
O&M Grade: **0**  
Clock Start/From: **11**  
Clock To:  
1st Value: **4.000**  
2nd Value:  
Value Percent:  
Continuous Index:  
Within 8" of Joint: **YES**  
Remarks: **ROOTS GROWING AROUND THE CAP**

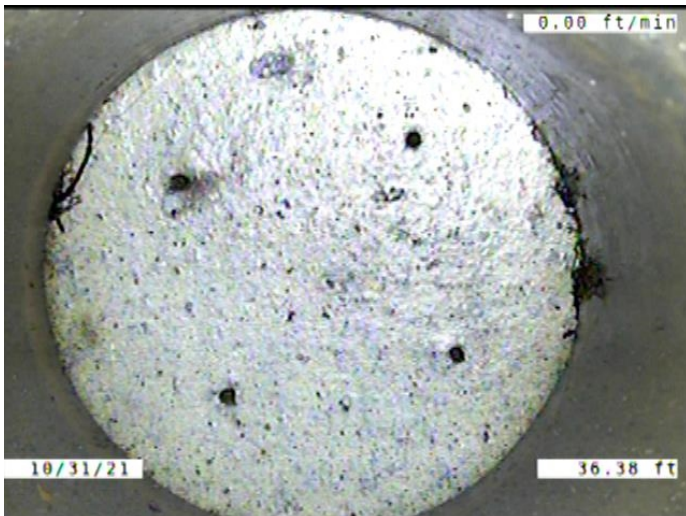
Code: **TFC**  
Description: **Tap Factory Capped**

Distance (ft): **36.4**  
Structural Grade: **0**  
O&M Grade: **0**  
Clock Start/From: **1**  
Clock To:  
1st Value: **4.000**  
2nd Value:  
Value Percent:  
Continuous Index:  
Within 8" of Joint: **YES**  
Remarks: **ROOTS GROWING AROUND THE CAP**

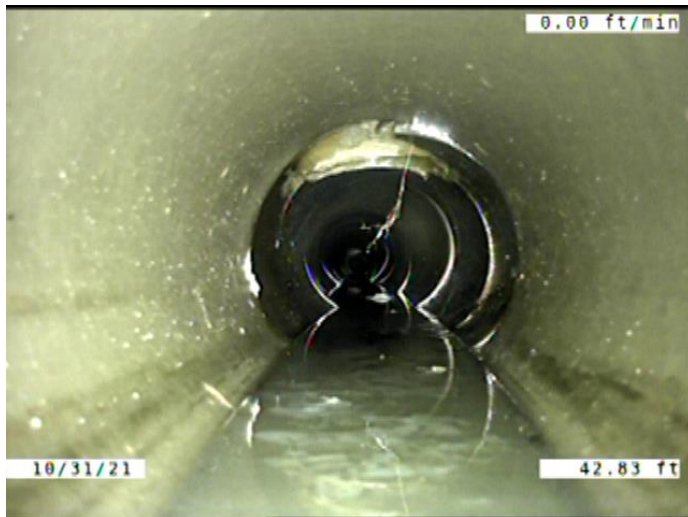
Code: **MWLS**  
 Description: **Miscellaneous Water Level Sag**

Distance (ft): **42.8**  
 Structural Grade: **2**  
 O&M Grade: **0**  
 Clock Start/From:  
 Clock To:  
 1st Value:  
 2nd Value:  
 Value Percent: **5.000**  
 Continuous Index:  
 Within 8" of Joint: **NO**  
 Remarks:

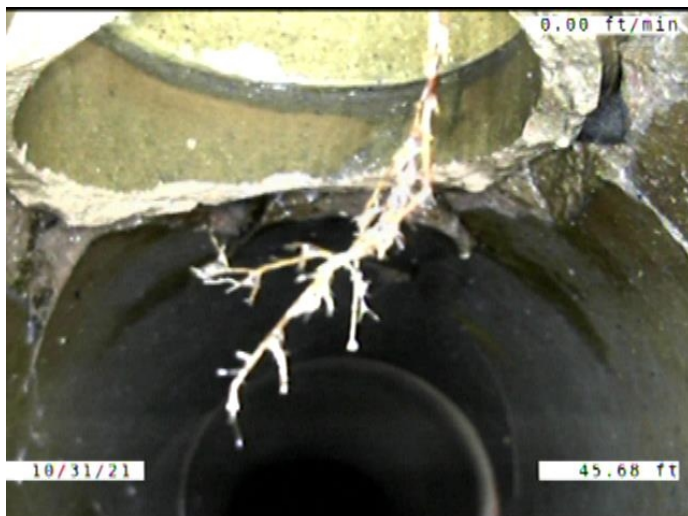
Code: **BSV**  
 Description: **Broken Soil Visible**

Distance (ft): **45.7**  
 Structural Grade: **5**  
 O&M Grade: **0**  
 Clock Start/From: **12**  
 Clock To: **12**  
 1st Value:  
 2nd Value:  
 Value Percent:  
 Continuous Index:  
 Within 8" of Joint: **YES**  
 Remarks:

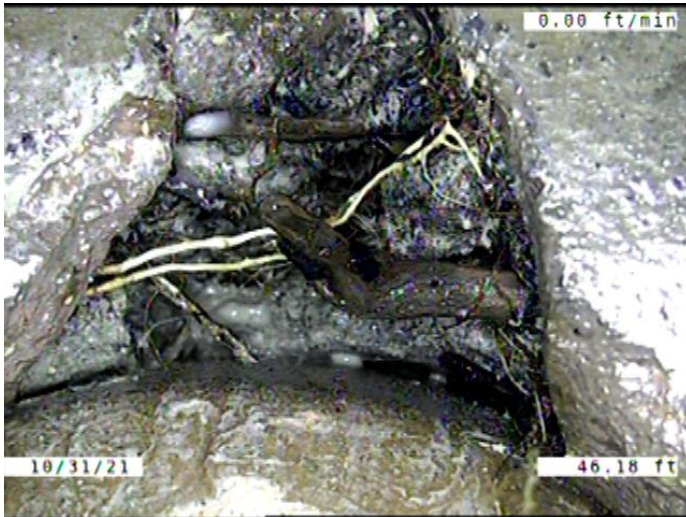
Code: **RFB**  
 Description: **Roots Fine Barrel**

Distance (ft): **46.2**  
 Structural Grade: **0**  
 O&M Grade: **2**  
 Clock Start/From: **11**  
 Clock To: **1**  
 1st Value:  
 2nd Value:  
 Value Percent:  
 Continuous Index:  
 Within 8" of Joint: **NO**  
 Remarks:

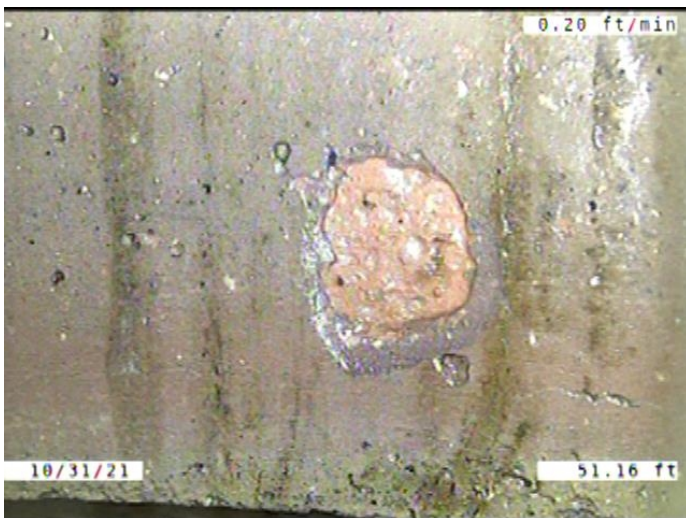
Code: **SSS**  
Description: **Surface Damage Surface Spalling**

Distance (ft): **51.2**  
Structural Grade: **2**  
O&M Grade: **0**  
Clock Start/From: **8**  
Clock To: **9**  
1st Value:  
2nd Value:  
Value Percent:  
Continuous Index:  
Within 8" of Joint: **YES**  
Remarks:

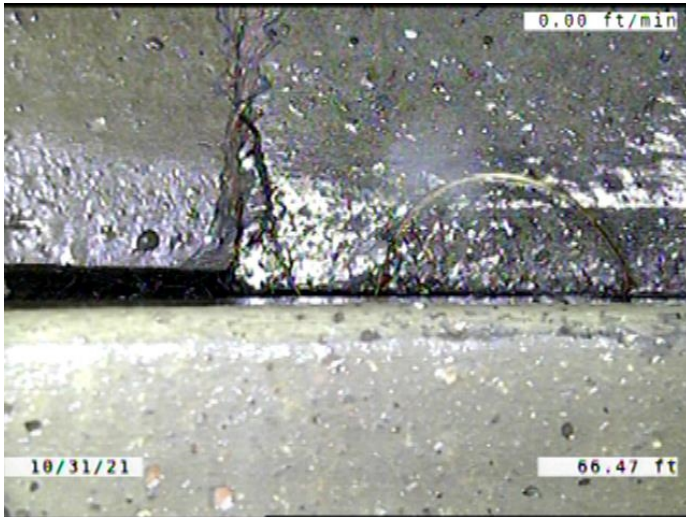
Code: **RFJ**  
 Description: **Roots Fine Joint**

Distance (ft): **66.5**  
 Structural Grade: **0**  
 O&M Grade: **1**  
 Clock Start/From: **2**  
 Clock To: **3**  
 1st Value:  
 2nd Value:  
 Value Percent:  
 Continuous Index:  
 Within 8" of Joint: **YES**  
 Remarks:

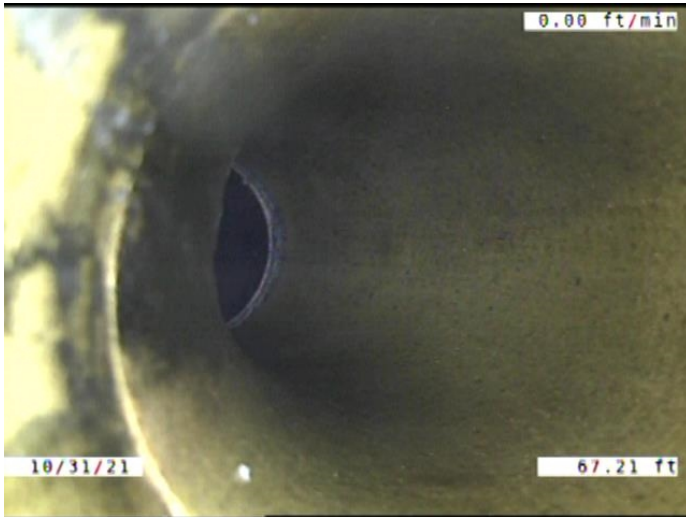
Code: **TBI**  
 Description: **Tap Break-in Intruding**

Distance (ft): **67.2**  
 Structural Grade: **0**  
 O&M Grade: **2**  
 Clock Start/From: **11**  
 Clock To:  
 1st Value: **4.000**  
 2nd Value: **1.000**  
 Value Percent:  
 Continuous Index:  
 Within 8" of Joint: **YES**  
 Remarks: **CONSTANTLY RUNNING WATER.**

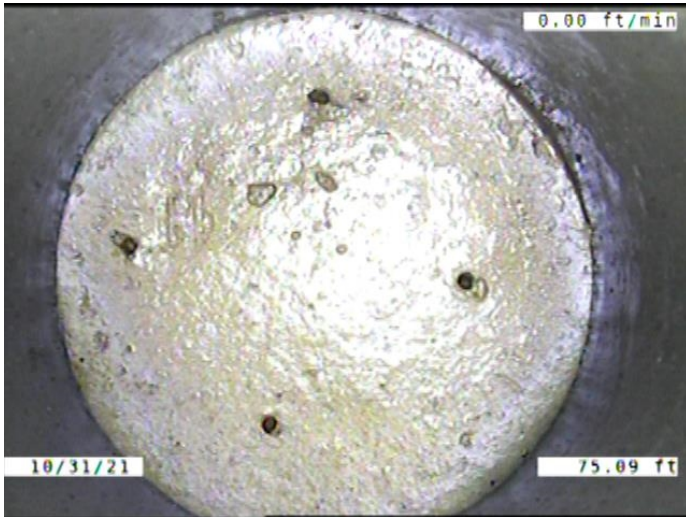
Code: **TFC**  
 Description: **Tap Factory Capped**

Distance (ft): **75.1**  
 Structural Grade: **0**  
 O&M Grade: **0**  
 Clock Start/From: **1**  
 Clock To:  
 1st Value: **4.000**  
 2nd Value:  
 Value Percent:  
 Continuous Index:  
 Within 8" of Joint: **YES**  
 Remarks:

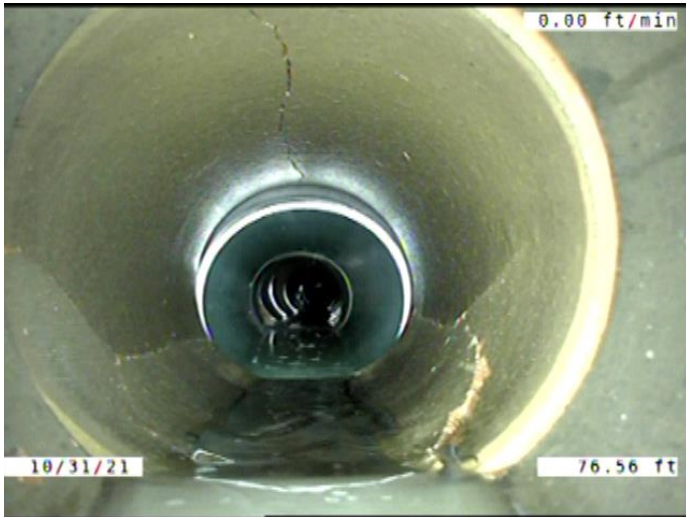
Code: **B**  
 Description: **Broken**

Distance (ft): **76.6**  
 Structural Grade: **4**  
 O&M Grade: **0**  
 Clock Start/From: **12**  
 Clock To: **12**  
 1st Value:  
 2nd Value:  
 Value Percent:  
 Continuous Index:  
 Within 8" of Joint: **YES**  
 Remarks:

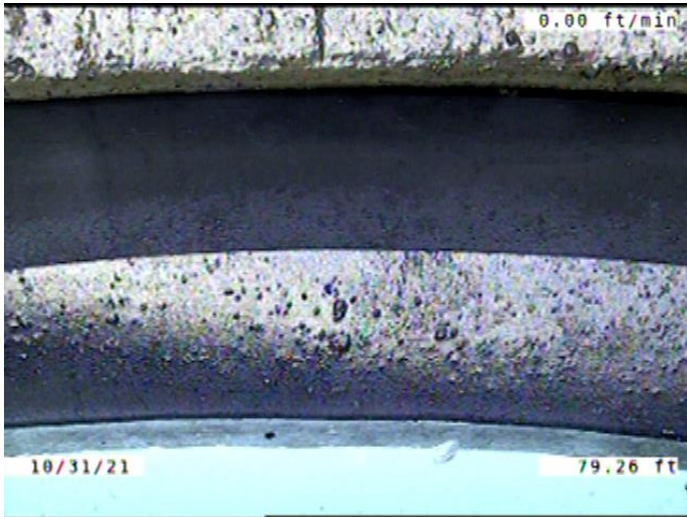
Code: **MMC**  
 Description: **Miscellaneous Material Change**

Distance (ft): **79.3**  
 Structural Grade: **0**  
 O&M Grade: **0**  
 Clock Start/From:  
 Clock To:  
 1st Value:  
 2nd Value:  
 Value Percent:  
 Continuous Index:  
 Within 8" of Joint: **NO**  
 Remarks: **VCP TO PVC**

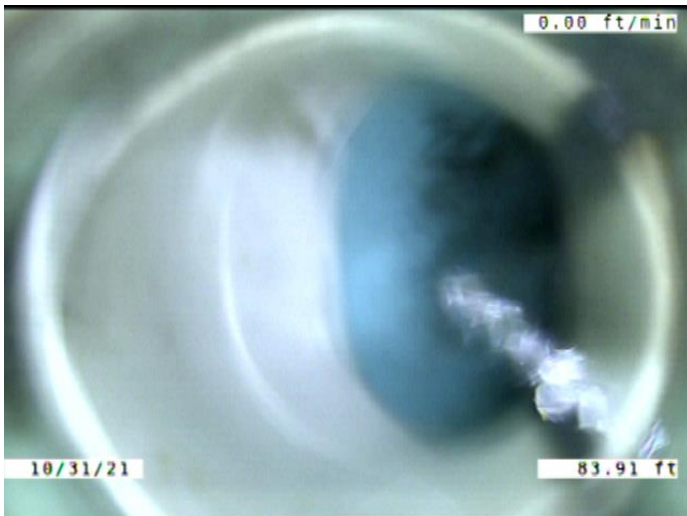
Code: **TF**  
 Description: **Tap Factory**

Distance (ft): **83.9**  
 Structural Grade: **0**  
 O&M Grade: **0**  
 Clock Start/From: **1**  
 Clock To:  
 1st Value: **4.000**  
 2nd Value:  
 Value Percent:  
 Continuous Index:  
 Within 8" of Joint: **YES**  
 Remarks: **CONSTANTLY RUNNING WATER.**

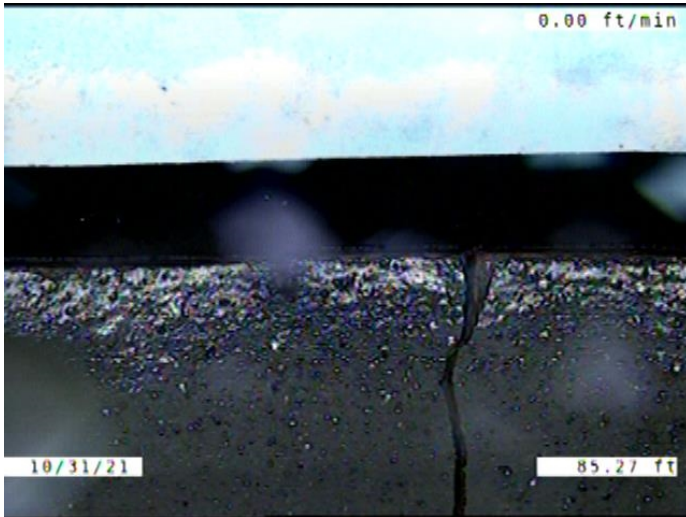
Code: **MMC**  
 Description: **Miscellaneous Material Change**

Distance (ft): **85.3**  
 Structural Grade: **0**  
 O&M Grade: **0**  
 Clock Start/From:  
 Clock To:  
 1st Value:  
 2nd Value:  
 Value Percent:  
 Continuous Index:  
 Within 8" of Joint: **NO**  
 Remarks: **PVC TO VCP**

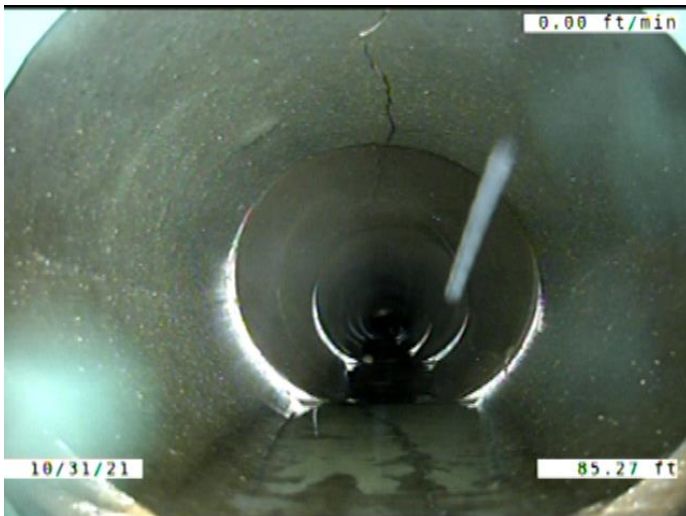
Code: **B**  
 Description: **Broken**

Distance (ft): **85.3**  
 Structural Grade: **4**  
 O&M Grade: **0**  
 Clock Start/From: **12**  
 Clock To: **12**  
 1st Value:  
 2nd Value:  
 Value Percent:  
 Continuous Index: **S02**  
 Within 8" of Joint: **YES**  
 Remarks:

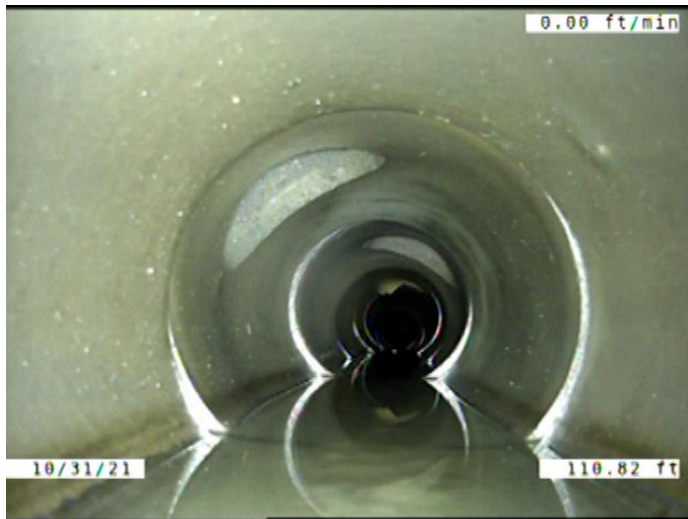
Code: **B**  
 Description: **Broken**

Distance (ft): **110.8**  
 Structural Grade: **4**  
 O&M Grade: **0**  
 Clock Start/From: **12**  
 Clock To: **12**  
 1st Value:  
 2nd Value:  
 Value Percent:  
 Continuous Index: **F02**  
 Within 8" of Joint: **YES**  
 Remarks:

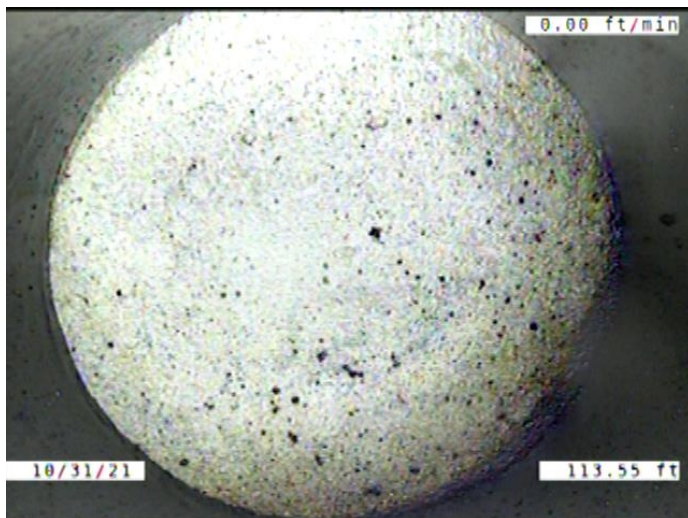
Code: **TFC**  
 Description: **Tap Factory Capped**

Distance (ft): **113.5**  
 Structural Grade: **0**  
 O&M Grade: **0**  
 Clock Start/From: **11**  
 Clock To:  
 1st Value: **4.000**  
 2nd Value:  
 Value Percent:  
 Continuous Index:  
 Within 8" of Joint: **YES**  
 Remarks:

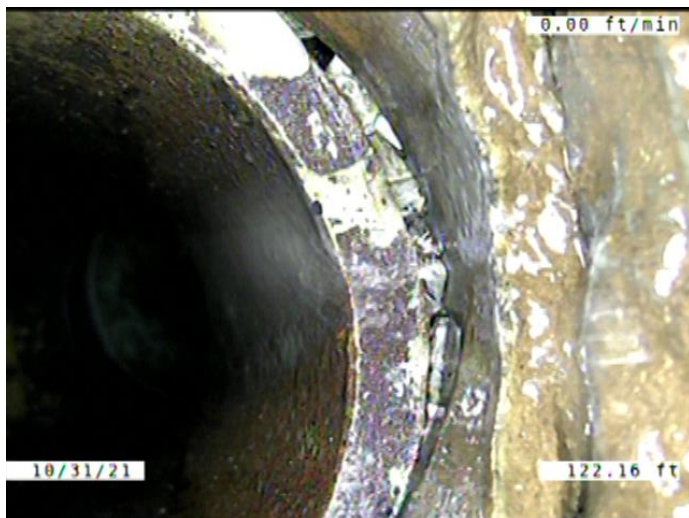
Code:	<b>IRC</b>
Description:	<b>Infiltration Runner Connection</b>
Distance (ft):	<b>122.2</b>
Structural Grade:	<b>0</b>
O&M Grade:	<b>4</b>
Clock Start/From:	<b>12</b>
Clock To:	<b>1</b>
1st Value:	
2nd Value:	
Value Percent:	
Continuous Index:	
Within 8" of Joint:	<b>YES</b>
Remarks:

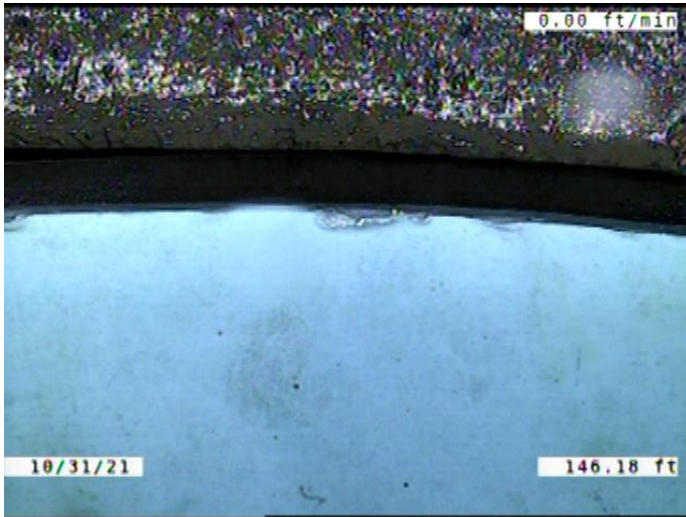
Code: **MMC**  
 Description: **Miscellaneous Material Change**

Distance (ft): **146.2**  
 Structural Grade: **0**  
 O&M Grade: **0**  
 Clock Start/From:  
 Clock To:  
 1st Value:  
 2nd Value:  
 Value Percent:  
 Continuous Index:  
 Within 8" of Joint: **NO**  
 Remarks: **VCP TO PVC**

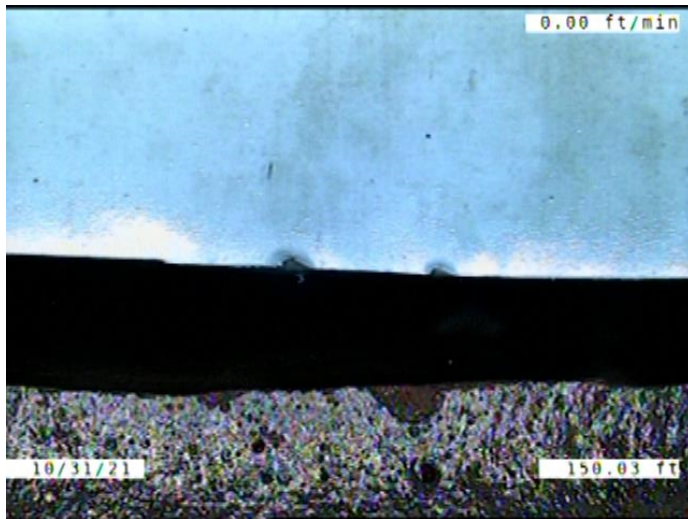
Code: **MMC**  
 Description: **Miscellaneous Material Change**

Distance (ft): **150.0**  
 Structural Grade: **0**  
 O&M Grade: **0**  
 Clock Start/From:  
 Clock To:  
 1st Value:  
 2nd Value:  
 Value Percent:  
 Continuous Index:  
 Within 8" of Joint: **NO**  
 Remarks: **PVC TO VCP**

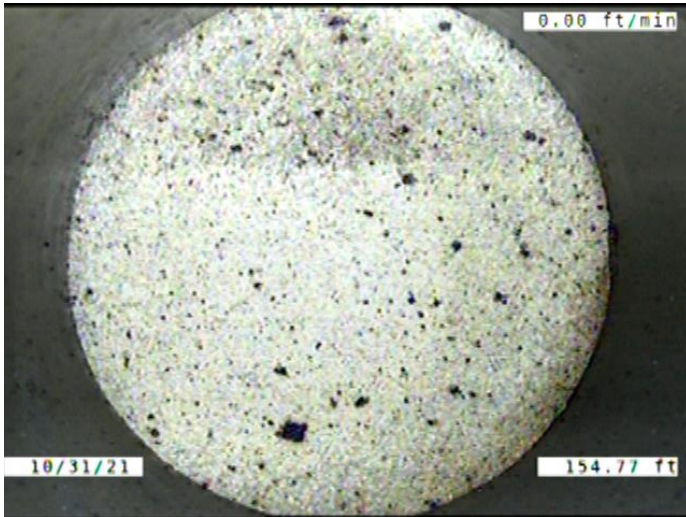
Code: **TFC**  
 Description: **Tap Factory Capped**

Distance (ft): **154.8**  
 Structural Grade: **0**  
 O&M Grade: **0**  
 Clock Start/From: **11**  
 Clock To:  
 1st Value: **4.000**  
 2nd Value:  
 Value Percent:  
 Continuous Index:  
 Within 8" of Joint: **YES**  
 Remarks:

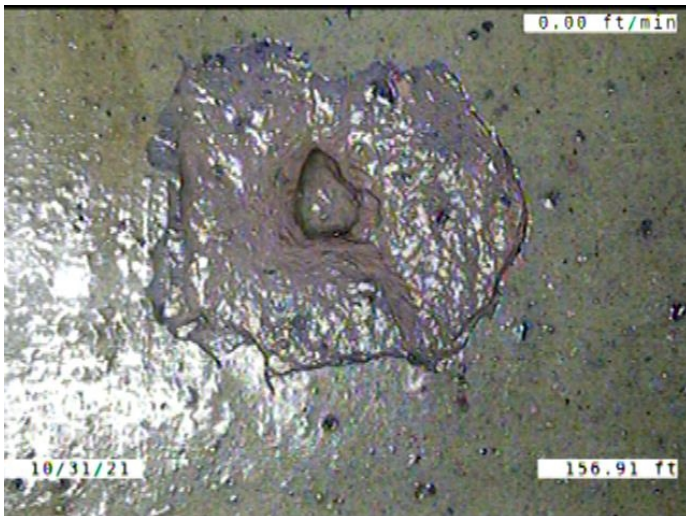
Code: **SSS**  
 Description: **Surface Damage Surface Spalling**

Distance (ft): **156.9**  
 Structural Grade: **2**  
 O&M Grade: **0**  
 Clock Start/From: **3**  
 Clock To: **4**  
 1st Value:  
 2nd Value:  
 Value Percent:  
 Continuous Index:  
 Within 8" of Joint: **YES**  
 Remarks:

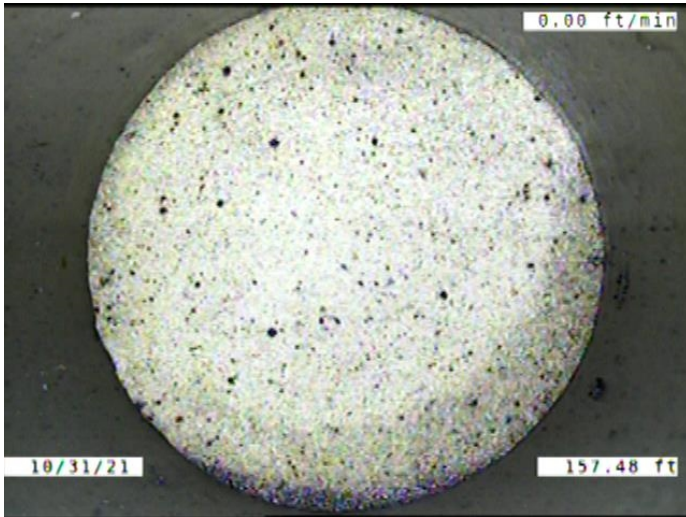
Code: **TFC**  
 Description: **Tap Factory Capped**

Distance (ft): **157.5**  
 Structural Grade: **0**  
 O&M Grade: **0**  
 Clock Start/From: **1**  
 Clock To:  
 1st Value: **4.000**  
 2nd Value:  
 Value Percent:  
 Continuous Index:  
 Within 8" of Joint: **YES**  
 Remarks:

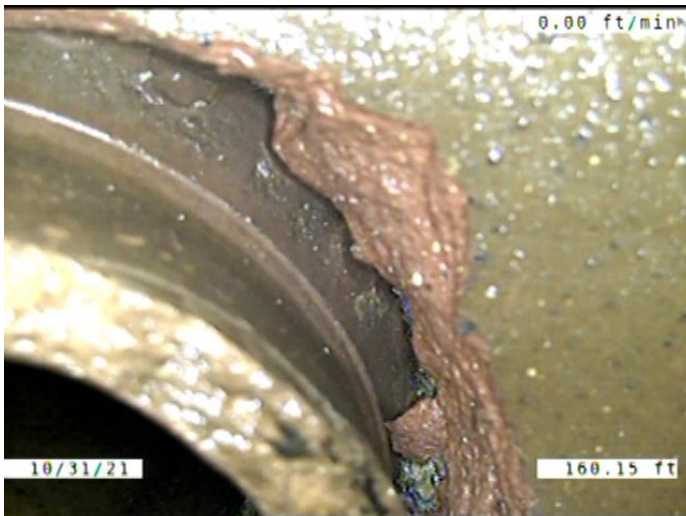
Code: **SSS**  
 Description: **Surface Damage Surface Spalling**

Distance (ft): **160.2**  
 Structural Grade: **2**  
 O&M Grade: **0**  
 Clock Start/From: **11**  
 Clock To: **2**  
 1st Value:  
 2nd Value:  
 Value Percent:  
 Continuous Index:  
 Within 8" of Joint: **YES**  
 Remarks:

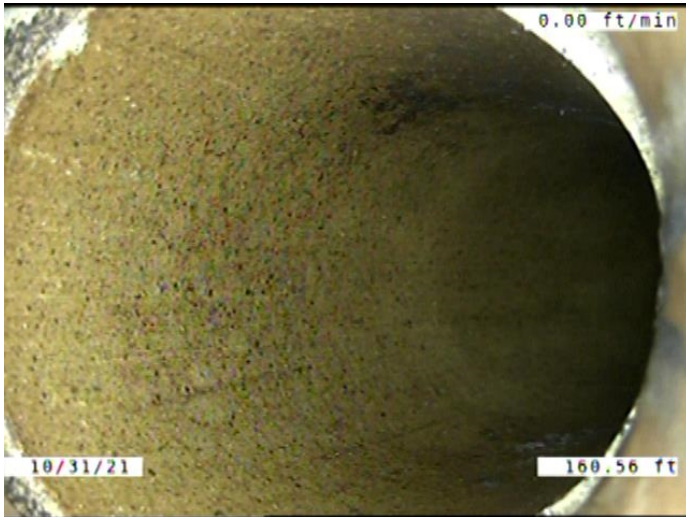
Code: **TBI**  
 Description: **Tap Break-in Intruding**

Distance (ft): **160.6**  
 Structural Grade: **0**  
 O&M Grade: **2**  
 Clock Start/From: **1**  
 Clock To:  
 1st Value: **4.000**  
 2nd Value: **1.000**  
 Value Percent:  
 Continuous Index:  
 Within 8" of Joint: **YES**  
 Remarks:

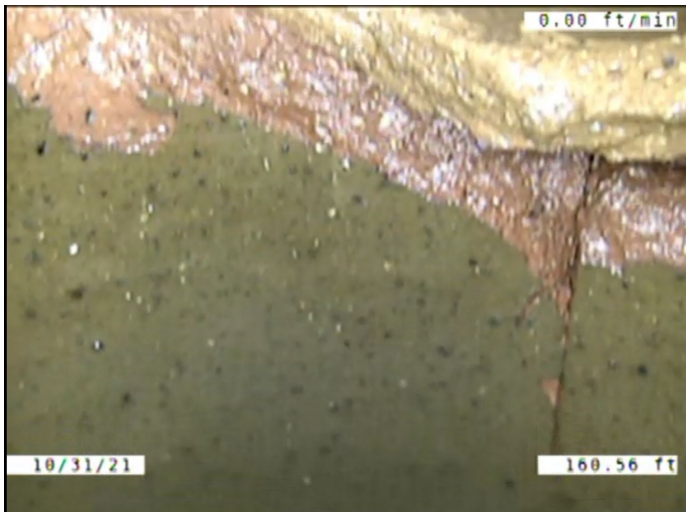
Code: **FL**  
 Description: **Fracture Longitudinal**

Distance (ft): **160.6**  
 Structural Grade: **3**  
 O&M Grade: **0**  
 Clock Start/From: **1**  
 Clock To:  
 1st Value:  
 2nd Value:  
 Value Percent:  
 Continuous Index:  
 Within 8" of Joint: **NO**  
 Remarks:

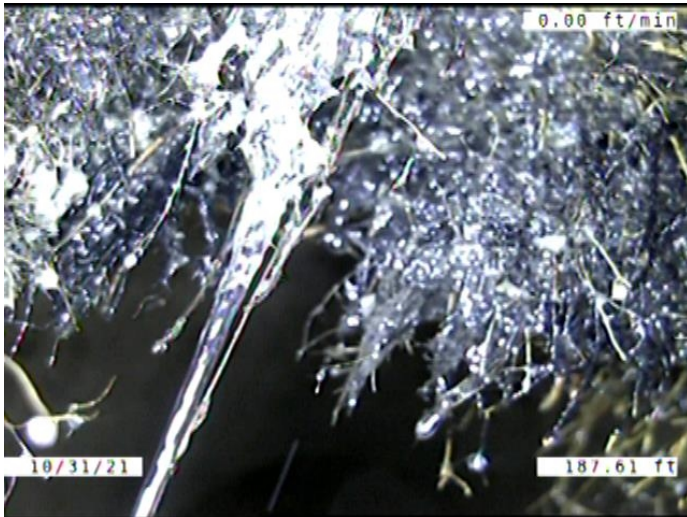
Code: **IRC**  
 Description: **Infiltration Runner Connection**

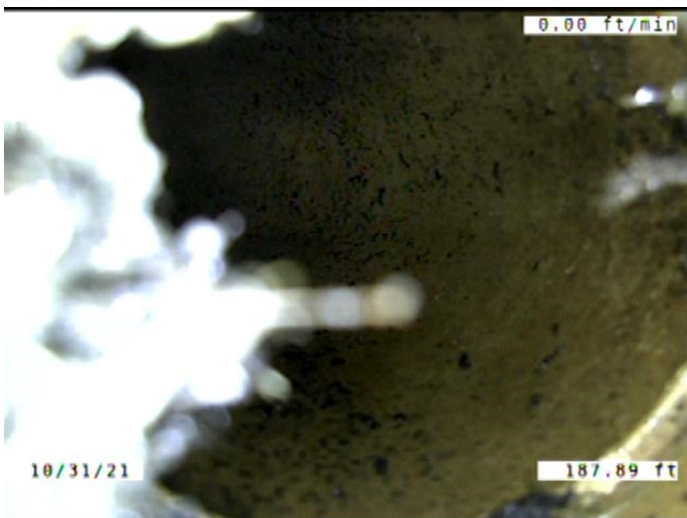
Code: **TBI**  
 Description: **Tap Break-in Intruding**

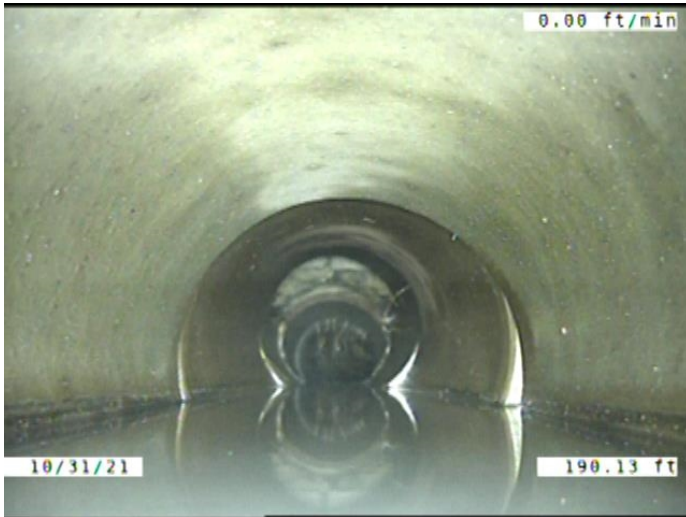
Code: **MWLS**  
 Description: **Miscellaneous Water Level Sag**

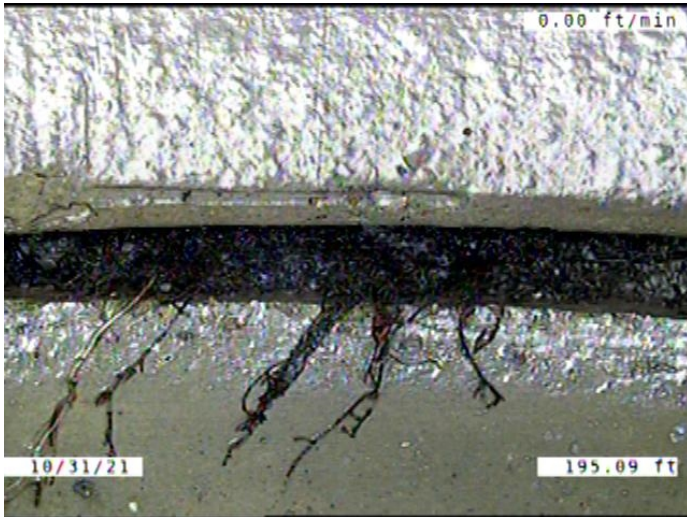
Code: **RFJ**  
 Description: **Roots Fine Joint**

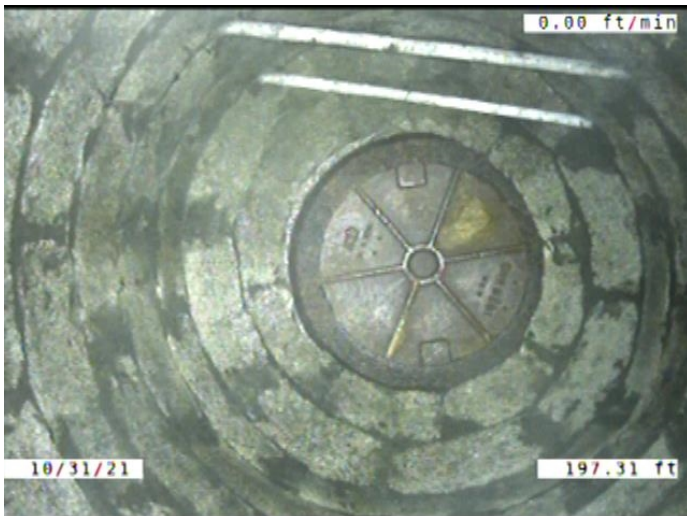
Code: **AMH**  
 Description: **Manhole**
