## **Profile/Photo Observation Report**

Date: 11/02/2021 Weather: **PACP 7.0** Coding: Pipe Length (ft): 213.2 Owner: **City of Hobart** Pre Clean: **Heavy Cleaning** P.O.#: S. Bucklin PSR: P-504-039-038 YES502259 Surveyor:

**North Colorado Street** Flow Control: **Not Controlled** Street:

US MH: M-504-038 DS MH: M-504-039 Total Length Surveyed (ft): 213.2

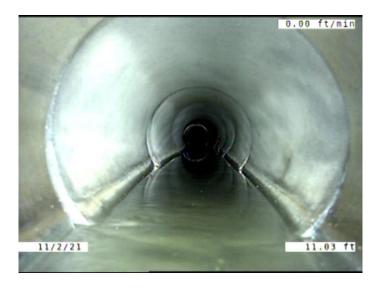
Code: **MWLS**

Description: **Miscellaneous Water Level Sag**

Distance (ft): 11.0 Structural Grade: 2 0 O&M Grade:

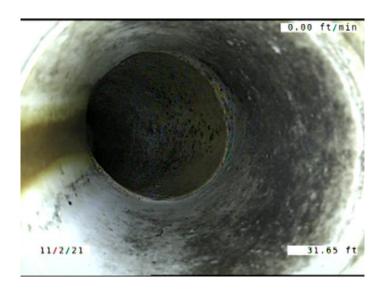
Code: **TF**

Description: Tap Factory

Distance (ft): 31.6
Structural Grade: 0

Remarks: CONSTANTLY RUNNING WATER.

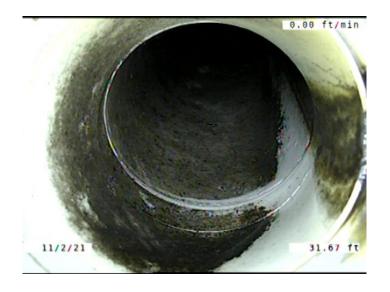
Code: **TF**

Description: Tap Factory

Distance (ft): 31.7
Structural Grade: 0

Remarks: CONSTANTLY RUNNING WATER.

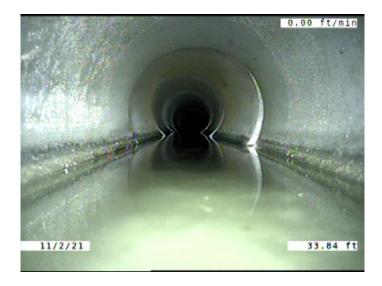
Code: **MWLS**

Description: **Miscellaneous Water Level Sag**

Distance (ft): 33.8 Structural Grade: 2 0 O&M Grade:

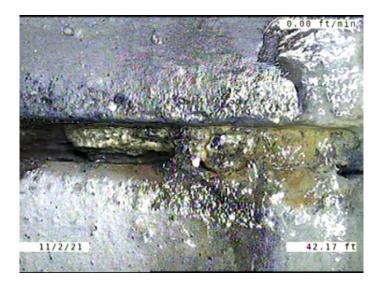
Code: DAE

Description: **Deposits Attached Encrustation**

42.2 Distance (ft): Structural Grade: 0 2 O&M Grade: Clock Start/From: 3 Clock To: 8

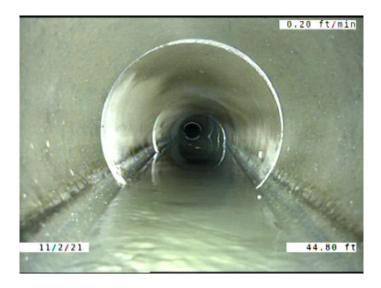
Code: **MWLS**

Description: **Miscellaneous Water Level Sag**

Distance (ft): 44.8 Structural Grade: 2 O&M Grade: 0

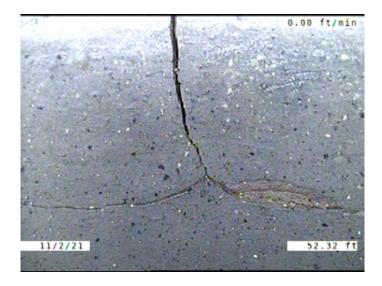
Code: B
Description: Broken

Distance (ft): 52.3
Structural Grade: 4

Clock Start/From: 9

Clock To: 2

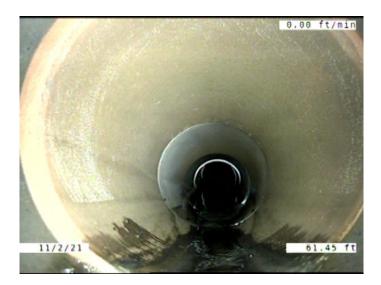
Code: LD

Description: Line Down

Distance (ft): 61.4
Structural Grade: 0

O&M Grade: 1

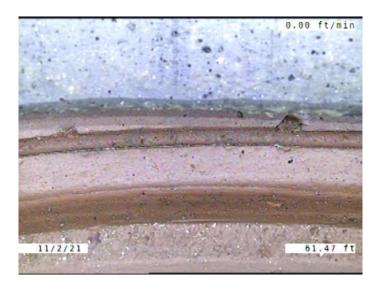
Code: JAM

Description: Joint Angular Medium

Distance (ft): 61.5
Structural Grade: 3
O&M Grade: 0

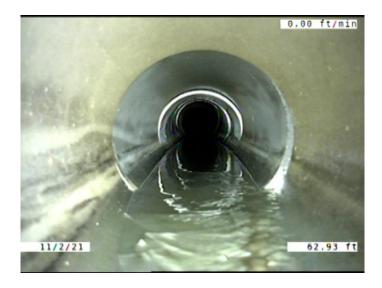
Code: MWLS

Description: Miscellaneous Water Level Sag

Distance (ft): 62.9
Structural Grade: 2
O&M Grade: 0

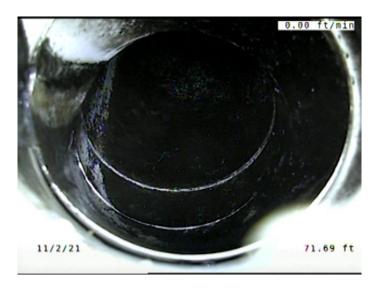
Code: **TF**

Description: Tap Factory

Distance (ft): 71.7
Structural Grade: 0

Remarks: CONSTANTLY RUNNING WATER.

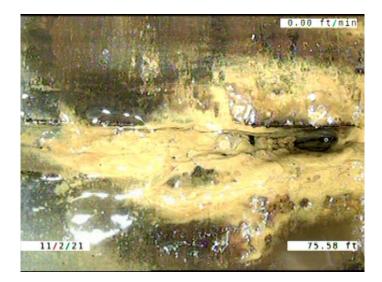
IRJ Code:

Description: **Infiltration Runner Joint**

Distance (ft): 75.6 Structural Grade: 0 O&M Grade: 4 Clock Start/From: 3

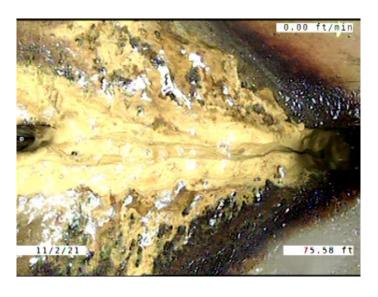
Code: DAE

Description: **Deposits Attached Encrustation**

Distance (ft): 75.6 Structural Grade: 0 O&M Grade: 2 Clock Start/From: 3 5 Clock To: 1st Value:

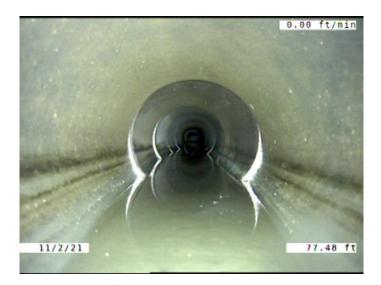
Code: **MWLS**

Description: **Miscellaneous Water Level Sag**

77.5 Distance (ft): Structural Grade: 2 0 O&M Grade:

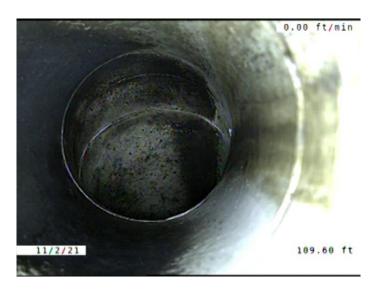
Code: TF

Description: Tap Factory

Distance (ft): 109.6
Structural Grade: 0

Remarks: CONSTANTLY RUNNING WATER.

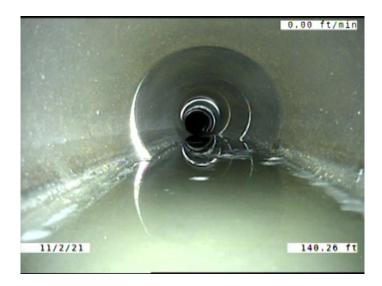
Code: **MWLS**

Description: **Miscellaneous Water Level Sag**

Distance (ft): 140.3 Structural Grade: 2 0 O&M Grade:

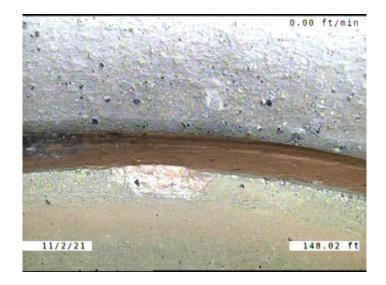
Code: SZ

Description: Surface Damage Other

Distance (ft): 148.0
Structural Grade: 0
O&M Grade: 0
Clock Start/From: 1

Remarks: A PIECE CHIPPED AWAY FROM THE

**JOINT**

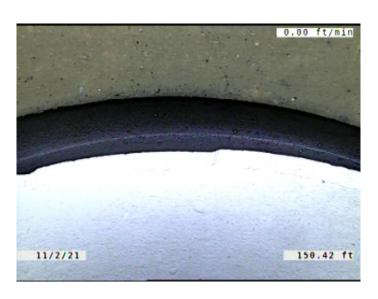
Code: **JOM**

Description: Joint Offset Medium

Distance (ft): 150.4
Structural Grade: 3
O&M Grade: 0

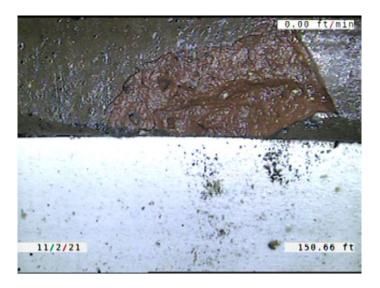
Code: SZ

Description: Surface Damage Other

Distance (ft): 150.7
Structural Grade: 0
O&M Grade: 0
Clock Start/From: 2
Clock To: 4
1st Value:

Remarks: A COUPLE PIECES CHIPPED AWAY

FROM THE JOINT

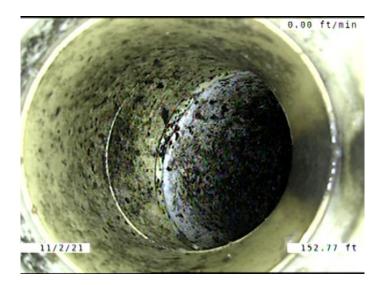
Code: **TF**

Description: Tap Factory

Distance (ft): 152.8
Structural Grade: 0
O&M Grade: 0
Clock Start/From: 1

Remarks: CONSTANTLY DRIPPING WATER.

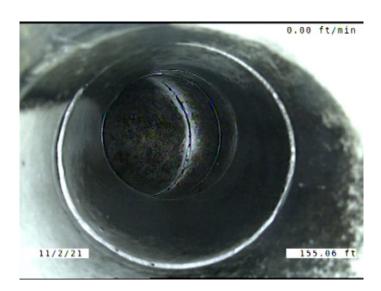
Code: TF

Description: Tap Factory

Distance (ft): 155.1
Structural Grade: 0
O&M Grade: 0
Clock Start/From: 11

Remarks: CONSTANTLY RUNNING WATER.

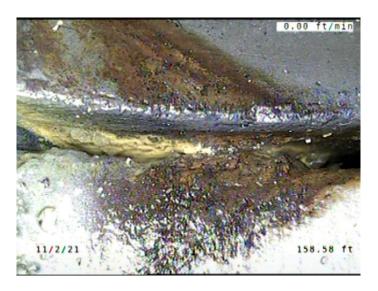
Code: DAE

Description: **Deposits Attached Encrustation**

Distance (ft): 158.6 Structural Grade: 0 O&M Grade: 2 Clock Start/From: 4 Clock To: 5 1st Value:

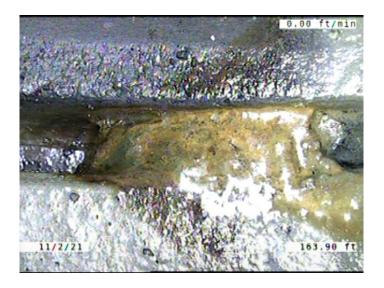
Code: DAE

Description: **Deposits Attached Encrustation**

Distance (ft): 163.9 Structural Grade: 0 2 O&M Grade: Clock Start/From: 7 Clock To: 8

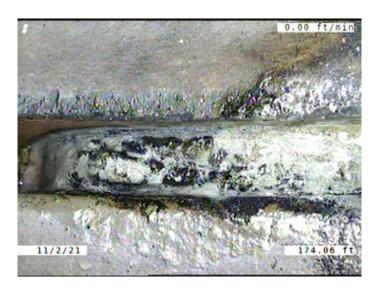
Code: DAE

Description: **Deposits Attached Encrustation**

Distance (ft): 174.1 Structural Grade: 0 O&M Grade: 2 Clock Start/From: 7 Clock To: 8 1st Value:

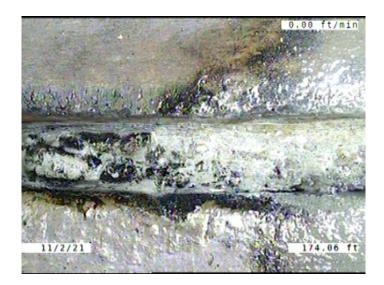
Code: IRJ

Description: Infiltration Runner Joint

Distance (ft): 174.1
Structural Grade: 0
O&M Grade: 4
Clock Start/From: 8

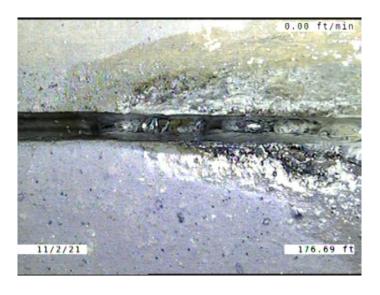
Code: IRJ

Description: Infiltration Runner Joint

Distance (ft): 176.7
Structural Grade: 0
O&M Grade: 4
Clock Start/From: 9

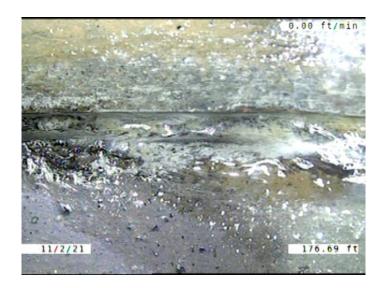
Code: DAE

Description: **Deposits Attached Encrustation**

Distance (ft): 176.7 Structural Grade: 0 2 O&M Grade: Clock Start/From: 7 Clock To: 9

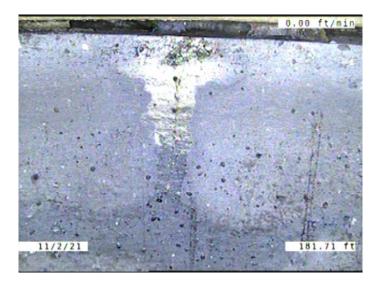
Code: CL

Description: **Crack Longitudinal**

Distance (ft): 181.7 Structural Grade: 2 O&M Grade: 0

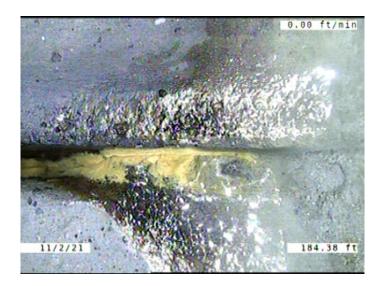
Code: DAE

Description: Deposits Attached Encrustation

Distance (ft): 184.4
Structural Grade: 0
O&M Grade: 2
Clock Start/From: 4
Clock To: 8

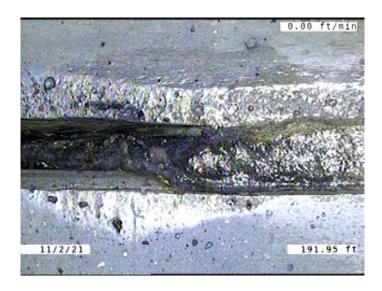
Code: DAE

Description: Deposits Attached Encrustation

Distance (ft): 191.9
Structural Grade: 0
O&M Grade: 2
Clock Start/From: 3
Clock To: 9
1st Value:

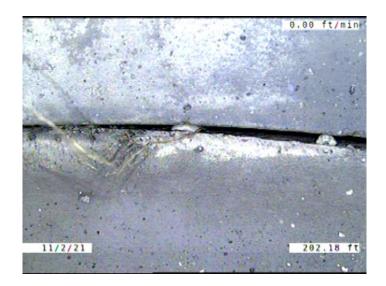
Code: RFJ

Description: Roots Fine Joint

Distance (ft): 202.2
Structural Grade: 0
O&M Grade: 1
Clock Start/From: 10
Clock To: 1

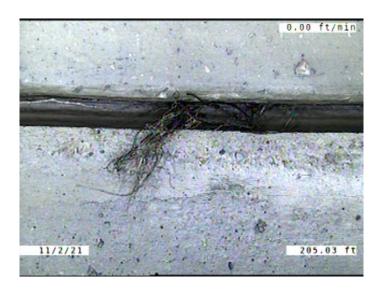
Code: RFJ

Description: Roots Fine Joint

Distance (ft): 205.0
Structural Grade: 0
O&M Grade: 1
Clock Start/From: 10
Clock To: 12
1st Value:
2nd Value:
