Profile/Photo Observation Report

Date:	11/02/2021	Weather:		Coding:	PACP 7.0
Pipe Length (ft):	213.2	Owner:	City of Hobart	Pre Clean:	Heavy Cleaning
P.O.#:	YES502259	Surveyor:	S. Bucklin	PSR:	P-504-039-038
Customer:	City of Hobart	Clean Date:	10/28/2021	Shape:	C

Street:	North Colorado Street	Flow Control:	Not Controlled
City:	Hobart, IN	Year Renewed:	
Location:	Alley	Tape/Media #:	
Purpose:	Routine Assessment	Dia/Height:	10"
Use:	Sanitary Sewage Pipe	Material:	VCP
Drain Area:		Lining:	None
Category:	NA		
Comment:			
Location Details:		Direction of Survey:	Downstream
US MH:	M-504-038	DS MH:	M-504-039
		Total Length Surveyed (ft):	213.2

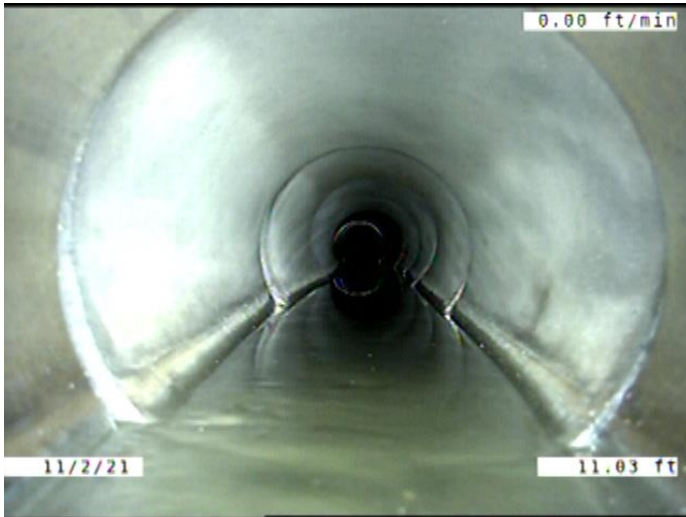
Code: **MWLS**
Description: **Miscellaneous Water Level Sag**

Distance (ft): **11.0**
Structural Grade: **2**
O&M Grade: **0**
Clock Start/From:
Clock To:
1st Value:
2nd Value:
Value Percent: **5.000**
Continuous Index: **S01**
Within 8" of Joint: **NO**
Remarks:

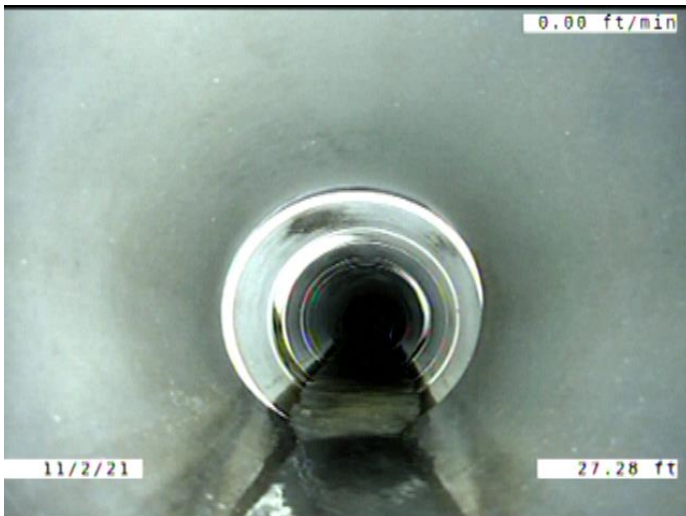
Code: **MWLS**
Description: **Miscellaneous Water Level Sag**

Distance (ft): **27.3**
Structural Grade: **2**
O&M Grade: **0**
Clock Start/From:
Clock To:
1st Value:
2nd Value:
Value Percent: **5.000**
Continuous Index: **F01**
Within 8" of Joint: **NO**
Remarks:

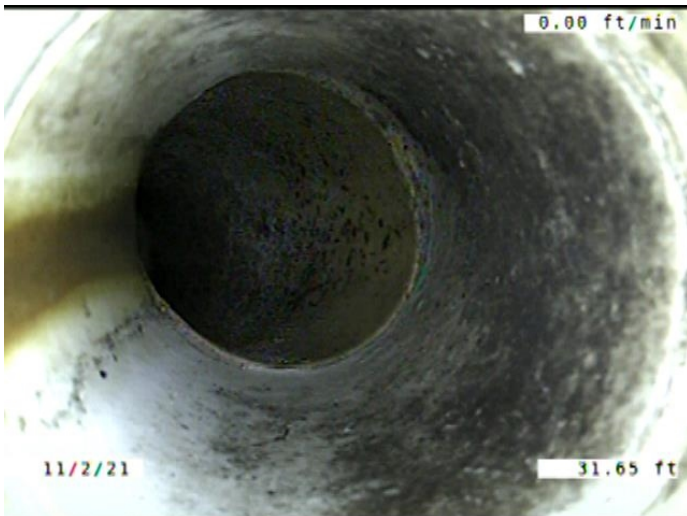
Code: **TF**
Description: **Tap Factory**

Distance (ft): **31.6**
Structural Grade: **0**
O&M Grade: **0**
Clock Start/From: **11**
Clock To:
1st Value: **4.000**
2nd Value:
Value Percent:
Continuous Index:
Within 8" of Joint: **YES**
Remarks: **CONSTANTLY RUNNING WATER.**

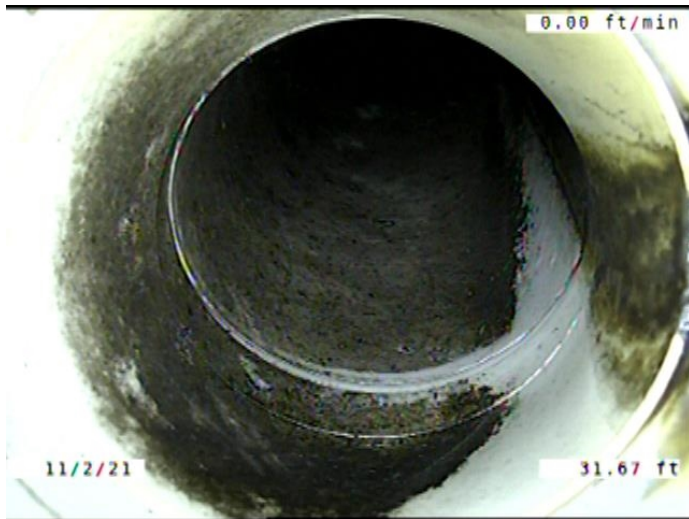
Code: **TF**
Description: **Tap Factory**

Distance (ft): **31.7**
Structural Grade: **0**
O&M Grade: **0**
Clock Start/From: **2**
Clock To:
1st Value: **4.000**
2nd Value:
Value Percent:
Continuous Index:
Within 8" of Joint: **YES**
Remarks: **CONSTANTLY RUNNING WATER.**

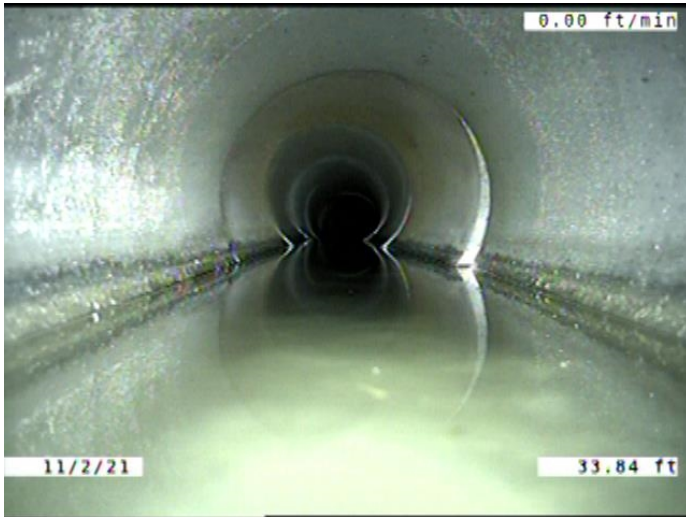
Code: **MWLS**
Description: **Miscellaneous Water Level Sag**

Distance (ft): **33.8**
Structural Grade: **2**
O&M Grade: **0**
Clock Start/From:
Clock To:
1st Value:
2nd Value:
Value Percent: **10.000**
Continuous Index: **S02**
Within 8" of Joint: **NO**
Remarks:

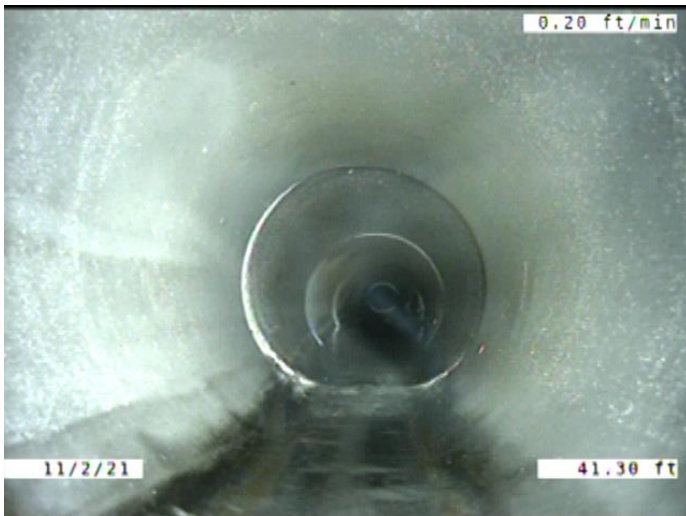
Code: **MWLS**
Description: **Miscellaneous Water Level Sag**

Distance (ft): **41.3**
Structural Grade: **2**
O&M Grade: **0**
Clock Start/From:
Clock To:
1st Value:
2nd Value:
Value Percent: **10.000**
Continuous Index: **F02**
Within 8" of Joint: **NO**
Remarks:

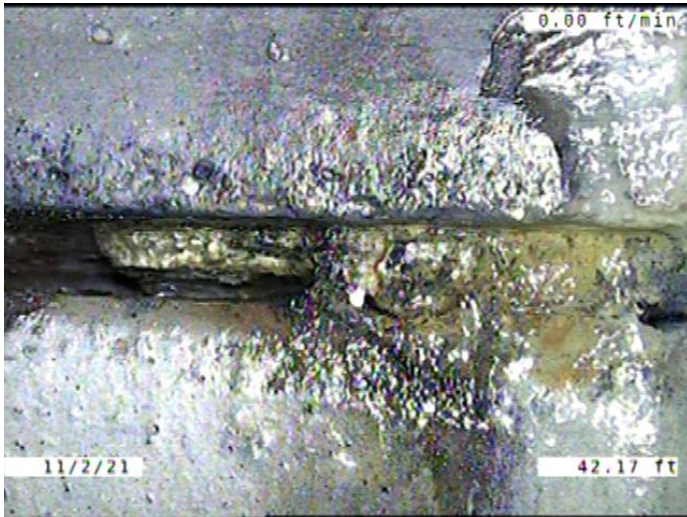
Code:	DAE
Description:	Deposits Attached Encrustation
Distance (ft):	42.2
Structural Grade:	0
O&M Grade:	2
Clock Start/From:	3
Clock To:	8
1st Value:	
2nd Value:	
Value Percent:	5.000
Continuous Index:	
Within 8" of Joint:	YES
Remarks:

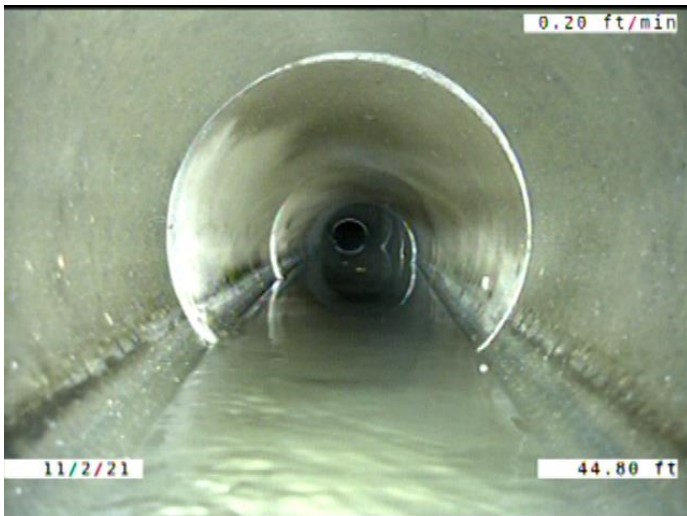
Code:	MWLS
Description:	Miscellaneous Water Level Sag
Distance (ft):	44.8
Structural Grade:	2
O&M Grade:	0
Clock Start/From:	
Clock To:	
1st Value:	
2nd Value:	
Value Percent:	15.000
Continuous Index:	S03
Within 8" of Joint:	NO
Remarks:

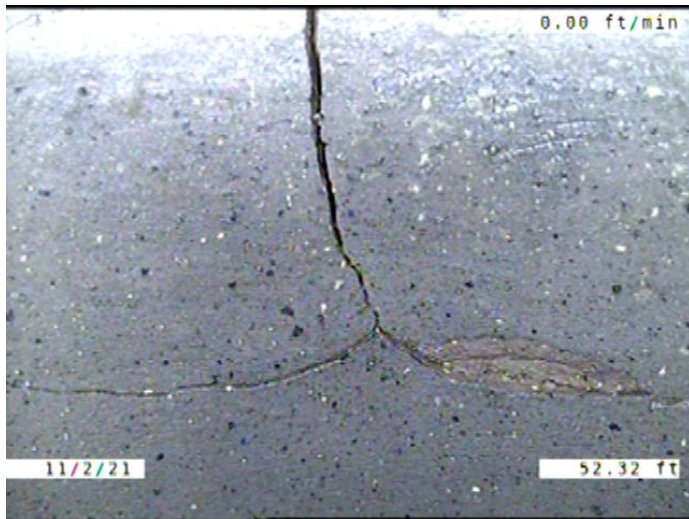
Code: **B**
 Description: **Broken**

Distance (ft): **52.3**
 Structural Grade: **4**
 O&M Grade: **0**
 Clock Start/From: **9**
 Clock To: **2**
 1st Value:
 2nd Value:
 Value Percent:
 Continuous Index:
 Within 8" of Joint: **YES**
 Remarks:

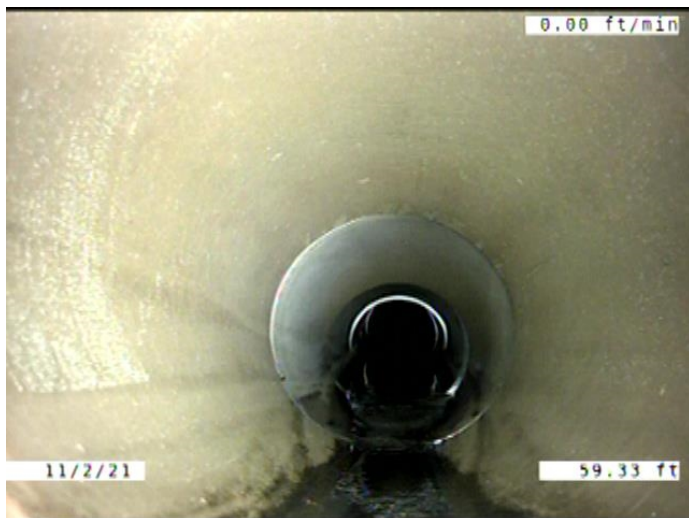
Code: **MWLS**
 Description: **Miscellaneous Water Level Sag**

Distance (ft): **59.3**
 Structural Grade: **2**
 O&M Grade: **0**
 Clock Start/From:
 Clock To:
 1st Value:
 2nd Value:
 Value Percent: **15.000**
 Continuous Index: **F03**
 Within 8" of Joint: **NO**
 Remarks:

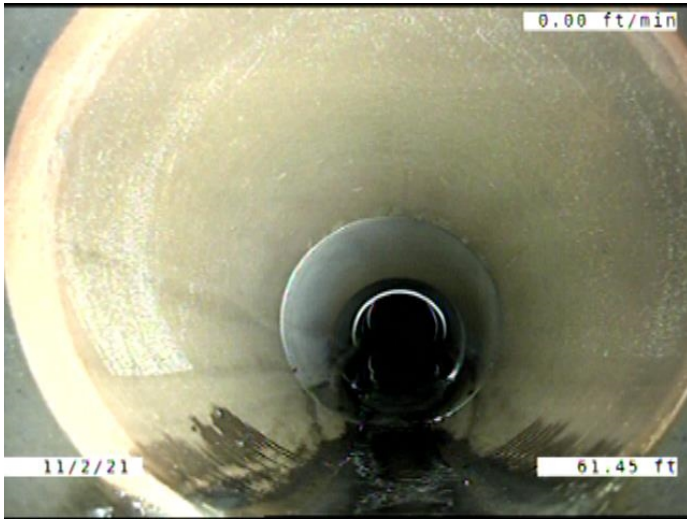
Code: **LD**
Description: **Line Down**

Distance (ft): **61.4**
Structural Grade: **0**
O&M Grade: **1**
Clock Start/From:
Clock To:
1st Value:
2nd Value:
Value Percent: **10.000**
Continuous Index:
Within 8" of Joint: **NO**
Remarks:

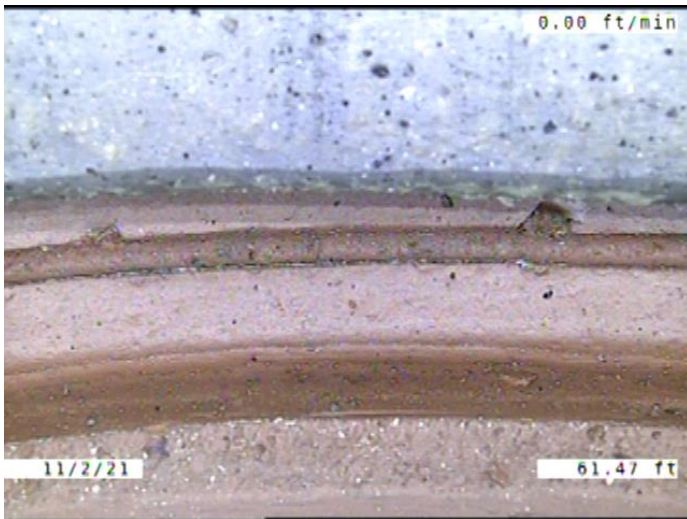
Code: **JAM**
Description: **Joint Angular Medium**

Distance (ft): **61.5**
Structural Grade: **3**
O&M Grade: **0**
Clock Start/From:
Clock To:
1st Value:
2nd Value:
Value Percent:
Continuous Index:
Within 8" of Joint: **NO**
Remarks:

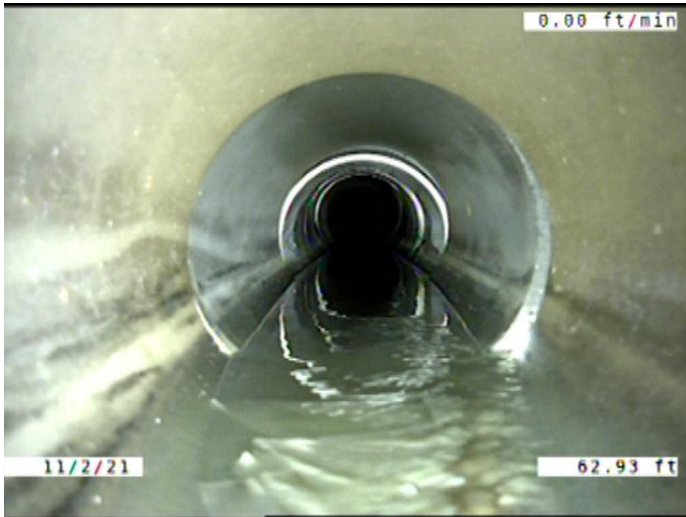
Code: **MWLS**
Description: **Miscellaneous Water Level Sag**

Distance (ft): **62.9**
Structural Grade: **2**
O&M Grade: **0**
Clock Start/From:
Clock To:
1st Value:
2nd Value:
Value Percent: **5.000**
Continuous Index: **S04**
Within 8" of Joint: **NO**
Remarks:

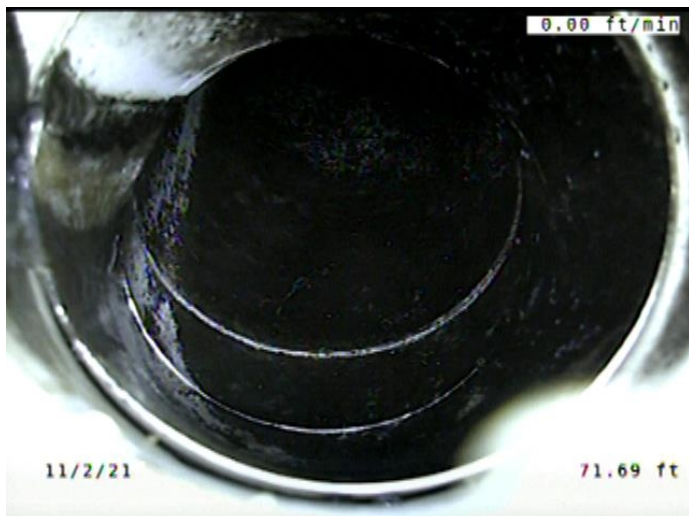
Code: **TF**
 Description: **Tap Factory**

Distance (ft): **71.7**
 Structural Grade: **0**
 O&M Grade: **0**
 Clock Start/From: **10**
 Clock To:
 1st Value: **4.000**
 2nd Value:
 Value Percent:
 Continuous Index:
 Within 8" of Joint: **YES**
 Remarks: **CONSTANTLY RUNNING WATER.**

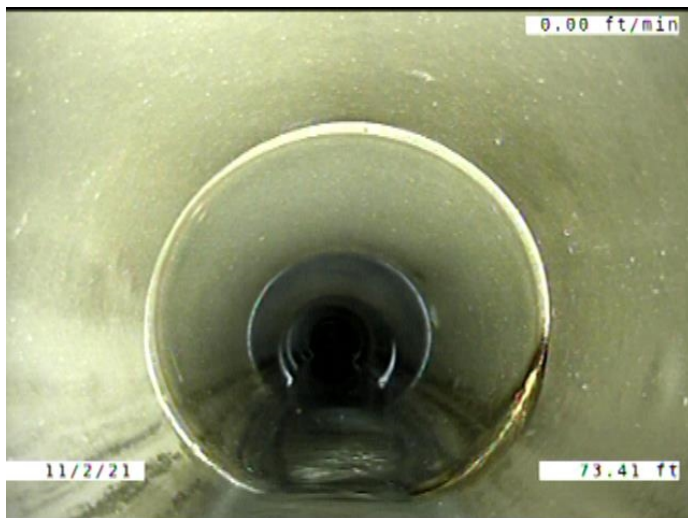
Code: **MWLS**
Description: **Miscellaneous Water Level Sag**

Distance (ft): **73.4**
Structural Grade: **2**
O&M Grade: **0**
Clock Start/From:
Clock To:
1st Value:
2nd Value:
Value Percent: **5.000**
Continuous Index: **F04**
Within 8" of Joint: **NO**
Remarks:

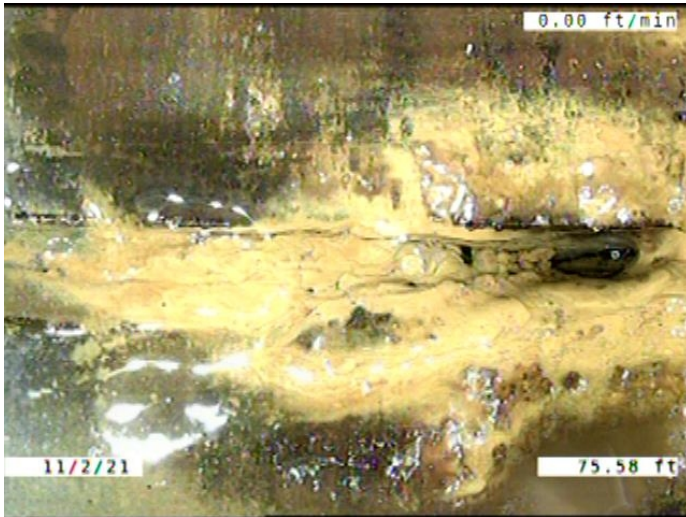
Code: **IRJ**
 Description: **Infiltration Runner Joint**

Distance (ft): **75.6**
 Structural Grade: **0**
 O&M Grade: **4**
 Clock Start/From: **3**
 Clock To:
 1st Value:
 2nd Value:
 Value Percent:
 Continuous Index:
 Within 8" of Joint: **YES**
 Remarks:

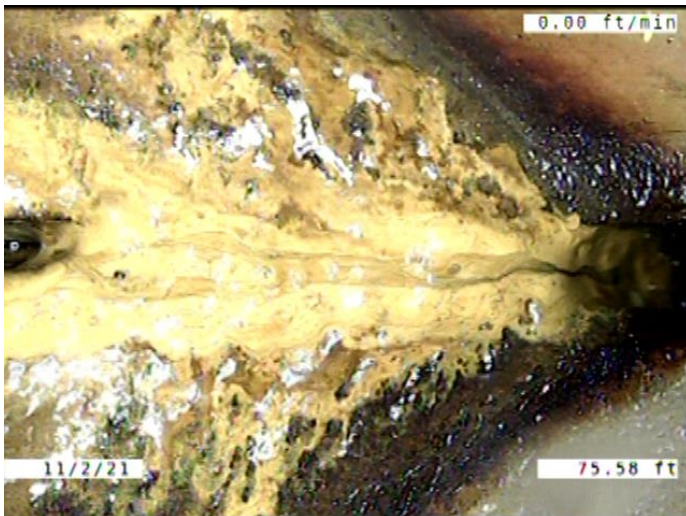
Code: **DAE**
 Description: **Deposits Attached Encrustation**

Distance (ft): **75.6**
 Structural Grade: **0**
 O&M Grade: **2**
 Clock Start/From: **3**
 Clock To: **5**
 1st Value:
 2nd Value:
 Value Percent: **5.000**
 Continuous Index:
 Within 8" of Joint: **YES**
 Remarks:

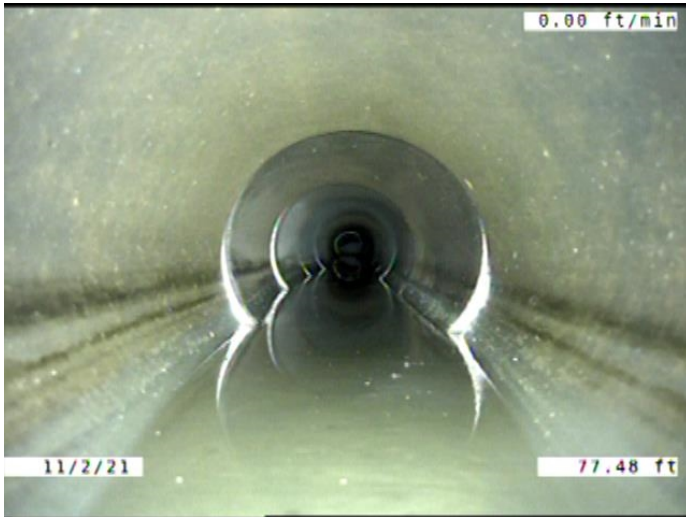
Code: **MWLS**
 Description: **Miscellaneous Water Level Sag**

Distance (ft): **77.5**
 Structural Grade: **2**
 O&M Grade: **0**
 Clock Start/From:
 Clock To:
 1st Value:
 2nd Value:
 Value Percent: **10.000**
 Continuous Index: **S05**
 Within 8" of Joint: **NO**
 Remarks:

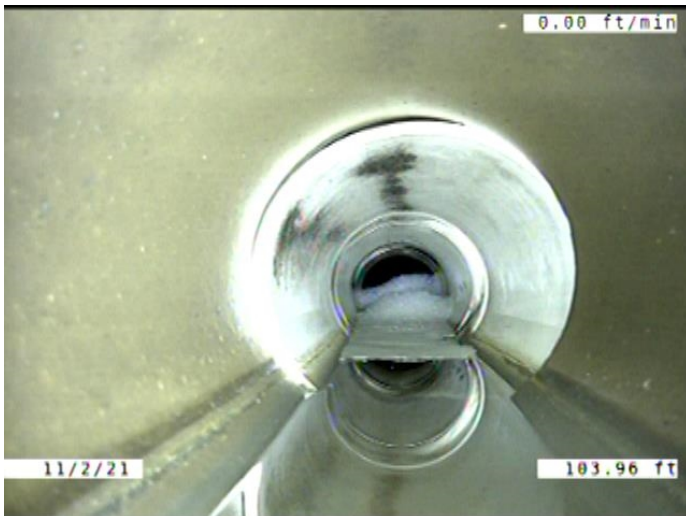
Code: **MWLS**
 Description: **Miscellaneous Water Level Sag**

Distance (ft): **104.0**
 Structural Grade: **2**
 O&M Grade: **0**
 Clock Start/From:
 Clock To:
 1st Value:
 2nd Value:
 Value Percent: **10.000**
 Continuous Index: **F05**
 Within 8" of Joint: **NO**
 Remarks:

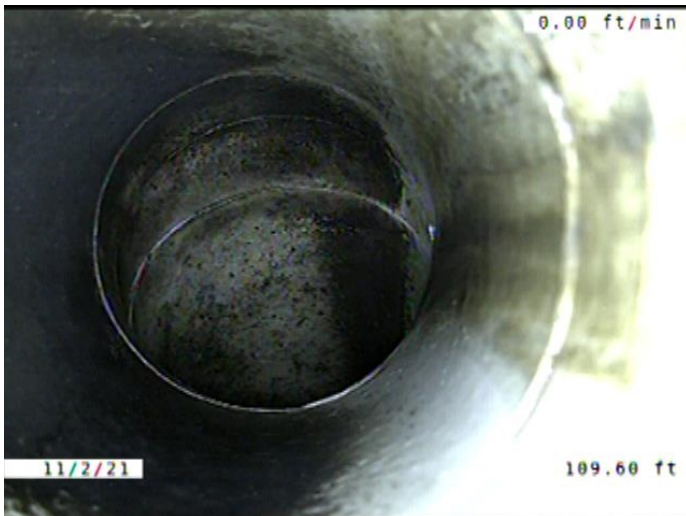
Code: **TF**
Description: **Tap Factory**

Distance (ft): **109.6**
Structural Grade: **0**
O&M Grade: **0**
Clock Start/From: **2**
Clock To:
1st Value: **4.000**
2nd Value:
Value Percent:
Continuous Index:
Within 8" of Joint: **YES**
Remarks: **CONSTANTLY RUNNING WATER.**

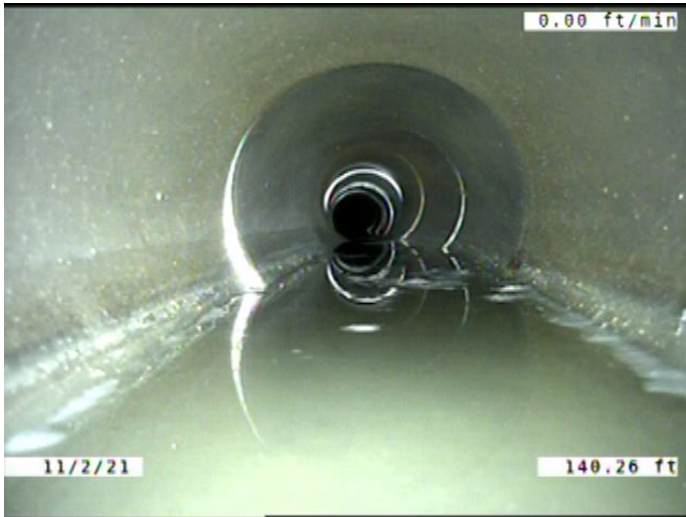
Code: **MWLS**
Description: **Miscellaneous Water Level Sag**

Distance (ft): **140.3**
Structural Grade: **2**
O&M Grade: **0**
Clock Start/From:
Clock To:
1st Value:
2nd Value:
Value Percent: **5.000**
Continuous Index: **S06**
Within 8" of Joint: **NO**
Remarks:

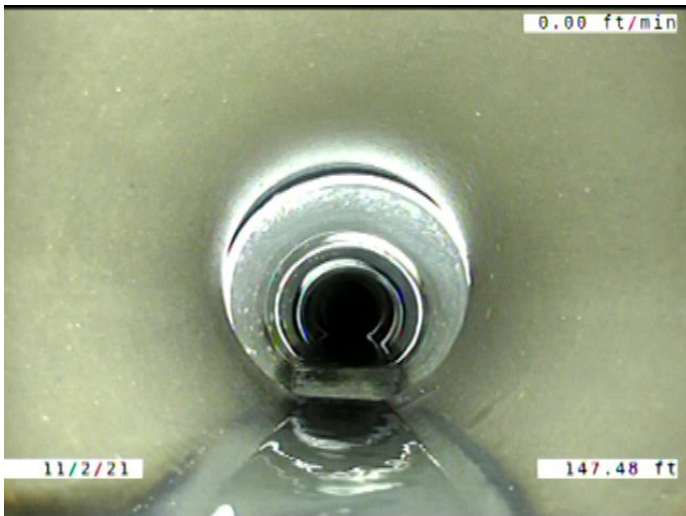
Code: **MWLS**
Description: **Miscellaneous Water Level Sag**

Distance (ft): **147.5**
Structural Grade: **2**
O&M Grade: **0**
Clock Start/From:
Clock To:
1st Value:
2nd Value:
Value Percent: **5.000**
Continuous Index: **F06**
Within 8" of Joint: **NO**
Remarks:

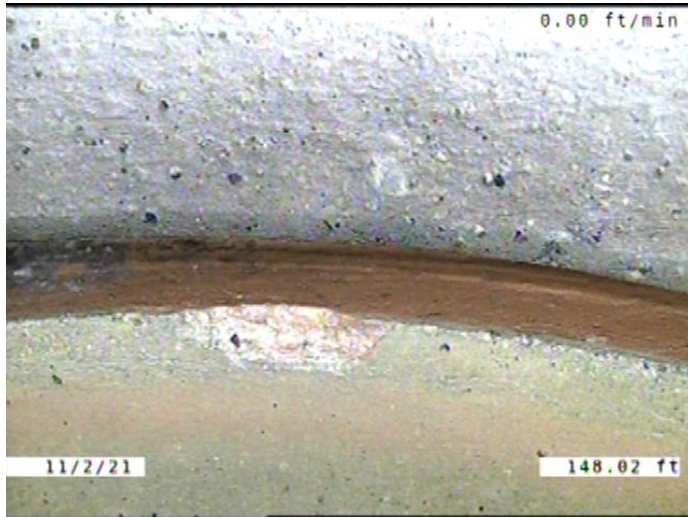
Code: **SZ**
Description: **Surface Damage Other**

Distance (ft): **148.0**
Structural Grade: **0**
O&M Grade: **0**
Clock Start/From: **1**
Clock To:
1st Value:
2nd Value:
Value Percent:
Continuous Index:
Within 8" of Joint: **YES**
Remarks: **A PIECE CHIPPED AWAY FROM THE JOINT**

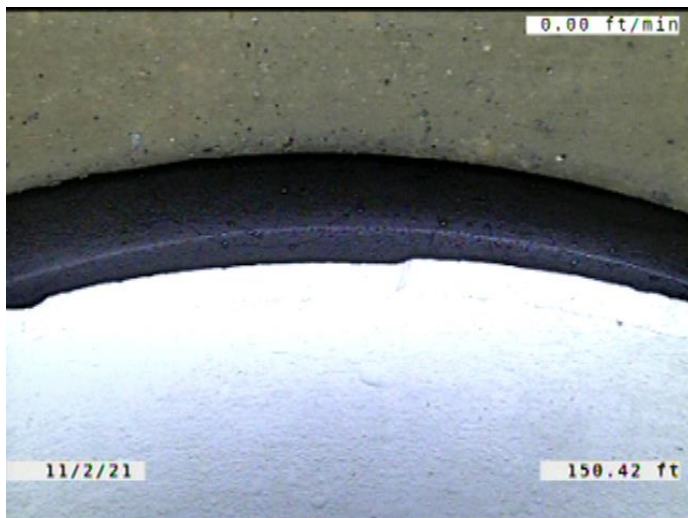
Code: **JOM**
Description: **Joint Offset Medium**

Distance (ft): **150.4**
Structural Grade: **3**
O&M Grade: **0**
Clock Start/From:
Clock To:
1st Value:
2nd Value:
Value Percent:
Continuous Index:
Within 8" of Joint: **NO**
Remarks:

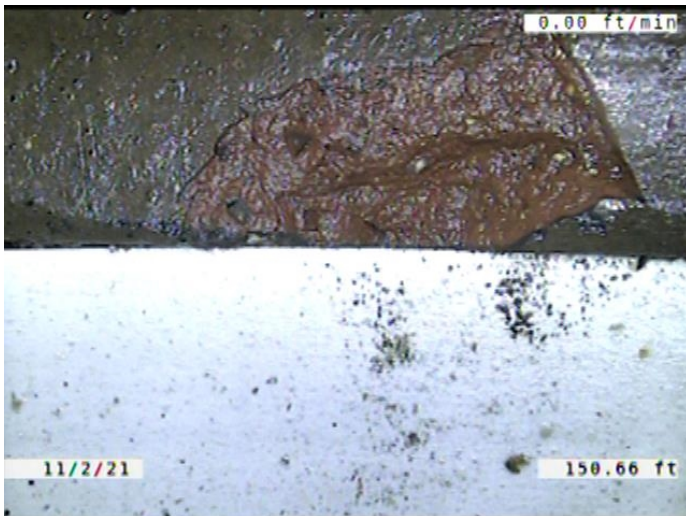
Code: **SZ**
Description: **Surface Damage Other**

Distance (ft): **150.7**
Structural Grade: **0**
O&M Grade: **0**
Clock Start/From: **2**
Clock To: **4**
1st Value:
2nd Value:
Value Percent:
Continuous Index:
Within 8" of Joint: **YES**
Remarks: **A COUPLE PIECES CHIPPED AWAY FROM THE JOINT**

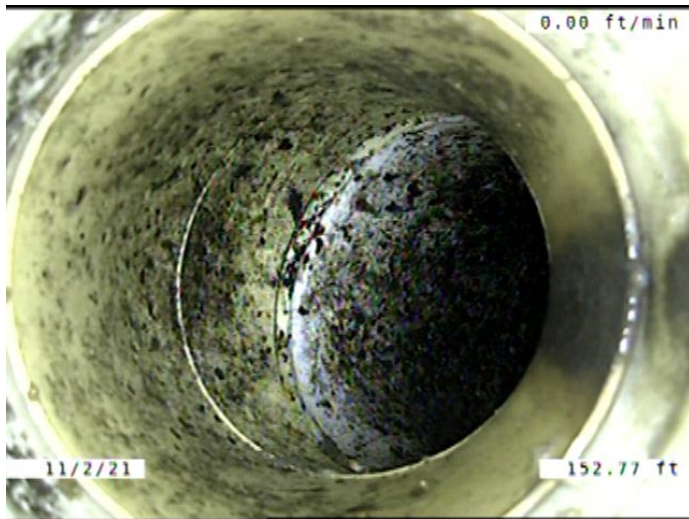
Code: **TF**
Description: **Tap Factory**

Distance (ft): **152.8**
Structural Grade: **0**
O&M Grade: **0**
Clock Start/From: **1**
Clock To:
1st Value: **4.000**
2nd Value:
Value Percent:
Continuous Index:
Within 8" of Joint: **YES**
Remarks: **CONSTANTLY DRIPPING WATER.**

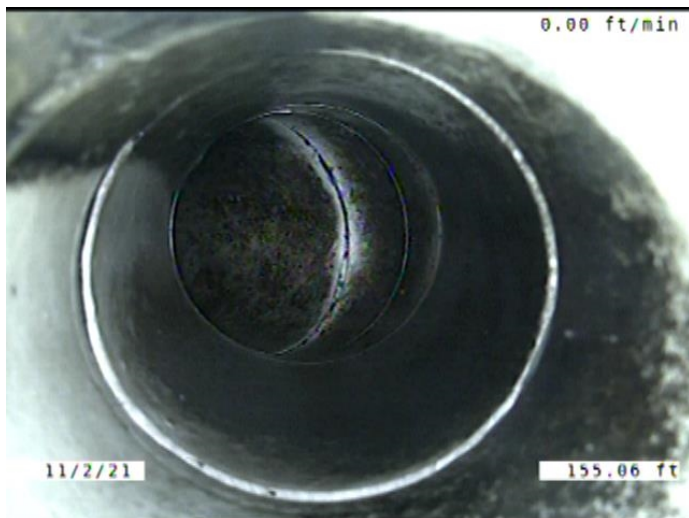
Code: **TF**
Description: **Tap Factory**

Distance (ft): **155.1**
Structural Grade: **0**
O&M Grade: **0**
Clock Start/From: **11**
Clock To:
1st Value: **4.000**
2nd Value:
Value Percent:
Continuous Index:
Within 8" of Joint: **YES**
Remarks: **CONSTANTLY RUNNING WATER.**

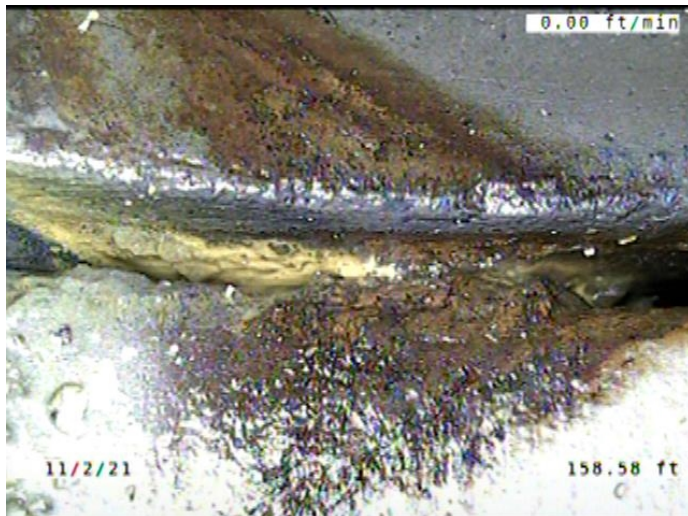
Code: **DAE**
Description: **Deposits Attached Encrustation**

Distance (ft): **158.6**
Structural Grade: **0**
O&M Grade: **2**
Clock Start/From: **4**
Clock To: **5**
1st Value:
2nd Value:
Value Percent: **5.000**
Continuous Index:
Within 8" of Joint: **YES**
Remarks:

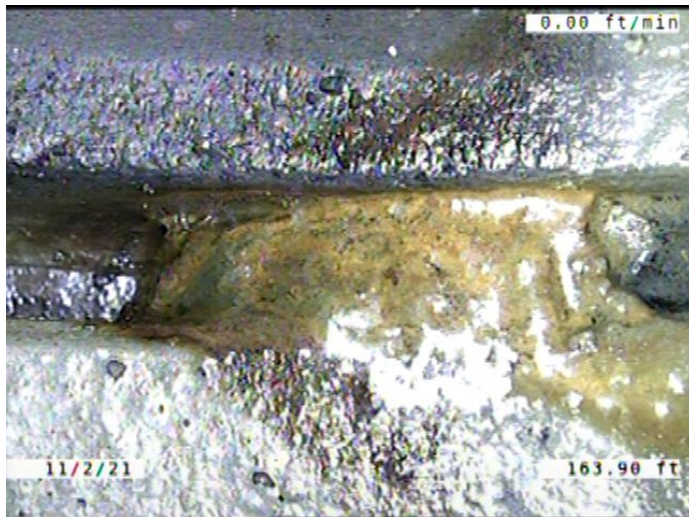
Code: **DAE**
 Description: **Deposits Attached Encrustation**

Distance (ft): **163.9**
 Structural Grade: **0**
 O&M Grade: **2**
 Clock Start/From: **7**
 Clock To: **8**
 1st Value:
 2nd Value:
 Value Percent: **5.000**
 Continuous Index:
 Within 8" of Joint: **YES**
 Remarks:

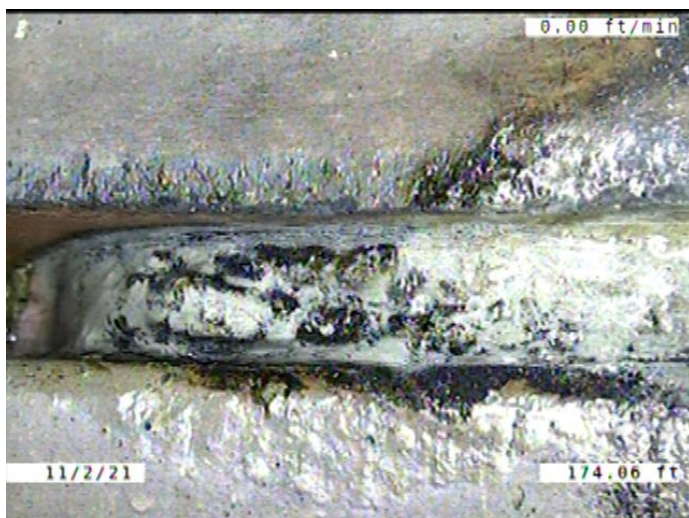
Code: **DAE**
 Description: **Deposits Attached Encrustation**

Distance (ft): **174.1**
 Structural Grade: **0**
 O&M Grade: **2**
 Clock Start/From: **7**
 Clock To: **8**
 1st Value:
 2nd Value:
 Value Percent: **5.000**
 Continuous Index:
 Within 8" of Joint: **YES**
 Remarks:

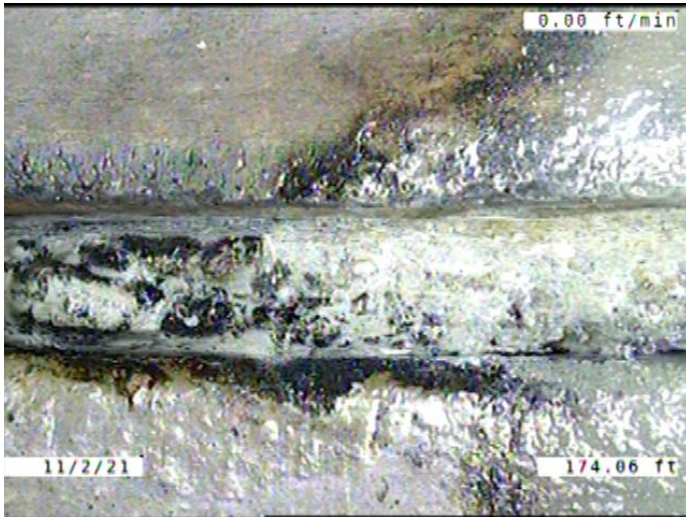
Code: **IRJ**
 Description: **Infiltration Runner Joint**

Distance (ft): **174.1**
 Structural Grade: **0**
 O&M Grade: **4**
 Clock Start/From: **8**
 Clock To:
 1st Value:
 2nd Value:
 Value Percent:
 Continuous Index:
 Within 8" of Joint: **YES**
 Remarks:

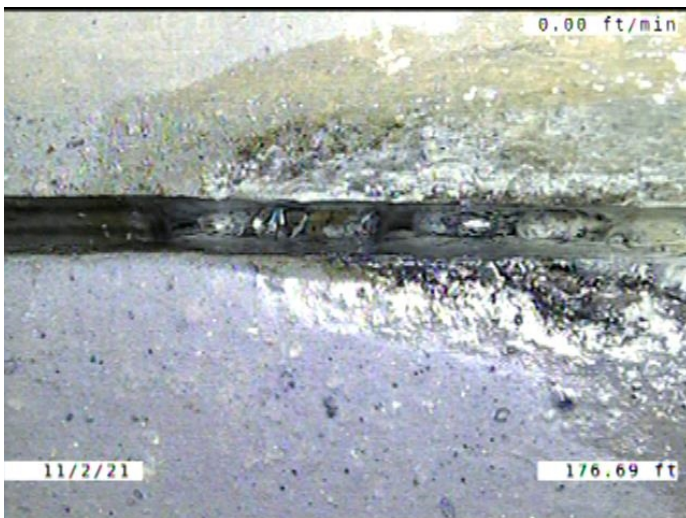
Code: **IRJ**
 Description: **Infiltration Runner Joint**

Distance (ft): **176.7**
 Structural Grade: **0**
 O&M Grade: **4**
 Clock Start/From: **9**
 Clock To:
 1st Value:
 2nd Value:
 Value Percent:
 Continuous Index:
 Within 8" of Joint: **YES**
 Remarks:

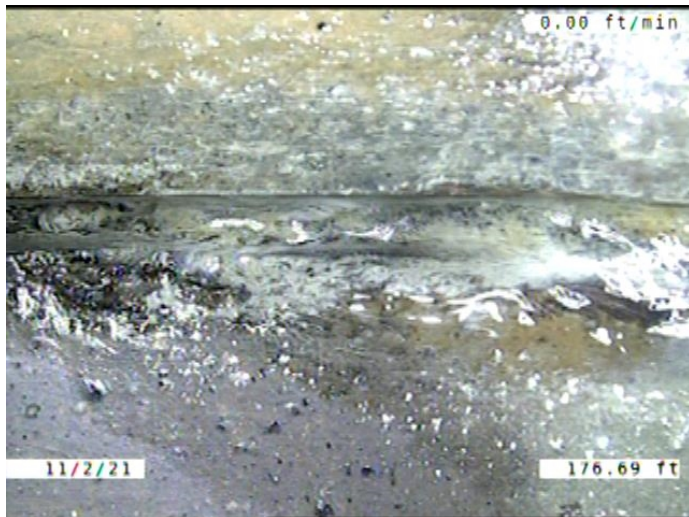
Code: **DAE**
 Description: **Deposits Attached Encrustation**

Distance (ft): **176.7**
 Structural Grade: **0**
 O&M Grade: **2**
 Clock Start/From: **7**
 Clock To: **9**
 1st Value:
 2nd Value:
 Value Percent: **5.000**
 Continuous Index:
 Within 8" of Joint: **YES**
 Remarks:

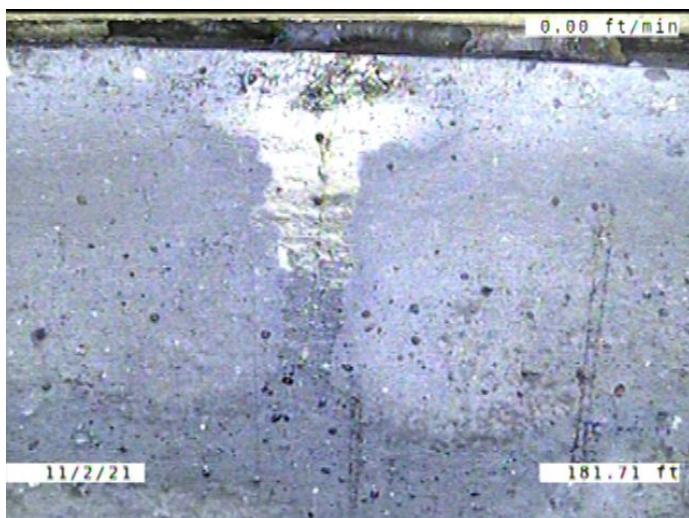
Code: **CL**
 Description: **Crack Longitudinal**

Distance (ft): **181.7**
 Structural Grade: **2**
 O&M Grade: **0**
 Clock Start/From: **12**
 Clock To:
 1st Value:
 2nd Value:
 Value Percent:
 Continuous Index:
 Within 8" of Joint: **YES**
 Remarks:

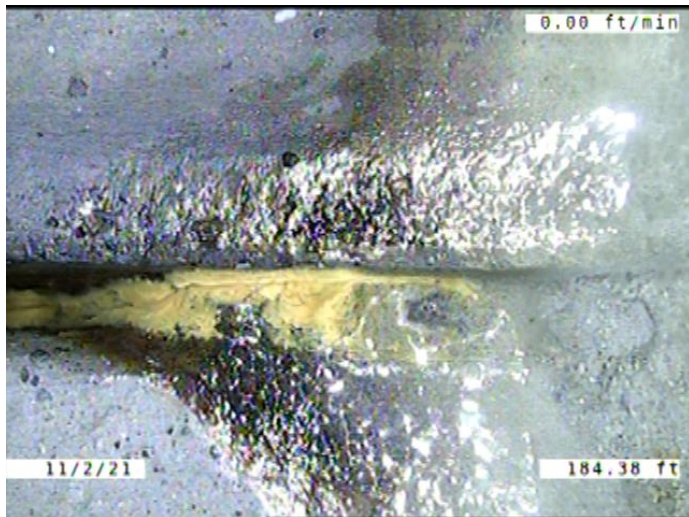
Code: **DAE**
 Description: **Deposits Attached Encrustation**

Distance (ft): **184.4**
 Structural Grade: **0**
 O&M Grade: **2**
 Clock Start/From: **4**
 Clock To: **8**
 1st Value:
 2nd Value:
 Value Percent: **5.000**
 Continuous Index:
 Within 8" of Joint: **YES**
 Remarks:

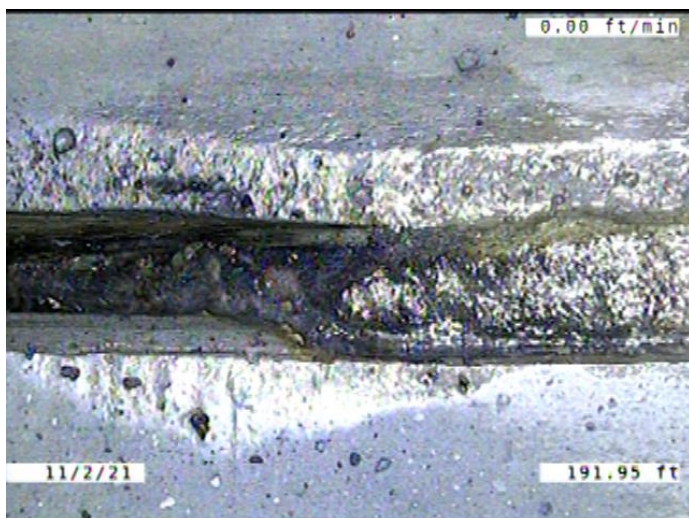
Code: **DAE**
 Description: **Deposits Attached Encrustation**

Distance (ft): **191.9**
 Structural Grade: **0**
 O&M Grade: **2**
 Clock Start/From: **3**
 Clock To: **9**
 1st Value:
 2nd Value:
 Value Percent: **5.000**
 Continuous Index:
 Within 8" of Joint: **YES**
 Remarks:

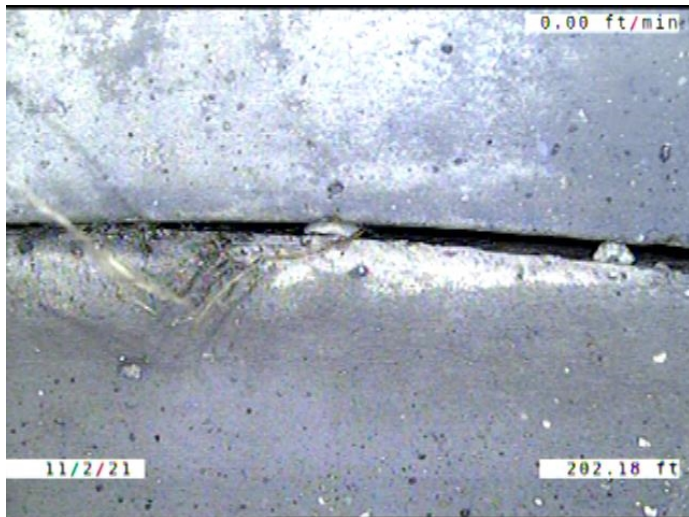
Code: **RFJ**
 Description: **Roots Fine Joint**

Distance (ft): **202.2**
 Structural Grade: **0**
 O&M Grade: **1**
 Clock Start/From: **10**
 Clock To: **1**
 1st Value:
 2nd Value:
 Value Percent:
 Continuous Index:
 Within 8" of Joint: **YES**
 Remarks:

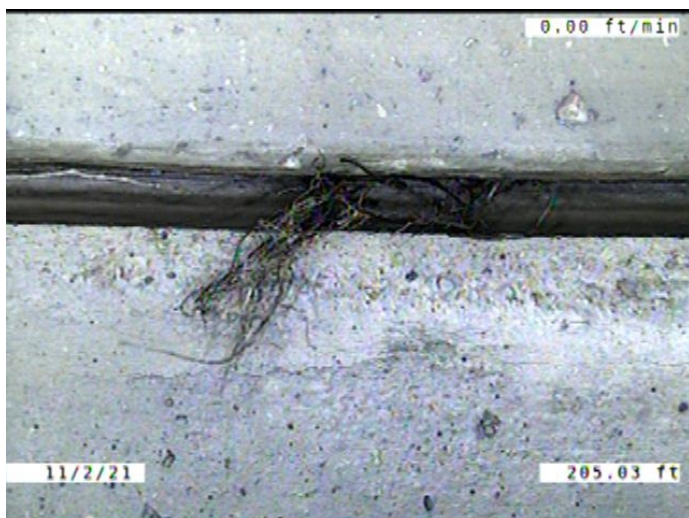
Code: **RFJ**
 Description: **Roots Fine Joint**

Distance (ft): **205.0**
 Structural Grade: **0**
 O&M Grade: **1**
 Clock Start/From: **10**
 Clock To: **12**
 1st Value:
 2nd Value:
 Value Percent:
 Continuous Index:
 Within 8" of Joint: **YES**
 Remarks:
