Profile/Photo Observation Report

Date:	11/02/2021	Weather:		Coding:	PACP 7.0
Pipe Length (ft):	215.2	Owner:	City of Hobart	Pre Clean:	Heavy Cleaning
P.O.#:	YES502259	Surveyor:	S. Bucklin	PSR:	P-504-040-039
Customer:	City of Hobart	Clean Date:	10/28/2021	Shape:	C

Street:	North Cavender Street	Flow Control:	Not Controlled
City:	Hobart, IN	Year Renewed:	
Location:	Alley	Tape/Media #:	
Purpose:	Routine Assessment	Dia/Height:	10"
Use:	Sanitary Sewage Pipe	Material:	VCP
Drain Area:		Lining:	None
Category:	NA		
Comment:			
Location Details:		Direction of Survey:	Downstream
US MH:	M-504-039	DS MH:	M-504-040
		Total Length Surveyed (ft):	215.2

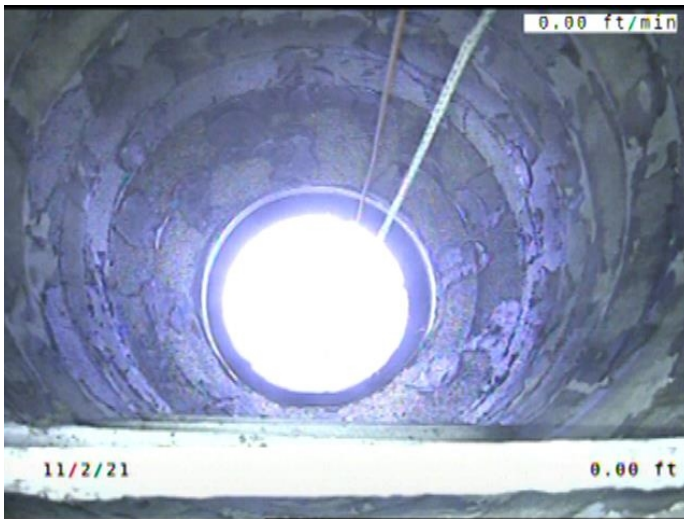
Code: **AMH**
Description: **Manhole**

Distance (ft): **.0**
Structural Grade: **0**
O&M Grade: **0**
Clock Start/From:
Clock To:
1st Value:
2nd Value:
Value Percent:
Continuous Index:
Within 8" of Joint: **NO**
Remarks: **M-504-039**

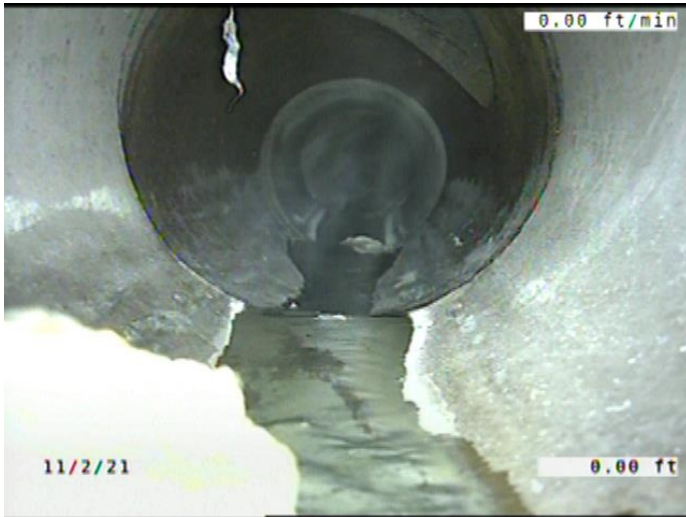
Code: **MWL**
 Description: **Miscellaneous Water Level**

Distance (ft): **.0**
 Structural Grade: **0**
 O&M Grade: **0**
 Clock Start/From:
 Clock To:
 1st Value:
 2nd Value:
 Value Percent: **5.000**
 Continuous Index:
 Within 8" of Joint: **NO**
 Remarks:

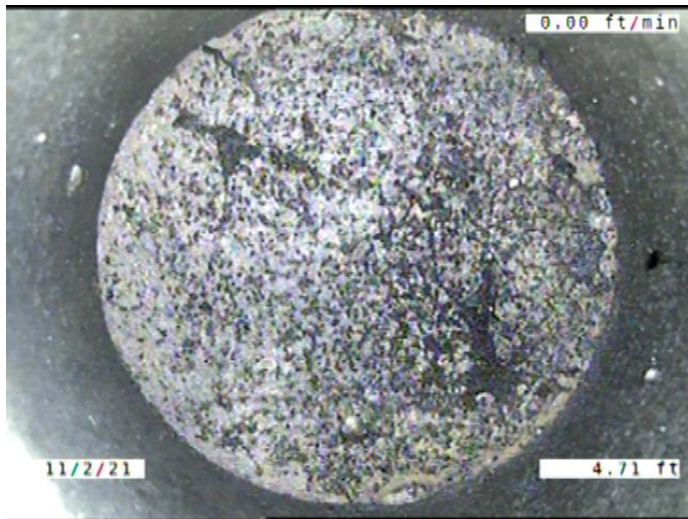
Code: **TFC**
 Description: **Tap Factory Capped**

Distance (ft): **4.7**
 Structural Grade: **0**
 O&M Grade: **0**
 Clock Start/From: **11**
 Clock To:
 1st Value: **4.000**
 2nd Value:
 Value Percent:
 Continuous Index:
 Within 8" of Joint: **YES**
 Remarks:

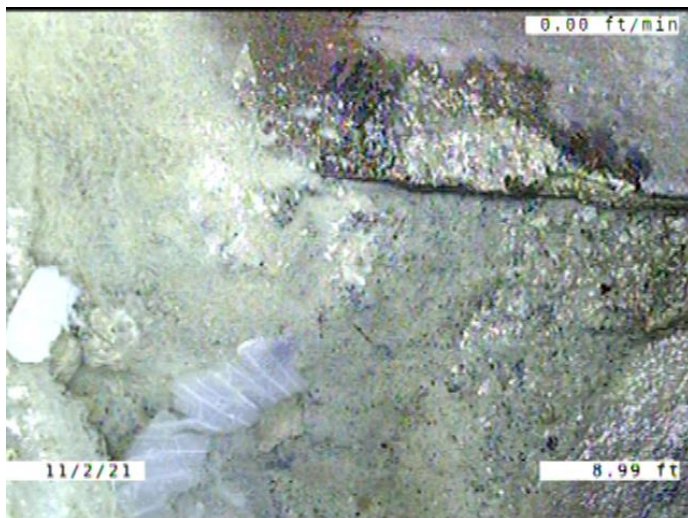
Code: **DAE**
 Description: **Deposits Attached Encrustation**

Distance (ft): **9.0**
 Structural Grade: **0**
 O&M Grade: **2**
 Clock Start/From: **3**
 Clock To: **9**
 1st Value:
 2nd Value:
 Value Percent: **5.000**
 Continuous Index:
 Within 8" of Joint: **YES**
 Remarks:

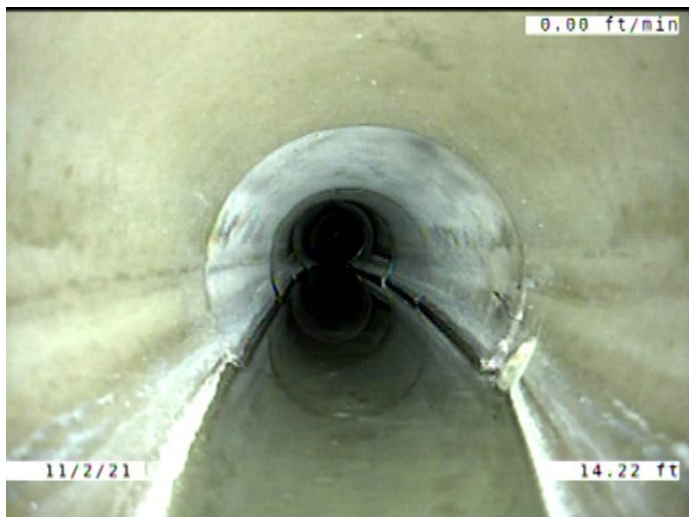
Code: **MWLS**
 Description: **Miscellaneous Water Level Sag**

Distance (ft): **14.2**
 Structural Grade: **2**
 O&M Grade: **0**
 Clock Start/From:
 Clock To:
 1st Value:
 2nd Value:
 Value Percent: **5.000**
 Continuous Index: **S02**
 Within 8" of Joint: **NO**
 Remarks:

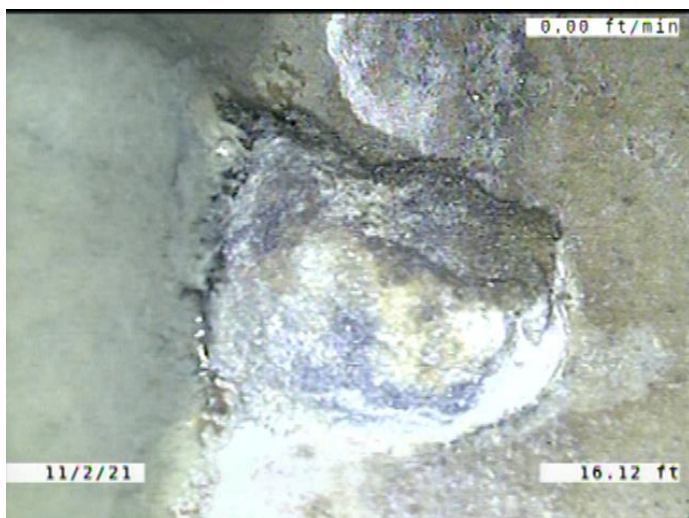
Code: **DAE**
 Description: **Deposits Attached Encrustation**

Distance (ft): **16.1**
 Structural Grade: **0**
 O&M Grade: **2**
 Clock Start/From: **4**
 Clock To:
 1st Value:
 2nd Value:
 Value Percent: **5.000**
 Continuous Index:
 Within 8" of Joint: **YES**
 Remarks:

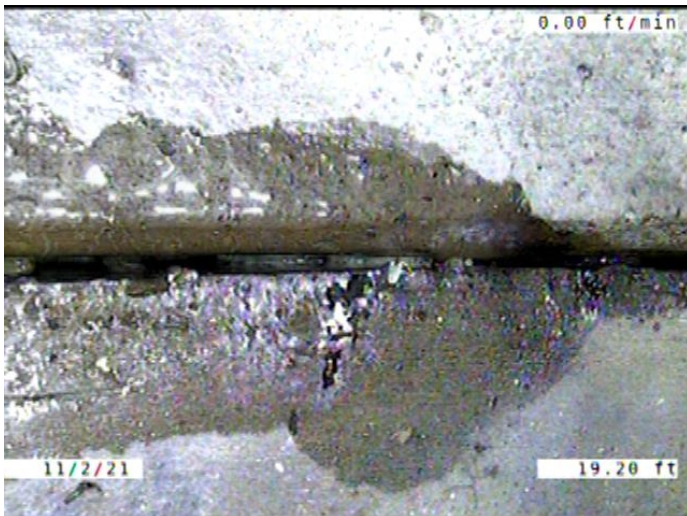
Code: **IRJ**
Description: **Infiltration Runner Joint**

Distance (ft): **19.2**
Structural Grade: **0**
O&M Grade: **4**
Clock Start/From: **10**
Clock To:
1st Value:
2nd Value:
Value Percent:
Continuous Index:
Within 8" of Joint: **YES**
Remarks:

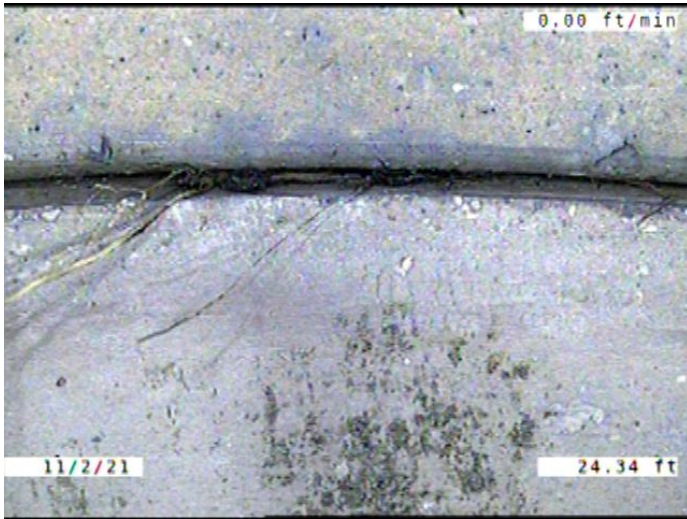
Code: **RFJ**
 Description: **Roots Fine Joint**

Distance (ft): **24.3**
 Structural Grade: **0**
 O&M Grade: **1**
 Clock Start/From: **11**
 Clock To: **12**
 1st Value:
 2nd Value:
 Value Percent:
 Continuous Index:
 Within 8" of Joint: **YES**
 Remarks:

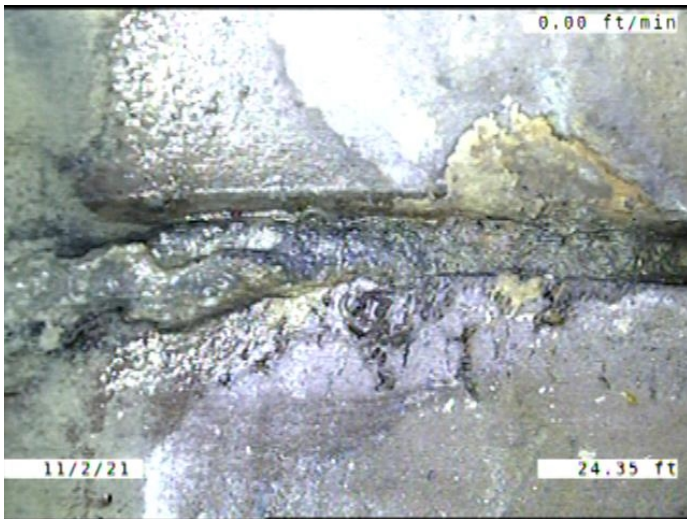
Code: **DAE**
 Description: **Deposits Attached Encrustation**

Distance (ft): **24.3**
 Structural Grade: **0**
 O&M Grade: **2**
 Clock Start/From: **4**
 Clock To: **8**
 1st Value:
 2nd Value:
 Value Percent: **5.000**
 Continuous Index:
 Within 8" of Joint: **YES**
 Remarks:

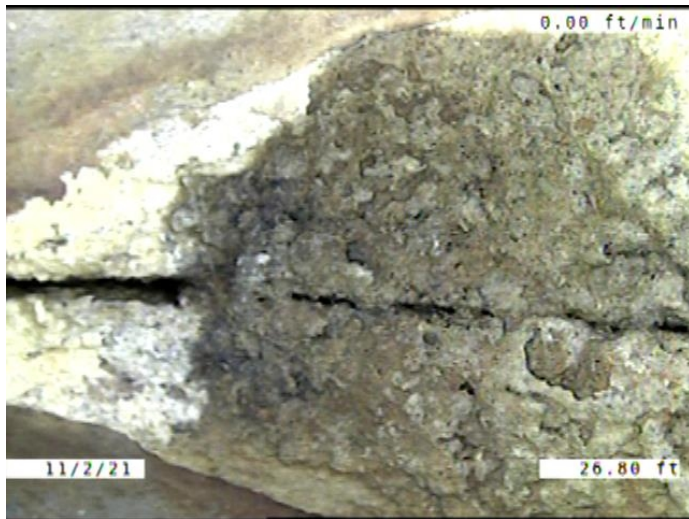
Code: **DAE**
 Description: **Deposits Attached Encrustation**

Distance (ft): **26.8**
 Structural Grade: **0**
 O&M Grade: **2**
 Clock Start/From: **8**
 Clock To: **4**
 1st Value:
 2nd Value:
 Value Percent: **5.000**
 Continuous Index: **S03**
 Within 8" of Joint: **YES**
 Remarks:

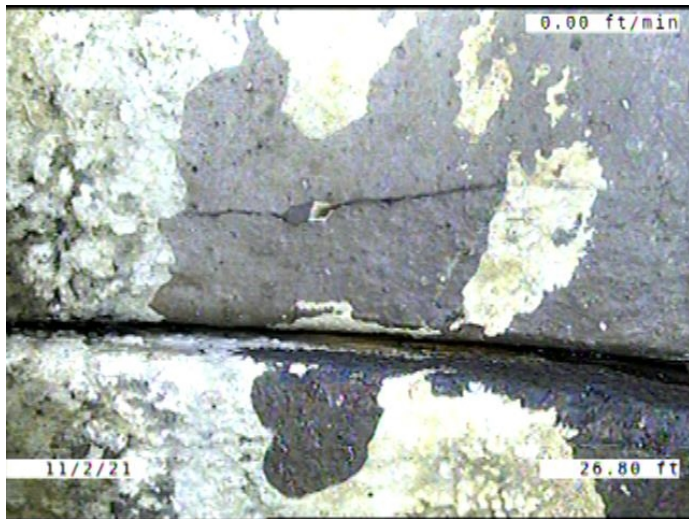
Code: **CS**
 Description: **Crack Spiral**

Distance (ft): **26.8**
 Structural Grade: **2**
 O&M Grade: **0**
 Clock Start/From: **3**
 Clock To: **4**
 1st Value:
 2nd Value:
 Value Percent:
 Continuous Index:
 Within 8" of Joint: **YES**
 Remarks:

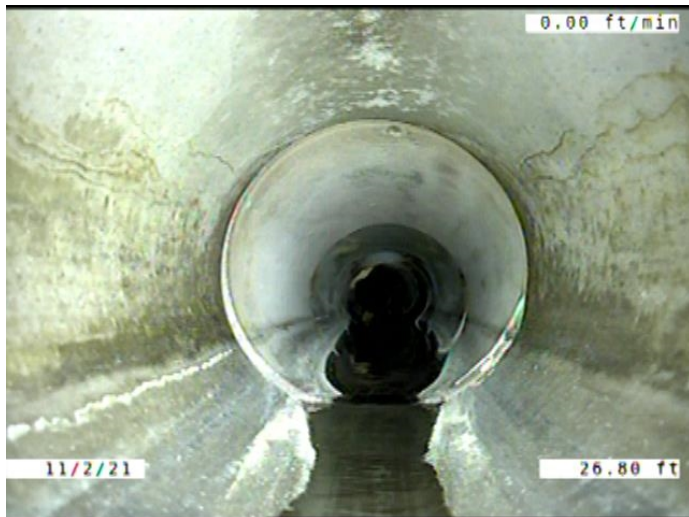
Code: **MWLS**
 Description: **Miscellaneous Water Level Sag**

Distance (ft): **26.8**
 Structural Grade: **2**
 O&M Grade: **0**
 Clock Start/From:
 Clock To:
 1st Value:
 2nd Value:
 Value Percent: **5.000**
 Continuous Index: **F02**
 Within 8" of Joint: **NO**
 Remarks:

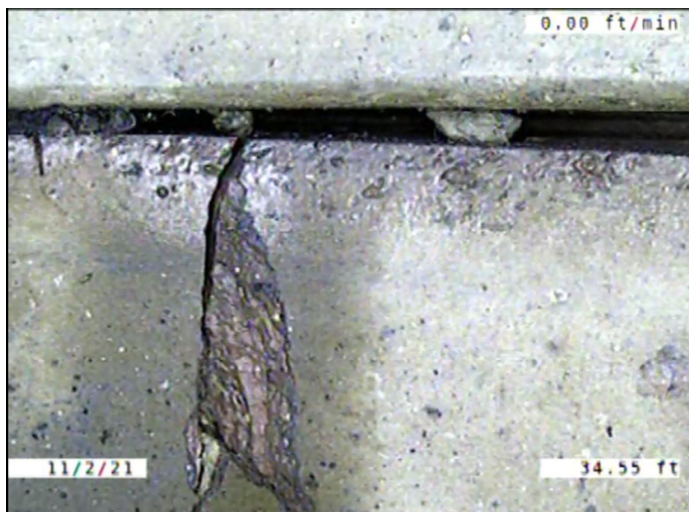
Code: **SSS**
 Description: **Surface Damage Surface Spalling**

Distance (ft): **34.6**
 Structural Grade: **2**
 O&M Grade: **0**
 Clock Start/From: **2**
 Clock To:
 1st Value:
 2nd Value:
 Value Percent:
 Continuous Index:
 Within 8" of Joint: **YES**
 Remarks:

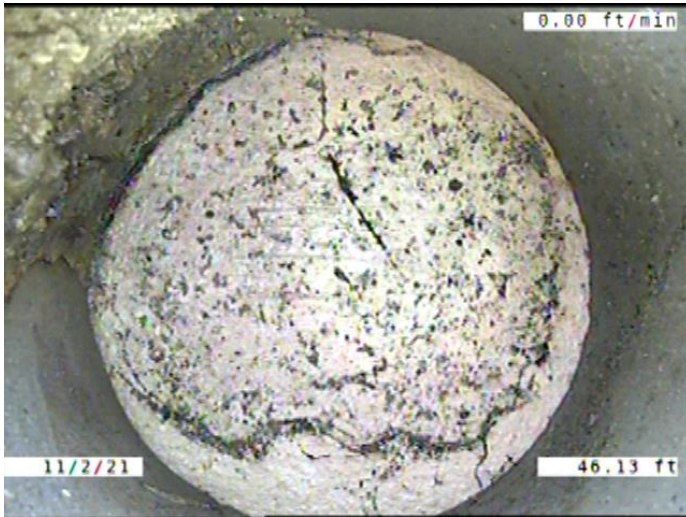
Code: **TFC**
 Description: **Tap Factory Capped**

Distance (ft): **46.1**
 Structural Grade: **0**
 O&M Grade: **0**
 Clock Start/From: **11**
 Clock To:
 1st Value: **4.000**
 2nd Value:
 Value Percent:
 Continuous Index:
 Within 8" of Joint: **YES**
 Remarks: **ENCRUSTATION COMING AROUND THE CAP**

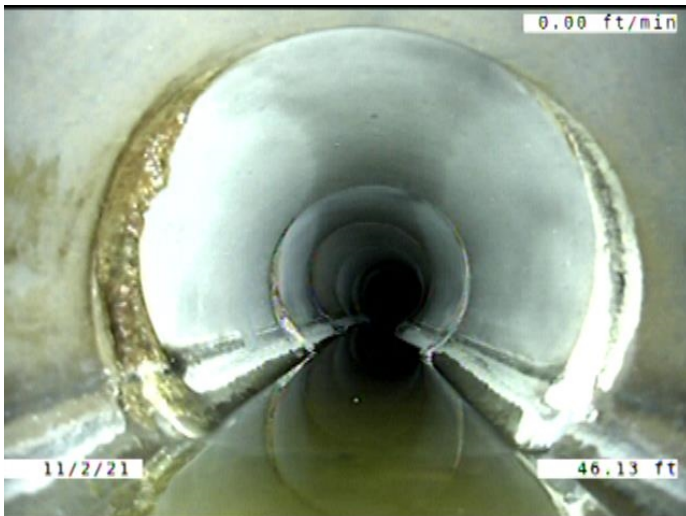
Code: **B**
 Description: **Broken**

Distance (ft): **46.1**
 Structural Grade: **4**
 O&M Grade: **0**
 Clock Start/From: **7**
 Clock To: **5**
 1st Value:
 2nd Value:
 Value Percent:
 Continuous Index: **F04**
 Within 8" of Joint: **YES**
 Remarks:

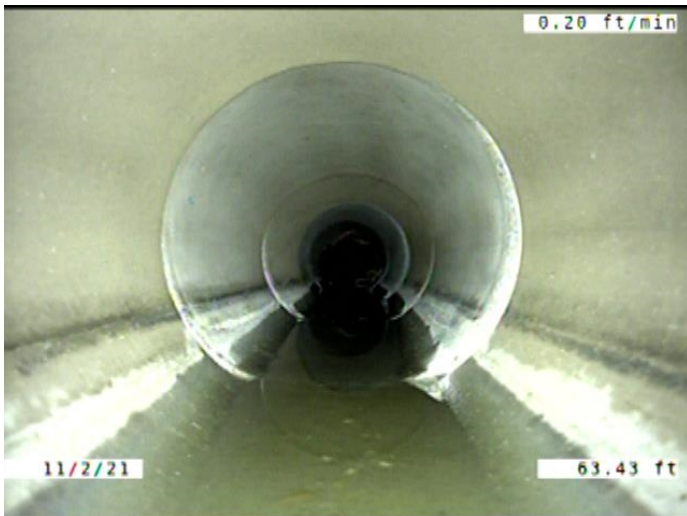
Code: **MWLS**
 Description: **Miscellaneous Water Level Sag**

Distance (ft): **62.5**
 Structural Grade: **2**
 O&M Grade: **0**
 Clock Start/From:
 Clock To:
 1st Value:
 2nd Value:
 Value Percent: **5.000**
 Continuous Index: **S05**
 Within 8" of Joint: **NO**
 Remarks:

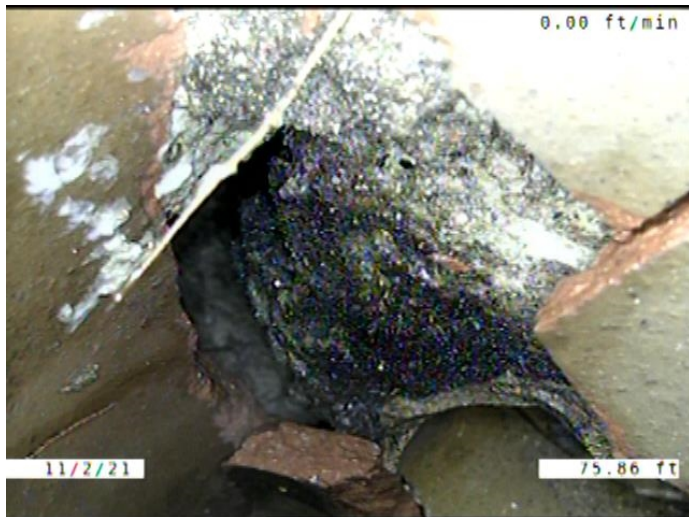
Code: **HVV**
 Description: **Hole Void Visible**

Distance (ft): **75.9**
 Structural Grade: **5**
 O&M Grade: **0**
 Clock Start/From: **10**
 Clock To: **11**
 1st Value:
 2nd Value:
 Value Percent:
 Continuous Index:
 Within 8" of Joint: **YES**
 Remarks: **SOIL AND VOID VISIBLE**

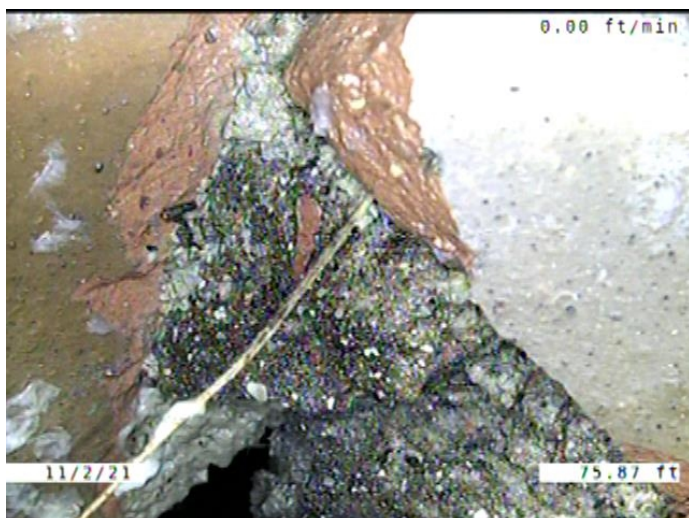
Code: **RFB**
 Description: **Roots Fine Barrel**

Distance (ft): **75.9**
 Structural Grade: **0**
 O&M Grade: **2**
 Clock Start/From: **10**
 Clock To:
 1st Value:
 2nd Value:
 Value Percent:
 Continuous Index:
 Within 8" of Joint: **NO**
 Remarks:

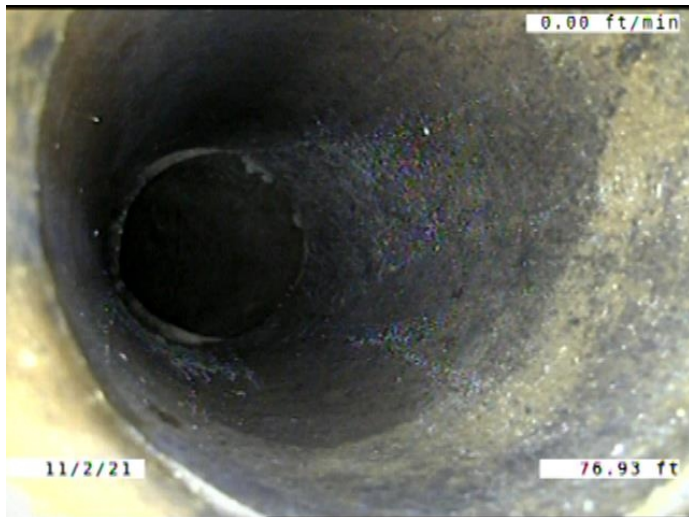
Code: **TBI**
 Description: **Tap Break-in Intruding**

Distance (ft): **76.9**
 Structural Grade: **0**
 O&M Grade: **2**
 Clock Start/From: **11**
 Clock To:
 1st Value: **4.000**
 2nd Value: **1.000**
 Value Percent:
 Continuous Index:
 Within 8" of Joint: **YES**
 Remarks:

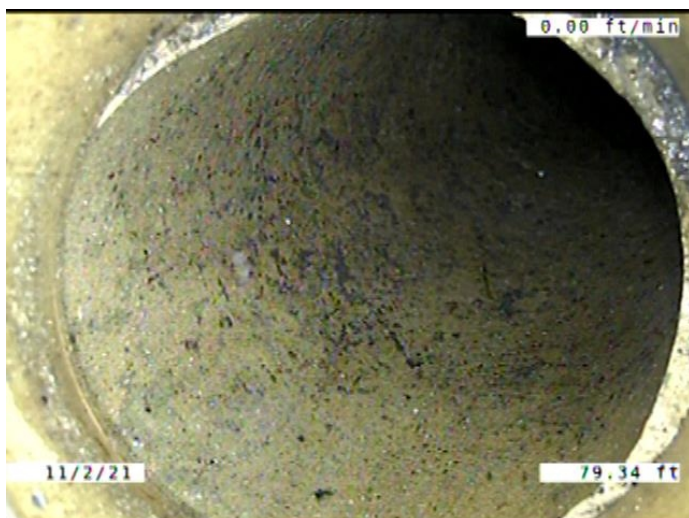
Code: **TBI**
 Description: **Tap Break-in Intruding**

Distance (ft): **79.3**
 Structural Grade: **0**
 O&M Grade: **2**
 Clock Start/From: **1**
 Clock To:
 1st Value: **4.000**
 2nd Value: **1.000**
 Value Percent:
 Continuous Index:
 Within 8" of Joint: **YES**
 Remarks:

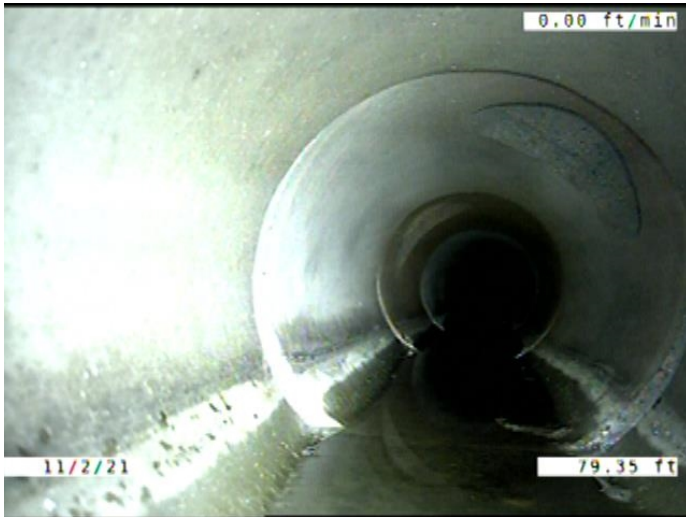
Code: **BSV**
Description: **Broken Soil Visible**

Distance (ft): **79.3**
Structural Grade: **5**
O&M Grade: **0**
Clock Start/From: **12**
Clock To: **12**
1st Value:
2nd Value:
Value Percent:
Continuous Index: **F07**
Within 8" of Joint: **YES**
Remarks:

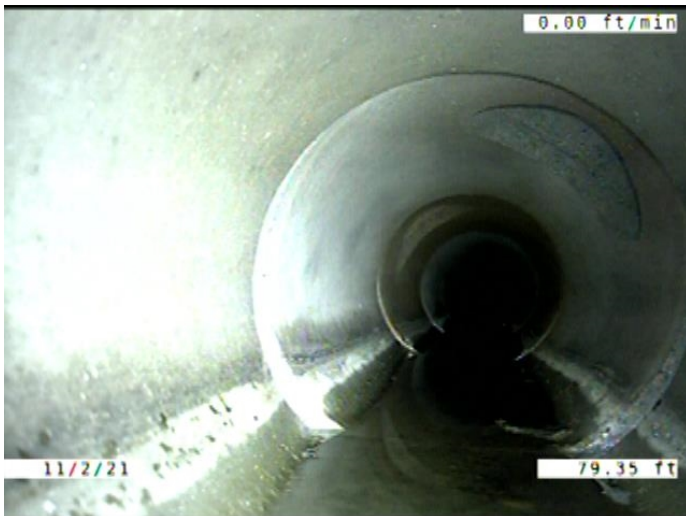
Code: **DR**
Description: **Deformed Rigid**

Distance (ft): **79.3**
Structural Grade: **5**
O&M Grade: **0**
Clock Start/From:
Clock To:
1st Value:
2nd Value:
Value Percent: **15.000**
Continuous Index: **F06**
Within 8" of Joint: **NO**
Remarks:

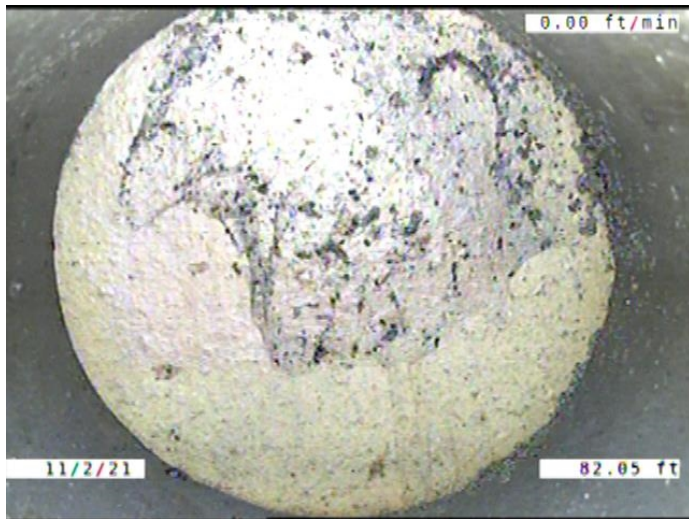
Code: **TFC**
Description: **Tap Factory Capped**

Distance (ft): **82.1**
Structural Grade: **0**
O&M Grade: **0**
Clock Start/From: **1**
Clock To:
1st Value: **4.000**
2nd Value:
Value Percent:
Continuous Index:
Within 8" of Joint: **YES**
Remarks:

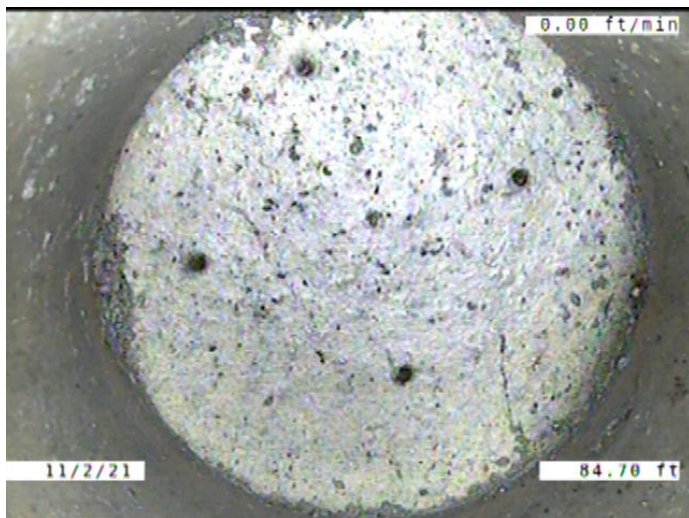
Code: **TFC**
Description: **Tap Factory Capped**

Distance (ft): **84.7**
Structural Grade: **0**
O&M Grade: **0**
Clock Start/From: **11**
Clock To:
1st Value: **4.000**
2nd Value:
Value Percent:
Continuous Index:
Within 8" of Joint: **YES**
Remarks:

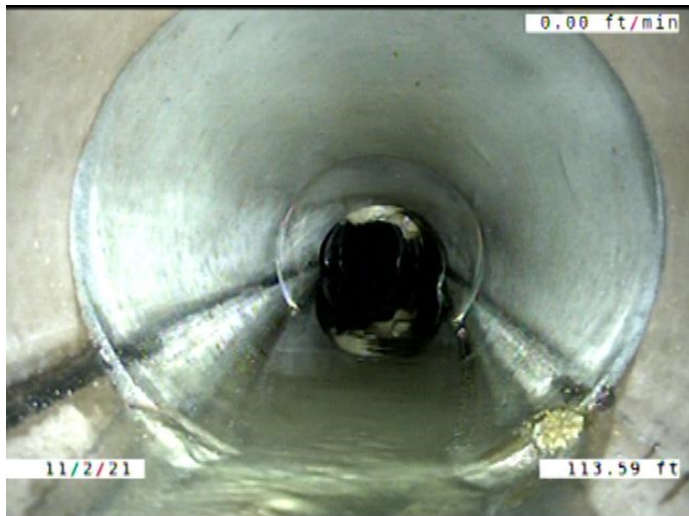
Code: **MWLS**
 Description: **Miscellaneous Water Level Sag**

Distance (ft): **113.6**
 Structural Grade: **2**
 O&M Grade: **0**
 Clock Start/From:
 Clock To:
 1st Value:
 2nd Value:
 Value Percent: **10.000**
 Continuous Index: **S08**
 Within 8" of Joint: **NO**
 Remarks:

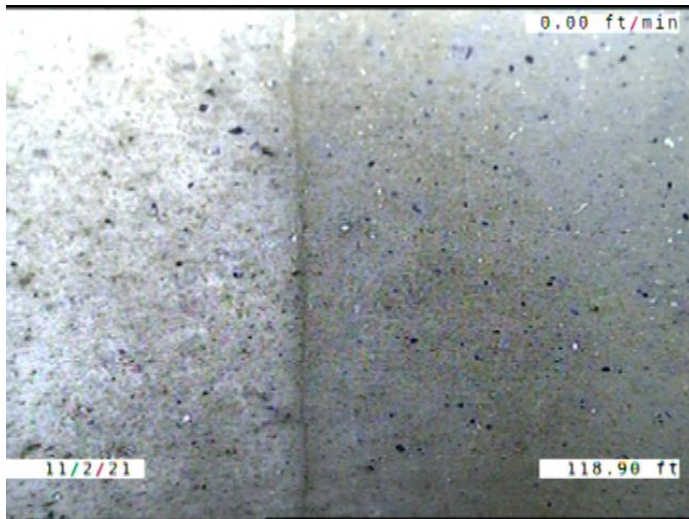
Code: **CM**
Description: **Crack Multiple**

Distance (ft): **118.9**
Structural Grade: **3**
O&M Grade: **0**
Clock Start/From: **11**
Clock To: **12**
1st Value:
2nd Value:
Value Percent:
Continuous Index:
Within 8" of Joint: **YES**
Remarks:

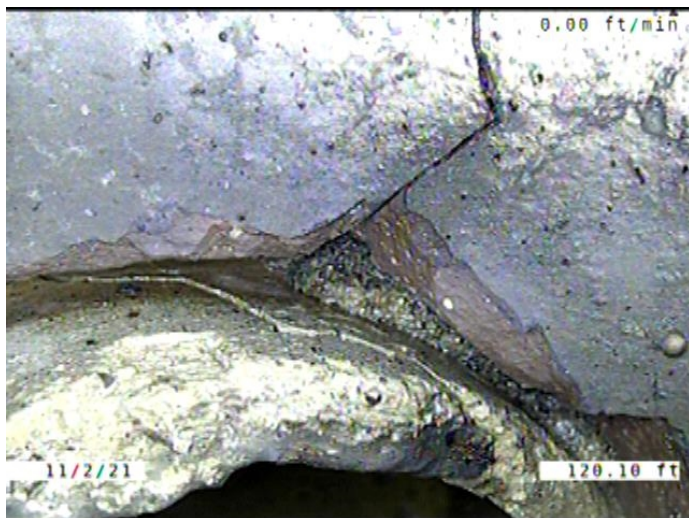
Code: **SSC**
Description: **Surface Spalling of Damage Coating**

Distance (ft): **120.1**
Structural Grade: **1**
O&M Grade: **0**
Clock Start/From: **11**
Clock To: **1**
1st Value:
2nd Value:
Value Percent:
Continuous Index:
Within 8" of Joint: **YES**
Remarks:

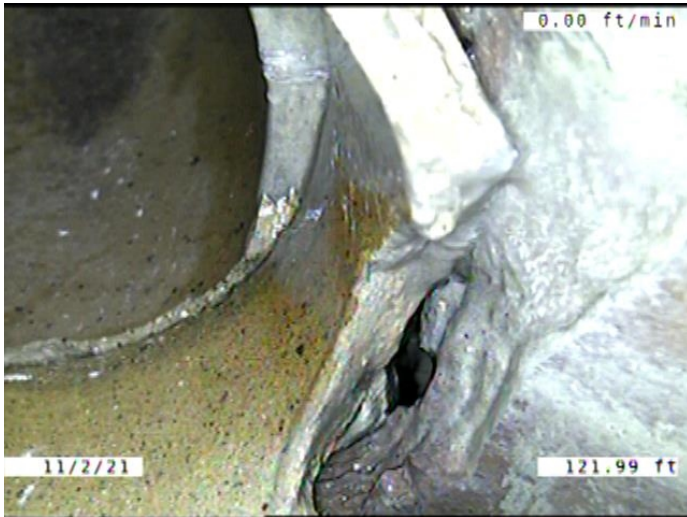
Code: **BSV**
Description: **Broken Soil Visible**

Distance (ft): **122.0**
Structural Grade: **5**
O&M Grade: **0**
Clock Start/From: **12**
Clock To: **2**
1st Value:
2nd Value:
Value Percent:
Continuous Index:
Within 8" of Joint: **YES**
Remarks:

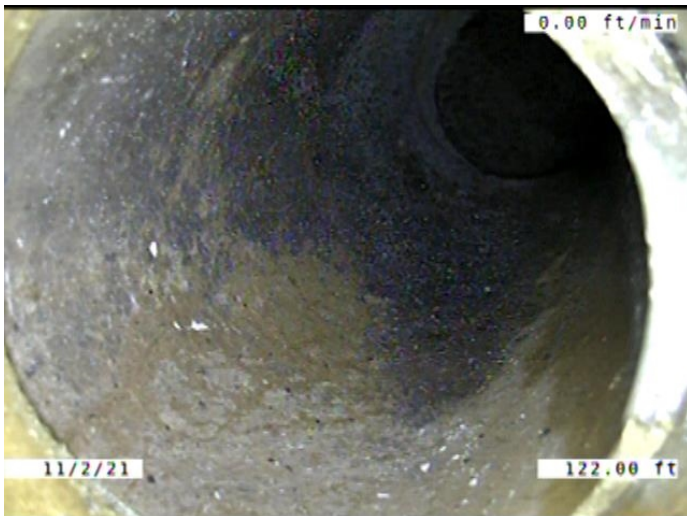
Code: **TBI**
Description: **Tap Break-in Intruding**

Distance (ft): **122.0**
Structural Grade: **0**
O&M Grade: **2**
Clock Start/From: **1**
Clock To:
1st Value: **4.000**
2nd Value: **1.000**
Value Percent:
Continuous Index:
Within 8" of Joint: **YES**
Remarks: **CONSTANTLY RUNNING WATER.**

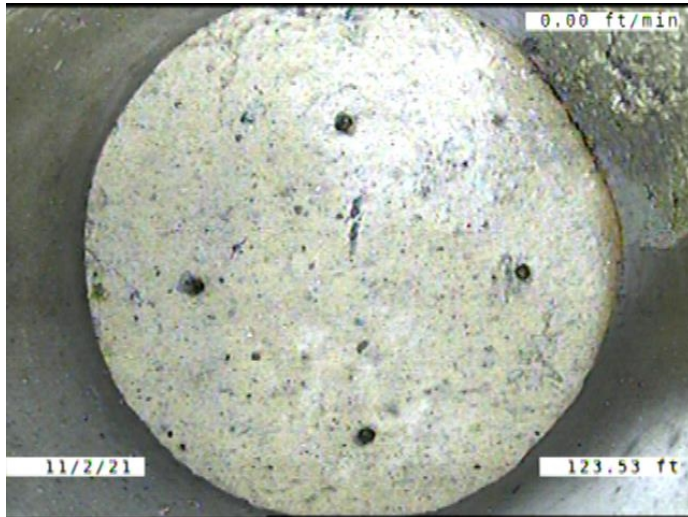
Code:	TFC
Description:	Tap Factory Capped
Distance (ft):	123.5
Structural Grade:	0
O&M Grade:	0
Clock Start/From:	1
Clock To:	
1st Value:	4.000
2nd Value:	
Value Percent:	
Continuous Index:	
Within 8" of Joint:	YES
Remarks:	ENCRUSTATION COMING AROUND THE CAP

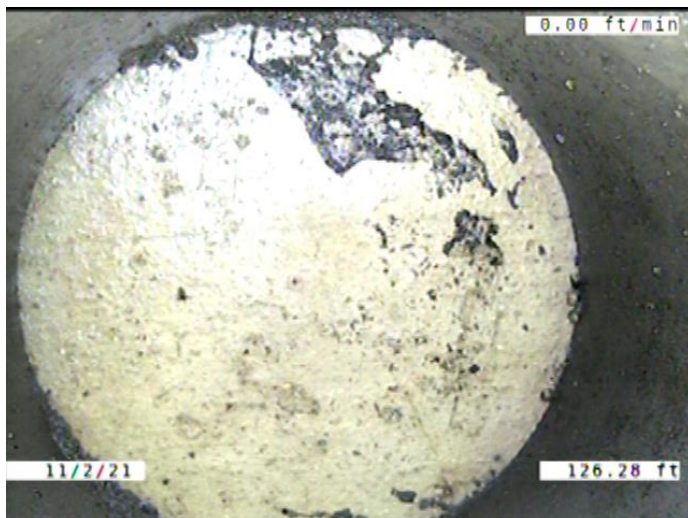
Code:	TFC
Description:	Tap Factory Capped
Distance (ft):	126.3
Structural Grade:	0
O&M Grade:	0
Clock Start/From:	11
Clock To:	
1st Value:	4.000
2nd Value:	
Value Percent:	
Continuous Index:	
Within 8" of Joint:	YES
Remarks:

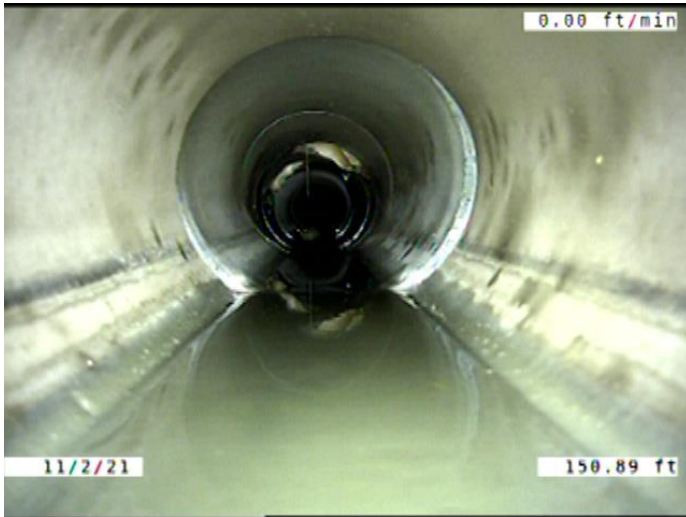
Code:	MWLS
Description:	Miscellaneous Water Level Sag
Distance (ft):	150.9
Structural Grade:	2
O&M Grade:	0
Clock Start/From:	
Clock To:	
1st Value:	
2nd Value:	
Value Percent:	5.000
Continuous Index:	
Within 8" of Joint:	NO
Remarks:

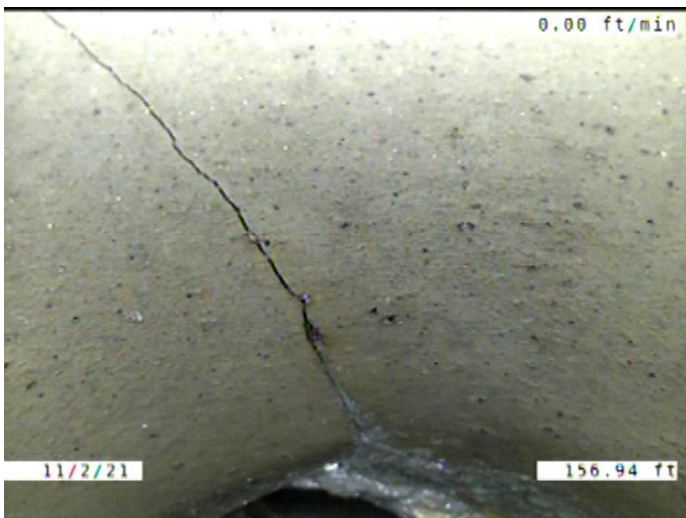
Code:	B
Description:	Broken
Distance (ft):	156.9
Structural Grade:	4
O&M Grade:	0
Clock Start/From:	10
Clock To:	4
1st Value:	
2nd Value:	
Value Percent:	
Continuous Index:	S09
Within 8" of Joint:	YES
Remarks:

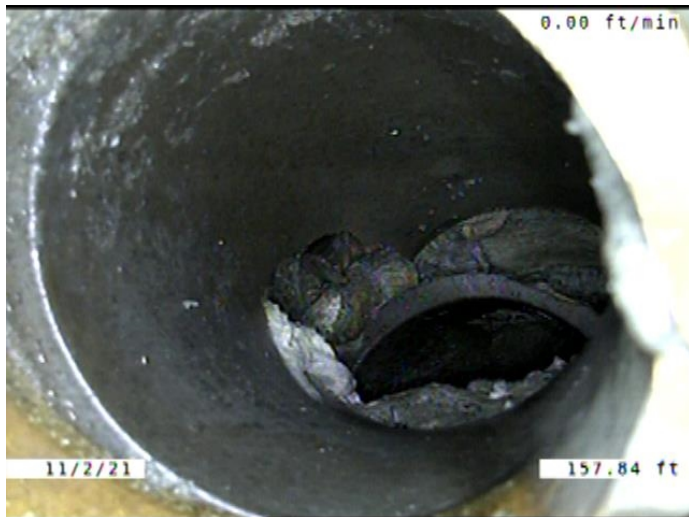
Code:	TBI
Description:	Tap Break-in Intruding
Distance (ft):	157.8
Structural Grade:	0
O&M Grade:	2
Clock Start/From:	1
Clock To:	
1st Value:	4.000
2nd Value:	1.000
Value Percent:	
Continuous Index:	
Within 8" of Joint:	YES
Remarks:

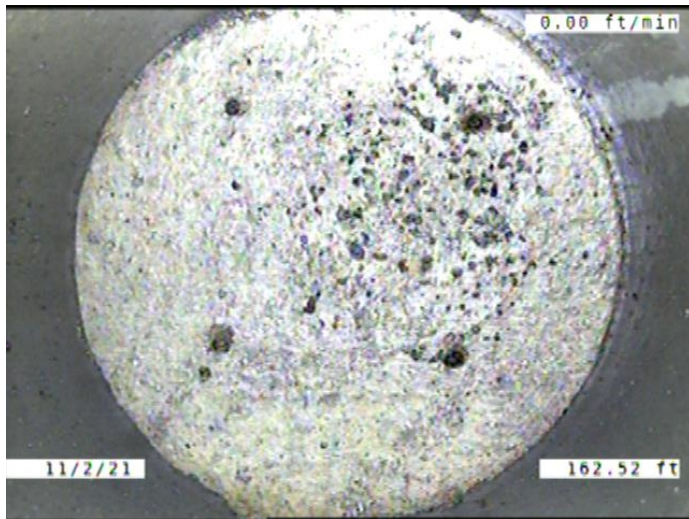
Code: **TFC**
 Description: **Tap Factory Capped**

Distance (ft): **162.5**
 Structural Grade: **0**
 O&M Grade: **0**
 Clock Start/From: **1**
 Clock To:
 1st Value: **4.000**
 2nd Value:
 Value Percent:
 Continuous Index:
 Within 8" of Joint: **YES**
 Remarks:

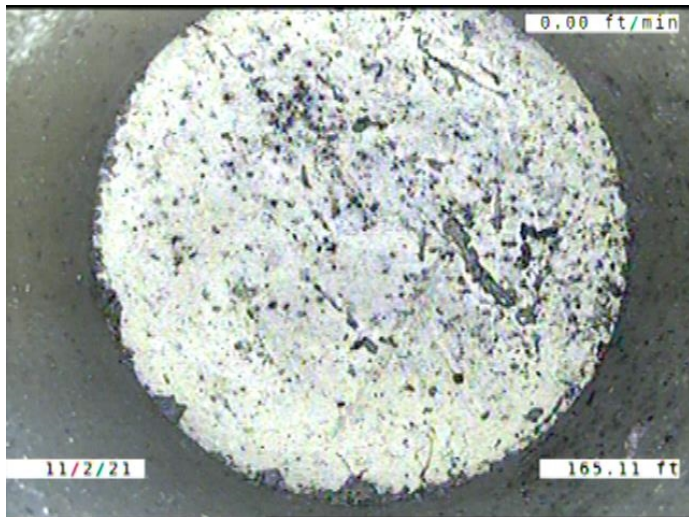
Code: **TFC**
 Description: **Tap Factory Capped**

Distance (ft): **165.1**
 Structural Grade: **0**
 O&M Grade: **0**
 Clock Start/From: **11**
 Clock To:
 1st Value: **4.000**
 2nd Value:
 Value Percent:
 Continuous Index:
 Within 8" of Joint: **YES**
 Remarks:

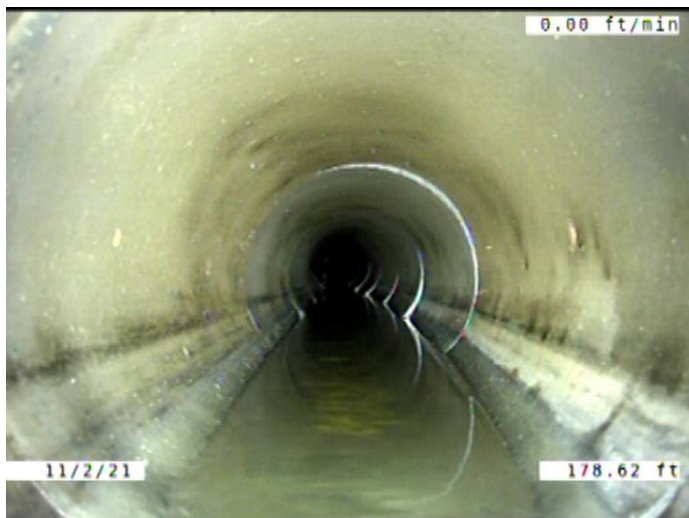
Code: **MWLS**
 Description: **Miscellaneous Water Level Sag**

Distance (ft): **178.6**
 Structural Grade: **2**
 O&M Grade: **0**
 Clock Start/From:
 Clock To:
 1st Value:
 2nd Value:
 Value Percent: **5.000**
 Continuous Index: **S10**
 Within 8" of Joint: **NO**
 Remarks:

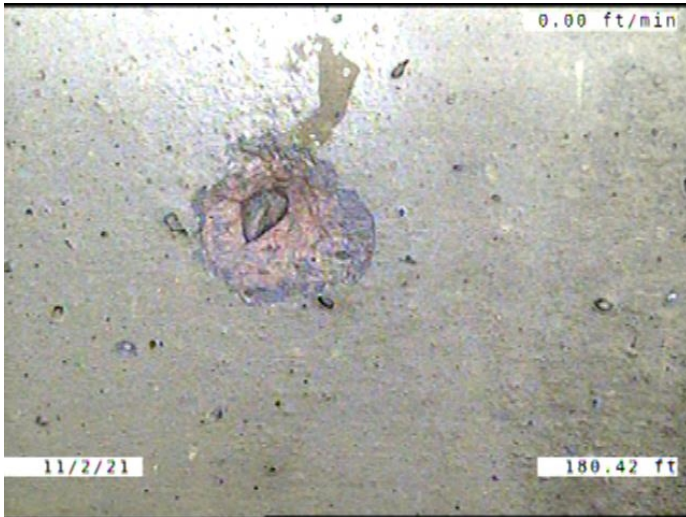
Code: **SSS**
Description: **Surface Damage Surface Spalling**

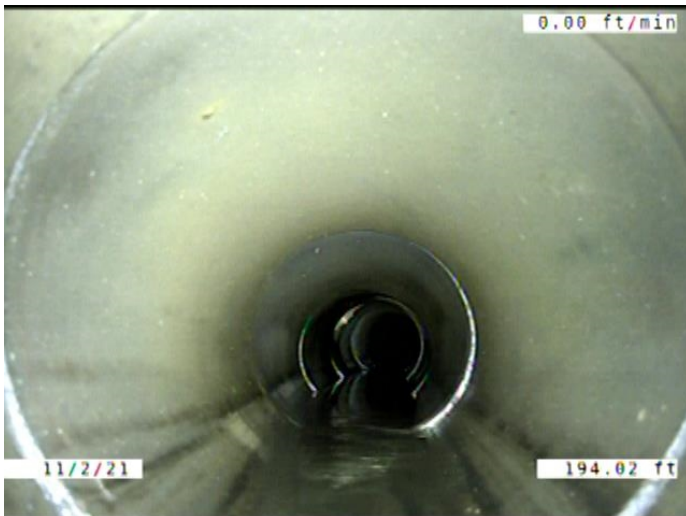
Code: **MWLS**
Description: **Miscellaneous Water Level Sag**

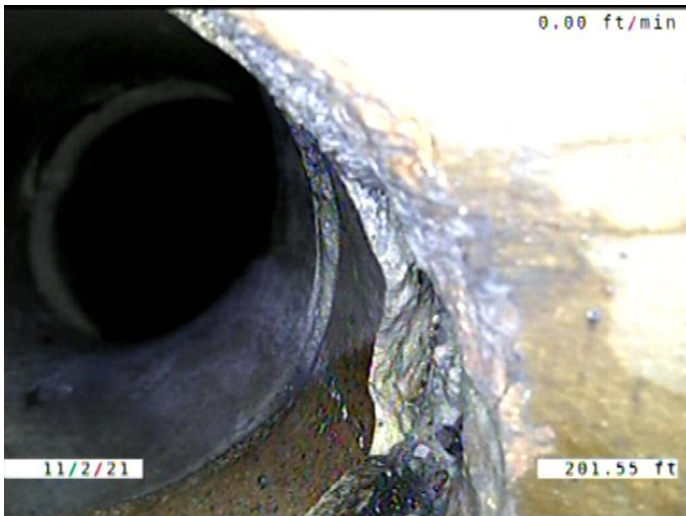
Code: **SSS**
Description: **Surface Damage Surface Spalling**

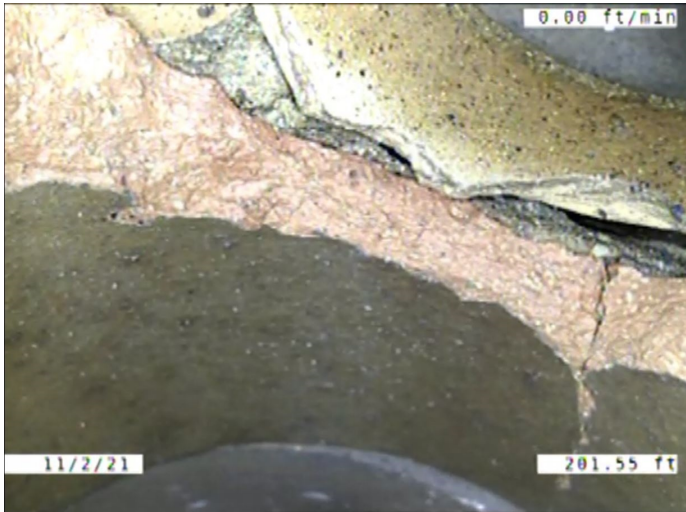
Code: **FL**
Description: **Fracture Longitudinal**

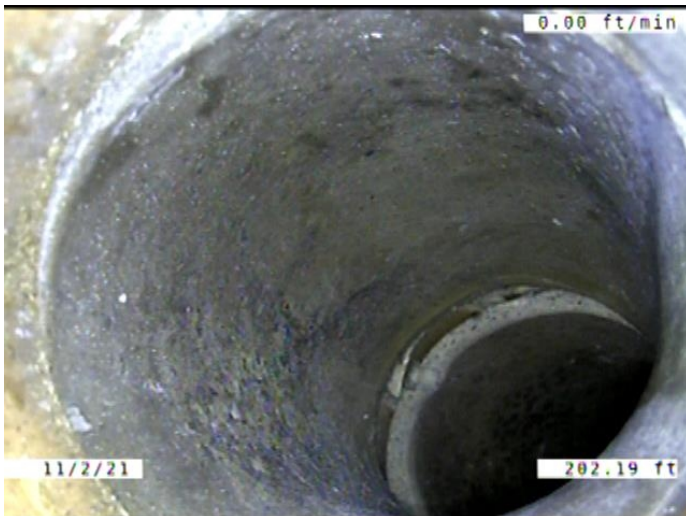
Code: **TB**
Description: **Tap Break-in/Hammer**

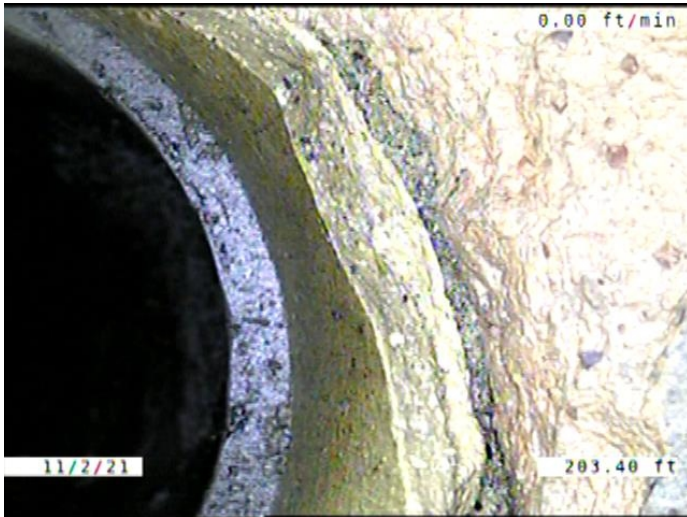
Code: **SSS**
Description: **Surface Damage Surface Spalling**

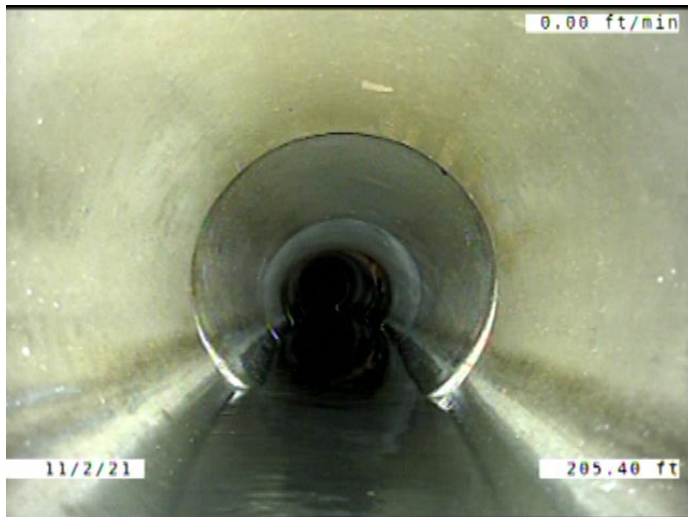
Code: **MWLS**
 Description: **Miscellaneous Water Level Sag**

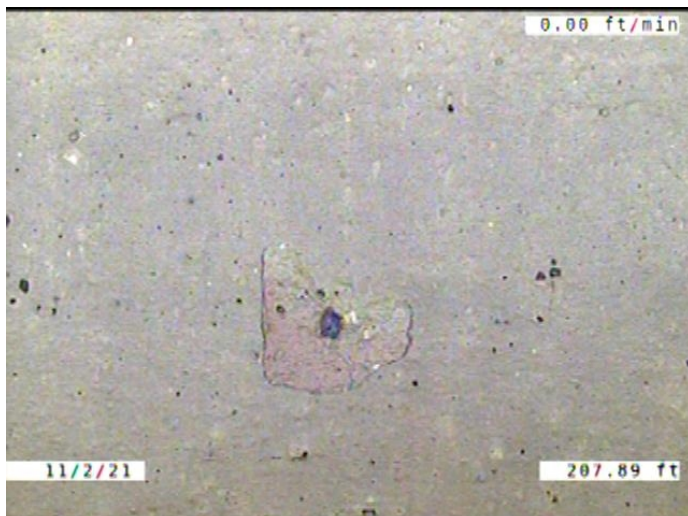
Code: **SSS**
 Description: **Surface Damage Surface Spalling**

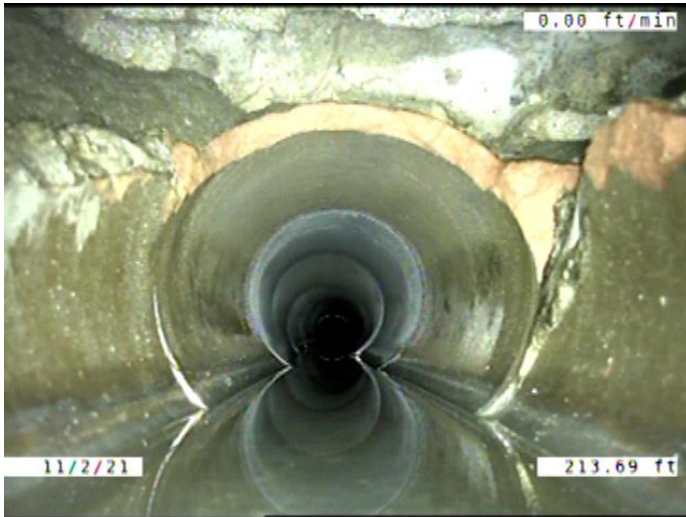
Code: **DSF**
Description: **Deposits Settled Fine**
