# Profile/Photo Observation Report

Date:	11/02/2021	Weather:		Coding:	PACP 7.0
Pipe Length (ft):	215.2	Owner:	City of Hobart	Pre Clean:	Heavy Cleaning
P.O.#:	YES502259	Surveyor:	S. Bucklin	PSR:	P-504-040-039
Customer:	City of Hobart	Clean Date:	10/28/2021	Shape:	C

Street:	North Cavender Street	Flow Control:	Not Controlled
City:	Hobart, IN	Year Renewed:	
Location:	Alley	Tape/Media #:	
Purpose:	Routine Assessment	Dia/Height:	10"
Use:	Sanitary Sewage Pipe	Material:	VCP
Drain Area:		Lining:	None
Category:	NA		
Comment:			
Location Details:		Direction of Survey:	Downstream
US MH:	M-504-039	DS MH:	M-504-040
		Total Length Surveyed (ft):	215.2

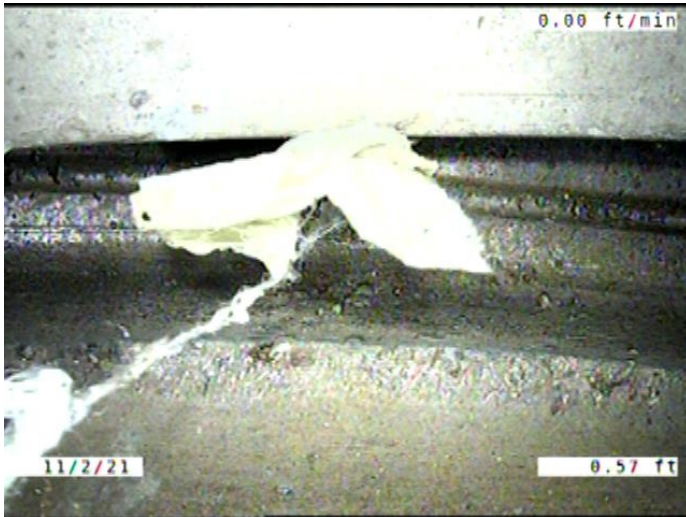
Code: **DAR**  
 Description: **Deposits Attached Ragging**

Distance (ft): **.6**  
 Structural Grade: **0**  
 O&M Grade: **2**  
 Clock Start/From: **11**  
 Clock To:  
 1st Value:  
 2nd Value:  
 Value Percent: **5.000**  
 Continuous Index:  
 Within 8" of Joint: **YES**  
 Remarks:

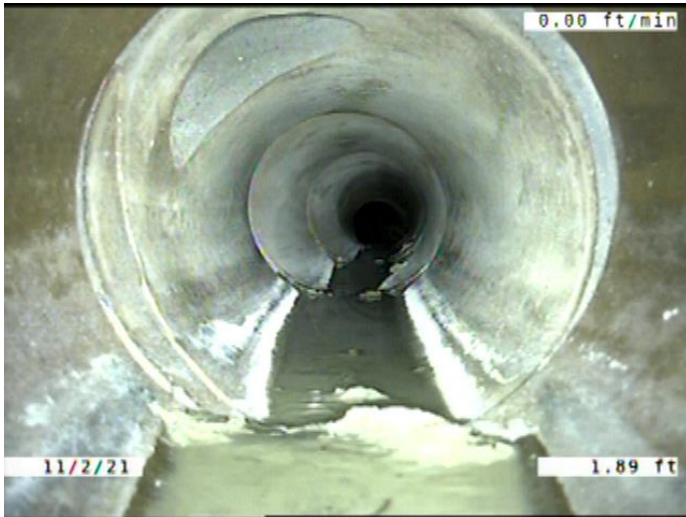
Code: **DSF**  
 Description: **Deposits Settled Fine**

Distance (ft): **1.9**  
 Structural Grade: **0**  
 O&M Grade: **2**  
 Clock Start/From: **5**  
 Clock To: **7**  
 1st Value:  
 2nd Value:  
 Value Percent: **5.000**  
 Continuous Index: **S01**  
 Within 8" of Joint: **YES**  
 Remarks:

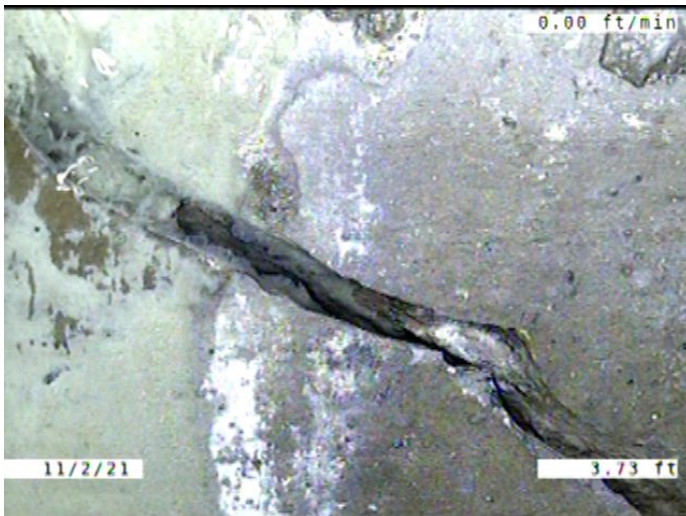
Code: **B**  
 Description: **Broken**

Distance (ft): **3.7**  
 Structural Grade: **4**  
 O&M Grade: **0**  
 Clock Start/From: **6**  
 Clock To: **11**  
 1st Value:  
 2nd Value:  
 Value Percent:  
 Continuous Index:  
 Within 8" of Joint: **YES**  
 Remarks:

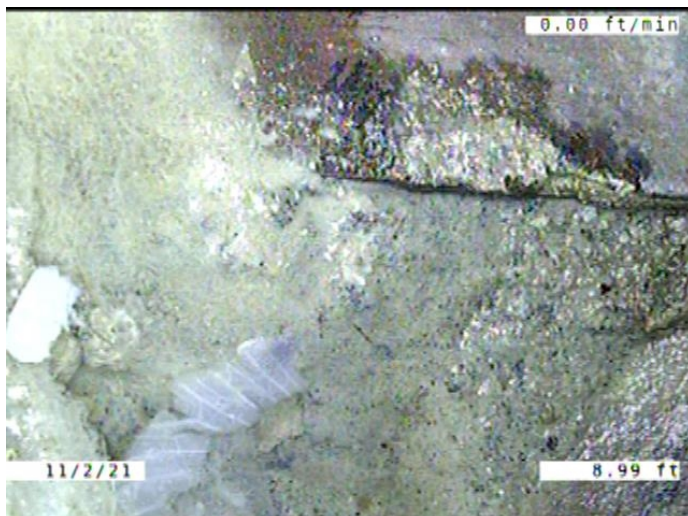
Code: **DAE**  
 Description: **Deposits Attached Encrustation**

Distance (ft): **9.0**  
 Structural Grade: **0**  
 O&M Grade: **2**  
 Clock Start/From: **3**  
 Clock To: **9**  
 1st Value:  
 2nd Value:  
 Value Percent: **5.000**  
 Continuous Index:  
 Within 8" of Joint: **YES**  
 Remarks:

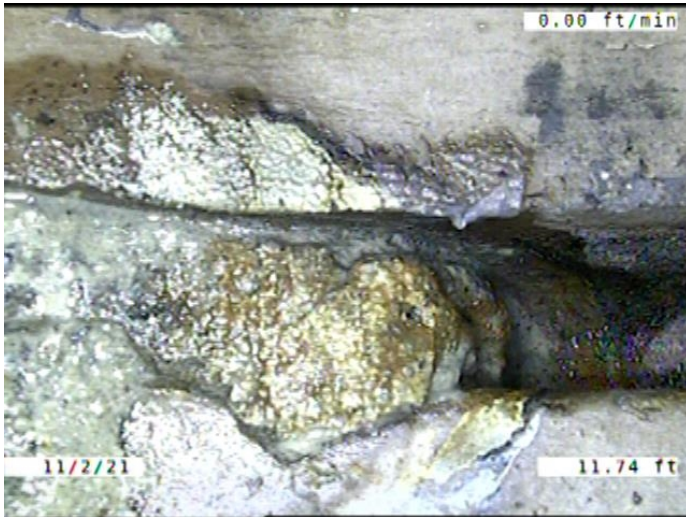
Code: **DAE**  
Description: **Deposits Attached Encrustation**

Distance (ft): **11.7**  
Structural Grade: **0**  
O&M Grade: **2**  
Clock Start/From: **4**  
Clock To: **8**  
1st Value:  
2nd Value:  
Value Percent: **5.000**  
Continuous Index:  
Within 8" of Joint: **YES**  
Remarks:

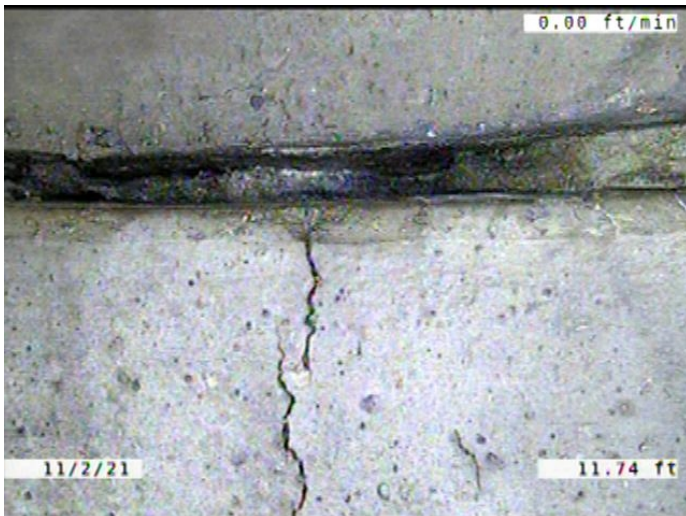
Code: **CL**  
Description: **Crack Longitudinal**

Distance (ft): **11.7**  
Structural Grade: **2**  
O&M Grade: **0**  
Clock Start/From: **8**  
Clock To:  
1st Value:  
2nd Value:  
Value Percent:  
Continuous Index:  
Within 8" of Joint: **YES**  
Remarks:

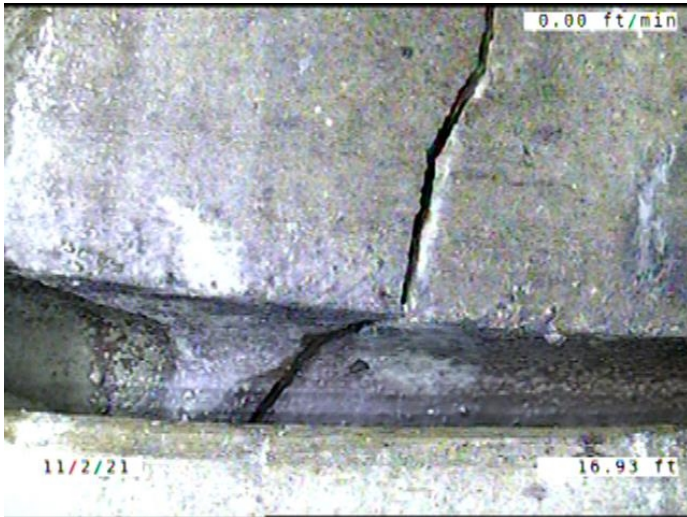
Code: **FM**  
 Description: **Fracture Multiple**

Distance (ft): **16.9**  
 Structural Grade: **4**  
 O&M Grade: **0**  
 Clock Start/From: **11**  
 Clock To: **4**  
 1st Value:  
 2nd Value:  
 Value Percent:  
 Continuous Index:  
 Within 8" of Joint: **YES**  
 Remarks:

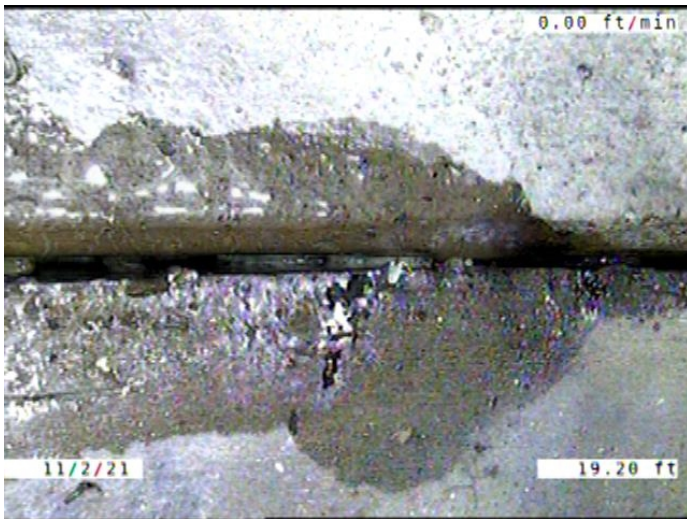
Code: **IRJ**  
 Description: **Infiltration Runner Joint**

Distance (ft): **19.2**  
 Structural Grade: **0**  
 O&M Grade: **4**  
 Clock Start/From: **10**  
 Clock To:  
 1st Value:  
 2nd Value:  
 Value Percent:  
 Continuous Index:  
 Within 8" of Joint: **YES**  
 Remarks:

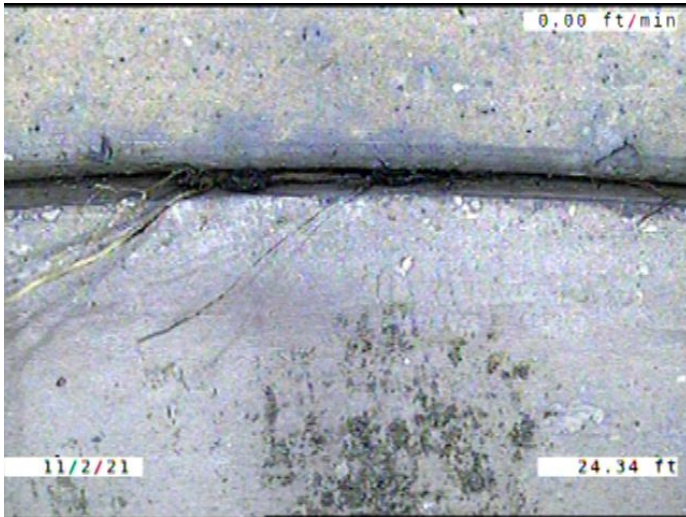
Code: **RFJ**  
 Description: **Roots Fine Joint**

Distance (ft): **24.3**  
 Structural Grade: **0**  
 O&M Grade: **1**  
 Clock Start/From: **11**  
 Clock To: **12**  
 1st Value:  
 2nd Value:  
 Value Percent:  
 Continuous Index:  
 Within 8" of Joint: **YES**  
 Remarks:

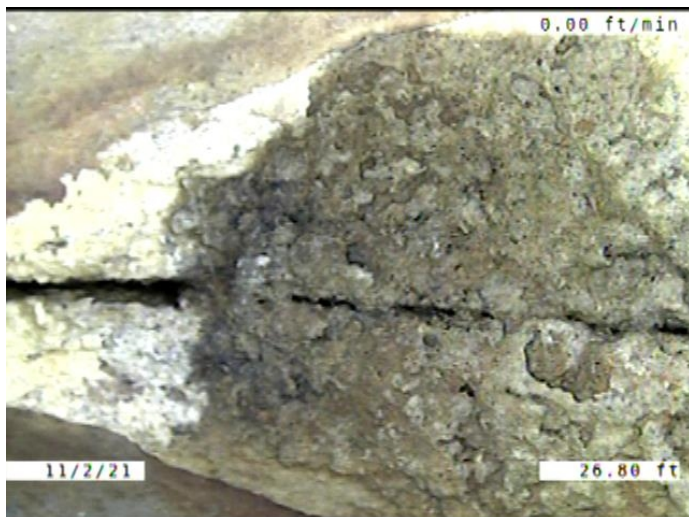
Code: **DAE**  
 Description: **Deposits Attached Encrustation**

Distance (ft): **26.8**  
 Structural Grade: **0**  
 O&M Grade: **2**  
 Clock Start/From: **8**  
 Clock To: **4**  
 1st Value:  
 2nd Value:  
 Value Percent: **5.000**  
 Continuous Index: **S03**  
 Within 8" of Joint: **YES**  
 Remarks:

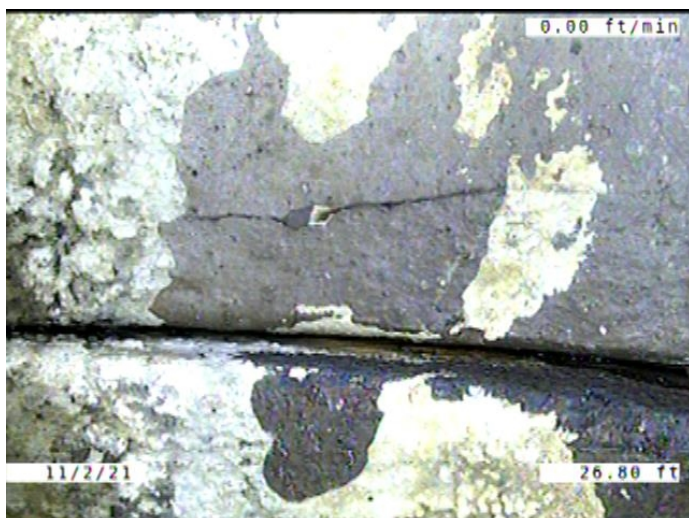
Code: **CS**  
 Description: **Crack Spiral**

Distance (ft): **26.8**  
 Structural Grade: **2**  
 O&M Grade: **0**  
 Clock Start/From: **3**  
 Clock To: **4**  
 1st Value:  
 2nd Value:  
 Value Percent:  
 Continuous Index:  
 Within 8" of Joint: **YES**  
 Remarks:

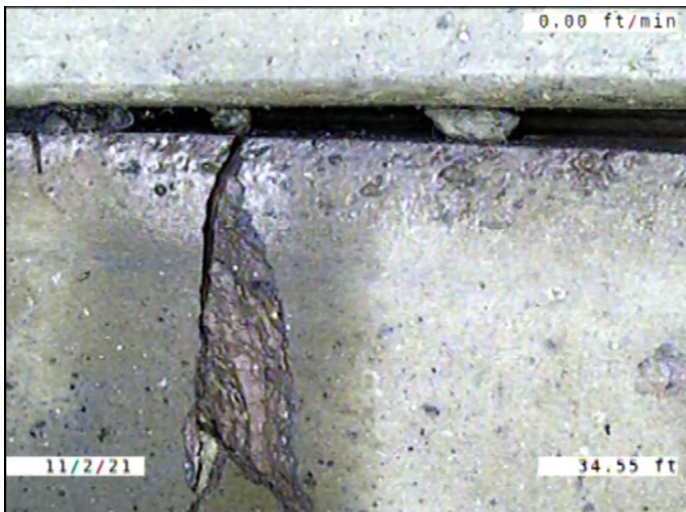
Code: **SSS**  
 Description: **Surface Damage Surface Spalling**

Distance (ft): **34.6**  
 Structural Grade: **2**  
 O&M Grade: **0**  
 Clock Start/From: **2**  
 Clock To:  
 1st Value:  
 2nd Value:  
 Value Percent:  
 Continuous Index:  
 Within 8" of Joint: **YES**  
 Remarks:

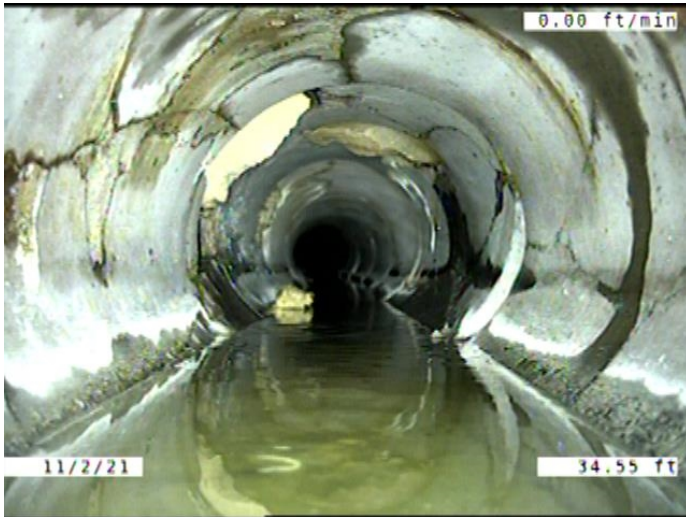
Code: **B**  
 Description: **Broken**

Distance (ft): **34.6**  
 Structural Grade: **4**  
 O&M Grade: **0**  
 Clock Start/From: **7**  
 Clock To: **5**  
 1st Value:  
 2nd Value:  
 Value Percent:  
 Continuous Index: **S04**  
 Within 8" of Joint: **YES**  
 Remarks:

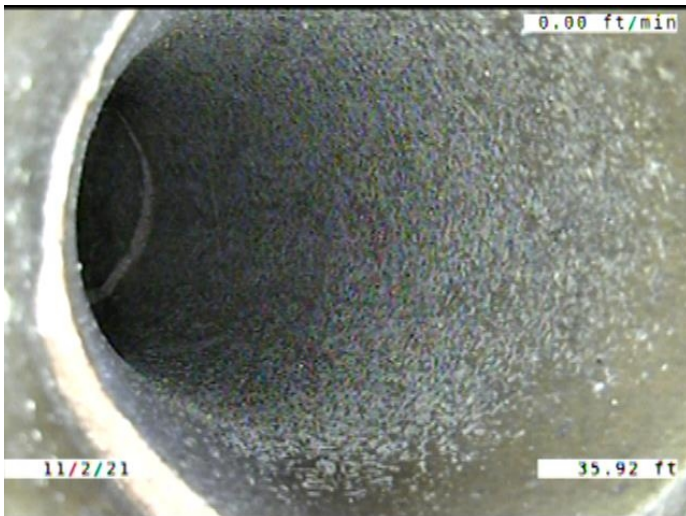
Code: **TBI**  
 Description: **Tap Break-in Intruding**

Distance (ft): **35.9**  
 Structural Grade: **0**  
 O&M Grade: **2**  
 Clock Start/From: **11**  
 Clock To:  
 1st Value: **6.000**  
 2nd Value: **1.000**  
 Value Percent:  
 Continuous Index:  
 Within 8" of Joint: **YES**  
 Remarks:

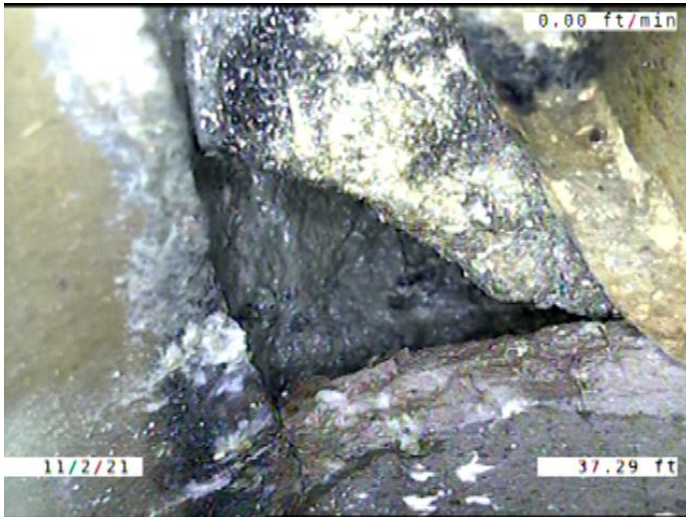
Code: **BSV**  
 Description: **Broken Soil Visible**

Distance (ft): **37.3**  
 Structural Grade: **5**  
 O&M Grade: **0**  
 Clock Start/From: **9**  
 Clock To:  
 1st Value:  
 2nd Value:  
 Value Percent:  
 Continuous Index:  
 Within 8" of Joint: **YES**  
 Remarks: **SOIL VISIBLE**

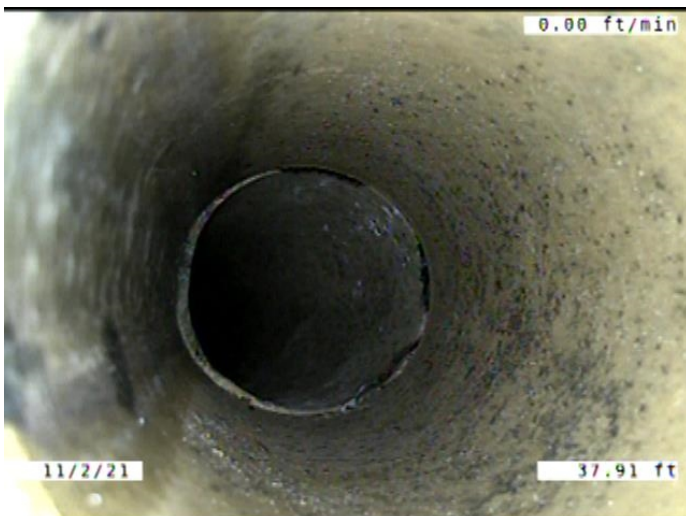
Code: **TBD**  
 Description: **Tap Break-in/Hammer Defective**

Distance (ft): **37.9**  
 Structural Grade: **0**  
 O&M Grade: **3**  
 Clock Start/From: **10**  
 Clock To:  
 1st Value: **4.000**  
 2nd Value:  
 Value Percent:  
 Continuous Index:  
 Within 8" of Joint: **YES**  
 Remarks: **CONSTANTLY RUNNING WATER.**

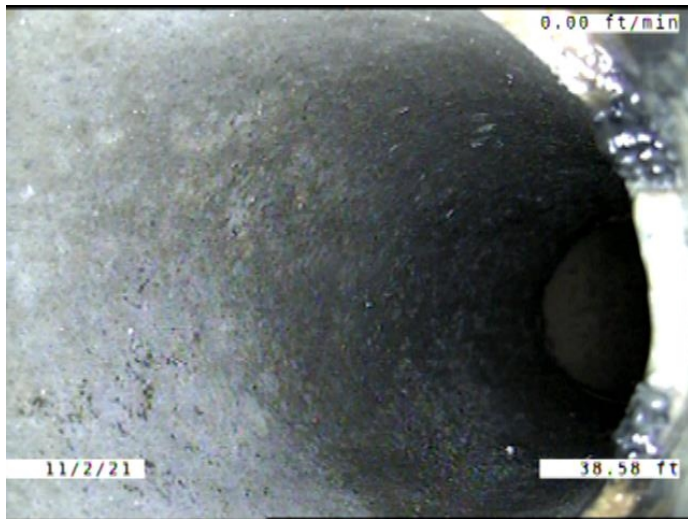
Code: **TBI**  
 Description: **Tap Break-in Intruding**

Distance (ft): **38.6**  
 Structural Grade: **0**  
 O&M Grade: **2**  
 Clock Start/From: **1**  
 Clock To:  
 1st Value: **6.000**  
 2nd Value: **1.000**  
 Value Percent:  
 Continuous Index:  
 Within 8" of Joint: **YES**  
 Remarks: **CONSTANTLY RUNNING WATER.**

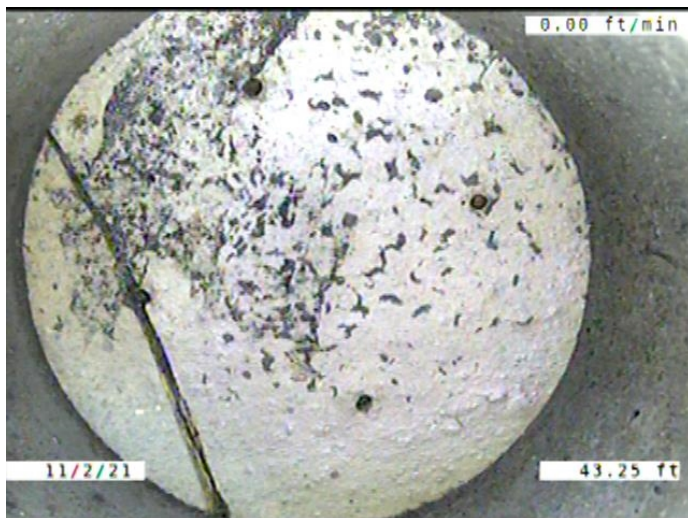
Code: **TFD**  
 Description: **Tap Factory Defective**

Distance (ft): **43.2**  
 Structural Grade: **0**  
 O&M Grade: **3**  
 Clock Start/From: **1**  
 Clock To:  
 1st Value: **4.000**  
 2nd Value:  
 Value Percent:  
 Continuous Index:  
 Within 8" of Joint: **YES**  
 Remarks: **CAP BROKEN**

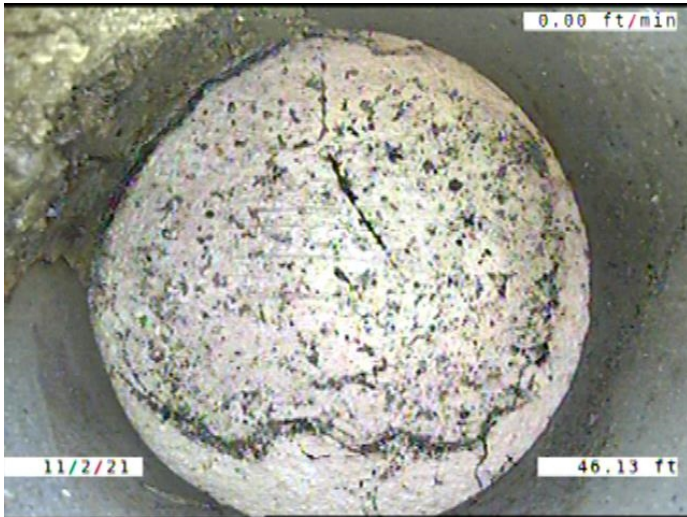
Code: **TFC**  
Description: **Tap Factory Capped**

Distance (ft): **46.1**  
Structural Grade: **0**  
O&M Grade: **0**  
Clock Start/From: **11**  
Clock To:  
1st Value: **4.000**  
2nd Value:  
Value Percent:  
Continuous Index:  
Within 8" of Joint: **YES**  
Remarks: **ENCRUSTATION COMING AROUND THE CAP**

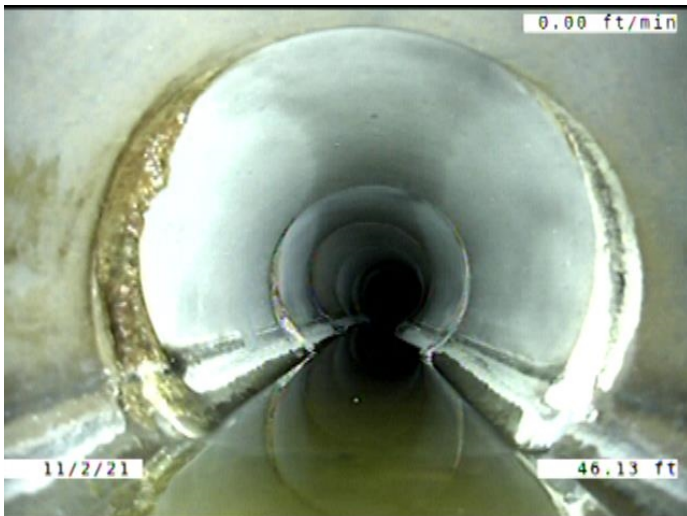
Code: **B**  
Description: **Broken**

Distance (ft): **46.1**  
Structural Grade: **4**  
O&M Grade: **0**  
Clock Start/From: **7**  
Clock To: **5**  
1st Value:  
2nd Value:  
Value Percent:  
Continuous Index: **F04**  
Within 8" of Joint: **YES**  
Remarks:

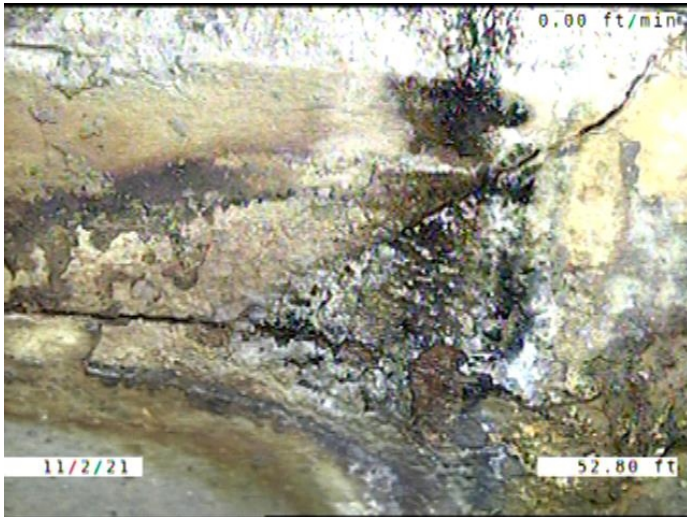
Code: **FM**  
 Description: **Fracture Multiple**

Distance (ft): **52.8**  
 Structural Grade: **4**  
 O&M Grade: **0**  
 Clock Start/From: **10**  
 Clock To: **5**  
 1st Value:  
 2nd Value:  
 Value Percent:  
 Continuous Index:  
 Within 8" of Joint: **YES**  
 Remarks:

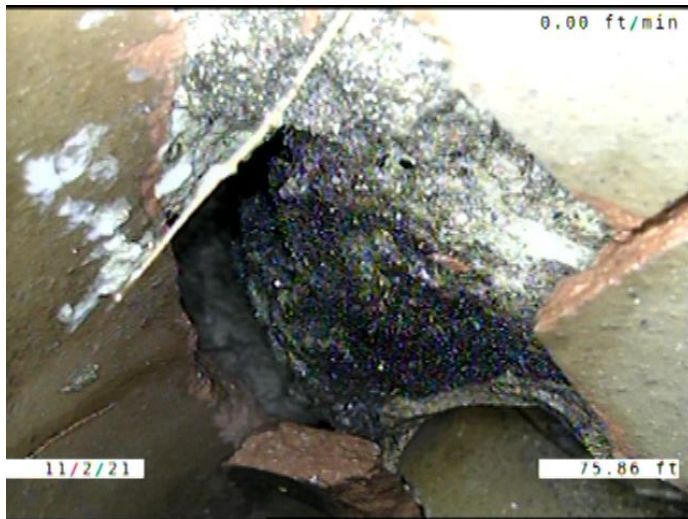
Code: **HVV**  
 Description: **Hole Void Visible**

Distance (ft): **75.9**  
 Structural Grade: **5**  
 O&M Grade: **0**  
 Clock Start/From: **10**  
 Clock To: **11**  
 1st Value:  
 2nd Value:  
 Value Percent:  
 Continuous Index:  
 Within 8" of Joint: **YES**  
 Remarks: **SOIL AND VOID VISIBLE**

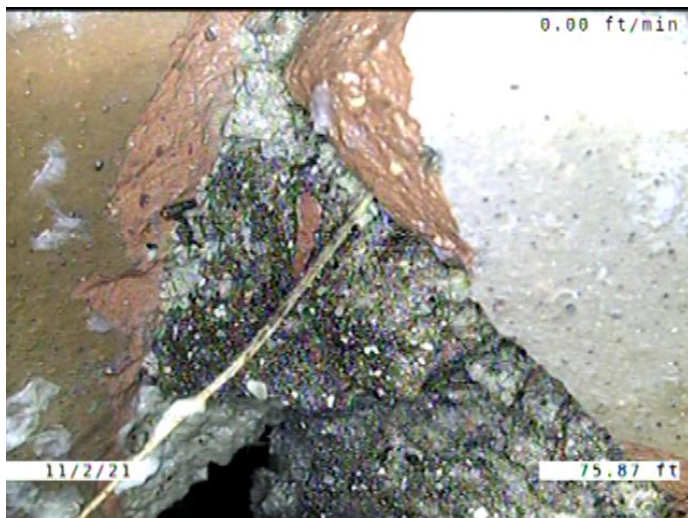
Code: **RFB**  
 Description: **Roots Fine Barrel**

Distance (ft): **75.9**  
 Structural Grade: **0**  
 O&M Grade: **2**  
 Clock Start/From: **10**  
 Clock To:  
 1st Value:  
 2nd Value:  
 Value Percent:  
 Continuous Index:  
 Within 8" of Joint: **NO**  
 Remarks:

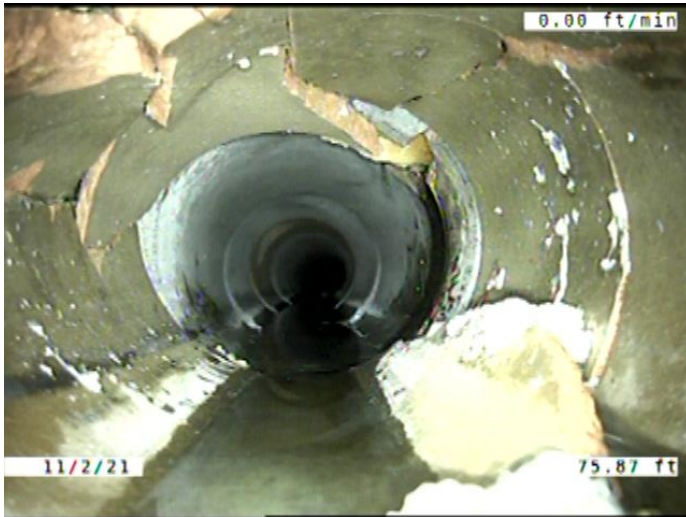
Code: **BSV**  
 Description: **Broken Soil Visible**

Distance (ft): **75.9**  
 Structural Grade: **5**  
 O&M Grade: **0**  
 Clock Start/From: **12**  
 Clock To: **12**  
 1st Value:  
 2nd Value:  
 Value Percent:  
 Continuous Index: **S07**  
 Within 8" of Joint: **YES**  
 Remarks:

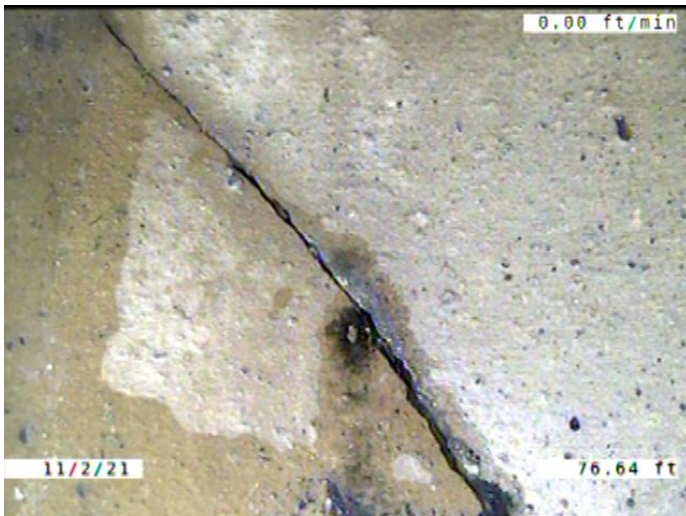
Code: **IWB**  
 Description: **Infiltration Weeper Barrel**

Distance (ft): **76.6**  
 Structural Grade: **0**  
 O&M Grade: **2**  
 Clock Start/From: **3**  
 Clock To:  
 1st Value:  
 2nd Value:  
 Value Percent:  
 Continuous Index:  
 Within 8" of Joint: **YES**  
 Remarks:

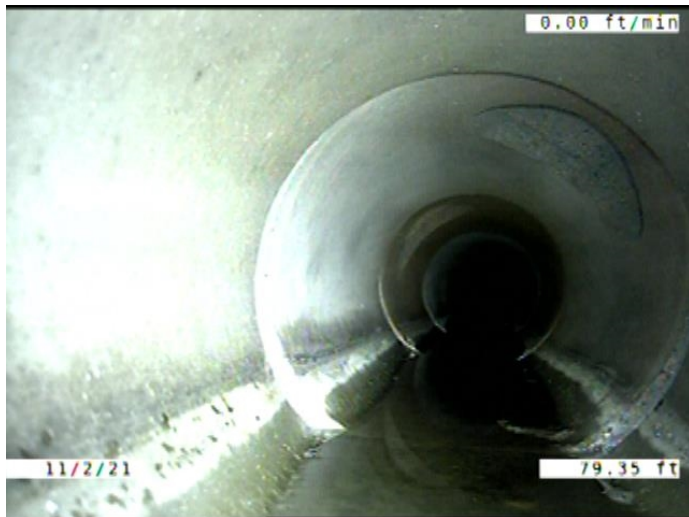
Code: **BSV**  
 Description: **Broken Soil Visible**

Distance (ft): **79.3**  
 Structural Grade: **5**  
 O&M Grade: **0**  
 Clock Start/From: **12**  
 Clock To: **12**  
 1st Value:  
 2nd Value:  
 Value Percent:  
 Continuous Index: **F07**  
 Within 8" of Joint: **YES**  
 Remarks:

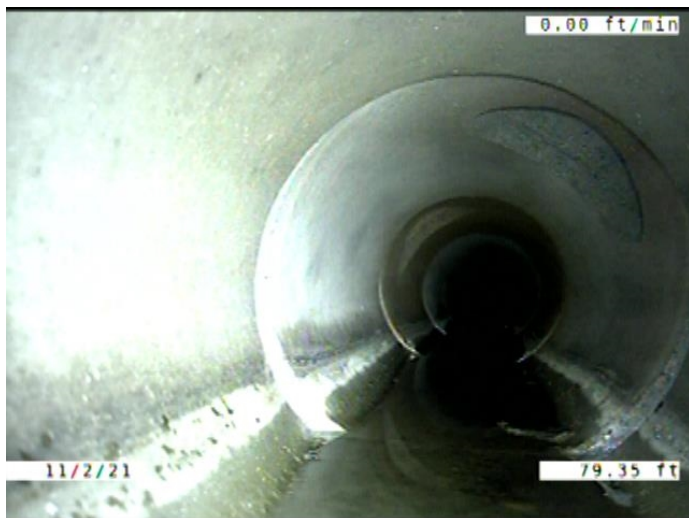
Code: **DR**  
 Description: **Deformed Rigid**

Distance (ft): **79.3**  
 Structural Grade: **5**  
 O&M Grade: **0**  
 Clock Start/From:  
 Clock To:  
 1st Value:  
 2nd Value:  
 Value Percent: **15.000**  
 Continuous Index: **F06**  
 Within 8" of Joint: **NO**  
 Remarks:

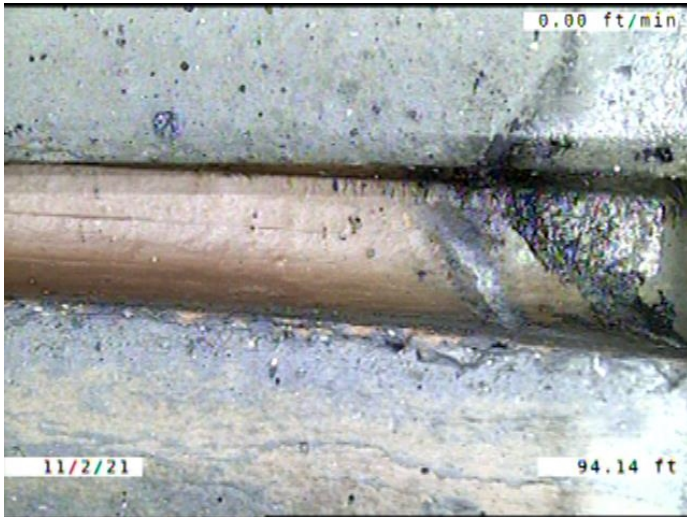
Code: **JAM**  
Description: **Joint Angular Medium**

Distance (ft): **94.1**  
Structural Grade: **3**  
O&M Grade: **0**  
Clock Start/From:  
Clock To:  
1st Value:  
2nd Value:  
Value Percent:  
Continuous Index:  
Within 8" of Joint: **NO**  
Remarks:

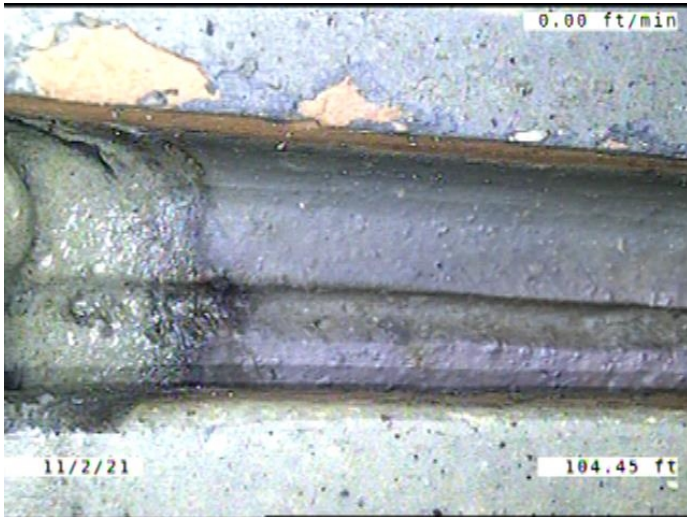
Code: **JAM**  
Description: **Joint Angular Medium**

Distance (ft): **104.4**  
Structural Grade: **3**  
O&M Grade: **0**  
Clock Start/From:  
Clock To:  
1st Value:  
2nd Value:  
Value Percent:  
Continuous Index:  
Within 8" of Joint: **NO**  
Remarks:

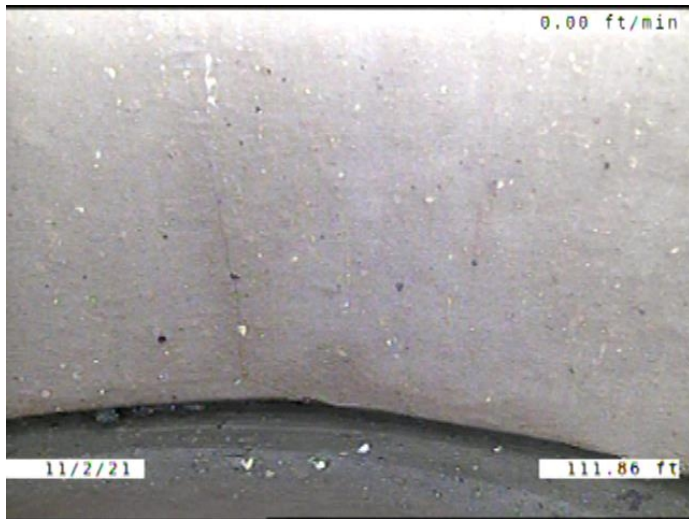
Code: **CL**  
 Description: **Crack Longitudinal**

Distance (ft): **111.9**  
 Structural Grade: **2**  
 O&M Grade: **0**  
 Clock Start/From: **2**  
 Clock To:  
 1st Value:  
 2nd Value:  
 Value Percent:  
 Continuous Index:  
 Within 8" of Joint: **YES**  
 Remarks:

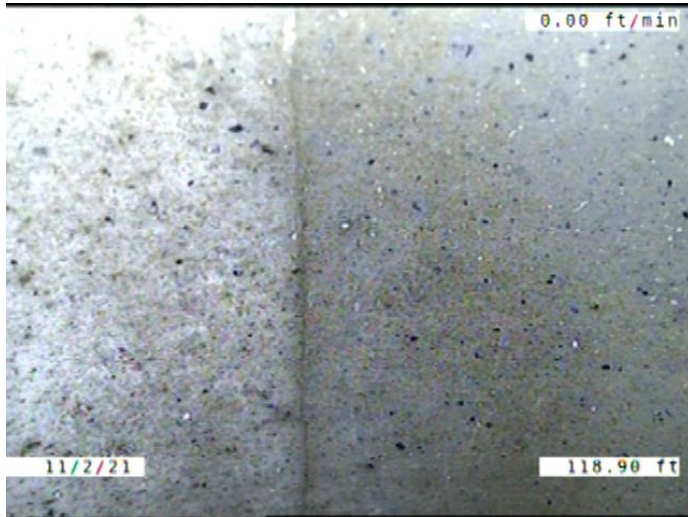
Code: **CM**  
 Description: **Crack Multiple**

Distance (ft): **118.9**  
 Structural Grade: **3**  
 O&M Grade: **0**  
 Clock Start/From: **11**  
 Clock To: **12**  
 1st Value:  
 2nd Value:  
 Value Percent:  
 Continuous Index:  
 Within 8" of Joint: **YES**  
 Remarks:

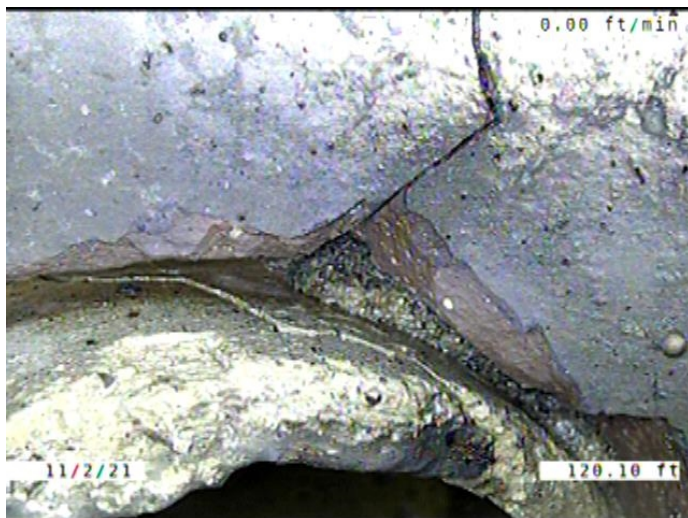
Code: **SSC**  
 Description: **Surface Spalling of Damage Coating**

Distance (ft): **120.1**  
 Structural Grade: **1**  
 O&M Grade: **0**  
 Clock Start/From: **11**  
 Clock To: **1**  
 1st Value:  
 2nd Value:  
 Value Percent:  
 Continuous Index:  
 Within 8" of Joint: **YES**  
 Remarks:

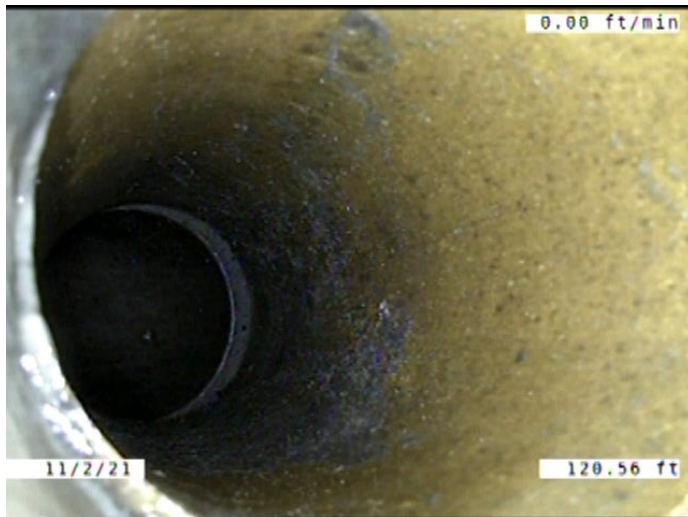
Code: **TBI**  
Description: **Tap Break-in Intruding**

Distance (ft): **120.6**  
Structural Grade: **0**  
O&M Grade: **2**  
Clock Start/From: **11**  
Clock To:  
1st Value: **4.000**  
2nd Value: **1.000**  
Value Percent:  
Continuous Index:  
Within 8" of Joint: **YES**  
Remarks: **CONSTANTLY RUNNING WATER.**

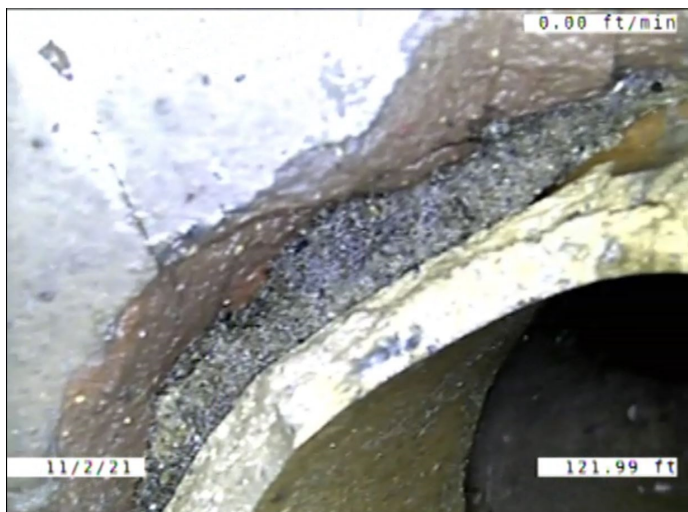
Code: **CM**  
Description: **Crack Multiple**

Distance (ft): **122.0**  
Structural Grade: **3**  
O&M Grade: **0**  
Clock Start/From: **12**  
Clock To: **2**  
1st Value:  
2nd Value:  
Value Percent:  
Continuous Index:  
Within 8" of Joint: **NO**  
Remarks:

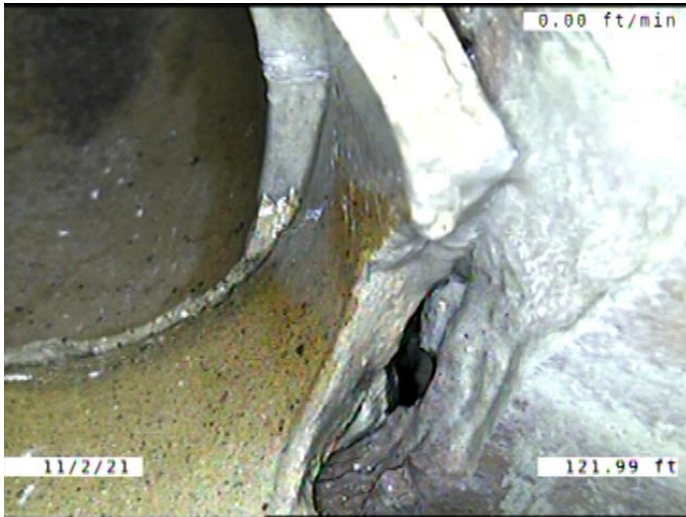
Code: **BSV**  
 Description: **Broken Soil Visible**

Distance (ft): **122.0**  
 Structural Grade: **5**  
 O&M Grade: **0**  
 Clock Start/From: **12**  
 Clock To: **2**  
 1st Value:  
 2nd Value:  
 Value Percent:  
 Continuous Index:  
 Within 8" of Joint: **YES**  
 Remarks:

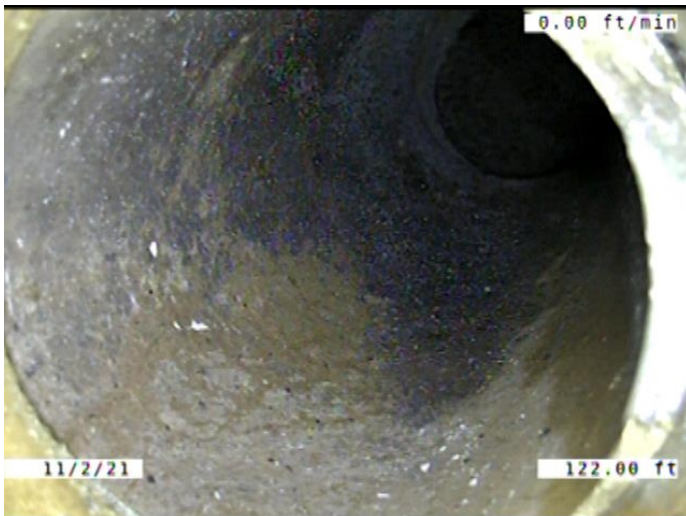
Code: **TBI**  
 Description: **Tap Break-in Intruding**

Distance (ft): **122.0**  
 Structural Grade: **0**  
 O&M Grade: **2**  
 Clock Start/From: **1**  
 Clock To:  
 1st Value: **4.000**  
 2nd Value: **1.000**  
 Value Percent:  
 Continuous Index:  
 Within 8" of Joint: **YES**  
 Remarks: **CONSTANTLY RUNNING WATER.**

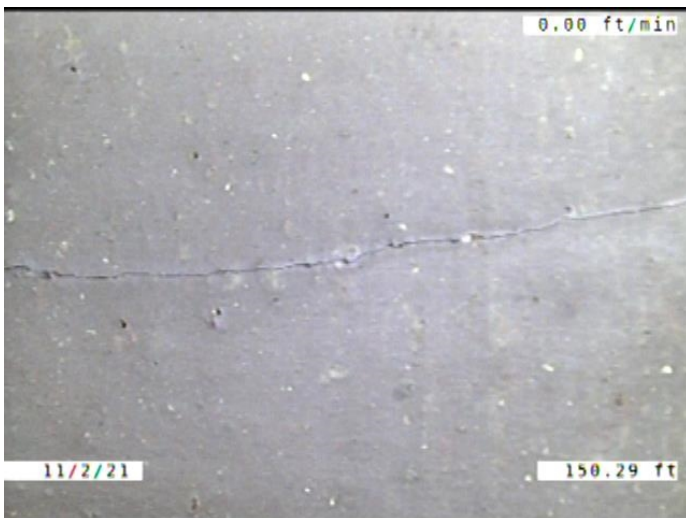
Code: **CM**  
Description: **Crack Multiple**

Distance (ft): **150.3**  
Structural Grade: **3**  
O&M Grade: **0**  
Clock Start/From: **12**  
Clock To: **12**  
1st Value:  
2nd Value:  
Value Percent:  
Continuous Index:  
Within 8" of Joint: **NO**  
Remarks:

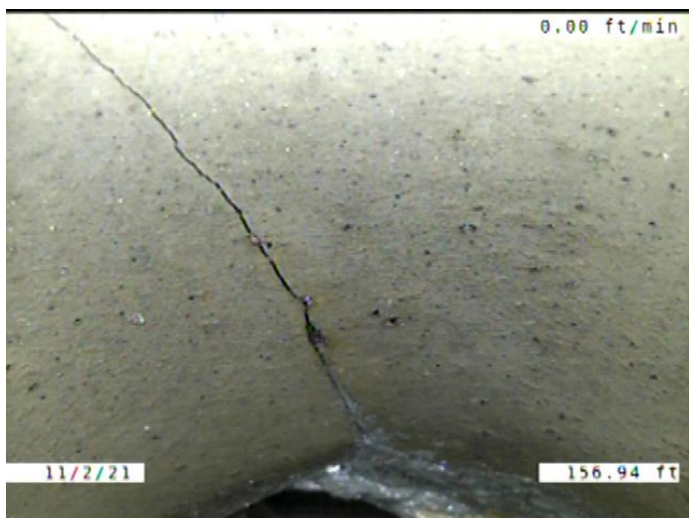
Code: **B**  
 Description: **Broken**

Distance (ft): **156.9**  
 Structural Grade: **4**  
 O&M Grade: **0**  
 Clock Start/From: **10**  
 Clock To: **4**  
 1st Value:  
 2nd Value:  
 Value Percent:  
 Continuous Index: **S09**  
 Within 8" of Joint: **YES**  
 Remarks:

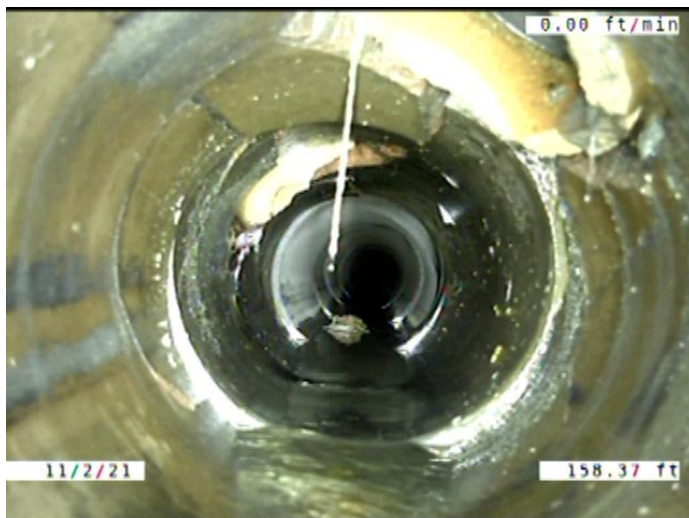
Code:	<b>DR</b>
Description:	<b>Deformed Rigid</b>
Distance (ft):	<b>158.4</b>
Structural Grade:	<b>4</b>
O&M Grade:	<b>0</b>
Clock Start/From:	
Clock To:	
1st Value:	
2nd Value:	
Value Percent:	<b>5.000</b>
Continuous Index:	
Within 8" of Joint:	<b>NO</b>
Remarks:

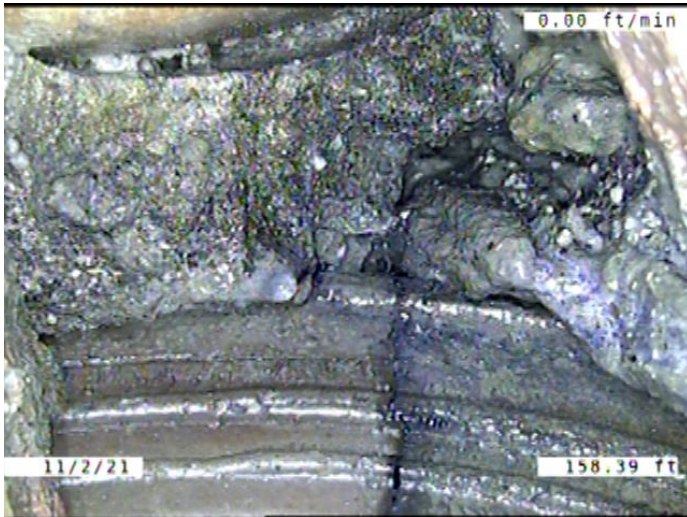
Code: **HSV**  
 Description: **Hole Soil Visible**

Distance (ft): **158.4**  
 Structural Grade: **5**  
 O&M Grade: **0**  
 Clock Start/From: **12**  
 Clock To: **1**  
 1st Value:  
 2nd Value:  
 Value Percent:  
 Continuous Index:  
 Within 8" of Joint: **YES**  
 Remarks:

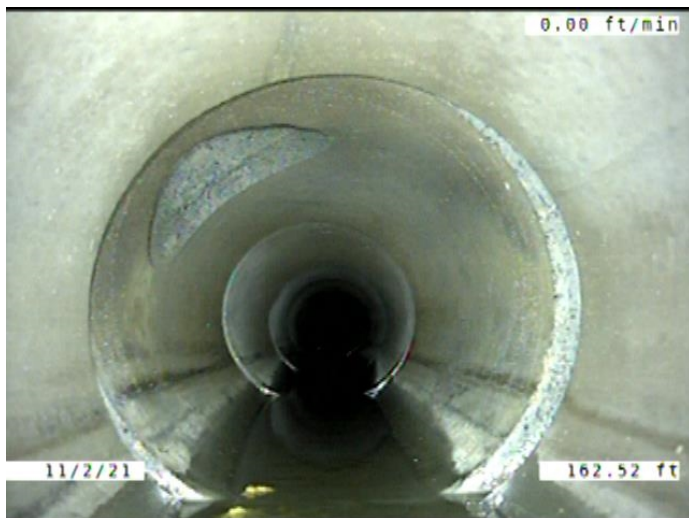
Code: **B**  
 Description: **Broken**

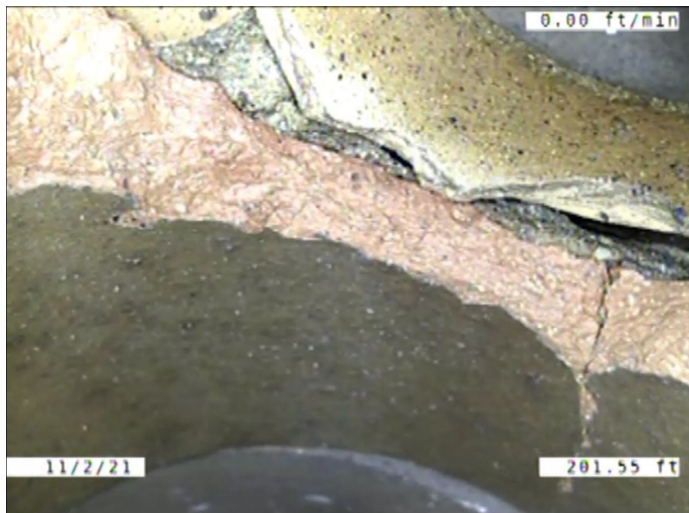
Code: **FL**  
 Description: **Fracture Longitudinal**

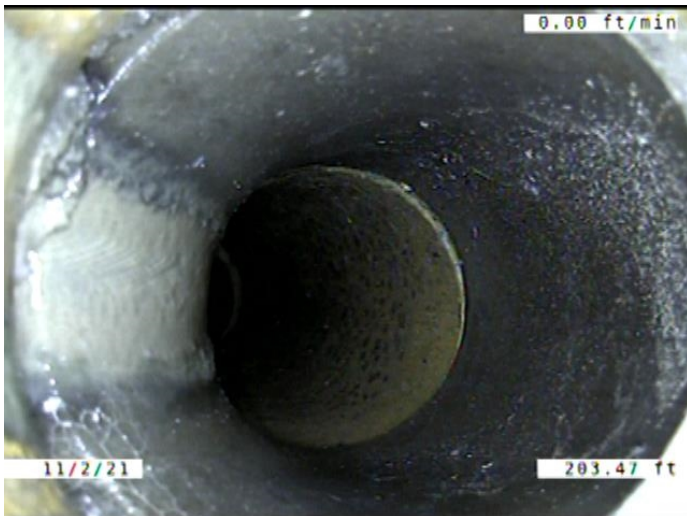
Code:	<b>TBD</b>
Description:	<b>Tap Break-in/Hammer Defective</b>
Distance (ft):	<b>203.5</b>
Structural Grade:	<b>0</b>
O&M Grade:	<b>3</b>
Clock Start/From:	<b>10</b>
Clock To:	
1st Value:	<b>4.000</b>
2nd Value:	
Value Percent:	
Continuous Index:	
Within 8" of Joint:	<b>YES</b>
Remarks:	<b>CONSTANTLY RUNNING WATER.</b>
