## Profile/Photo Observation Report

Street:	<b>N DELAWARE ST &amp; N COLORADO ST</b>	Flow Control:	<b>Not Controlled</b>
City:	<b>Hobart, IN</b>	Year Renewed:	
Location:	<b>Light Highway</b>	Tape/Media #:	
Purpose:	<b>Not Known</b>	Dia/Height:	<b>12"</b>
Use:	<b>Sanitary</b>	Material:	<b>VCP</b>
Drain Area:	<b>NA</b>	Lining:	
Category:	<b>NA</b>		
Comment:

Location Details:		Direction of Survey:	<b>Downstream</b>
US MH:	<b>M-504-045</b>	DS MH:	<b>M-504-046</b>
		Total Length Surveyed (ft):	<b>101.7</b>

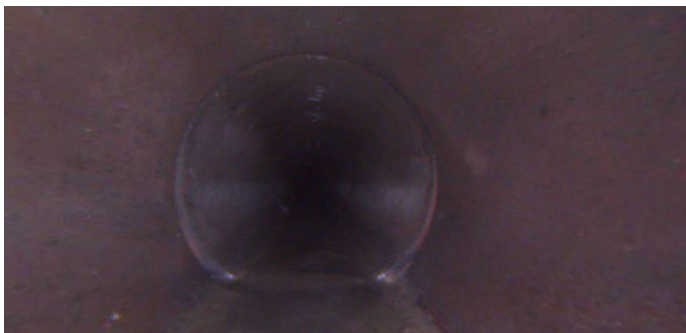
Code: **AMH**  
Description: **Manhole**

Distance (ft): **.0**  
Structural Grade: **0**  
O&M Grade: **0**  
Clock Start/From:  
Clock To:  
1st Value:  
2nd Value:  
Value Percent:  
Continuous Index:  
Within 8" of Joint: **NO**  
Remarks: **M-504-045**

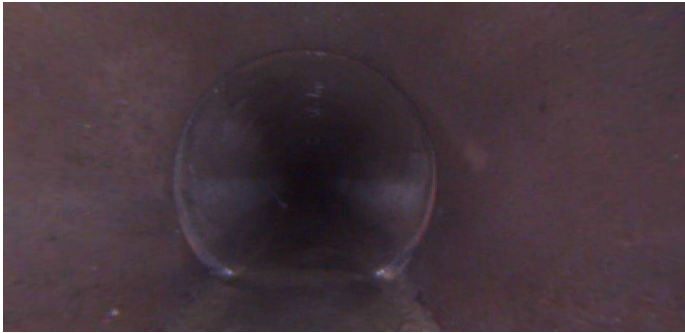
Code:	<b>MWL</b>
Description:	<b>Water Level</b>

Distance (ft):	<b>.0</b>
Structural Grade:	<b>0</b>
O&M Grade:	<b>0</b>
Clock Start/From:	
Clock To:	
1st Value:	
2nd Value:	
Value Percent:	<b>5.000</b>
Continuous Index:	
Within 8" of Joint:	<b>NO</b>
Remarks:

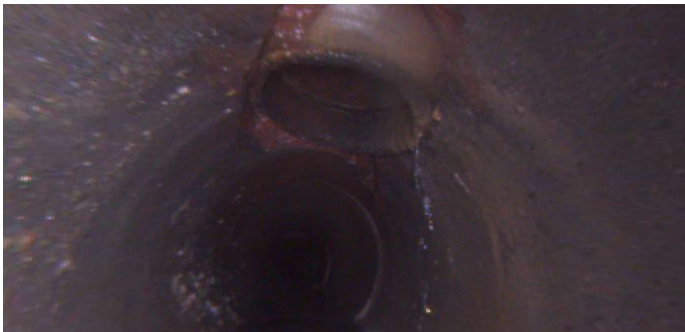
Code:	<b>TB</b>
Description:	<b>Tap Break-in</b>

Distance (ft):	<b>12.9</b>
Structural Grade:	<b>0</b>
O&M Grade:	<b>0</b>
Clock Start/From:	<b>1</b>
Clock To:	
1st Value:	<b>4.000</b>
2nd Value:	
Value Percent:	
Continuous Index:	
Within 8" of Joint:	<b>YES</b>
Remarks:

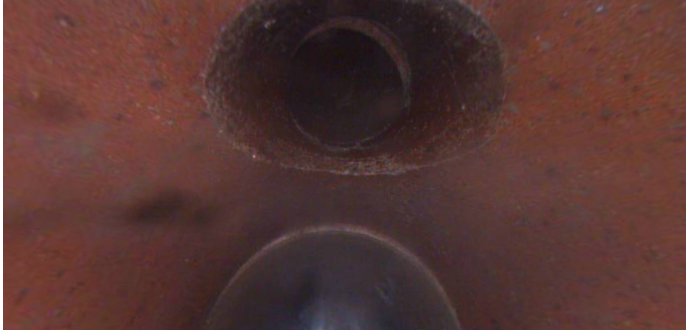
Code: **TF**  
Description: **Tap Factory**

Distance (ft): **18.3**  
Structural Grade: **0**  
O&M Grade: **0**  
Clock Start/From: **12**  
Clock To:  
1st Value: **4.000**  
2nd Value:  
Value Percent:  
Continuous Index:  
Within 8" of Joint:  
Remarks:

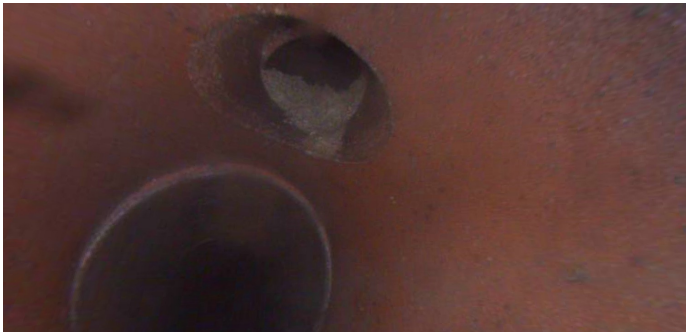
Code: **TF**  
Description: **Tap Factory**

Distance (ft): **35.7**  
Structural Grade: **0**  
O&M Grade: **0**  
Clock Start/From: **11**  
Clock To:  
1st Value: **4.000**  
2nd Value:  
Value Percent:  
Continuous Index:  
Within 8" of Joint:  
Remarks:

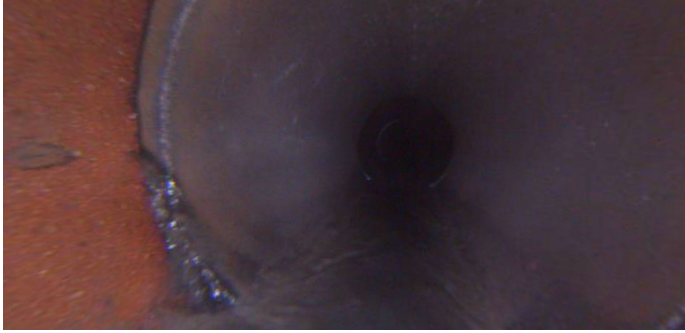
Code: **IW**  
Description: **Infil Weeper**

Distance (ft): **35.7**  
Structural Grade: **0**  
O&M Grade: **2**  
Clock Start/From: **7**  
Clock To: **9**  
1st Value:  
2nd Value:  
Value Percent:  
Continuous Index:  
Within 8" of Joint: **YES**  
Remarks:

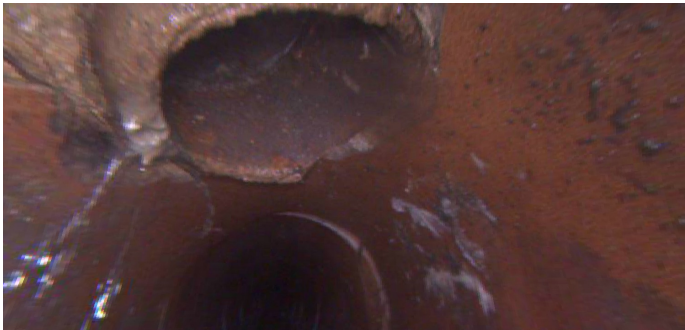
Code: **TBI**  
Description: **Tap Break-in Intruding**

Distance (ft): **47.9**  
Structural Grade: **0**  
O&M Grade: **2**  
Clock Start/From: **12**  
Clock To:  
1st Value: **4.000**  
2nd Value: **1.000**  
Value Percent:  
Continuous Index:  
Within 8" of Joint:  
Remarks:

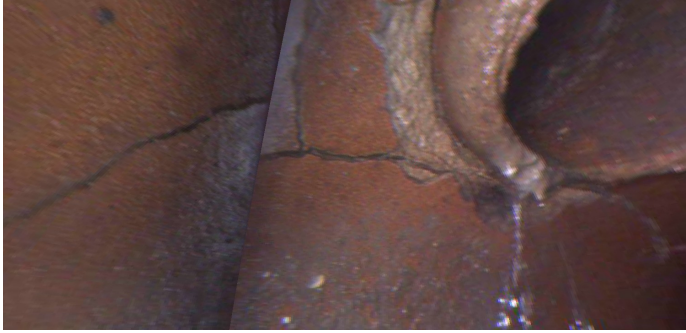
Code: **FM**  
Description: **Fracture Multiple**

Distance (ft): **47.9**  
Structural Grade: **4**  
O&M Grade: **0**  
Clock Start/From: **7**  
Clock To: **11**  
1st Value:  
2nd Value:  
Value Percent:  
Continuous Index:  
Within 8" of Joint: **YES**  
Remarks:

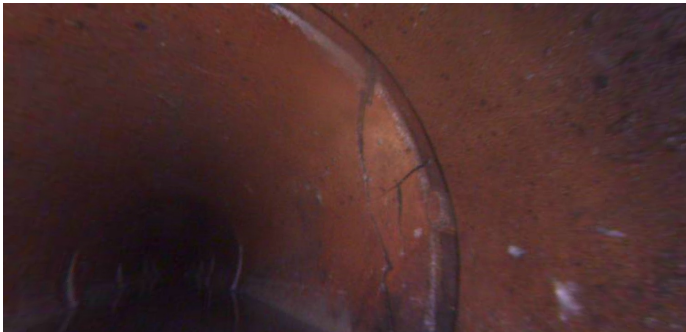
Code: **FM**  
Description: **Fracture Multiple**

Distance (ft): **49.0**  
Structural Grade: **4**  
O&M Grade: **0**  
Clock Start/From: **2**  
Clock To: **4**  
1st Value:  
2nd Value:  
Value Percent:  
Continuous Index:  
Within 8" of Joint: **YES**  
Remarks:

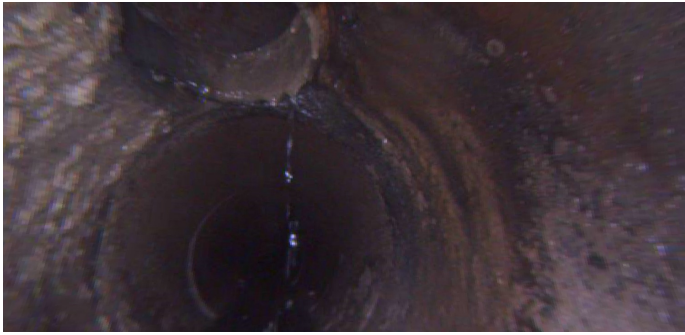
Code: **TBI**  
Description: **Tap Break-in Intruding**

Distance (ft): **64.0**  
Structural Grade: **0**  
O&M Grade: **2**  
Clock Start/From: **11**  
Clock To:  
1st Value: **4.000**  
2nd Value: **1.000**  
Value Percent:  
Continuous Index:  
Within 8" of Joint:  
Remarks:

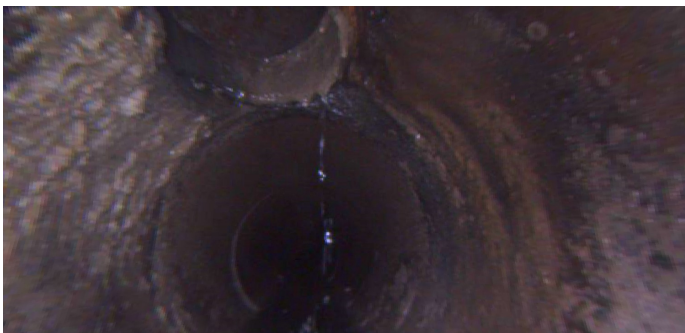
Code: **DAGS**  
Description: **Deposits Attached Grease**

Distance (ft): **64.0**  
Structural Grade: **0**  
O&M Grade: **2**  
Clock Start/From: **7**  
Clock To: **5**  
1st Value:  
2nd Value:  
Value Percent: **5.000**  
Continuous Index:  
Within 8" of Joint: **NO**  
Remarks:

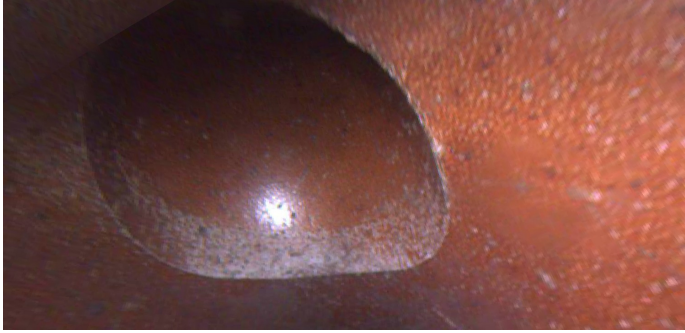
Code: **TF**  
Description: **Tap Factory**

Distance (ft): **72.1**  
Structural Grade: **0**  
O&M Grade: **0**  
Clock Start/From: **12**  
Clock To:  
1st Value: **4.000**  
2nd Value:  
Value Percent:  
Continuous Index:  
Within 8" of Joint:  
Remarks:

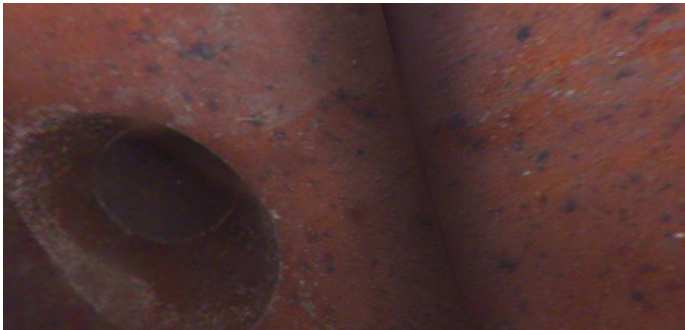
Code: **TF**  
Description: **Tap Factory**

Distance (ft): **74.8**  
Structural Grade: **0**  
O&M Grade: **0**  
Clock Start/From: **11**  
Clock To:  
1st Value: **4.000**  
2nd Value:  
Value Percent:  
Continuous Index:  
Within 8" of Joint: **YES**  
Remarks:

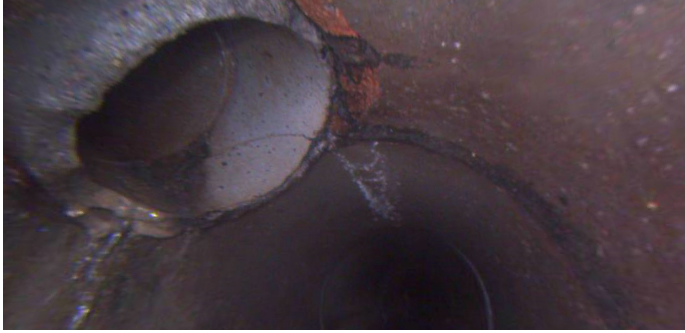
Code: **TBI**  
Description: **Tap Break-in Intruding**

Distance (ft): **76.1**  
Structural Grade: **0**  
O&M Grade: **2**  
Clock Start/From: **10**  
Clock To:  
1st Value: **4.000**  
2nd Value: **1.000**  
Value Percent:  
Continuous Index:  
Within 8" of Joint:  
Remarks: **active**

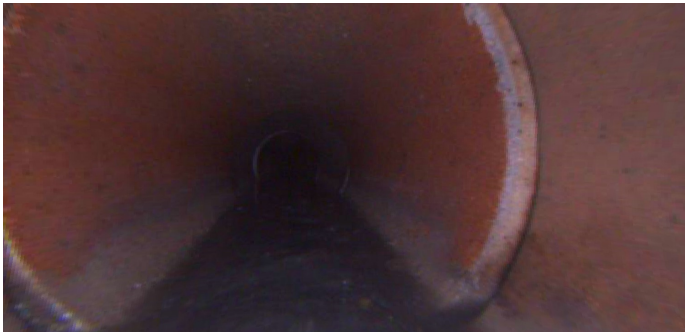
Code: **MSA**  
Description: **Abandoned Survey**

Distance (ft): **101.7**  
Structural Grade: **0**  
O&M Grade: **0**  
Clock Start/From:  
Clock To:  
1st Value:  
2nd Value:  
Value Percent:  
Continuous Index:  
Within 8" of Joint: **NO**  
Remarks: **no blockage**
