Profile/Photo Observation Report

Date:	04/18/2018	Weather:		Coding:	PACP 6.0
Pipe Length (ft):	159.0	Owner:	NA	Pre Clean:	Not Known
P.O.#:		Surveyor:	Byrd Fitzgerald	PSR:	P-504-046-045
Customer:		Clean Date:	01/01/1900	Shape:	C

Street:	Summerlin	Flow Control:	Not Controlled
City:	Hobart, IN	Year Renewed:	
Location:	Light Highway	Tape/Media #:	
Purpose:	Not Known	Dia/Height:	12"
Use:	Sanitary	Material:	VCP
Drain Area:	NA	Lining:	
Category:	NA		
Comment:

Location Details:		Direction of Survey:	Upstream
US MH:	M-504-045	DS MH:	M-504-046
		Total Length Surveyed (ft):	39.1

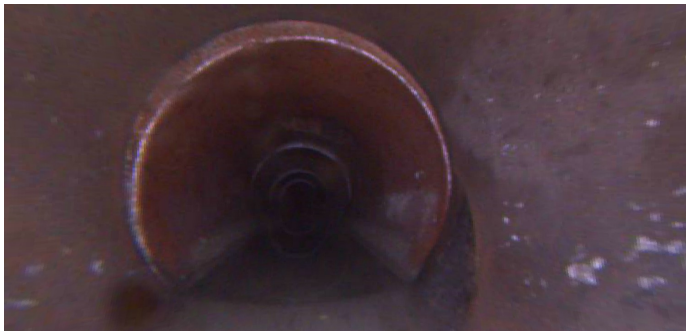
Code: **AMH**
Description: **Manhole**

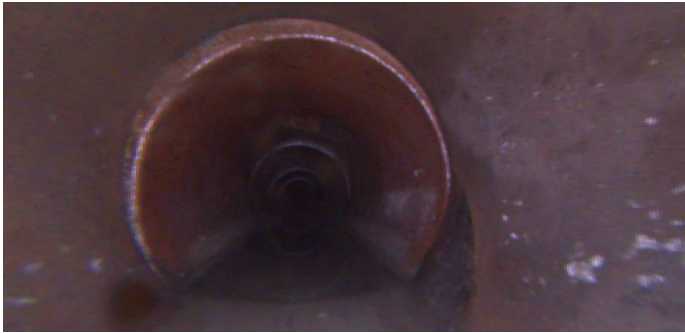
Code:	MWL
Description:	Water Level

Distance (ft):	.0
Structural Grade:	0
O&M Grade:	0
Clock Start/From:	
Clock To:	
1st Value:	
2nd Value:	
Value Percent:	5.000
Continuous Index:	
Within 8" of Joint:	NO
Remarks:

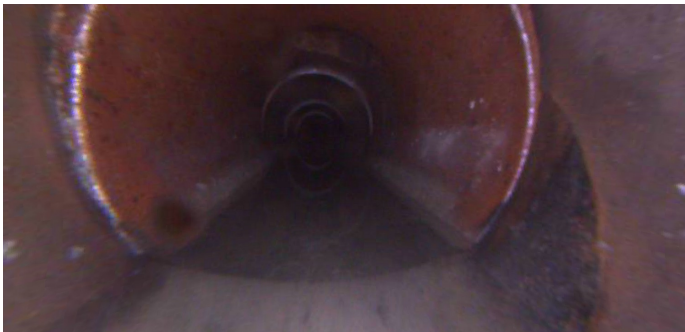
Code:	FC
Description:	Fracture Circumferential

Distance (ft):	.3
Structural Grade:	2
O&M Grade:	0
Clock Start/From:	3
Clock To:	5
1st Value:	
2nd Value:	
Value Percent:	
Continuous Index:	
Within 8" of Joint:	YES
Remarks:

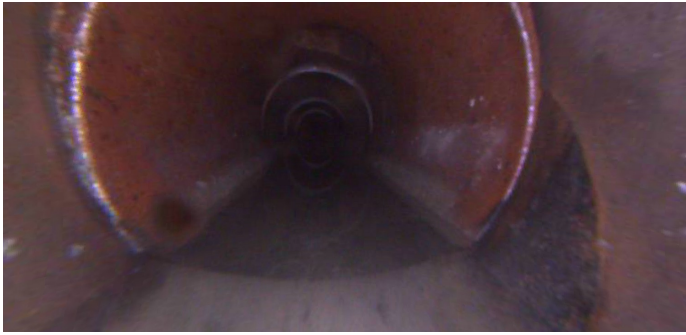
Code: **IW**
Description: **Infil Weeper**

Distance (ft): **.3**
Structural Grade: **0**
O&M Grade: **2**
Clock Start/From: **3**
Clock To: **4**
1st Value:
2nd Value:
Value Percent:
Continuous Index:
Within 8" of Joint: **YES**
Remarks:

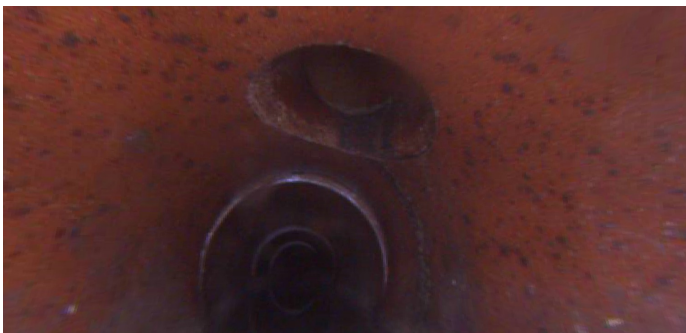
Code: **TF**
Description: **Tap Factory**

Distance (ft): **2.5**
Structural Grade: **0**
O&M Grade: **0**
Clock Start/From: **1**
Clock To:
1st Value: **4.000**
2nd Value:
Value Percent:
Continuous Index:
Within 8" of Joint: **YES**
Remarks:

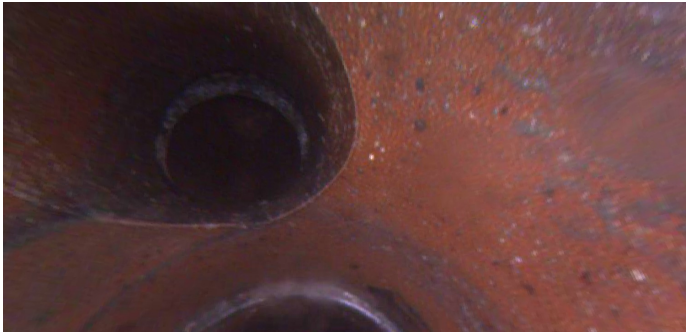
Code: **TF**
Description: **Tap Factory**

Distance (ft): **4.9**
Structural Grade: **0**
O&M Grade: **0**
Clock Start/From: **11**
Clock To:
1st Value: **4.000**
2nd Value:
Value Percent:
Continuous Index:
Within 8" of Joint: **YES**
Remarks:

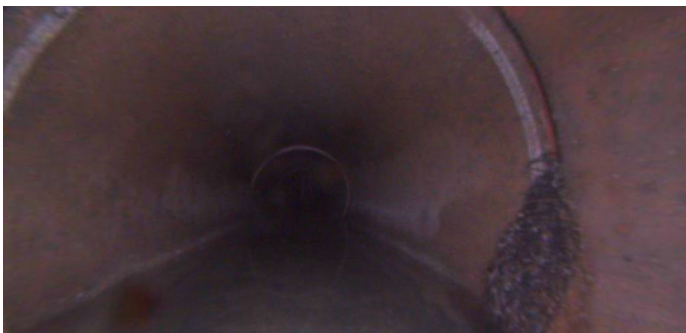
Code: **RFJ**
Description: **Roots Fine Joint**

Distance (ft): **28.2**
Structural Grade: **0**
O&M Grade: **1**
Clock Start/From: **3**
Clock To: **4**
1st Value:
2nd Value:
Value Percent:
Continuous Index:
Within 8" of Joint: **YES**
Remarks:

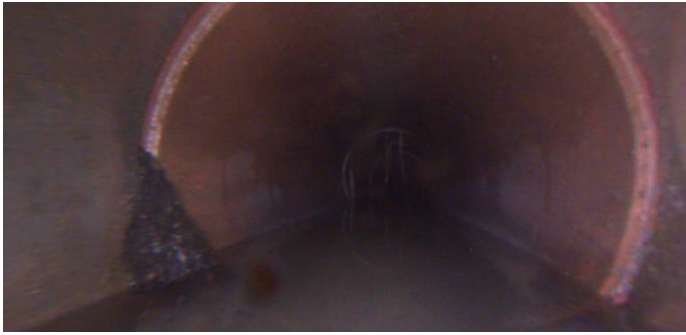
Code: **RFJ**
Description: **Roots Fine Joint**

Distance (ft): **30.6**
Structural Grade: **0**
O&M Grade: **1**
Clock Start/From: **8**
Clock To: **9**
1st Value:
2nd Value:
Value Percent:
Continuous Index:
Within 8" of Joint: **YES**
Remarks:

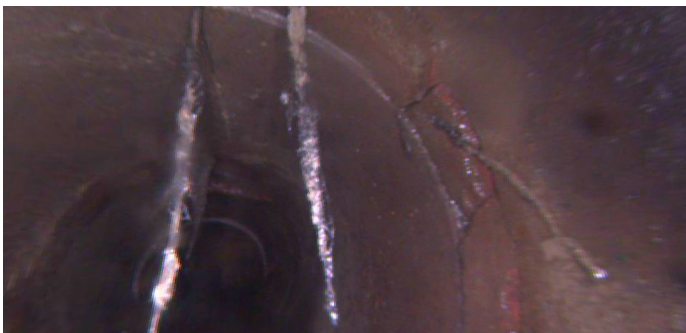
Code: **FM**
Description: **Fracture Multiple**

Distance (ft): **33.3**
Structural Grade: **4**
O&M Grade: **0**
Clock Start/From: **2**
Clock To: **3**
1st Value:
2nd Value:
Value Percent:
Continuous Index:
Within 8" of Joint: **YES**
Remarks:

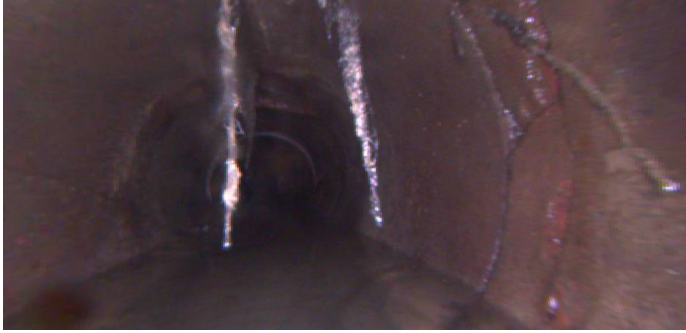
Code: **RFJ**
Description: **Roots Fine Joint**

Distance (ft): **33.3**
Structural Grade: **0**
O&M Grade: **1**
Clock Start/From: **7**
Clock To: **1**
1st Value:
2nd Value:
Value Percent:
Continuous Index:
Within 8" of Joint: **YES**
Remarks:

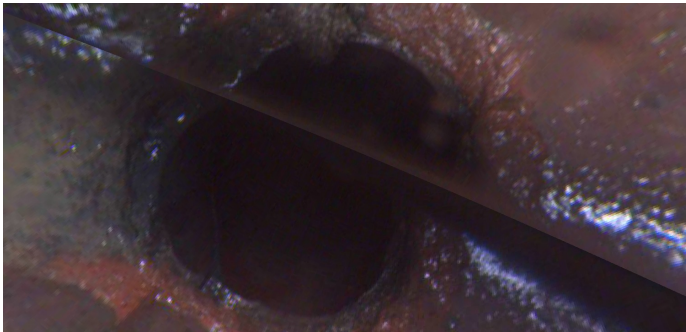
Code: **TB**
Description: **Tap Break-in**

Distance (ft): **34.9**
Structural Grade: **0**
O&M Grade: **0**
Clock Start/From: **1**
Clock To:
1st Value: **4.000**
2nd Value:
Value Percent:
Continuous Index:
Within 8" of Joint:
Remarks:

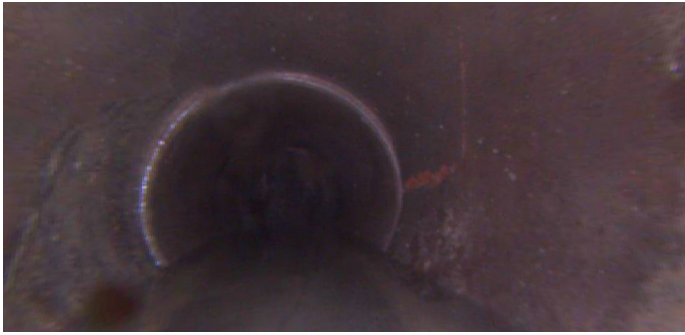
Code: **FM**
Description: **Fracture Multiple**

Distance (ft): **35.1**
Structural Grade: **4**
O&M Grade: **0**
Clock Start/From: **7**
Clock To: **3**
1st Value:
2nd Value:
Value Percent:
Continuous Index:
Within 8" of Joint: **YES**
Remarks:

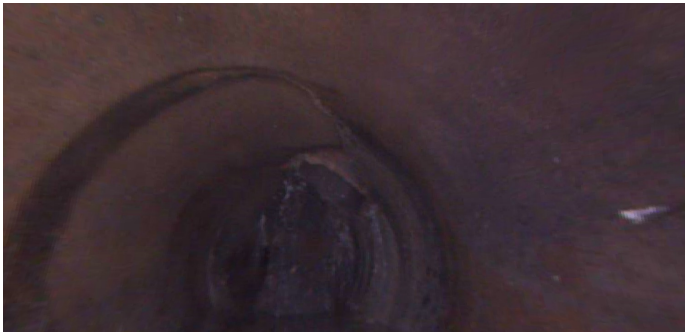
Code: **FC**
Description: **Fracture Circumferential**

Distance (ft): **36.7**
Structural Grade: **2**
O&M Grade: **0**
Clock Start/From: **7**
Clock To: **5**
1st Value:
2nd Value:
Value Percent:
Continuous Index:
Within 8" of Joint:
Remarks:

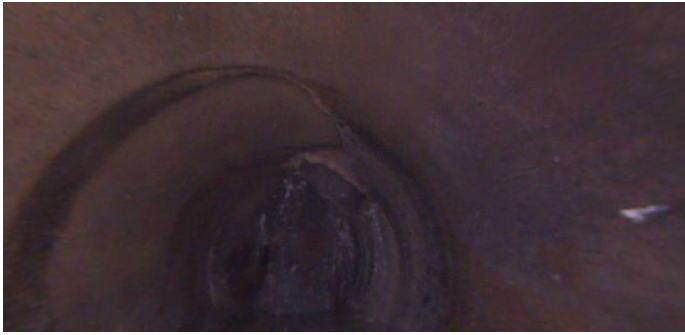
Code: **IW**
Description: **Infil Weeper**

Distance (ft): **36.7**
Structural Grade: **0**
O&M Grade: **2**
Clock Start/From: **8**
Clock To: **4**
1st Value:
2nd Value:
Value Percent:
Continuous Index:
Within 8" of Joint:
Remarks:

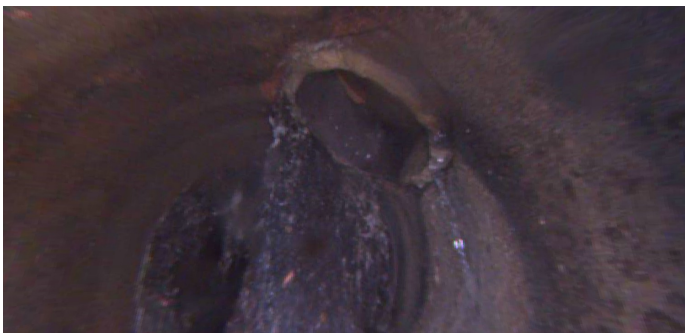
Code: **TBD**
Description: **Tap Break-in Defective**

Distance (ft): **37.5**
Structural Grade: **0**
O&M Grade: **3**
Clock Start/From: **1**
Clock To:
1st Value: **4.000**
2nd Value:
Value Percent:
Continuous Index:
Within 8" of Joint:
Remarks: **roots**

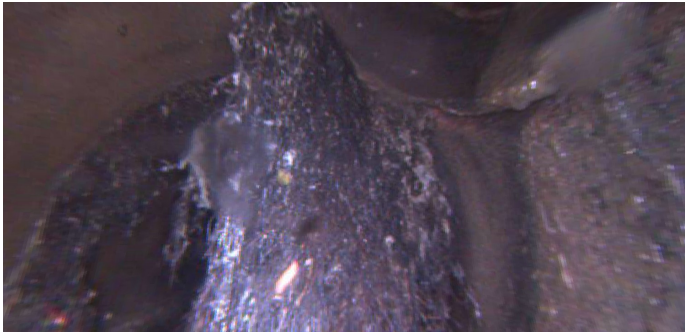
Code: **RBC**
Description: **Roots Ball Connection**

Distance (ft): **38.0**
Structural Grade: **0**
O&M Grade: **4**
Clock Start/From: **12**
Clock To: **5**
1st Value:
2nd Value:
Value Percent: **55.000**
Continuous Index:
Within 8" of Joint: **NO**
Remarks:

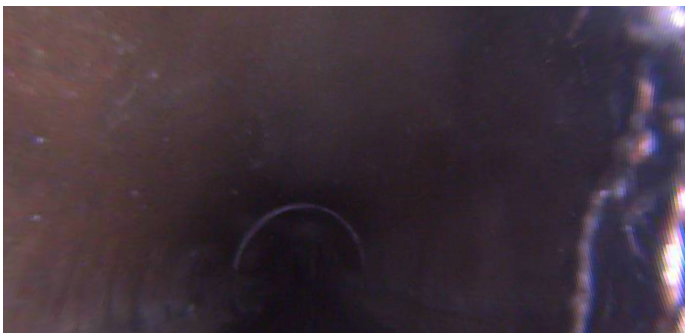
Code: **MSA**
Description: **Abandoned Survey**

Distance (ft): **39.1**
Structural Grade: **0**
O&M Grade: **0**
Clock Start/From:
Clock To:
1st Value:
2nd Value:
Value Percent:
Continuous Index:
Within 8" of Joint: **NO**
Remarks: **rbc**
