Profile/Photo Observation Report

Date: 10/30/2021 Weather: **PACP 7.0** Coding: Pipe Length (ft): 170.1 Owner: **City of Hobart** Pre Clean: **Heavy Cleaning** P.O.#: YES502259 S. Bucklin PSR: P-504-046-045 Surveyor:

North Colorado Street Flow Control: **Not Controlled** Street:

US MH: M-504-045 DS MH: M-504-046 Total Length Surveyed (ft): 170.1

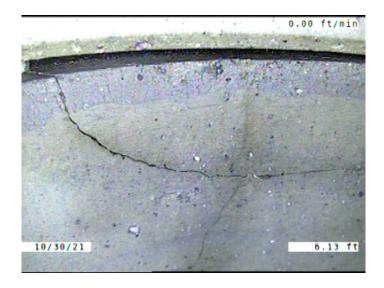
Code: CM

Description: Crack Multiple

Distance (ft): 6.1
Structural Grade: 3
O&M Grade: 0
Clock Start/From: 9
Clock To: 1

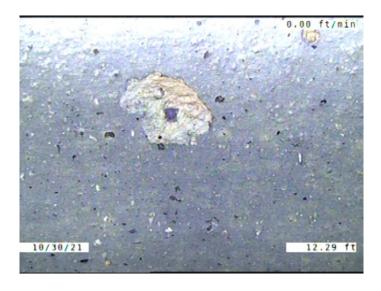
Code: SSS

Description: Surface Damage Surface Spalling

Distance (ft): 12.3
Structural Grade: 2
O&M Grade: 0
Clock Start/From: 9
Clock To:
1st Value:

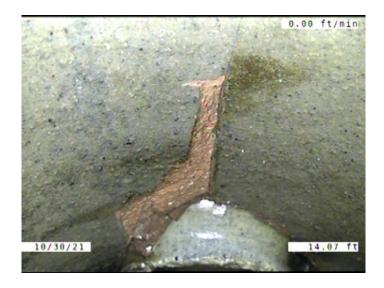
Code: **FM**

Description: Fracture Multiple

Distance (ft): 14.1
Structural Grade: 4

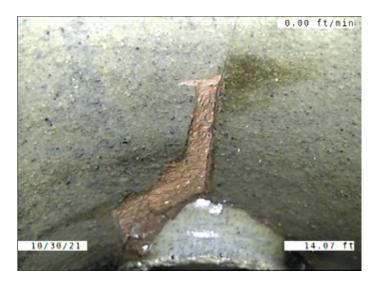
Code: SSS

Description: Surface Damage Surface Spalling

Distance (ft): 14.1
Structural Grade: 2
O&M Grade: 0
Clock Start/From: 12

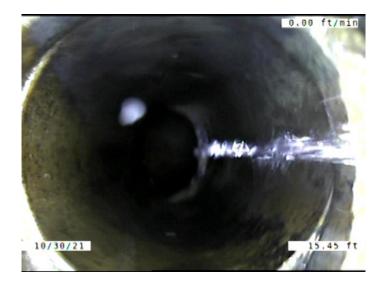
Code: **TBI**

Description: Tap Break-in Intruding

Distance (ft): 15.4
Structural Grade: 0

Remarks: CONSTANTLY RUNNING WATER.

OFFSET JOINT

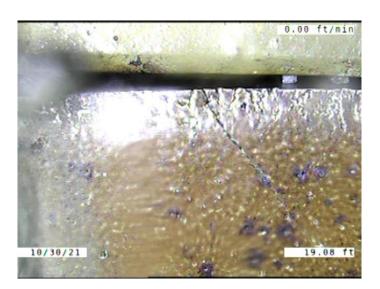
Code: CM

Description: Crack Multiple

Distance (ft): 19.1
Structural Grade: 3
O&M Grade: 0
Clock Start/From: 9
Clock To: 11
1st Value:
2nd Value:
Value Percent:

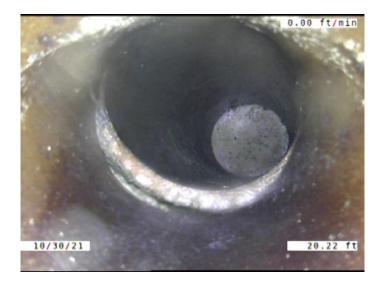
Code: **TFD**

Description: Tap Factory Defective

Distance (ft): 20.2
Structural Grade: 0
O&M Grade: 3
Clock Start/From: 12

Remarks: CAPPED. OFFSET JIONT

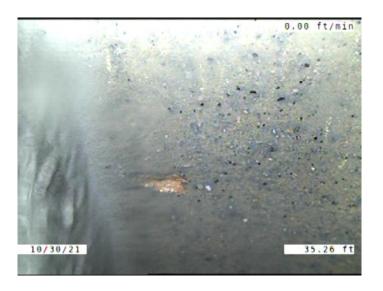
Code: SSS

Description: Surface Damage Surface Spalling

Distance (ft): 35.3
Structural Grade: 2
O&M Grade: 0
Clock Start/From: 7
Clock To: 8
1st Value:
2nd Value:
Value Percent:
Continuous Index:

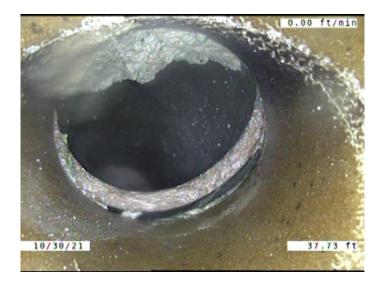
Code: **TFD**

Description: **Tap Factory Defective**

Distance (ft): 37.7 Structural Grade: 0 3 O&M Grade: Clock Start/From: 11

Remarks: **OFFSET JOINT**

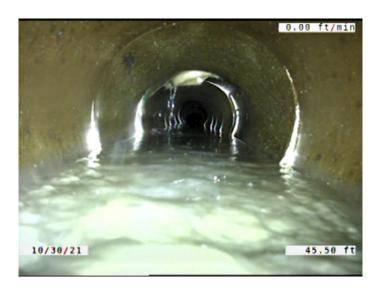
Code: **MWLS**

Description: **Miscellaneous Water Level Sag**

45.5 Distance (ft): Structural Grade: 2 O&M Grade: 0

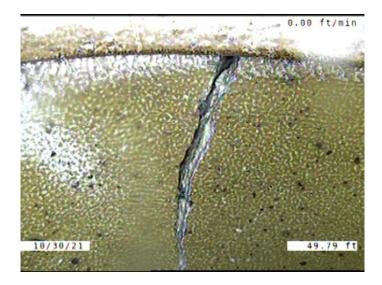
Code: B
Description: Broken

Distance (ft): 49.8
Structural Grade: 4

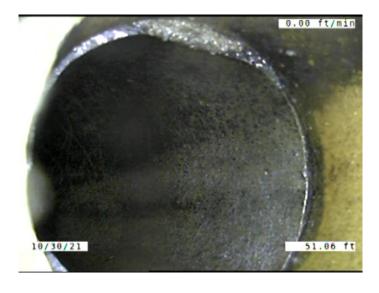
Code: TBI

Description: Tap Break-in Intruding

Distance (ft): 51.1
Structural Grade: 0
O&M Grade: 2
Clock Start/From: 11

Remarks: CONSTANTLY RUNNING WATER

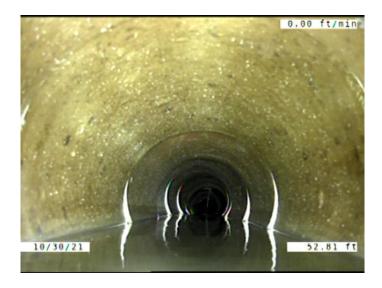
Code: Description: Broken

Distance (ft): 52.8 Structural Grade: 4 0 O&M Grade: Clock Start/From: 8 Clock To: 4 1st Value:

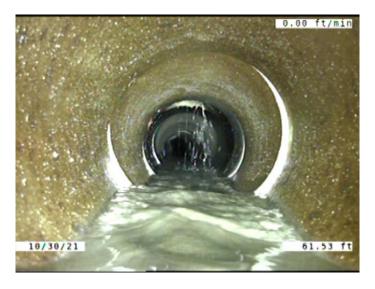
Code: **MWLS**

Description: **Miscellaneous Water Level Sag**

Distance (ft): 61.5 Structural Grade: 2 O&M Grade: 0

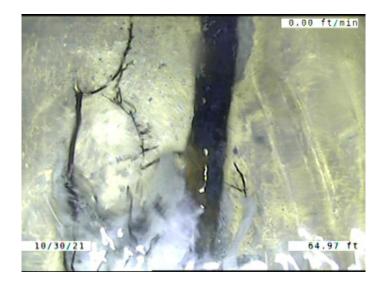
Code: OBN

Description: Obstruction Construction Debris

Distance (ft): 65.0
Structural Grade: 0
O&M Grade: 2
Clock Start/From: 6

Remarks: METAL ROD

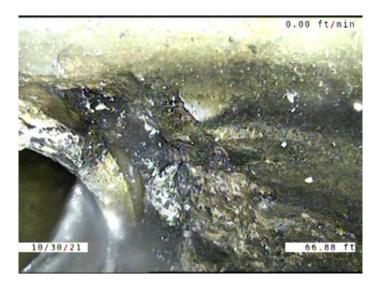
Code: SSS

Description: Surface Damage Surface Spalling

Distance (ft): 66.9
Structural Grade: 2
O&M Grade: 0
Clock Start/From: 10
Clock To: 1
1st Value:
2nd Value:
Value Percent:
Continuous Index:

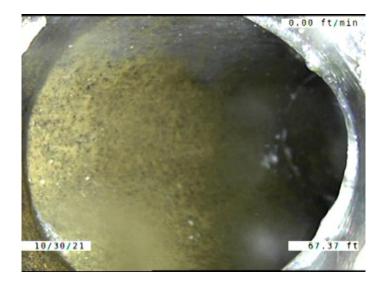
Code: TBD

Description: Tap Break-in/Hammer Defective

Distance (ft): 67.4
Structural Grade: 0

Remarks: CONSTANTLY RUNNING WATER

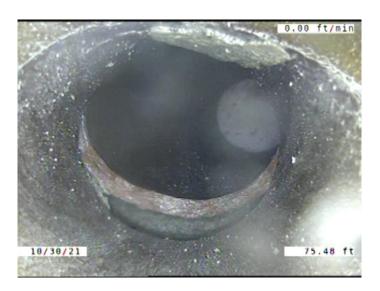
Code: **TFD**

Description: Tap Factory Defective

Distance (ft): 75.5
Structural Grade: 0
O&M Grade: 3
Clock Start/From: 12

Remarks: CAPPED. LARGE OFFSET. SOIL

VISIBLE.

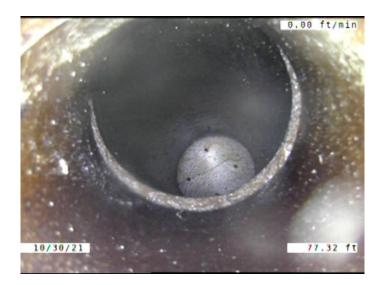
Code: TFC

Description: Tap Factory Capped

Remarks: CAP CRACKED

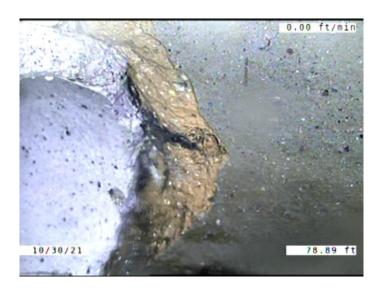
Code: SSS

Description: Surface Damage Surface Spalling

Distance (ft): 78.9
Structural Grade: 2
O&M Grade: 0
Clock Start/From: 10
Clock To: 12
1st Value:
2nd Value:
Value Percent:

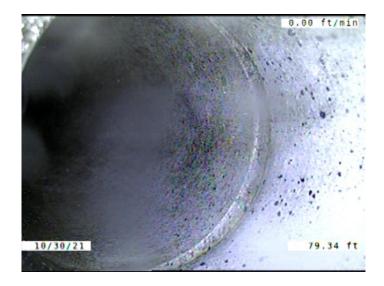
Code: **TBI**

Description: Tap Break-in Intruding

Distance (ft): 79.3
Structural Grade: 0
O&M Grade: 2
Clock Start/From: 11

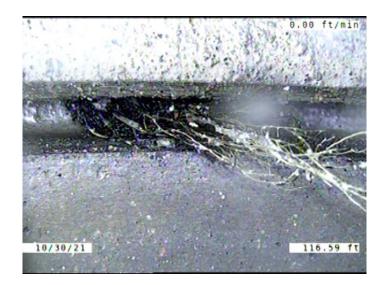
Code: RFJ

Description: Roots Fine Joint

Distance (ft): 116.6
Structural Grade: 0
O&M Grade: 1
Clock Start/From: 10

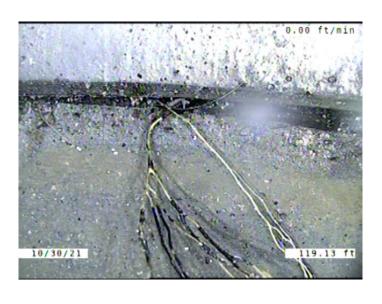
Code: RFJ

Description: Roots Fine Joint

Distance (ft): 119.1
Structural Grade: 0
O&M Grade: 1
Clock Start/From: 2
Clock To:
1st Value:

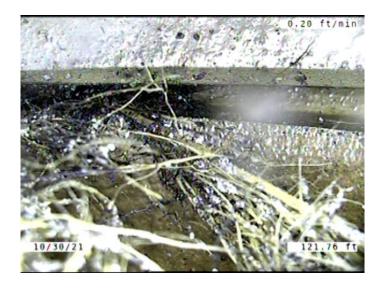
Code: RMJ

Description: Roots Medium Joint

Distance (ft): 121.8
Structural Grade: 0
O&M Grade: 3
Clock Start/From: 12
Clock To: 2

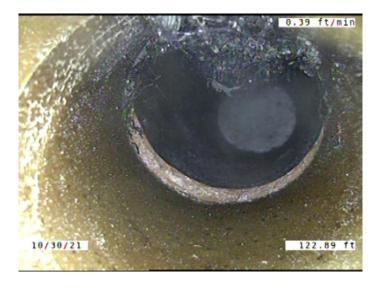
Code: TFC

Description: Tap Factory Capped

Remarks: ROOTS GROWING DOWN THE TAP

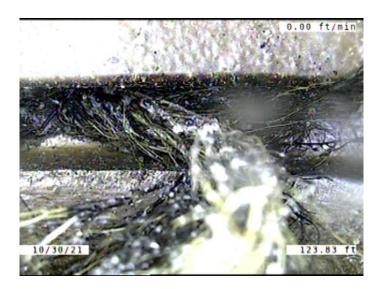
Code: RMJ

Description: Roots Medium Joint

Distance (ft): 123.8
Structural Grade: 0
O&M Grade: 3
Clock Start/From: 8
Clock To: 11

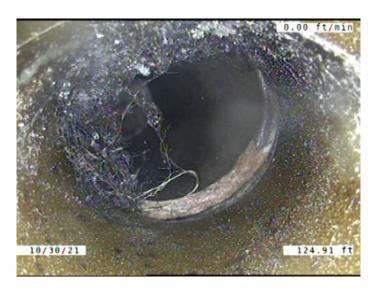
Code: **TFD**

Description: Tap Factory Defective

Distance (ft): 124.9
Structural Grade: 0
O&M Grade: 3
Clock Start/From: 11

Remarks: ROOTS GROWING DOWN THE TAP.

OFFSET JOINT. SOIL VISIBLE

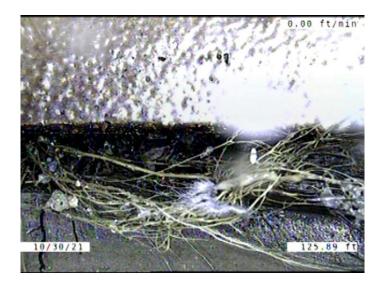
Code: RFJ

Description: Roots Fine Joint

Distance (ft): 125.9
Structural Grade: 0
O&M Grade: 1
Clock Start/From: 2

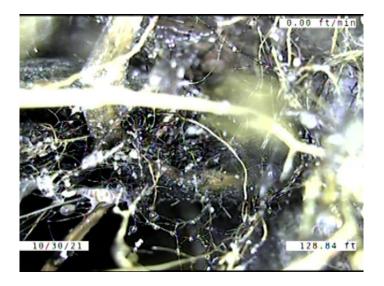
Code: RMC

Description: Roots Medium Connection

Distance (ft): 128.8
Structural Grade: 0
O&M Grade: 3
Clock Start/From: 10

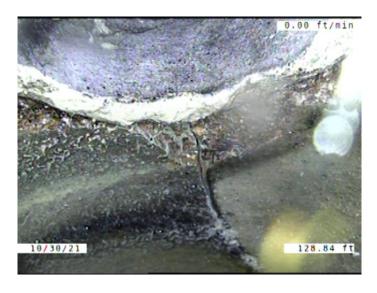
Code: FM

Description: Fracture Multiple

Distance (ft): 128.8
Structural Grade: 4

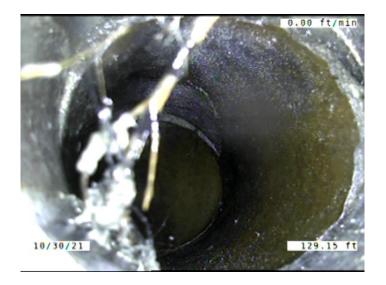
Code: TBI

Description: Tap Break-in Intruding

Distance (ft): 129.1
Structural Grade: 0
O&M Grade: 2
Clock Start/From: 11

Remarks: **CONSTANTLY RUNNING WATER.**

ROOTS GROWING AROUND THE TAP

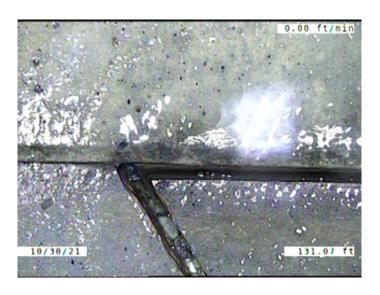
Code: IRJ

Description: Infiltration Runner Joint

Distance (ft): 131.1
Structural Grade: 0
O&M Grade: 4
Clock Start/From: 1
Clock To: 4
1st Value:
2nd Value:

Remarks: ALSO RUNNING OUT OF THE

BARRELL

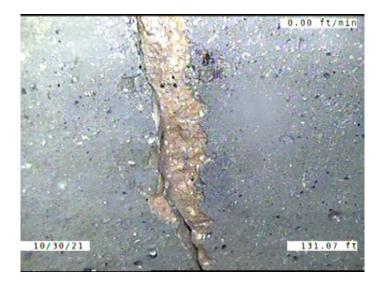
Code: IRB

Description: Infiltration Runner Barrel

Distance (ft): 131.1
Structural Grade: 0
O&M Grade: 4
Clock Start/From: 10

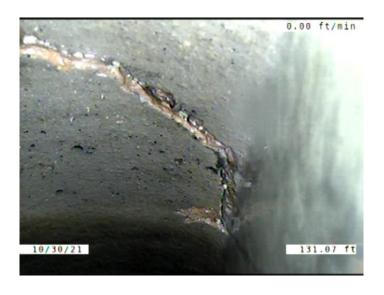
Code: B
Description: Broken

Distance (ft): 131.1
Structural Grade: 4
O&M Grade: 0
Clock Start/From: 12
Clock To: 12
1st Value:
2nd Value:
Value Percent:

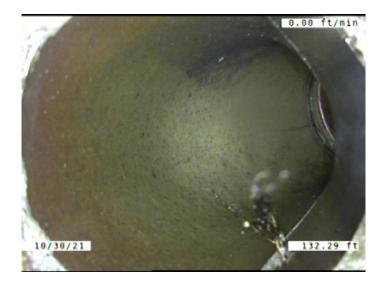
Code: TBD

Description: Tap Break-in/Hammer Defective

Distance (ft): 132.3 Structural Grade: 0 O&M Grade: 3 Clock Start/From: 12

Remarks: **CONSTANTLY RUNNING WATER.**

BROKEN. ROOTS GROWING IN IT

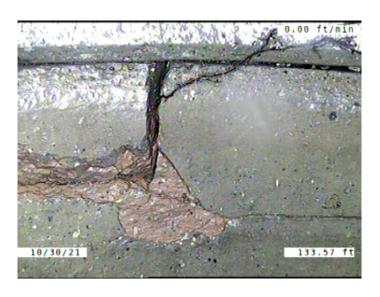
Code: **RFB**

Description: **Roots Fine Barrel**

Distance (ft): 133.6 Structural Grade: 0 O&M Grade: 2 Clock Start/From: 11

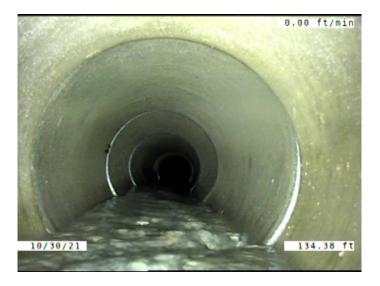
Code: Description: Broken

Distance (ft): 134.4 Structural Grade: 4 O&M Grade: 0 Clock Start/From: 12 Clock To: 12 1st Value:

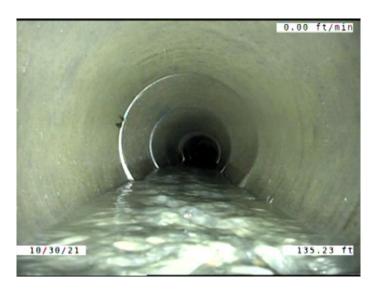
DSF Code:

Description: **Deposits Settled Fine**

Distance (ft): 135.2 Structural Grade: 0 O&M Grade: 2 Clock Start/From: 5 7 Clock To: 1st Value:

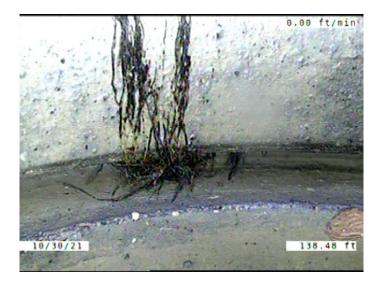
Code: RFJ

Description: Roots Fine Joint

Distance (ft): 138.5
Structural Grade: 0
O&M Grade: 1
Clock Start/From: 10

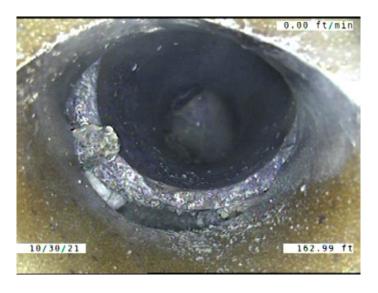
Code: **TFD**

Description: Tap Factory Defective

Distance (ft): 163.0
Structural Grade: 0
O&M Grade: 3
Clock Start/From: 1

Remarks: LARGE OFFSET. SOIL VISIBLE. LOOKS

TO BE CAPPED

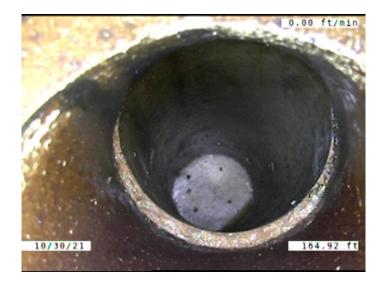
Code: TFC

Description: Tap Factory Capped

Distance (ft): 164.9
Structural Grade: 0
O&M Grade: 0
Clock Start/From: 11

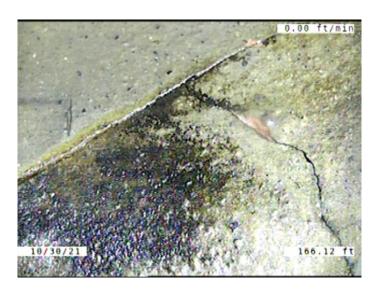
Code: **B**

Description: Broken

Distance (ft): 166.1
Structural Grade: 4

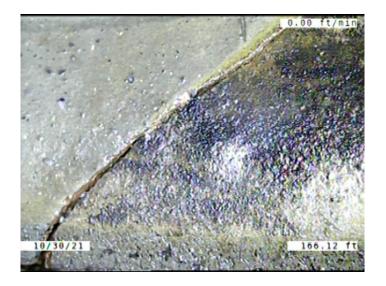
Code: ISB

Description: Infiltration Stain Barrel

Distance (ft): 166.1
Structural Grade: 0
O&M Grade: 1
Clock Start/From: 8
Clock To: 9

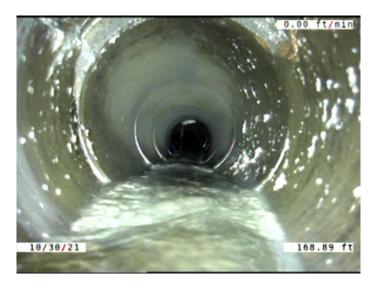
Code: **DSF**

Description: Deposits Settled Fine

Distance (ft): 168.9
Structural Grade: 0
O&M Grade: 2
Clock Start/From: 5
Clock To: 7
1st Value:
