# Profile/Photo Observation Report

Date:	<b>10/30/2021</b>	Weather:		Coding:	<b>PACP 7.0</b>
Pipe Length (ft):	<b>170.1</b>	Owner:	<b>City of Hobart</b>	Pre Clean:	<b>Heavy Cleaning</b>
P.O.#:	<b>YES502259</b>	Surveyor:	<b>S. Bucklin</b>	PSR:	<b>P-504-046-045</b>
Customer:	<b>City of Hobart</b>	Clean Date:	<b>10/26/2021</b>	Shape:	<b>C</b>

Street:	<b>North Colorado Street</b>	Flow Control:	<b>Not Controlled</b>
City:	<b>Hobart, IN</b>	Year Renewed:	
Location:	<b>Alley</b>	Tape/Media #:	
Purpose:	<b>Routine Assessment</b>	Dia/Height:	<b>12"</b>
Use:	<b>Sanitary Sewage Pipe</b>	Material:	<b>VCP</b>
Drain Area:		Lining:	<b>None</b>
Category:	<b>NA</b>		
Comment:			
Location Details:		Direction of Survey:	<b>Downstream</b>
US MH:	<b>M-504-045</b>	DS MH:	<b>M-504-046</b>
		Total Length Surveyed (ft):	<b>170.1</b>

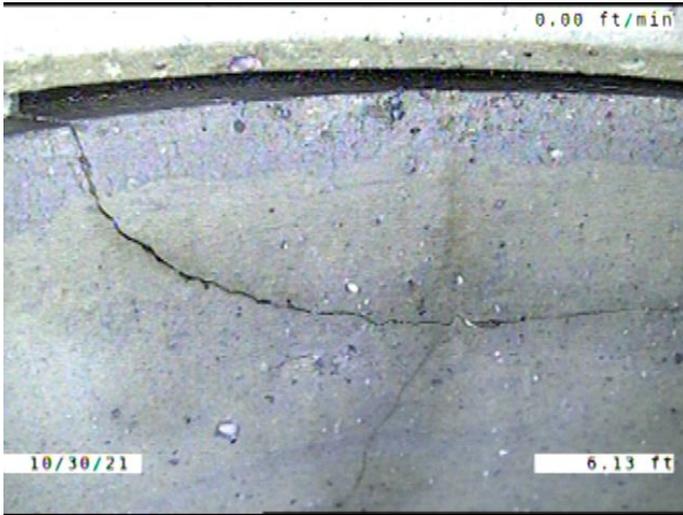
Code: **CM**  
Description: **Crack Multiple**

Distance (ft): **6.1**  
Structural Grade: **3**  
O&M Grade: **0**  
Clock Start/From: **9**  
Clock To: **1**  
1st Value:  
2nd Value:  
Value Percent:  
Continuous Index:  
Within 8" of Joint: **YES**  
Remarks:

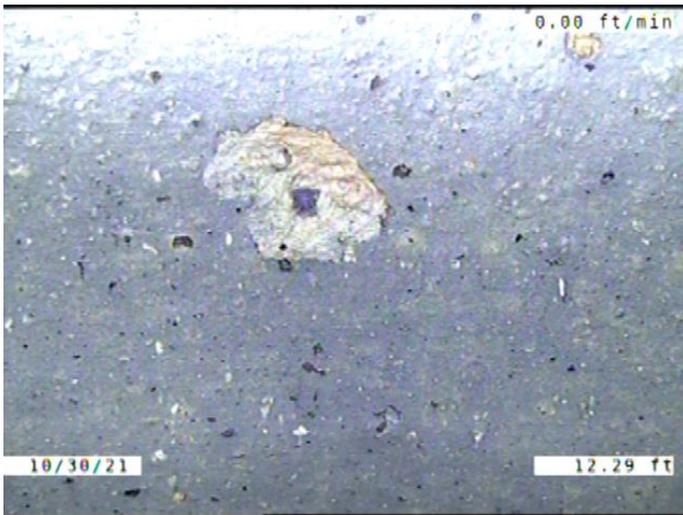
Code: **SSS**  
Description: **Surface Damage Surface Spalling**

Distance (ft): **12.3**  
Structural Grade: **2**  
O&M Grade: **0**  
Clock Start/From: **9**  
Clock To:  
1st Value:  
2nd Value:  
Value Percent:  
Continuous Index:  
Within 8" of Joint: **YES**  
Remarks:

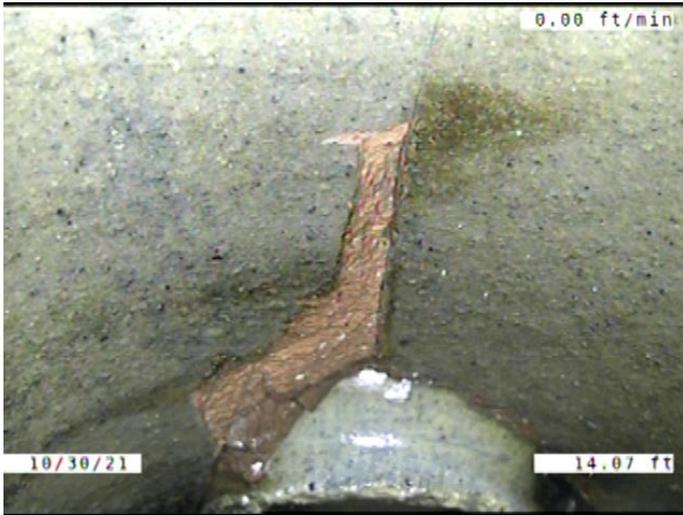
Code: **FM**  
 Description: **Fracture Multiple**

Distance (ft): **14.1**  
 Structural Grade: **4**  
 O&M Grade: **0**  
 Clock Start/From: **10**  
 Clock To: **2**  
 1st Value:  
 2nd Value:  
 Value Percent:  
 Continuous Index:  
 Within 8" of Joint: **YES**  
 Remarks:

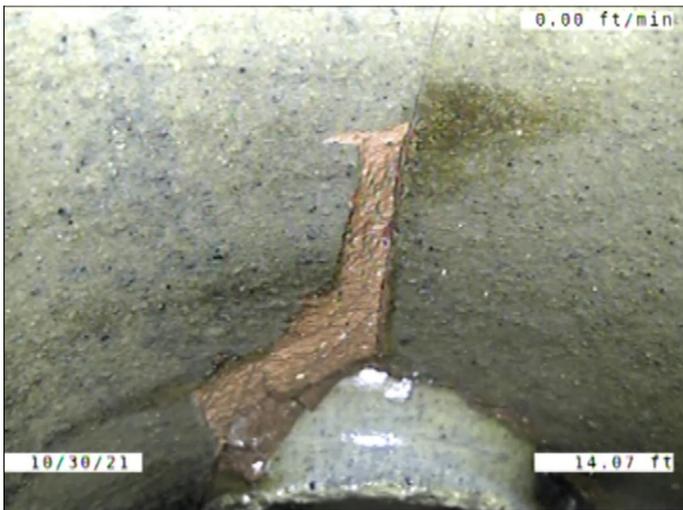
Code: **SSS**  
 Description: **Surface Damage Surface Spalling**

Distance (ft): **14.1**  
 Structural Grade: **2**  
 O&M Grade: **0**  
 Clock Start/From: **12**  
 Clock To:  
 1st Value:  
 2nd Value:  
 Value Percent:  
 Continuous Index:  
 Within 8" of Joint: **NO**  
 Remarks:

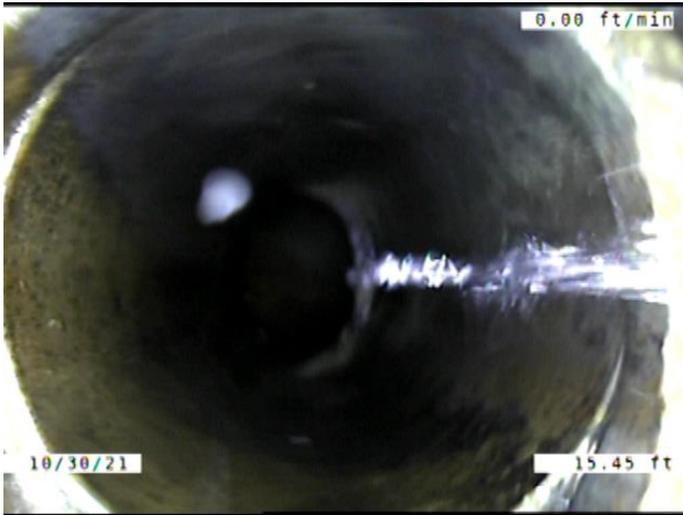
Code: **TBI**  
Description: **Tap Break-in Intruding**

Distance (ft): **15.4**  
Structural Grade: **0**  
O&M Grade: **2**  
Clock Start/From: **12**  
Clock To:  
1st Value: **4.000**  
2nd Value: **1.000**  
Value Percent:  
Continuous Index:  
Within 8" of Joint: **YES**  
Remarks: **CONSTANTLY RUNNING WATER.  
OFFSET JOINT**

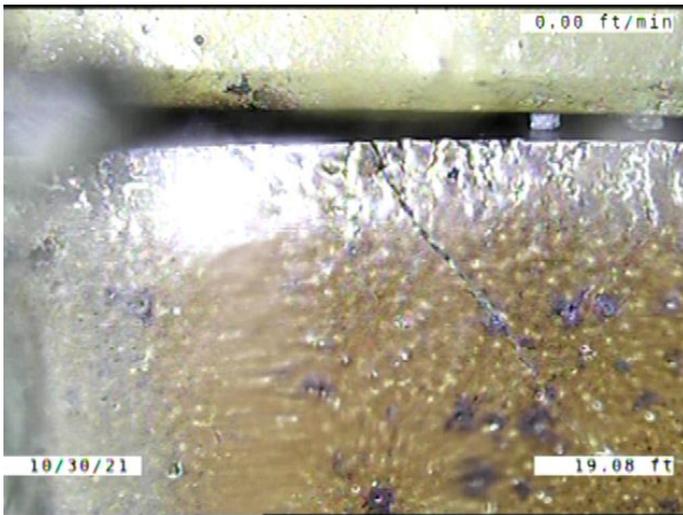
Code: **CM**  
Description: **Crack Multiple**

Distance (ft): **19.1**  
Structural Grade: **3**  
O&M Grade: **0**  
Clock Start/From: **9**  
Clock To: **11**  
1st Value:  
2nd Value:  
Value Percent:  
Continuous Index:  
Within 8" of Joint: **YES**  
Remarks:

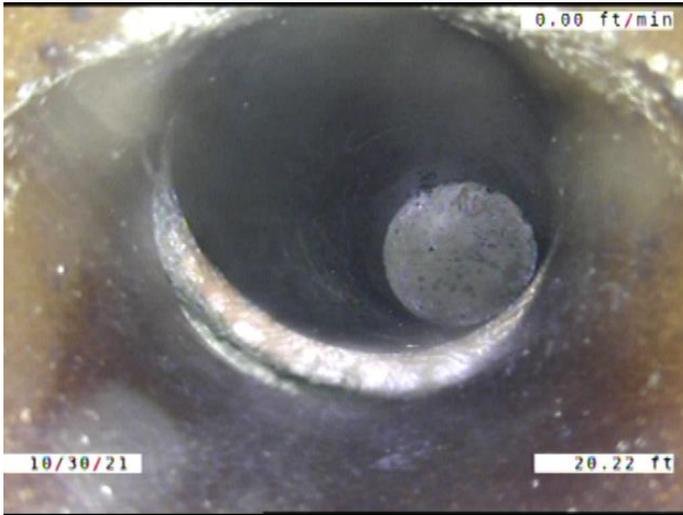
Code: **TFD**  
Description: **Tap Factory Defective**

Distance (ft): **20.2**  
Structural Grade: **0**  
O&M Grade: **3**  
Clock Start/From: **12**  
Clock To:  
1st Value: **4.000**  
2nd Value:  
Value Percent:  
Continuous Index:  
Within 8" of Joint: **YES**  
Remarks: **CAPPED. OFFSET JIONT**

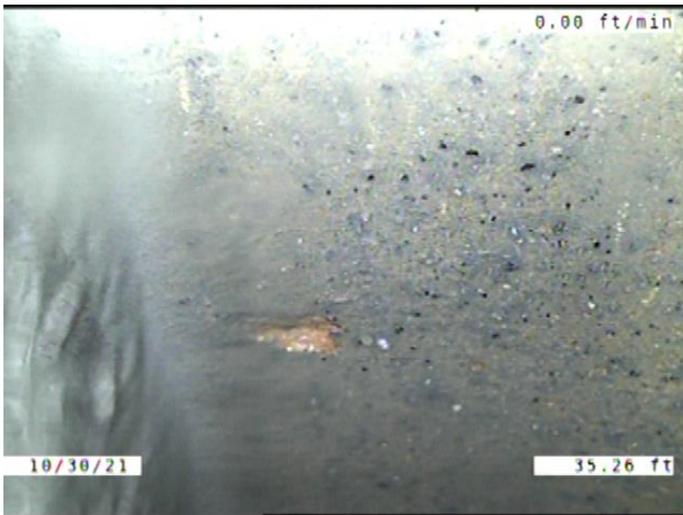
Code: **SSS**  
Description: **Surface Damage Surface Spalling**

Distance (ft): **35.3**  
Structural Grade: **2**  
O&M Grade: **0**  
Clock Start/From: **7**  
Clock To: **8**  
1st Value:  
2nd Value:  
Value Percent:  
Continuous Index:  
Within 8" of Joint: **YES**  
Remarks:

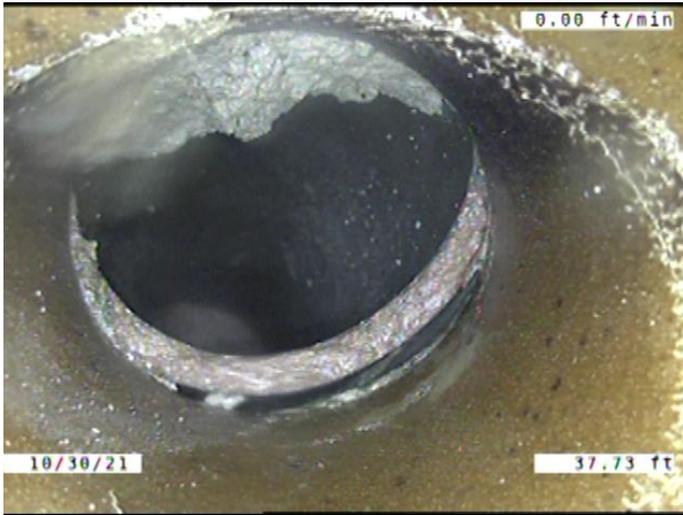
Code: **TFD**  
Description: **Tap Factory Defective**

Distance (ft): **37.7**  
Structural Grade: **0**  
O&M Grade: **3**  
Clock Start/From: **11**  
Clock To:  
1st Value: **4.000**  
2nd Value:  
Value Percent:  
Continuous Index:  
Within 8" of Joint: **YES**  
Remarks: **OFFSET JOINT**

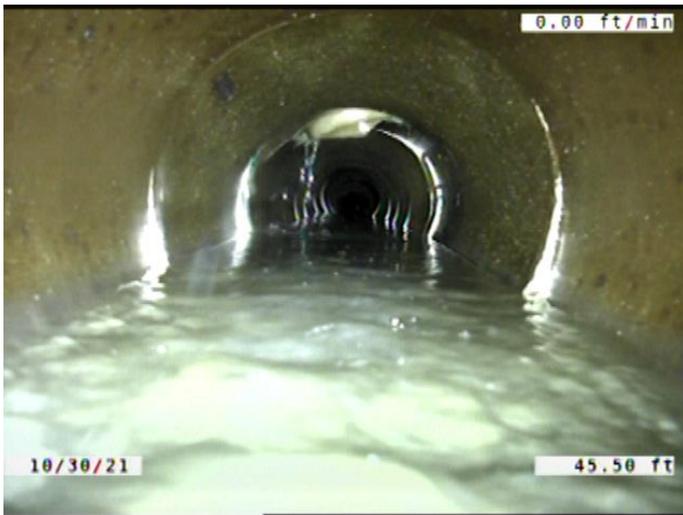
Code: **MWLS**  
Description: **Miscellaneous Water Level Sag**

Distance (ft): **45.5**  
Structural Grade: **2**  
O&M Grade: **0**  
Clock Start/From:  
Clock To:  
1st Value:  
2nd Value:  
Value Percent: **15.000**  
Continuous Index: **S01**  
Within 8" of Joint: **NO**  
Remarks:

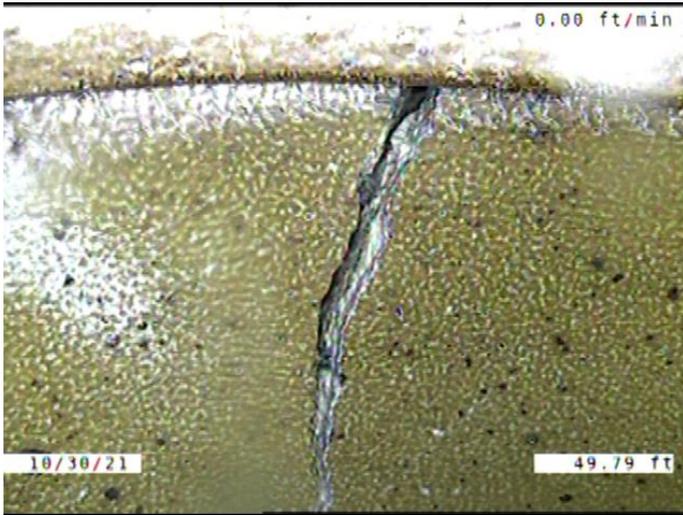
Code: **B**  
Description: **Broken**

Distance (ft): **49.8**  
Structural Grade: **4**  
O&M Grade: **0**  
Clock Start/From: **8**  
Clock To: **4**  
1st Value:  
2nd Value:  
Value Percent:  
Continuous Index: **S02**  
Within 8" of Joint: **YES**  
Remarks:

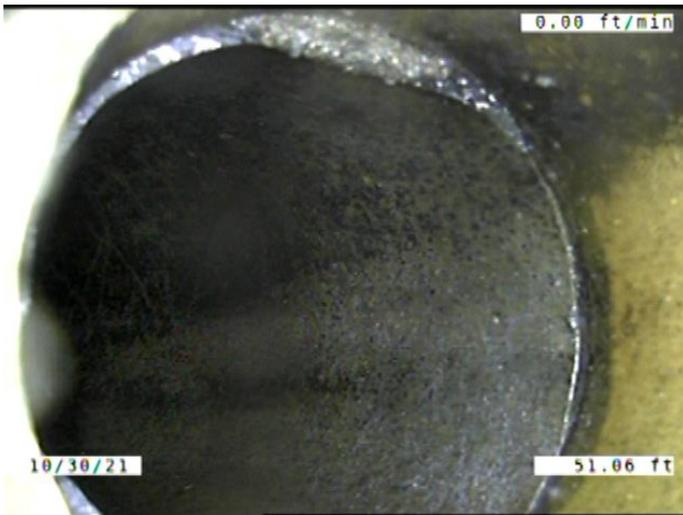
Code: **TBI**  
Description: **Tap Break-in Intruding**

Distance (ft): **51.1**  
Structural Grade: **0**  
O&M Grade: **2**  
Clock Start/From: **11**  
Clock To:  
1st Value: **4.000**  
2nd Value: **2.000**  
Value Percent:  
Continuous Index:  
Within 8" of Joint: **YES**  
Remarks: **CONSTANTLY RUNNING WATER**

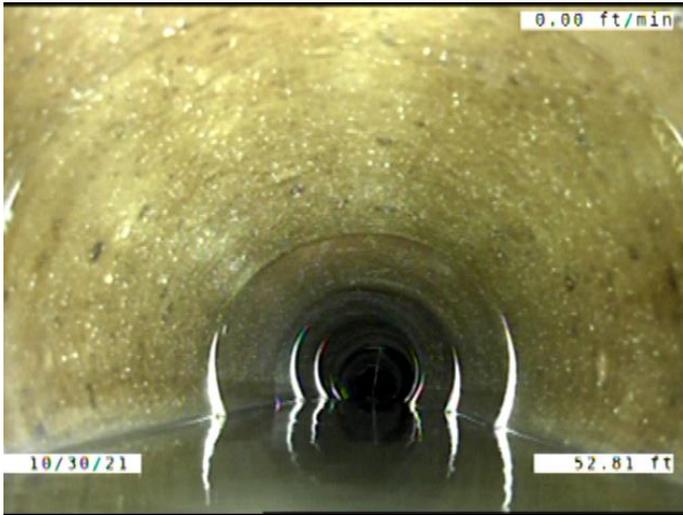
Code: **B**  
Description: **Broken**

Distance (ft): **52.8**  
Structural Grade: **4**  
O&M Grade: **0**  
Clock Start/From: **8**  
Clock To: **4**  
1st Value:  
2nd Value:  
Value Percent:  
Continuous Index: **F02**  
Within 8" of Joint: **YES**  
Remarks:

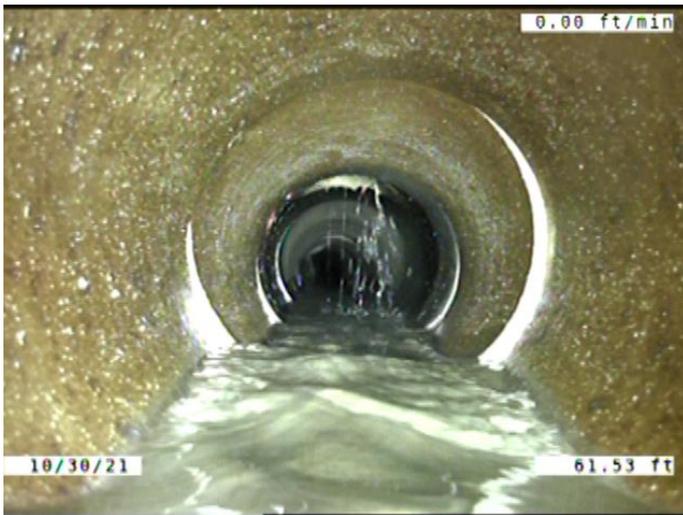
Code: **MWLS**  
Description: **Miscellaneous Water Level Sag**

Distance (ft): **61.5**  
Structural Grade: **2**  
O&M Grade: **0**  
Clock Start/From:  
Clock To:  
1st Value:  
2nd Value:  
Value Percent: **15.000**  
Continuous Index: **F01**  
Within 8" of Joint: **NO**  
Remarks:

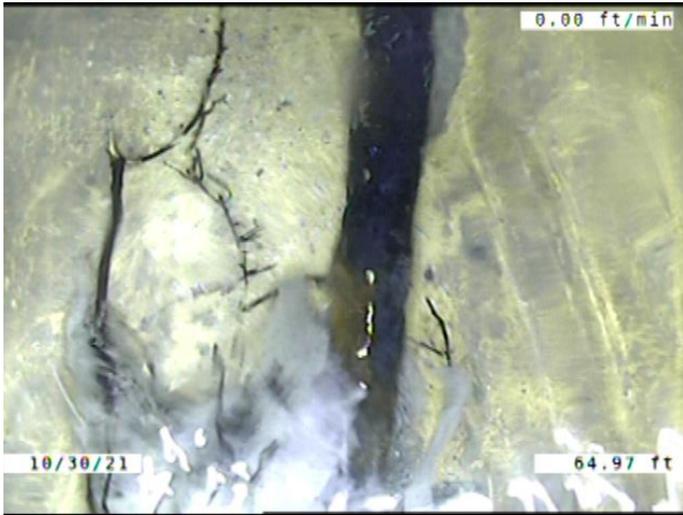
Code: **OBN**  
Description: **Obstruction Construction Debris**

Distance (ft): **65.0**  
Structural Grade: **0**  
O&M Grade: **2**  
Clock Start/From: **6**  
Clock To:  
1st Value:  
2nd Value:  
Value Percent: **5.000**  
Continuous Index:  
Within 8" of Joint: **YES**  
Remarks: **METAL ROD**

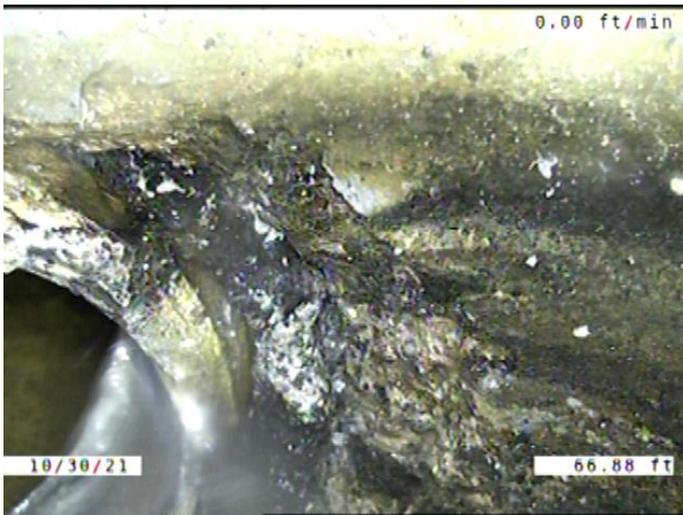
Code: **SSS**  
Description: **Surface Damage Surface Spalling**

Distance (ft): **66.9**  
Structural Grade: **2**  
O&M Grade: **0**  
Clock Start/From: **10**  
Clock To: **1**  
1st Value:  
2nd Value:  
Value Percent:  
Continuous Index:  
Within 8" of Joint: **NO**  
Remarks:

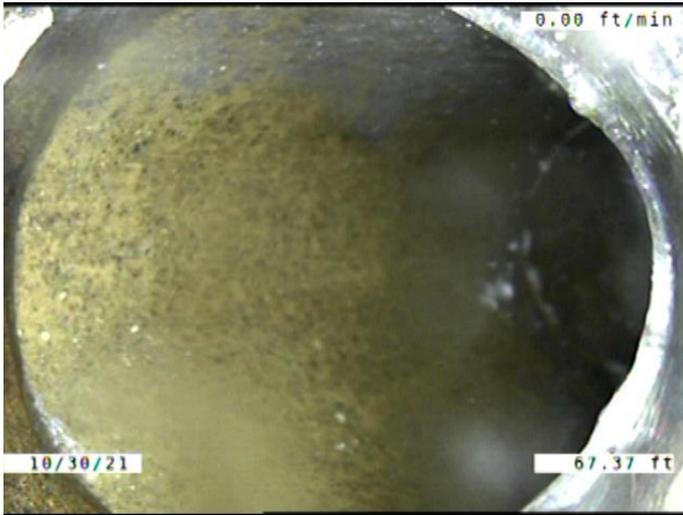
Code: **TBD**  
Description: **Tap Break-in/Hammer Defective**

Distance (ft): **67.4**  
Structural Grade: **0**  
O&M Grade: **3**  
Clock Start/From: **12**  
Clock To:  
1st Value: **4.000**  
2nd Value:  
Value Percent:  
Continuous Index:  
Within 8" of Joint: **YES**  
Remarks: **CONSTANTLY RUNNING WATER**

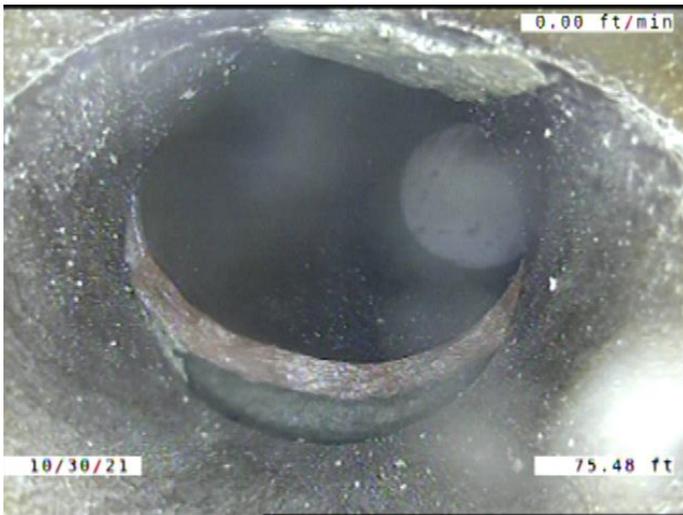
Code: **TFD**  
Description: **Tap Factory Defective**

Distance (ft): **75.5**  
Structural Grade: **0**  
O&M Grade: **3**  
Clock Start/From: **12**  
Clock To:  
1st Value: **4.000**  
2nd Value:  
Value Percent:  
Continuous Index:  
Within 8" of Joint: **YES**  
Remarks: **CAPPED. LARGE OFFSET. SOIL VISIBLE.**

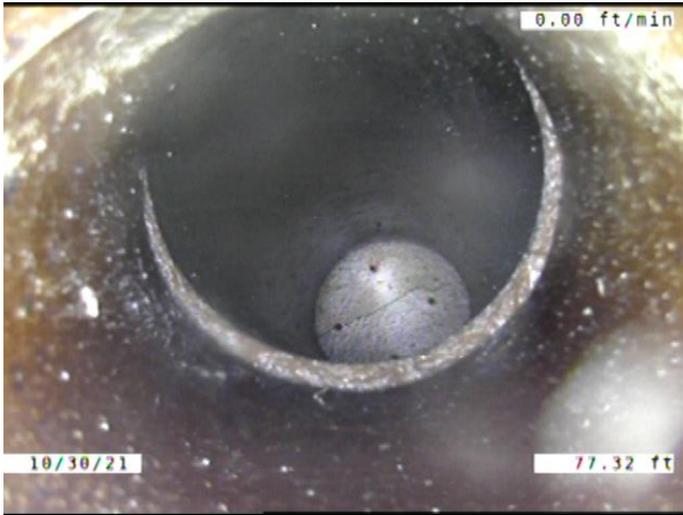
Code: **TFC**  
 Description: **Tap Factory Capped**

Distance (ft): **77.3**  
 Structural Grade: **0**  
 O&M Grade: **0**  
 Clock Start/From: **11**  
 Clock To:  
 1st Value: **4.000**  
 2nd Value:  
 Value Percent:  
 Continuous Index:  
 Within 8" of Joint: **YES**  
 Remarks: **CAP CRACKED**

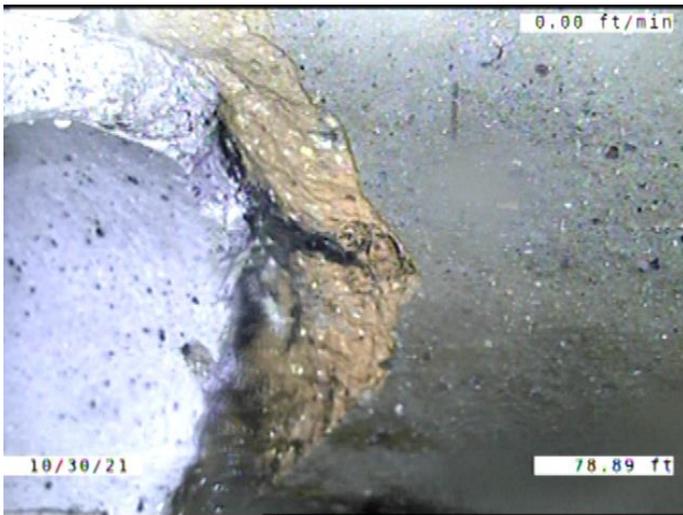
Code: **SSS**  
 Description: **Surface Damage Surface Spalling**

Distance (ft): **78.9**  
 Structural Grade: **2**  
 O&M Grade: **0**  
 Clock Start/From: **10**  
 Clock To: **12**  
 1st Value:  
 2nd Value:  
 Value Percent:  
 Continuous Index:  
 Within 8" of Joint: **NO**  
 Remarks:

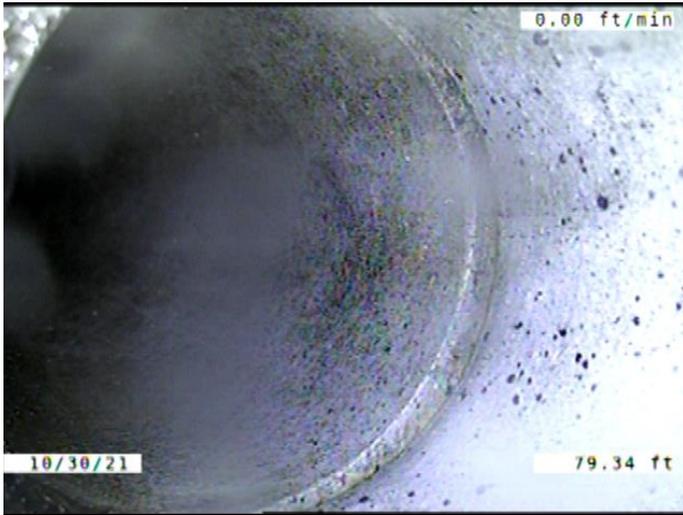
Code: **TBI**  
Description: **Tap Break-in Intruding**

Distance (ft): **79.3**  
Structural Grade: **0**  
O&M Grade: **2**  
Clock Start/From: **11**  
Clock To:  
1st Value: **4.000**  
2nd Value: **1.000**  
Value Percent:  
Continuous Index:  
Within 8" of Joint: **YES**  
Remarks:

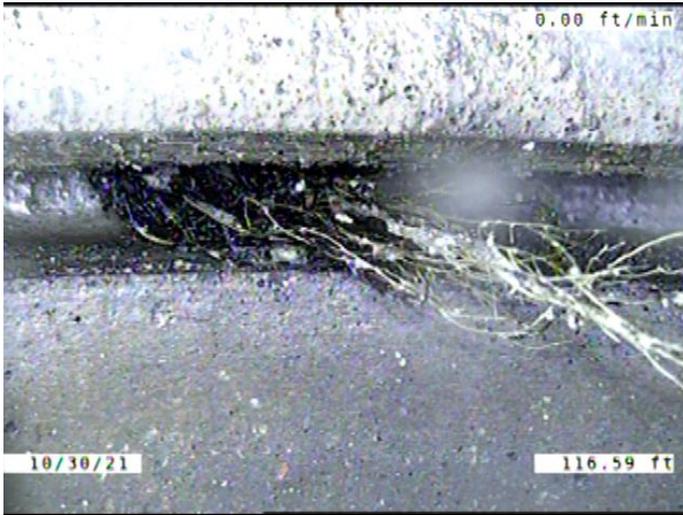
Code: **RFJ**  
Description: **Roots Fine Joint**

Distance (ft): **116.6**  
Structural Grade: **0**  
O&M Grade: **1**  
Clock Start/From: **10**  
Clock To:  
1st Value:  
2nd Value:  
Value Percent:  
Continuous Index:  
Within 8" of Joint: **YES**  
Remarks:

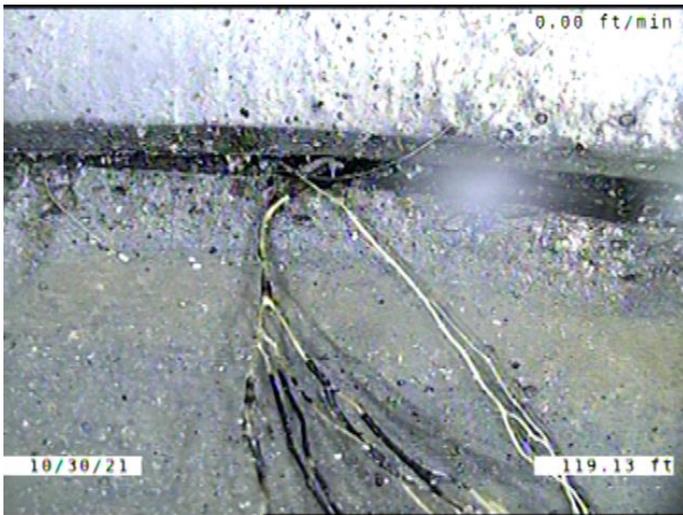
Code: **RFJ**  
Description: **Roots Fine Joint**

Distance (ft): **119.1**  
Structural Grade: **0**  
O&M Grade: **1**  
Clock Start/From: **2**  
Clock To:  
1st Value:  
2nd Value:  
Value Percent:  
Continuous Index:  
Within 8" of Joint: **YES**  
Remarks:

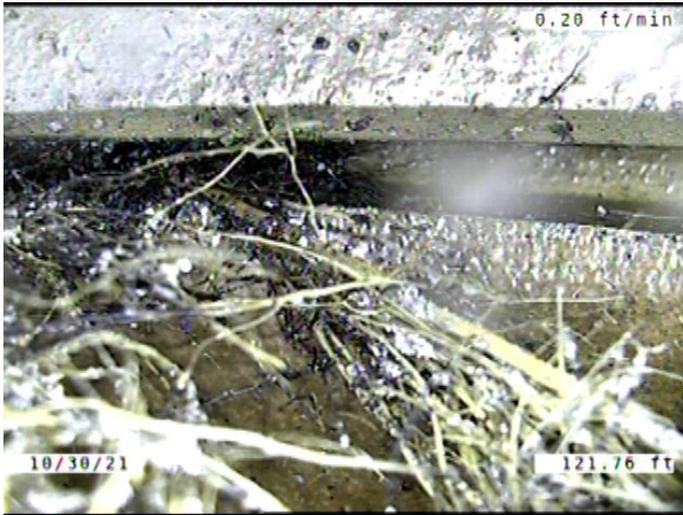
Code: **RMJ**  
Description: **Roots Medium Joint**

Distance (ft): **121.8**  
Structural Grade: **0**  
O&M Grade: **3**  
Clock Start/From: **12**  
Clock To: **2**  
1st Value:  
2nd Value:  
Value Percent: **5.000**  
Continuous Index:  
Within 8" of Joint: **YES**  
Remarks:

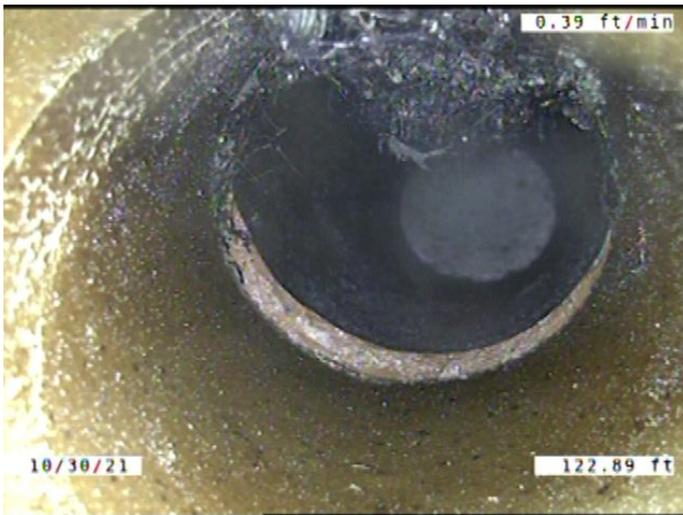
Code: **TFC**  
Description: **Tap Factory Capped**

Distance (ft): **122.9**  
Structural Grade: **0**  
O&M Grade: **0**  
Clock Start/From: **12**  
Clock To:  
1st Value: **4.000**  
2nd Value:  
Value Percent:  
Continuous Index:  
Within 8" of Joint: **YES**  
Remarks: **ROOTS GROWING DOWN THE TAP**

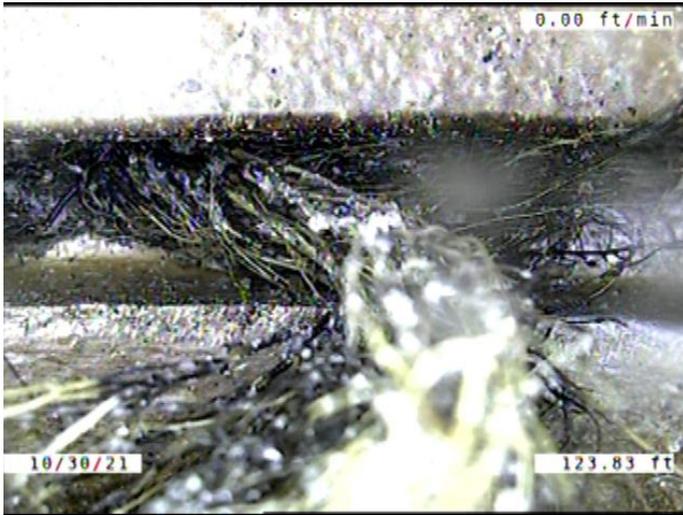
Code: **RMJ**  
 Description: **Roots Medium Joint**

Distance (ft): **123.8**  
 Structural Grade: **0**  
 O&M Grade: **3**  
 Clock Start/From: **8**  
 Clock To: **11**  
 1st Value:  
 2nd Value:  
 Value Percent: **5.000**  
 Continuous Index:  
 Within 8" of Joint: **YES**  
 Remarks:

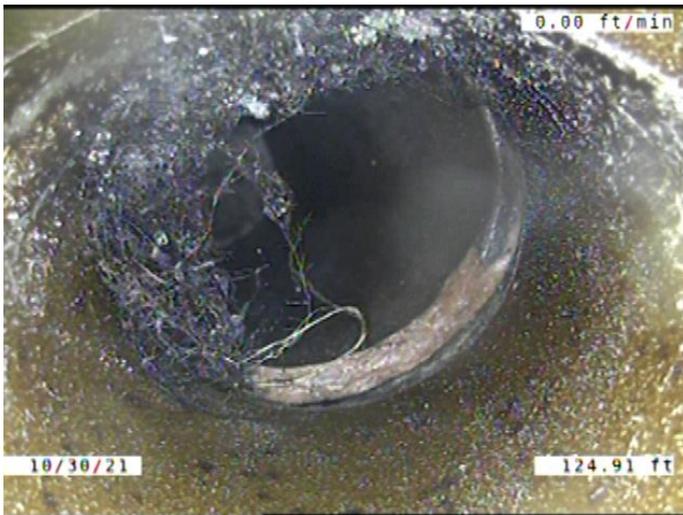
Code: **TFD**  
 Description: **Tap Factory Defective**

Distance (ft): **124.9**  
 Structural Grade: **0**  
 O&M Grade: **3**  
 Clock Start/From: **11**  
 Clock To:  
 1st Value: **4.000**  
 2nd Value:  
 Value Percent:  
 Continuous Index:  
 Within 8" of Joint: **YES**  
 Remarks: **ROOTS GROWING DOWN THE TAP. OFFSET JOINT. SOIL VISIBLE**

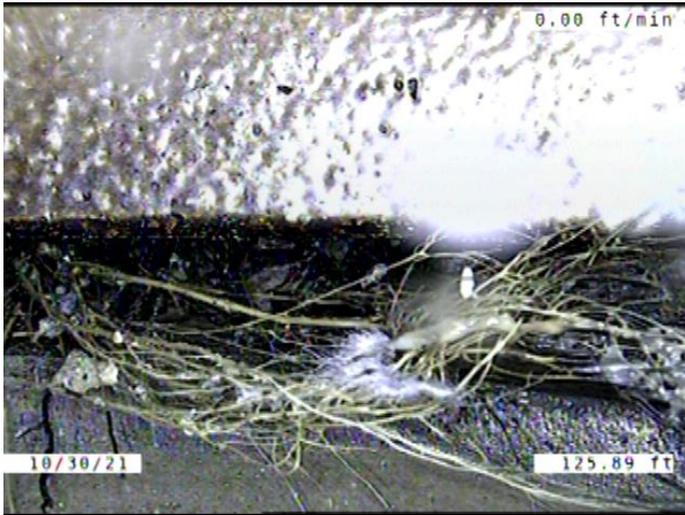
Code: **RFJ**  
Description: **Roots Fine Joint**

Distance (ft): **125.9**  
Structural Grade: **0**  
O&M Grade: **1**  
Clock Start/From: **2**  
Clock To: **4**  
1st Value:  
2nd Value:  
Value Percent:  
Continuous Index:  
Within 8" of Joint: **YES**  
Remarks:

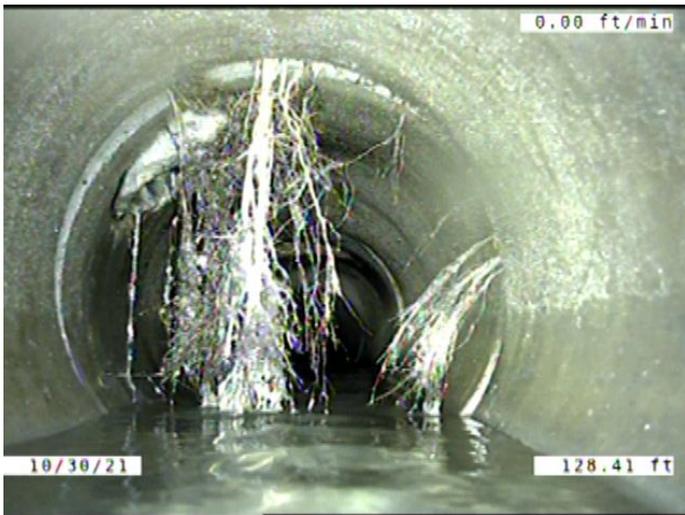
Code: **RMJ**  
Description: **Roots Medium Joint**

Distance (ft): **128.4**  
Structural Grade: **0**  
O&M Grade: **3**  
Clock Start/From: **10**  
Clock To: **3**  
1st Value:  
2nd Value:  
Value Percent: **25.000**  
Continuous Index:  
Within 8" of Joint: **YES**  
Remarks:

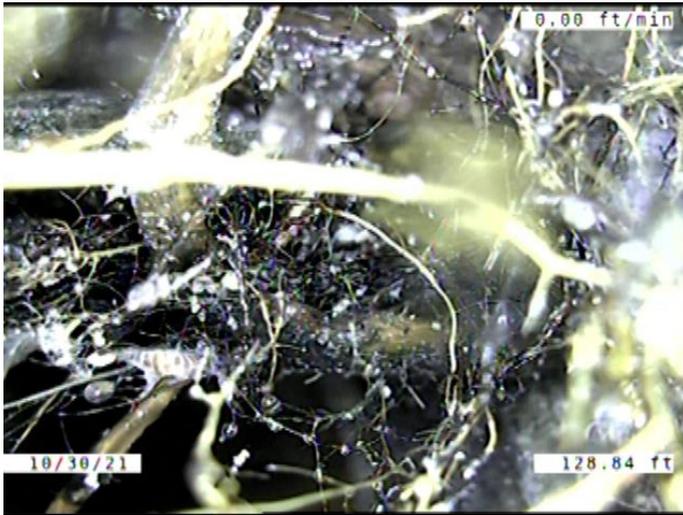
Code: **RMC**  
 Description: **Roots Medium Connection**

Distance (ft): **128.8**  
 Structural Grade: **0**  
 O&M Grade: **3**  
 Clock Start/From: **10**  
 Clock To: **12**  
 1st Value:  
 2nd Value:  
 Value Percent: **5.000**  
 Continuous Index:  
 Within 8" of Joint: **NO**  
 Remarks:

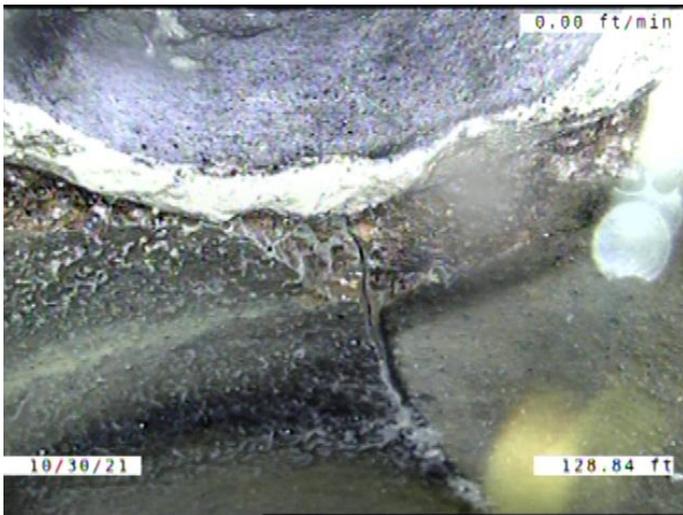
Code: **FM**  
 Description: **Fracture Multiple**

Distance (ft): **128.8**  
 Structural Grade: **4**  
 O&M Grade: **0**  
 Clock Start/From: **10**  
 Clock To: **5**  
 1st Value:  
 2nd Value:  
 Value Percent:  
 Continuous Index:  
 Within 8" of Joint: **YES**  
 Remarks:

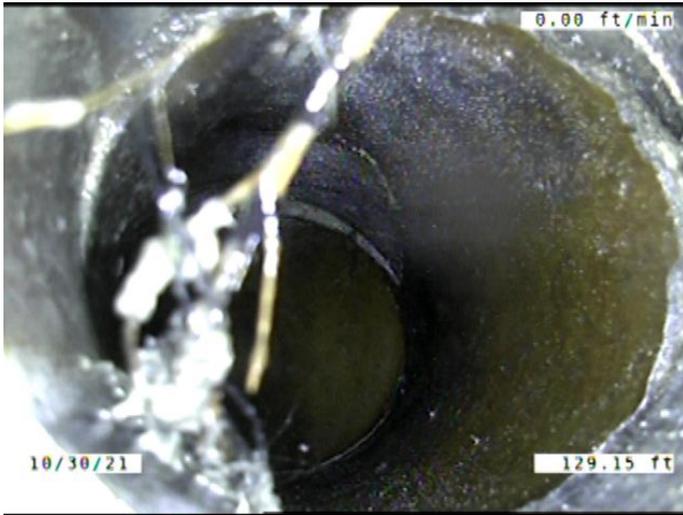
Code: **TBI**  
 Description: **Tap Break-in Intruding**

Distance (ft): **129.1**  
 Structural Grade: **0**  
 O&M Grade: **2**  
 Clock Start/From: **11**  
 Clock To:  
 1st Value: **4.000**  
 2nd Value: **1.000**

Value Percent:  
 Continuous Index:  
 Within 8" of Joint: **YES**  
 Remarks: **CONSTANTLY RUNNING WATER.  
 ROOTS GROWING AROUND THE TAP**

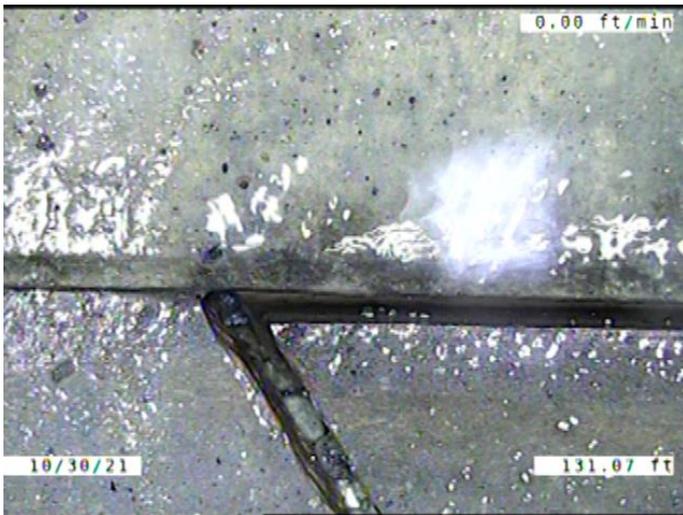
Code: **IRJ**  
 Description: **Infiltration Runner Joint**

Distance (ft): **131.1**  
 Structural Grade: **0**  
 O&M Grade: **4**  
 Clock Start/From: **1**  
 Clock To: **4**

1st Value:  
 2nd Value:  
 Value Percent:  
 Continuous Index:  
 Within 8" of Joint: **YES**  
 Remarks: **ALSO RUNNING OUT OF THE  
 BARRELL**

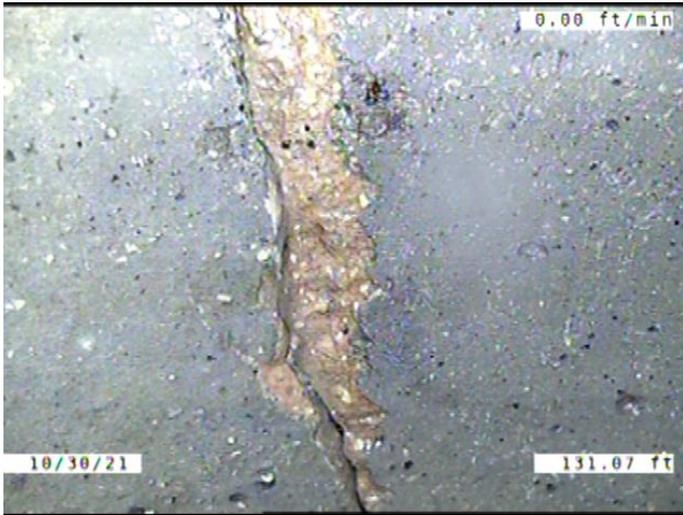
Code: **IRB**  
 Description: **Infiltration Runner Barrel**

Distance (ft): **131.1**  
 Structural Grade: **0**  
 O&M Grade: **4**  
 Clock Start/From: **10**  
 Clock To:  
 1st Value:  
 2nd Value:  
 Value Percent:  
 Continuous Index:  
 Within 8" of Joint: **NO**  
 Remarks:

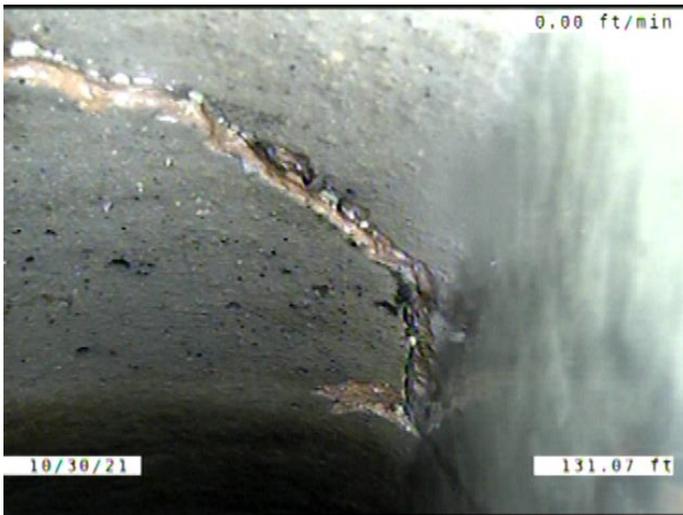
Code: **B**  
 Description: **Broken**

Distance (ft): **131.1**  
 Structural Grade: **4**  
 O&M Grade: **0**  
 Clock Start/From: **12**  
 Clock To: **12**  
 1st Value:  
 2nd Value:  
 Value Percent:  
 Continuous Index: **S03**  
 Within 8" of Joint: **YES**  
 Remarks:

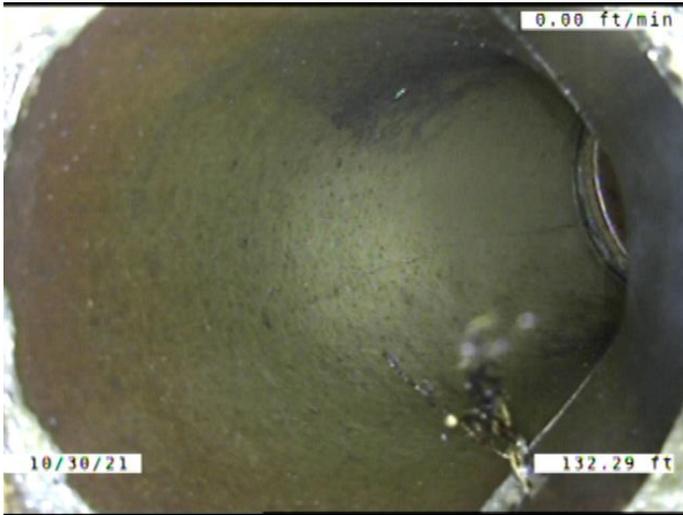
Code: **TBD**  
 Description: **Tap Break-in/Hammer Defective**

Distance (ft): **132.3**  
 Structural Grade: **0**  
 O&M Grade: **3**  
 Clock Start/From: **12**  
 Clock To:  
 1st Value: **4.000**  
 2nd Value:  
 Value Percent:  
 Continuous Index:  
 Within 8" of Joint: **YES**  
 Remarks: **CONSTANTLY RUNNING WATER. BROKEN. ROOTS GROWING IN IT**

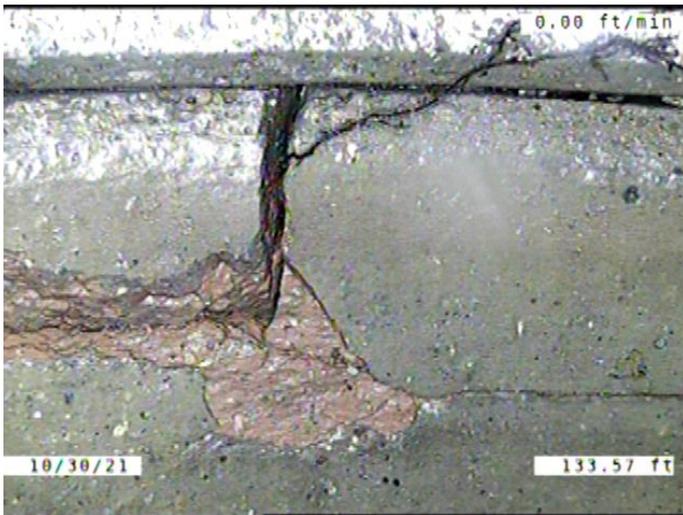
Code: **RFB**  
 Description: **Roots Fine Barrel**

Distance (ft): **133.6**  
 Structural Grade: **0**  
 O&M Grade: **2**  
 Clock Start/From: **11**  
 Clock To:  
 1st Value:  
 2nd Value:  
 Value Percent:  
 Continuous Index:  
 Within 8" of Joint: **NO**  
 Remarks:

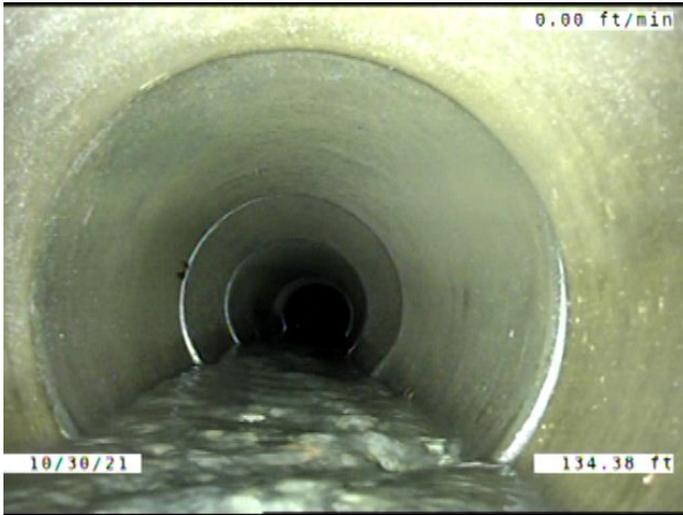
Code: **B**  
 Description: **Broken**

Distance (ft): **134.4**  
 Structural Grade: **4**  
 O&M Grade: **0**  
 Clock Start/From: **12**  
 Clock To: **12**  
 1st Value:  
 2nd Value:  
 Value Percent:  
 Continuous Index: **F03**  
 Within 8" of Joint: **YES**  
 Remarks:

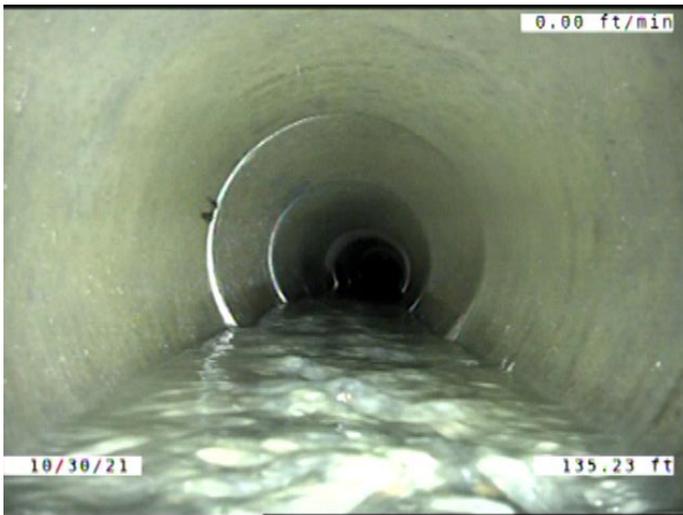
Code: **DSF**  
 Description: **Deposits Settled Fine**

Distance (ft): **135.2**  
 Structural Grade: **0**  
 O&M Grade: **2**  
 Clock Start/From: **5**  
 Clock To: **7**  
 1st Value:  
 2nd Value:  
 Value Percent: **5.000**  
 Continuous Index: **S04**  
 Within 8" of Joint: **YES**  
 Remarks:

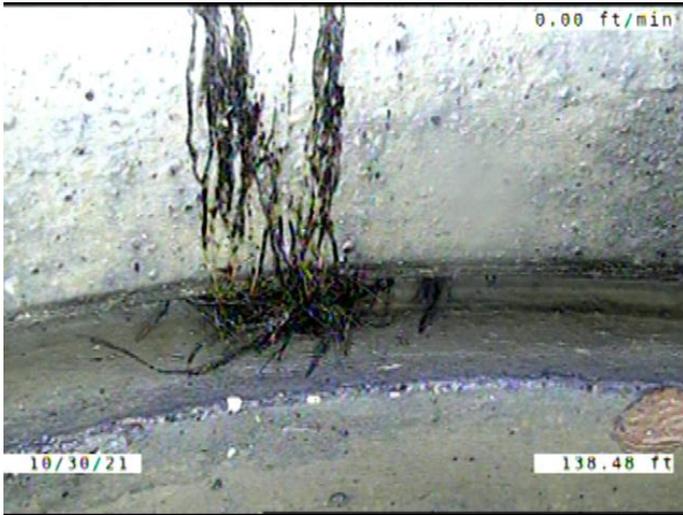
Code: **RFJ**  
Description: **Roots Fine Joint**

Distance (ft): **138.5**  
Structural Grade: **0**  
O&M Grade: **1**  
Clock Start/From: **10**  
Clock To:  
1st Value:  
2nd Value:  
Value Percent:  
Continuous Index:  
Within 8" of Joint: **YES**  
Remarks:

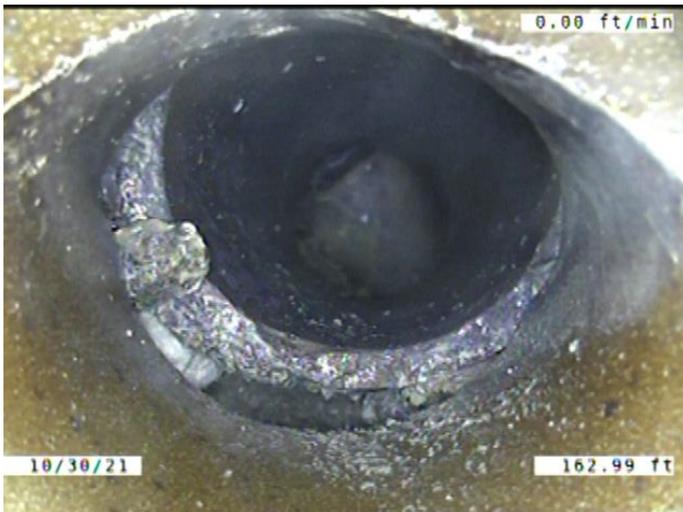
Code: **TFD**  
Description: **Tap Factory Defective**

Distance (ft): **163.0**  
Structural Grade: **0**  
O&M Grade: **3**  
Clock Start/From: **1**  
Clock To:  
1st Value: **4.000**  
2nd Value:  
Value Percent:  
Continuous Index:  
Within 8" of Joint: **YES**  
Remarks: **LARGE OFFSET. SOIL VISIBLE. LOOKS TO BE CAPPED**

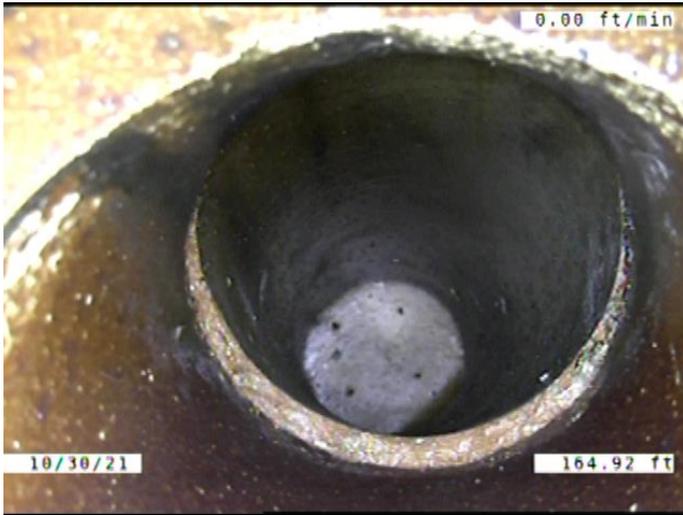
Code: **TFC**  
Description: **Tap Factory Capped**

Distance (ft): **164.9**  
Structural Grade: **0**  
O&M Grade: **0**  
Clock Start/From: **11**  
Clock To:  
1st Value: **4.000**  
2nd Value:  
Value Percent:  
Continuous Index:  
Within 8" of Joint: **YES**  
Remarks:

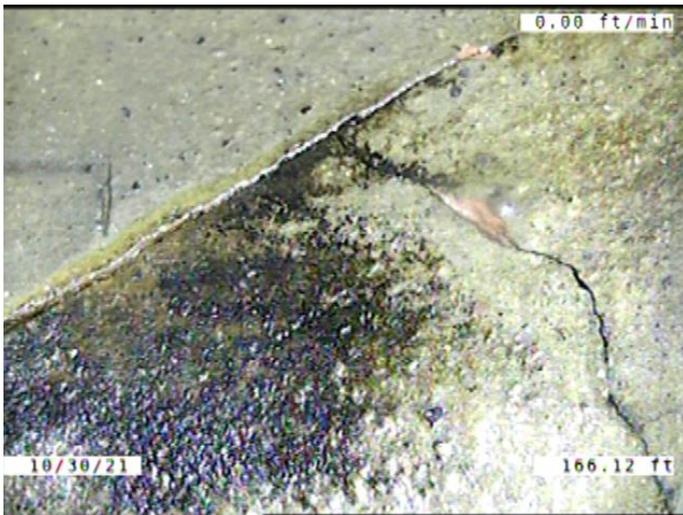
Code: **B**  
Description: **Broken**

Distance (ft): **166.1**  
Structural Grade: **4**  
O&M Grade: **0**  
Clock Start/From: **5**  
Clock To: **10**  
1st Value:  
2nd Value:  
Value Percent:  
Continuous Index:  
Within 8" of Joint: **YES**  
Remarks:

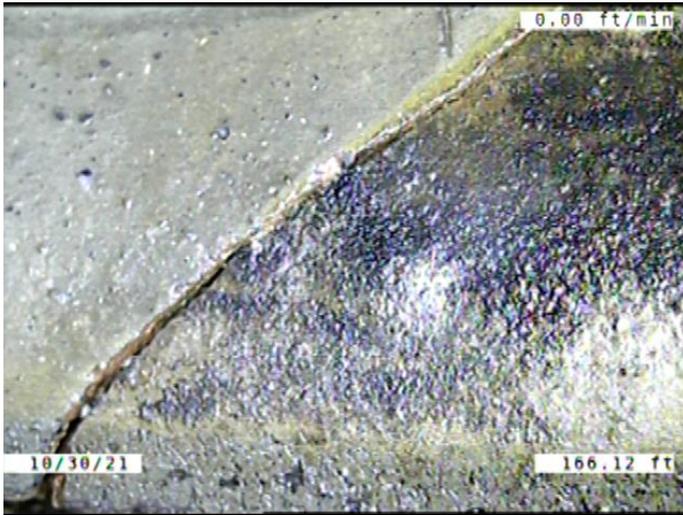
Code: **ISB**  
Description: **Infiltration Stain Barrel**

Distance (ft): **166.1**  
Structural Grade: **0**  
O&M Grade: **1**  
Clock Start/From: **8**  
Clock To: **9**  
1st Value:  
2nd Value:  
Value Percent:  
Continuous Index:  
Within 8" of Joint: **YES**  
Remarks:

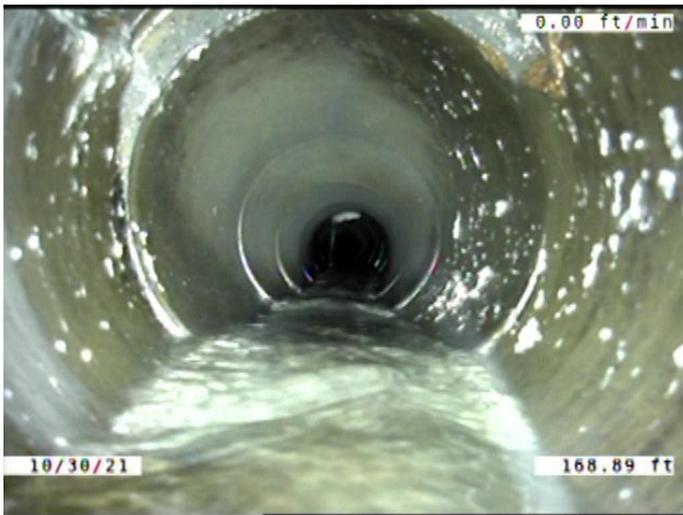
Code: **DSF**  
Description: **Deposits Settled Fine**

Distance (ft): **168.9**  
Structural Grade: **0**  
O&M Grade: **2**  
Clock Start/From: **5**  
Clock To: **7**  
1st Value:  
2nd Value:  
Value Percent: **5.000**  
Continuous Index: **F04**  
Within 8" of Joint: **YES**  
Remarks:
