Profile/Photo Observation Report

Date:	10/30/2021	Weather:		Coding:	PACP 7.0
Pipe Length (ft):	205.0	Owner:	City of Hobart	Pre Clean:	Heavy Cleaning
P.O.#:	YES502259	Surveyor:	S. Bucklin	PSR:	P-504-048-046
Customer:	City of Hobart	Clean Date:	10/27/2021	Shape:	C

Street:	North Colorado Street	Flow Control:	Not Controlled
City:	Hobart, IN	Year Renewed:	
Location:	Alley	Tape/Media #:	
Purpose:	Routine Assessment	Dia/Height:	12"
Use:	Sanitary Sewage Pipe	Material:	VCP
Drain Area:		Lining:	None
Category:	NA		
Comment:

Location Details:		Direction of Survey:	Downstream
US MH:	M-504-046	DS MH:	M-504-048
		Total Length Surveyed (ft):	205.0

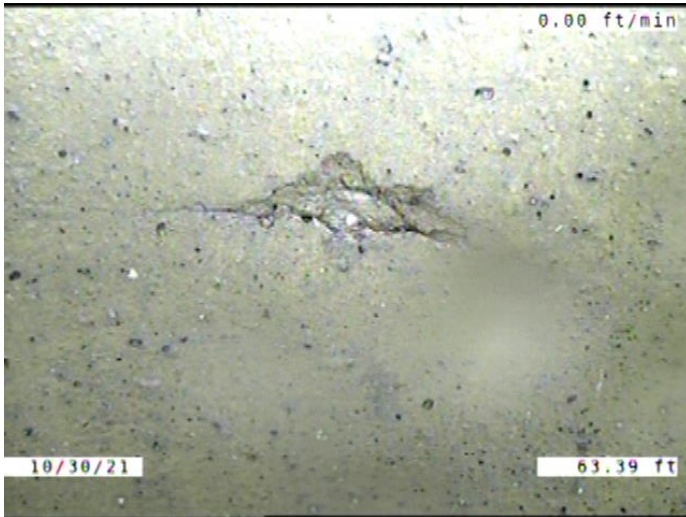
Code: **SSS**
 Description: **Surface Damage Surface Spalling**

Distance (ft): **63.4**
 Structural Grade: **2**
 O&M Grade: **0**
 Clock Start/From: **2**
 Clock To:
 1st Value:
 2nd Value:
 Value Percent:
 Continuous Index:
 Within 8" of Joint: **YES**
 Remarks:

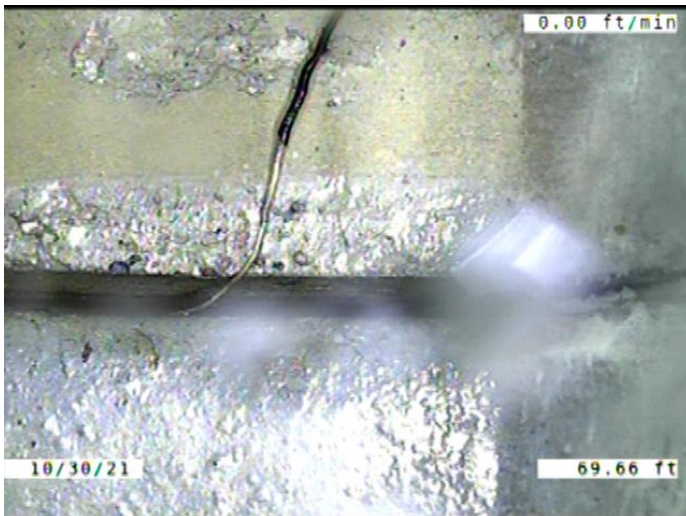
Code: **RFJ**
 Description: **Roots Fine Joint**

Distance (ft): **69.7**
 Structural Grade: **0**
 O&M Grade: **1**
 Clock Start/From: **8**
 Clock To:
 1st Value:
 2nd Value:
 Value Percent:
 Continuous Index:
 Within 8" of Joint: **YES**
 Remarks:

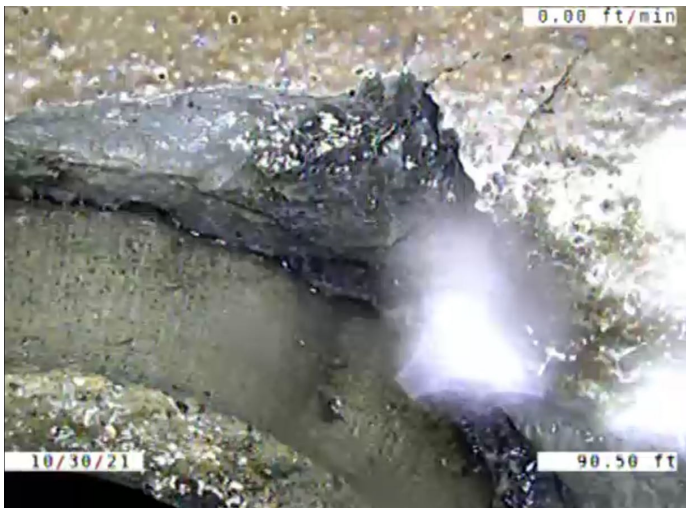
Code: **CM**
Description: **Crack Multiple**

Distance (ft): **90.5**
Structural Grade: **3**
O&M Grade: **0**
Clock Start/From: **10**
Clock To: **1**
1st Value:
2nd Value:
Value Percent:
Continuous Index:
Within 8" of Joint: **NO**
Remarks:

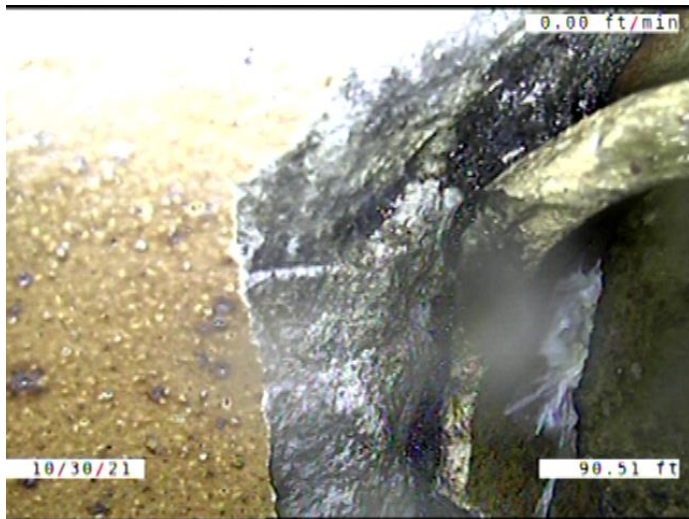
Code: **SSS**
 Description: **Surface Damage Surface Spalling**

Distance (ft): **90.5**
 Structural Grade: **2**
 O&M Grade: **0**
 Clock Start/From: **10**
 Clock To: **1**
 1st Value:
 2nd Value:
 Value Percent:
 Continuous Index:
 Within 8" of Joint: **YES**
 Remarks:

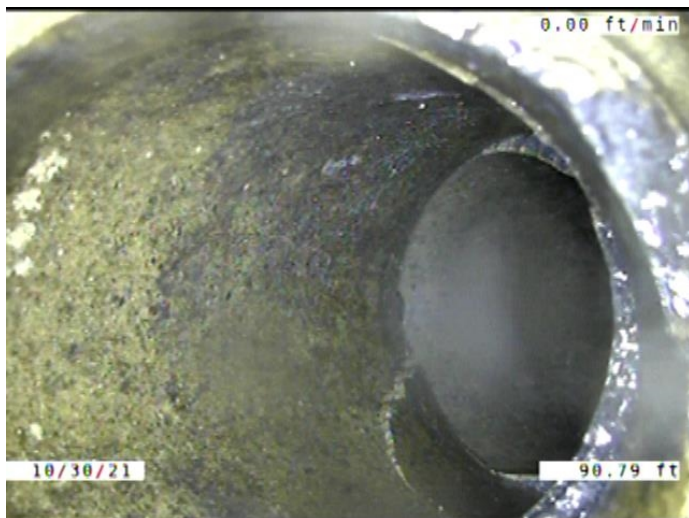
Code: **TBD**
 Description: **Tap Break-in/Hammer Defective**

Distance (ft): **90.8**
 Structural Grade: **0**
 O&M Grade: **3**
 Clock Start/From: **1**
 Clock To:
 1st Value: **4.000**
 2nd Value:
 Value Percent:
 Continuous Index:
 Within 8" of Joint: **YES**
 Remarks: **Defective**

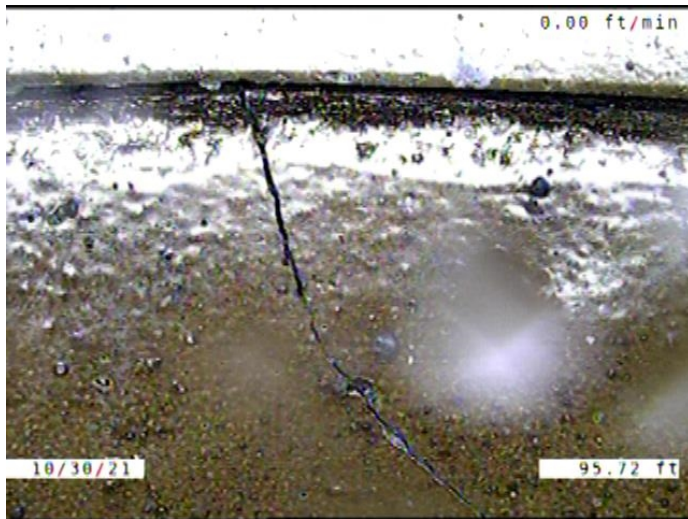
Code: **FM**
 Description: **Fracture Multiple**

Distance (ft): **95.7**
 Structural Grade: **4**
 O&M Grade: **0**
 Clock Start/From: **12**
 Clock To: **3**
 1st Value:
 2nd Value:
 Value Percent:
 Continuous Index:
 Within 8" of Joint: **YES**
 Remarks:

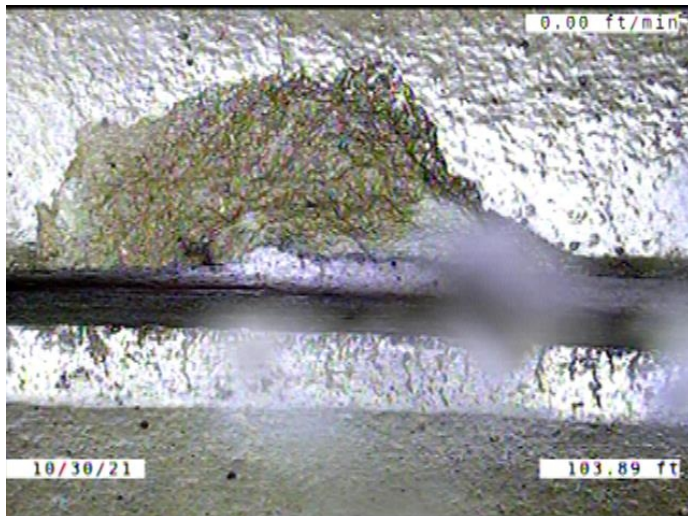
Code: **SZ**
 Description: **Surface Damage Other**

Distance (ft): **103.9**
 Structural Grade: **0**
 O&M Grade: **0**
 Clock Start/From: **11**
 Clock To: **12**
 1st Value:
 2nd Value:
 Value Percent:
 Continuous Index:
 Within 8" of Joint: **YES**
 Remarks: **A PIECE CHIPPED AWAY FROM THE JOINT**

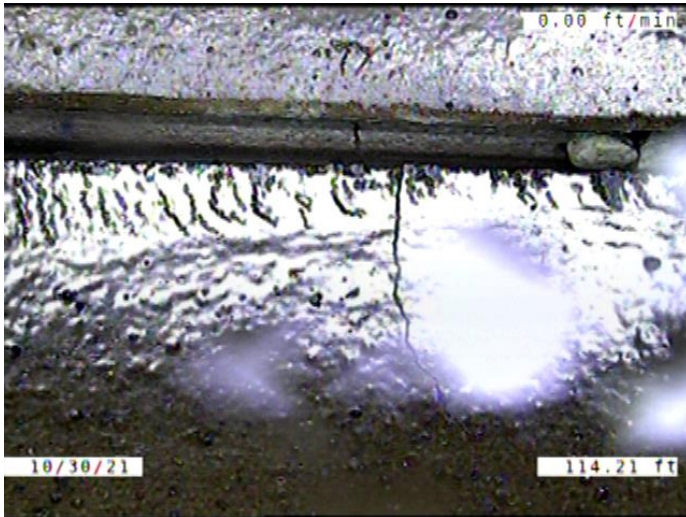
Code: **CS**
 Description: **Crack Spiral**

Distance (ft): **114.2**
 Structural Grade: **2**
 O&M Grade: **0**
 Clock Start/From: **12**
 Clock To: **1**
 1st Value:
 2nd Value:
 Value Percent:
 Continuous Index:
 Within 8" of Joint: **YES**
 Remarks:

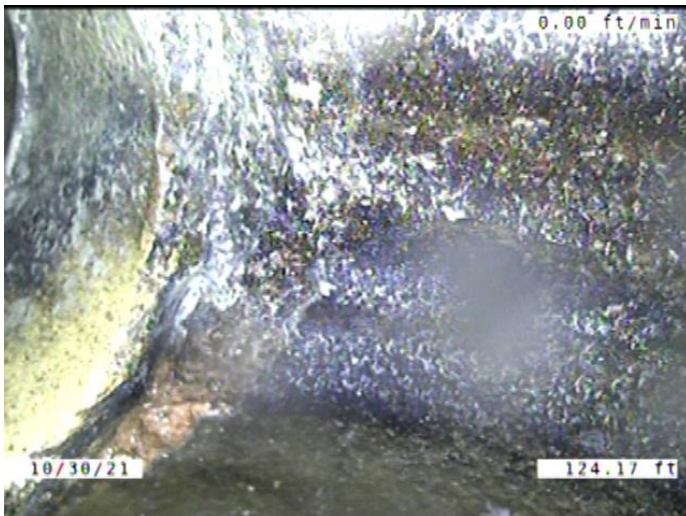
Code: **SSS**
 Description: **Surface Damage Surface Spalling**

Distance (ft): **124.2**
 Structural Grade: **2**
 O&M Grade: **0**
 Clock Start/From: **11**
 Clock To: **1**
 1st Value:
 2nd Value:
 Value Percent:
 Continuous Index:
 Within 8" of Joint: **YES**
 Remarks:

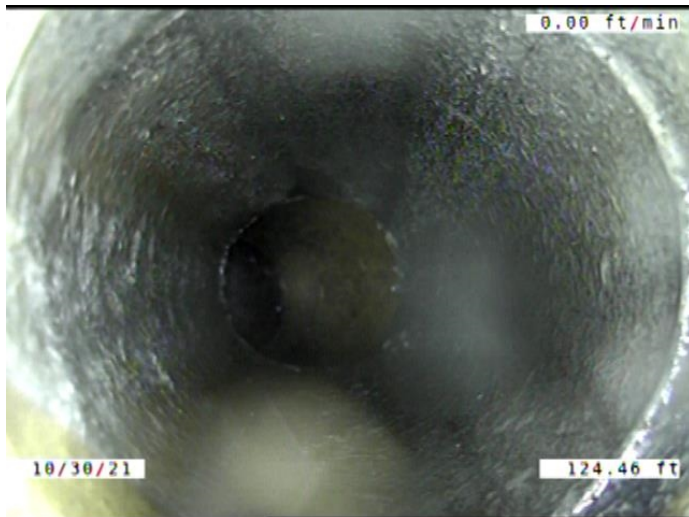
Code: **TB**
Description: **Tap Break-in/Hammer**

Distance (ft): **124.5**
Structural Grade: **0**
O&M Grade: **0**
Clock Start/From: **12**
Clock To:
1st Value: **4.000**
2nd Value:
Value Percent:
Continuous Index:
Within 8" of Joint: **YES**
Remarks: **CONSTANTLY RUNNING WATER**

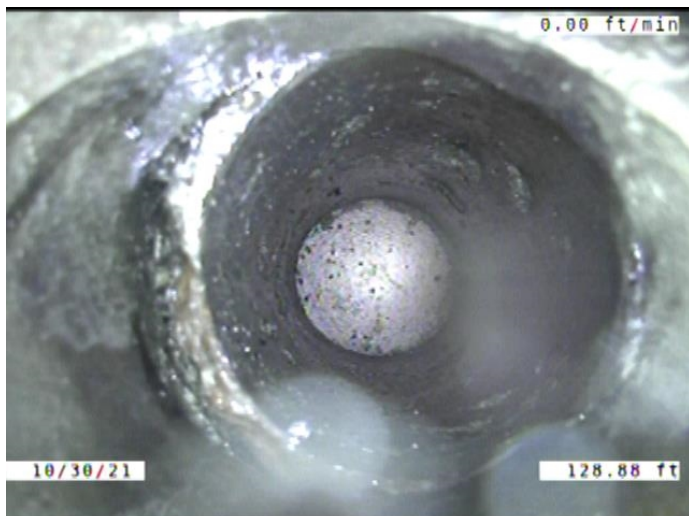
Code: **TFD**
Description: **Tap Factory Defective**

Distance (ft): **128.9**
Structural Grade: **0**
O&M Grade: **3**
Clock Start/From: **1**
Clock To:
1st Value: **4.000**
2nd Value:
Value Percent:
Continuous Index:
Within 8" of Joint: **YES**
Remarks: **CAPPED. DRIPPING WATER. OFFSET JOINT**

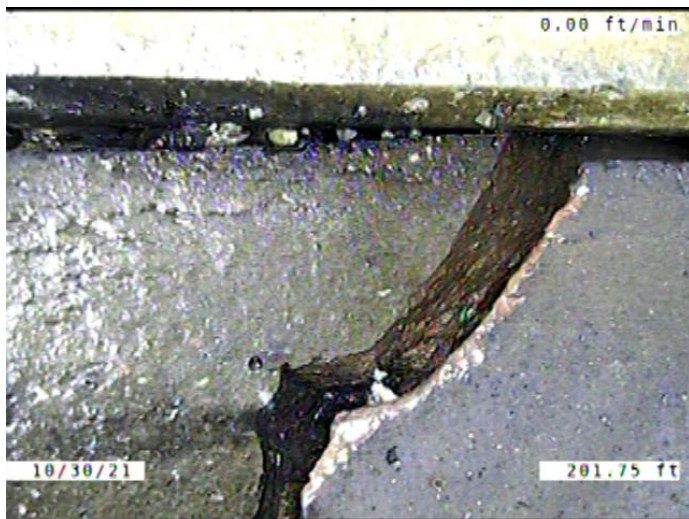
Code: **B**
 Description: **Broken**

Distance (ft): **201.8**
 Structural Grade: **4**
 O&M Grade: **0**
 Clock Start/From: **7**
 Clock To: **10**
 1st Value:
 2nd Value:
 Value Percent:
 Continuous Index:
 Within 8" of Joint: **YES**
 Remarks:

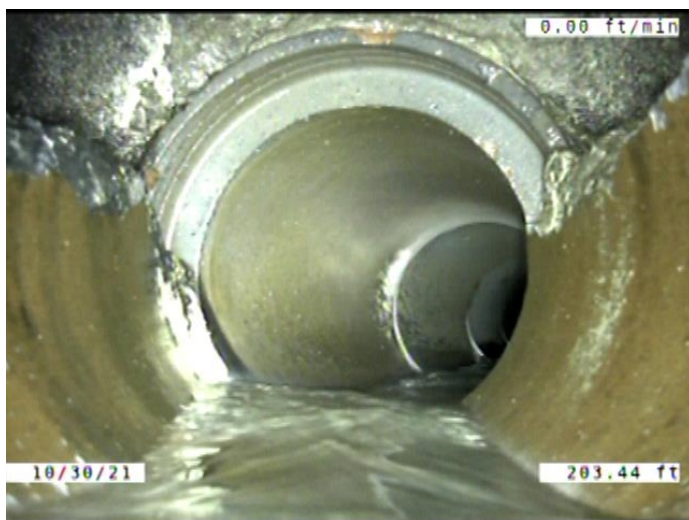
Code: **DSF**
 Description: **Deposits Settled Fine**

Distance (ft): **203.4**
 Structural Grade: **0**
 O&M Grade: **2**
 Clock Start/From: **5**
 Clock To: **7**
 1st Value:
 2nd Value:
 Value Percent: **5.000**
 Continuous Index: **F02**
 Within 8" of Joint: **YES**
 Remarks:
