Profile/Photo Observation Report

Date:	10/30/2021	Weather:		Coding:	PACP 7.0
Pipe Length (ft):	205.0	Owner:	City of Hobart	Pre Clean:	Heavy Cleaning
P.O.#:	YES502259	Surveyor:	S. Bucklin	PSR:	P-504-048-046
Customer:	City of Hobart	Clean Date:	10/27/2021	Shape:	C

Street:	North Colorado Street	Flow Control:	Not Controlled
City:	Hobart, IN	Year Renewed:	
Location:	Alley	Tape/Media #:	
Purpose:	Routine Assessment	Dia/Height:	12"
Use:	Sanitary Sewage Pipe	Material:	VCP
Drain Area:		Lining:	None
Category:	NA		
Comment:

Location Details:		Direction of Survey:	Downstream
US MH:	M-504-046	DS MH:	M-504-048
		Total Length Surveyed (ft):	205.0

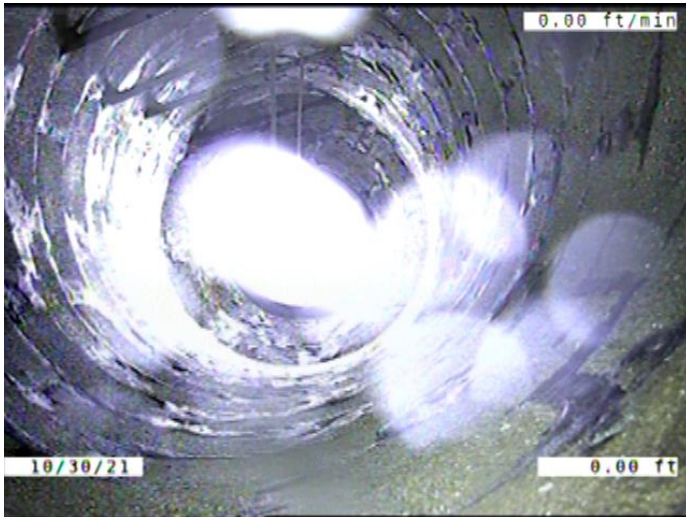
Code: **AMH**
Description: **Manhole**

Distance (ft): **.0**
Structural Grade: **0**
O&M Grade: **0**
Clock Start/From:
Clock To:
1st Value:
2nd Value:
Value Percent:
Continuous Index:
Within 8" of Joint: **NO**
Remarks: **M-504-046**

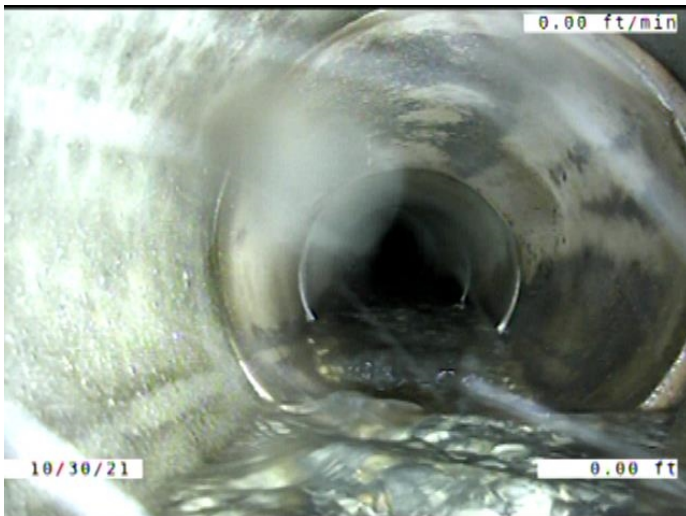
Code: **MWL**
Description: **Miscellaneous Water Level**

Distance (ft): **.0**
Structural Grade: **0**
O&M Grade: **0**
Clock Start/From:
Clock To:
1st Value:
2nd Value:
Value Percent: **10.000**
Continuous Index:
Within 8" of Joint: **NO**
Remarks:

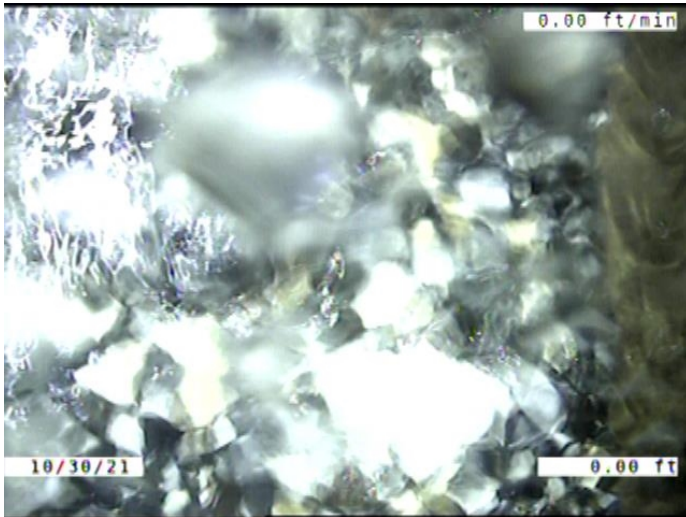
Code: **DSC**
 Description: **Deposits Settled Hard/Compacted**

Distance (ft): **.0**
 Structural Grade: **0**
 O&M Grade: **2**
 Clock Start/From: **5**
 Clock To: **7**
 1st Value:
 2nd Value:
 Value Percent: **5.000**
 Continuous Index: **S01**
 Within 8" of Joint: **YES**
 Remarks:

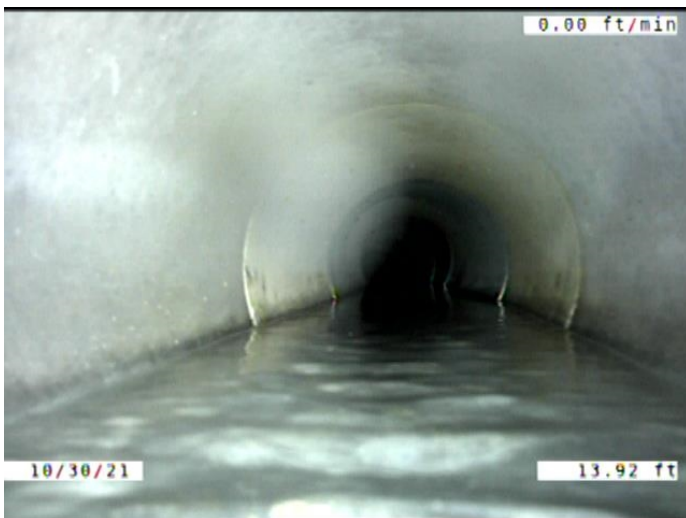
Code: **DSC**
 Description: **Deposits Settled Hard/Compacted**

Distance (ft): **13.9**
 Structural Grade: **0**
 O&M Grade: **2**
 Clock Start/From: **5**
 Clock To: **7**
 1st Value:
 2nd Value:
 Value Percent: **5.000**
 Continuous Index: **F01**
 Within 8" of Joint: **YES**
 Remarks:

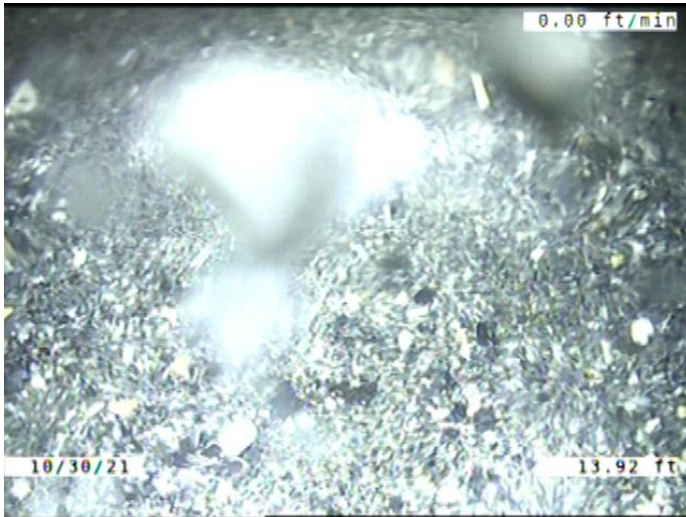
Code: **DSF**
Description: **Deposits Settled Fine**

Distance (ft): **13.9**
Structural Grade: **0**
O&M Grade: **2**
Clock Start/From: **5**
Clock To: **7**
1st Value:
2nd Value:
Value Percent: **5.000**
Continuous Index: **S02**
Within 8" of Joint: **YES**
Remarks:

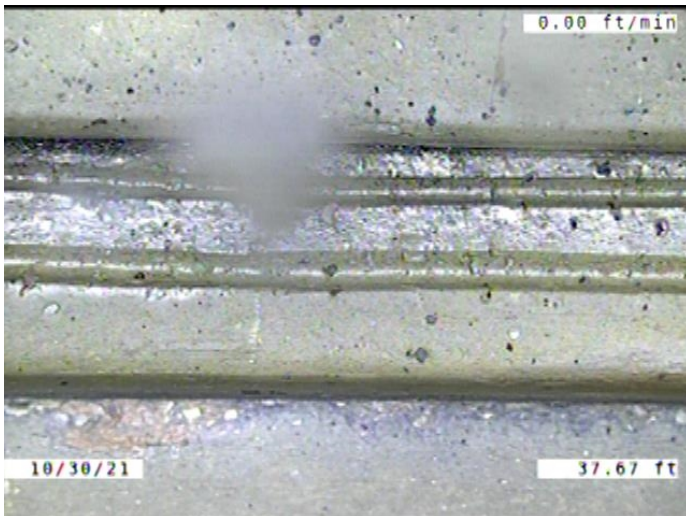
Code: **JAL**
Description: **Joint Angular Large**

Distance (ft): **37.7**
Structural Grade: **4**
O&M Grade: **0**
Clock Start/From:
Clock To:
1st Value:
2nd Value:
Value Percent:
Continuous Index:
Within 8" of Joint: **NO**
Remarks:

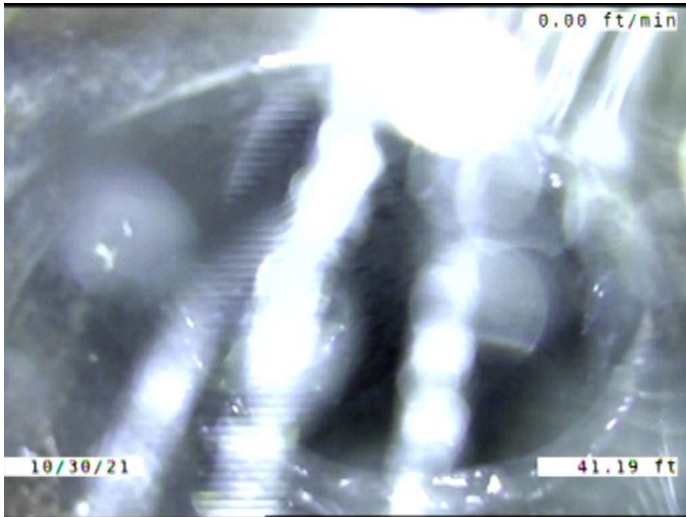
Code: **TFD**
 Description: **Tap Factory Defective**

Distance (ft): **41.2**
 Structural Grade: **0**
 O&M Grade: **3**
 Clock Start/From: **1**
 Clock To:
 1st Value: **4.000**
 2nd Value:
 Value Percent:
 Continuous Index:
 Within 8" of Joint: **YES**
 Remarks: **BROKEN TAP. CONSTANTLY RUNNING WATER**

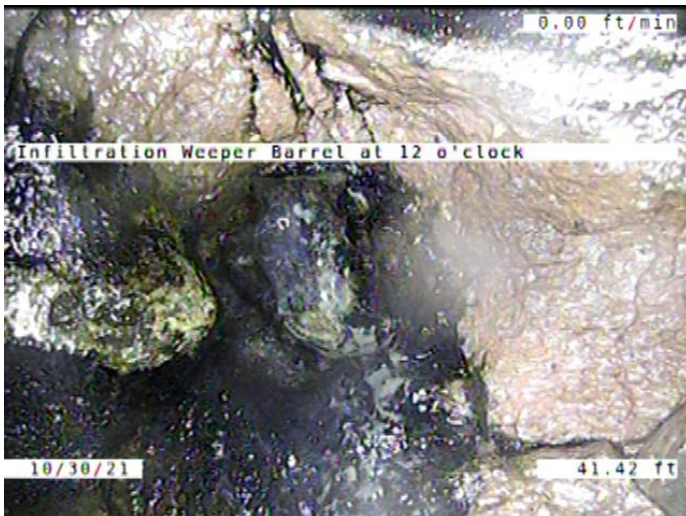
Code: **IDB**
 Description: **Infiltration Dripper Barrel**

Distance (ft): **41.4**
 Structural Grade: **0**
 O&M Grade: **3**
 Clock Start/From: **12**
 Clock To:
 1st Value:
 2nd Value:
 Value Percent:
 Continuous Index:
 Within 8" of Joint: **NO**
 Remarks:

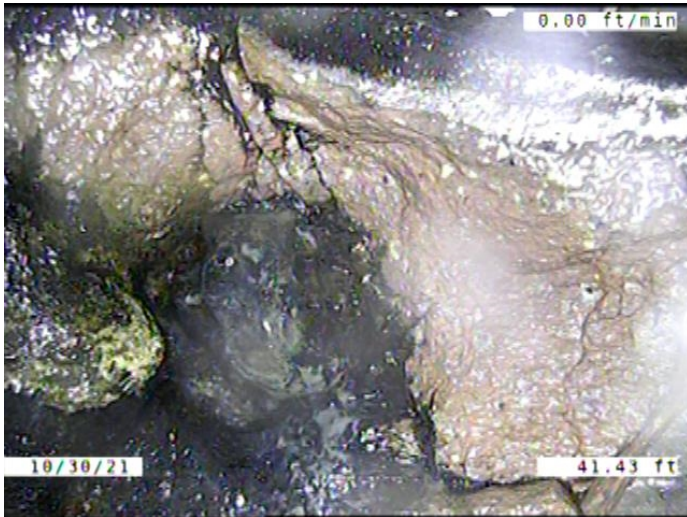
Code: **SMW**
 Description: **Surface Damage Missing Wall**

Distance (ft): **41.4**
 Structural Grade: **5**
 O&M Grade: **0**
 Clock Start/From: **11**
 Clock To: **1**
 1st Value:
 2nd Value:
 Value Percent:
 Continuous Index:
 Within 8" of Joint: **YES**
 Remarks:

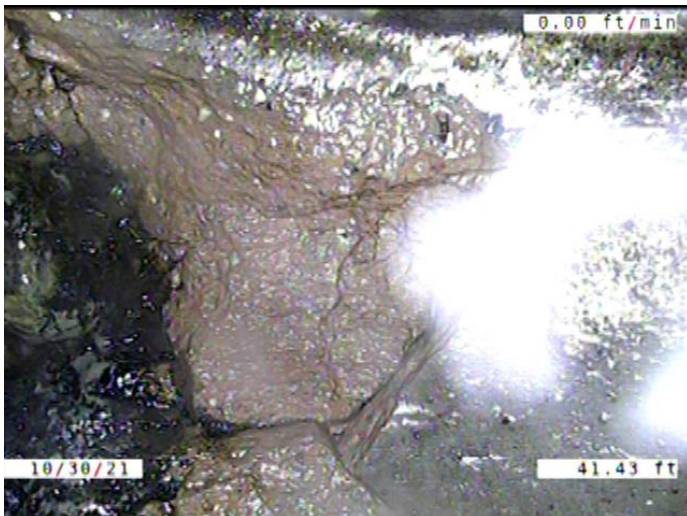
Code: **B**
 Description: **Broken**

Distance (ft): **41.4**
 Structural Grade: **4**
 O&M Grade: **0**
 Clock Start/From: **11**
 Clock To: **3**
 1st Value:
 2nd Value:
 Value Percent:
 Continuous Index:
 Within 8" of Joint: **YES**
 Remarks:

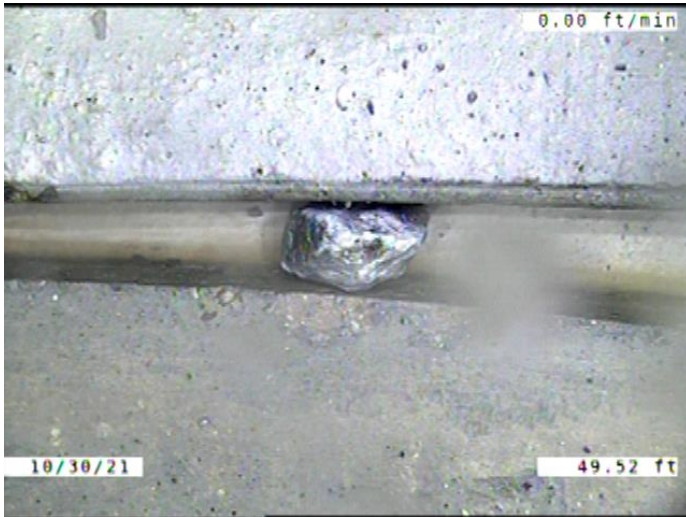
Code: **OBJ**
 Description: **Obstruction Wedged In The Joint**

Distance (ft): **49.5**
 Structural Grade: **0**
 O&M Grade: **2**
 Clock Start/From: **1**
 Clock To: **2**
 1st Value:
 2nd Value:
 Value Percent: **5.000**
 Continuous Index:
 Within 8" of Joint: **YES**
 Remarks:

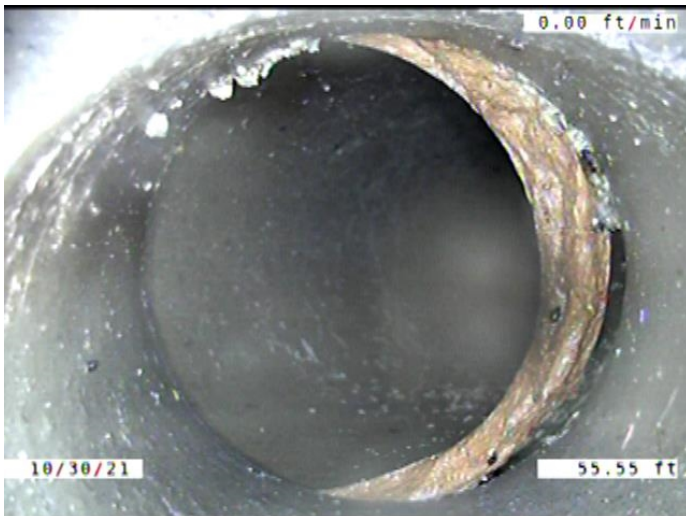
Code: **TFD**
 Description: **Tap Factory Defective**

Distance (ft): **55.6**
 Structural Grade: **0**
 O&M Grade: **3**
 Clock Start/From: **10**
 Clock To:
 1st Value: **4.000**
 2nd Value:
 Value Percent:
 Continuous Index:
 Within 8" of Joint: **YES**
 Remarks: **OFFSET JOINT**

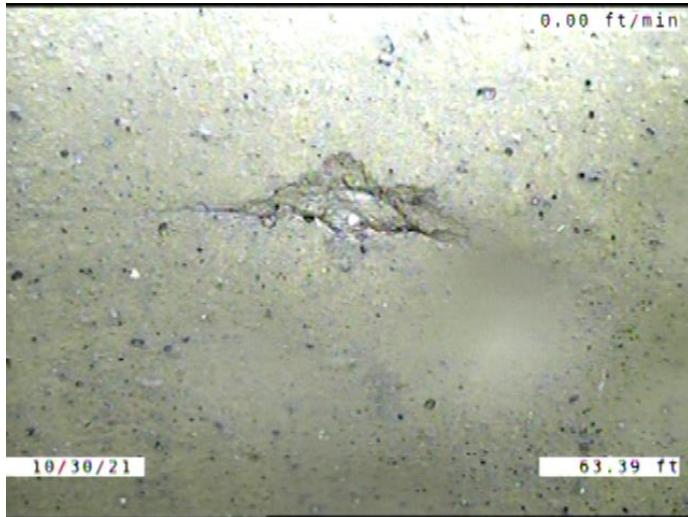
Code: **SSS**
 Description: **Surface Damage Surface Spalling**

Distance (ft): **63.4**
 Structural Grade: **2**
 O&M Grade: **0**
 Clock Start/From: **2**
 Clock To:
 1st Value:
 2nd Value:
 Value Percent:
 Continuous Index:
 Within 8" of Joint: **YES**
 Remarks:

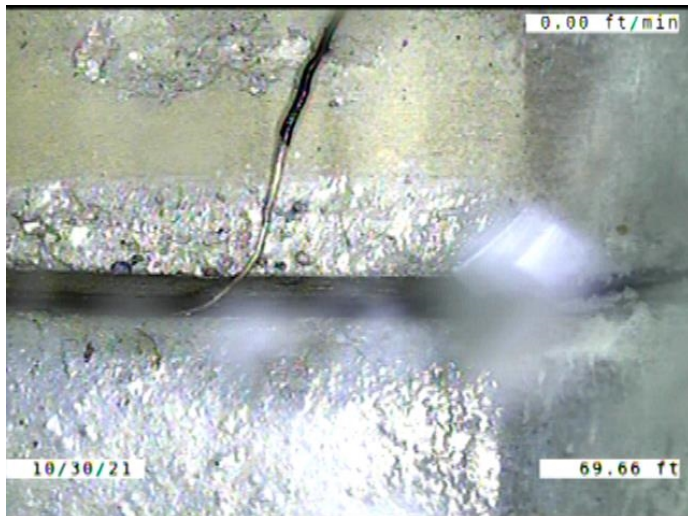
Code: **RFJ**
 Description: **Roots Fine Joint**

Distance (ft): **69.7**
 Structural Grade: **0**
 O&M Grade: **1**
 Clock Start/From: **8**
 Clock To:
 1st Value:
 2nd Value:
 Value Percent:
 Continuous Index:
 Within 8" of Joint: **YES**
 Remarks:

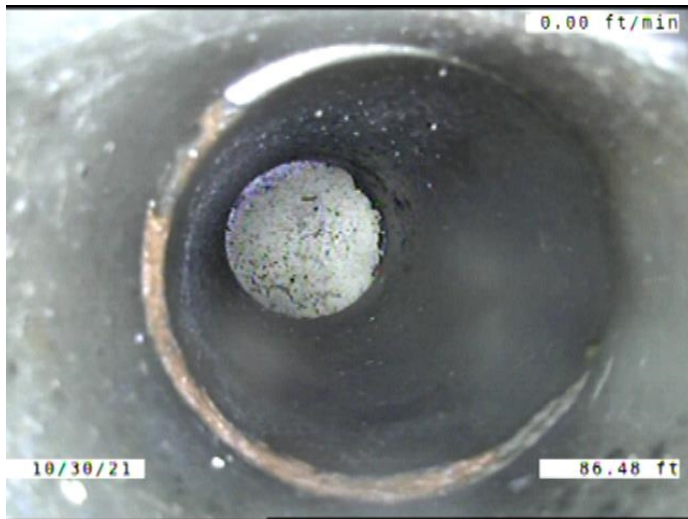
Code: **TFC**
 Description: **Tap Factory Capped**

Distance (ft): **86.5**
 Structural Grade: **0**
 O&M Grade: **0**
 Clock Start/From: **1**
 Clock To:
 1st Value: **4.000**
 2nd Value:
 Value Percent:
 Continuous Index:
 Within 8" of Joint: **YES**
 Remarks:

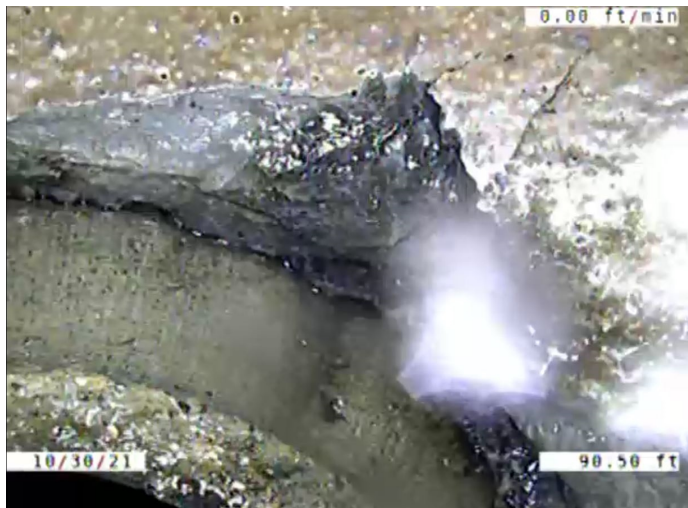
Code: **CM**
 Description: **Crack Multiple**

Distance (ft): **90.5**
 Structural Grade: **3**
 O&M Grade: **0**
 Clock Start/From: **10**
 Clock To: **1**
 1st Value:
 2nd Value:
 Value Percent:
 Continuous Index:
 Within 8" of Joint: **NO**
 Remarks:

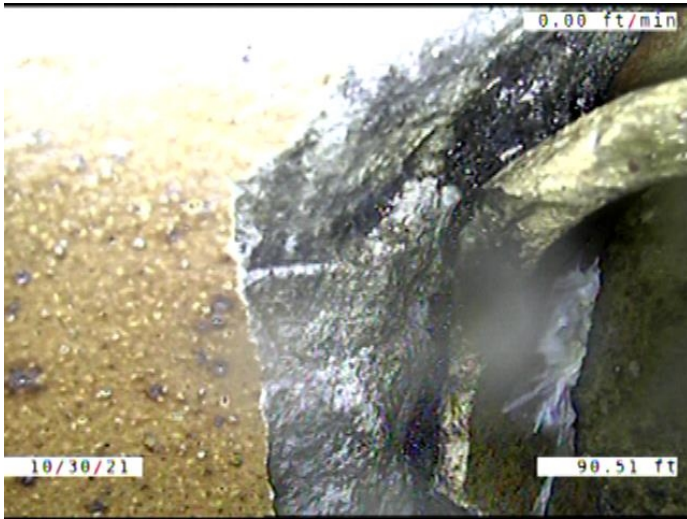
Code: **SSS**
 Description: **Surface Damage Surface Spalling**

Distance (ft): **90.5**
 Structural Grade: **2**
 O&M Grade: **0**
 Clock Start/From: **10**
 Clock To: **1**
 1st Value:
 2nd Value:
 Value Percent:
 Continuous Index:
 Within 8" of Joint: **YES**
 Remarks:

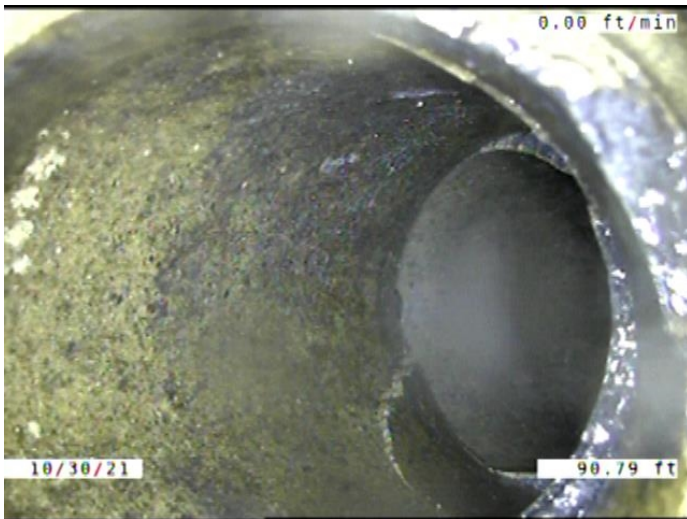
Code: **TBD**
 Description: **Tap Break-in/Hammer Defective**

Distance (ft): **90.8**
 Structural Grade: **0**
 O&M Grade: **3**
 Clock Start/From: **1**
 Clock To:
 1st Value: **4.000**
 2nd Value:
 Value Percent:
 Continuous Index:
 Within 8" of Joint: **YES**
 Remarks: **Defective**

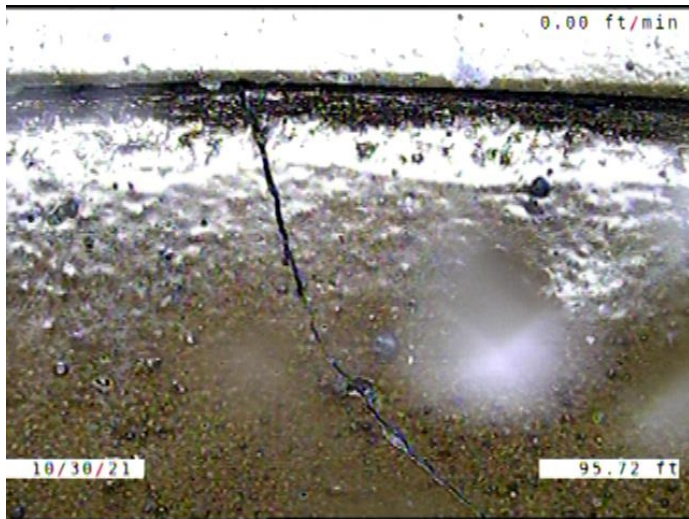
Code: **FM**
 Description: **Fracture Multiple**

Distance (ft): **95.7**
 Structural Grade: **4**
 O&M Grade: **0**
 Clock Start/From: **12**
 Clock To: **3**
 1st Value:
 2nd Value:
 Value Percent:
 Continuous Index:
 Within 8" of Joint: **YES**
 Remarks:

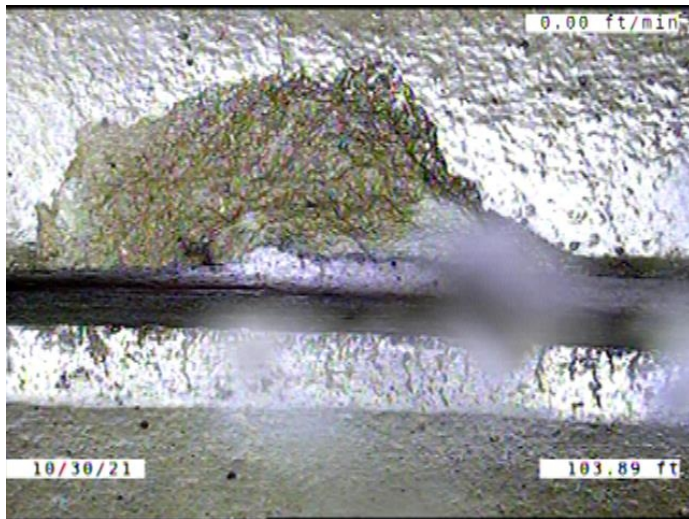
Code: **SZ**
 Description: **Surface Damage Other**

Distance (ft): **103.9**
 Structural Grade: **0**
 O&M Grade: **0**
 Clock Start/From: **11**
 Clock To: **12**
 1st Value:
 2nd Value:
 Value Percent:
 Continuous Index:
 Within 8" of Joint: **YES**
 Remarks: **A PIECE CHIPPED AWAY FROM THE JOINT**

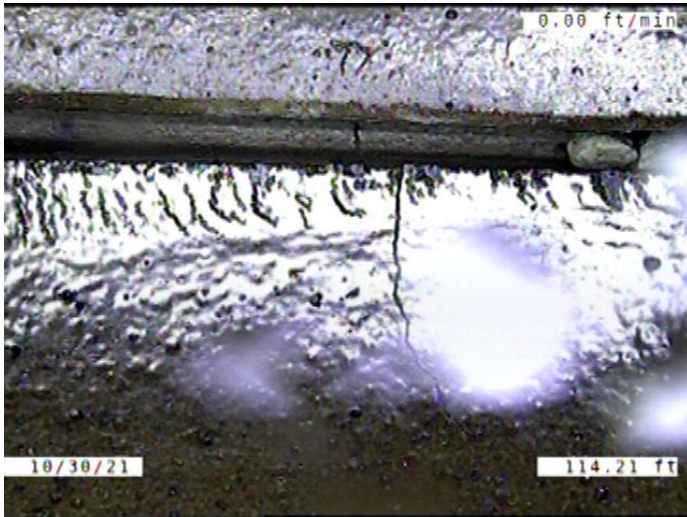
Code: **CS**
 Description: **Crack Spiral**

Distance (ft): **114.2**
 Structural Grade: **2**
 O&M Grade: **0**
 Clock Start/From: **12**
 Clock To: **1**
 1st Value:
 2nd Value:
 Value Percent:
 Continuous Index:
 Within 8" of Joint: **YES**
 Remarks:

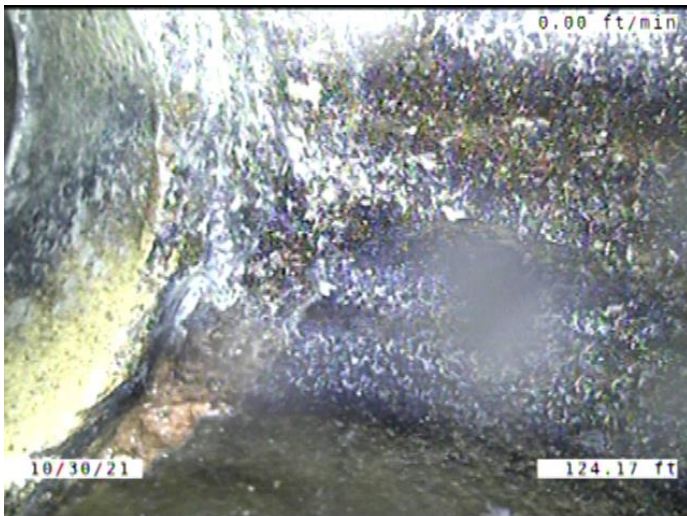
Code: **SSS**
 Description: **Surface Damage Surface Spalling**

Distance (ft): **124.2**
 Structural Grade: **2**
 O&M Grade: **0**
 Clock Start/From: **11**
 Clock To: **1**
 1st Value:
 2nd Value:
 Value Percent:
 Continuous Index:
 Within 8" of Joint: **YES**
 Remarks:

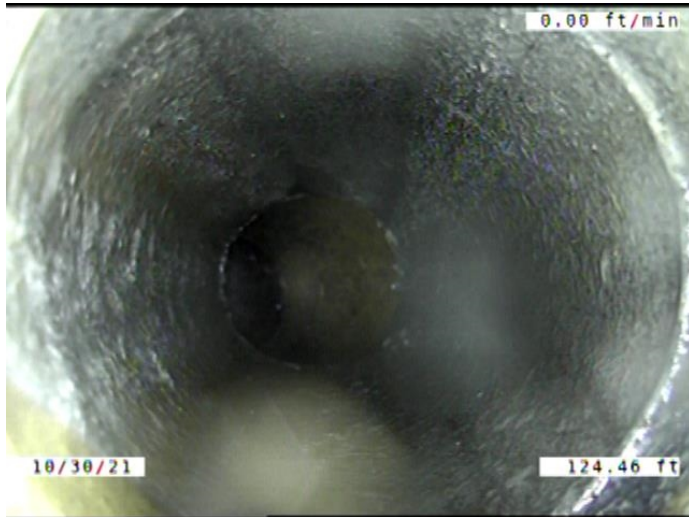
Code: **TB**
Description: **Tap Break-in/Hammer**

Distance (ft): **124.5**
Structural Grade: **0**
O&M Grade: **0**
Clock Start/From: **12**
Clock To:
1st Value: **4.000**
2nd Value:
Value Percent:
Continuous Index:
Within 8" of Joint: **YES**
Remarks: **CONSTANTLY RUNNING WATER**

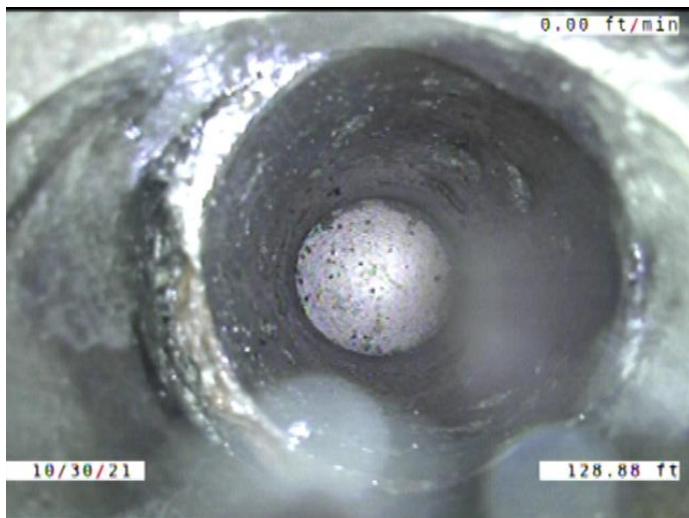
Code: **TFD**
Description: **Tap Factory Defective**

Distance (ft): **128.9**
Structural Grade: **0**
O&M Grade: **3**
Clock Start/From: **1**
Clock To:
1st Value: **4.000**
2nd Value:
Value Percent:
Continuous Index:
Within 8" of Joint: **YES**
Remarks: **CAPPED. DRIPPING WATER. OFFSET JOINT**

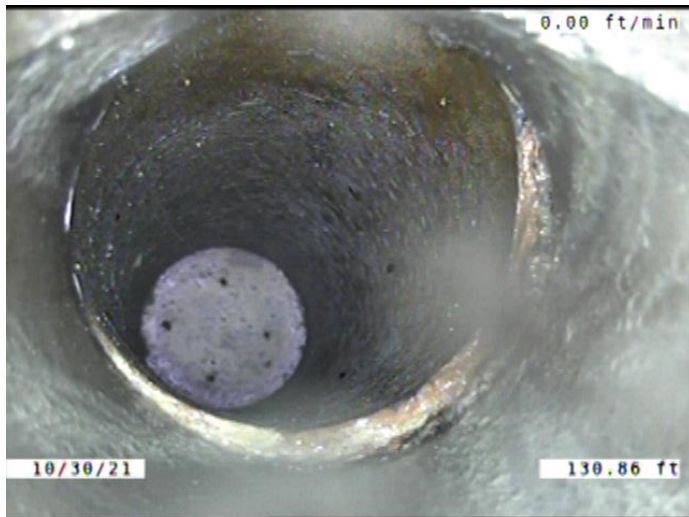
Code:	TFD
Description:	Tap Factory Defective
Distance (ft):	130.9
Structural Grade:	0
O&M Grade:	3
Clock Start/From:	11
Clock To:	
1st Value:	4.000
2nd Value:	
Value Percent:	
Continuous Index:	
Within 8" of Joint:	YES
Remarks:	CAPPED. DRIPPING WATER. OFFSET JOINT

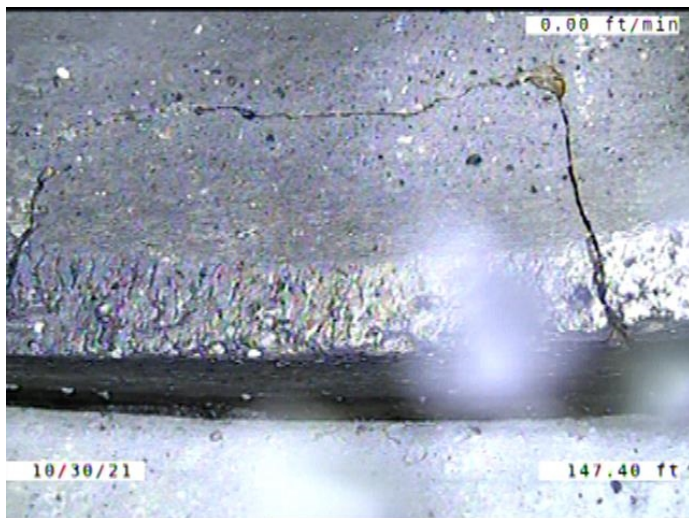
Code:	FM
Description:	Fracture Multiple
Distance (ft):	147.4
Structural Grade:	4
O&M Grade:	0
Clock Start/From:	8
Clock To:	9
1st Value:	
2nd Value:	
Value Percent:	
Continuous Index:	
Within 8" of Joint:	YES
Remarks:

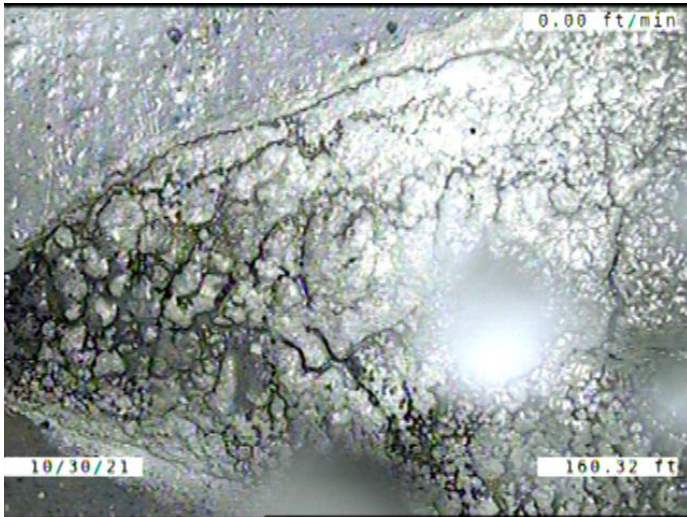
Code: **DAE**
 Description: **Deposits Attached Encrustation**

Distance (ft): **160.3**
 Structural Grade: **0**
 O&M Grade: **2**
 Clock Start/From: **2**
 Clock To: **5**
 1st Value:
 2nd Value:
 Value Percent: **5.000**
 Continuous Index:
 Within 8" of Joint: **YES**
 Remarks:

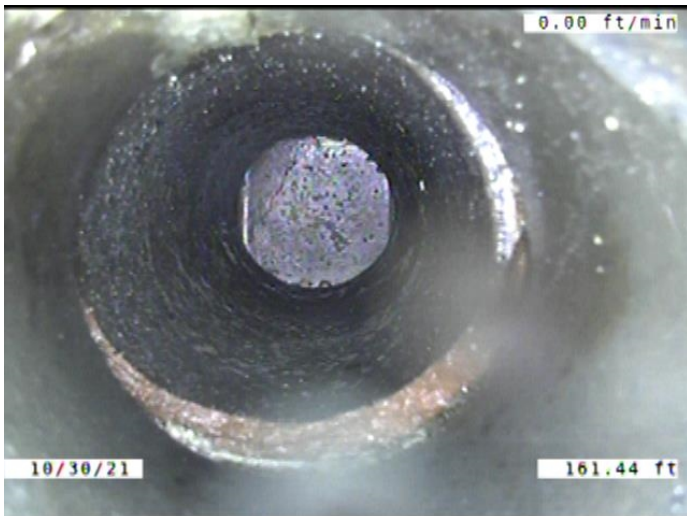
Code: **TFD**
 Description: **Tap Factory Defective**

Distance (ft): **161.4**
 Structural Grade: **0**
 O&M Grade: **3**
 Clock Start/From: **11**
 Clock To:
 1st Value: **4.000**
 2nd Value:
 Value Percent:
 Continuous Index:
 Within 8" of Joint: **YES**
 Remarks: **CAPPED. OFFSET JOINT. ENCUSTATION COMING DOWN THE**

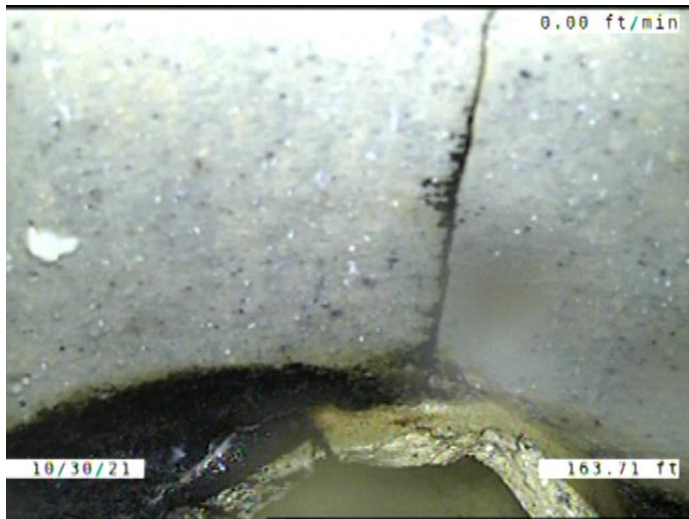
Code: **FL**
 Description: **Fracture Longitudinal**

Distance (ft): **163.7**
 Structural Grade: **3**
 O&M Grade: **0**
 Clock Start/From: **12**
 Clock To:
 1st Value:
 2nd Value:
 Value Percent:
 Continuous Index:
 Within 8" of Joint: **NO**
 Remarks:

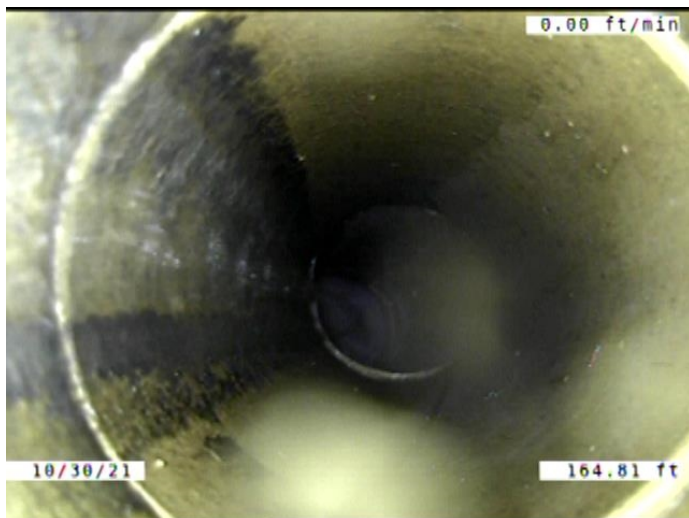
Code: **TBI**
 Description: **Tap Break-in Intruding**

Distance (ft): **164.8**
 Structural Grade: **0**
 O&M Grade: **2**
 Clock Start/From: **11**
 Clock To:
 1st Value: **4.000**
 2nd Value: **1.000**
 Value Percent:
 Continuous Index:
 Within 8" of Joint: **YES**
 Remarks: **CONSTANTLY RUNNING WATER**

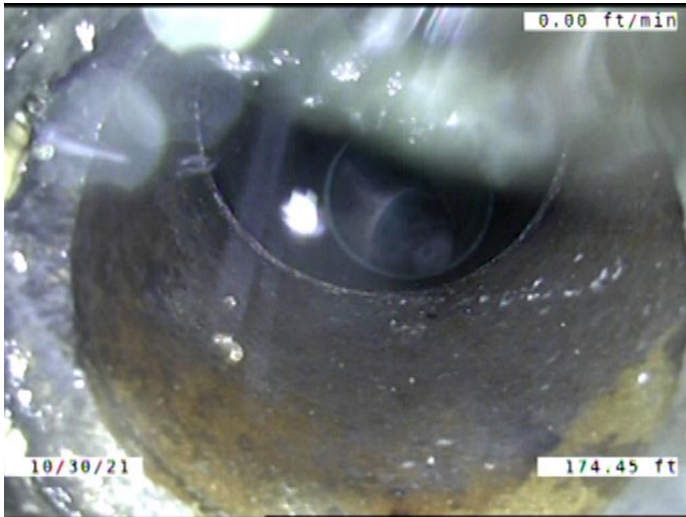
Code: **TFD**
 Description: **Tap Factory Defective**

Distance (ft): **174.4**
 Structural Grade: **0**
 O&M Grade: **3**
 Clock Start/From: **12**
 Clock To:
 1st Value: **4.000**
 2nd Value:
 Value Percent:
 Continuous Index:
 Within 8" of Joint: **YES**
 Remarks: **CONSTANTLY RUNNING WATER**

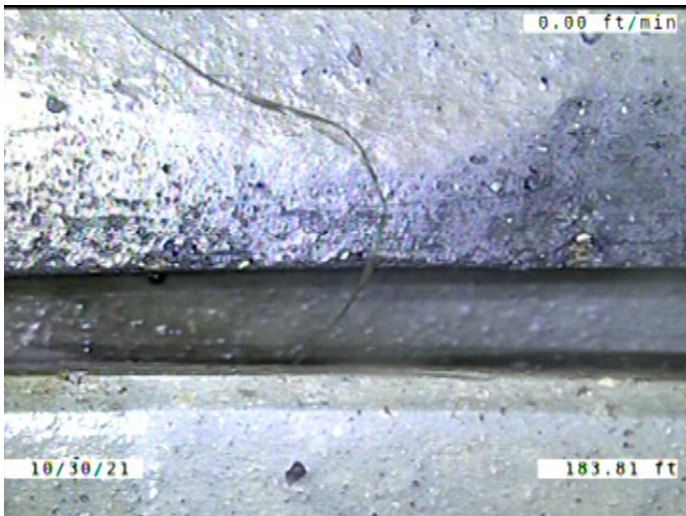
Code: **RFJ**
 Description: **Roots Fine Joint**

Distance (ft): **183.8**
 Structural Grade: **0**
 O&M Grade: **1**
 Clock Start/From: **3**
 Clock To: **4**
 1st Value:
 2nd Value:
 Value Percent:
 Continuous Index:
 Within 8" of Joint: **YES**
 Remarks:

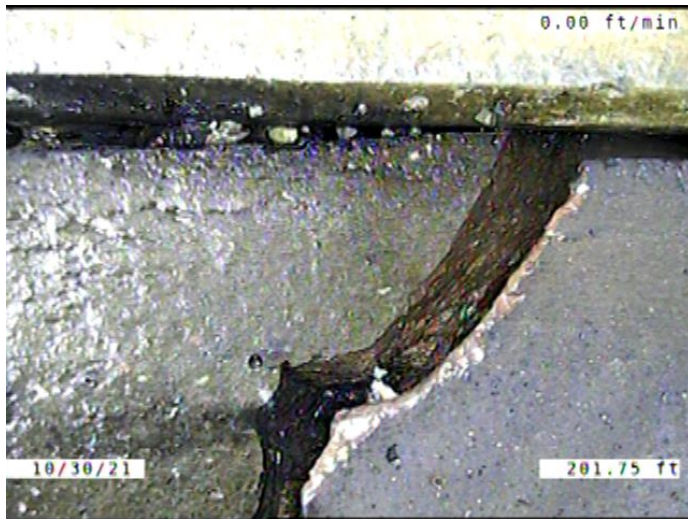
Code: **B**
 Description: **Broken**

Distance (ft): **201.8**
 Structural Grade: **4**
 O&M Grade: **0**
 Clock Start/From: **7**
 Clock To: **10**
 1st Value:
 2nd Value:
 Value Percent:
 Continuous Index:
 Within 8" of Joint: **YES**
 Remarks:

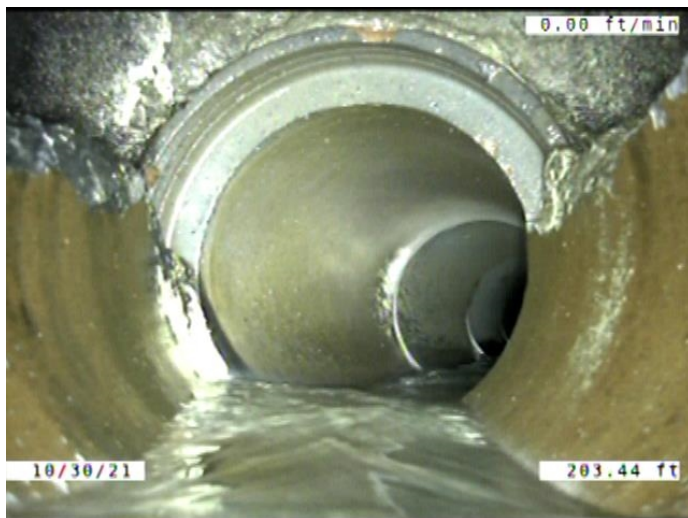
Code: **DSF**
 Description: **Deposits Settled Fine**

Distance (ft): **203.4**
 Structural Grade: **0**
 O&M Grade: **2**
 Clock Start/From: **5**
 Clock To: **7**
 1st Value:
 2nd Value:
 Value Percent: **5.000**
 Continuous Index: **F02**
 Within 8" of Joint: **YES**
 Remarks:

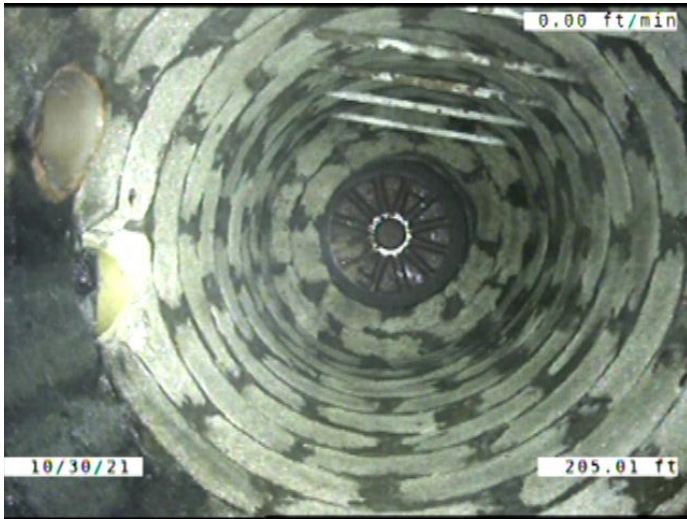
Code:	AMH
Description:	Manhole
Distance (ft):	205.0
Structural Grade:	0
O&M Grade:	0
Clock Start/From:	
Clock To:	
1st Value:	
2nd Value:	
Value Percent:	
Continuous Index:	
Within 8" of Joint:	NO
Remarks:	M-504-048
