RedZone<sup>®</sup>  
ROBOTICS

Street:	North Delaware Street		Flow Control:	Not Controlled	
City:	Hobart, IN		Year Renewed:		
Location:	Alley		Tape/Media #:		
Purpose:	Routine Assessment		Dia/Height:	10"	
Use:	Sanitary Sewage Pipe		Material:	VCP	
Drain Area:			Lining:	None	
Category:	NA				
Comment:					
Location Details:			Direction of Survey: Downstream		
US MH:	M-504-048	DS MH:	M-504-047	Total Length Surveyed (ft):	167.0

**Tuesday, April 25, 2023**

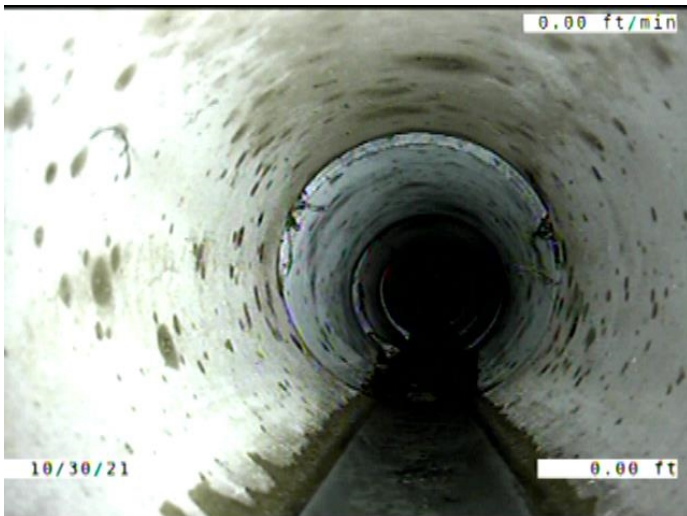
Code: **DSF**  
 Description: **Deposits Settled Fine**

Distance (ft): **.0**  
 Structural Grade: **0**  
 O&M Grade: **2**  
 Clock Start/From: **5**  
 Clock To: **7**  
 1st Value:  
 2nd Value:  
 Value Percent: **5.000**  
 Continuous Index: **S01**  
 Within 8" of Joint: **YES**  
 Remarks:

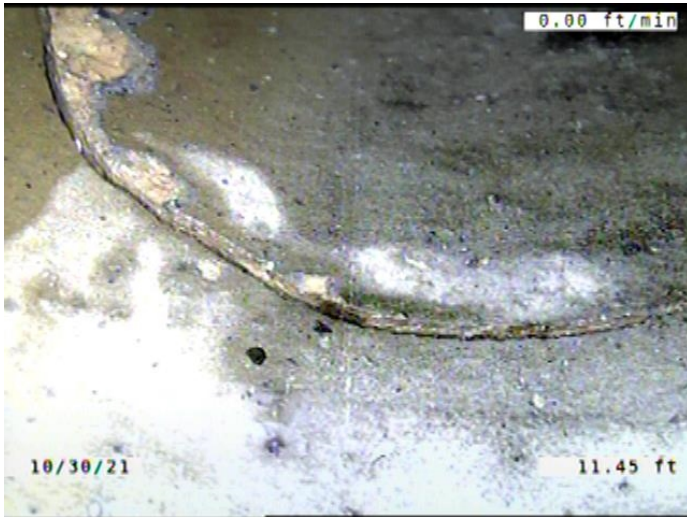
Code: **B**  
Description: **Broken**

Distance (ft): **11.5**  
Structural Grade: **4**  
O&M Grade: **0**  
Clock Start/From: **12**  
Clock To: **7**  
1st Value:  
2nd Value:  
Value Percent:  
Continuous Index:  
Within 8" of Joint: **YES**  
Remarks:

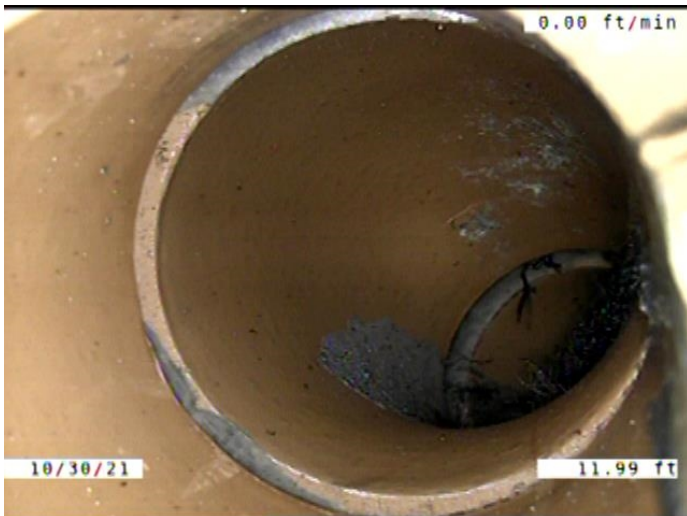
Code: **TBI**  
Description: **Tap Break-in Intruding**

Distance (ft): **12.0**  
Structural Grade: **0**  
O&M Grade: **2**  
Clock Start/From: **2**  
Clock To:  
1st Value: **4.000**  
2nd Value: **1.000**  
Value Percent:  
Continuous Index:  
Within 8" of Joint: **YES**  
Remarks: **CONSTANTLY RUNNING WATER**

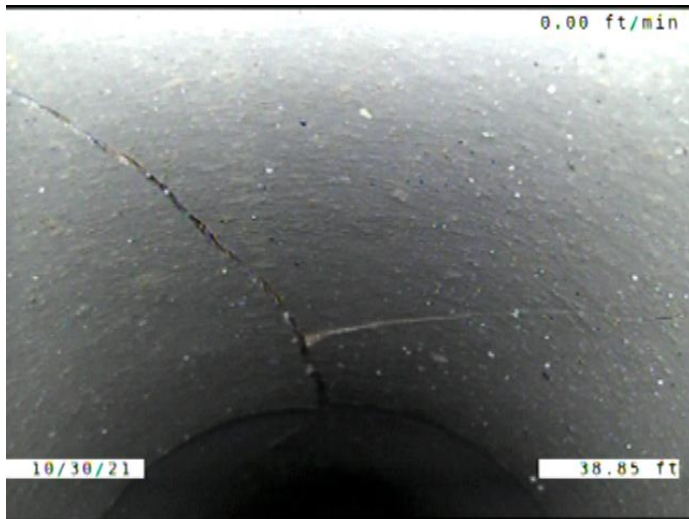
Code: **B**  
Description: **Broken**

Distance (ft): **38.8**  
Structural Grade: **4**  
O&M Grade: **0**  
Clock Start/From: **12**  
Clock To: **12**  
1st Value:  
2nd Value:  
Value Percent:  
Continuous Index: **S04**  
Within 8" of Joint: **YES**  
Remarks:

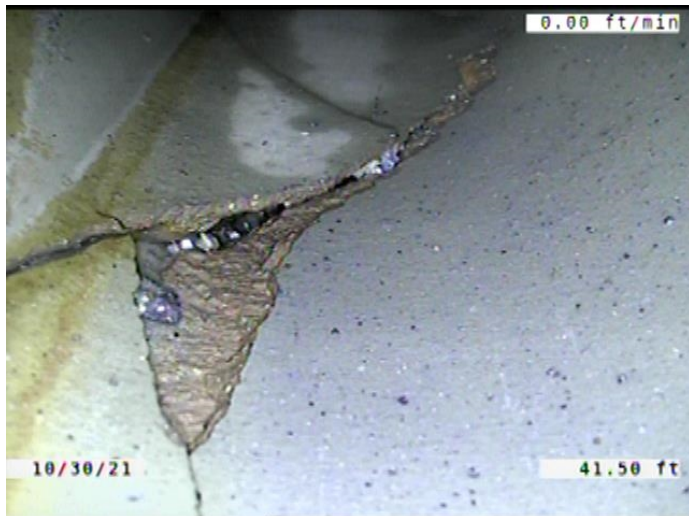
Code: **BSV**  
Description: **Broken Soil Visible**

Distance (ft): **41.5**  
Structural Grade: **5**  
O&M Grade: **0**  
Clock Start/From: **4**  
Clock To: **5**  
1st Value:  
2nd Value:  
Value Percent:  
Continuous Index:  
Within 8" of Joint: **YES**  
Remarks:

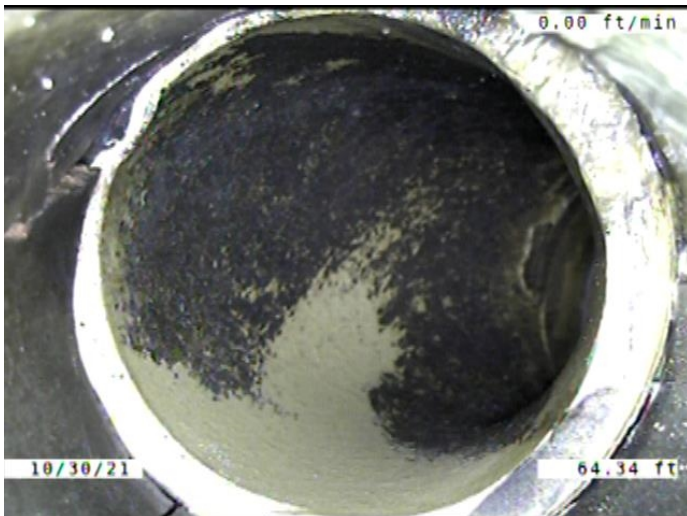
Code: **TFD**  
 Description: **Tap Factory Defective**

Distance (ft): **64.3**  
 Structural Grade: **0**  
 O&M Grade: **3**  
 Clock Start/From: **1**  
 Clock To:  
 1st Value: **4.000**  
 2nd Value:  
 Value Percent:  
 Continuous Index:  
 Within 8" of Joint: **YES**  
 Remarks: **TAP BROKEN. CONSTANTLY RUNNING WATER**

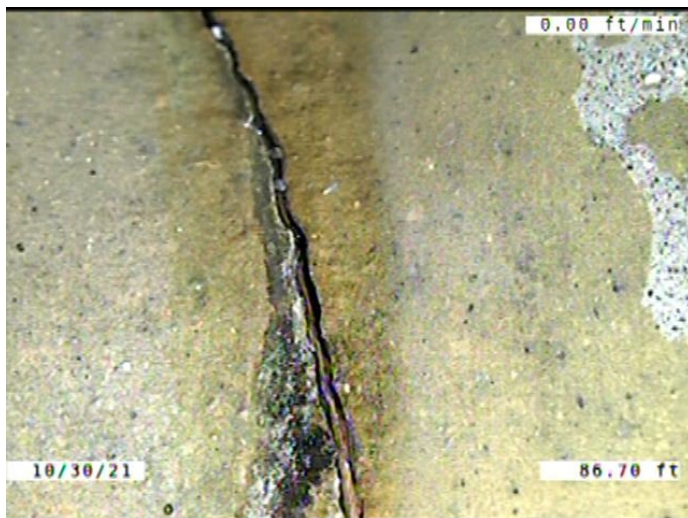
Code: **FM**  
 Description: **Fracture Multiple**

Distance (ft): **86.7**  
 Structural Grade: **4**  
 O&M Grade: **0**  
 Clock Start/From: **7**  
 Clock To: **2**  
 1st Value:  
 2nd Value:  
 Value Percent:  
 Continuous Index:  
 Within 8" of Joint: **YES**  
 Remarks:

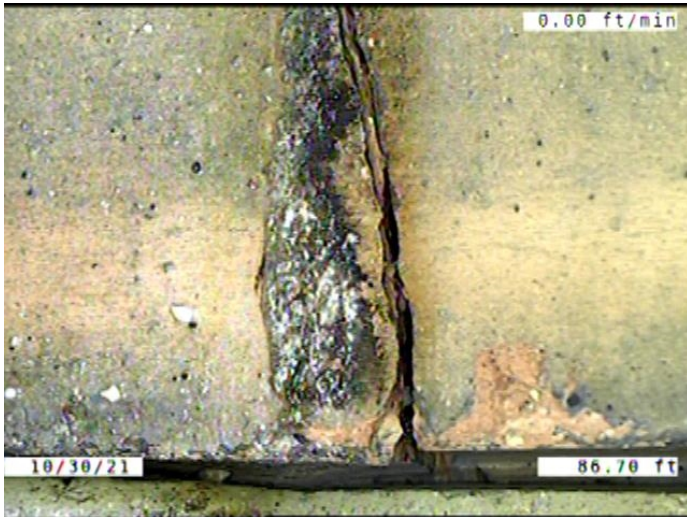
Code: **DAE**  
Description: **Deposits Attached Encrustation**

Distance (ft): **86.7**  
Structural Grade: **0**  
O&M Grade: **2**  
Clock Start/From: **7**  
Clock To: **9**  
1st Value:  
2nd Value:  
Value Percent: **5.000**  
Continuous Index:  
Within 8" of Joint: **YES**  
Remarks:

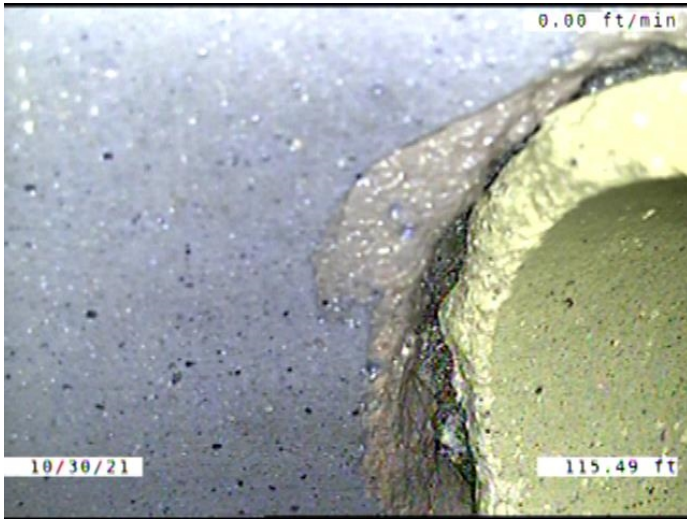
Code:	<b>SSS</b>
Description:	<b>Surface Damage Surface Spalling</b>
Distance (ft):	<b>115.5</b>
Structural Grade:	<b>2</b>
O&M Grade:	<b>0</b>
Clock Start/From:	<b>12</b>
Clock To:	<b>3</b>
1st Value:	
2nd Value:	
Value Percent:	
Continuous Index:	
Within 8" of Joint:	<b>NO</b>
Remarks:

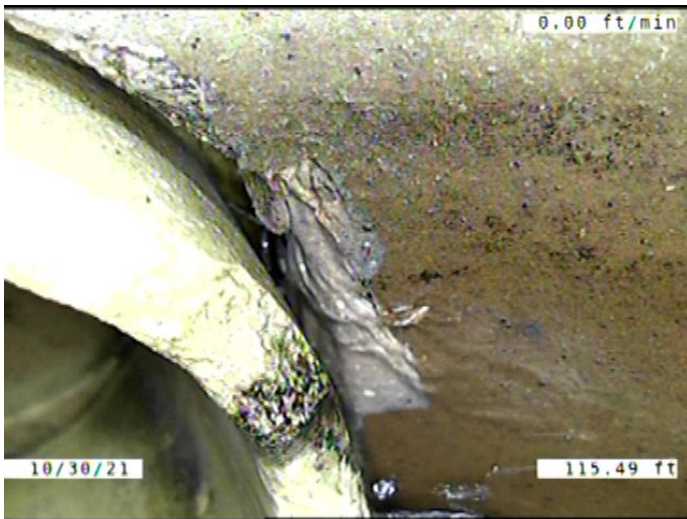
Code:	<b>IRC</b>
Description:	<b>Infiltration Runner Connection</b>
Distance (ft):	<b>115.5</b>
Structural Grade:	<b>0</b>
O&M Grade:	<b>4</b>
Clock Start/From:	<b>3</b>
Clock To:	
1st Value:	
2nd Value:	
Value Percent:	
Continuous Index:	
Within 8" of Joint:	<b>YES</b>
Remarks:

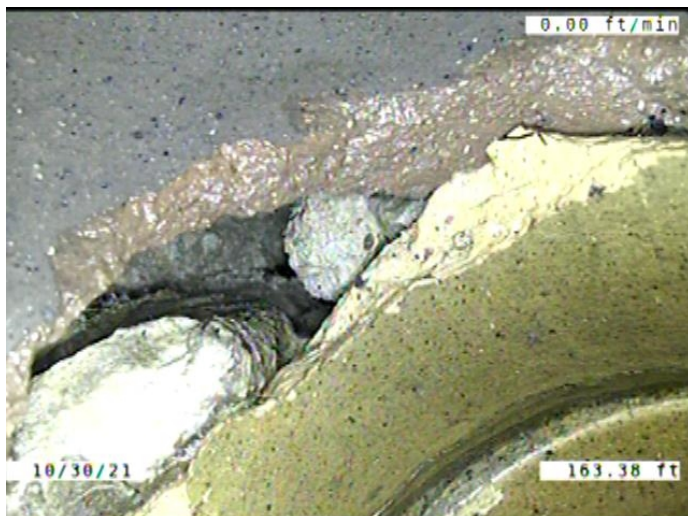
Code: **BSV**  
 Description: **Broken Soil Visible**

Distance (ft): **162.9**  
 Structural Grade: **5**  
 O&M Grade: **0**  
 Clock Start/From: **12**  
 Clock To: **3**  
 1st Value:  
 2nd Value:  
 Value Percent:  
 Continuous Index:  
 Within 8" of Joint: **NO**  
 Remarks:
