RedZone  
ROBOTICS

Street:	North Delaware Street		Flow Control:	Not Controlled	
City:	Hobart, IN		Year Renewed:		
Location:	Alley		Tape/Media #:		
Purpose:	Routine Assessment		Dia/Height:	10"	
Use:	Sanitary Sewage Pipe		Material:	VCP	
Drain Area:			Lining:	None	
Category:	NA				
Comment:					
Location Details:			Direction of Survey: Downstream		
US MH:	M-504-048	DS MH:	M-504-047	Total Length Surveyed (ft):	167.0

**Thursday, December 30, 2021**

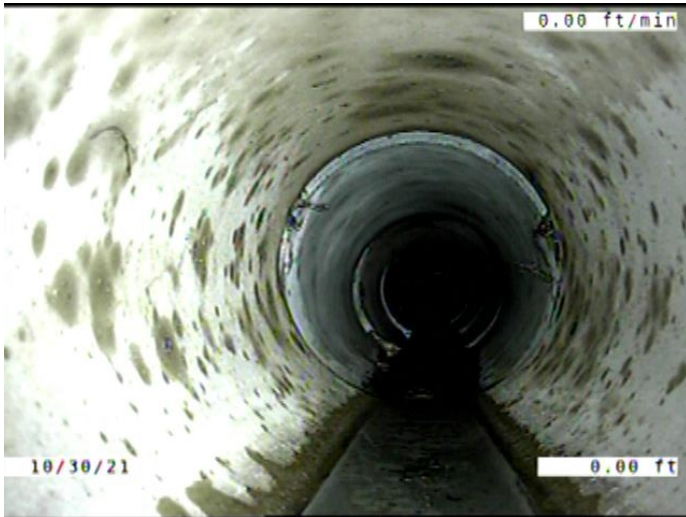
Code: **MWL**  
 Description: **Miscellaneous Water Level**

Distance (ft): **.0**  
 Structural Grade: **0**  
 O&M Grade: **0**  
 Clock Start/From:  
 Clock To:  
 1st Value:  
 2nd Value:  
 Value Percent: **5.000**  
 Continuous Index:  
 Within 8" of Joint: **NO**  
 Remarks:

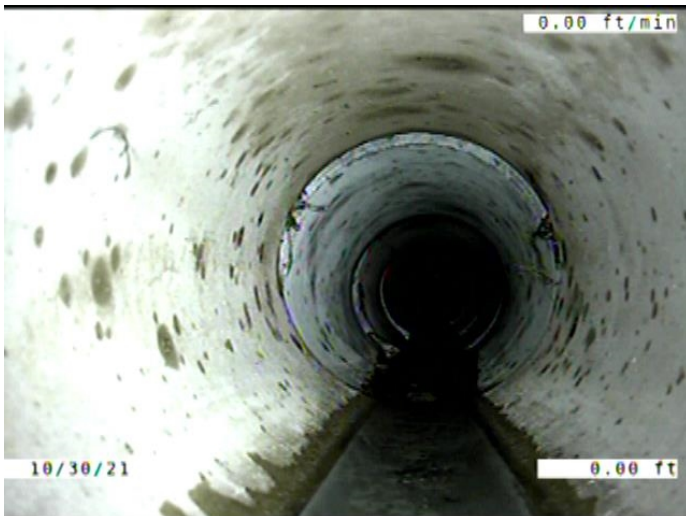
Code: **DSF**  
 Description: **Deposits Settled Fine**

Distance (ft): **.0**  
 Structural Grade: **0**  
 O&M Grade: **2**  
 Clock Start/From: **5**  
 Clock To: **7**  
 1st Value:  
 2nd Value:  
 Value Percent: **5.000**  
 Continuous Index: **S01**  
 Within 8" of Joint: **YES**  
 Remarks:

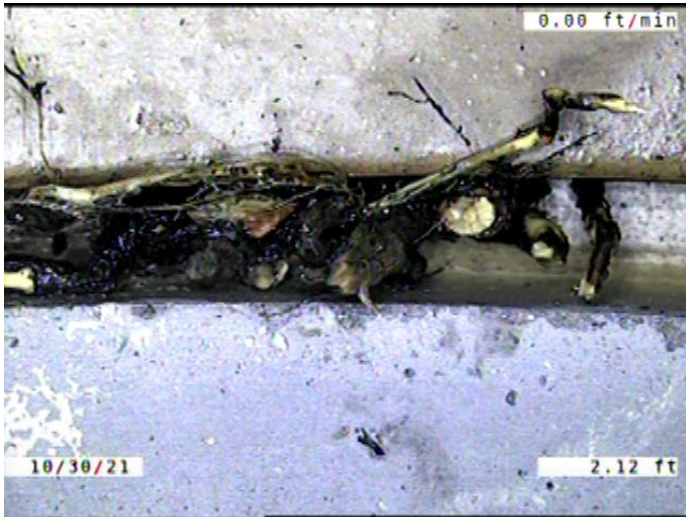
Code: **RFJ**  
 Description: **Roots Fine Joint**

Distance (ft): **2.1**  
 Structural Grade: **0**  
 O&M Grade: **1**  
 Clock Start/From: **9**  
 Clock To: **4**  
 1st Value:  
 2nd Value:  
 Value Percent:  
 Continuous Index:  
 Within 8" of Joint: **YES**  
 Remarks:

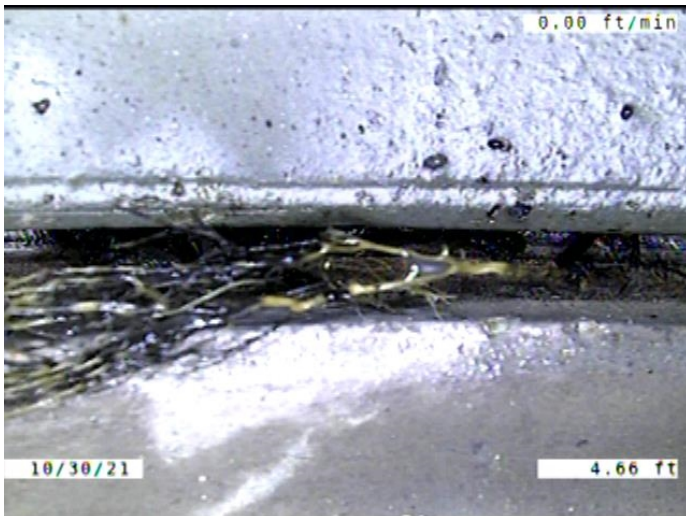
Code: **RFJ**  
 Description: **Roots Fine Joint**

Distance (ft): **4.7**  
 Structural Grade: **0**  
 O&M Grade: **1**  
 Clock Start/From: **9**  
 Clock To: **11**  
 1st Value:  
 2nd Value:  
 Value Percent:  
 Continuous Index:  
 Within 8" of Joint: **YES**  
 Remarks:

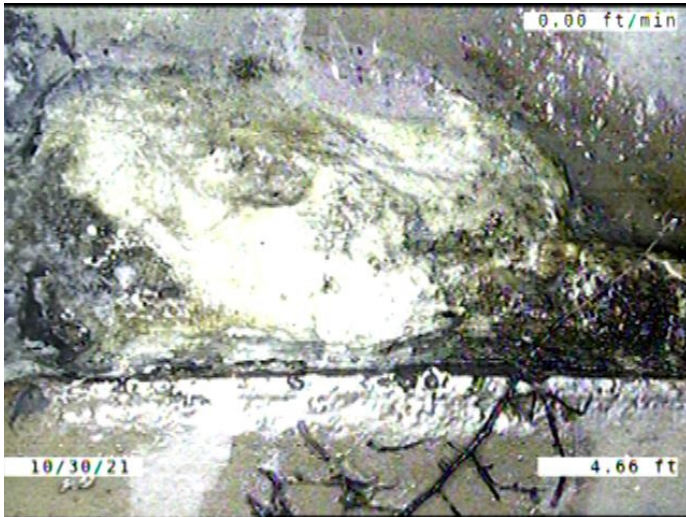
Code: **DAE**  
 Description: **Deposits Attached Encrustation**

Distance (ft): **4.7**  
 Structural Grade: **0**  
 O&M Grade: **2**  
 Clock Start/From: **4**  
 Clock To: **8**  
 1st Value:  
 2nd Value:  
 Value Percent: **5.000**  
 Continuous Index:  
 Within 8" of Joint: **YES**  
 Remarks:

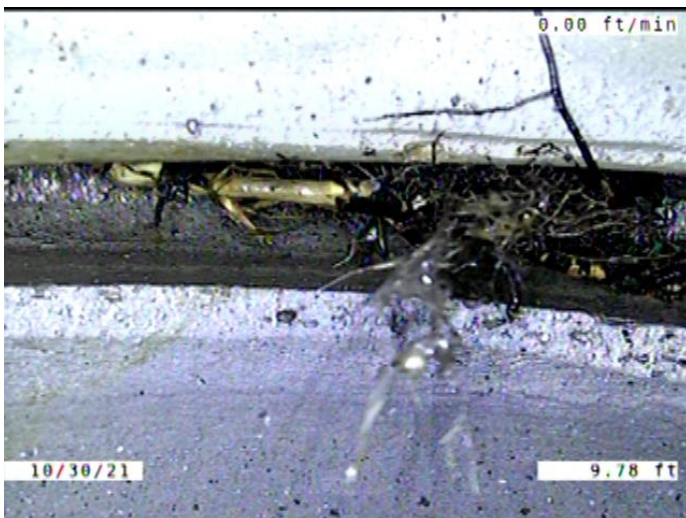
Code: **RFJ**  
 Description: **Roots Fine Joint**

Distance (ft): **9.8**  
 Structural Grade: **0**  
 O&M Grade: **1**  
 Clock Start/From: **8**  
 Clock To: **4**  
 1st Value:  
 2nd Value:  
 Value Percent:  
 Continuous Index: **S03**  
 Within 8" of Joint: **YES**  
 Remarks:

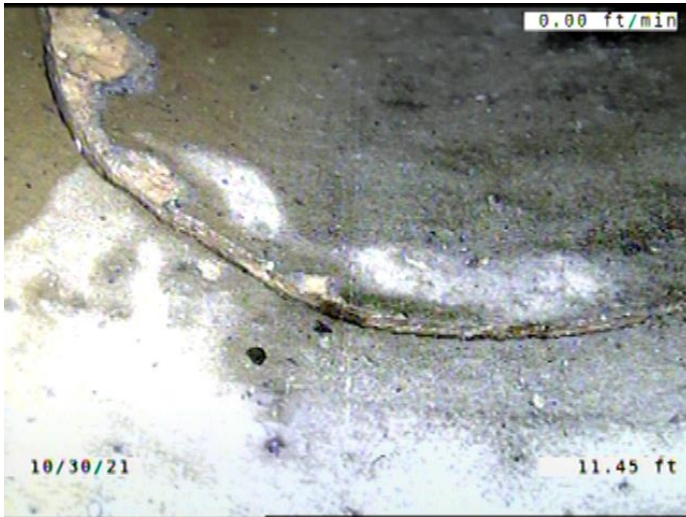
Code: **B**  
Description: **Broken**

Distance (ft): **11.5**  
Structural Grade: **4**  
O&M Grade: **0**  
Clock Start/From: **12**  
Clock To: **7**  
1st Value:  
2nd Value:  
Value Percent:  
Continuous Index:  
Within 8" of Joint: **YES**  
Remarks:

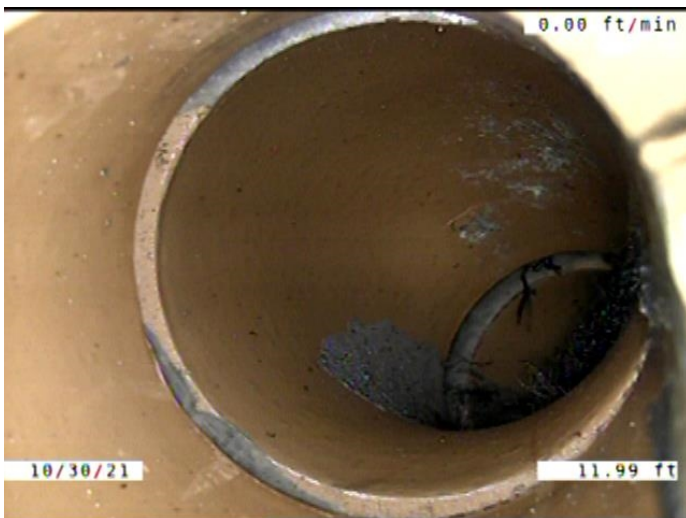
Code: **TBI**  
Description: **Tap Break-in Intruding**

Distance (ft): **12.0**  
Structural Grade: **0**  
O&M Grade: **2**  
Clock Start/From: **2**  
Clock To:  
1st Value: **4.000**  
2nd Value: **1.000**  
Value Percent:  
Continuous Index:  
Within 8" of Joint: **YES**  
Remarks: **CONSTANTLY RUNNING WATER**

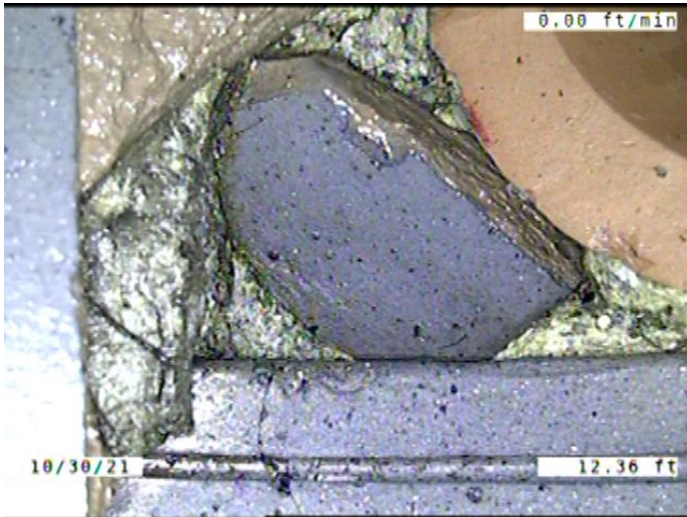
Code: **SMW**  
 Description: **Surface Damage Missing Wall**

Distance (ft): **12.4**  
 Structural Grade: **5**  
 O&M Grade: **0**  
 Clock Start/From: **12**  
 Clock To: **3**  
 1st Value:  
 2nd Value:  
 Value Percent:  
 Continuous Index:  
 Within 8" of Joint: **YES**  
 Remarks:

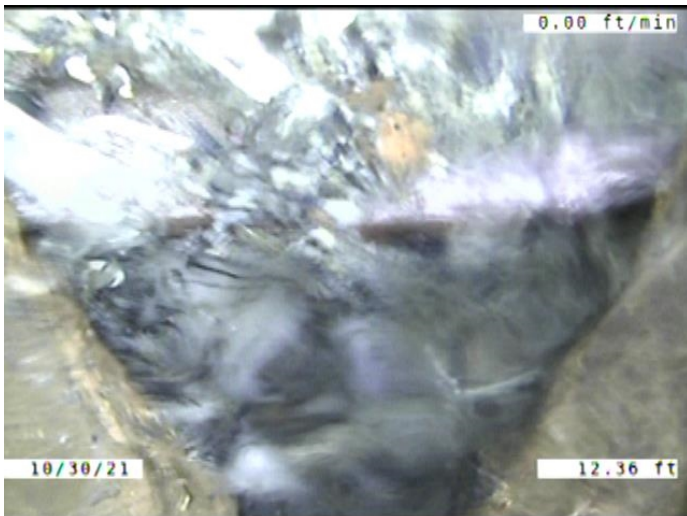
Code: **HSV**  
 Description: **Hole Soil Visible**

Distance (ft): **12.4**  
 Structural Grade: **5**  
 O&M Grade: **0**  
 Clock Start/From: **6**  
 Clock To:  
 1st Value:  
 2nd Value:  
 Value Percent:  
 Continuous Index:  
 Within 8" of Joint: **YES**  
 Remarks:

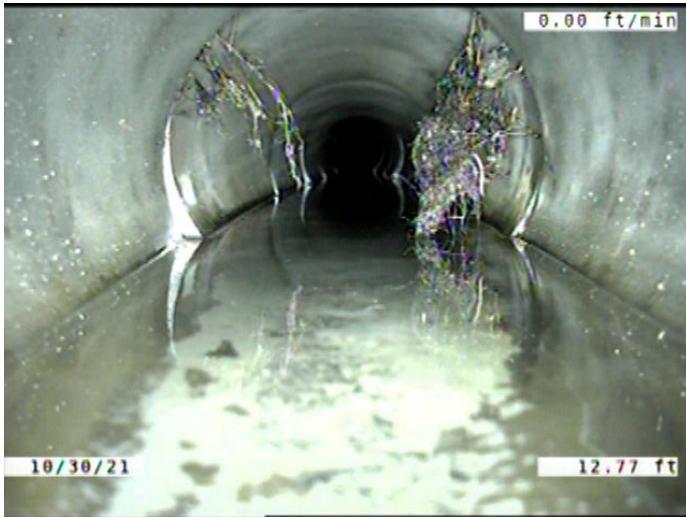
Code: **MWLS**  
 Description: **Miscellaneous Water Level Sag**

Distance (ft): **12.8**  
 Structural Grade: **2**  
 O&M Grade: **0**  
 Clock Start/From:  
 Clock To:  
 1st Value:  
 2nd Value:  
 Value Percent: **5.000**  
 Continuous Index: **S02**  
 Within 8" of Joint: **NO**  
 Remarks:

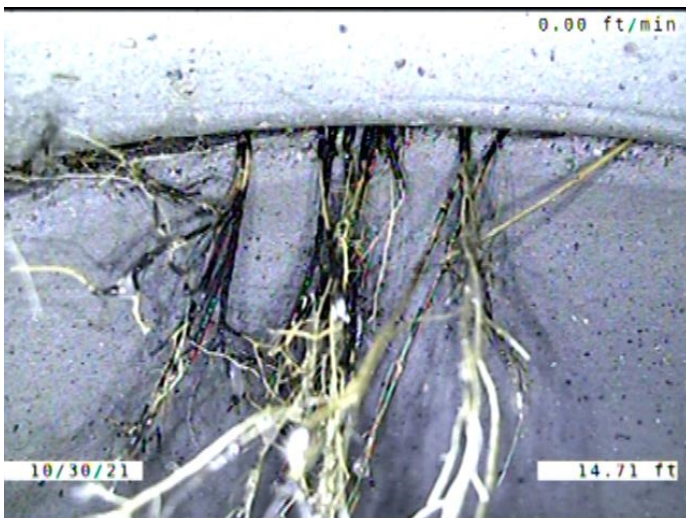
Code: **RMJ**  
 Description: **Roots Medium Joint**

Distance (ft): **14.7**  
 Structural Grade: **0**  
 O&M Grade: **3**  
 Clock Start/From: **10**  
 Clock To: **3**  
 1st Value:  
 2nd Value:  
 Value Percent: **5.000**  
 Continuous Index:  
 Within 8" of Joint: **YES**  
 Remarks:

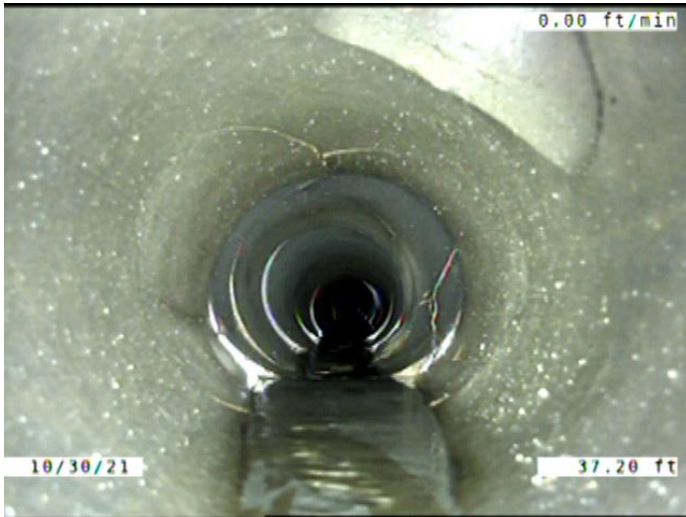
Code: **MWLS**  
 Description: **Miscellaneous Water Level Sag**

Distance (ft): **37.2**  
 Structural Grade: **2**  
 O&M Grade: **0**  
 Clock Start/From:  
 Clock To:  
 1st Value:  
 2nd Value:  
 Value Percent: **5.000**  
 Continuous Index: **F02**  
 Within 8" of Joint: **NO**  
 Remarks:

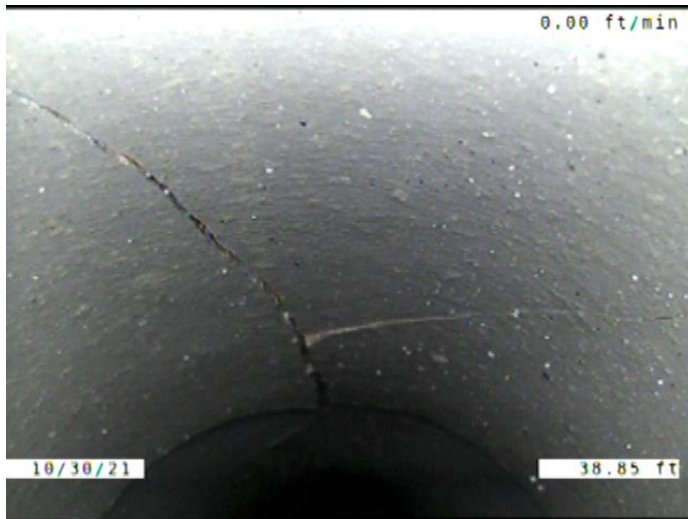
Code: **B**  
 Description: **Broken**

Distance (ft): **38.8**  
 Structural Grade: **4**  
 O&M Grade: **0**  
 Clock Start/From: **12**  
 Clock To: **12**  
 1st Value:  
 2nd Value:  
 Value Percent:  
 Continuous Index: **S04**  
 Within 8" of Joint: **YES**  
 Remarks:

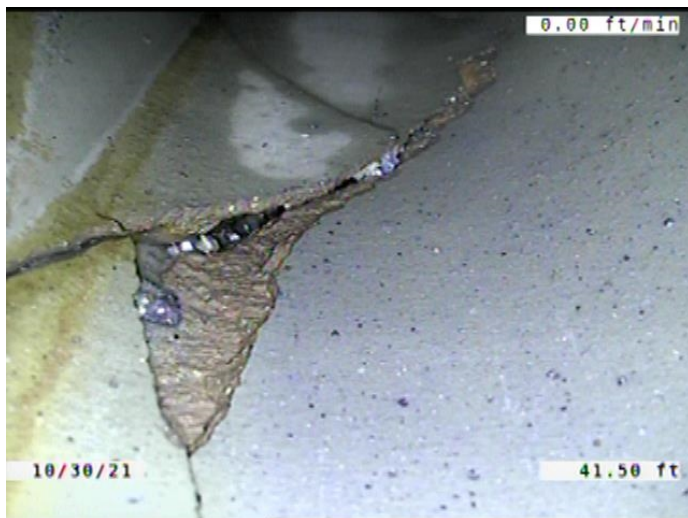
Code: **BSV**  
 Description: **Broken Soil Visible**

Distance (ft): **41.5**  
 Structural Grade: **5**  
 O&M Grade: **0**  
 Clock Start/From: **4**  
 Clock To: **5**  
 1st Value:  
 2nd Value:  
 Value Percent:  
 Continuous Index:  
 Within 8" of Joint: **YES**  
 Remarks:

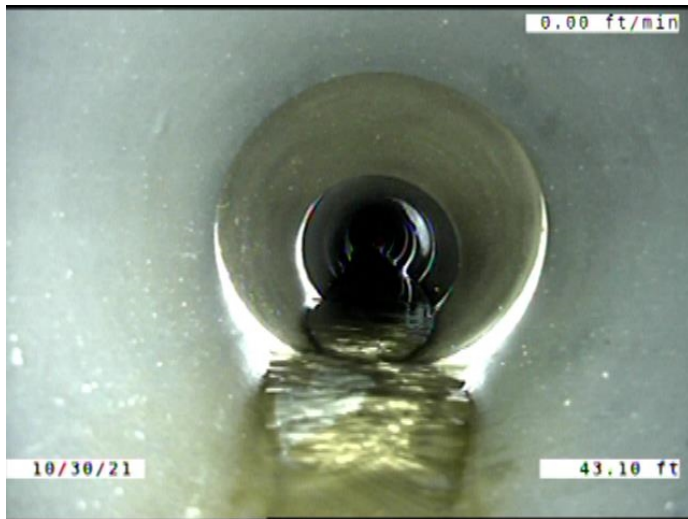
Code: **B**  
Description: **Broken**

Distance (ft): **43.1**  
Structural Grade: **4**  
O&M Grade: **0**  
Clock Start/From: **12**  
Clock To: **12**  
1st Value:  
2nd Value:  
Value Percent:  
Continuous Index: **F04**  
Within 8" of Joint: **YES**  
Remarks:

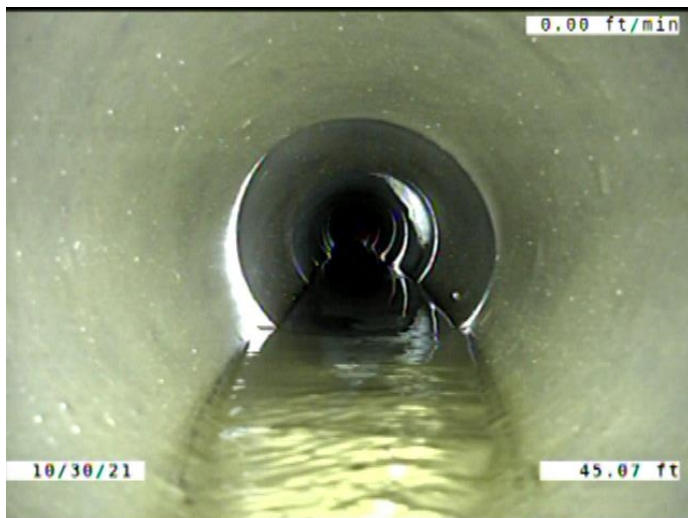
Code: **RFJ**  
Description: **Roots Fine Joint**

Distance (ft): **45.1**  
Structural Grade: **0**  
O&M Grade: **1**  
Clock Start/From: **8**  
Clock To: **4**  
1st Value:  
2nd Value:  
Value Percent:  
Continuous Index: **F03**  
Within 8" of Joint: **YES**  
Remarks:

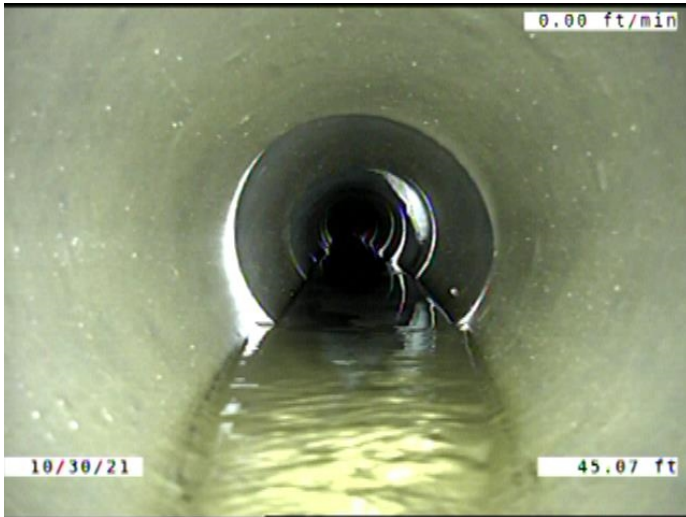
Code: **MWLS**  
 Description: **Miscellaneous Water Level Sag**

Distance (ft): **45.1**  
 Structural Grade: **2**  
 O&M Grade: **0**  
 Clock Start/From:  
 Clock To:  
 1st Value:  
 2nd Value:  
 Value Percent: **5.000**  
 Continuous Index: **S05**  
 Within 8" of Joint: **NO**  
 Remarks:

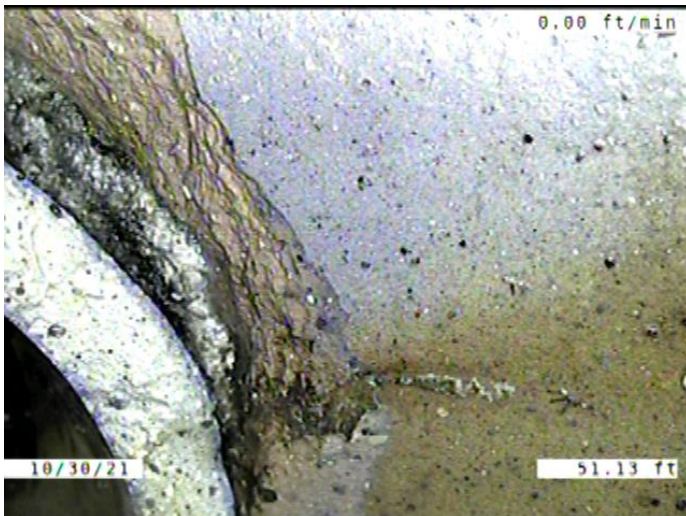
Code: **SSS**  
 Description: **Surface Damage Surface Spalling**

Distance (ft): **51.1**  
 Structural Grade: **2**  
 O&M Grade: **0**  
 Clock Start/From: **12**  
 Clock To: **3**  
 1st Value:  
 2nd Value:  
 Value Percent:  
 Continuous Index:  
 Within 8" of Joint: **YES**  
 Remarks:

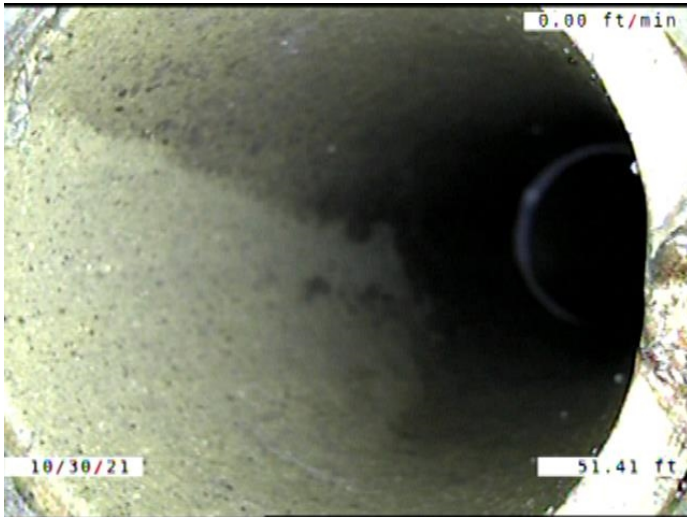
Code: **TBI**  
 Description: **Tap Break-in Intruding**

Distance (ft): **51.4**  
 Structural Grade: **0**  
 O&M Grade: **2**  
 Clock Start/From: **2**  
 Clock To:  
 1st Value: **4.000**  
 2nd Value: **1.000**  
 Value Percent:  
 Continuous Index:  
 Within 8" of Joint: **YES**  
 Remarks: **CONSTANTLY RUNNING WATER**

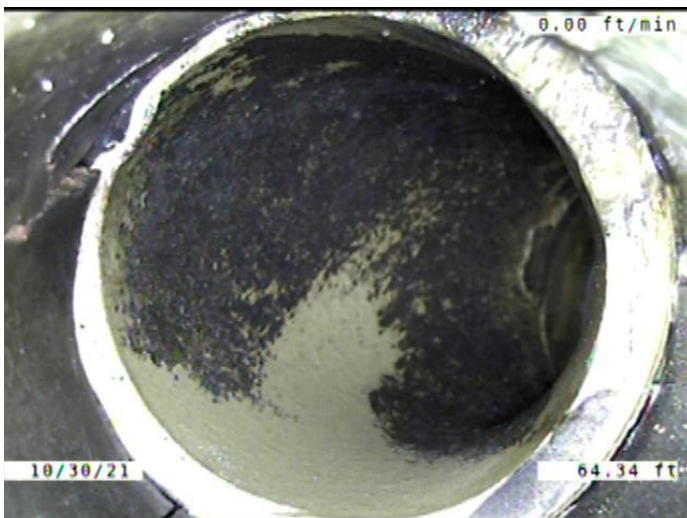
Code: **TFD**  
 Description: **Tap Factory Defective**

Distance (ft): **64.3**  
 Structural Grade: **0**  
 O&M Grade: **3**  
 Clock Start/From: **1**  
 Clock To:  
 1st Value: **4.000**  
 2nd Value:  
 Value Percent:  
 Continuous Index:  
 Within 8" of Joint: **YES**  
 Remarks: **TAP BROKEN. CONSTANTLY RUNNING WATER**

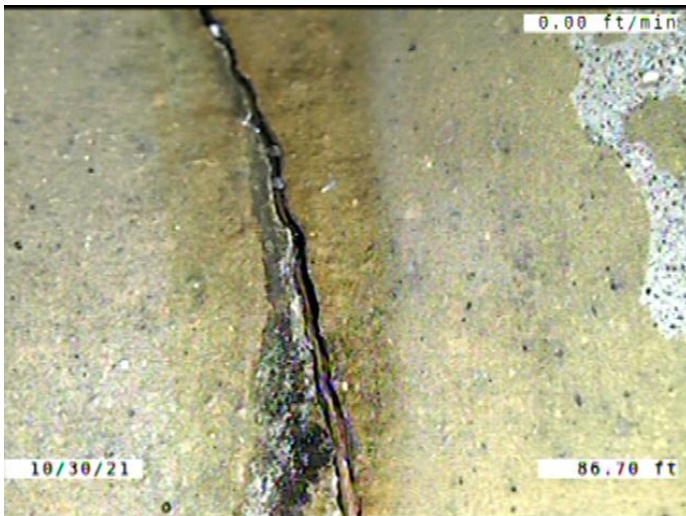
Code: **FM**  
 Description: **Fracture Multiple**

Distance (ft): **86.7**  
 Structural Grade: **4**  
 O&M Grade: **0**  
 Clock Start/From: **7**  
 Clock To: **2**  
 1st Value:  
 2nd Value:  
 Value Percent:  
 Continuous Index:  
 Within 8" of Joint: **YES**  
 Remarks:

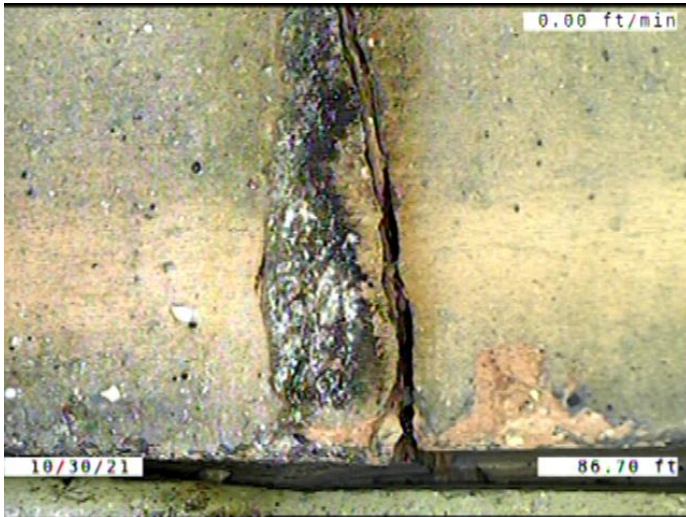
Code: **DAE**  
 Description: **Deposits Attached Encrustation**

Distance (ft): **86.7**  
 Structural Grade: **0**  
 O&M Grade: **2**  
 Clock Start/From: **7**  
 Clock To: **9**  
 1st Value:  
 2nd Value:  
 Value Percent: **5.000**  
 Continuous Index:  
 Within 8" of Joint: **YES**  
 Remarks:

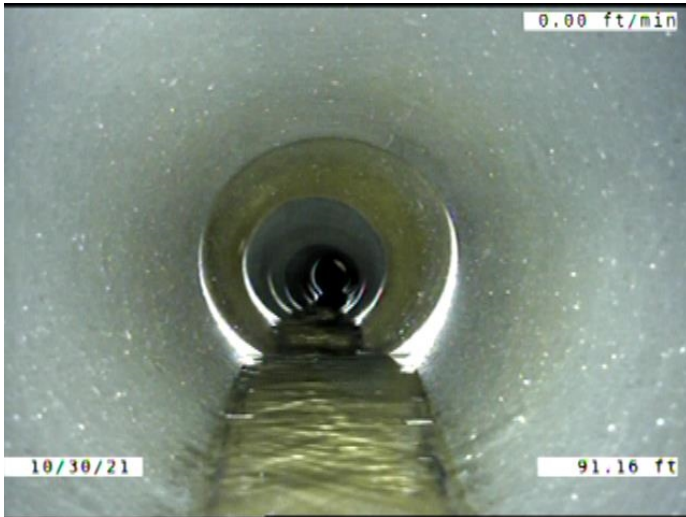
Code: **MWLS**  
 Description: **Miscellaneous Water Level Sag**

Distance (ft): **91.2**  
 Structural Grade: **2**  
 O&M Grade: **0**  
 Clock Start/From:  
 Clock To:  
 1st Value:  
 2nd Value:  
 Value Percent: **5.000**  
 Continuous Index: **F05**  
 Within 8" of Joint: **NO**  
 Remarks:

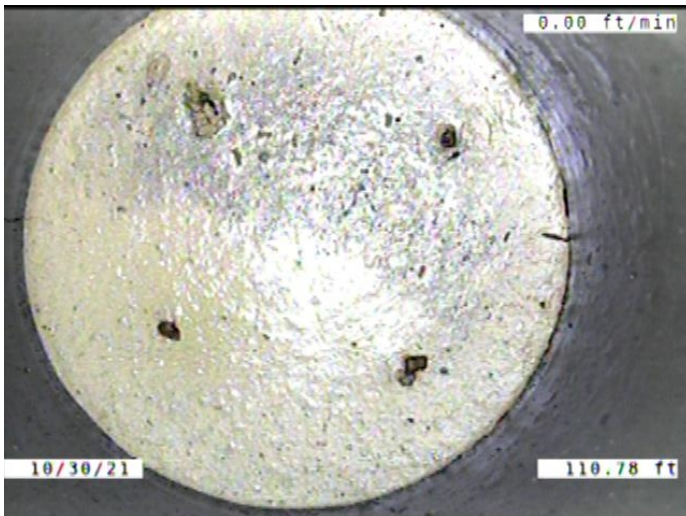
Code: **TFC**  
 Description: **Tap Factory Capped**

Distance (ft): **110.8**  
 Structural Grade: **0**  
 O&M Grade: **0**  
 Clock Start/From: **2**  
 Clock To:  
 1st Value: **4.000**  
 2nd Value:  
 Value Percent:  
 Continuous Index:  
 Within 8" of Joint: **YES**  
 Remarks: **TAP CRACKED**

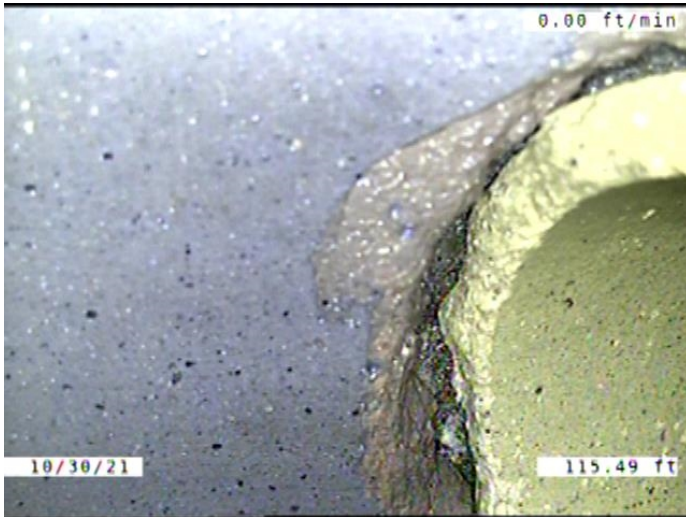
Code: **SSS**  
 Description: **Surface Damage Surface Spalling**

Distance (ft): **115.5**  
 Structural Grade: **2**  
 O&M Grade: **0**  
 Clock Start/From: **12**  
 Clock To: **3**  
 1st Value:  
 2nd Value:  
 Value Percent:  
 Continuous Index:  
 Within 8" of Joint: **NO**  
 Remarks:

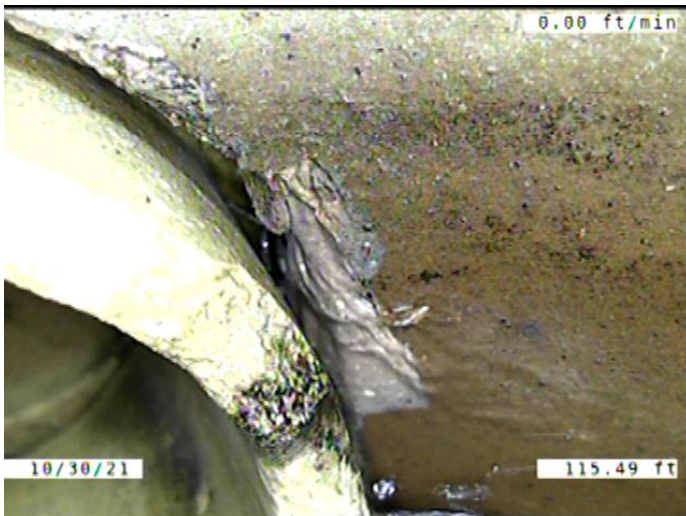
Code: **IRC**  
 Description: **Infiltration Runner Connection**

Distance (ft): **115.5**  
 Structural Grade: **0**  
 O&M Grade: **4**  
 Clock Start/From: **3**  
 Clock To:  
 1st Value:  
 2nd Value:  
 Value Percent:  
 Continuous Index:  
 Within 8" of Joint: **YES**  
 Remarks:

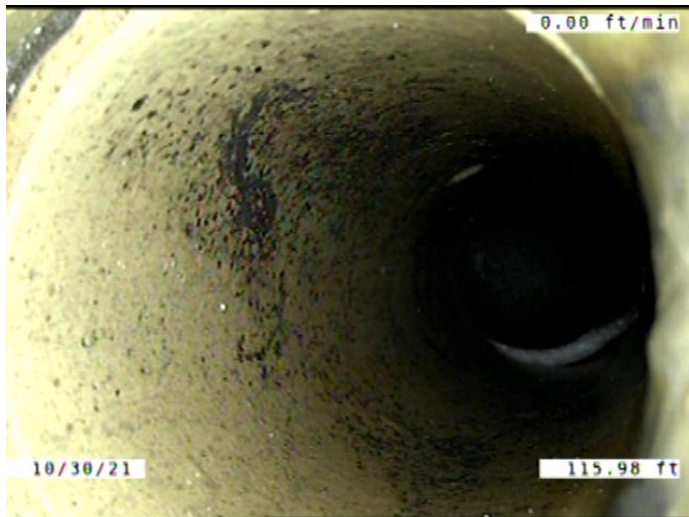
Code: **TBI**  
 Description: **Tap Break-in Intruding**

Distance (ft): **116.0**  
 Structural Grade: **0**  
 O&M Grade: **2**  
 Clock Start/From: **1**  
 Clock To:  
 1st Value: **4.000**  
 2nd Value: **1.000**  
 Value Percent:  
 Continuous Index:  
 Within 8" of Joint: **YES**  
 Remarks: **CONSTANTLY RUNNING WATER**

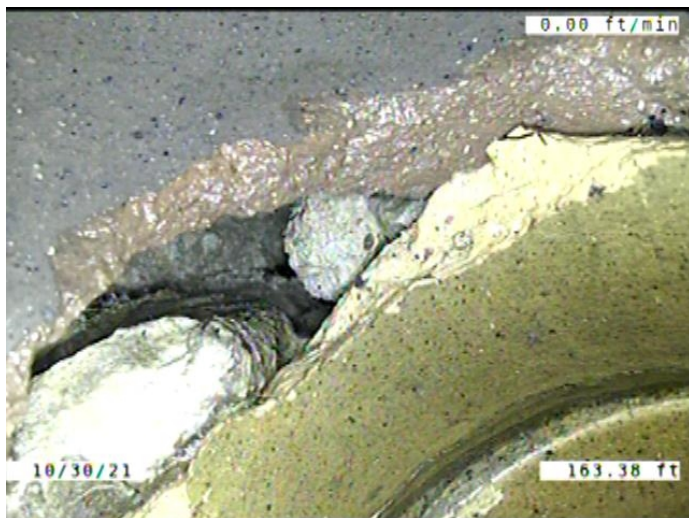
Code: **BSV**  
 Description: **Broken Soil Visible**

Distance (ft): **162.9**  
 Structural Grade: **5**  
 O&M Grade: **0**  
 Clock Start/From: **12**  
 Clock To: **3**  
 1st Value:  
 2nd Value:  
 Value Percent:  
 Continuous Index:  
 Within 8" of Joint: **NO**  
 Remarks:

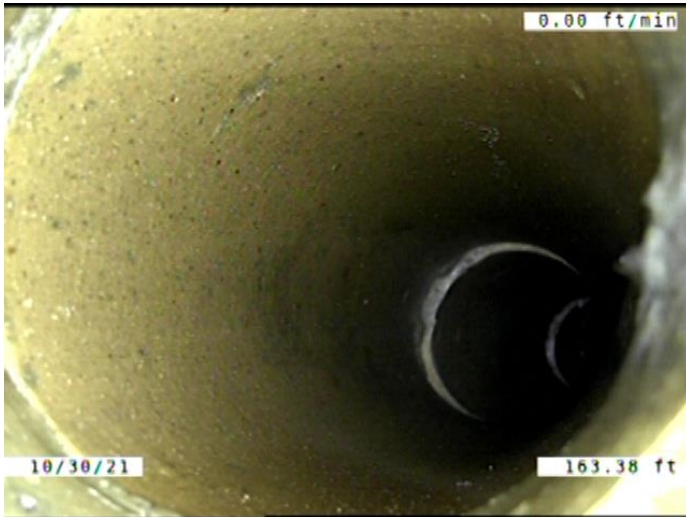
Code: **TBI**  
 Description: **Tap Break-in Intruding**

Distance (ft): **163.4**  
 Structural Grade: **0**  
 O&M Grade: **2**  
 Clock Start/From: **2**  
 Clock To:  
 1st Value: **4.000**  
 2nd Value: **1.000**  
 Value Percent:  
 Continuous Index:  
 Within 8" of Joint: **YES**  
 Remarks: **CONSTANTLY RUNNING WATER**

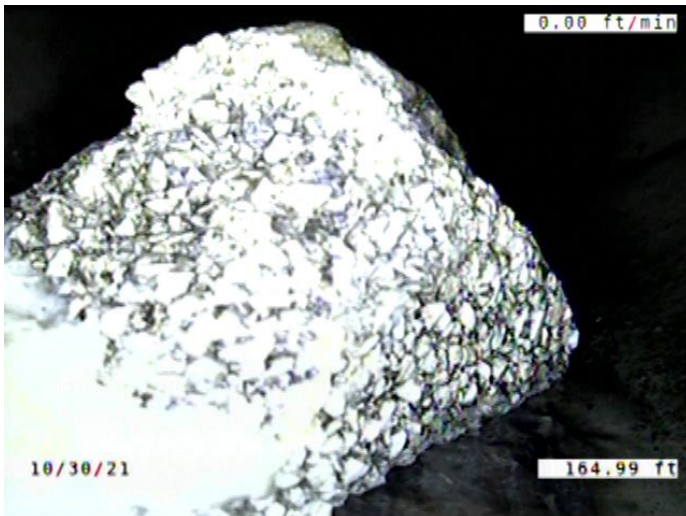
Code: **OBN**  
 Description: **Obstruction Construction Debris**

Distance (ft): **165.0**  
 Structural Grade: **0**  
 O&M Grade: **2**  
 Clock Start/From: **6**  
 Clock To:  
 1st Value:  
 2nd Value:  
 Value Percent: **5.000**  
 Continuous Index:  
 Within 8" of Joint: **YES**  
 Remarks:

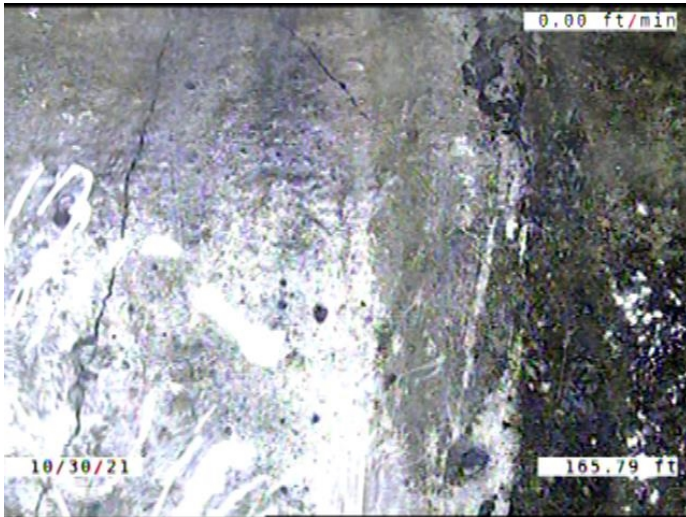
Code: **B**  
Description: **Broken**

Distance (ft): **165.8**  
Structural Grade: **4**  
O&M Grade: **0**  
Clock Start/From: **12**  
Clock To: **12**  
1st Value:  
2nd Value:  
Value Percent:  
Continuous Index:  
Within 8" of Joint: **YES**  
Remarks:

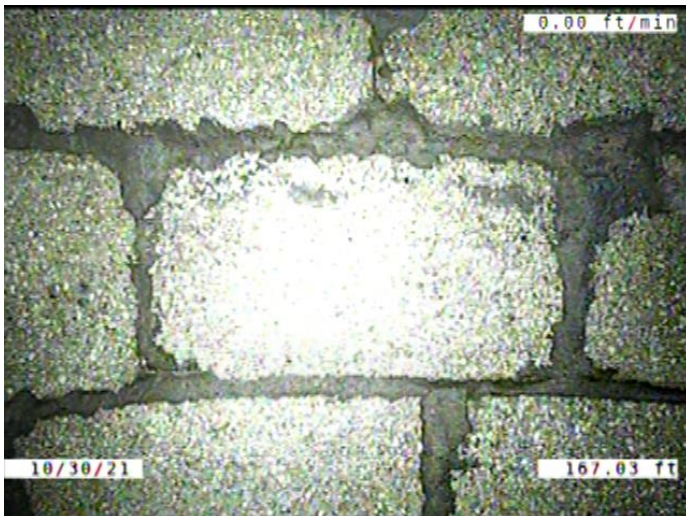
Code: **DSF**  
Description: **Deposits Settled Fine**

Distance (ft): **167.0**  
Structural Grade: **0**  
O&M Grade: **2**  
Clock Start/From: **5**  
Clock To: **7**  
1st Value:  
2nd Value:  
Value Percent: **5.000**  
Continuous Index: **F01**  
Within 8" of Joint: **YES**  
Remarks:
