Profile/Photo Observation Report						
Date:	04/19/2018	Weather:		Coding:	PACP 6.0	
Pipe Length (f	t): 166.1	Owner:	NA	Pre Clean:	Not Known	
P.O.#:		Surveyor:	Jen Costello	PSR:	P-504-050-049	
Customer:		Clean Date:	01/01/1900	Shape:	с	
Street:	N COLORADO ST		Flow Control:			
City:	Hobart, IN		Year Renewed:			
Location:	Light Highway		Tape/Media #:			
Purpose:	Not Known		Dia/Height:	10"		
Use:	Sanitary		Material:	VCP		
Drain Area:	NA		Lining:			
Category:	NA					
Comment:						
Location Details:			Direction of Surv	vey: Downstream		
US MH:	M-504-049	DS MH:	M-504-050	Total Length Surveyed (ft)	: 5.0	
0&M Index:	4.00	O&M Quick:	410	0 O&M Rating:	4.00	
structural Index	. 0.00	Structural Qu	iick: 000		0.00	
Overall Index:	4.00	Overall Quick	. 410		4.00

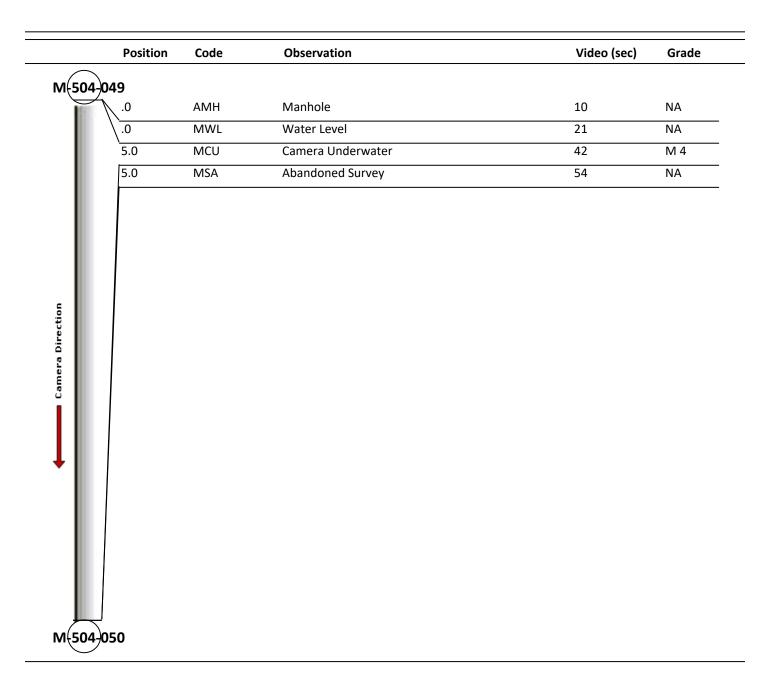
Code: Description:	AMH Manhole
Distance (ft):	.0
Structural Grade:	0
O&M Grade:	0
Clock Start/From:	
Clock To:	
1st Value:	
2nd Value:	
Value Percent:	
Continuous Index:	
Within 8" of Joint:	NO
Remarks:	M-504-049
