Profile/Photo Observation Report

Date:	10/30/2021	Weather:		Coding:	PACP 7.0
Pipe Length (ft):	202.6	Owner:	City of Hobart	Pre Clean:	Heavy Cleaning
P.O.#:	YES502259	Surveyor:	S. Bucklin	PSR:	P-504-050-049
Customer:	City of Hobart	Clean Date:	10/26/2021	Shape:	C

Street:	North Cavender Street	Flow Control:	Not Controlled
City:	Hobart, IN	Year Renewed:	
Location:	Alley	Tape/Media #:	
Purpose:	Routine Assessment	Dia/Height:	10"
Use:	Sanitary Sewage Pipe	Material:	VCP
Drain Area:		Lining:	None
Category:	NA		
Comment:			
Location Details:		Direction of Survey:	Upstream
US MH:	M-504-049	DS MH:	M-504-050
		Total Length Surveyed (ft):	202.6

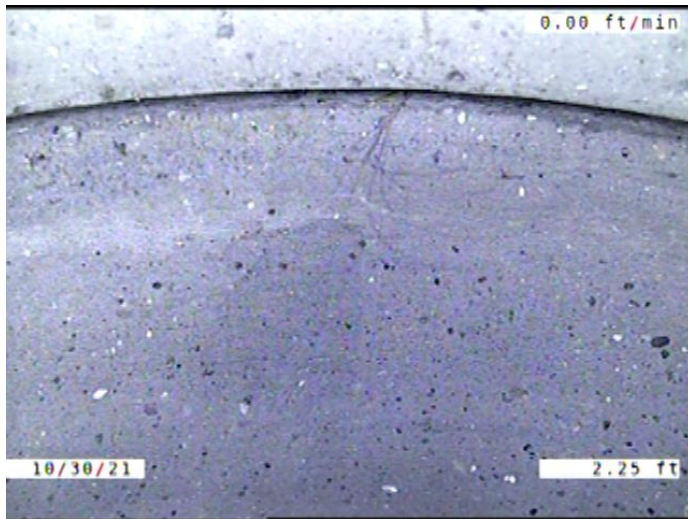
Code: **RFJ**
Description: **Roots Fine Joint**

Distance (ft): **2.3**
Structural Grade: **0**
O&M Grade: **1**
Clock Start/From: **12**
Clock To:
1st Value:
2nd Value:
Value Percent:
Continuous Index:
Within 8" of Joint: **YES**
Remarks:

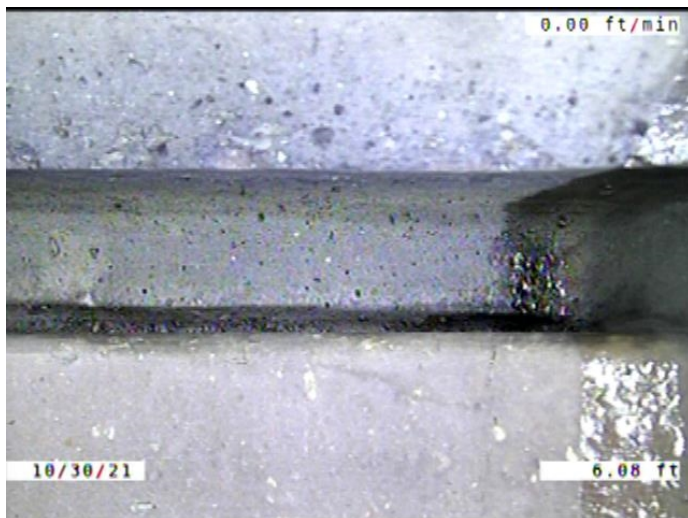
Code: **JAM**
Description: **Joint Angular Medium**

Distance (ft): **6.1**
Structural Grade: **3**
O&M Grade: **0**
Clock Start/From:
Clock To:
1st Value:
2nd Value:
Value Percent:
Continuous Index:
Within 8" of Joint: **NO**
Remarks:

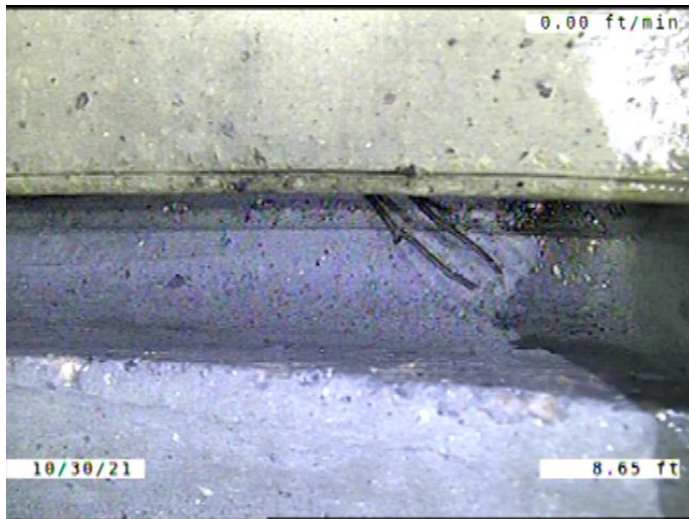
Code: **JAM**
 Description: **Joint Angular Medium**

Distance (ft): **8.7**
 Structural Grade: **3**
 O&M Grade: **0**
 Clock Start/From:
 Clock To:
 1st Value:
 2nd Value:
 Value Percent:
 Continuous Index:
 Within 8" of Joint: **NO**
 Remarks:

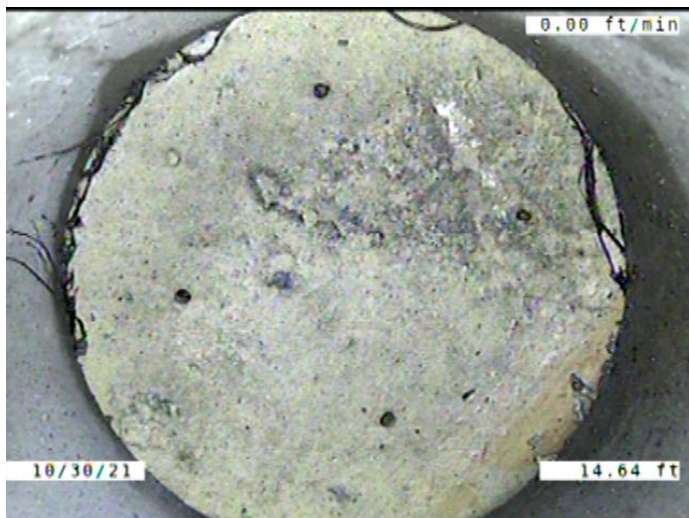
Code: **TFC**
 Description: **Tap Factory Capped**

Distance (ft): **14.6**
 Structural Grade: **0**
 O&M Grade: **0**
 Clock Start/From: **11**
 Clock To:
 1st Value: **4.000**
 2nd Value:
 Value Percent:
 Continuous Index:
 Within 8" of Joint: **YES**
 Remarks: **ROOTS GROWING AROUND THE CAP**

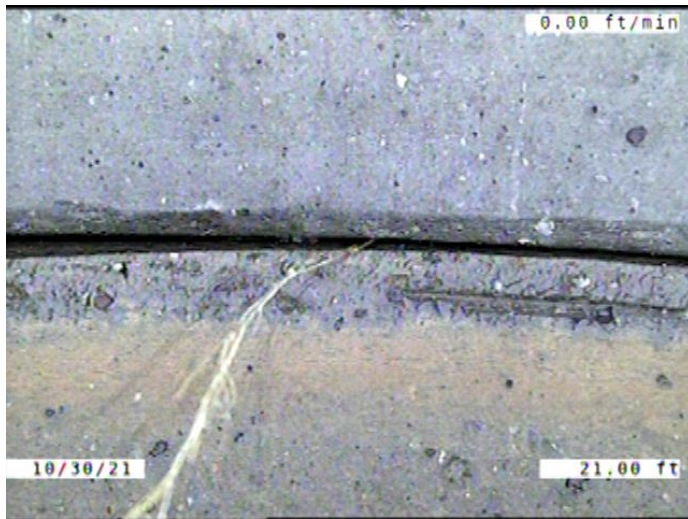
Code: **RFJ**
 Description: **Roots Fine Joint**

Distance (ft): **21.0**
 Structural Grade: **0**
 O&M Grade: **1**
 Clock Start/From: **1**
 Clock To:
 1st Value:
 2nd Value:
 Value Percent:
 Continuous Index:
 Within 8" of Joint: **YES**
 Remarks:

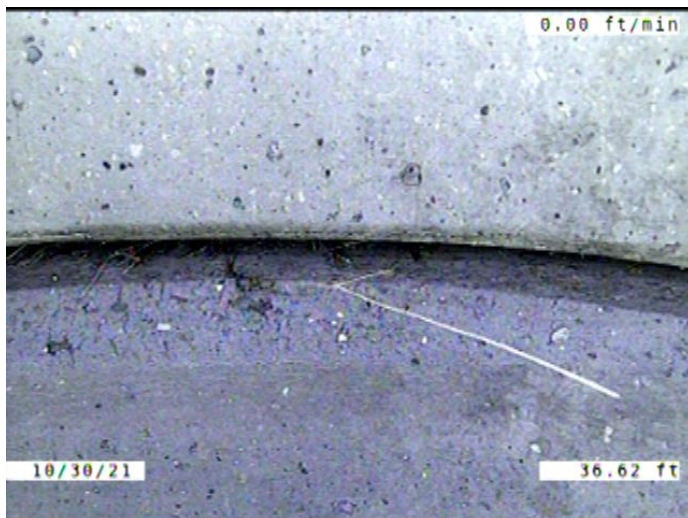
Code: **RFJ**
 Description: **Roots Fine Joint**

Distance (ft): **36.6**
 Structural Grade: **0**
 O&M Grade: **1**
 Clock Start/From: **11**
 Clock To: **2**
 1st Value:
 2nd Value:
 Value Percent:
 Continuous Index:
 Within 8" of Joint: **YES**
 Remarks:

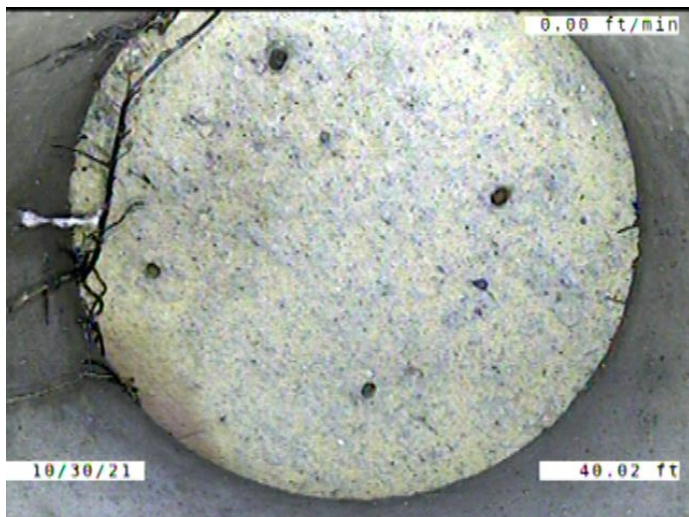
Code: **TFC**
 Description: **Tap Factory Capped**

Distance (ft): **40.0**
 Structural Grade: **0**
 O&M Grade: **0**
 Clock Start/From: **11**
 Clock To:
 1st Value: **4.000**
 2nd Value:
 Value Percent:
 Continuous Index:
 Within 8" of Joint: **YES**
 Remarks: **ROOTS GROWING AROUND THE CAP**

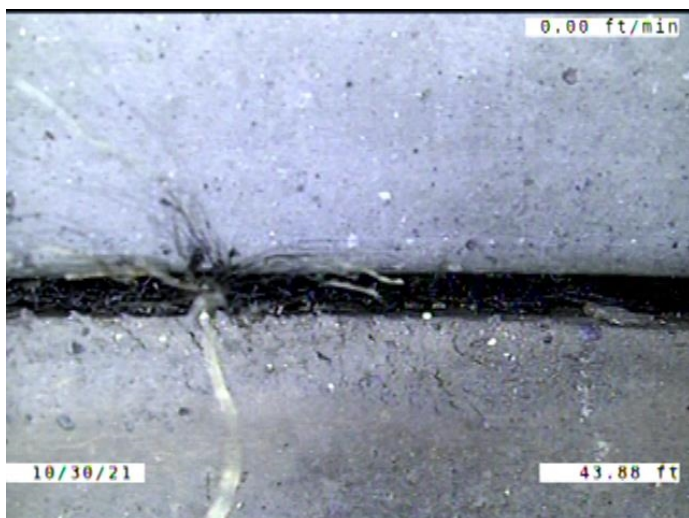
Code: **RFJ**
 Description: **Roots Fine Joint**

Distance (ft): **43.9**
 Structural Grade: **0**
 O&M Grade: **1**
 Clock Start/From: **9**
 Clock To: **1**
 1st Value:
 2nd Value:
 Value Percent:
 Continuous Index:
 Within 8" of Joint: **YES**
 Remarks:

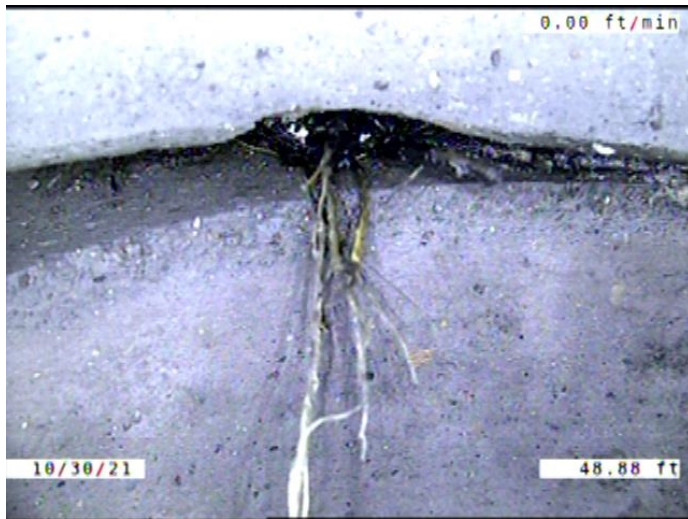
Code: **RFJ**
 Description: **Roots Fine Joint**

Distance (ft): **48.9**
 Structural Grade: **0**
 O&M Grade: **1**
 Clock Start/From: **11**
 Clock To: **1**
 1st Value:
 2nd Value:
 Value Percent:
 Continuous Index:
 Within 8" of Joint: **YES**
 Remarks:

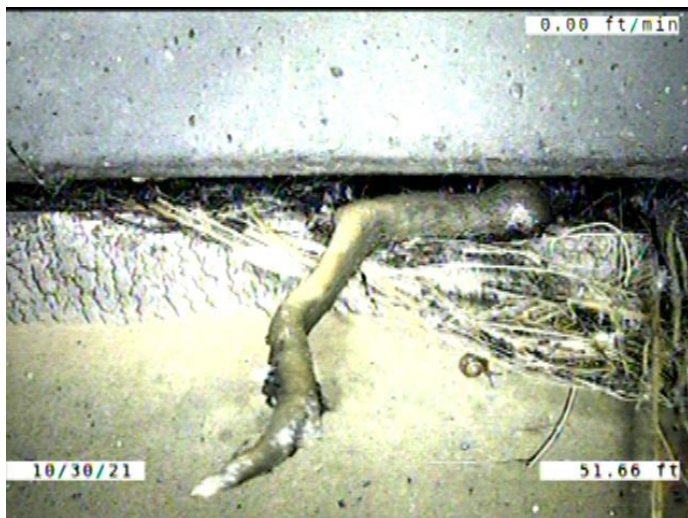
Code: **RMJ**
 Description: **Roots Medium Joint**

Distance (ft): **51.7**
 Structural Grade: **0**
 O&M Grade: **3**
 Clock Start/From: **11**
 Clock To: **2**
 1st Value:
 2nd Value:
 Value Percent: **5.000**
 Continuous Index:
 Within 8" of Joint: **YES**
 Remarks:

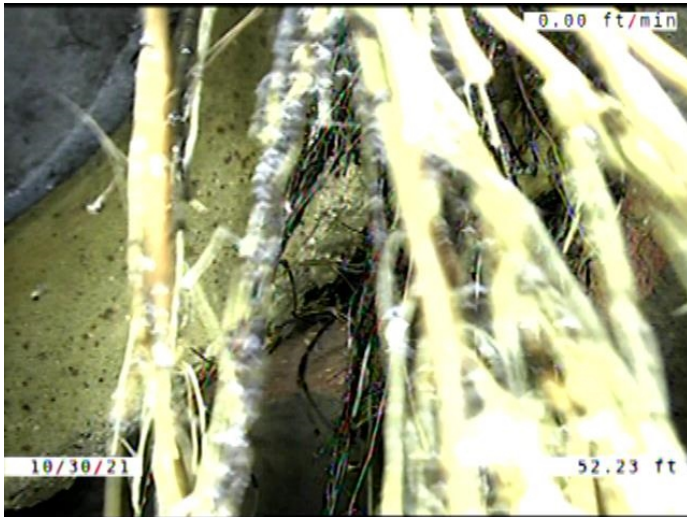
Code: **RMC**
 Description: **Roots Medium Connection**

Distance (ft): **52.2**
 Structural Grade: **0**
 O&M Grade: **3**
 Clock Start/From: **10**
 Clock To: **2**
 1st Value:
 2nd Value:
 Value Percent: **5.000**
 Continuous Index:
 Within 8" of Joint: **NO**
 Remarks:

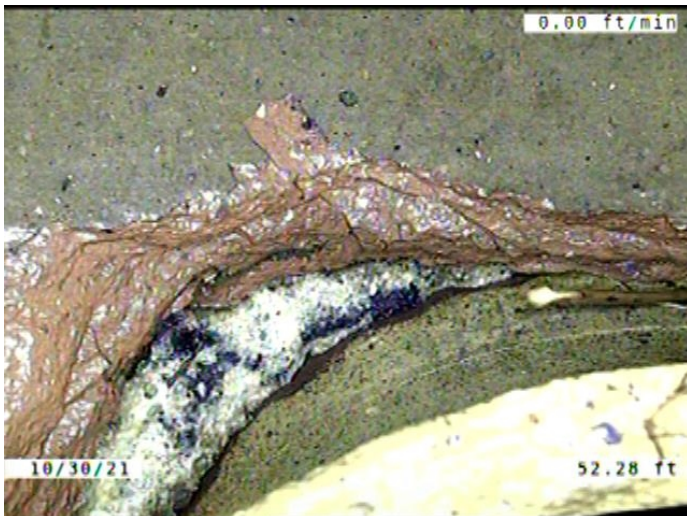
Code: **CM**
 Description: **Crack Multiple**

Distance (ft): **52.3**
 Structural Grade: **3**
 O&M Grade: **0**
 Clock Start/From: **10**
 Clock To: **1**
 1st Value:
 2nd Value:
 Value Percent:
 Continuous Index:
 Within 8" of Joint: **NO**
 Remarks:

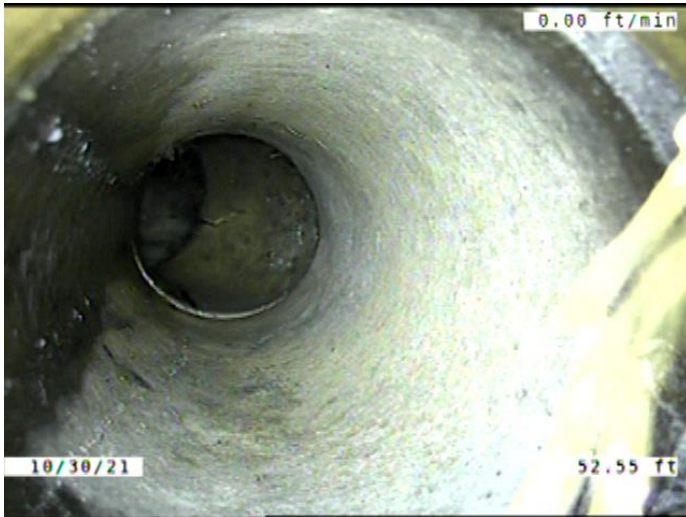
Code:	TBI
Description:	Tap Break-in Intruding
Distance (ft):	52.5
Structural Grade:	0
O&M Grade:	2
Clock Start/From:	11
Clock To:	
1st Value:	4.000
2nd Value:	1.000
Value Percent:	
Continuous Index:	
Within 8" of Joint:	YES
Remarks:	CONSTANTLY RUNNING WATER. ROOTS GROWING INSIDE AND OUTS

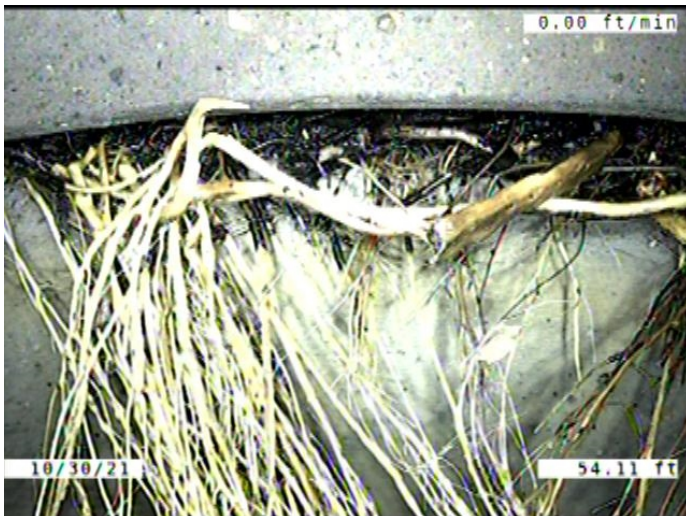
Code:	RMJ
Description:	Roots Medium Joint
Distance (ft):	54.1
Structural Grade:	0
O&M Grade:	3
Clock Start/From:	11
Clock To:	2
1st Value:	
2nd Value:	
Value Percent:	10.000
Continuous Index:	
Within 8" of Joint:	YES
Remarks:

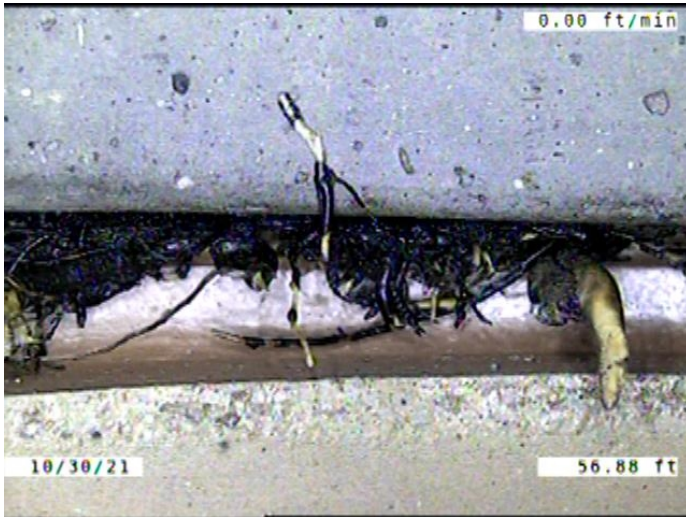
Code: **RFJ**
 Description: **Roots Fine Joint**

Distance (ft): **56.9**
 Structural Grade: **0**
 O&M Grade: **1**
 Clock Start/From: **10**
 Clock To: **12**
 1st Value:
 2nd Value:
 Value Percent:
 Continuous Index:
 Within 8" of Joint: **YES**
 Remarks:

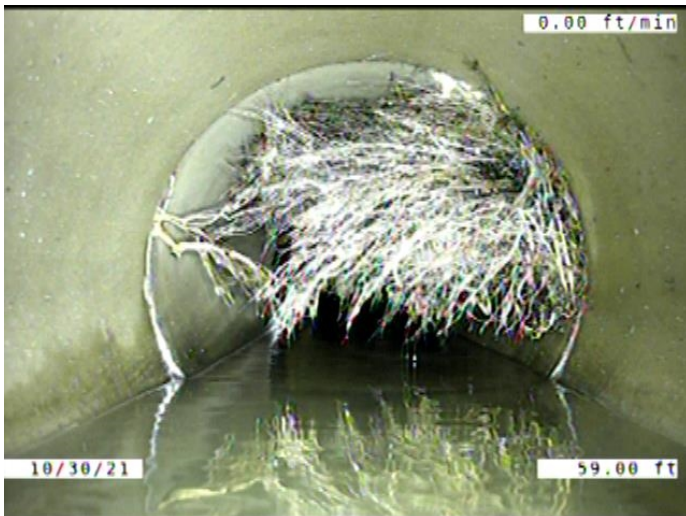
Code: **RMJ**
 Description: **Roots Medium Joint**

Distance (ft): **59.0**
 Structural Grade: **0**
 O&M Grade: **3**
 Clock Start/From: **9**
 Clock To: **3**
 1st Value:
 2nd Value:
 Value Percent: **50.000**
 Continuous Index:
 Within 8" of Joint: **YES**
 Remarks:

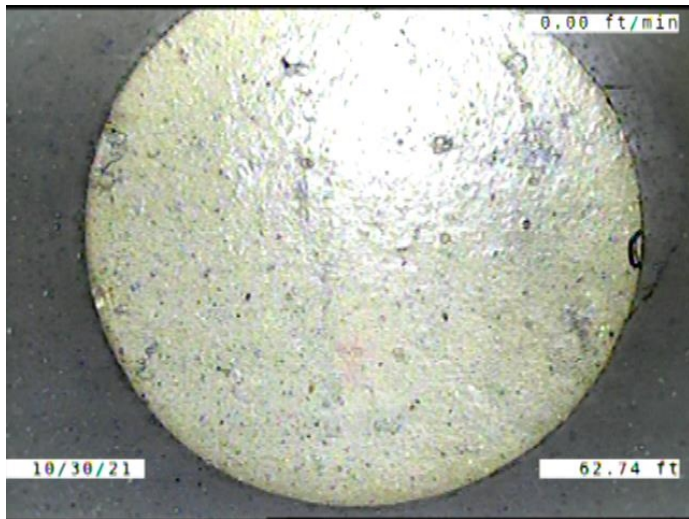
Code: **TFC**
 Description: **Tap Factory Capped**

Distance (ft): **62.7**
 Structural Grade: **0**
 O&M Grade: **0**
 Clock Start/From: **1**
 Clock To:
 1st Value: **4.000**
 2nd Value:
 Value Percent:
 Continuous Index:
 Within 8" of Joint: **YES**
 Remarks: **SERVICE CRACKED**

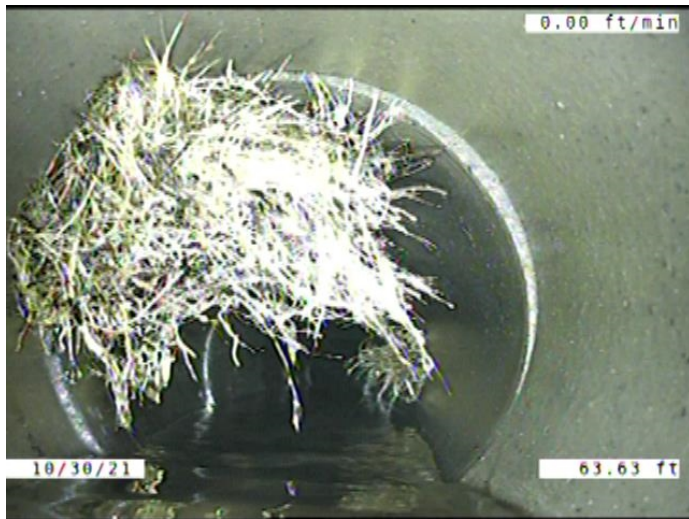
Code: **RMJ**
 Description: **Roots Medium Joint**

Distance (ft): **63.6**
 Structural Grade: **0**
 O&M Grade: **3**
 Clock Start/From: **8**
 Clock To: **2**
 1st Value:
 2nd Value:
 Value Percent: **40.000**
 Continuous Index:
 Within 8" of Joint: **YES**
 Remarks:

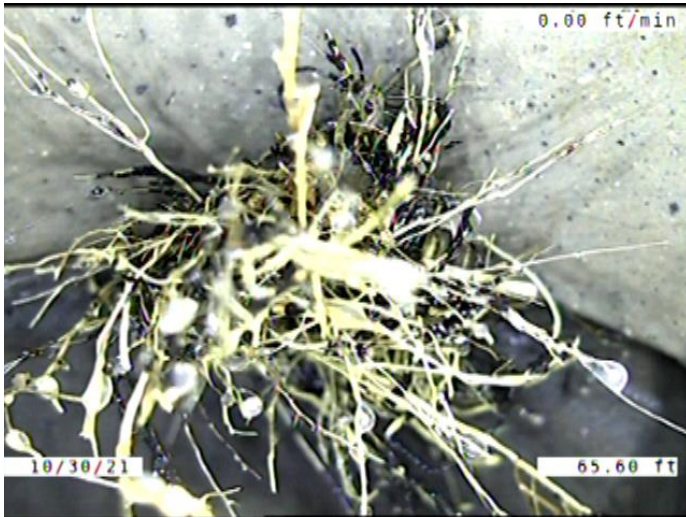
Code: **RMJ**
 Description: **Roots Medium Joint**

Distance (ft): **65.6**
 Structural Grade: **0**
 O&M Grade: **3**
 Clock Start/From: **2**
 Clock To: **3**
 1st Value:
 2nd Value:
 Value Percent: **5.000**
 Continuous Index:
 Within 8" of Joint: **YES**
 Remarks:

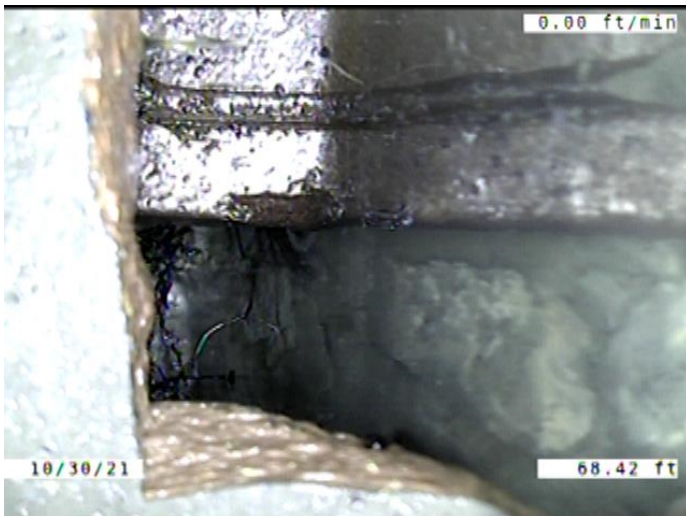
Code: **SMW**
 Description: **Surface Damage Missing Wall**

Distance (ft): **68.4**
 Structural Grade: **5**
 O&M Grade: **0**
 Clock Start/From: **6**
 Clock To: **9**
 1st Value:
 2nd Value:
 Value Percent:
 Continuous Index:
 Within 8" of Joint: **YES**
 Remarks:

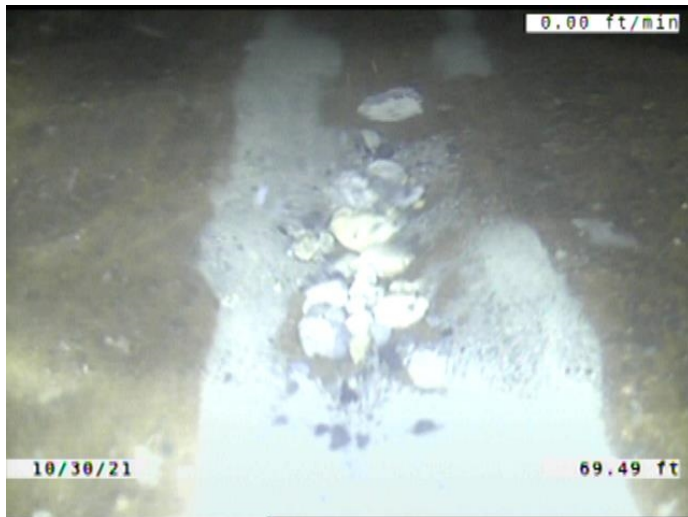
Code: **DSF**
 Description: **Deposits Settled Fine**

Distance (ft): **69.5**
 Structural Grade: **0**
 O&M Grade: **2**
 Clock Start/From: **5**
 Clock To: **7**
 1st Value:
 2nd Value:
 Value Percent: **5.000**
 Continuous Index: **S01**
 Within 8" of Joint: **YES**
 Remarks:

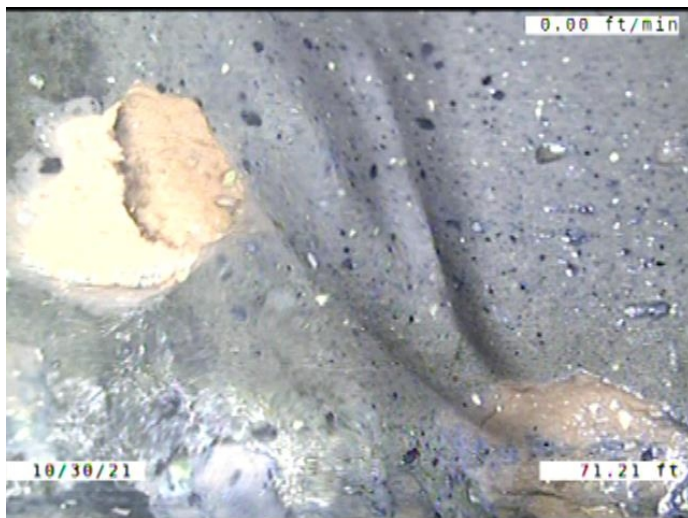
Code: **SSS**
 Description: **Surface Damage Surface Spalling**

Distance (ft): **71.2**
 Structural Grade: **2**
 O&M Grade: **0**
 Clock Start/From: **4**
 Clock To: **5**
 1st Value:
 2nd Value:
 Value Percent:
 Continuous Index:
 Within 8" of Joint: **YES**
 Remarks:

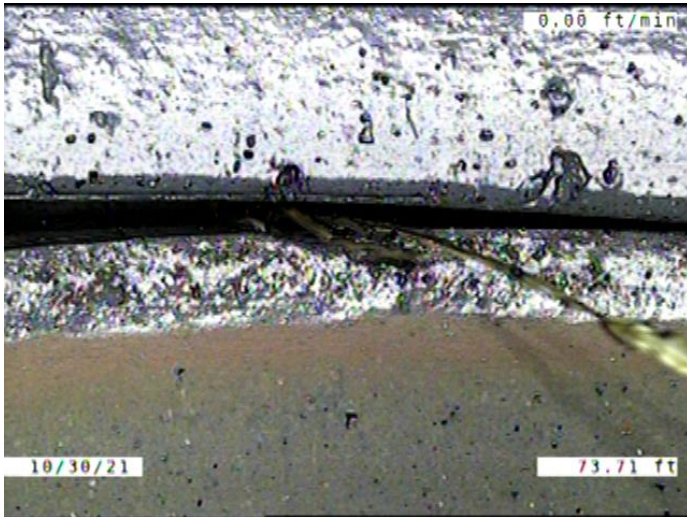
Code: **RFJ**
 Description: **Roots Fine Joint**

Distance (ft): **73.7**
 Structural Grade: **0**
 O&M Grade: **1**
 Clock Start/From: **11**
 Clock To:
 1st Value:
 2nd Value:
 Value Percent:
 Continuous Index:
 Within 8" of Joint: **YES**
 Remarks:

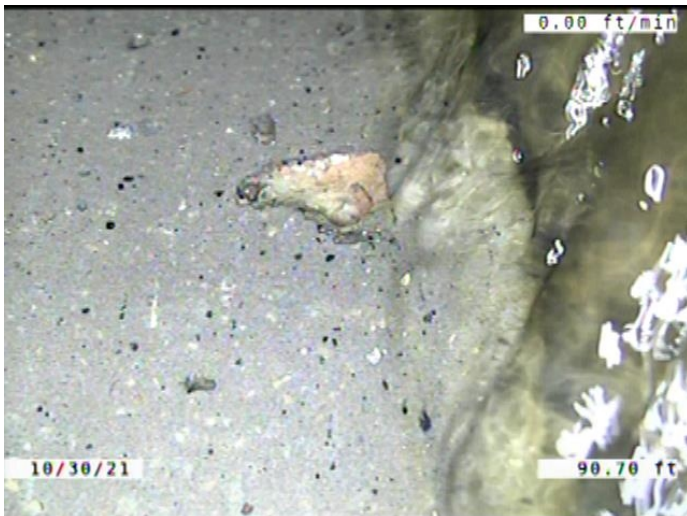
Code: **SSS**
 Description: **Surface Damage Surface Spalling**

Distance (ft): **90.7**
 Structural Grade: **2**
 O&M Grade: **0**
 Clock Start/From: **5**
 Clock To: **8**
 1st Value:
 2nd Value:
 Value Percent:
 Continuous Index:
 Within 8" of Joint: **YES**
 Remarks:

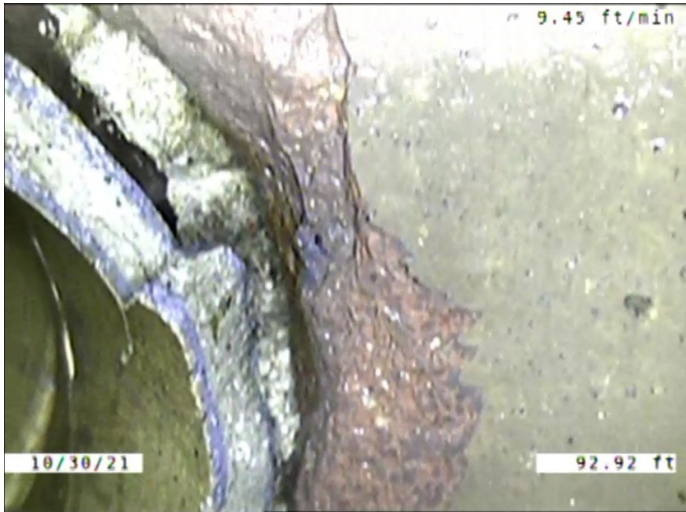
Code: **SSS**
 Description: **Surface Damage Surface Spalling**

Distance (ft): **92.9**
 Structural Grade: **2**
 O&M Grade: **0**
 Clock Start/From: **10**
 Clock To: **1**
 1st Value:
 2nd Value:
 Value Percent:
 Continuous Index:
 Within 8" of Joint: **NO**
 Remarks:

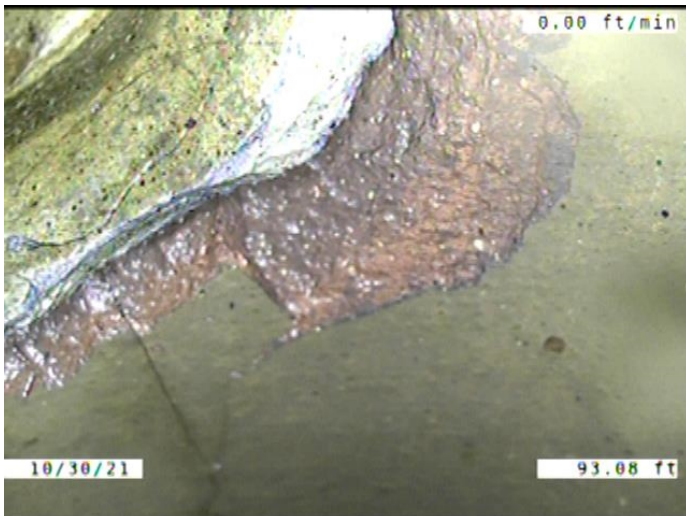
Code: **CM**
 Description: **Crack Multiple**

Distance (ft): **93.1**
 Structural Grade: **3**
 O&M Grade: **0**
 Clock Start/From: **10**
 Clock To: **11**
 1st Value:
 2nd Value:
 Value Percent:
 Continuous Index:
 Within 8" of Joint: **NO**
 Remarks:

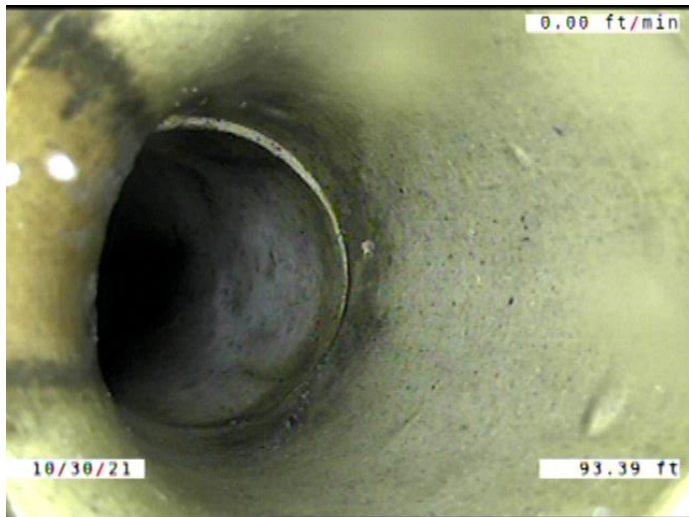
Code: **TB**
 Description: **Tap Break-in/Hammer**

Distance (ft): **93.4**
 Structural Grade: **0**
 O&M Grade: **0**
 Clock Start/From: **11**
 Clock To:
 1st Value: **4.000**
 2nd Value:
 Value Percent:
 Continuous Index:
 Within 8" of Joint: **YES**
 Remarks: **CONSTANTLY RUNNING WATER**

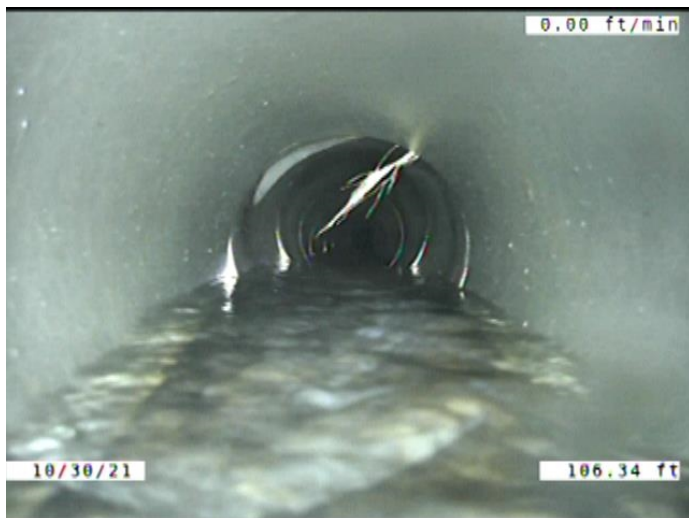
Code: **MWLS**
 Description: **Miscellaneous Water Level Sag**

Distance (ft): **106.3**
 Structural Grade: **2**
 O&M Grade: **0**
 Clock Start/From:
 Clock To:
 1st Value:
 2nd Value:
 Value Percent: **10.000**
 Continuous Index: **S02**
 Within 8" of Joint: **NO**
 Remarks:

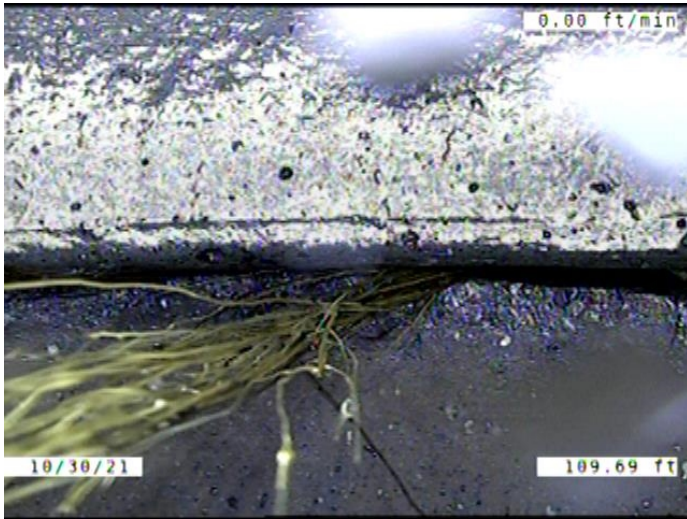
Code: **RFJ**
 Description: **Roots Fine Joint**

Distance (ft): **109.7**
 Structural Grade: **0**
 O&M Grade: **1**
 Clock Start/From: **10**
 Clock To: **1**
 1st Value:
 2nd Value:
 Value Percent:
 Continuous Index:
 Within 8" of Joint: **YES**
 Remarks:

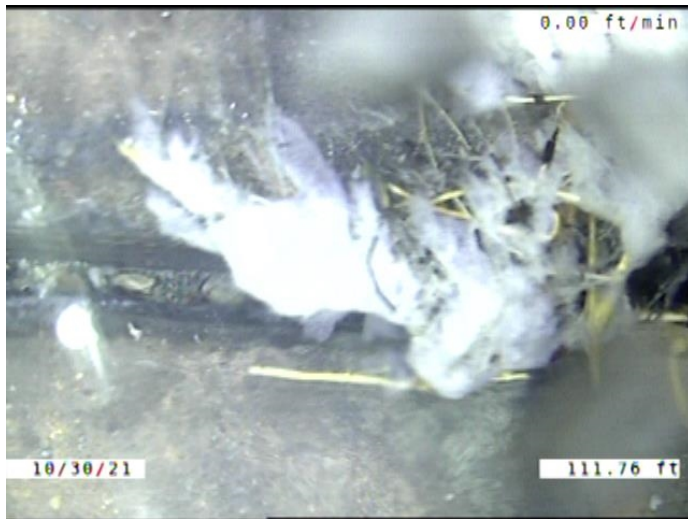
Code: **RFJ**
 Description: **Roots Fine Joint**

Distance (ft): **111.8**
 Structural Grade: **0**
 O&M Grade: **1**
 Clock Start/From: **4**
 Clock To: **5**
 1st Value:
 2nd Value:
 Value Percent:
 Continuous Index:
 Within 8" of Joint: **YES**
 Remarks:

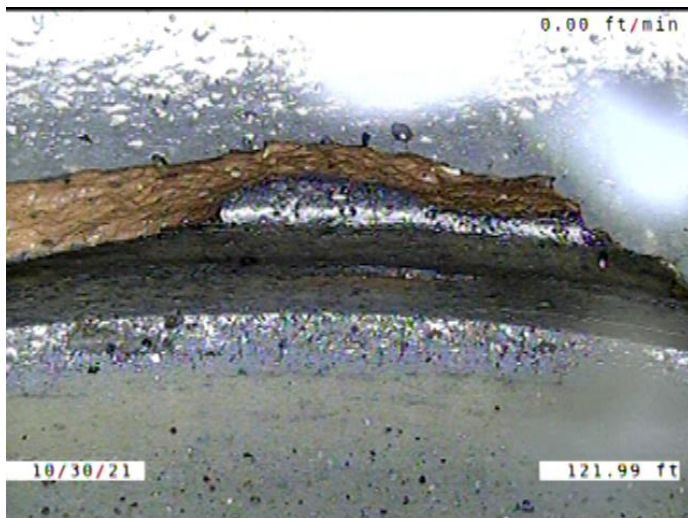
Code: **SZ**
 Description: **Surface Damage Other**

Distance (ft): **122.0**
 Structural Grade: **0**
 O&M Grade: **0**
 Clock Start/From: **11**
 Clock To: **1**
 1st Value:
 2nd Value:
 Value Percent:
 Continuous Index:
 Within 8" of Joint: **YES**
 Remarks: **A PIECE OF THE INSIDE JOINT
CHIPPED AWAY**

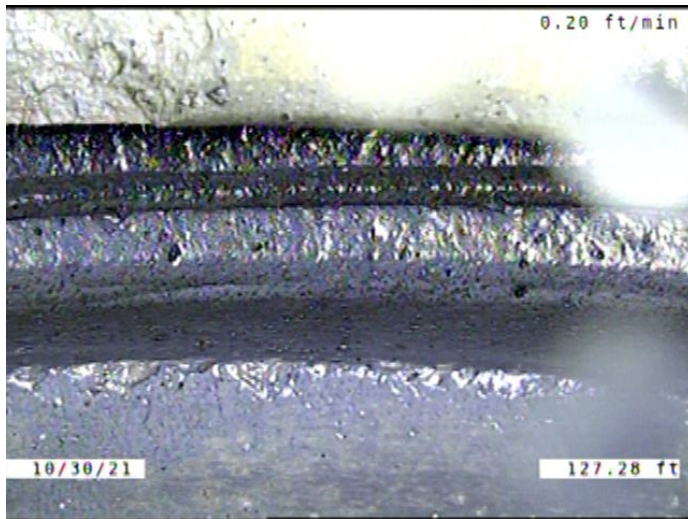
Code: **JAM**
 Description: **Joint Angular Medium**

Distance (ft): **127.3**
 Structural Grade: **3**
 O&M Grade: **0**
 Clock Start/From:
 Clock To:
 1st Value:
 2nd Value:
 Value Percent:
 Continuous Index:
 Within 8" of Joint: **NO**
 Remarks:

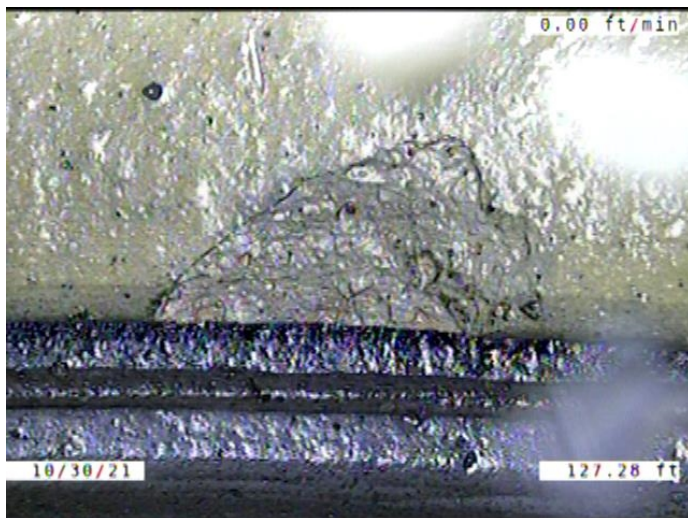
Code: **SZ**
 Description: **Surface Damage Other**

Distance (ft): **127.3**
 Structural Grade: **0**
 O&M Grade: **0**
 Clock Start/From: **2**
 Clock To:
 1st Value:
 2nd Value:
 Value Percent:
 Continuous Index:
 Within 8" of Joint: **YES**
 Remarks: **A PIECE CHIPPED AWAY FROM THE JOINT**

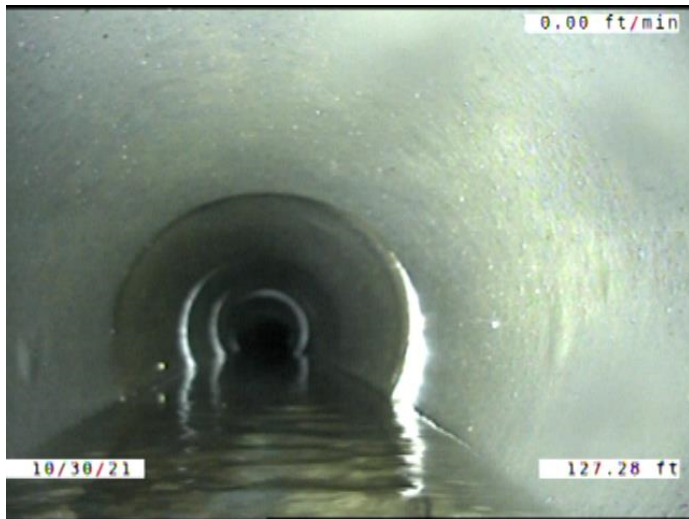
Code: **MWLS**
 Description: **Miscellaneous Water Level Sag**

Distance (ft): **127.3**
 Structural Grade: **2**
 O&M Grade: **0**
 Clock Start/From:
 Clock To:
 1st Value:
 2nd Value:
 Value Percent: **10.000**
 Continuous Index: **F02**
 Within 8" of Joint: **NO**
 Remarks:

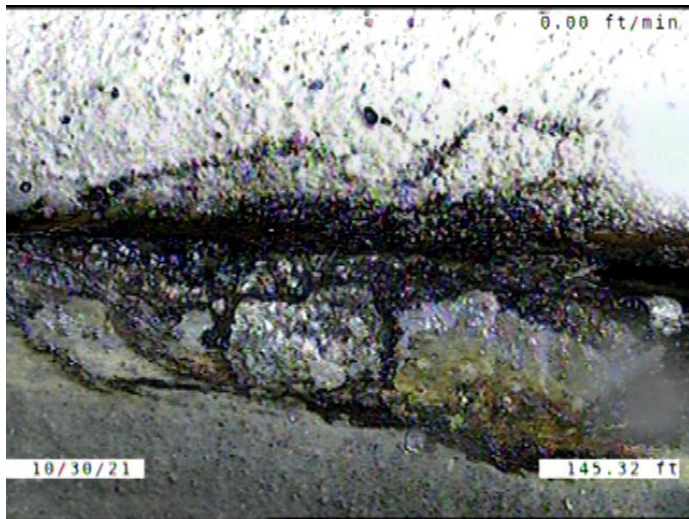
Code: **DAE**
 Description: **Deposits Attached Encrustation**

Distance (ft): **145.3**
 Structural Grade: **0**
 O&M Grade: **2**
 Clock Start/From: **1**
 Clock To: **3**
 1st Value:
 2nd Value:
 Value Percent: **5.000**
 Continuous Index:
 Within 8" of Joint: **YES**
 Remarks:

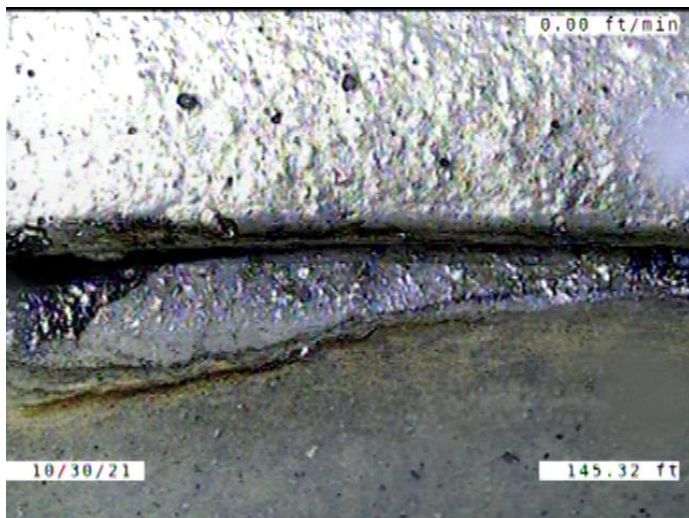
Code: **DAE**
 Description: **Deposits Attached Encrustation**

Distance (ft): **145.3**
 Structural Grade: **0**
 O&M Grade: **2**
 Clock Start/From: **10**
 Clock To: **12**
 1st Value:
 2nd Value:
 Value Percent: **5.000**
 Continuous Index: **S03**
 Within 8" of Joint: **YES**
 Remarks:

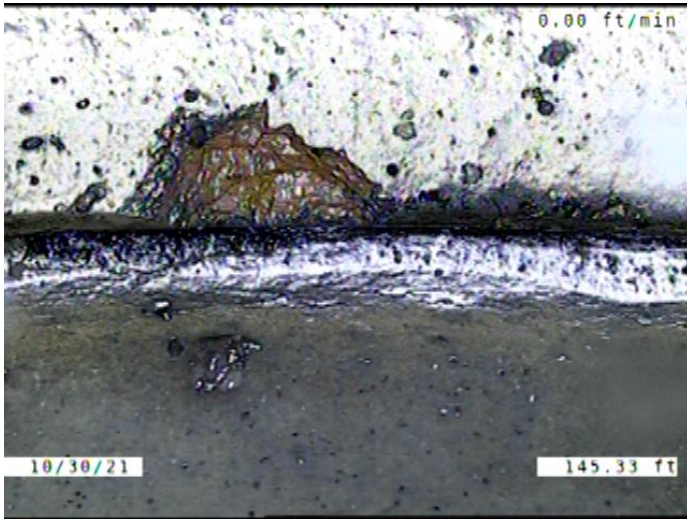
Code:	SZ
Description:	Surface Damage Other
Distance (ft):	145.3
Structural Grade:	0
O&M Grade:	0
Clock Start/From:	11
Clock To:	12
1st Value:	
2nd Value:	
Value Percent:	
Continuous Index:	
Within 8" of Joint:	YES
Remarks:	A PIECE CHIPPED AWAY FRO THE JOINT

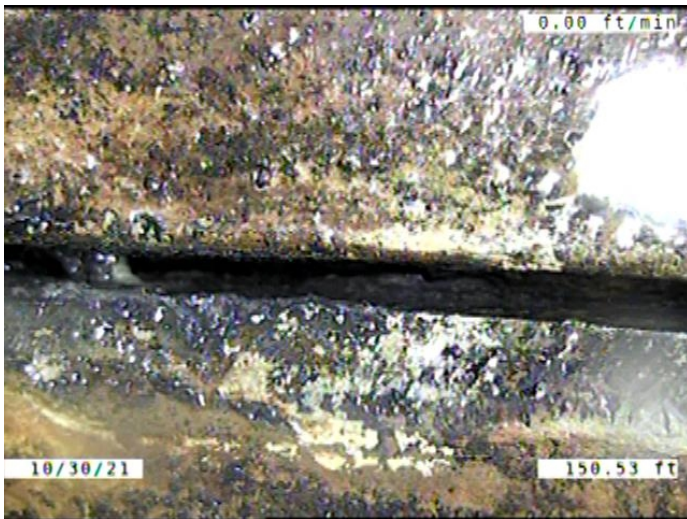
Code:	ISJ
Description:	Infiltration Stain Joint
Distance (ft):	150.5
Structural Grade:	0
O&M Grade:	1
Clock Start/From:	1
Clock To:	4
1st Value:	
2nd Value:	
Value Percent:	
Continuous Index:	
Within 8" of Joint:	YES
Remarks:

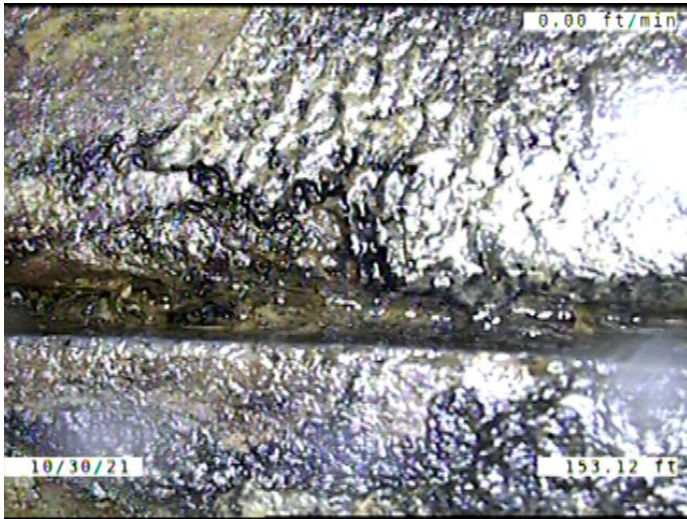
Code: **DAE**
 Description: **Deposits Attached Encrustation**

Distance (ft): **153.1**
 Structural Grade: **0**
 O&M Grade: **2**
 Clock Start/From: **1**
 Clock To: **4**
 1st Value:
 2nd Value:
 Value Percent: **5.000**
 Continuous Index:
 Within 8" of Joint: **YES**
 Remarks:

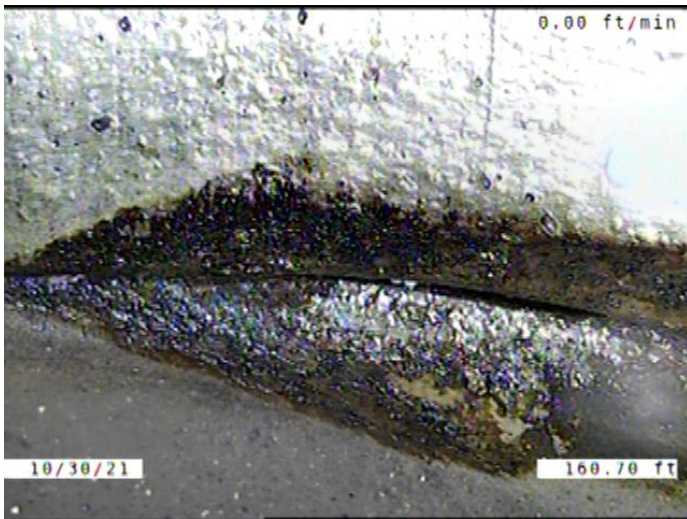
Code: **ISJ**
 Description: **Infiltration Stain Joint**

Distance (ft): **160.7**
 Structural Grade: **0**
 O&M Grade: **1**
 Clock Start/From: **1**
 Clock To: **3**
 1st Value:
 2nd Value:
 Value Percent:
 Continuous Index:
 Within 8" of Joint: **YES**
 Remarks:

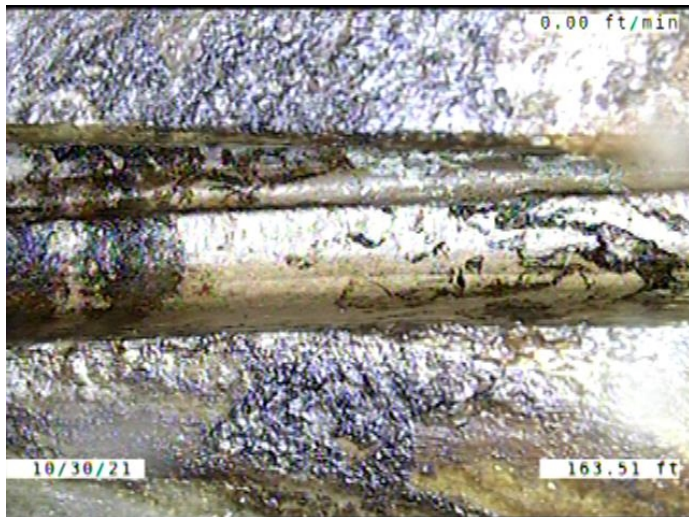
Code: **ISJ**
 Description: **Infiltration Stain Joint**

Distance (ft): **163.5**
 Structural Grade: **0**
 O&M Grade: **1**
 Clock Start/From: **1**
 Clock To: **4**
 1st Value:
 2nd Value:
 Value Percent:
 Continuous Index:
 Within 8" of Joint: **YES**
 Remarks:

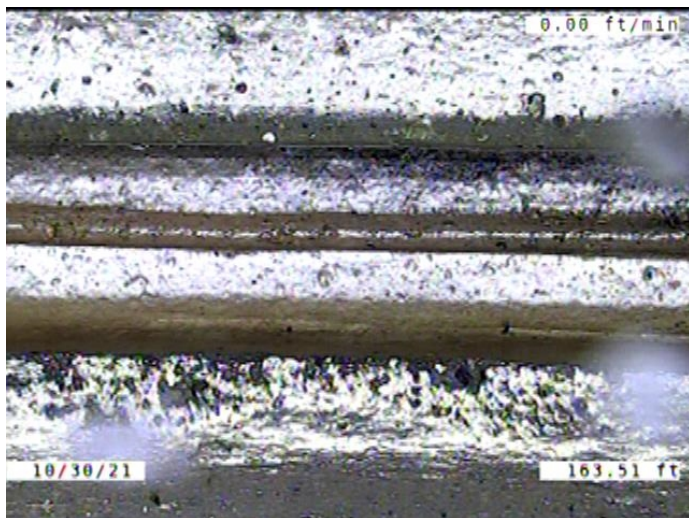
Code: **JAM**
 Description: **Joint Angular Medium**

Distance (ft): **163.5**
 Structural Grade: **3**
 O&M Grade: **0**
 Clock Start/From:
 Clock To:
 1st Value:
 2nd Value:
 Value Percent:
 Continuous Index:
 Within 8" of Joint: **NO**
 Remarks:

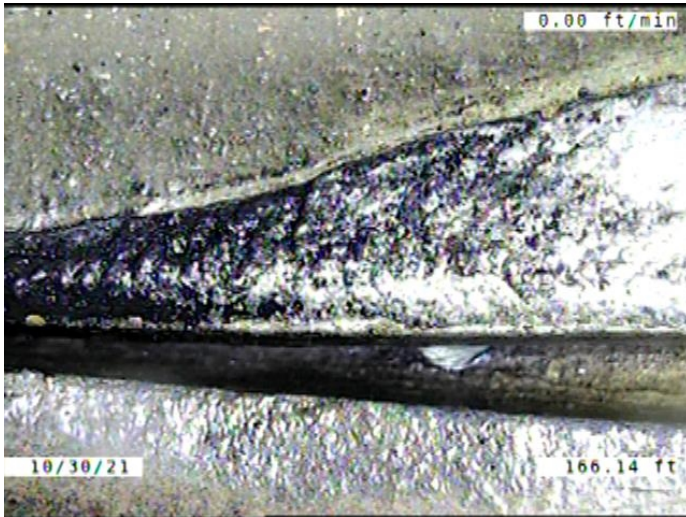
Code: **DAE**
 Description: **Deposits Attached Encrustation**

Distance (ft): **166.1**
 Structural Grade: **0**
 O&M Grade: **2**
 Clock Start/From: **12**
 Clock To: **4**
 1st Value:
 2nd Value:
 Value Percent: **5.000**
 Continuous Index: **S04**
 Within 8" of Joint: **YES**
 Remarks:

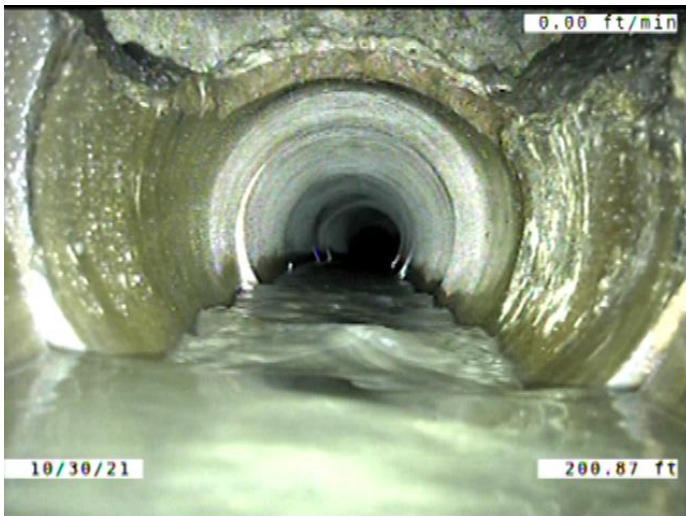
Code: **DSF**
 Description: **Deposits Settled Fine**

Distance (ft): **200.9**
 Structural Grade: **0**
 O&M Grade: **2**
 Clock Start/From: **5**
 Clock To: **7**
 1st Value:
 2nd Value:
 Value Percent: **5.000**
 Continuous Index: **F01**
 Within 8" of Joint: **YES**
 Remarks:

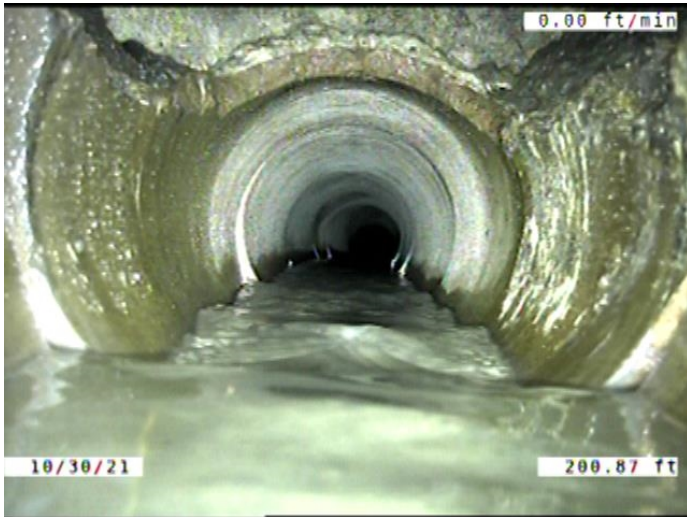
Code: **DAE**
 Description: **Deposits Attached Encrustation**

Distance (ft): **200.9**
 Structural Grade: **0**
 O&M Grade: **2**
 Clock Start/From: **10**
 Clock To: **12**
 1st Value:
 2nd Value:
 Value Percent: **5.000**
 Continuous Index: **F03**
 Within 8" of Joint: **YES**
 Remarks:

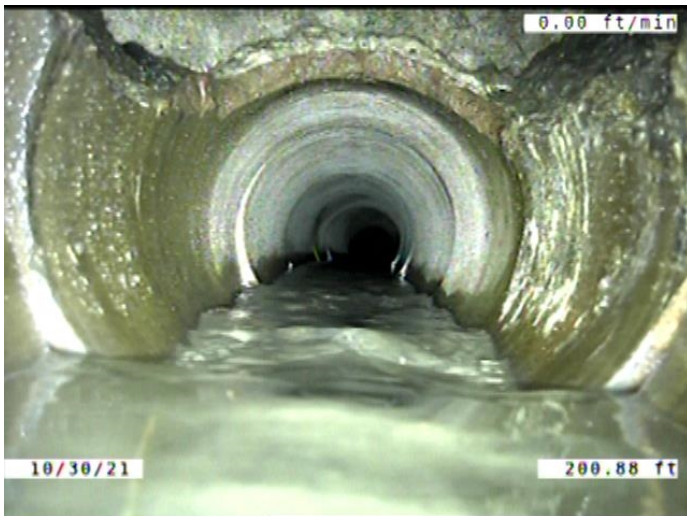
Code: **DAE**
 Description: **Deposits Attached Encrustation**

Distance (ft): **200.9**
 Structural Grade: **0**
 O&M Grade: **2**
 Clock Start/From: **12**
 Clock To: **4**
 1st Value:
 2nd Value:
 Value Percent: **5.000**
 Continuous Index: **F04**
 Within 8" of Joint: **YES**
 Remarks:
