Profile/Photo Observation Report

Date:	04/19/2018	Weather:		Coding:	PACP 6.0
Pipe Length (ft):	133.6	Owner:	NA	Pre Clean:	Not Known
P.O.#:		Surveyor:	Byrd Fitzgerald	PSR:	P-504-051-050
Customer:		Clean Date:	01/01/1900	Shape:	C

Street:	N COLORADO ST & N CAVENDER ST	Flow Control:	Not Controlled
City:	Hobart, IN	Year Renewed:	
Location:	Light Highway	Tape/Media #:	
Purpose:	Not Known	Dia/Height:	10"
Use:	Sanitary	Material:	VCP
Drain Area:	NA	Lining:	
Category:	NA		
Comment:

Location Details:		Direction of Survey:	Downstream
US MH:	M-504-050	DS MH:	M-504-051
		Total Length Surveyed (ft):	38.2

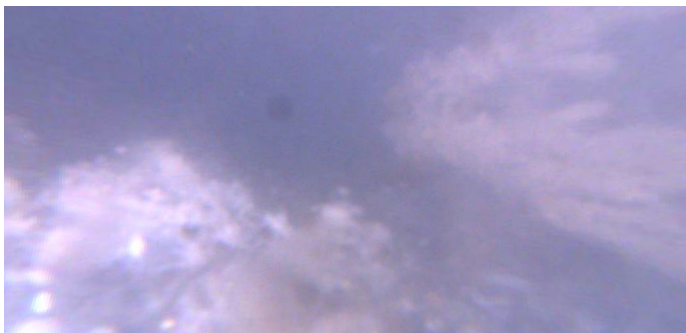
Code: **AMH**
Description: **Manhole**

Distance (ft): **.0**
Structural Grade: **0**
O&M Grade: **0**
Clock Start/From:
Clock To:
1st Value:
2nd Value:
Value Percent:
Continuous Index:
Within 8" of Joint: **NO**
Remarks: **M-504-050**

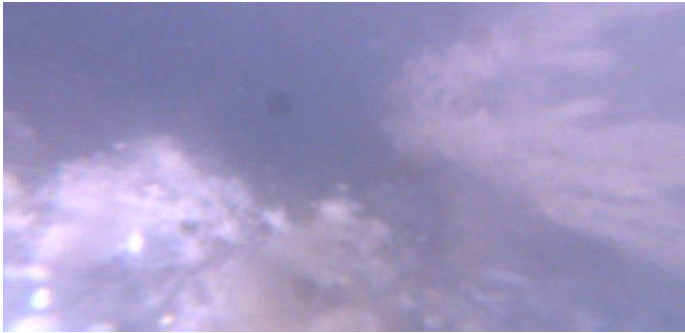
Code:	MWL
Description:	Water Level

Distance (ft):	.0
Structural Grade:	0
O&M Grade:	0
Clock Start/From:	
Clock To:	
1st Value:	
2nd Value:	
Value Percent:	100.000
Continuous Index:	
Within 8" of Joint:	NO
Remarks:

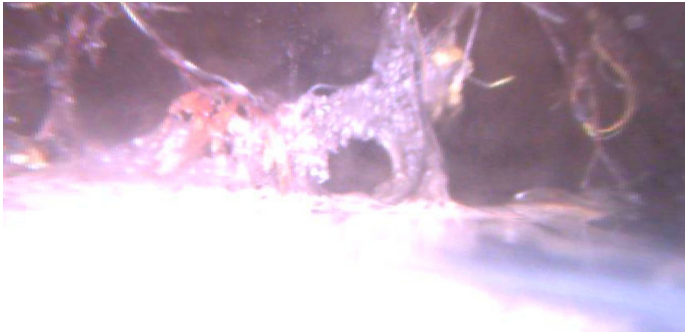
Code: **MCU**
Description: **Camera Underwater**

Distance (ft): **13.9**
Structural Grade: **0**
O&M Grade: **4**
Clock Start/From:
Clock To:
1st Value:
2nd Value:
Value Percent:
Continuous Index: **F01**
Within 8" of Joint: **NO**
Remarks:

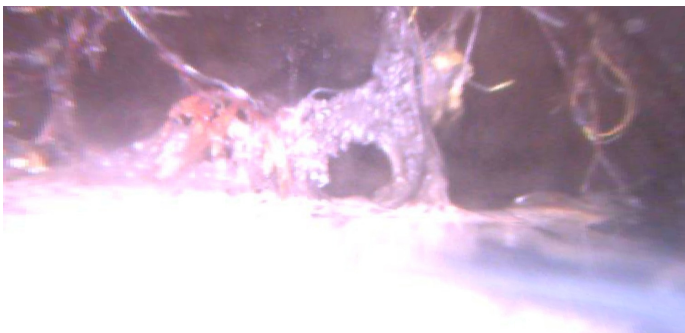
Code: **MWL**
Description: **Water Level**

Distance (ft): **13.9**
Structural Grade: **0**
O&M Grade: **0**
Clock Start/From:
Clock To:
1st Value:
2nd Value:
Value Percent: **50.000**
Continuous Index:
Within 8" of Joint: **NO**
Remarks:

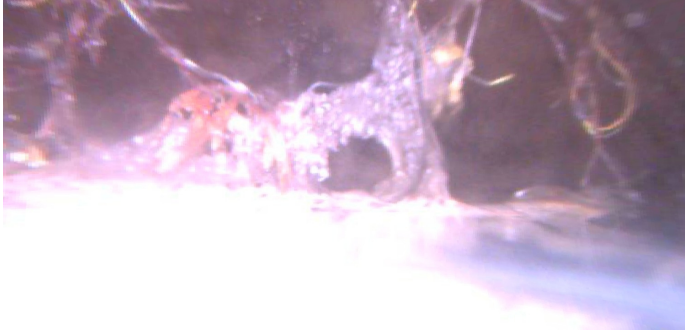
Code: **RFJ**
Description: **Roots Fine Joint**

Distance (ft): **13.9**
Structural Grade: **0**
O&M Grade: **1**
Clock Start/From: **9**
Clock To: **3**
1st Value:
2nd Value:
Value Percent:
Continuous Index: **S02**
Within 8" of Joint: **YES**
Remarks:

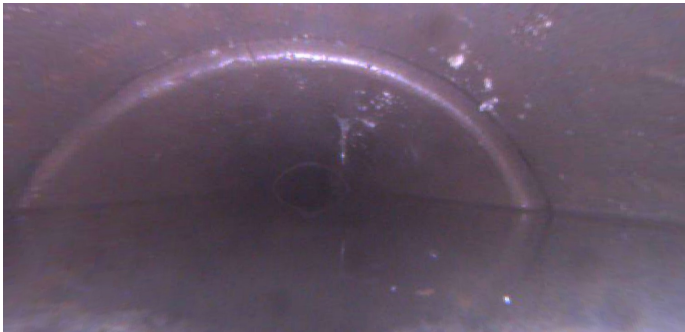
Code: **MWL**
Description: **Water Level**

Distance (ft): **19.4**
Structural Grade: **0**
O&M Grade: **0**
Clock Start/From:
Clock To:
1st Value:
2nd Value:
Value Percent: **75.000**
Continuous Index:
Within 8" of Joint: **NO**
Remarks:

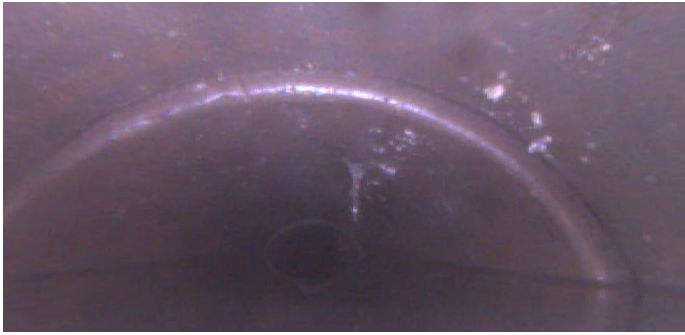
Code: **CM**
Description: **Crack Multiple**

Distance (ft): **19.4**
Structural Grade: **3**
O&M Grade: **0**
Clock Start/From: **11**
Clock To: **12**
1st Value:
2nd Value:
Value Percent:
Continuous Index:
Within 8" of Joint: **YES**
Remarks:

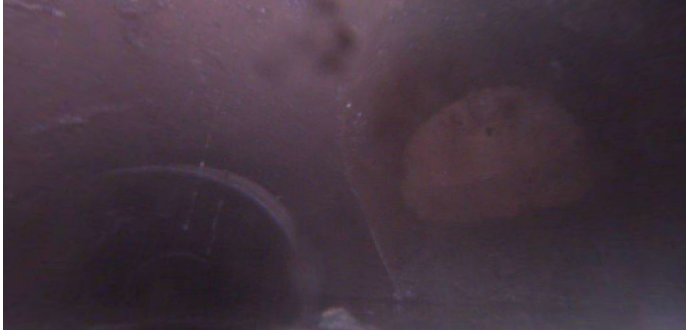
Code: **TFC**
Description: **Tap Factory Capped**

Distance (ft): **31.1**
Structural Grade: **0**
O&M Grade: **0**
Clock Start/From: **2**
Clock To:
1st Value: **4.000**
2nd Value:
Value Percent:
Continuous Index:
Within 8" of Joint: **YES**
Remarks:
