Profile/Photo Observation Report

Date:	04/19/2018	Weather:		Coding:	PACP 6.0
Pipe Length (ft):	133.6	Owner:	NA	Pre Clean:	Not Known
P.O.#:		Surveyor:	Byrd Fitzgerald	PSR:	P-504-051-050
Customer:		Clean Date:	01/01/1900	Shape:	C

Street:	Summerlin	Flow Control:	Not Controlled
City:	Hobart, IN	Year Renewed:	
Location:	Light Highway	Tape/Media #:	
Purpose:	Not Known	Dia/Height:	10"
Use:	Sanitary	Material:	VCP
Drain Area:	NA	Lining:	
Category:	NA		
Comment:

Location Details:		Direction of Survey:	Downstream
US MH:	M-504-050	DS MH:	M-504-051
		Total Length Surveyed (ft):	38.2

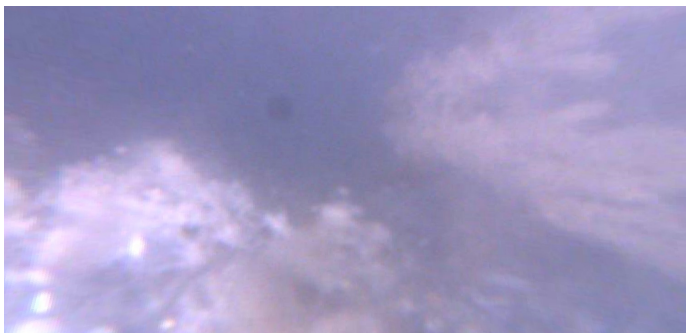
Code: **AMH**
Description: **Manhole**

Distance (ft): **.0**
Structural Grade: **0**
O&M Grade: **0**
Clock Start/From:
Clock To:
1st Value:
2nd Value:
Value Percent:
Continuous Index:
Within 8" of Joint: **NO**
Remarks: **M-504-050**

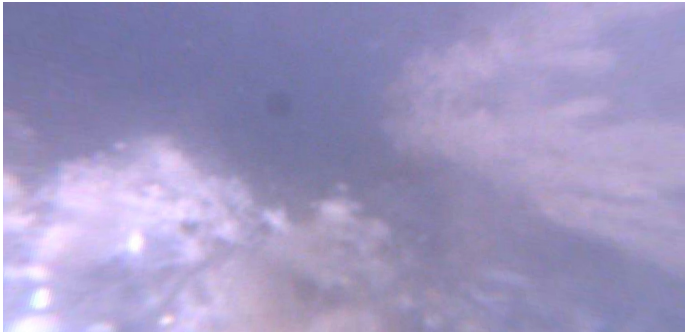
Code:	MWL
Description:	Water Level

Distance (ft):	.0
Structural Grade:	0
O&M Grade:	0
Clock Start/From:	
Clock To:	
1st Value:	
2nd Value:	
Value Percent:	100.000
Continuous Index:	
Within 8" of Joint:	NO
Remarks:

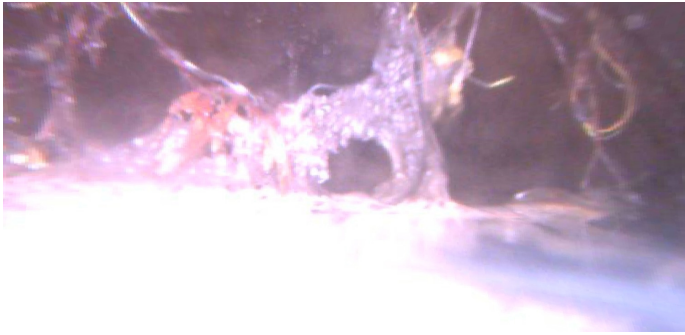
Code: **MCU**
Description: **Camera Underwater**

Distance (ft): **13.9**
Structural Grade: **0**
O&M Grade: **4**
Clock Start/From:
Clock To:
1st Value:
2nd Value:
Value Percent:
Continuous Index: **F01**
Within 8" of Joint: **NO**
Remarks:

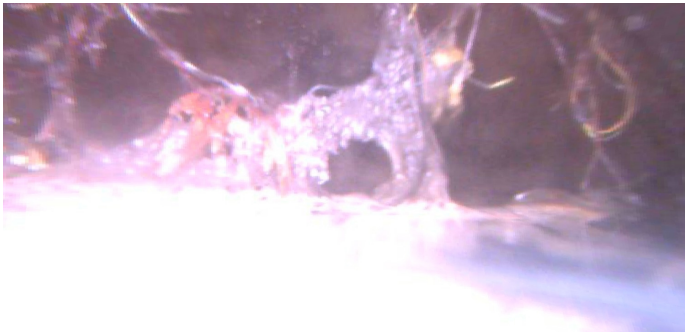
Code: **MWL**
Description: **Water Level**

Distance (ft): **13.9**
Structural Grade: **0**
O&M Grade: **0**
Clock Start/From:
Clock To:
1st Value:
2nd Value:
Value Percent: **50.000**
Continuous Index:
Within 8" of Joint: **NO**
Remarks:

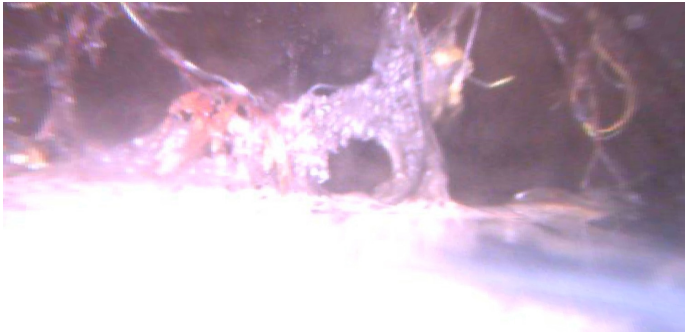
Code: **RFJ**
Description: **Roots Fine Joint**

Distance (ft): **13.9**
Structural Grade: **0**
O&M Grade: **1**
Clock Start/From: **9**
Clock To: **3**
1st Value:
2nd Value:
Value Percent:
Continuous Index: **S02**
Within 8" of Joint: **YES**
Remarks:

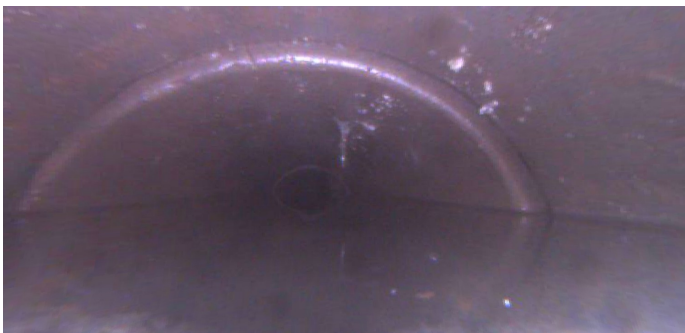
Code: **MWL**
Description: **Water Level**

Distance (ft): **19.4**
Structural Grade: **0**
O&M Grade: **0**
Clock Start/From:
Clock To:
1st Value:
2nd Value:
Value Percent: **75.000**
Continuous Index:
Within 8" of Joint: **NO**
Remarks:

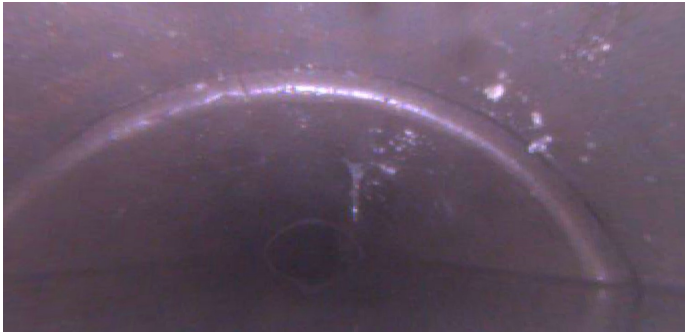
Code: **CM**
Description: **Crack Multiple**

Distance (ft): **19.4**
Structural Grade: **3**
O&M Grade: **0**
Clock Start/From: **11**
Clock To: **12**
1st Value:
2nd Value:
Value Percent:
Continuous Index:
Within 8" of Joint: **YES**
Remarks:

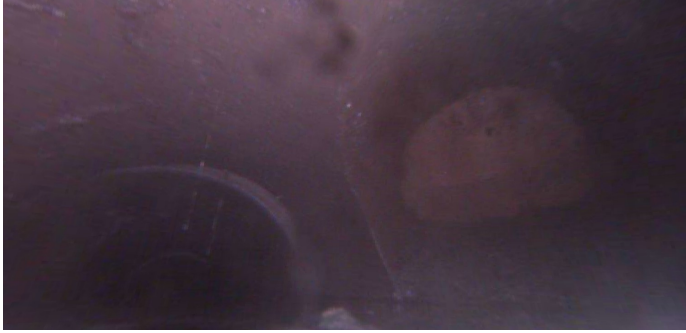
Code: **TFC**
Description: **Tap Factory Capped**

Distance (ft): **31.1**
Structural Grade: **0**
O&M Grade: **0**
Clock Start/From: **2**
Clock To:
1st Value: **4.000**
2nd Value:
Value Percent:
Continuous Index:
Within 8" of Joint: **YES**
Remarks:
