Profile/Photo Observation Report

Street:	N COLORADO ST & N CAVENDER ST	Flow Control:	Not Controlled
City:	Hobart, IN	Year Renewed:	
Location:	Light Highway	Tape/Media #:	
Purpose:	Not Known	Dia/Height:	10"
Use:	Sanitary	Material:	VCP
Drain Area:	NA	Lining:	
Category:	NA		
Comment:

Location Details:		Direction of Survey:	Upstream
US MH:	M-504-050	DS MH:	M-504-051
		Total Length Surveyed (ft):	72.6

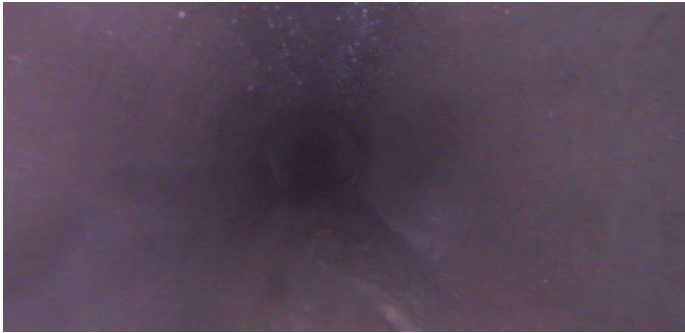
Code:	MWL
Description:	Water Level

Distance (ft):	.0
Structural Grade:	0
O&M Grade:	0
Clock Start/From:	
Clock To:	
1st Value:	
2nd Value:	
Value Percent:	5.000
Continuous Index:	
Within 8" of Joint:	NO
Remarks:

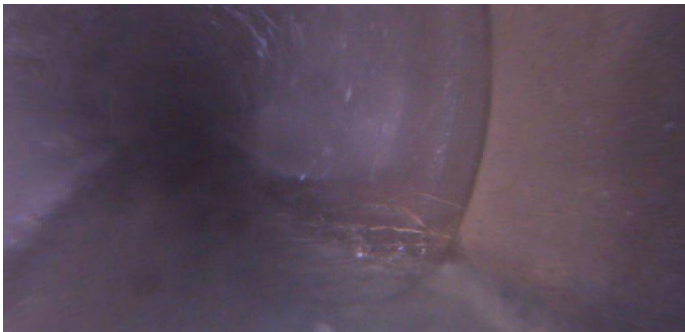
Code:	RFJ
Description:	Roots Fine Joint

Distance (ft):	3.7
Structural Grade:	0
O&M Grade:	1
Clock Start/From:	7
Clock To:	5
1st Value:	
2nd Value:	
Value Percent:	
Continuous Index:	S01
Within 8" of Joint:	YES
Remarks:	wandering

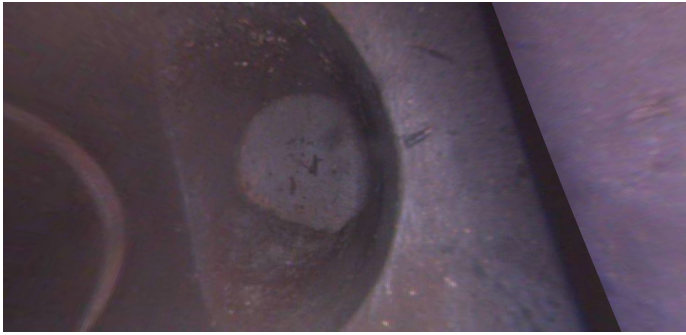
Code: **TFC**
Description: **Tap Factory Capped**

Distance (ft): **17.7**
Structural Grade: **0**
O&M Grade: **0**
Clock Start/From: **10**
Clock To:
1st Value: **4.000**
2nd Value:
Value Percent:
Continuous Index:
Within 8" of Joint: **YES**
Remarks:

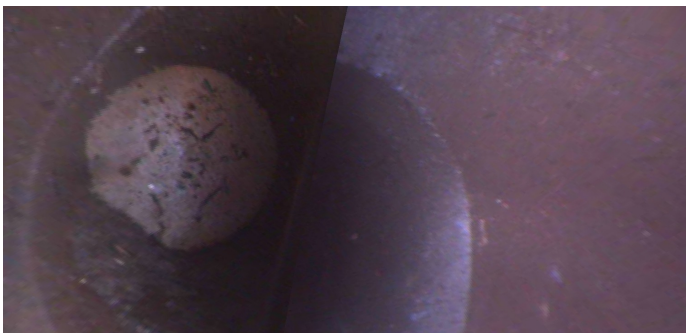
Code: **TFC**
Description: **Tap Factory Capped**

Distance (ft): **42.7**
Structural Grade: **0**
O&M Grade: **0**
Clock Start/From: **10**
Clock To:
1st Value: **4.000**
2nd Value:
Value Percent:
Continuous Index:
Within 8" of Joint: **YES**
Remarks:

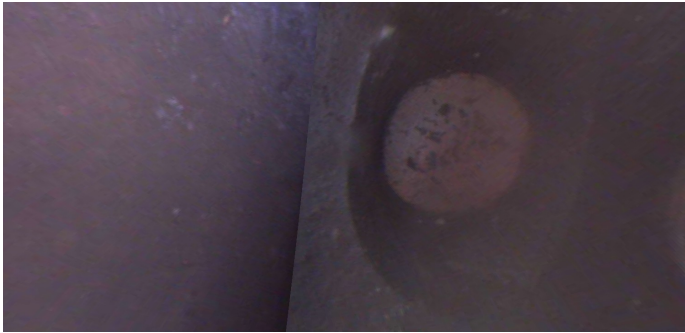
Code: **TFC**
Description: **Tap Factory Capped**

Distance (ft): **65.0**
Structural Grade: **0**
O&M Grade: **0**
Clock Start/From: **2**
Clock To:
1st Value: **4.000**
2nd Value:
Value Percent:
Continuous Index:
Within 8" of Joint: **YES**
Remarks:

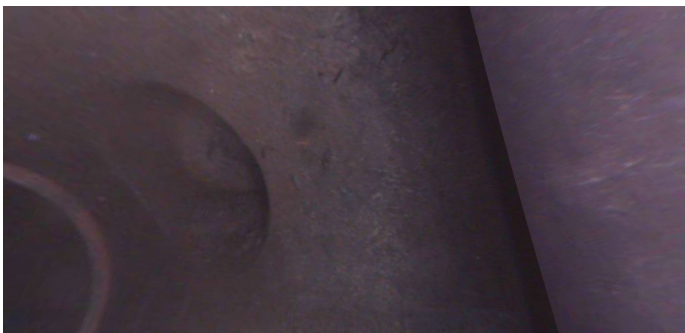
Code: **TFC**
Description: **Tap Factory Capped**

Distance (ft): **67.5**
Structural Grade: **0**
O&M Grade: **0**
Clock Start/From: **11**
Clock To:
1st Value: **4.000**
2nd Value:
Value Percent:
Continuous Index:
Within 8" of Joint: **YES**
Remarks:

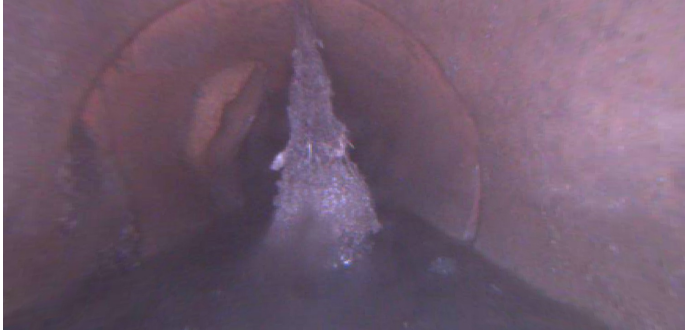
Code: **RMJ**
Description: **Roots Medium Joint**

Distance (ft): **67.5**
Structural Grade: **0**
O&M Grade: **3**
Clock Start/From: **12**
Clock To:
1st Value:
2nd Value:
Value Percent: **10.000**
Continuous Index:
Within 8" of Joint: **YES**
Remarks:

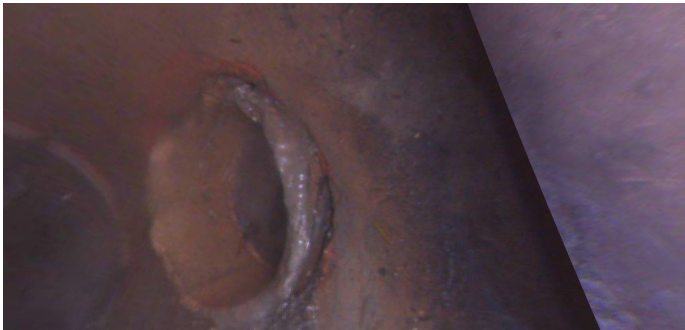
Code: **TB**
Description: **Tap Break-in**

Distance (ft): **69.3**
Structural Grade: **0**
O&M Grade: **0**
Clock Start/From: **10**
Clock To:
1st Value: **4.000**
2nd Value:
Value Percent:
Continuous Index:
Within 8" of Joint: **YES**
Remarks:

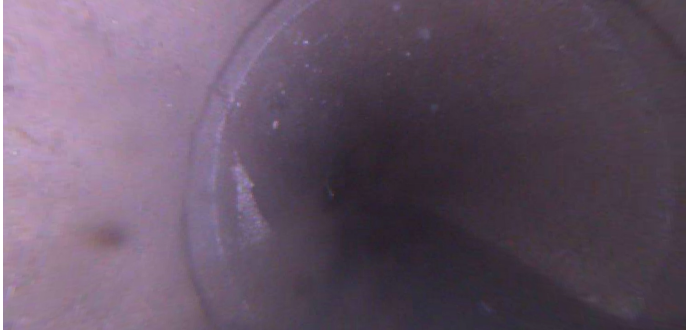
Code: **MSA**
Description: **Abandoned Survey**

Distance (ft): **72.6**
Structural Grade: **0**
O&M Grade: **0**
Clock Start/From:
Clock To:
1st Value:
2nd Value:
Value Percent:
Continuous Index:
Within 8" of Joint: **NO**
Remarks: **stuck on wall**

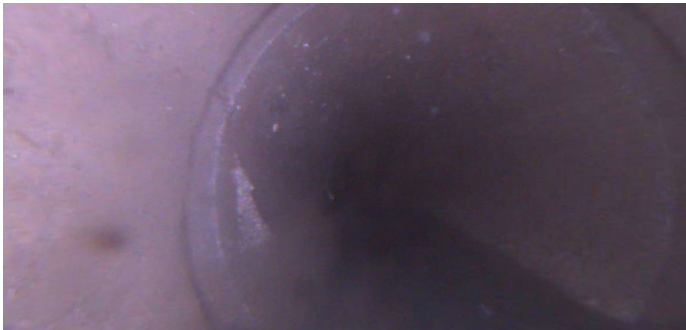
Code: **RFJ**
Description: **Roots Fine Joint**

Distance (ft): **72.6**
Structural Grade: **0**
O&M Grade: **1**
Clock Start/From: **7**
Clock To: **5**
1st Value:
2nd Value:
Value Percent:
Continuous Index: **F01**
Within 8" of Joint: **YES**
Remarks: **wandering**
