Profile/Photo Observation Report

Date:	04/19/2018	Weather:		Coding:	PACP 6.0
Pipe Length (ft):	371.5	Owner:	NA	Pre Clean:	Not Known
P.O.#:		Surveyor:	Byrd Fitzgerald	PSR:	P-504-065.1-051
Customer:		Clean Date:	01/01/1900	Shape:	C

Street:	ALLEY BETWEEN N GUYER ST & N CA	Flow Control:	Not Controlled
City:	Hobart, IN	Year Renewed:	
Location:	Light Highway	Tape/Media #:	
Purpose:	Not Known	Dia/Height:	8"
Use:	Sanitary	Material:	CP
Drain Area:	NA	Lining:	
Category:	NA		
Comment:

Location Details:		Direction of Survey:	Downstream
US MH:	M-504-051	DS MH:	M-504-065.1
		Total Length Surveyed (ft):	165.5

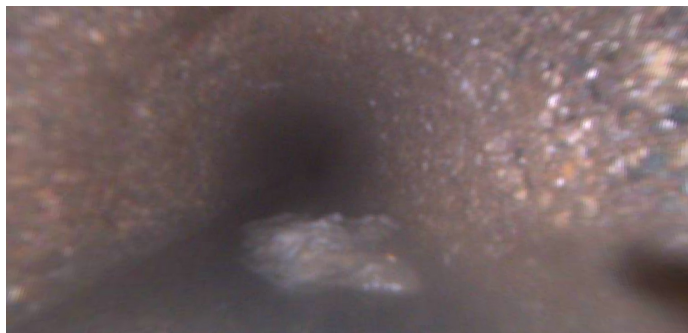
Code: **AMH**
 Description: **Manhole**
 Distance (ft): **.0**
 Structural Grade: **0**
 O&M Grade: **0**
 Clock Start/From:
 Clock To:
 1st Value:
 2nd Value:
 Value Percent:
 Continuous Index:
 Within 8" of Joint: **NO**
 Remarks: **M-504-051**

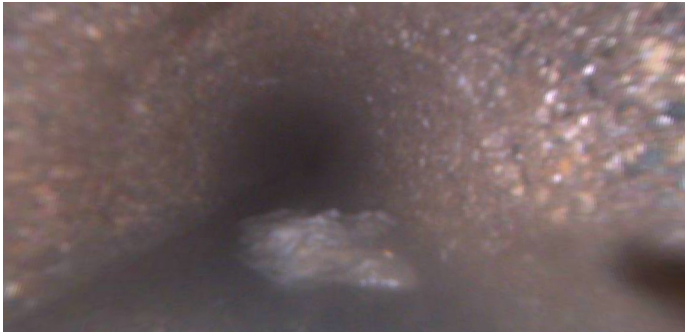
Code:	MWL
Description:	Water Level

Distance (ft):	.0
Structural Grade:	0
O&M Grade:	0
Clock Start/From:	
Clock To:	
1st Value:	
2nd Value:	
Value Percent:	5.000
Continuous Index:	
Within 8" of Joint:	NO
Remarks:

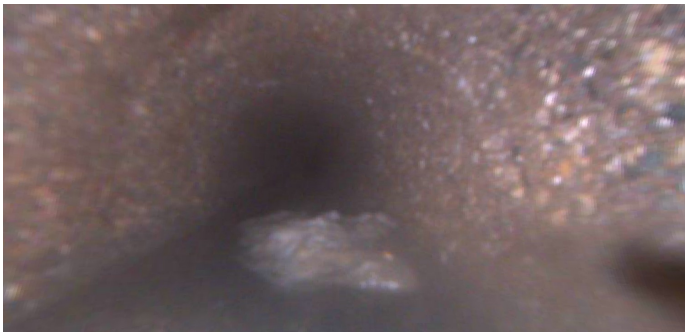
Code:	SAV
Description:	Surface Aggregate Visible

Distance (ft):	.0
Structural Grade:	3
O&M Grade:	0
Clock Start/From:	7
Clock To:	5
1st Value:	
2nd Value:	
Value Percent:	
Continuous Index:	S01
Within 8" of Joint:	
Remarks:

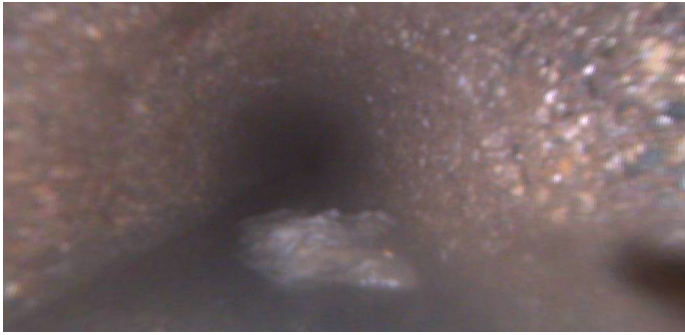
Code: **DSZ**
Description: **Deposits Settled Other**

Distance (ft): **.0**
Structural Grade: **0**
O&M Grade: **2**
Clock Start/From: **6**
Clock To:
1st Value:
2nd Value:
Value Percent: **5.000**
Continuous Index: **S02**
Within 8" of Joint: **NO**
Remarks: **tissue**

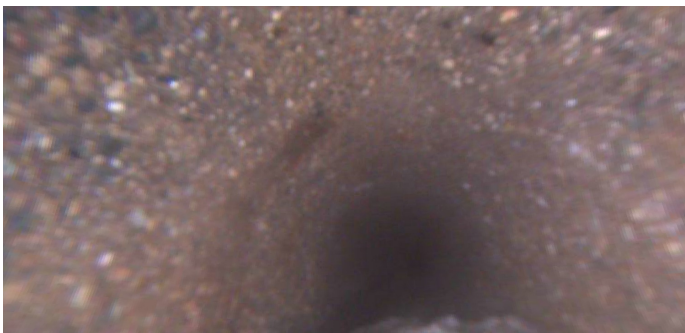
Code: **IS**
Description: **Infil Stain**

Distance (ft): **.0**
Structural Grade: **0**
O&M Grade: **0**
Clock Start/From: **11**
Clock To:
1st Value:
2nd Value:
Value Percent:
Continuous Index:
Within 8" of Joint:
Remarks: **possible pinhole**

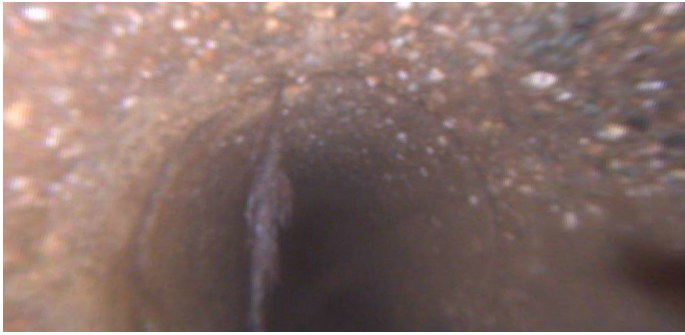
Code: **RFJ**
Description: **Roots Fine Joint**

Distance (ft): **35.8**
Structural Grade: **0**
O&M Grade: **1**
Clock Start/From: **11**
Clock To:
1st Value:
2nd Value:
Value Percent:
Continuous Index:
Within 8" of Joint: **YES**
Remarks:

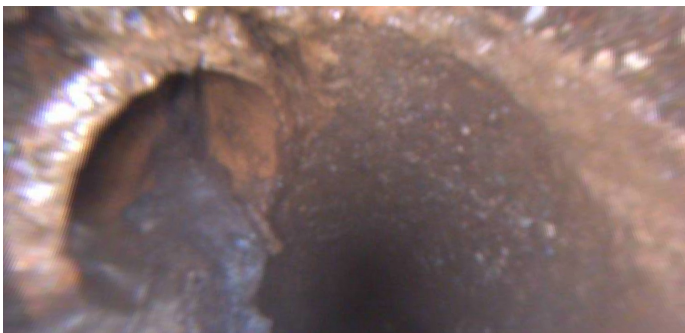
Code: **TB**
Description: **Tap Break-in**

Distance (ft): **53.0**
Structural Grade: **0**
O&M Grade: **0**
Clock Start/From: **10**
Clock To:
1st Value: **4.000**
2nd Value:
Value Percent:
Continuous Index:
Within 8" of Joint:
Remarks:

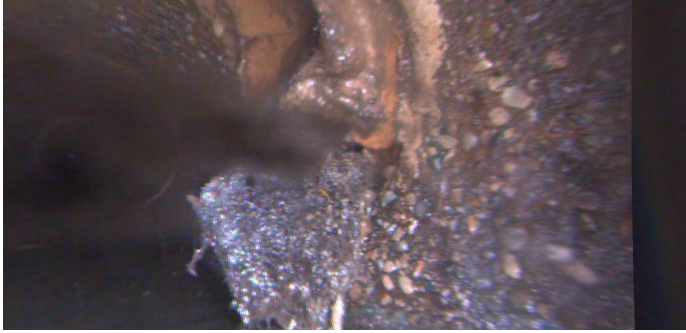
Code: **RMC**
Description: **Roots Medium Connection**

Distance (ft): **54.2**
Structural Grade: **0**
O&M Grade: **3**
Clock Start/From: **7**
Clock To: **9**
1st Value:
2nd Value:
Value Percent: **5.000**
Continuous Index:
Within 8" of Joint: **NO**
Remarks:

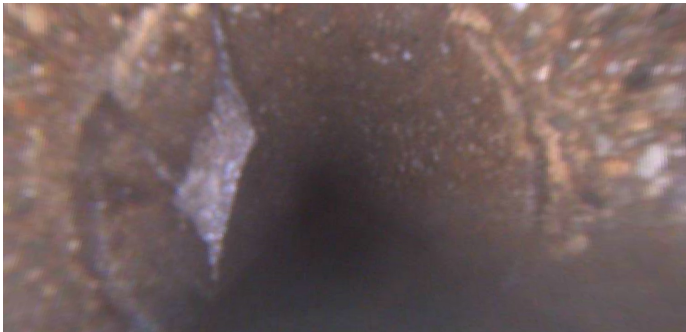
Code: **RFJ**
Description: **Roots Fine Joint**

Distance (ft): **57.9**
Structural Grade: **0**
O&M Grade: **1**
Clock Start/From: **10**
Clock To: **11**
1st Value:
2nd Value:
Value Percent:
Continuous Index:
Within 8" of Joint: **YES**
Remarks:

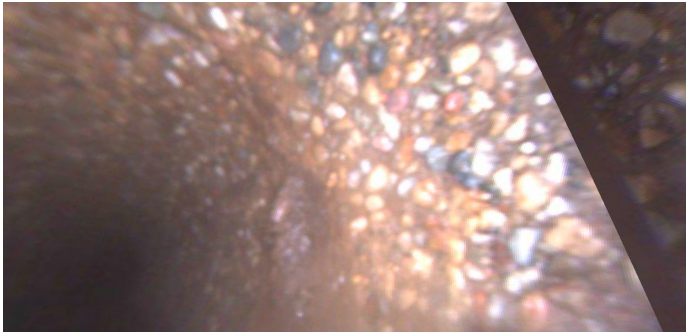
Code: **SAP**
Description: **Surface Aggregate Projecting**

Distance (ft): **64.2**
Structural Grade: **3**
O&M Grade: **0**
Clock Start/From: **7**
Clock To: **5**
1st Value:
2nd Value:
Value Percent:
Continuous Index: **S03**
Within 8" of Joint:
Remarks:

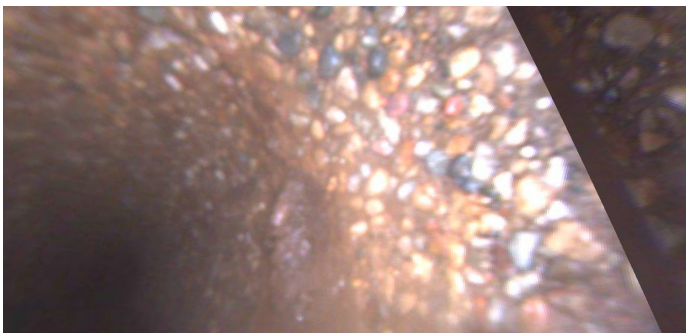
Code: **SAV**
Description: **Surface Aggregate Visible**

Distance (ft): **64.2**
Structural Grade: **3**
O&M Grade: **0**
Clock Start/From: **7**
Clock To: **5**
1st Value:
2nd Value:
Value Percent:
Continuous Index: **F01**
Within 8" of Joint:
Remarks:

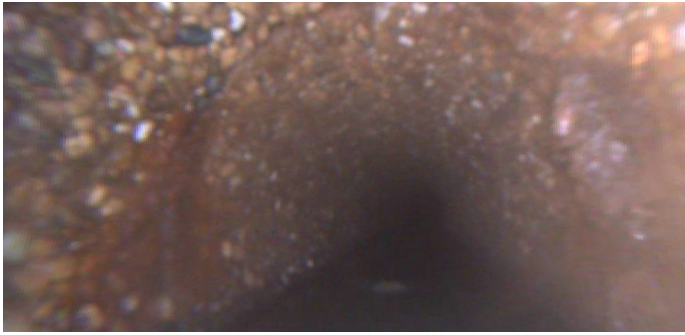
Code: **IS**
Description: **Infil Stain**

Distance (ft): **64.2**
Structural Grade: **0**
O&M Grade: **0**
Clock Start/From: **7**
Clock To: **10**
1st Value:
2nd Value:
Value Percent:
Continuous Index:
Within 8" of Joint: **YES**
Remarks:

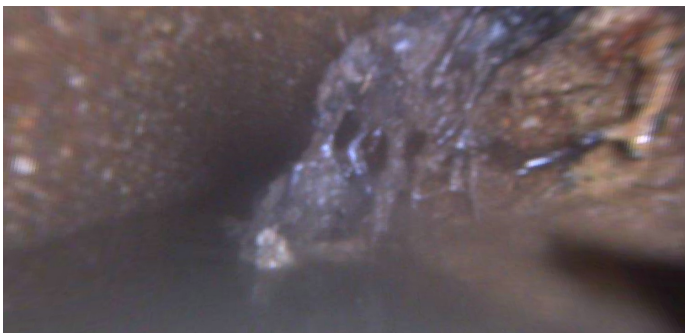
Code: **RMJ**
Description: **Roots Medium Joint**

Distance (ft): **77.2**
Structural Grade: **0**
O&M Grade: **3**
Clock Start/From: **2**
Clock To: **5**
1st Value:
2nd Value:
Value Percent: **10.000**
Continuous Index:
Within 8" of Joint: **YES**
Remarks:

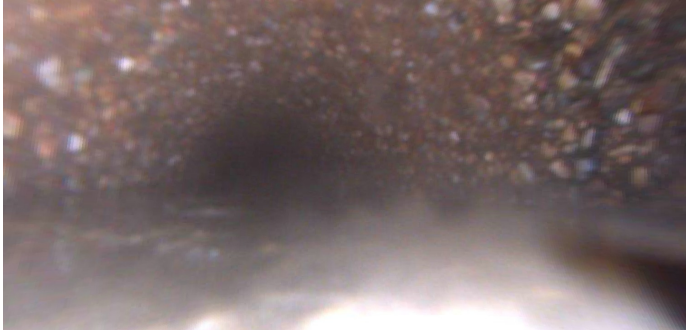
Code: **MWL**
Description: **Water Level**

Distance (ft): **85.2**
Structural Grade: **0**
O&M Grade: **0**
Clock Start/From:
Clock To:
1st Value:
2nd Value:
Value Percent: **40.000**
Continuous Index:
Within 8" of Joint: **NO**
Remarks:

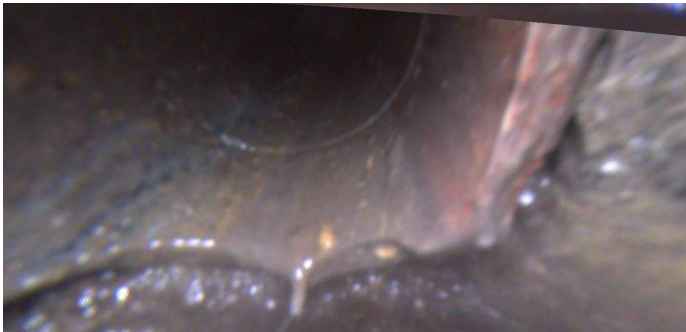
Code: **TB**
Description: **Tap Break-in**

Distance (ft): **111.3**
Structural Grade: **0**
O&M Grade: **0**
Clock Start/From: **12**
Clock To:
1st Value: **6.000**
2nd Value:
Value Percent:
Continuous Index:
Within 8" of Joint:
Remarks:

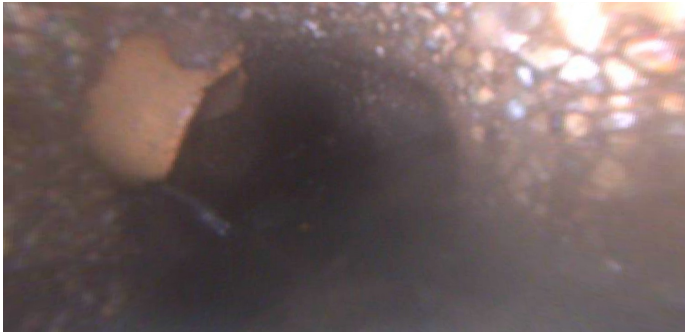
Code: **TBI**
Description: **Tap Break-in Intruding**

Distance (ft): **118.7**
Structural Grade: **0**
O&M Grade: **2**
Clock Start/From: **10**
Clock To:
1st Value: **4.000**
2nd Value: **2.000**
Value Percent:
Continuous Index:
Within 8" of Joint:
Remarks:

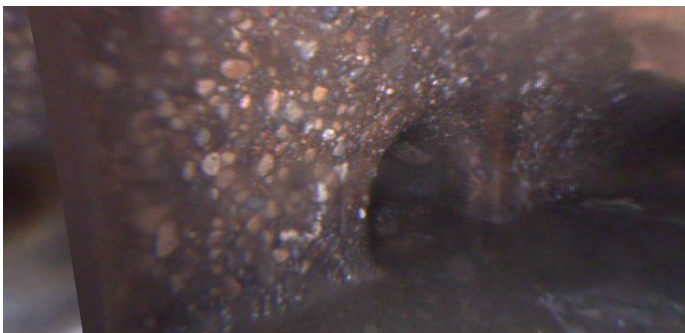
Code: **TFD**
Description: **Tap Factory Defective**

Distance (ft): **120.5**
Structural Grade: **0**
O&M Grade: **2**
Clock Start/From: **3**
Clock To:
1st Value: **4.000**
2nd Value:
Value Percent:
Continuous Index:
Within 8" of Joint:
Remarks: **partially blocked**

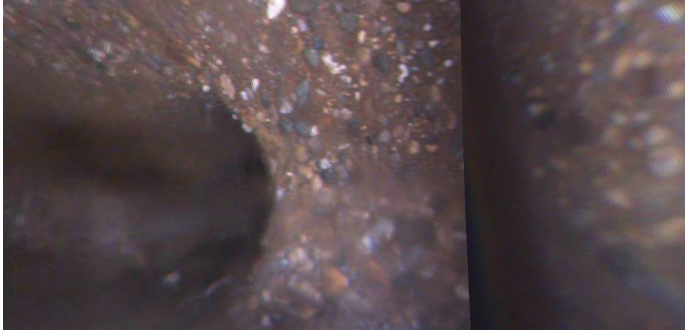
Code: **TF**
Description: **Tap Factory**

Distance (ft): **126.7**
Structural Grade: **0**
O&M Grade: **0**
Clock Start/From: **9**
Clock To:
1st Value: **4.000**
2nd Value:
Value Percent:
Continuous Index:
Within 8" of Joint: **YES**
Remarks:

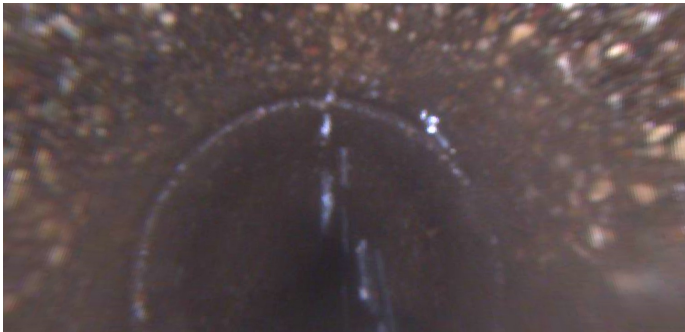
Code: **ID**
Description: **Infil Dripper**

Distance (ft): **130.4**
Structural Grade: **0**
O&M Grade: **3**
Clock Start/From: **12**
Clock To:
1st Value:
2nd Value:
Value Percent:
Continuous Index:
Within 8" of Joint: **YES**
Remarks:

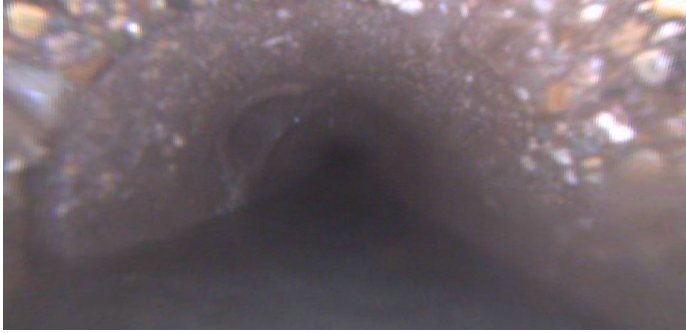
Code: **MSA**
Description: **Abandoned Survey**

Distance (ft): **165.5**
Structural Grade: **0**
O&M Grade: **0**
Clock Start/From:
Clock To:
1st Value:
2nd Value:
Value Percent:
Continuous Index:
Within 8" of Joint: **NO**
Remarks: **DSF**

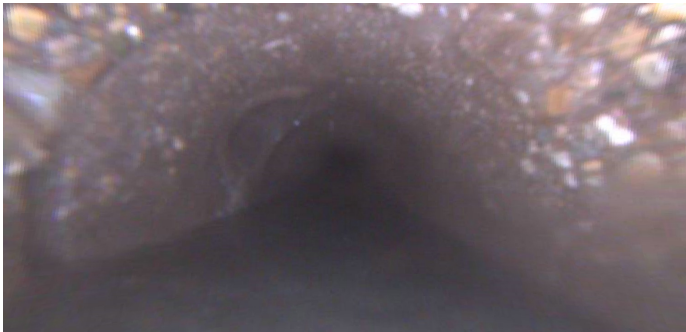
Code: **DSZ**
Description: **Deposits Settled Other**

Distance (ft): **165.5**
Structural Grade: **0**
O&M Grade: **2**
Clock Start/From: **6**
Clock To:
1st Value:
2nd Value:
Value Percent: **5.000**
Continuous Index: **F02**
Within 8" of Joint: **NO**
Remarks: **tissue**

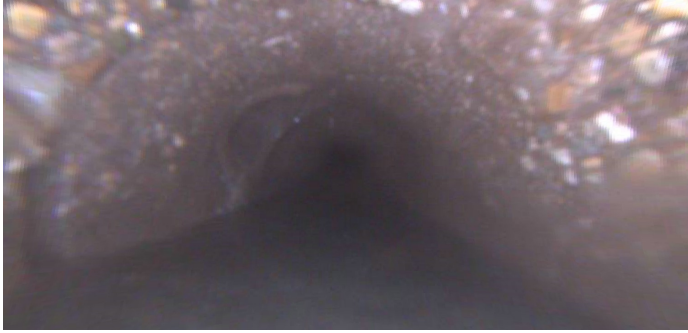
Code:	SAP
Description:	Surface Aggregate Projecting
Distance (ft):	165.5
Structural Grade:	3
O&M Grade:	0
Clock Start/From:	7
Clock To:	5
1st Value:	
2nd Value:	
Value Percent:	
Continuous Index:	F03
Within 8" of Joint:	
Remarks:
