Profile/Photo Observation Report

Date:	04/19/2018	Weather:		Coding:	PACP 6.0
Pipe Length (ft):	371.5	Owner:	NA	Pre Clean:	Not Known
P.O.#:		Surveyor:	Byrd Fitzgerald	PSR:	P-504-065.1-051
Customer:		Clean Date:	01/01/1900	Shape:	C

Street:	Summerlin	Flow Control:	Not Controlled		
City:	Hobart, IN	Year Renewed:			
Location:	Light Highway	Tape/Media #:			
Purpose:	Not Known	Dia/Height:	8"		
Use:	Sanitary	Material:	CP		
Drain Area:	NA	Lining:			
Category:	NA				
Comment:					
Location Details:		Direction of Survey:	Downstream		
US MH:	M-504-051	DS MH:	M-504-065.1	Total Length Surveyed (ft):	165.5

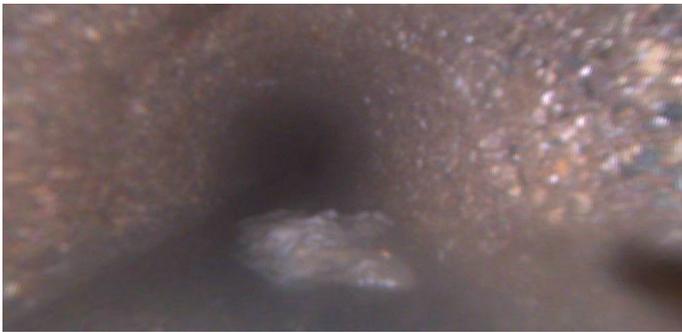
Code: **SAV**
Description: **Surface Aggregate Visible**

Distance (ft): **.0**
Structural Grade: **3**
O&M Grade: **0**
Clock Start/From: **7**
Clock To: **5**
1st Value:
2nd Value:
Value Percent:
Continuous Index: **S01**
Within 8" of Joint:
Remarks:

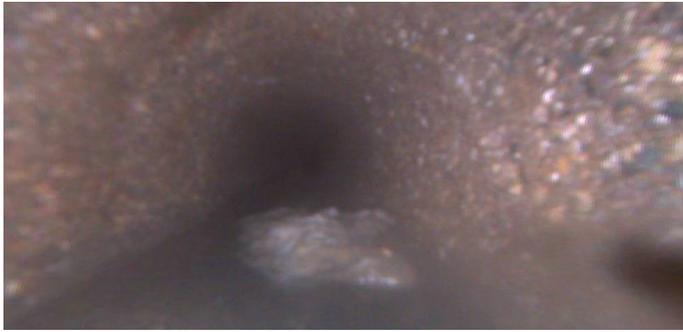
Code: **DSZ**
Description: **Deposits Settled Other**

Distance (ft): **.0**
Structural Grade: **0**
O&M Grade: **2**
Clock Start/From: **6**
Clock To:
1st Value:
2nd Value:
Value Percent: **5.000**
Continuous Index: **S02**
Within 8" of Joint: **NO**
Remarks: **tissue**

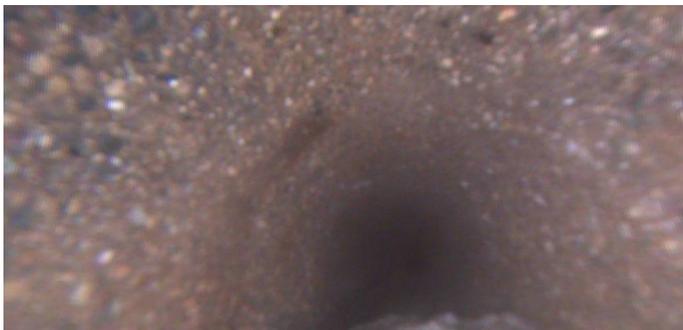
Code: **IS**
Description: **Infil Stain**

Distance (ft): **.0**
Structural Grade: **0**
O&M Grade: **0**
Clock Start/From: **11**
Clock To:
1st Value:
2nd Value:
Value Percent:
Continuous Index:
Within 8" of Joint:
Remarks: **possible pinhole**

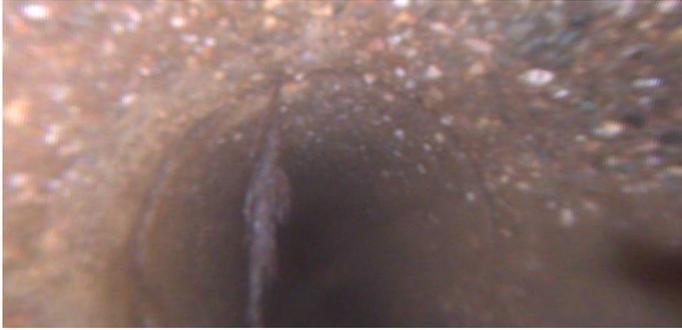
Code: **RFJ**
Description: **Roots Fine Joint**

Distance (ft): **35.8**
Structural Grade: **0**
O&M Grade: **1**
Clock Start/From: **11**
Clock To:
1st Value:
2nd Value:
Value Percent:
Continuous Index:
Within 8" of Joint: **YES**
Remarks:

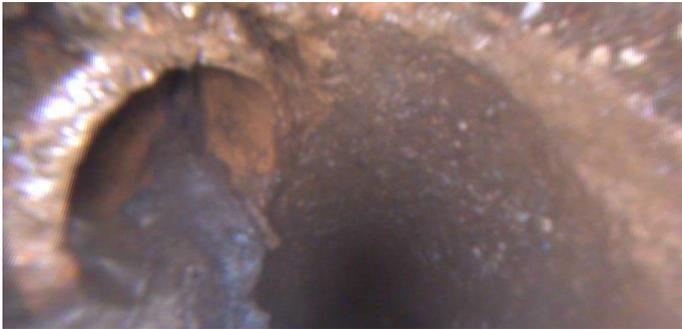
Code: **TB**
Description: **Tap Break-in**

Distance (ft): **53.0**
Structural Grade: **0**
O&M Grade: **0**
Clock Start/From: **10**
Clock To:
1st Value: **4.000**
2nd Value:
Value Percent:
Continuous Index:
Within 8" of Joint:
Remarks:

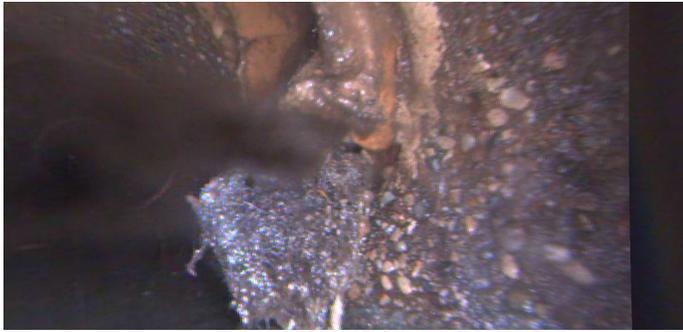
Code: **RMC**
Description: **Roots Medium Connection**

Distance (ft): **54.2**
Structural Grade: **0**
O&M Grade: **3**
Clock Start/From: **7**
Clock To: **9**
1st Value:
2nd Value:
Value Percent: **5.000**
Continuous Index:
Within 8" of Joint: **NO**
Remarks:

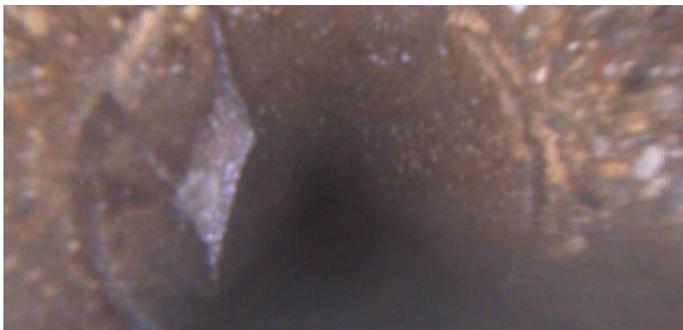
Code: **RFJ**
Description: **Roots Fine Joint**

Distance (ft): **57.9**
Structural Grade: **0**
O&M Grade: **1**
Clock Start/From: **10**
Clock To: **11**
1st Value:
2nd Value:
Value Percent:
Continuous Index:
Within 8" of Joint: **YES**
Remarks:

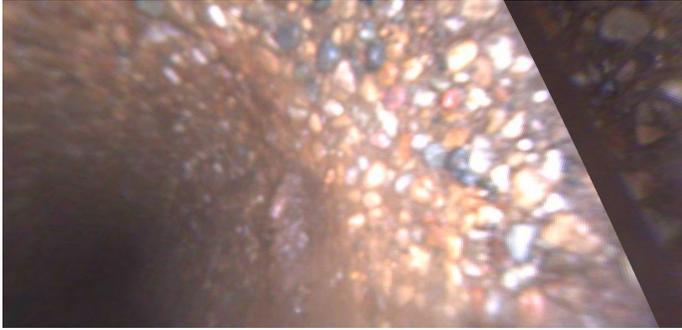
Code: **SAP**
Description: **Surface Aggregate Projecting**

Distance (ft): **64.2**
Structural Grade: **3**
O&M Grade: **0**
Clock Start/From: **7**
Clock To: **5**
1st Value:
2nd Value:
Value Percent:
Continuous Index: **S03**
Within 8" of Joint:
Remarks:

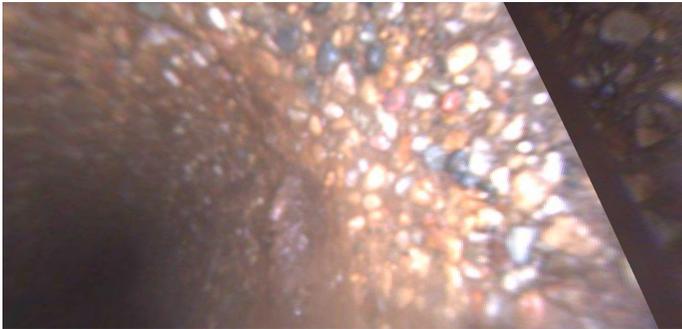
Code: **SAV**
Description: **Surface Aggregate Visible**

Distance (ft): **64.2**
Structural Grade: **3**
O&M Grade: **0**
Clock Start/From: **7**
Clock To: **5**
1st Value:
2nd Value:
Value Percent:
Continuous Index: **F01**
Within 8" of Joint:
Remarks:

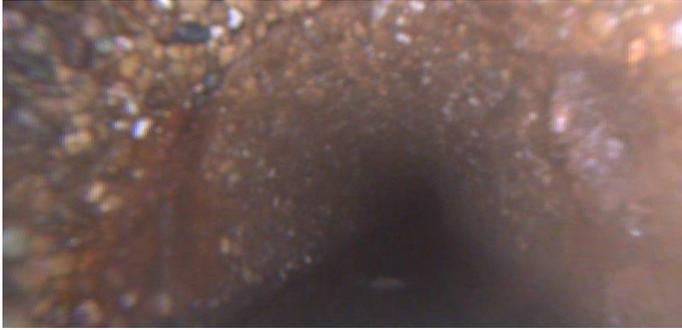
Code: **IS**
Description: **Infil Stain**

Distance (ft): **64.2**
Structural Grade: **0**
O&M Grade: **0**
Clock Start/From: **7**
Clock To: **10**
1st Value:
2nd Value:
Value Percent:
Continuous Index:
Within 8" of Joint: **YES**
Remarks:

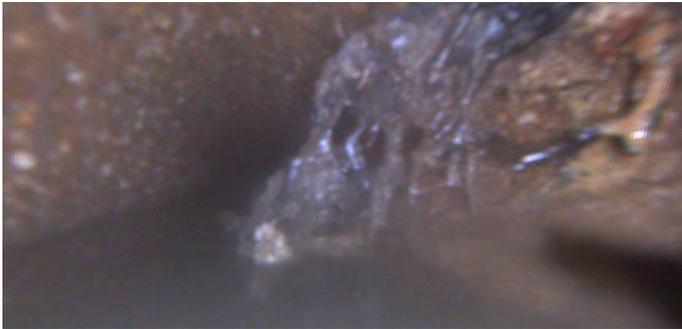
Code: **RMJ**
Description: **Roots Medium Joint**

Distance (ft): **77.2**
Structural Grade: **0**
O&M Grade: **3**
Clock Start/From: **2**
Clock To: **5**
1st Value:
2nd Value:
Value Percent: **10.000**
Continuous Index:
Within 8" of Joint: **YES**
Remarks:

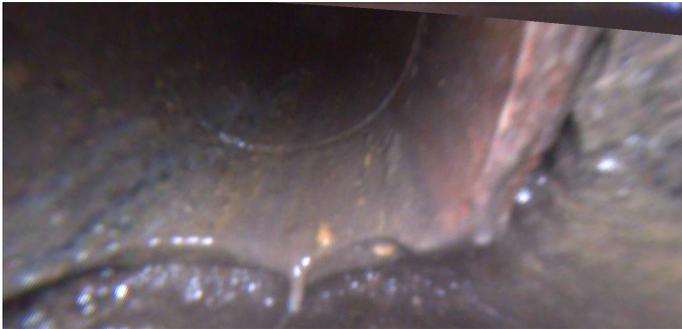
Code: **TB**
Description: **Tap Break-in**

Distance (ft): **111.3**
Structural Grade: **0**
O&M Grade: **0**
Clock Start/From: **12**
Clock To:
1st Value: **6.000**
2nd Value:
Value Percent:
Continuous Index:
Within 8" of Joint:
Remarks:

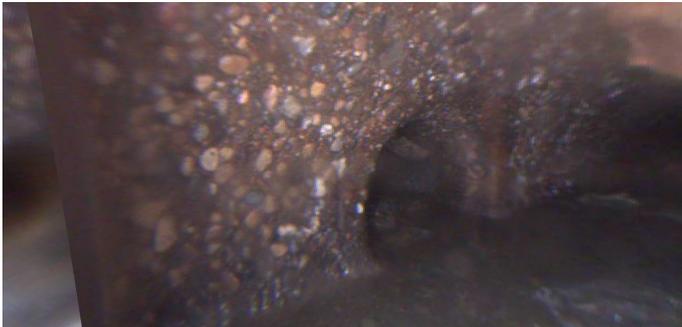
Code: **TFD**
Description: **Tap Factory Defective**

Distance (ft): **120.5**
Structural Grade: **0**
O&M Grade: **2**
Clock Start/From: **3**
Clock To:
1st Value: **4.000**
2nd Value:
Value Percent:
Continuous Index:
Within 8" of Joint:
Remarks: **partially blocked**

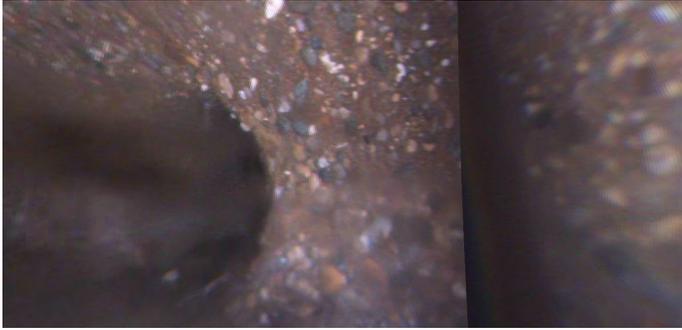
Code: **TF**
Description: **Tap Factory**

Distance (ft): **126.7**
Structural Grade: **0**
O&M Grade: **0**
Clock Start/From: **9**
Clock To:
1st Value: **4.000**
2nd Value:
Value Percent:
Continuous Index:
Within 8" of Joint: **YES**
Remarks:

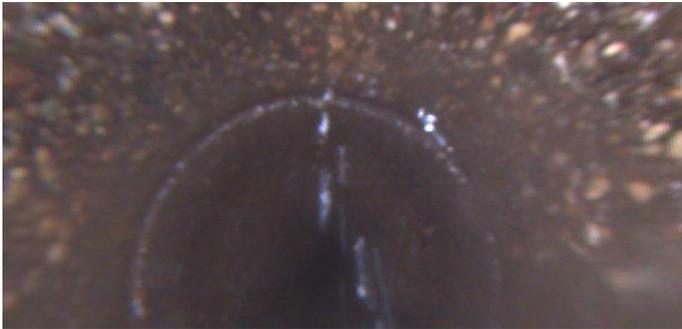
Code: **ID**
Description: **Infil Dripper**

Distance (ft): **130.4**
Structural Grade: **0**
O&M Grade: **3**
Clock Start/From: **12**
Clock To:
1st Value:
2nd Value:
Value Percent:
Continuous Index:
Within 8" of Joint: **YES**
Remarks:

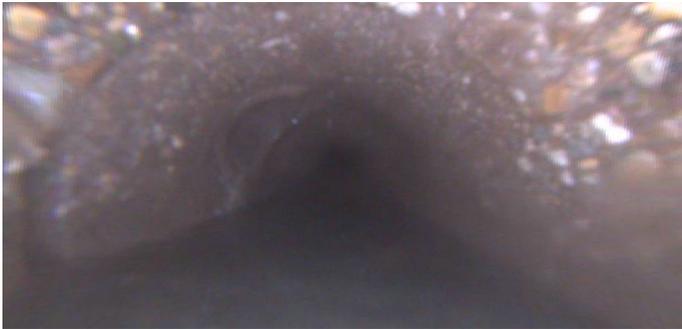
Code: **DSZ**
Description: **Deposits Settled Other**

Distance (ft): **165.5**
Structural Grade: **0**
O&M Grade: **2**
Clock Start/From: **6**
Clock To:
1st Value:
2nd Value:
Value Percent: **5.000**
Continuous Index: **F02**
Within 8" of Joint: **NO**
Remarks: **tissue**

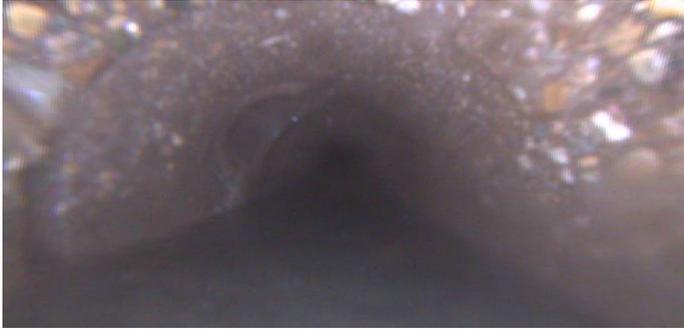
Code: **SAP**
Description: **Surface Aggregate Projecting**

Distance (ft): **165.5**
Structural Grade: **3**
O&M Grade: **0**
Clock Start/From: **7**
Clock To: **5**
1st Value:
2nd Value:
Value Percent:
Continuous Index: **F03**
Within 8" of Joint:
Remarks:
