Profile/Photo Observation Report

Date:	09/13/2021	Weather:		Coding:	PACP 7.0
Pipe Length (ft):	372.0	Owner:	City of Hobart	Pre Clean:	Light Cleaning
P.O.#:	YES502259	Surveyor:	S. Bucklin	PSR:	P-504-065.1-051
Customer:	City of Hobart	Clean Date:	09/09/2021	Shape:	C

Street:	North Guyer Street	Flow Control:	Not Controlled
City:	Hobart, IN	Year Renewed:	
Location:	Local rural streets with light traffic, t	Tape/Media #:	
Purpose:	Routine Assessment	Dia/Height:	8"
Use:	Sanitary Sewage Pipe	Material:	CP
Drain Area:		Lining:	None
Category:	NA		
Comment:			
Location Details:		Direction of Survey:	Downstream
US MH:	M-504-051	DS MH:	M-504-065.1
		Total Length Surveyed (ft):	166.3

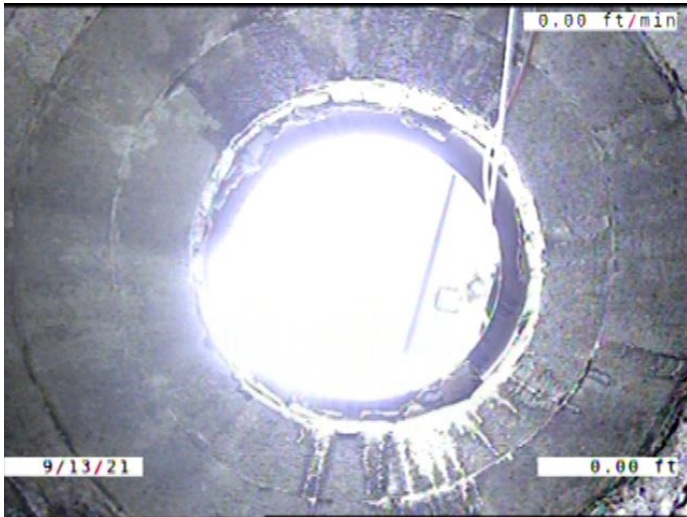
Code: **AMH**
 Description: **Manhole**

Distance (ft): **.0**
 Structural Grade: **0**
 O&M Grade: **0**
 Clock Start/From:
 Clock To:
 1st Value:
 2nd Value:
 Value Percent:
 Continuous Index:
 Within 8" of Joint: **NO**
 Remarks: **M-504-051**

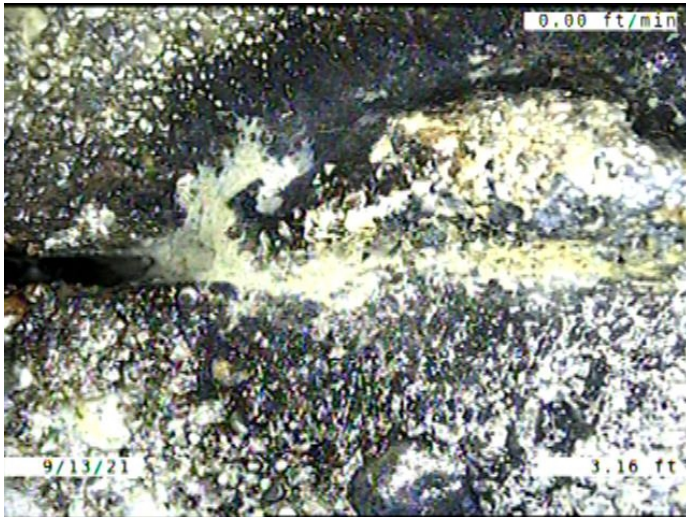
Code: **DAE**
 Description: **Deposits Attached Encrustation**

Distance (ft): **3.2**
 Structural Grade: **0**
 O&M Grade: **2**
 Clock Start/From: **7**
 Clock To: **8**
 1st Value:
 2nd Value:
 Value Percent: **5.000**
 Continuous Index:
 Within 8" of Joint: **YES**
 Remarks:

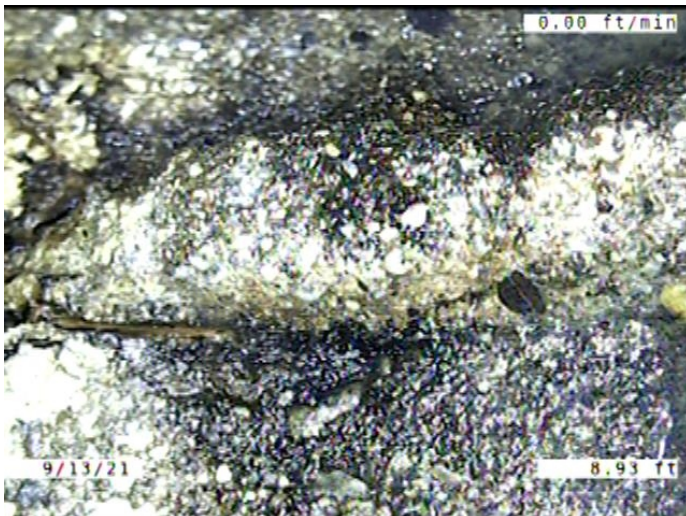
Code: **DAE**
 Description: **Deposits Attached Encrustation**

Distance (ft): **8.9**
 Structural Grade: **0**
 O&M Grade: **2**
 Clock Start/From: **4**
 Clock To: **8**
 1st Value:
 2nd Value:
 Value Percent: **5.000**
 Continuous Index: **S01**
 Within 8" of Joint: **YES**
 Remarks:

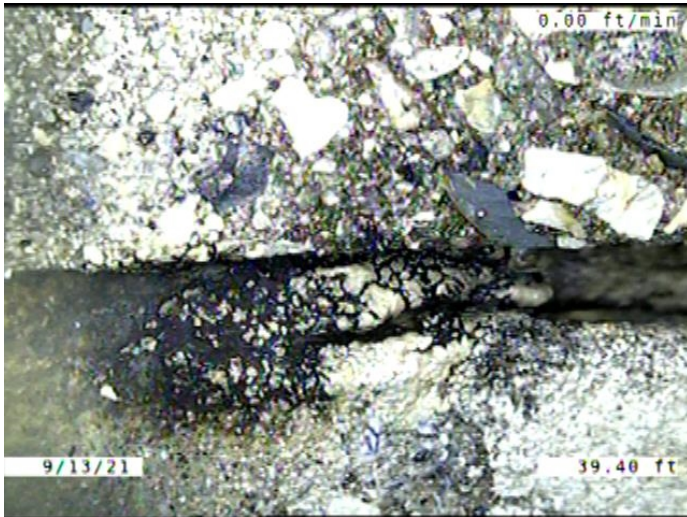
Code: **DAE**
Description: **Deposits Attached Encrustation**

Distance (ft): **39.4**
Structural Grade: **0**
O&M Grade: **2**
Clock Start/From: **7**
Clock To: **11**
1st Value:
2nd Value:
Value Percent: **5.000**
Continuous Index:
Within 8" of Joint: **YES**
Remarks:

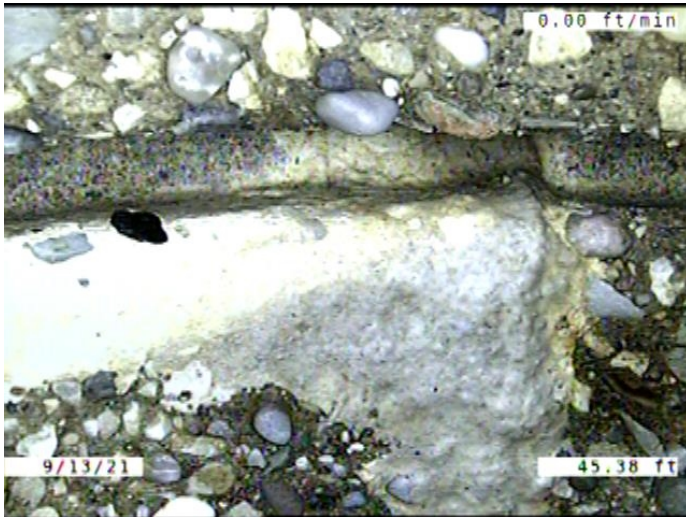
Code: **DAE**
Description: **Deposits Attached Encrustation**

Distance (ft): **45.4**
Structural Grade: **0**
O&M Grade: **2**
Clock Start/From: **9**
Clock To: **11**
1st Value:
2nd Value:
Value Percent: **5.000**
Continuous Index:
Within 8" of Joint: **YES**
Remarks:

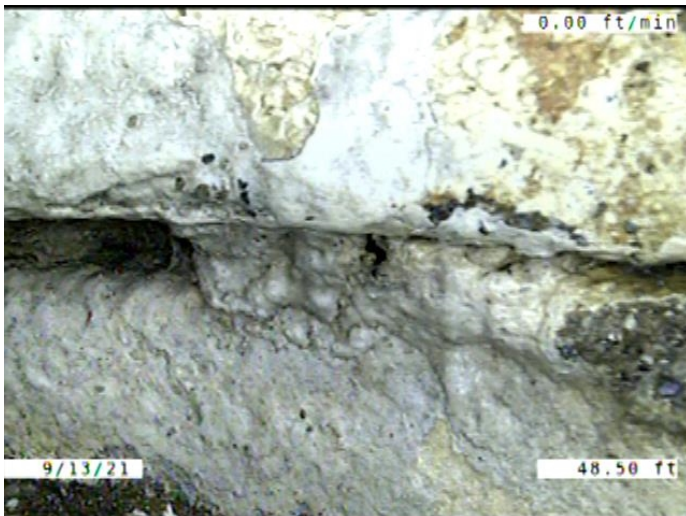
Code: **DAE**
Description: **Deposits Attached Encrustation**

Distance (ft): **48.5**
Structural Grade: **0**
O&M Grade: **2**
Clock Start/From: **8**
Clock To: **4**
1st Value:
2nd Value:
Value Percent: **5.000**
Continuous Index:
Within 8" of Joint: **YES**
Remarks:

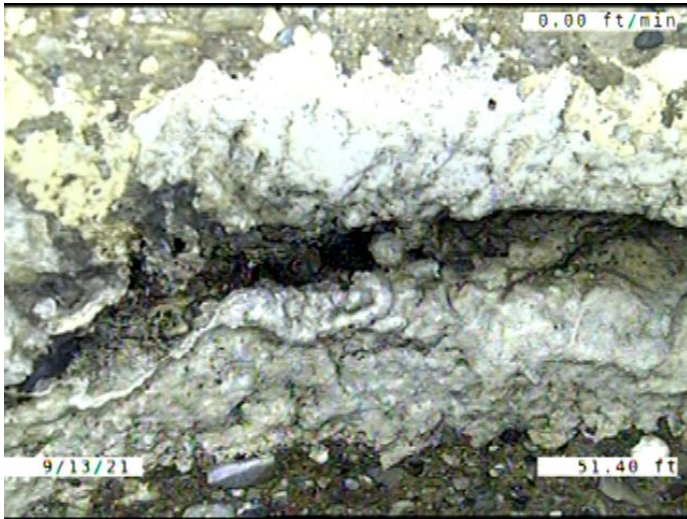
Code: **DAE**
 Description: **Deposits Attached Encrustation**

Distance (ft): **51.4**
 Structural Grade: **0**
 O&M Grade: **2**
 Clock Start/From: **7**
 Clock To: **5**
 1st Value:
 2nd Value:
 Value Percent: **5.000**
 Continuous Index:
 Within 8" of Joint: **YES**
 Remarks:

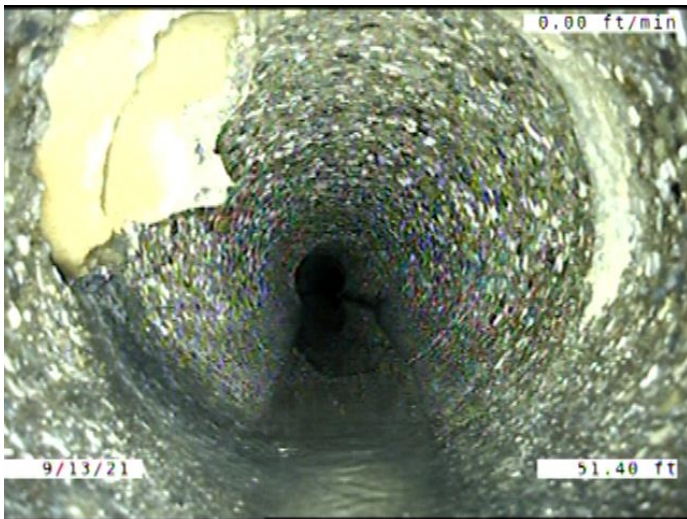
Code: **MWLS**
 Description: **Miscellaneous Water Level Sag**

Distance (ft): **51.4**
 Structural Grade: **2**
 O&M Grade: **0**
 Clock Start/From:
 Clock To:
 1st Value:
 2nd Value:
 Value Percent: **15.000**
 Continuous Index: **F02**
 Within 8" of Joint: **NO**
 Remarks:

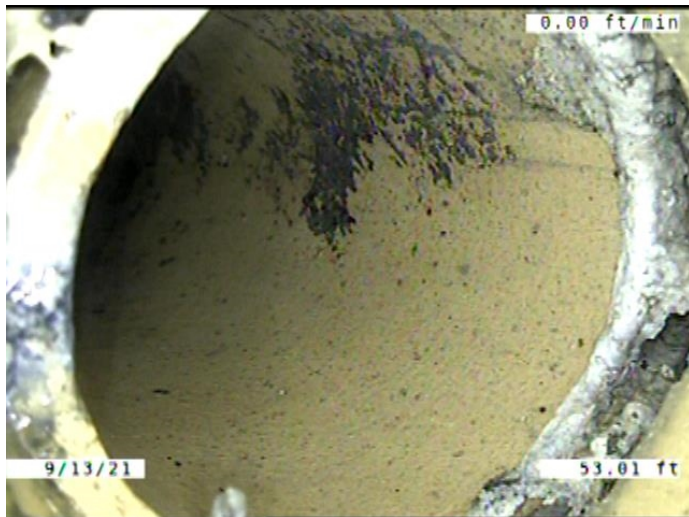
Code: **TBI**
 Description: **Tap Break-in Intruding**

Distance (ft): **53.0**
 Structural Grade: **0**
 O&M Grade: **2**
 Clock Start/From: **10**
 Clock To:
 1st Value: **4.000**
 2nd Value: **1.000**
 Value Percent:
 Continuous Index:
 Within 8" of Joint: **YES**
 Remarks:

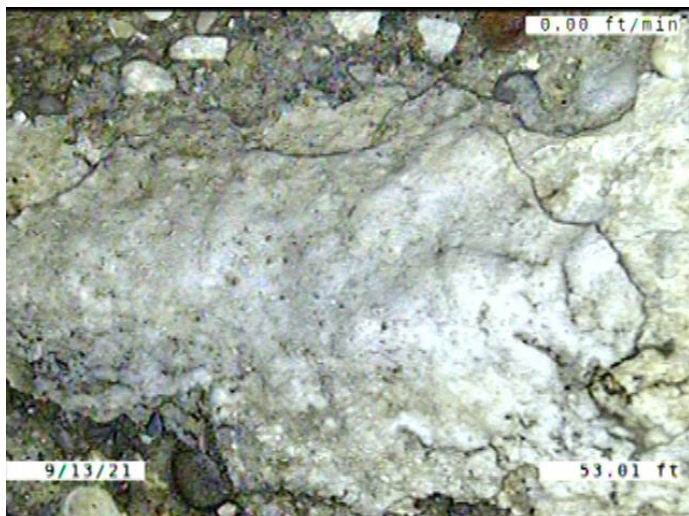
Code: **DAE**
 Description: **Deposits Attached Encrustation**

Distance (ft): **53.0**
 Structural Grade: **0**
 O&M Grade: **2**
 Clock Start/From: **8**
 Clock To: **4**
 1st Value:
 2nd Value:
 Value Percent: **5.000**
 Continuous Index:
 Within 8" of Joint: **NO**
 Remarks:

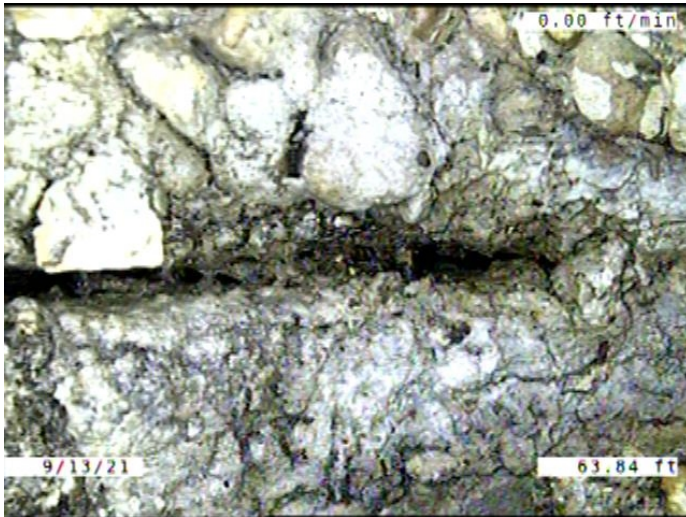
Code: **DAE**
 Description: **Deposits Attached Encrustation**

Distance (ft): **63.8**
 Structural Grade: **0**
 O&M Grade: **2**
 Clock Start/From: **9**
 Clock To: **11**
 1st Value:
 2nd Value:
 Value Percent: **5.000**
 Continuous Index:
 Within 8" of Joint: **YES**
 Remarks:

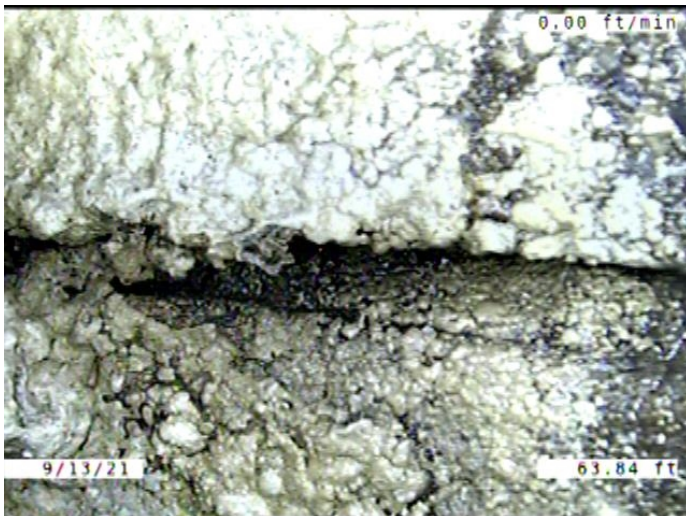
Code: **DAE**
 Description: **Deposits Attached Encrustation**

Distance (ft): **63.8**
 Structural Grade: **0**
 O&M Grade: **2**
 Clock Start/From: **1**
 Clock To: **4**
 1st Value:
 2nd Value:
 Value Percent: **5.000**
 Continuous Index:
 Within 8" of Joint: **YES**
 Remarks:

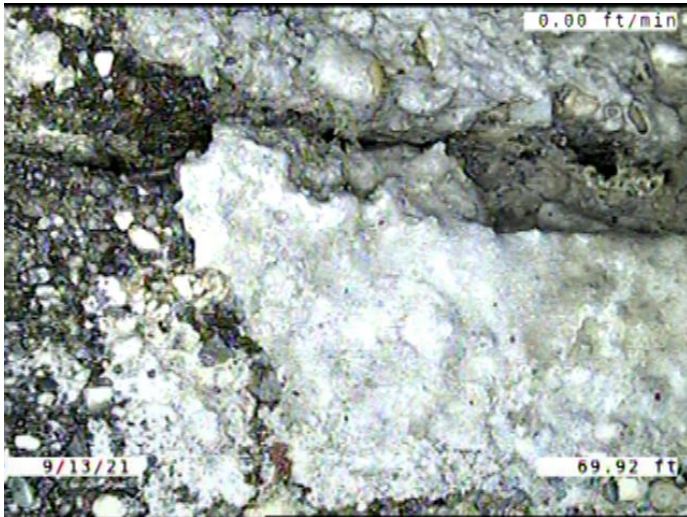
Code: **DAE**
 Description: **Deposits Attached Encrustation**

Distance (ft): **69.9**
 Structural Grade: **0**
 O&M Grade: **2**
 Clock Start/From: **12**
 Clock To: **12**
 1st Value:
 2nd Value:
 Value Percent: **5.000**
 Continuous Index: **S03**
 Within 8" of Joint: **YES**
 Remarks:

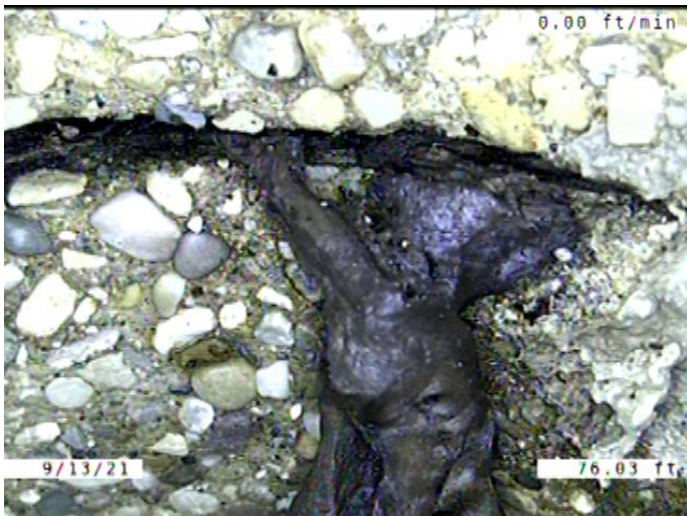
Code: **RFJ**
 Description: **Roots Fine Joint**

Distance (ft): **76.0**
 Structural Grade: **0**
 O&M Grade: **1**
 Clock Start/From: **1**
 Clock To:
 1st Value:
 2nd Value:
 Value Percent:
 Continuous Index:
 Within 8" of Joint: **YES**
 Remarks:

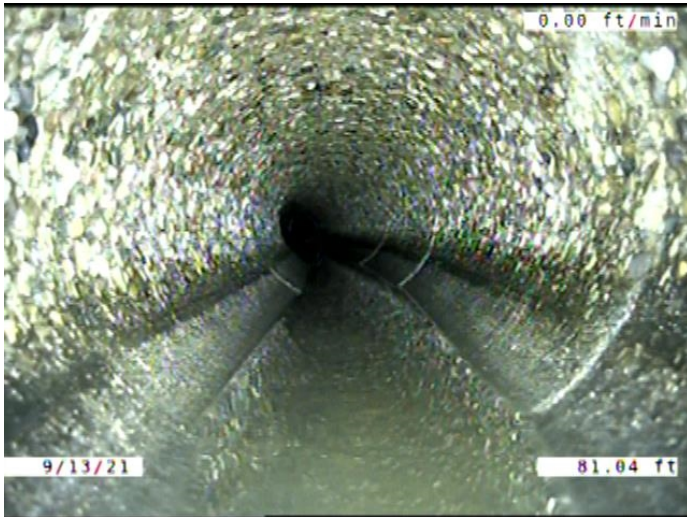
Code: **MWLS**
Description: **Miscellaneous Water Level Sag**

Distance (ft): **81.0**
Structural Grade: **2**
O&M Grade: **0**
Clock Start/From:
Clock To:
1st Value:
2nd Value:
Value Percent: **5.000**
Continuous Index: **S04**
Within 8" of Joint: **NO**
Remarks:

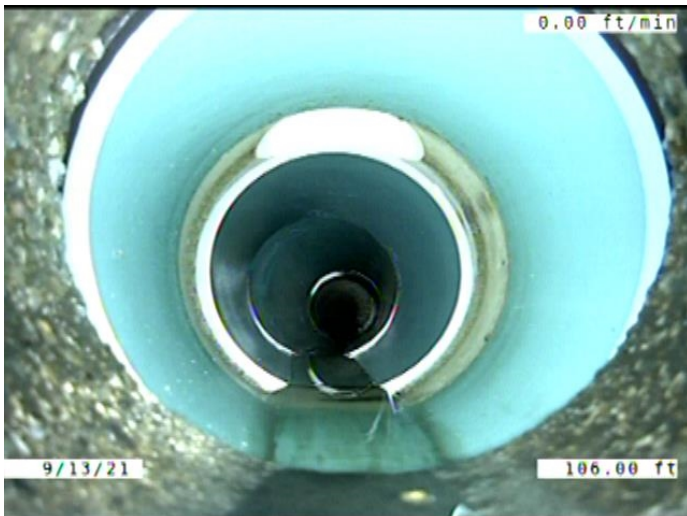
Code: **MWLS**
Description: **Miscellaneous Water Level Sag**

Distance (ft): **106.0**
Structural Grade: **2**
O&M Grade: **0**
Clock Start/From:
Clock To:
1st Value:
2nd Value:
Value Percent: **5.000**
Continuous Index: **F04**
Within 8" of Joint: **NO**
Remarks:

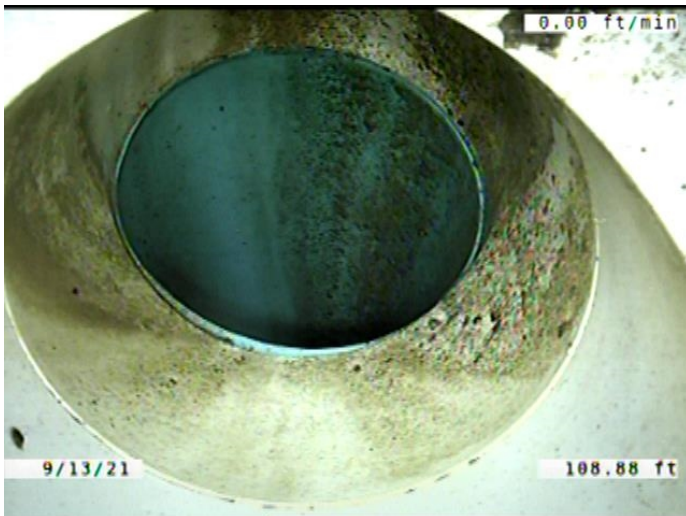
Code: **TF**
 Description: **Tap Factory**

Distance (ft): **108.9**
 Structural Grade: **0**
 O&M Grade: **0**
 Clock Start/From: **12**
 Clock To:
 1st Value: **4.000**
 2nd Value:
 Value Percent:
 Continuous Index:
 Within 8" of Joint: **YES**
 Remarks:

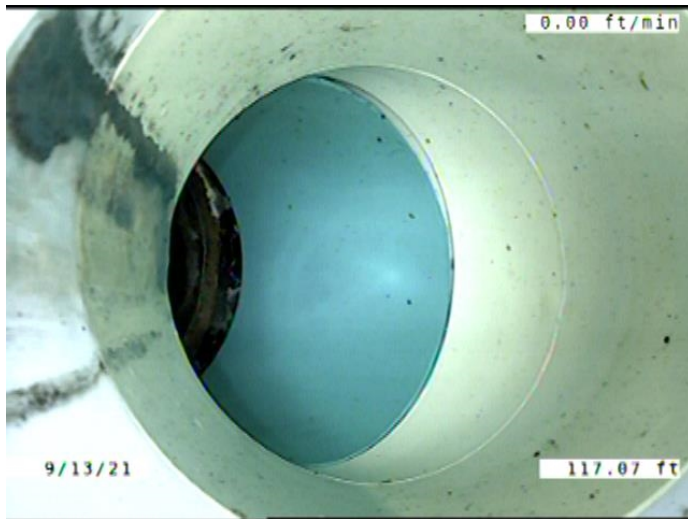
Code: **TF**
Description: **Tap Factory**

Distance (ft): **117.1**
Structural Grade: **0**
O&M Grade: **0**
Clock Start/From: **11**
Clock To:
1st Value: **4.000**
2nd Value:
Value Percent:
Continuous Index:
Within 8" of Joint: **YES**
Remarks:

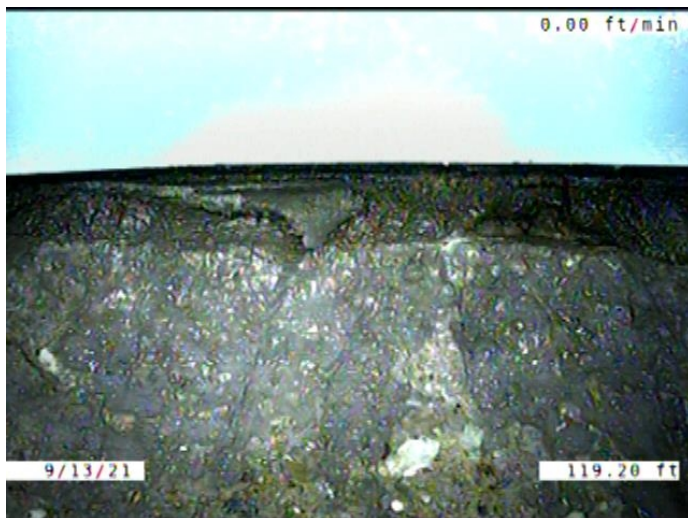
Code: **MMC**
Description: **Miscellaneous Material Change**

Distance (ft): **119.2**
Structural Grade: **0**
O&M Grade: **0**
Clock Start/From:
Clock To:
1st Value:
2nd Value:
Value Percent:
Continuous Index:
Within 8" of Joint: **NO**
Remarks: **PVC TO CONCRETE**

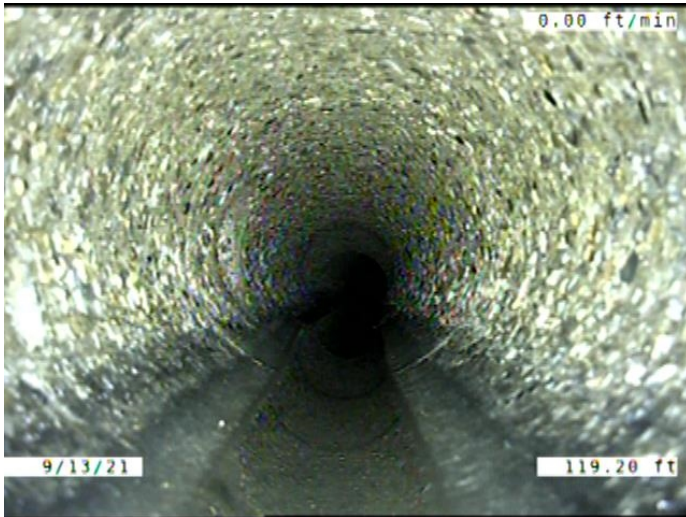
Code: **DAE**
 Description: **Deposits Attached Encrustation**

Distance (ft): **119.2**
 Structural Grade: **0**
 O&M Grade: **2**
 Clock Start/From: **12**
 Clock To: **12**
 1st Value:
 2nd Value:
 Value Percent: **5.000**
 Continuous Index: **F03**
 Within 8" of Joint: **YES**
 Remarks:

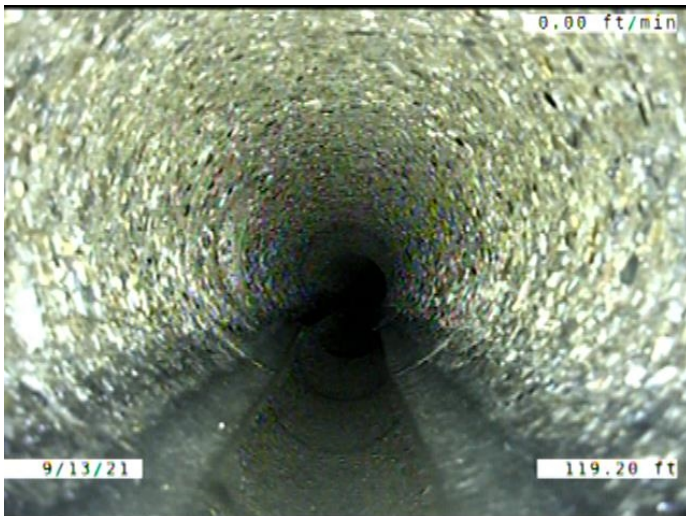
Code: **DAE**
 Description: **Deposits Attached Encrustation**

Distance (ft): **119.2**
 Structural Grade: **0**
 O&M Grade: **2**
 Clock Start/From: **4**
 Clock To: **8**
 1st Value:
 2nd Value:
 Value Percent: **5.000**
 Continuous Index: **F01**
 Within 8" of Joint: **YES**
 Remarks:

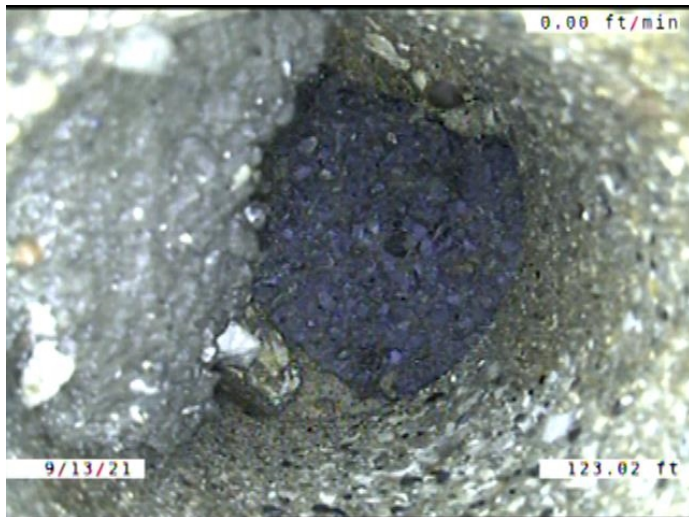
Code: **TFC**
 Description: **Tap Factory Capped**

Distance (ft): **123.0**
 Structural Grade: **0**
 O&M Grade: **0**
 Clock Start/From: **10**
 Clock To:
 1st Value: **4.000**
 2nd Value:
 Value Percent:
 Continuous Index:
 Within 8" of Joint: **YES**
 Remarks:

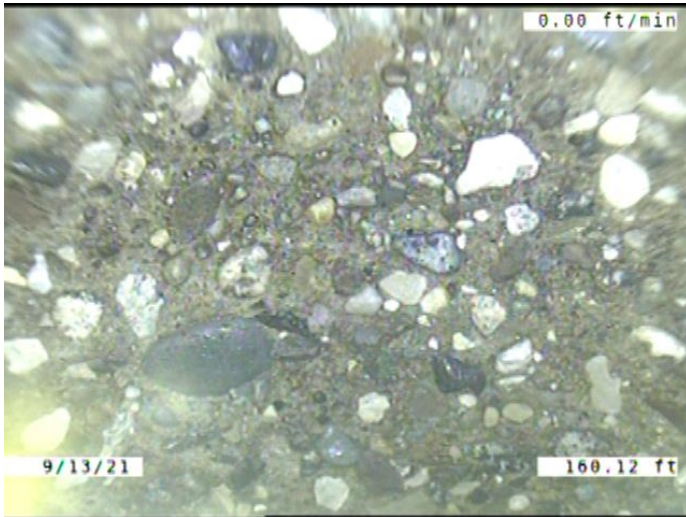
Code:	MCU
Description:	Miscellaneous Camera Underwater
Distance (ft):	160.1
Structural Grade:	0
O&M Grade:	4
Clock Start/From:	
Clock To:	
1st Value:	
2nd Value:	
Value Percent:	
Continuous Index:	S06
Within 8" of Joint:	NO
Remarks:

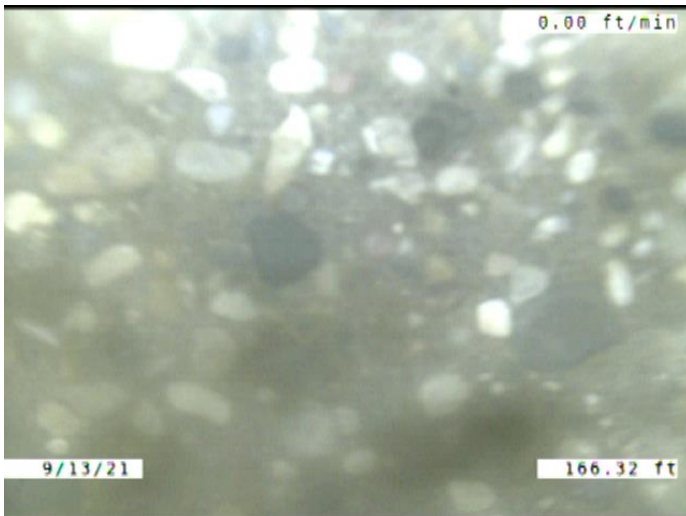
Code:	DSF
Description:	Deposits Settled Fine
Distance (ft):	166.3
Structural Grade:	0
O&M Grade:	2
Clock Start/From:	4
Clock To:	8
1st Value:	
2nd Value:	
Value Percent:	10.000
Continuous Index:	F05
Within 8" of Joint:	YES
Remarks:

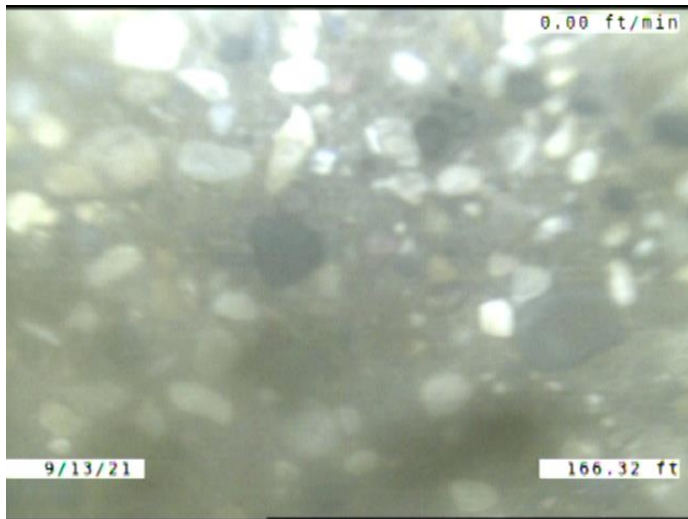
Code:	MCU
Description:	Miscellaneous Camera Underwater
Distance (ft):	166.3
Structural Grade:	0
O&M Grade:	4
Clock Start/From:	
Clock To:	
1st Value:	
2nd Value:	
Value Percent:	
Continuous Index:	F06
Within 8" of Joint:	NO
Remarks:
