Profile/Photo Observation Report

Date:	09/13/2021	Weather:		Coding:	PACP 7.0
Pipe Length (ft):	372.0	Owner:	City of Hobart	Pre Clean:	Light Cleaning
P.O.#:	YES502259	Surveyor:	S. Bucklin	PSR:	P-504-065.1-051
Customer:	City of Hobart	Clean Date:	09/09/2021	Shape:	C

Location Details:		Direction of Survey:	Downstream
US MH:	M-504-051	DS MH:	M-504-065.1
		Total Length Surveyed (ft):	166.3

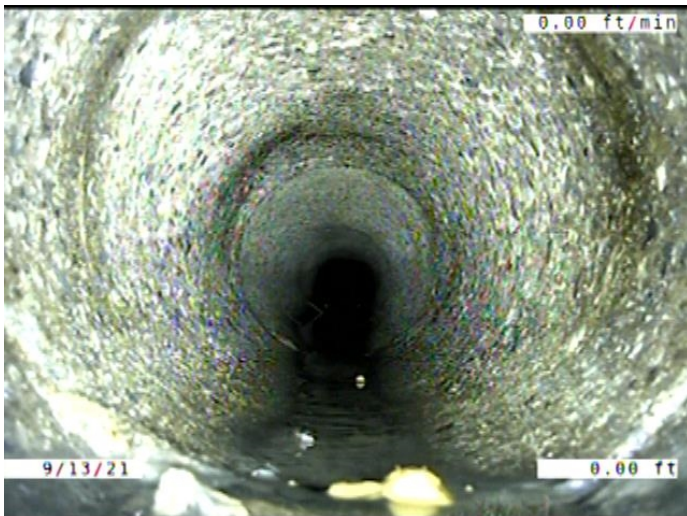
Code: **MWL**
 Description: **Miscellaneous Water Level**

Distance (ft): **.0**
 Structural Grade: **0**
 O&M Grade: **0**
 Clock Start/From:
 Clock To:
 1st Value:
 2nd Value:
 Value Percent: **5.000**
 Continuous Index:
 Within 8" of Joint: **NO**
 Remarks:

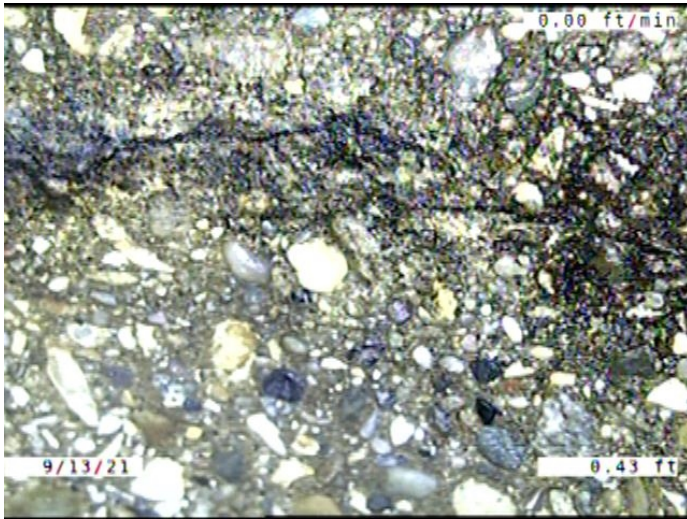
Code: **FS**
 Description: **Fracture Spiral**

Distance (ft): **.4**
 Structural Grade: **3**
 O&M Grade: **0**
 Clock Start/From: **9**
 Clock To: **5**
 1st Value:
 2nd Value:
 Value Percent:
 Continuous Index:
 Within 8" of Joint: **YES**
 Remarks:

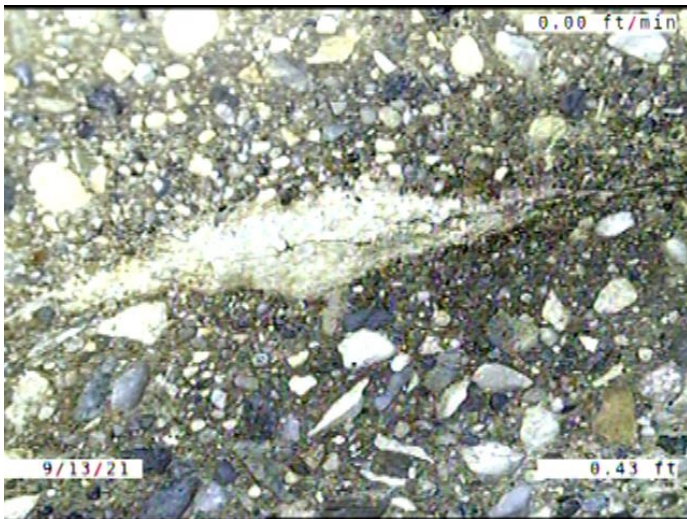
Code: **DAE**
 Description: **Deposits Attached Encrustation**

Distance (ft): **.4**
 Structural Grade: **0**
 O&M Grade: **2**
 Clock Start/From: **9**
 Clock To: **10**
 1st Value:
 2nd Value:
 Value Percent: **5.000**
 Continuous Index:
 Within 8" of Joint: **YES**
 Remarks:

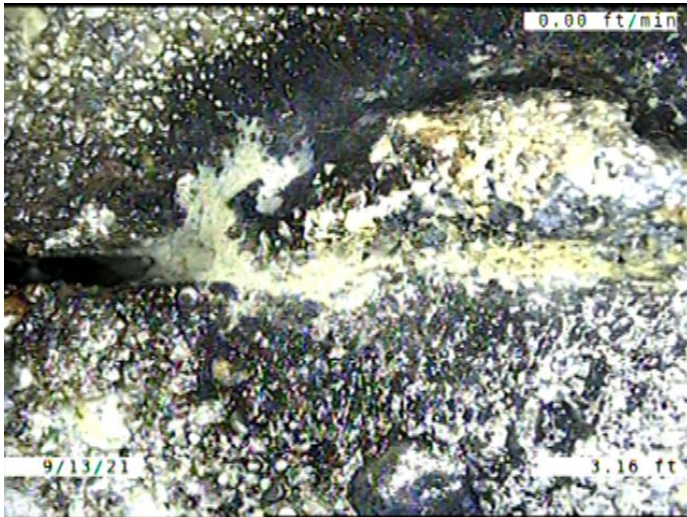
Code: **DAE**
 Description: **Deposits Attached Encrustation**

Distance (ft): **3.2**
 Structural Grade: **0**
 O&M Grade: **2**
 Clock Start/From: **7**
 Clock To: **8**
 1st Value:
 2nd Value:
 Value Percent: **5.000**
 Continuous Index:
 Within 8" of Joint: **YES**
 Remarks:

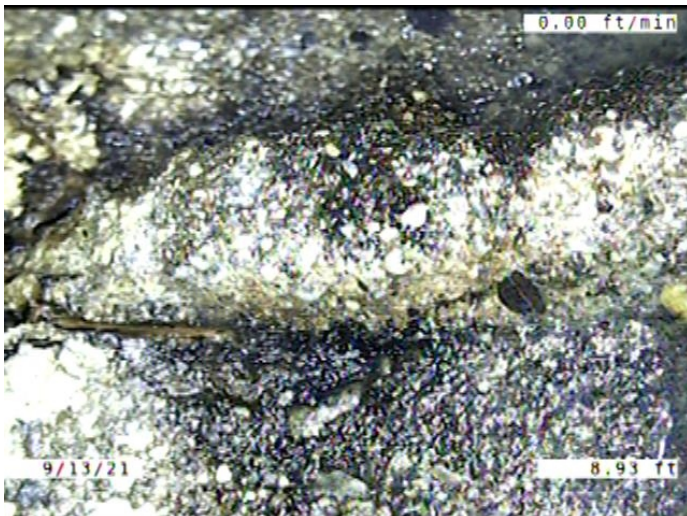
Code: **DAE**
 Description: **Deposits Attached Encrustation**

Distance (ft): **8.9**
 Structural Grade: **0**
 O&M Grade: **2**
 Clock Start/From: **4**
 Clock To: **8**
 1st Value:
 2nd Value:
 Value Percent: **5.000**
 Continuous Index: **S01**
 Within 8" of Joint: **YES**
 Remarks:

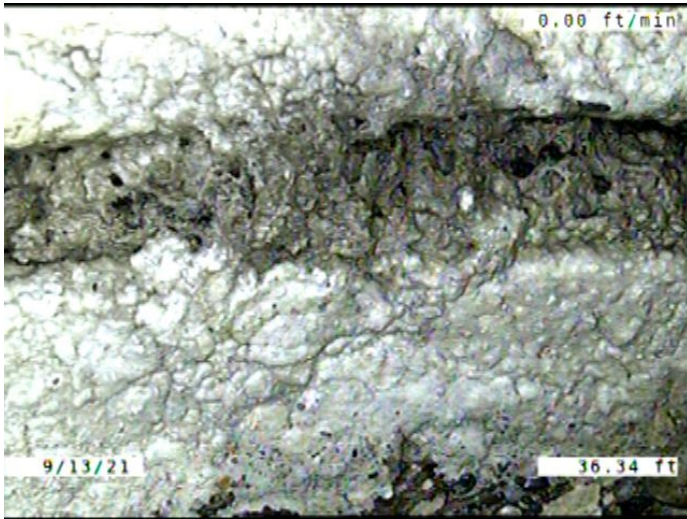
Code: **DAE**
Description: **Deposits Attached Encrustation**

Distance (ft): **36.3**
Structural Grade: **0**
O&M Grade: **2**
Clock Start/From: **3**
Clock To: **11**
1st Value:
2nd Value:
Value Percent: **5.000**
Continuous Index:
Within 8" of Joint: **YES**
Remarks:

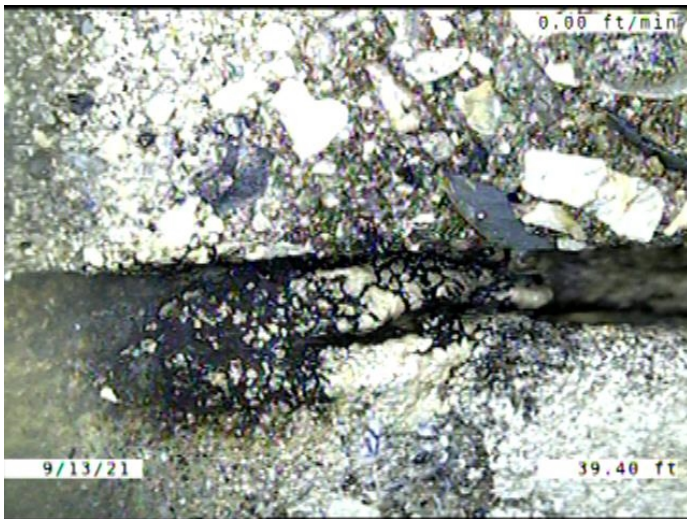
Code: **DAE**
Description: **Deposits Attached Encrustation**

Distance (ft): **39.4**
Structural Grade: **0**
O&M Grade: **2**
Clock Start/From: **7**
Clock To: **11**
1st Value:
2nd Value:
Value Percent: **5.000**
Continuous Index:
Within 8" of Joint: **YES**
Remarks:

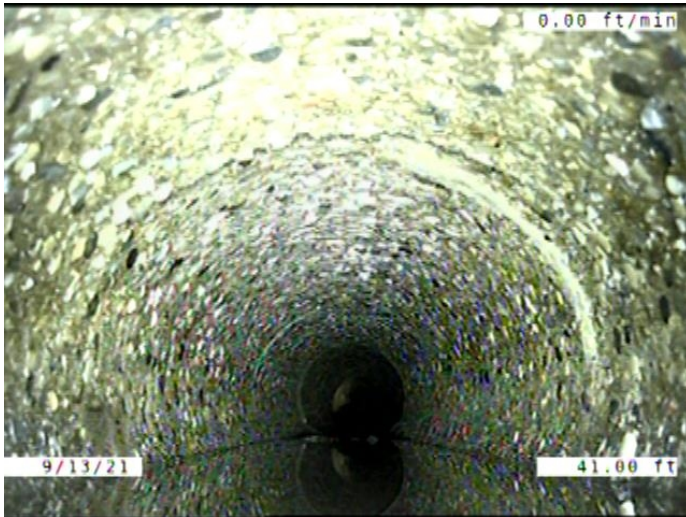
Code: **MWLS**
 Description: **Miscellaneous Water Level Sag**

Distance (ft): **41.0**
 Structural Grade: **2**
 O&M Grade: **0**
 Clock Start/From:
 Clock To:
 1st Value:
 2nd Value:
 Value Percent: **15.000**
 Continuous Index: **S02**
 Within 8" of Joint: **NO**
 Remarks:

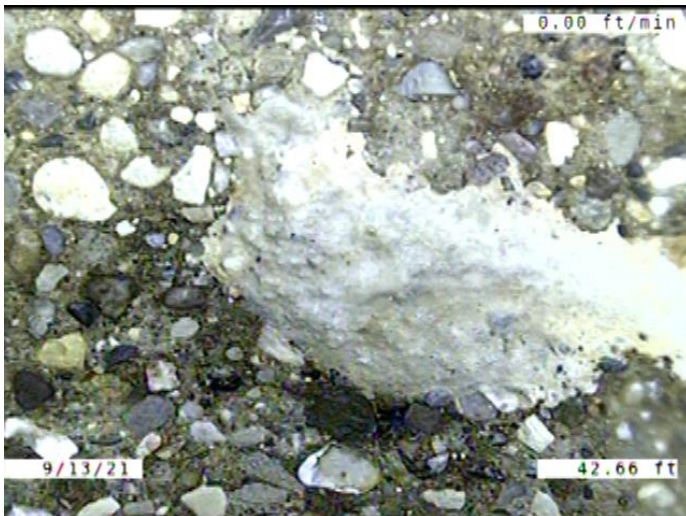
Code: **DAE**
 Description: **Deposits Attached Encrustation**

Distance (ft): **42.7**
 Structural Grade: **0**
 O&M Grade: **2**
 Clock Start/From: **12**
 Clock To: **2**
 1st Value:
 2nd Value:
 Value Percent: **5.000**
 Continuous Index:
 Within 8" of Joint: **YES**
 Remarks:

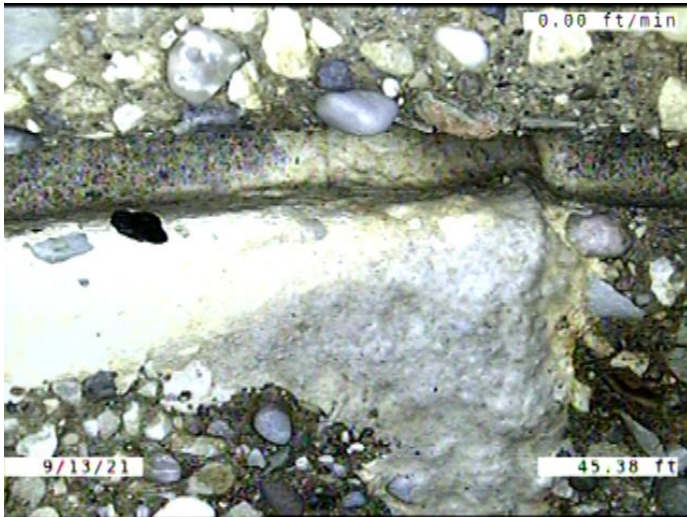
Code: **DAE**
 Description: **Deposits Attached Encrustation**

Distance (ft): **45.4**
 Structural Grade: **0**
 O&M Grade: **2**
 Clock Start/From: **9**
 Clock To: **11**
 1st Value:
 2nd Value:
 Value Percent: **5.000**
 Continuous Index:
 Within 8" of Joint: **YES**
 Remarks:

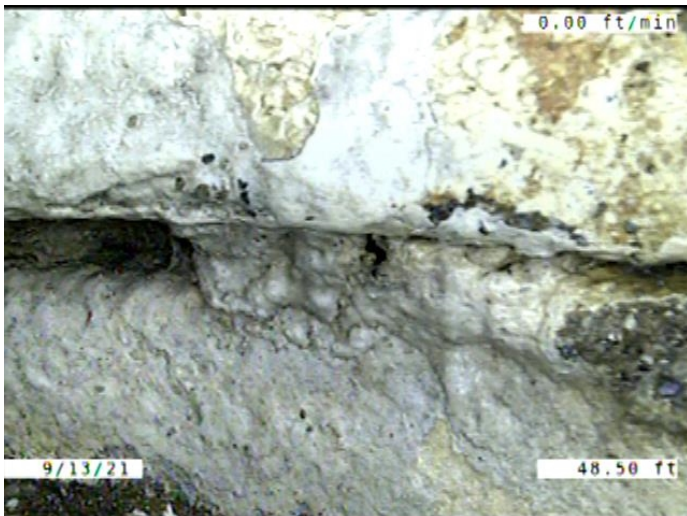
Code: **DAE**
 Description: **Deposits Attached Encrustation**

Distance (ft): **48.5**
 Structural Grade: **0**
 O&M Grade: **2**
 Clock Start/From: **8**
 Clock To: **4**
 1st Value:
 2nd Value:
 Value Percent: **5.000**
 Continuous Index:
 Within 8" of Joint: **YES**
 Remarks:

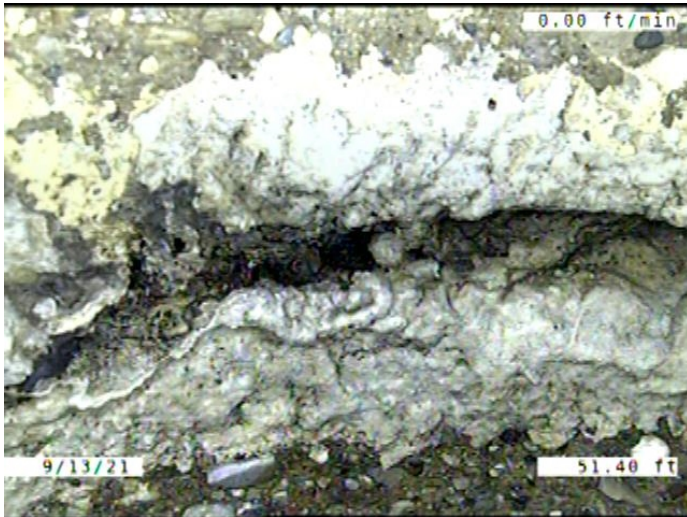
Code: **DAE**
 Description: **Deposits Attached Encrustation**

Distance (ft): **51.4**
 Structural Grade: **0**
 O&M Grade: **2**
 Clock Start/From: **7**
 Clock To: **5**
 1st Value:
 2nd Value:
 Value Percent: **5.000**
 Continuous Index:
 Within 8" of Joint: **YES**
 Remarks:

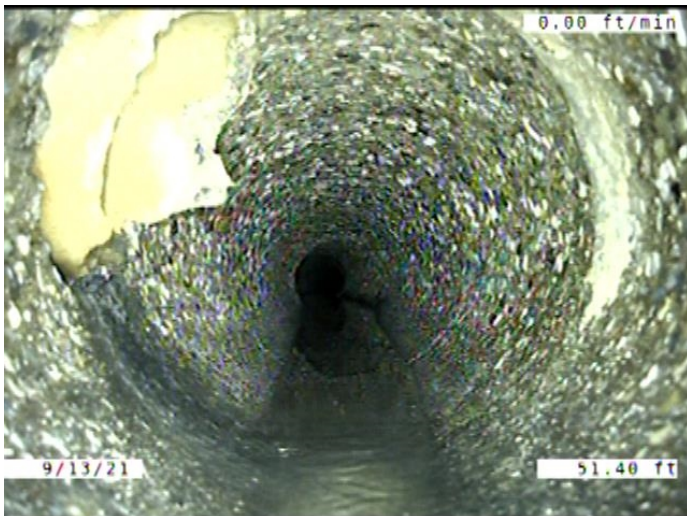
Code: **MWLS**
 Description: **Miscellaneous Water Level Sag**

Distance (ft): **51.4**
 Structural Grade: **2**
 O&M Grade: **0**
 Clock Start/From:
 Clock To:
 1st Value:
 2nd Value:
 Value Percent: **15.000**
 Continuous Index: **F02**
 Within 8" of Joint: **NO**
 Remarks:

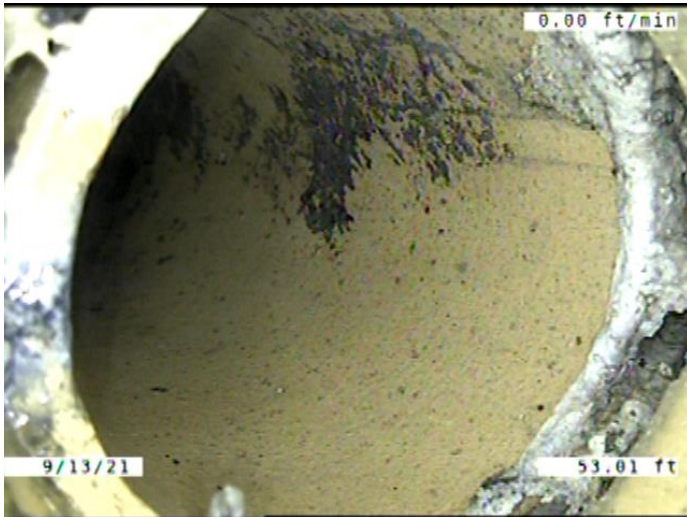
Code: **TBI**
 Description: **Tap Break-in Intruding**

Distance (ft): **53.0**
 Structural Grade: **0**
 O&M Grade: **2**
 Clock Start/From: **10**
 Clock To:
 1st Value: **4.000**
 2nd Value: **1.000**
 Value Percent:
 Continuous Index:
 Within 8" of Joint: **YES**
 Remarks:

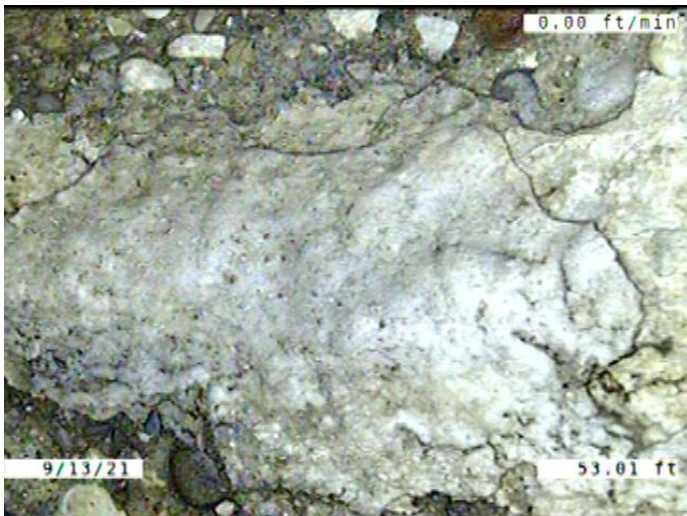
Code: **DAE**
 Description: **Deposits Attached Encrustation**

Distance (ft): **53.0**
 Structural Grade: **0**
 O&M Grade: **2**
 Clock Start/From: **8**
 Clock To: **4**
 1st Value:
 2nd Value:
 Value Percent: **5.000**
 Continuous Index:
 Within 8" of Joint: **NO**
 Remarks:

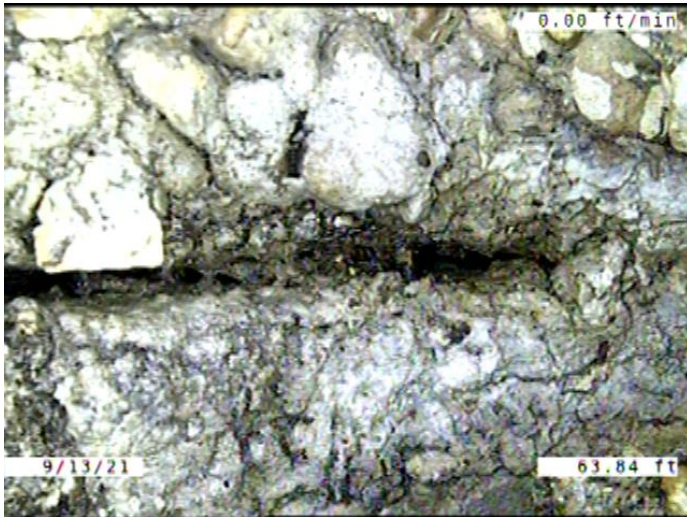
Code: **DAE**
 Description: **Deposits Attached Encrustation**

Distance (ft): **63.8**
 Structural Grade: **0**
 O&M Grade: **2**
 Clock Start/From: **9**
 Clock To: **11**
 1st Value:
 2nd Value:
 Value Percent: **5.000**
 Continuous Index:
 Within 8" of Joint: **YES**
 Remarks:

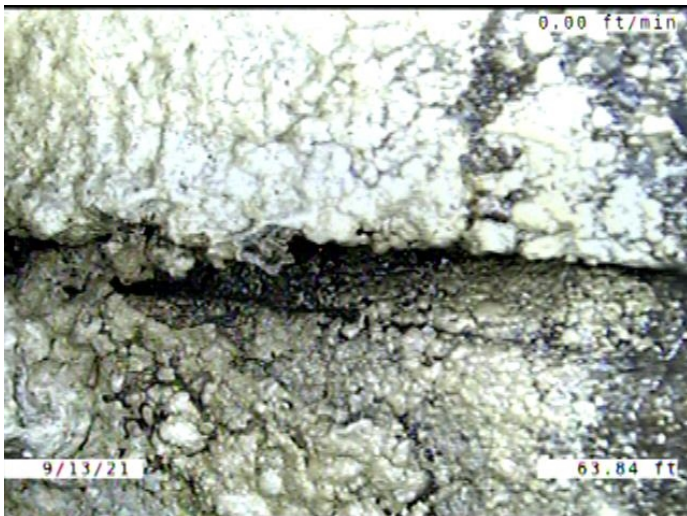
Code: **DAE**
 Description: **Deposits Attached Encrustation**

Distance (ft): **63.8**
 Structural Grade: **0**
 O&M Grade: **2**
 Clock Start/From: **1**
 Clock To: **4**
 1st Value:
 2nd Value:
 Value Percent: **5.000**
 Continuous Index:
 Within 8" of Joint: **YES**
 Remarks:

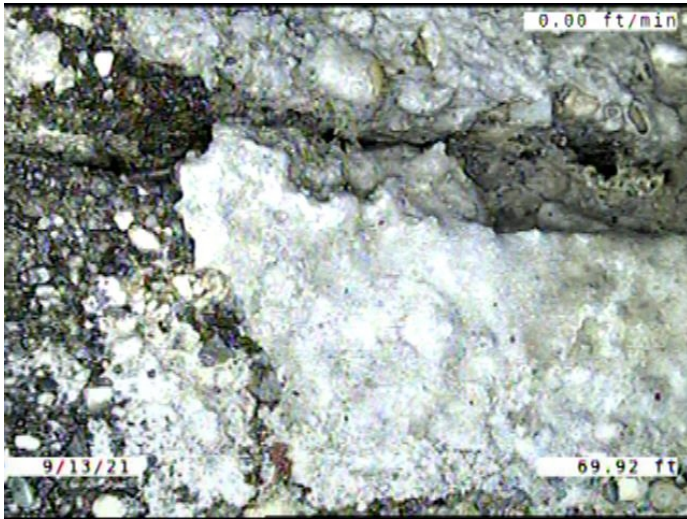
Code: **DAE**
Description: **Deposits Attached Encrustation**

Distance (ft): **69.9**
Structural Grade: **0**
O&M Grade: **2**
Clock Start/From: **12**
Clock To: **12**
1st Value:
2nd Value:
Value Percent: **5.000**
Continuous Index: **S03**
Within 8" of Joint: **YES**
Remarks:

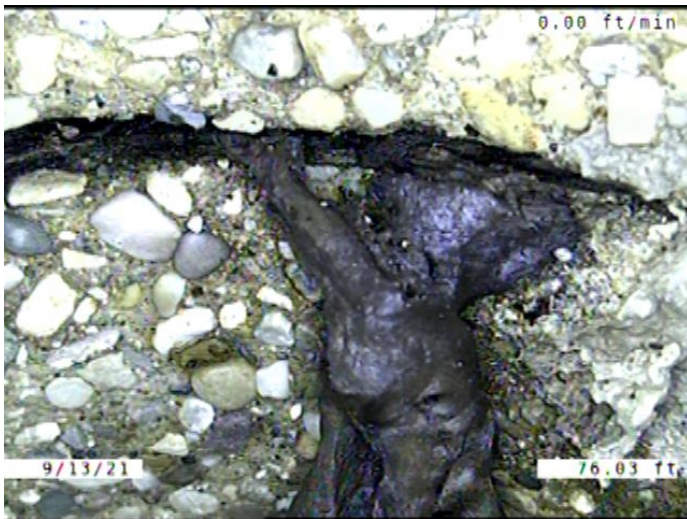
Code: **RFJ**
Description: **Roots Fine Joint**

Distance (ft): **76.0**
Structural Grade: **0**
O&M Grade: **1**
Clock Start/From: **1**
Clock To:
1st Value:
2nd Value:
Value Percent:
Continuous Index:
Within 8" of Joint: **YES**
Remarks:

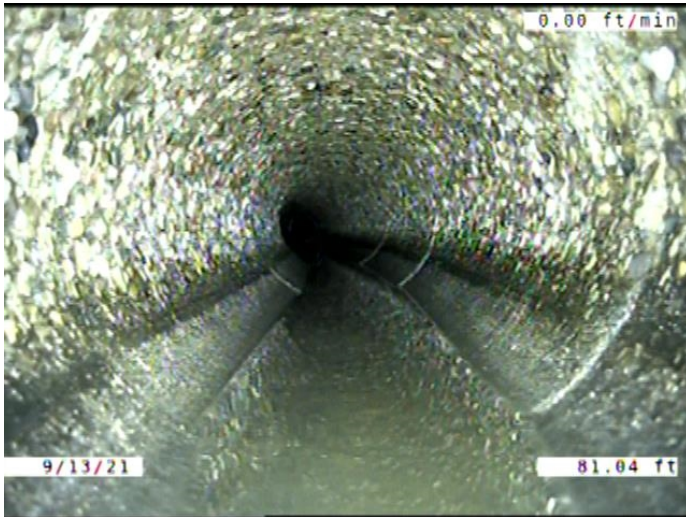
Code: **MWLS**
Description: **Miscellaneous Water Level Sag**

Distance (ft): **81.0**
Structural Grade: **2**
O&M Grade: **0**
Clock Start/From:
Clock To:
1st Value:
2nd Value:
Value Percent: **5.000**
Continuous Index: **S04**
Within 8" of Joint: **NO**
Remarks:

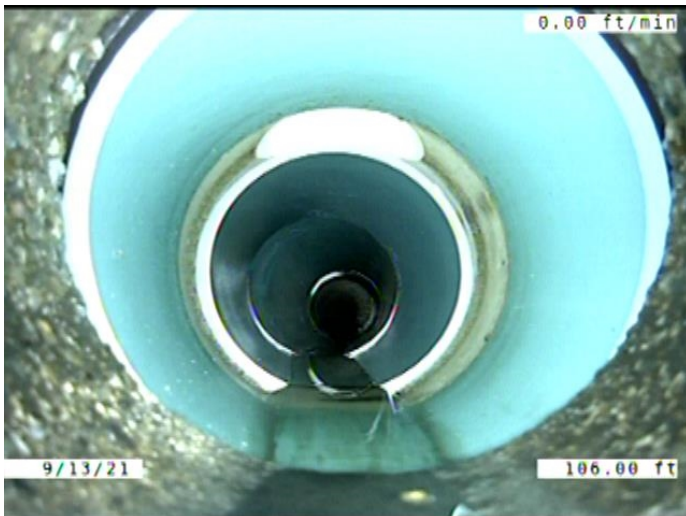
Code: **MWLS**
Description: **Miscellaneous Water Level Sag**

Distance (ft): **106.0**
Structural Grade: **2**
O&M Grade: **0**
Clock Start/From:
Clock To:
1st Value:
2nd Value:
Value Percent: **5.000**
Continuous Index: **F04**
Within 8" of Joint: **NO**
Remarks:

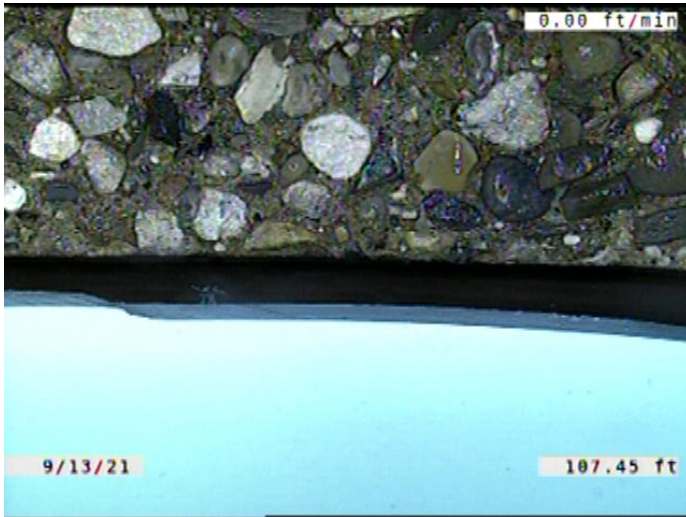
Code: **MMC**
Description: **Miscellaneous Material Change**

Distance (ft): **107.4**
Structural Grade: **0**
O&M Grade: **0**
Clock Start/From:
Clock To:
1st Value:
2nd Value:
Value Percent:
Continuous Index:
Within 8" of Joint: **NO**
Remarks: **CONCRETE TO PVC**

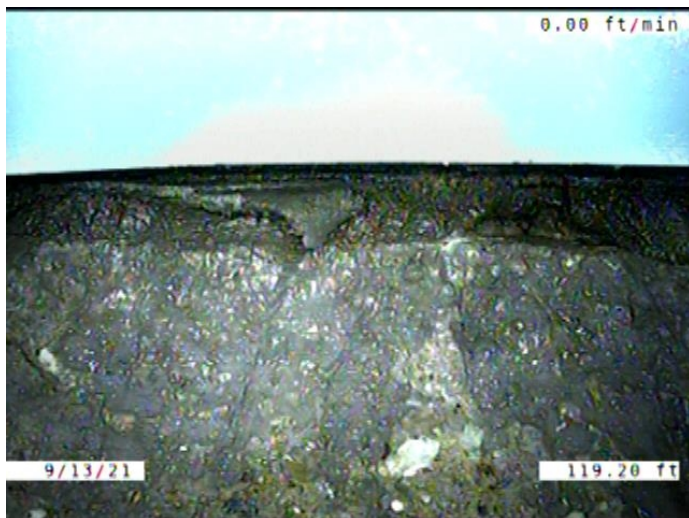
Code: **MMC**
Description: **Miscellaneous Material Change**

Distance (ft): **119.2**
Structural Grade: **0**
O&M Grade: **0**
Clock Start/From:
Clock To:
1st Value:
2nd Value:
Value Percent:
Continuous Index:
Within 8" of Joint: **NO**
Remarks: **PVC TO CONCRETE**

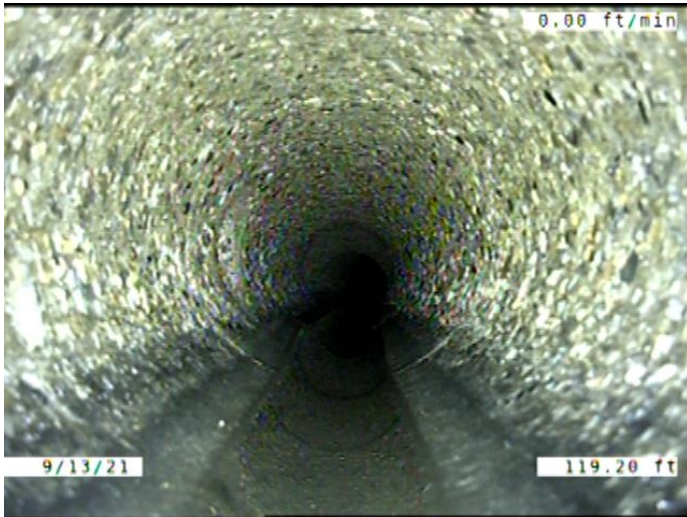
Code: **DAE**
Description: **Deposits Attached Encrustation**

Distance (ft): **119.2**
Structural Grade: **0**
O&M Grade: **2**
Clock Start/From: **12**
Clock To: **12**
1st Value:
2nd Value:
Value Percent: **5.000**
Continuous Index: **F03**
Within 8" of Joint: **YES**
Remarks:

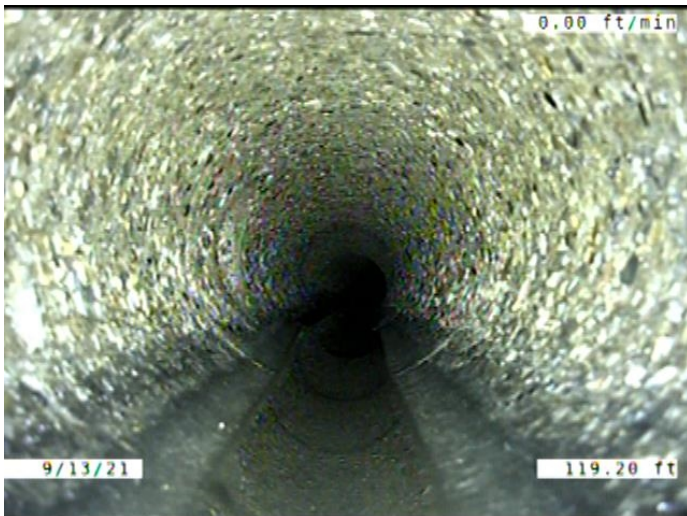
Code: **DAE**
Description: **Deposits Attached Encrustation**

Distance (ft): **119.2**
Structural Grade: **0**
O&M Grade: **2**
Clock Start/From: **4**
Clock To: **8**
1st Value:
2nd Value:
Value Percent: **5.000**
Continuous Index: **F01**
Within 8" of Joint: **YES**
Remarks:

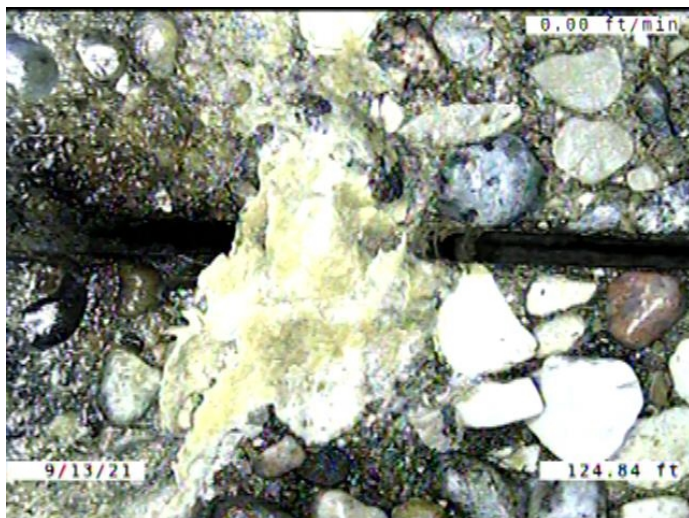
Code: **DAE**
 Description: **Deposits Attached Encrustation**

Distance (ft): **124.8**
 Structural Grade: **0**
 O&M Grade: **2**
 Clock Start/From: **3**
 Clock To: **4**
 1st Value:
 2nd Value:
 Value Percent: **5.000**
 Continuous Index:
 Within 8" of Joint: **YES**
 Remarks:

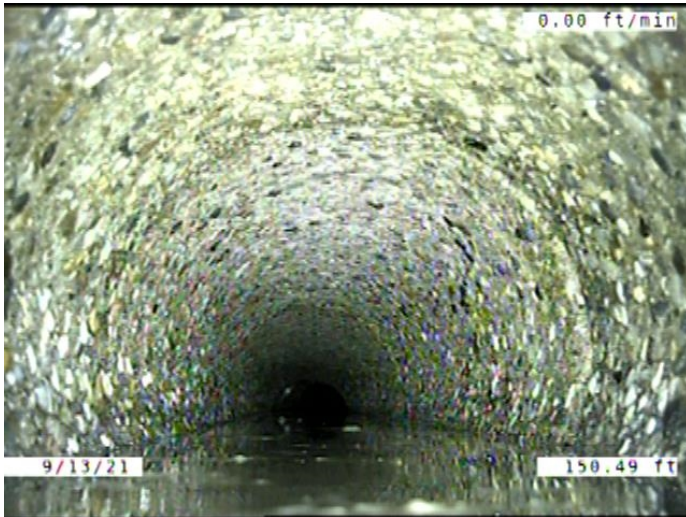
Code: **DSF**
 Description: **Deposits Settled Fine**

Distance (ft): **150.5**
 Structural Grade: **0**
 O&M Grade: **2**
 Clock Start/From: **4**
 Clock To: **8**
 1st Value:
 2nd Value:
 Value Percent: **10.000**
 Continuous Index: **S05**
 Within 8" of Joint: **YES**
 Remarks:

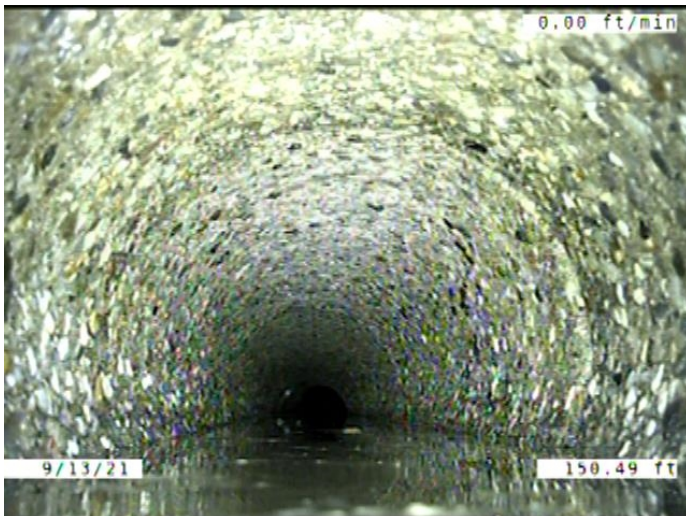
Code: **MWL**
 Description: **Miscellaneous Water Level**

Distance (ft): **150.5**
 Structural Grade: **0**
 O&M Grade: **0**
 Clock Start/From:
 Clock To:
 1st Value:
 2nd Value:
 Value Percent: **35.000**
 Continuous Index:
 Within 8" of Joint: **NO**
 Remarks:

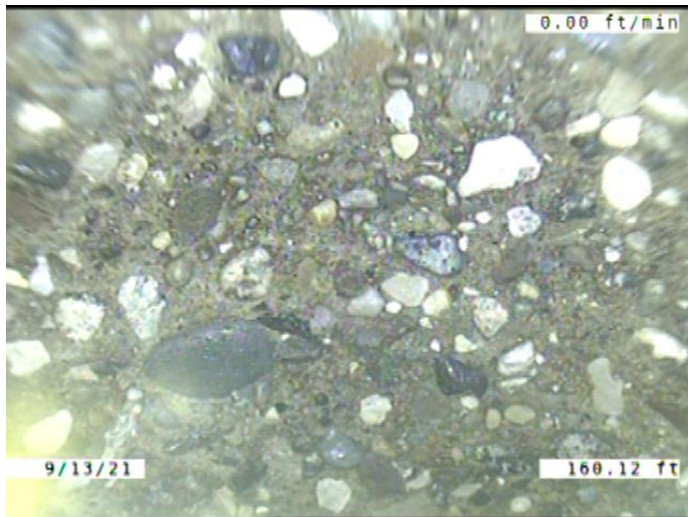
Code:	MCU
Description:	Miscellaneous Camera Underwater
Distance (ft):	160.1
Structural Grade:	0
O&M Grade:	4
Clock Start/From:	
Clock To:	
1st Value:	
2nd Value:	
Value Percent:	
Continuous Index:	S06
Within 8" of Joint:	NO
Remarks:

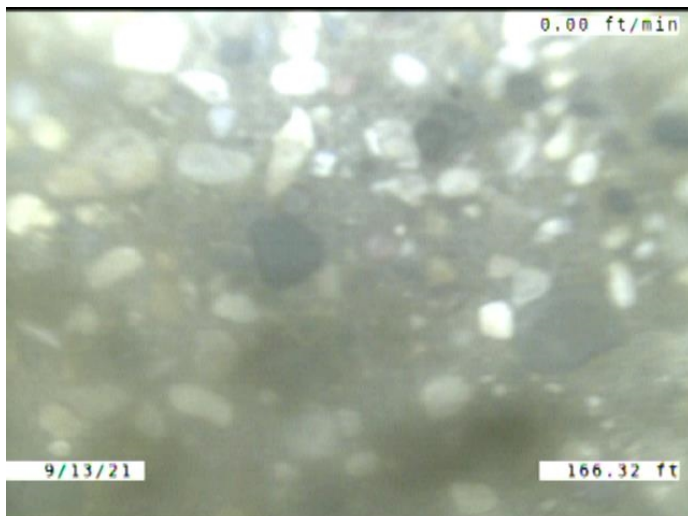
Code:	DSF
Description:	Deposits Settled Fine
Distance (ft):	166.3
Structural Grade:	0
O&M Grade:	2
Clock Start/From:	4
Clock To:	8
1st Value:	
2nd Value:	
Value Percent:	10.000
Continuous Index:	F05
Within 8" of Joint:	YES
Remarks:

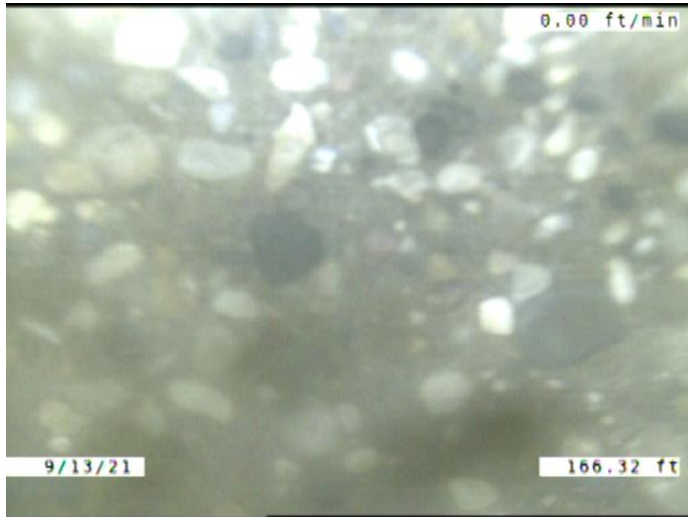
Code: **MCU**
 Description: **Miscellaneous Camera Underwater**

Distance (ft): **166.3**
 Structural Grade: **0**
 O&M Grade: **4**
 Clock Start/From:
 Clock To:
 1st Value:
 2nd Value:
 Value Percent:
 Continuous Index: **F06**
 Within 8" of Joint: **NO**
 Remarks:

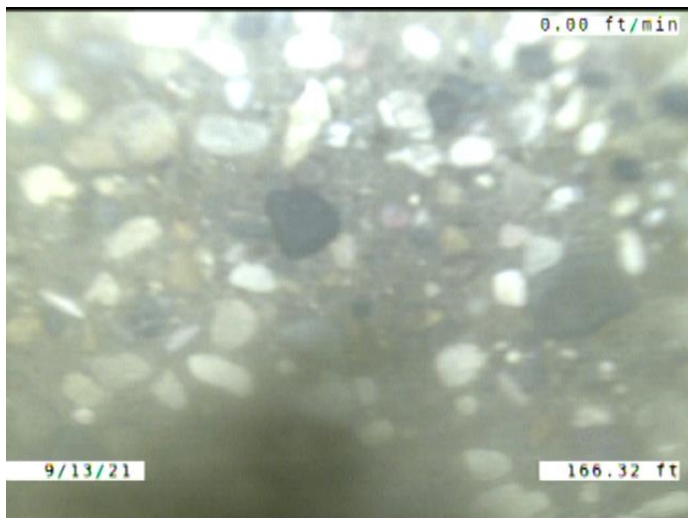
Code: **MSA**
 Description: **Miscellaneous Survey Abandoned**

Distance (ft): **166.3**
 Structural Grade: **0**
 O&M Grade: **0**
 Clock Start/From:
 Clock To:
 1st Value:
 2nd Value:
 Value Percent:
 Continuous Index:
 Within 8" of Joint: **NO**
 Remarks: **CAMERA CANT MAKE IT PAST
 UNKNOWN DEBRIS UNDER THE FLO**
