# Profile/Photo Observation Report

Date:	<b>09/14/2021</b>	Weather:		Coding:	<b>PACP 7.0</b>
Pipe Length (ft):	<b>372.0</b>	Owner:	<b>City of Hobart</b>	Pre Clean:	<b>Heavy Cleaning</b>
P.O.#:	<b>YES502259</b>	Surveyor:	<b>S. Bucklin</b>	PSR:	<b>P-504-065.1-051</b>
Customer:	<b>City of Hobart</b>	Clean Date:	<b>09/14/2021</b>	Shape:	<b>C</b>

Street:	<b>North Guyer Street</b>	Flow Control:	<b>Not Controlled</b>
City:	<b>Hobart, IN</b>	Year Renewed:	
Location:	<b>Local rural streets with light traffic, t</b>	Tape/Media #:	
Purpose:	<b>Routine Assessment</b>	Dia/Height:	<b>8"</b>
Use:	<b>Sanitary Sewage Pipe</b>	Material:	<b>CP</b>
Drain Area:		Lining:	<b>None</b>
Category:	<b>NA</b>		
Comment:			
Location Details:		Direction of Survey:	<b>Upstream</b>
US MH:	<b>M-504-051</b>	DS MH:	<b>M-504-065.1</b>
		Total Length Surveyed (ft):	<b>241.9</b>

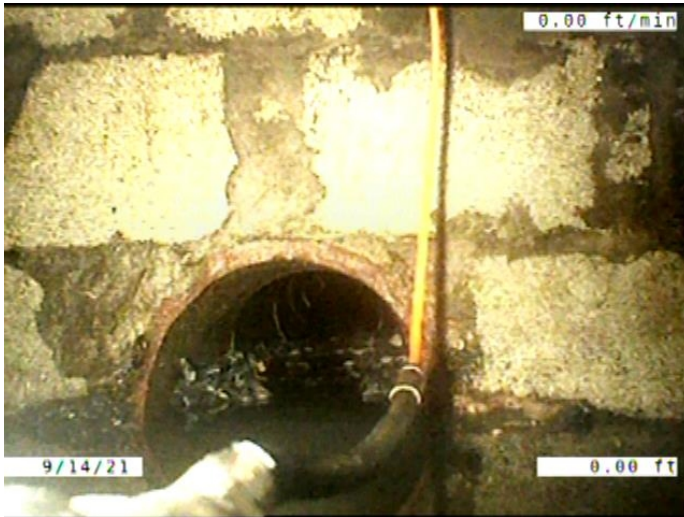
Code: **AMH**  
Description: **Manhole**

Distance (ft): **.0**  
Structural Grade: **0**  
O&M Grade: **0**  
Clock Start/From:  
Clock To:  
1st Value:  
2nd Value:  
Value Percent:  
Continuous Index:  
Within 8" of Joint: **NO**  
Remarks: **M-504-065.1**

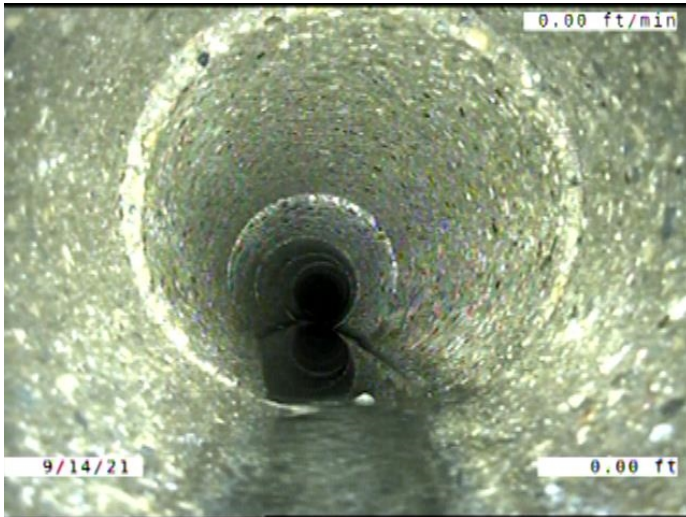
Code: **MWL**  
 Description: **Miscellaneous Water Level**

Distance (ft): **.0**  
 Structural Grade: **0**  
 O&M Grade: **0**  
 Clock Start/From:  
 Clock To:  
 1st Value:  
 2nd Value:  
 Value Percent: **5.000**  
 Continuous Index:  
 Within 8" of Joint: **NO**  
 Remarks:

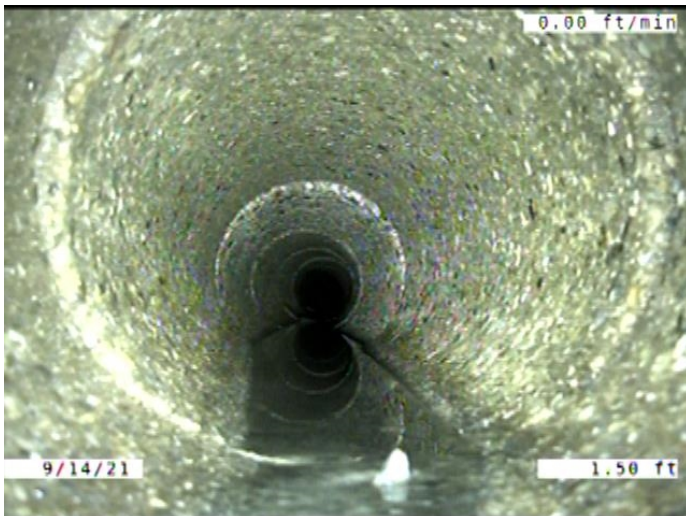
Code: **MGO**  
 Description: **Miscellaneous General Observation**

Distance (ft): **1.5**  
 Structural Grade: **0**  
 O&M Grade: **0**  
 Clock Start/From:  
 Clock To:  
 1st Value:  
 2nd Value:  
 Value Percent:  
 Continuous Index:  
 Within 8" of Joint: **NO**  
 Remarks: **DROP INTO THE MANHOLE. HAD TO START IN THE PIPE.**

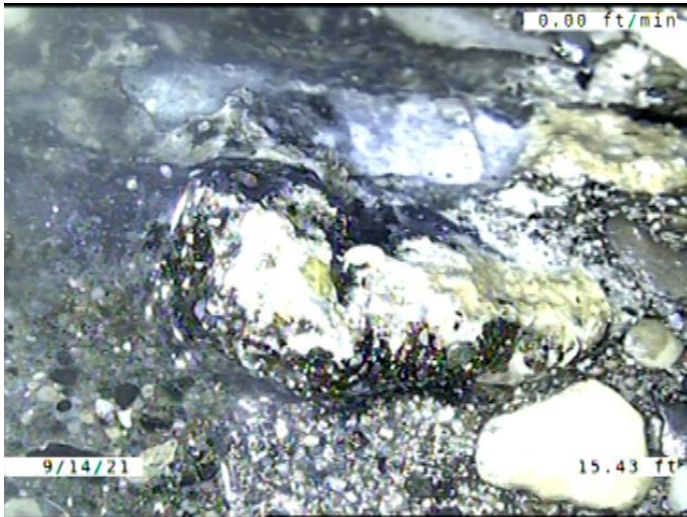
Code: **DAE**  
Description: **Deposits Attached Encrustation**

Distance (ft): **12.4**  
Structural Grade: **0**  
O&M Grade: **2**  
Clock Start/From: **4**  
Clock To: **8**  
1st Value:  
2nd Value:  
Value Percent: **5.000**  
Continuous Index: **S01**  
Within 8" of Joint: **YES**  
Remarks:

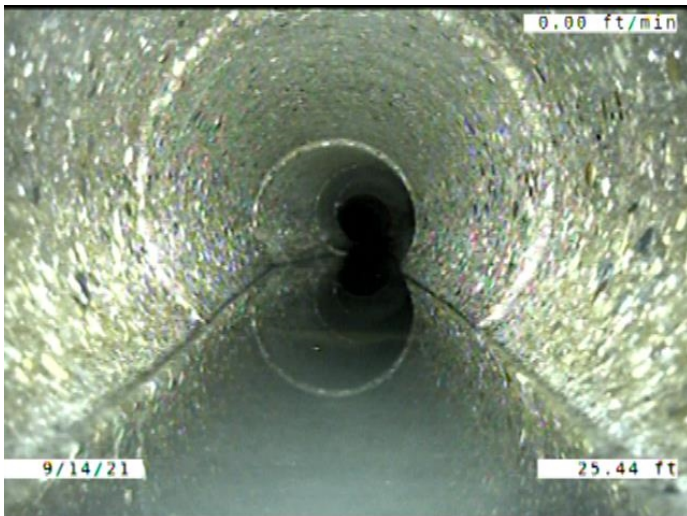
Code: **DAE**  
Description: **Deposits Attached Encrustation**

Distance (ft): **25.4**  
Structural Grade: **0**  
O&M Grade: **2**  
Clock Start/From: **4**  
Clock To: **8**  
1st Value:  
2nd Value:  
Value Percent: **5.000**  
Continuous Index: **F01**  
Within 8" of Joint: **YES**  
Remarks:

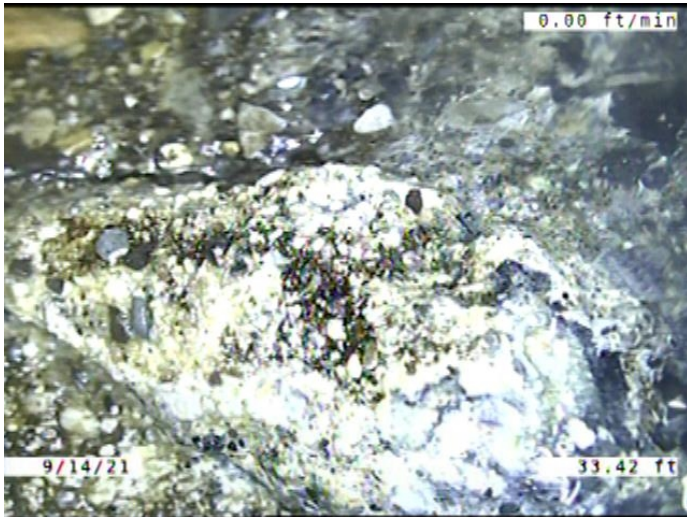
Code: **DAE**  
 Description: **Deposits Attached Encrustation**

Distance (ft): **33.4**  
 Structural Grade: **0**  
 O&M Grade: **2**  
 Clock Start/From: **7**  
 Clock To: **8**  
 1st Value:  
 2nd Value:  
 Value Percent: **5.000**  
 Continuous Index:  
 Within 8" of Joint: **YES**  
 Remarks:

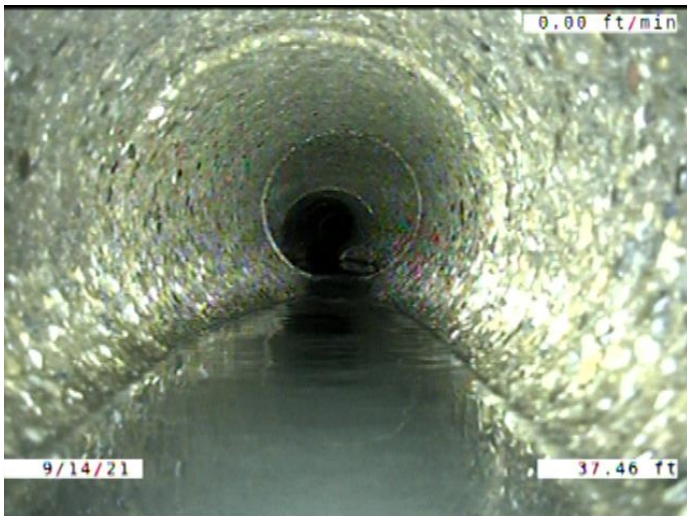
Code: **MWLS**  
 Description: **Miscellaneous Water Level Sag**

Distance (ft): **37.5**  
 Structural Grade: **2**  
 O&M Grade: **0**  
 Clock Start/From:  
 Clock To:  
 1st Value:  
 2nd Value:  
 Value Percent: **5.000**  
 Continuous Index: **S02**  
 Within 8" of Joint: **NO**  
 Remarks:

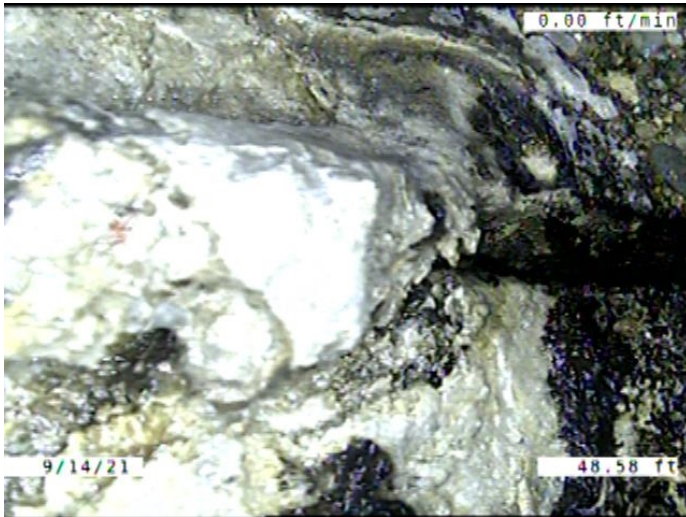
Code: **DAE**  
 Description: **Deposits Attached Encrustation**

Distance (ft): **48.6**  
 Structural Grade: **0**  
 O&M Grade: **2**  
 Clock Start/From: **3**  
 Clock To: **5**  
 1st Value:  
 2nd Value:  
 Value Percent: **5.000**  
 Continuous Index:  
 Within 8" of Joint: **YES**  
 Remarks:

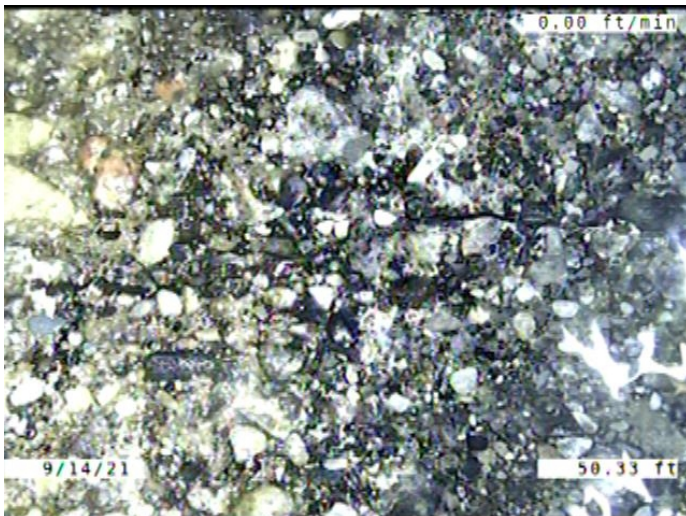
Code: **CS**  
 Description: **Crack Spiral**

Distance (ft): **50.3**  
 Structural Grade: **2**  
 O&M Grade: **0**  
 Clock Start/From: **6**  
 Clock To: **10**  
 1st Value:  
 2nd Value:  
 Value Percent:  
 Continuous Index:  
 Within 8" of Joint: **NO**  
 Remarks:

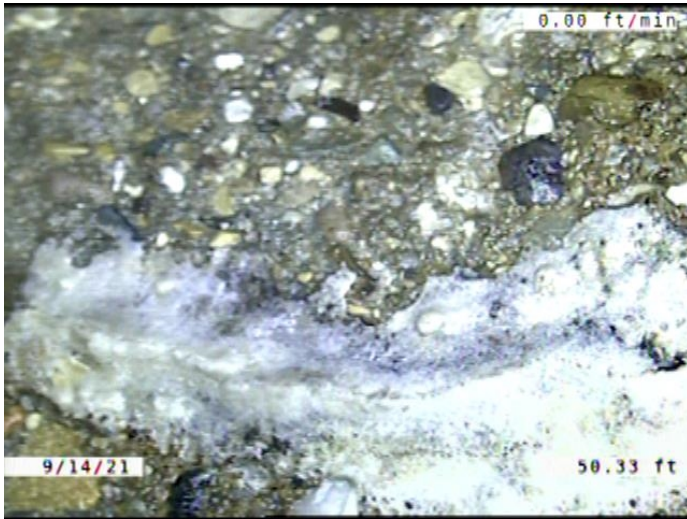
Code: **DAE**  
Description: **Deposits Attached Encrustation**

Distance (ft): **50.3**  
Structural Grade: **0**  
O&M Grade: **2**  
Clock Start/From: **8**  
Clock To: **9**  
1st Value:  
2nd Value:  
Value Percent: **5.000**  
Continuous Index:  
Within 8" of Joint: **YES**  
Remarks:

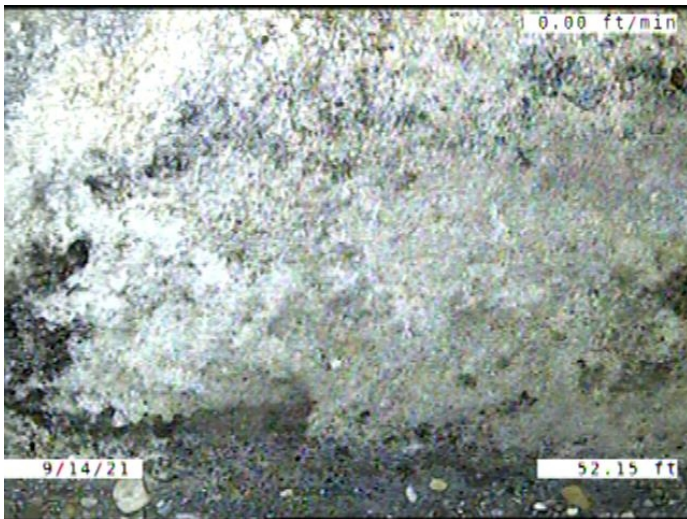
Code: **DAE**  
Description: **Deposits Attached Encrustation**

Distance (ft): **52.1**  
Structural Grade: **0**  
O&M Grade: **2**  
Clock Start/From: **8**  
Clock To: **1**  
1st Value:  
2nd Value:  
Value Percent: **5.000**  
Continuous Index:  
Within 8" of Joint: **YES**  
Remarks:

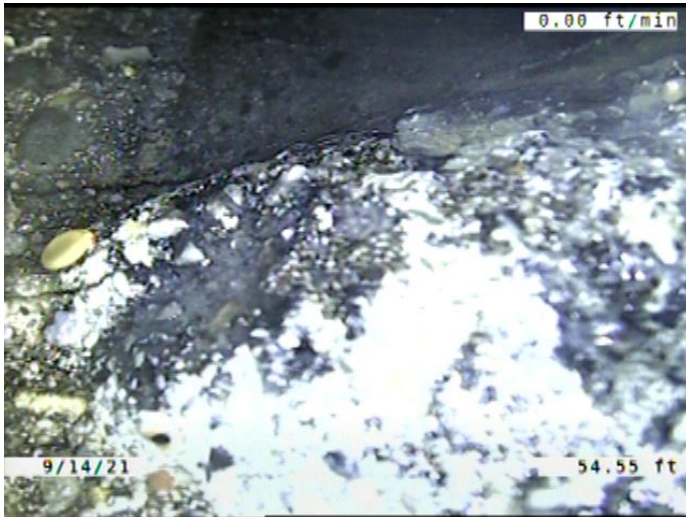
Code:	<b>DAE</b>
Description:	<b>Deposits Attached Encrustation</b>
Distance (ft):	<b>54.5</b>
Structural Grade:	<b>0</b>
O&M Grade:	<b>2</b>
Clock Start/From:	<b>5</b>
Clock To:	<b>8</b>
1st Value:	
2nd Value:	
Value Percent:	<b>5.000</b>
Continuous Index:	
Within 8" of Joint:	<b>YES</b>
Remarks:

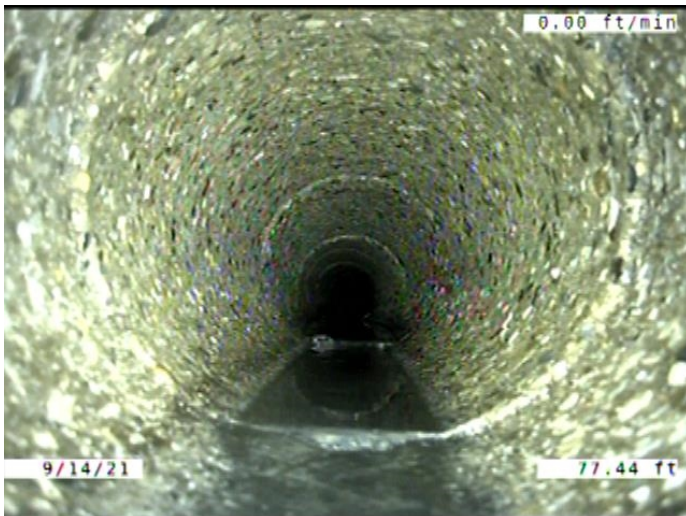
Code:	<b>MWLS</b>
Description:	<b>Miscellaneous Water Level Sag</b>
Distance (ft):	<b>77.4</b>
Structural Grade:	<b>2</b>
O&M Grade:	<b>0</b>
Clock Start/From:	
Clock To:	
1st Value:	
2nd Value:	
Value Percent:	<b>5.000</b>
Continuous Index:	<b>F02</b>
Within 8" of Joint:	<b>NO</b>
Remarks:

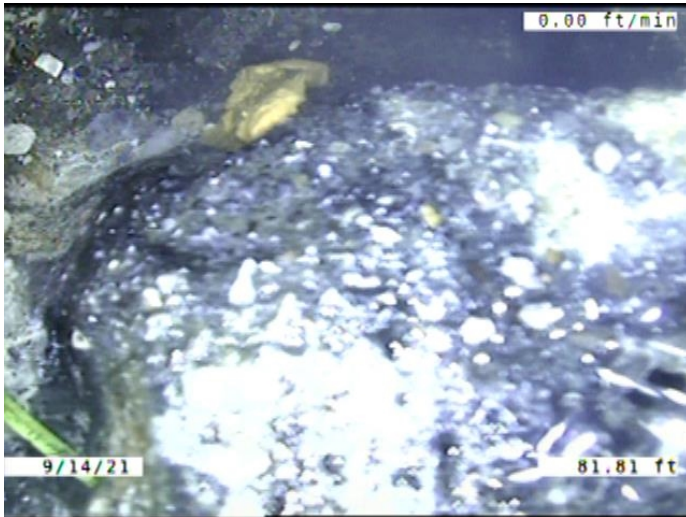
Code: **DAE**  
Description: **Deposits Attached Encrustation**

Distance (ft): **81.8**  
Structural Grade: **0**  
O&M Grade: **2**  
Clock Start/From: **4**  
Clock To: **8**  
1st Value:  
2nd Value:  
Value Percent: **5.000**  
Continuous Index:  
Within 8" of Joint: **YES**  
Remarks:

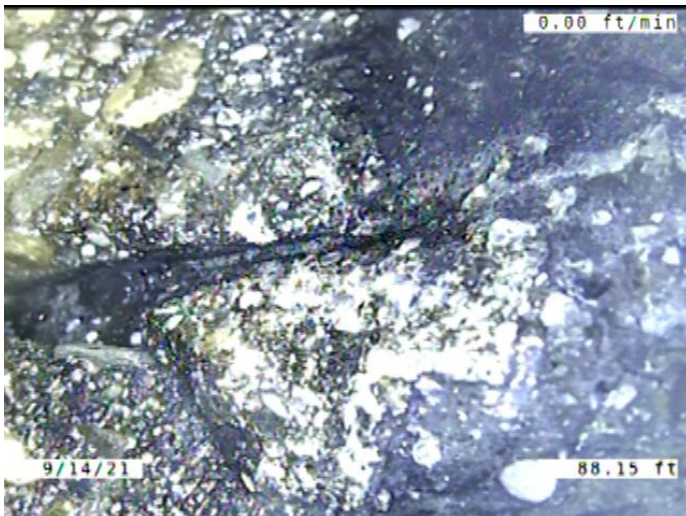
Code: **DAE**  
Description: **Deposits Attached Encrustation**

Distance (ft): **88.1**  
Structural Grade: **0**  
O&M Grade: **2**  
Clock Start/From: **4**  
Clock To: **8**  
1st Value:  
2nd Value:  
Value Percent: **5.000**  
Continuous Index:  
Within 8" of Joint: **YES**  
Remarks:

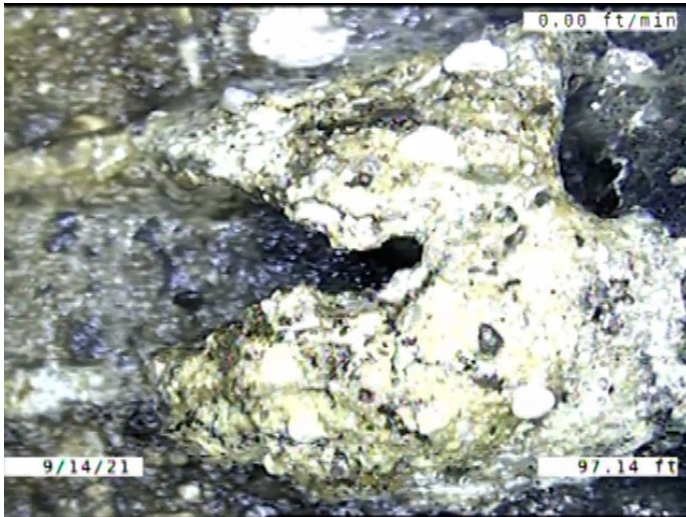
Code: **DAE**  
 Description: **Deposits Attached Encrustation**

Distance (ft): **97.1**  
 Structural Grade: **0**  
 O&M Grade: **2**  
 Clock Start/From: **6**  
 Clock To: **8**  
 1st Value:  
 2nd Value:  
 Value Percent: **5.000**  
 Continuous Index:  
 Within 8" of Joint: **YES**  
 Remarks:

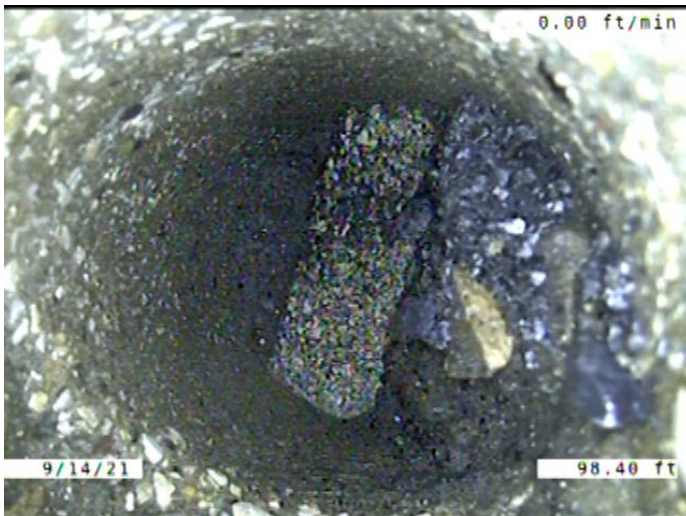
Code: **TFC**  
 Description: **Tap Factory Capped**

Distance (ft): **98.4**  
 Structural Grade: **0**  
 O&M Grade: **0**  
 Clock Start/From: **2**  
 Clock To:  
 1st Value: **4.000**  
 2nd Value:  
 Value Percent:  
 Continuous Index:  
 Within 8" of Joint: **YES**  
 Remarks:

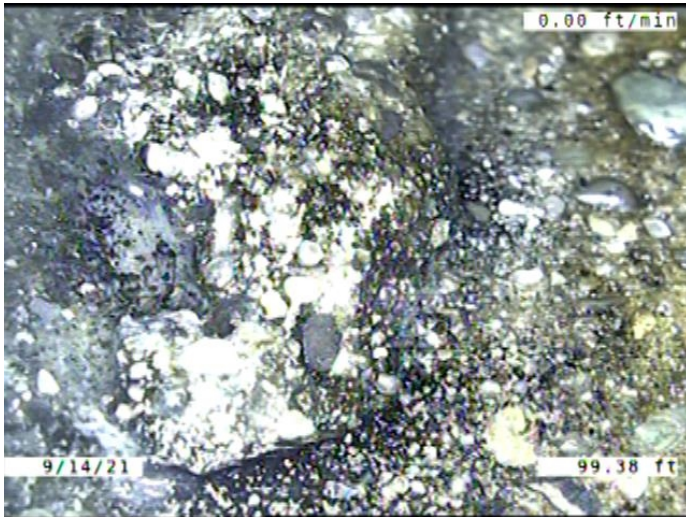
Code: **DAE**  
Description: **Deposits Attached Encrustation**

Distance (ft): **99.4**  
Structural Grade: **0**  
O&M Grade: **2**  
Clock Start/From: **5**  
Clock To:  
1st Value:  
2nd Value:  
Value Percent: **5.000**  
Continuous Index:  
Within 8" of Joint: **YES**  
Remarks:

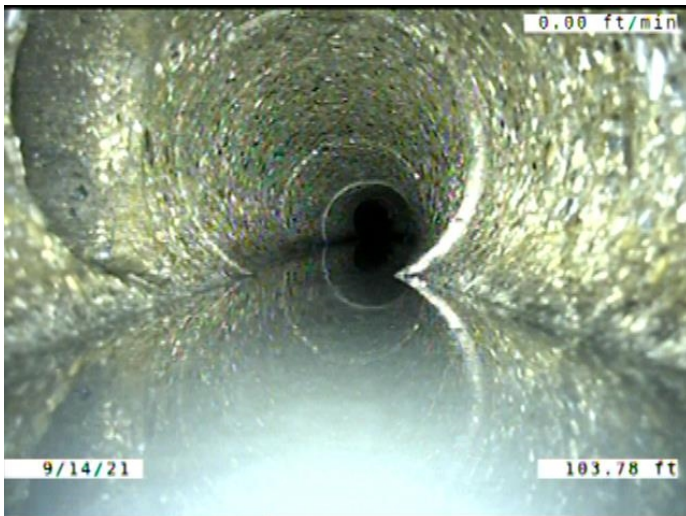
Code: **MWLS**  
Description: **Miscellaneous Water Level Sag**

Distance (ft): **103.8**  
Structural Grade: **2**  
O&M Grade: **0**  
Clock Start/From:  
Clock To:  
1st Value:  
2nd Value:  
Value Percent: **10.000**  
Continuous Index: **S03**  
Within 8" of Joint: **NO**  
Remarks:

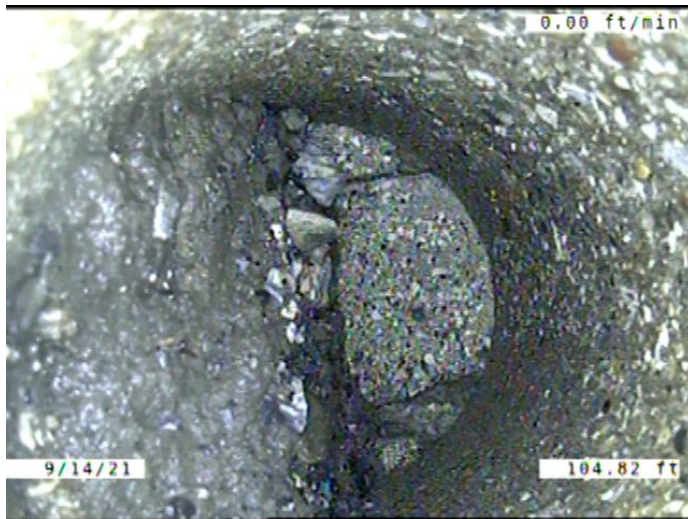
Code: **TBC**  
Description: **Tap Break-in Capped**

Distance (ft): **104.8**  
Structural Grade: **0**  
O&M Grade: **0**  
Clock Start/From: **10**  
Clock To:  
1st Value: **4.000**  
2nd Value:  
Value Percent:  
Continuous Index:  
Within 8" of Joint: **YES**  
Remarks:

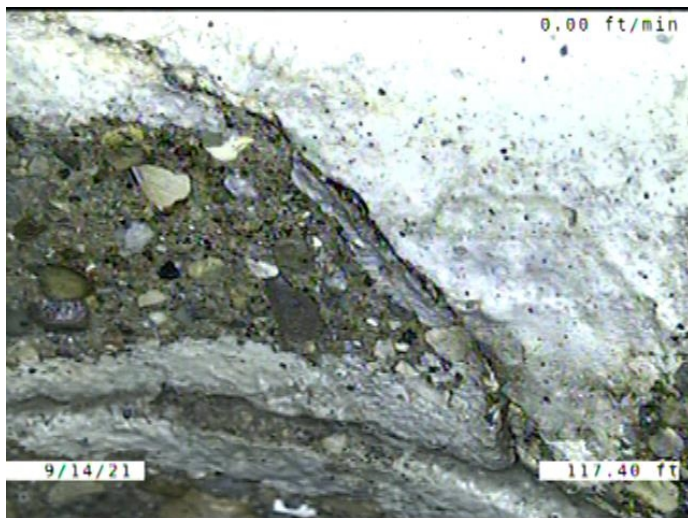
Code: **FM**  
Description: **Fracture Multiple**

Distance (ft): **117.4**  
Structural Grade: **4**  
O&M Grade: **0**  
Clock Start/From: **9**  
Clock To: **3**  
1st Value:  
2nd Value:  
Value Percent:  
Continuous Index:  
Within 8" of Joint: **YES**  
Remarks:

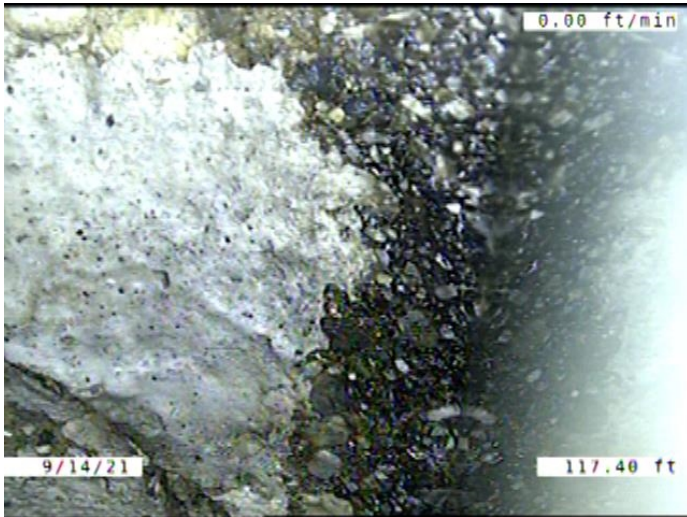
Code: **DAE**  
 Description: **Deposits Attached Encrustation**

Distance (ft): **117.4**  
 Structural Grade: **0**  
 O&M Grade: **2**  
 Clock Start/From: **9**  
 Clock To: **3**  
 1st Value:  
 2nd Value:  
 Value Percent: **5.000**  
 Continuous Index:  
 Within 8" of Joint: **YES**  
 Remarks:

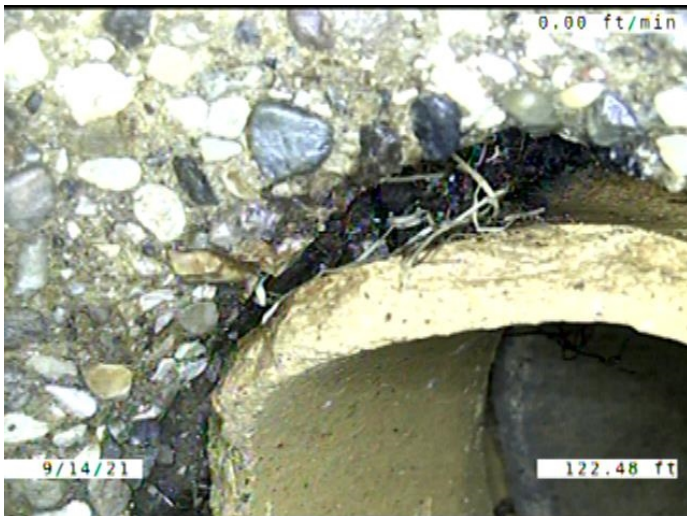
Code: **RFL**  
 Description: **Roots Fine Lateral**

Distance (ft): **122.5**  
 Structural Grade: **0**  
 O&M Grade: **1**  
 Clock Start/From: **1**  
 Clock To:  
 1st Value:  
 2nd Value:  
 Value Percent:  
 Continuous Index:  
 Within 8" of Joint: **NO**  
 Remarks:

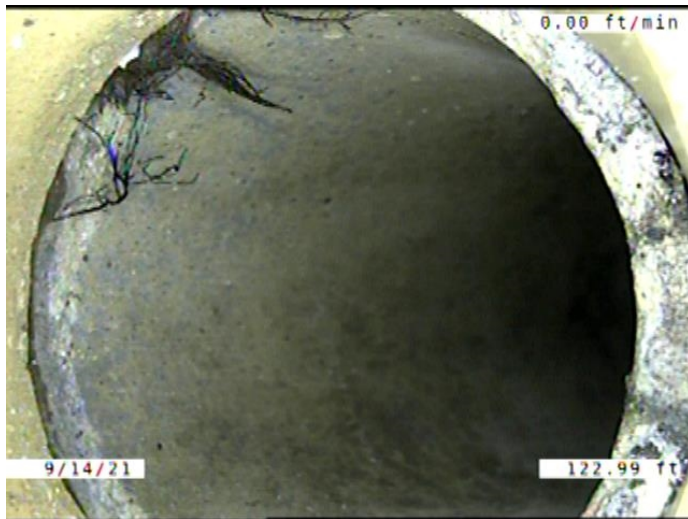
Code: **TBI**  
 Description: **Tap Break-in Intruding**

Distance (ft): **123.0**  
 Structural Grade: **0**  
 O&M Grade: **2**  
 Clock Start/From: **2**  
 Clock To:  
 1st Value: **4.000**  
 2nd Value: **1.000**  
 Value Percent:  
 Continuous Index:  
 Within 8" of Joint: **NO**  
 Remarks:

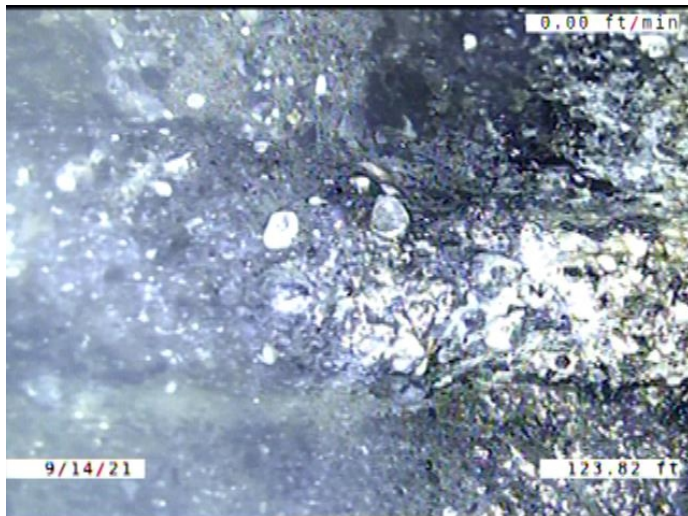
Code: **DAE**  
 Description: **Deposits Attached Encrustation**

Distance (ft): **123.8**  
 Structural Grade: **0**  
 O&M Grade: **2**  
 Clock Start/From: **4**  
 Clock To: **8**  
 1st Value:  
 2nd Value:  
 Value Percent: **5.000**  
 Continuous Index:  
 Within 8" of Joint: **YES**  
 Remarks:

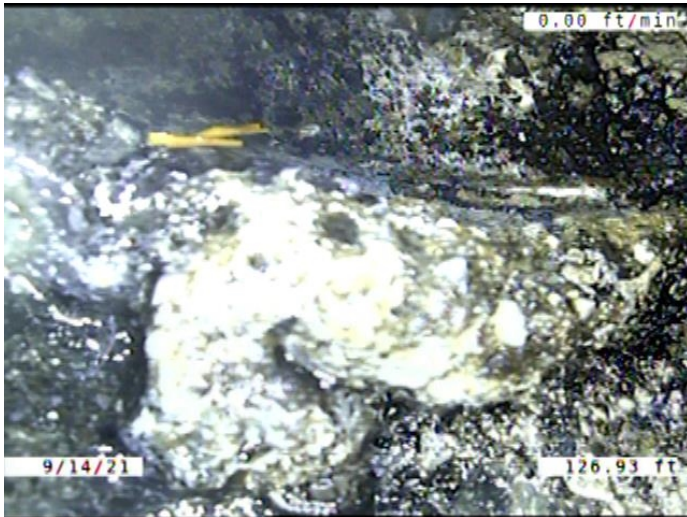
Code:	<b>DAE</b>
Description:	<b>Deposits Attached Encrustation</b>
Distance (ft):	<b>126.9</b>
Structural Grade:	<b>0</b>
O&M Grade:	<b>2</b>
Clock Start/From:	<b>4</b>
Clock To:	<b>8</b>
1st Value:	
2nd Value:	
Value Percent:	<b>5.000</b>
Continuous Index:	
Within 8" of Joint:	<b>YES</b>
Remarks:

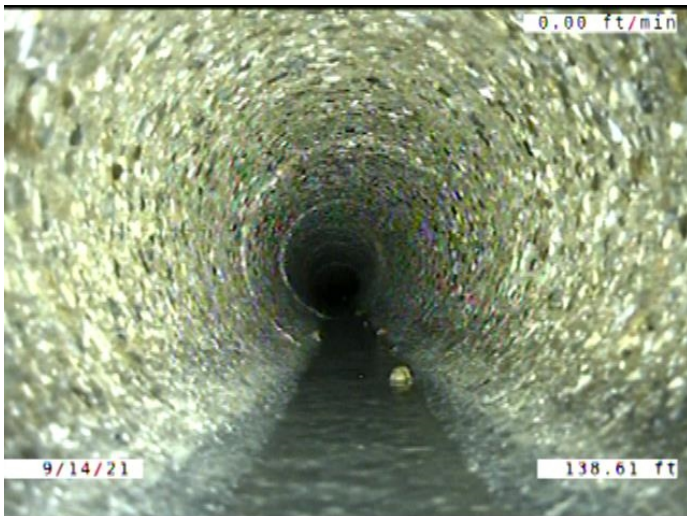
Code:	<b>MWLS</b>
Description:	<b>Miscellaneous Water Level Sag</b>
Distance (ft):	<b>138.6</b>
Structural Grade:	<b>2</b>
O&M Grade:	<b>0</b>
Clock Start/From:	
Clock To:	
1st Value:	
2nd Value:	
Value Percent:	<b>10.000</b>
Continuous Index:	<b>F03</b>
Within 8" of Joint:	<b>NO</b>
Remarks:

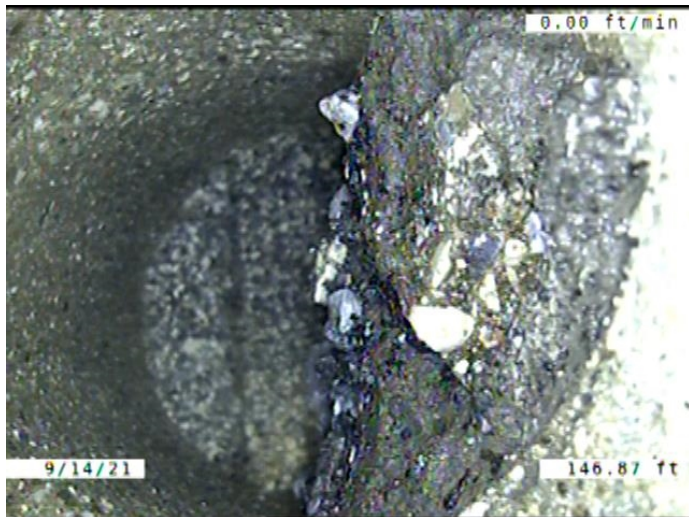
Code: **TFC**  
Description: **Tap Factory Capped**

Distance (ft): **146.9**  
Structural Grade: **0**  
O&M Grade: **0**  
Clock Start/From: **2**  
Clock To:  
1st Value: **4.000**  
2nd Value:  
Value Percent:  
Continuous Index:  
Within 8" of Joint: **YES**  
Remarks:

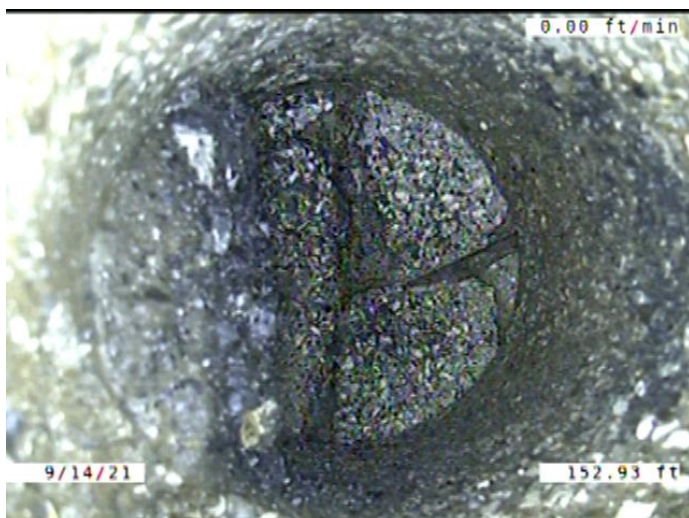
Code: **TBC**  
Description: **Tap Break-in Capped**

Distance (ft): **152.9**  
Structural Grade: **0**  
O&M Grade: **0**  
Clock Start/From: **10**  
Clock To:  
1st Value: **4.000**  
2nd Value:  
Value Percent:  
Continuous Index:  
Within 8" of Joint: **YES**  
Remarks:

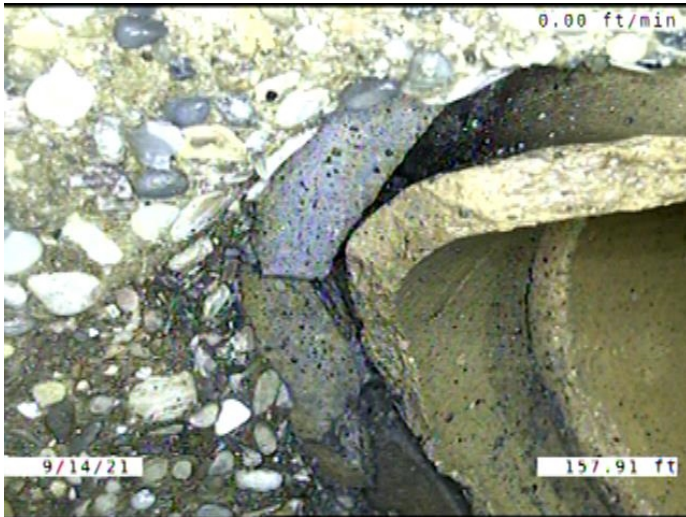
Code: **B**  
 Description: **Broken**

Distance (ft): **157.9**  
 Structural Grade: **4**  
 O&M Grade: **0**  
 Clock Start/From: **12**  
 Clock To:  
 1st Value:  
 2nd Value:  
 Value Percent:  
 Continuous Index:  
 Within 8" of Joint: **YES**  
 Remarks:

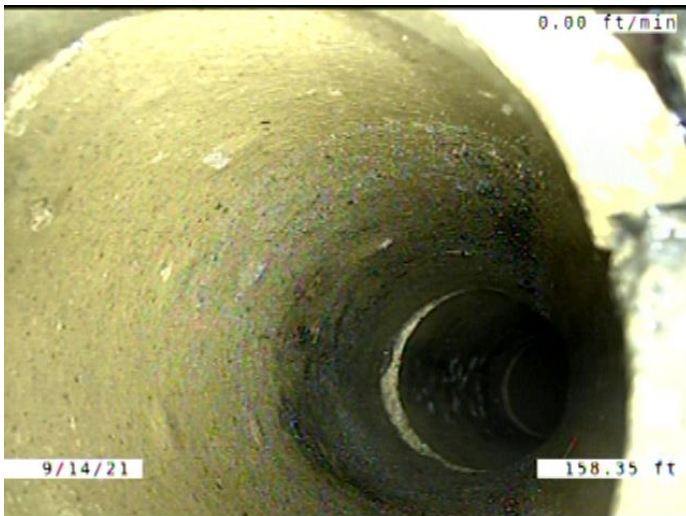
Code: **TBI**  
 Description: **Tap Break-in Intruding**

Distance (ft): **158.3**  
 Structural Grade: **0**  
 O&M Grade: **2**  
 Clock Start/From: **2**  
 Clock To:  
 1st Value: **4.000**  
 2nd Value: **1.000**  
 Value Percent:  
 Continuous Index:  
 Within 8" of Joint: **YES**  
 Remarks:

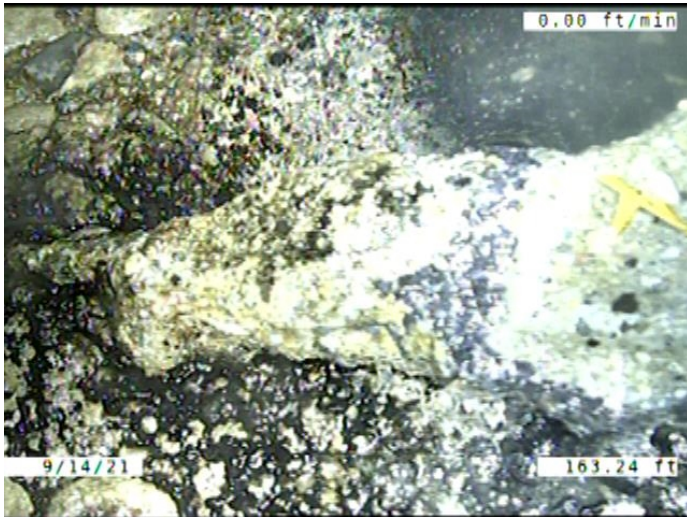
Code: **DAE**  
 Description: **Deposits Attached Encrustation**

Distance (ft): **163.2**  
 Structural Grade: **0**  
 O&M Grade: **2**  
 Clock Start/From: **4**  
 Clock To: **8**  
 1st Value:  
 2nd Value:  
 Value Percent: **5.000**  
 Continuous Index:  
 Within 8" of Joint: **YES**  
 Remarks:

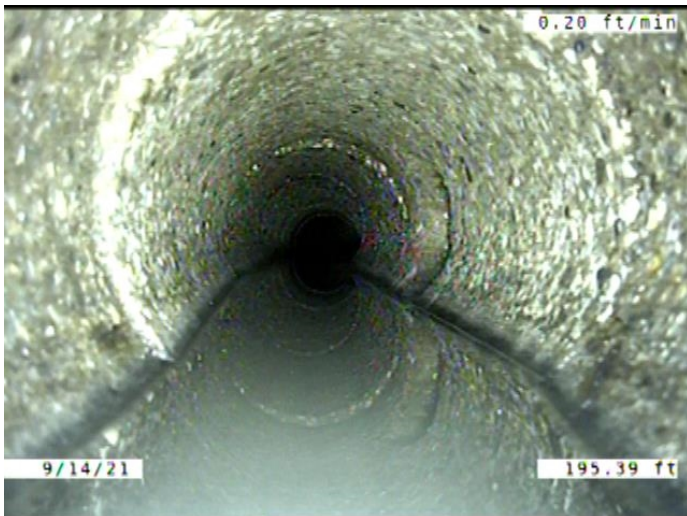
Code: **MWLS**  
 Description: **Miscellaneous Water Level Sag**

Distance (ft): **195.4**  
 Structural Grade: **2**  
 O&M Grade: **0**  
 Clock Start/From:  
 Clock To:  
 1st Value:  
 2nd Value:  
 Value Percent: **10.000**  
 Continuous Index: **S04**  
 Within 8" of Joint: **NO**  
 Remarks:

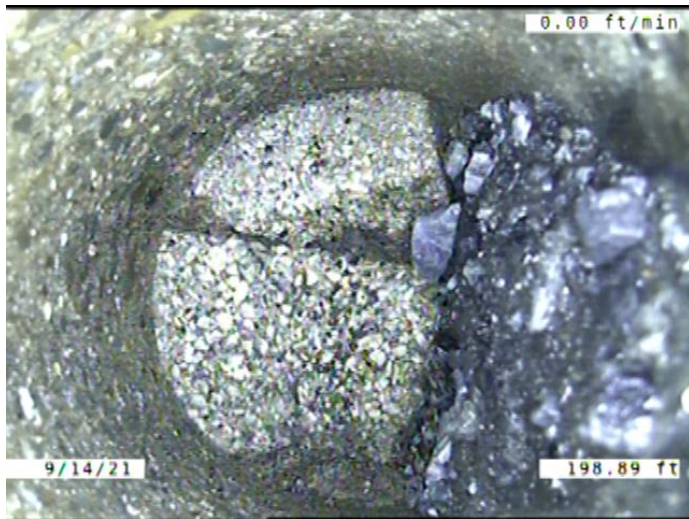
Code: **TFC**  
Description: **Tap Factory Capped**

Distance (ft): **198.9**  
Structural Grade: **0**  
O&M Grade: **0**  
Clock Start/From: **3**  
Clock To:  
1st Value: **4.000**  
2nd Value:  
Value Percent:  
Continuous Index:  
Within 8" of Joint: **YES**  
Remarks:

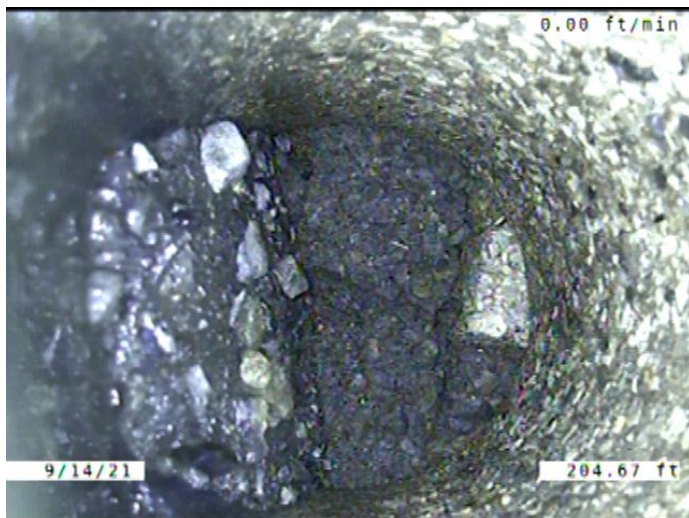
Code: **TFC**  
Description: **Tap Factory Capped**

Distance (ft): **204.7**  
Structural Grade: **0**  
O&M Grade: **0**  
Clock Start/From: **9**  
Clock To:  
1st Value: **4.000**  
2nd Value:  
Value Percent:  
Continuous Index:  
Within 8" of Joint: **YES**  
Remarks:

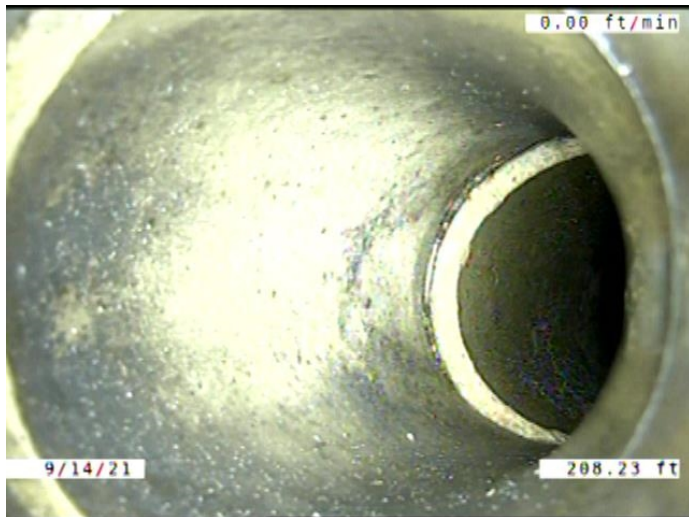
Code: **TBI**  
 Description: **Tap Break-in Intruding**

Distance (ft): **208.2**  
 Structural Grade: **0**  
 O&M Grade: **2**  
 Clock Start/From: **1**  
 Clock To:  
 1st Value: **4.000**  
 2nd Value: **1.000**  
 Value Percent:  
 Continuous Index:  
 Within 8" of Joint: **NO**  
 Remarks:

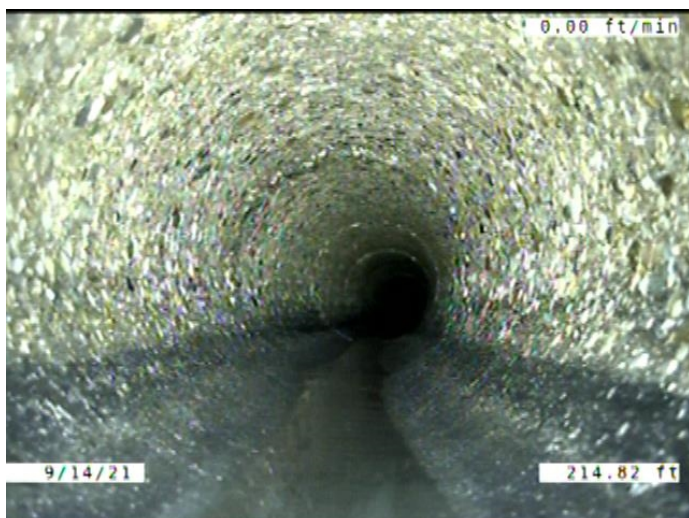
Code: **MWLS**  
 Description: **Miscellaneous Water Level Sag**

Distance (ft): **214.8**  
 Structural Grade: **2**  
 O&M Grade: **0**  
 Clock Start/From:  
 Clock To:  
 1st Value:  
 2nd Value:  
 Value Percent: **10.000**  
 Continuous Index: **F04**  
 Within 8" of Joint: **NO**  
 Remarks:

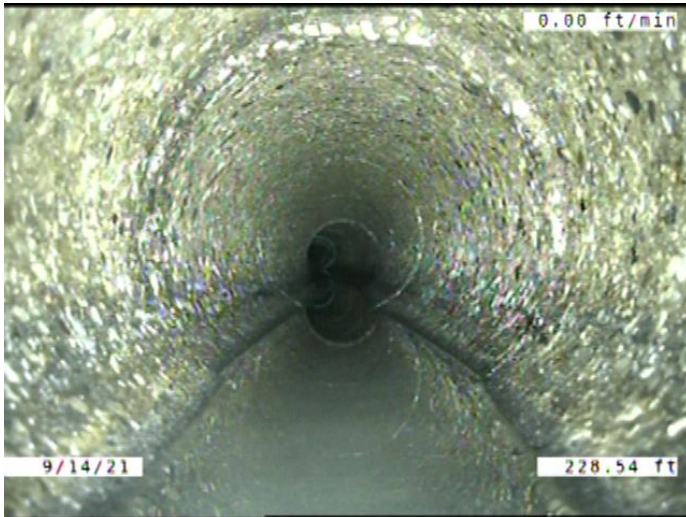
Code: **MWLS**  
Description: **Miscellaneous Water Level Sag**

Distance (ft): **228.5**  
Structural Grade: **2**  
O&M Grade: **0**  
Clock Start/From:  
Clock To:  
1st Value:  
2nd Value:  
Value Percent: **5.000**  
Continuous Index: **S05**  
Within 8" of Joint: **NO**  
Remarks:

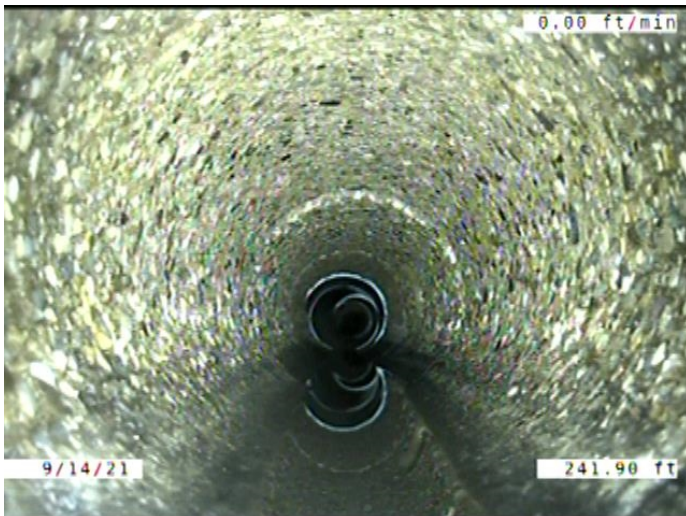
Code: **MWLS**  
Description: **Miscellaneous Water Level Sag**

Distance (ft): **241.9**  
Structural Grade: **2**  
O&M Grade: **0**  
Clock Start/From:  
Clock To:  
1st Value:  
2nd Value:  
Value Percent: **5.000**  
Continuous Index: **F05**  
Within 8" of Joint: **NO**  
Remarks:

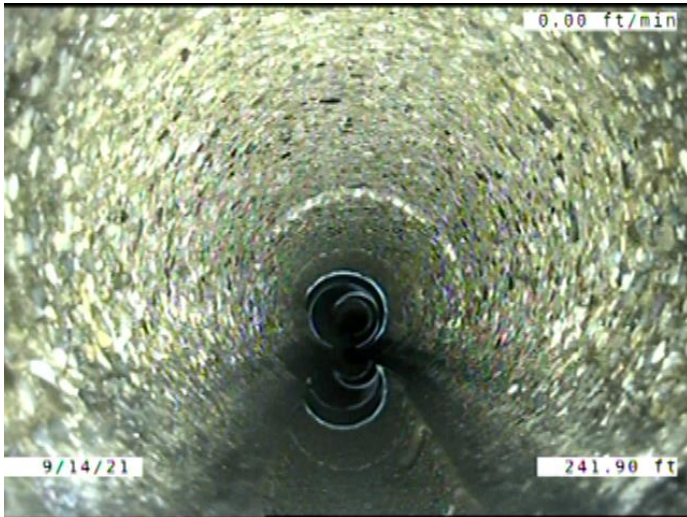
Code:	<b>MSA</b>
Description:	<b>Miscellaneous Survey Abandoned</b>
Distance (ft):	<b>241.9</b>
Structural Grade:	<b>0</b>
O&M Grade:	<b>0</b>
Clock Start/From:	
Clock To:	
1st Value:	
2nd Value:	
Value Percent:	
Continuous Index:	
Within 8" of Joint:	<b>NO</b>
Remarks:	<b>MADE IT TO THE POINT OF OVERLAP. REVERSAL COMPLETE</b>
