Profile/Photo Observation Report

Date:	09/14/2021	Weather:		Coding:	PACP 7.0
Pipe Length (ft):	372.0	Owner:	City of Hobart	Pre Clean:	Heavy Cleaning
P.O.#:	YES502259	Surveyor:	S. Bucklin	PSR:	P-504-065.1-051
Customer:	City of Hobart	Clean Date:	09/14/2021	Shape:	C

Street:	North Guyer Street	Flow Control:	Not Controlled
City:	Hobart, IN	Year Renewed:	
Location:	Local rural streets with light traffic, t	Tape/Media #:	
Purpose:	Routine Assessment	Dia/Height:	8"
Use:	Sanitary Sewage Pipe	Material:	CP
Drain Area:		Lining:	None
Category:	NA		
Comment:			
Location Details:		Direction of Survey:	Upstream
US MH:	M-504-051	DS MH:	M-504-065.1
		Total Length Surveyed (ft):	241.9

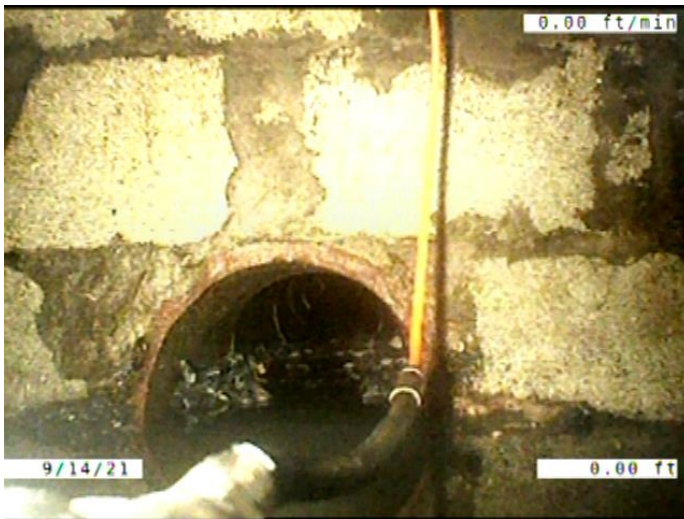
Code: **AMH**
Description: **Manhole**

Distance (ft): **.0**
Structural Grade: **0**
O&M Grade: **0**
Clock Start/From:
Clock To:
1st Value:
2nd Value:
Value Percent:
Continuous Index:
Within 8" of Joint: **NO**
Remarks: **M-504-065.1**

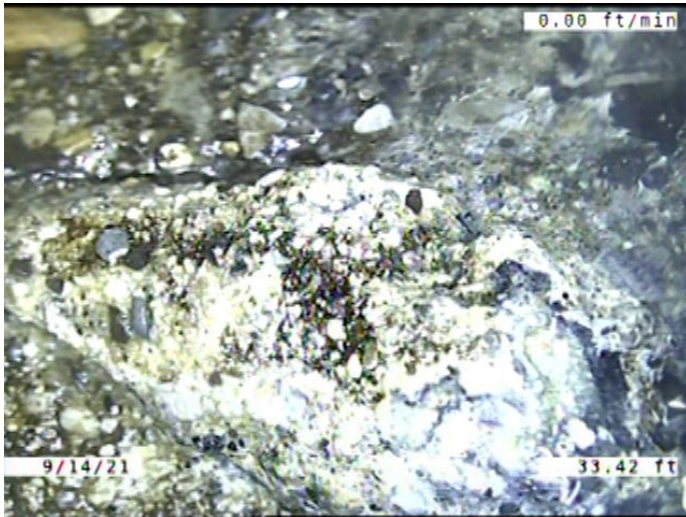
Code: **DAE**
 Description: **Deposits Attached Encrustation**

Distance (ft): **33.4**
 Structural Grade: **0**
 O&M Grade: **2**
 Clock Start/From: **7**
 Clock To: **8**
 1st Value:
 2nd Value:
 Value Percent: **5.000**
 Continuous Index:
 Within 8" of Joint: **YES**
 Remarks:

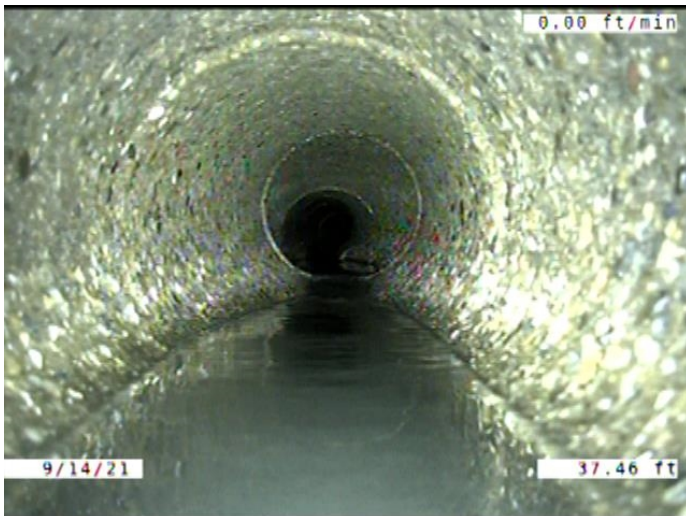
Code: **MWLS**
 Description: **Miscellaneous Water Level Sag**

Distance (ft): **37.5**
 Structural Grade: **2**
 O&M Grade: **0**
 Clock Start/From:
 Clock To:
 1st Value:
 2nd Value:
 Value Percent: **5.000**
 Continuous Index: **S02**
 Within 8" of Joint: **NO**
 Remarks:

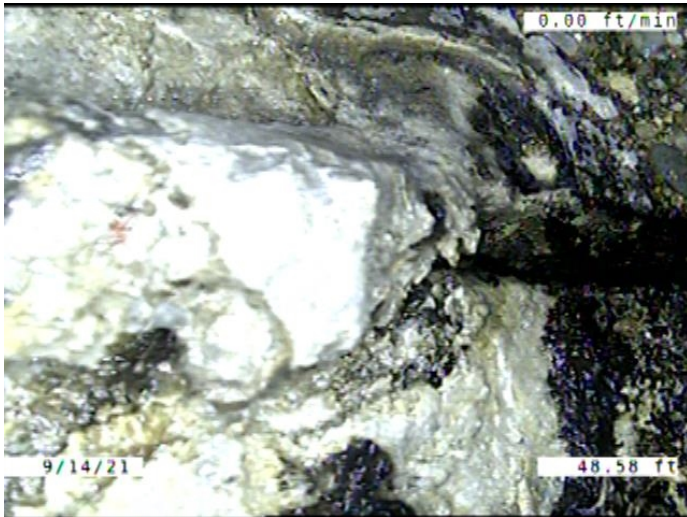
Code: **DAE**
 Description: **Deposits Attached Encrustation**

Distance (ft): **48.6**
 Structural Grade: **0**
 O&M Grade: **2**
 Clock Start/From: **3**
 Clock To: **5**
 1st Value:
 2nd Value:
 Value Percent: **5.000**
 Continuous Index:
 Within 8" of Joint: **YES**
 Remarks:

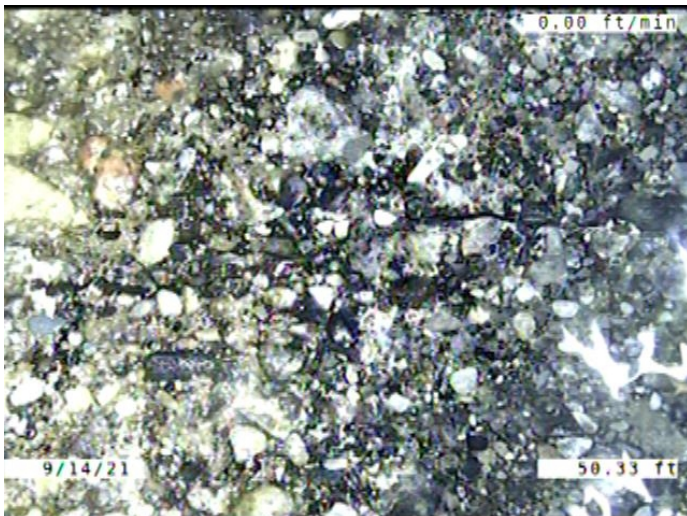
Code: **CS**
 Description: **Crack Spiral**

Distance (ft): **50.3**
 Structural Grade: **2**
 O&M Grade: **0**
 Clock Start/From: **6**
 Clock To: **10**
 1st Value:
 2nd Value:
 Value Percent:
 Continuous Index:
 Within 8" of Joint: **NO**
 Remarks:

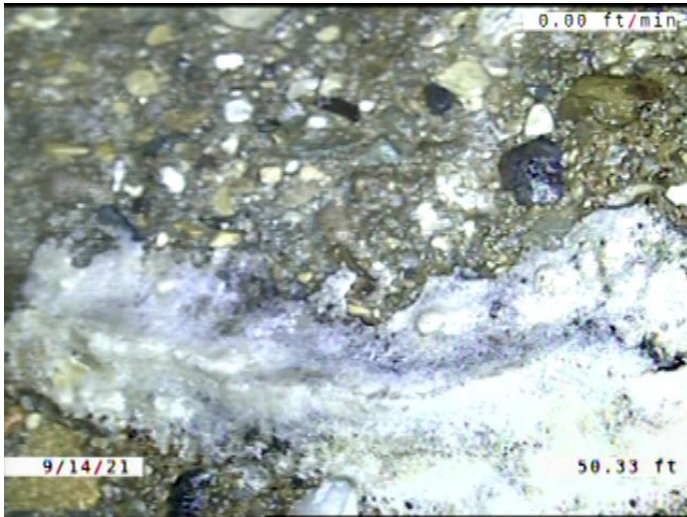
Code: **DAE**
 Description: **Deposits Attached Encrustation**

Distance (ft): **50.3**
 Structural Grade: **0**
 O&M Grade: **2**
 Clock Start/From: **8**
 Clock To: **9**
 1st Value:
 2nd Value:
 Value Percent: **5.000**
 Continuous Index:
 Within 8" of Joint: **YES**
 Remarks:

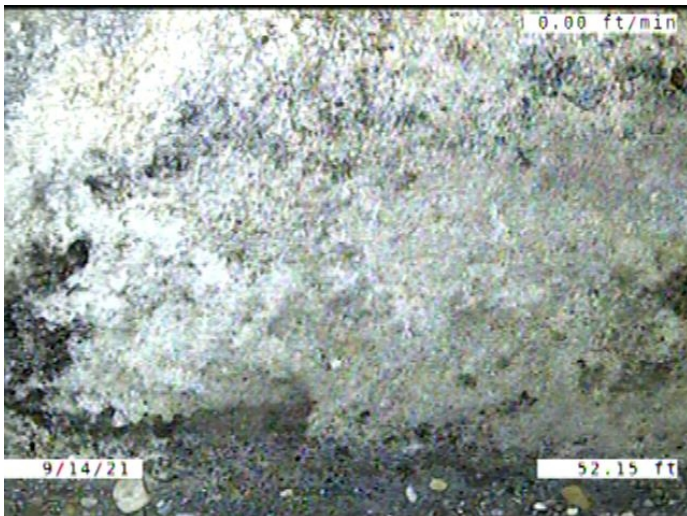
Code: **DAE**
 Description: **Deposits Attached Encrustation**

Distance (ft): **52.1**
 Structural Grade: **0**
 O&M Grade: **2**
 Clock Start/From: **8**
 Clock To: **1**
 1st Value:
 2nd Value:
 Value Percent: **5.000**
 Continuous Index:
 Within 8" of Joint: **YES**
 Remarks:

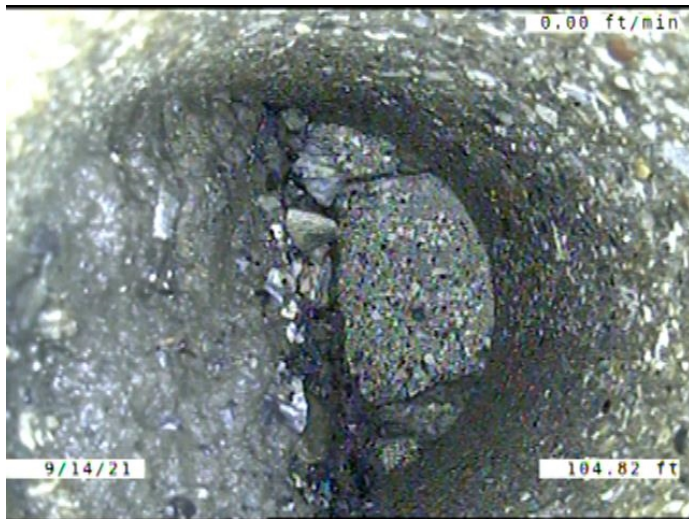
Code: **TBC**
Description: **Tap Break-in Capped**

Distance (ft): **104.8**
Structural Grade: **0**
O&M Grade: **0**
Clock Start/From: **10**
Clock To:
1st Value: **4.000**
2nd Value:
Value Percent:
Continuous Index:
Within 8" of Joint: **YES**
Remarks:

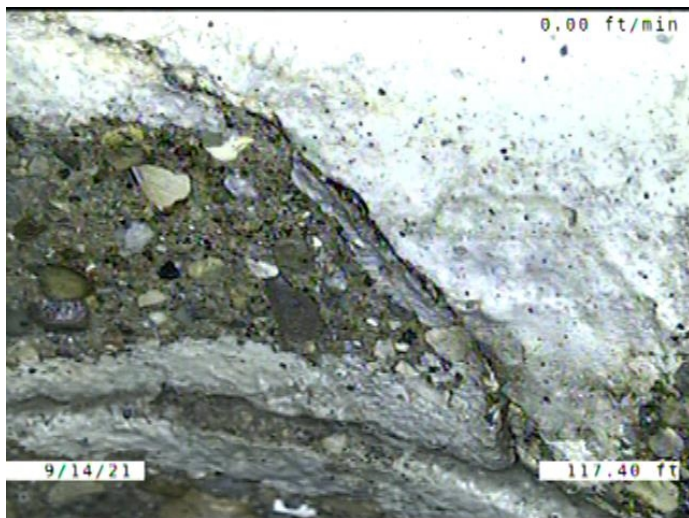
Code: **FM**
Description: **Fracture Multiple**

Distance (ft): **117.4**
Structural Grade: **4**
O&M Grade: **0**
Clock Start/From: **9**
Clock To: **3**
1st Value:
2nd Value:
Value Percent:
Continuous Index:
Within 8" of Joint: **YES**
Remarks:

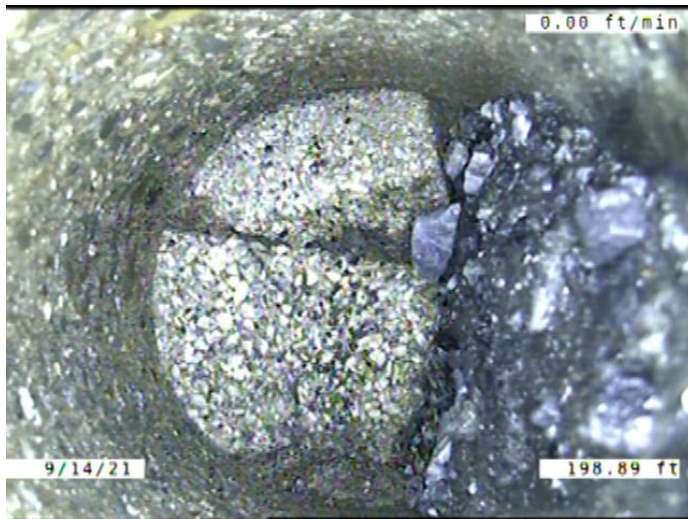
Code: **TFC**
Description: **Tap Factory Capped**

Distance (ft): **198.9**
Structural Grade: **0**
O&M Grade: **0**
Clock Start/From: **3**
Clock To:
1st Value: **4.000**
2nd Value:
Value Percent:
Continuous Index:
Within 8" of Joint: **YES**
Remarks:

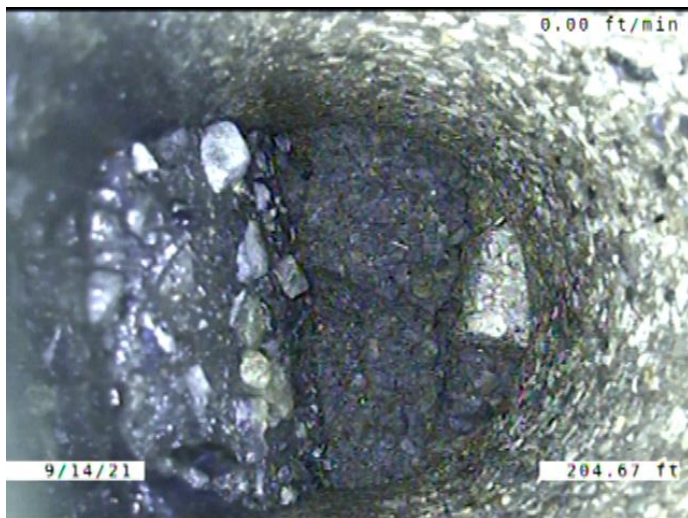
Code: **TFC**
Description: **Tap Factory Capped**

Distance (ft): **204.7**
Structural Grade: **0**
O&M Grade: **0**
Clock Start/From: **9**
Clock To:
1st Value: **4.000**
2nd Value:
Value Percent:
Continuous Index:
Within 8" of Joint: **YES**
Remarks:

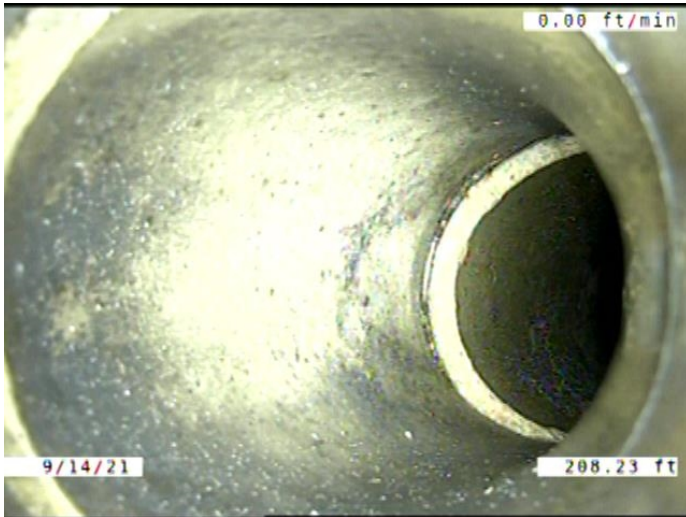
Code: **TBI**
 Description: **Tap Break-in Intruding**

Distance (ft): **208.2**
 Structural Grade: **0**
 O&M Grade: **2**
 Clock Start/From: **1**
 Clock To:
 1st Value: **4.000**
 2nd Value: **1.000**
 Value Percent:
 Continuous Index:
 Within 8" of Joint: **NO**
 Remarks:

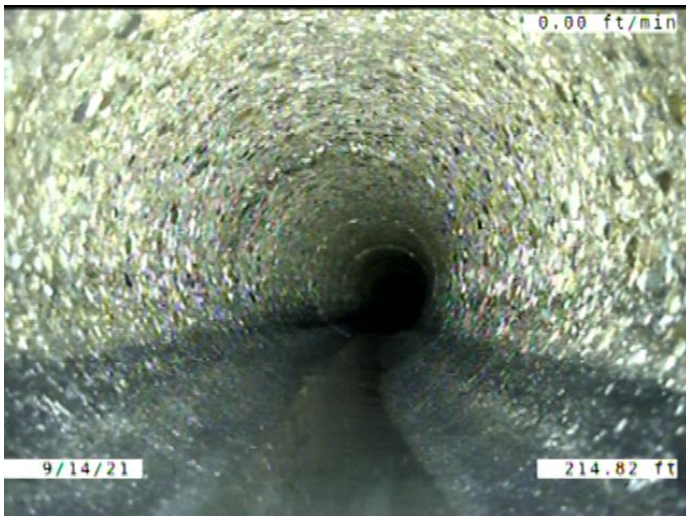
Code: **MWLS**
 Description: **Miscellaneous Water Level Sag**

Distance (ft): **214.8**
 Structural Grade: **2**
 O&M Grade: **0**
 Clock Start/From:
 Clock To:
 1st Value:
 2nd Value:
 Value Percent: **10.000**
 Continuous Index: **F04**
 Within 8" of Joint: **NO**
 Remarks:

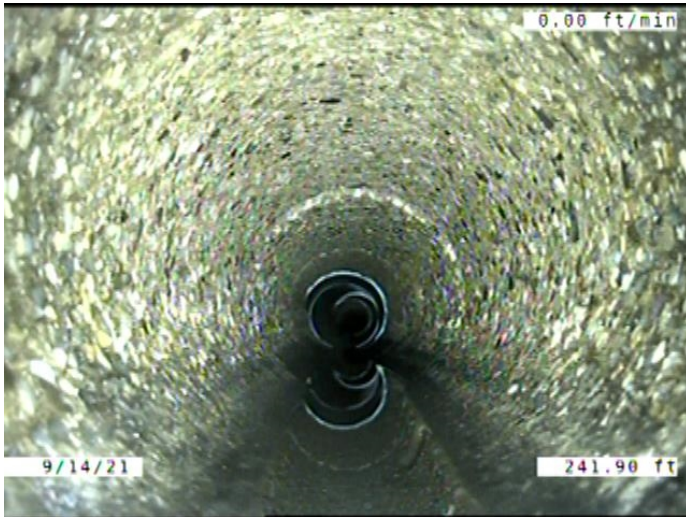
Code:	MSA
Description:	Miscellaneous Survey Abandoned
Distance (ft):	241.9
Structural Grade:	0
O&M Grade:	0
Clock Start/From:	
Clock To:	
1st Value:	
2nd Value:	
Value Percent:	
Continuous Index:	
Within 8" of Joint:	NO
Remarks:	MADE IT TO THE POINT OF OVERLAP. REVERSAL COMPLETE
