# Profile/Photo Observation Report

Date:	<b>04/22/2018</b>	Weather:		Coding:	<b>PACP 6.0</b>
Pipe Length (ft):	<b>329.5</b>	Owner:	<b>NA</b>	Pre Clean:	<b>No Pre-Cleaning</b>
P.O.#:		Surveyor:	<b>Byrd Fitzgerald</b>	PSR:	<b>P-504-053-052</b>
Customer:		Clean Date:	<b>01/01/1900</b>	Shape:	<b>C</b>

Street:	<b>FOXCROFT STREET</b>	Flow Control:	<b>Not Controlled</b>
City:	<b>Hobart, IN</b>	Year Renewed:	
Location:	<b>Light Highway</b>	Tape/Media #:	
Purpose:	<b>Routine Assessment</b>	Dia/Height:	<b>12"</b>
Use:	<b>Sanitary</b>	Material:	<b>CP</b>
Drain Area:	<b>NA</b>	Lining:	
Category:	<b>NA</b>		
Comment:	<b>P_C at 298ft nothing visible . Flow direction wrong</b>		
Location Details:		Direction of Survey:	<b>Upstream</b>
US MH:	<b>M-504-052</b>	DS MH:	<b>M-504-053</b>
		Total Length Surveyed (ft):	<b>299.1</b>

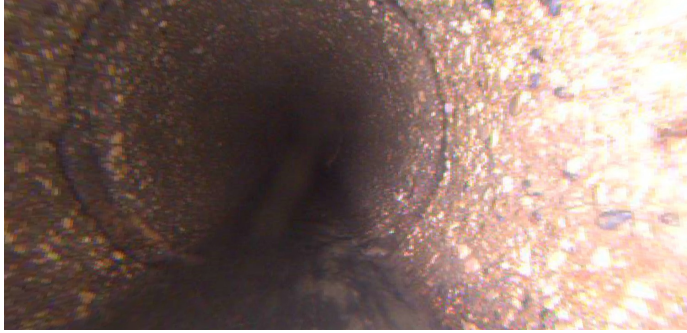
Code:	<b>SAV</b>
Description:	<b>Surface Aggregate Visible</b>
Distance (ft):	<b>.0</b>
Structural Grade:	<b>3</b>
O&M Grade:	<b>0</b>
Clock Start/From:	<b>7</b>
Clock To:	<b>5</b>
1st Value:	
2nd Value:	
Value Percent:	
Continuous Index:	<b>S01</b>
Within 8" of Joint:	<b>NO</b>
Remarks:

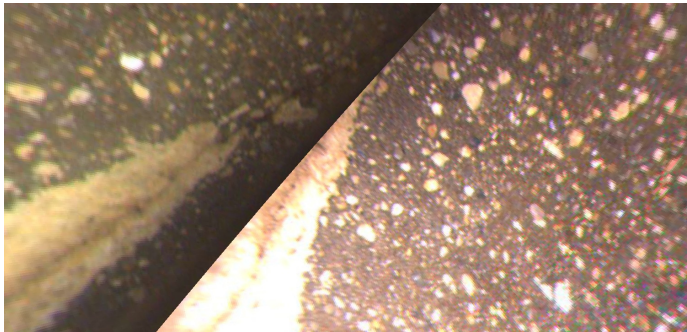
Code:	<b>CC</b>
Description:	<b>Crack Circumferential</b>
Distance (ft):	<b>17.5</b>
Structural Grade:	<b>1</b>
O&M Grade:	<b>0</b>
Clock Start/From:	<b>7</b>
Clock To:	<b>5</b>
1st Value:	
2nd Value:	
Value Percent:	
Continuous Index:	
Within 8" of Joint:	
Remarks:

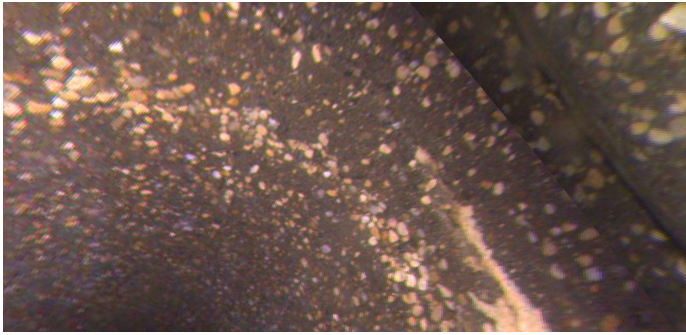
Code: **CC**  
Description: **Crack Circumferential**

Distance (ft): **26.1**  
Structural Grade: **1**  
O&M Grade: **0**  
Clock Start/From: **7**  
Clock To: **5**  
1st Value:  
2nd Value:  
Value Percent:  
Continuous Index: **S02**  
Within 8" of Joint:  
Remarks:

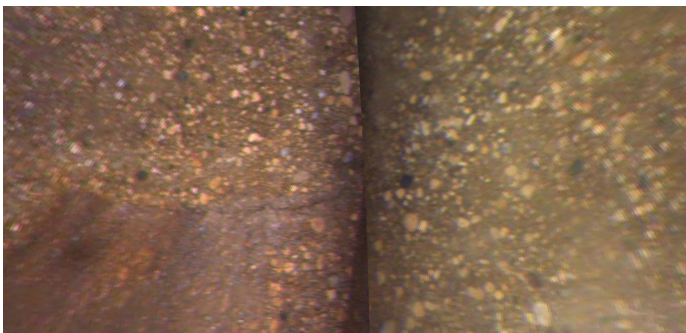
Code: **CL**  
Description: **Crack Longitudinal**

Distance (ft): **46.8**  
Structural Grade: **2**  
O&M Grade: **0**  
Clock Start/From: **3**  
Clock To:  
1st Value:  
2nd Value:  
Value Percent:  
Continuous Index:  
Within 8" of Joint:  
Remarks:

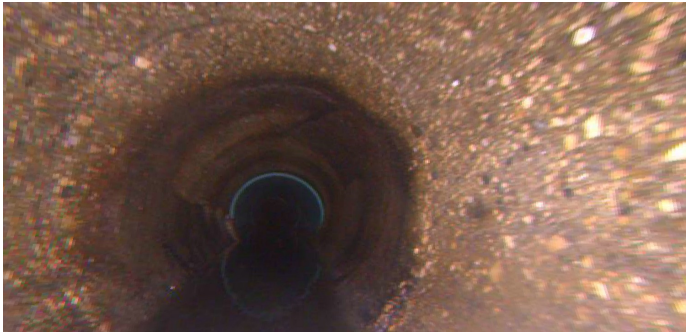
Code: **CM**  
Description: **Crack Multiple**

Distance (ft): **49.0**  
Structural Grade: **3**  
O&M Grade: **0**  
Clock Start/From: **7**  
Clock To: **5**  
1st Value:  
2nd Value:  
Value Percent:  
Continuous Index: **S04**  
Within 8" of Joint:  
Remarks: **wandering**

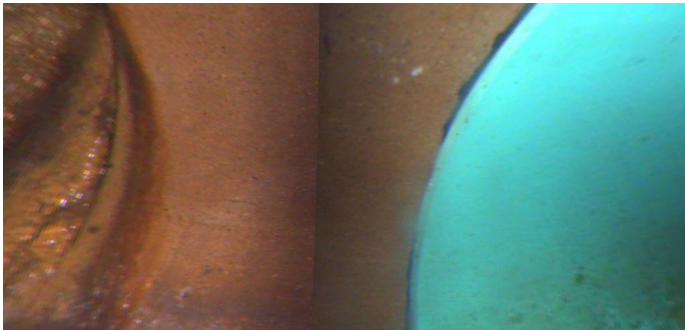
Code: **RPR**  
Description: **Repair Point Pipe Replaced**

Distance (ft): **93.9**  
Structural Grade: **0**  
O&M Grade: **0**  
Clock Start/From:  
Clock To:  
1st Value:  
2nd Value:  
Value Percent:  
Continuous Index:  
Within 8" of Joint: **NO**  
Remarks: **vcp**

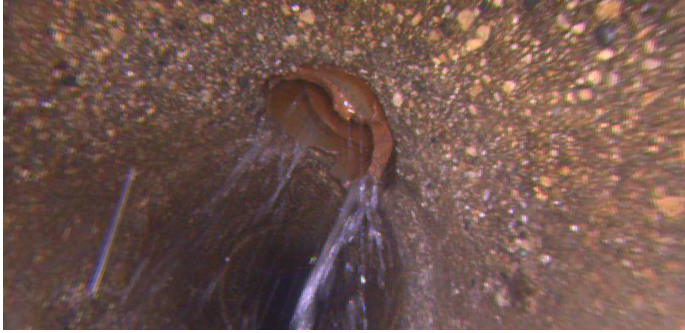
Code: **TBA**  
Description: **Tap Break-in Active**

Distance (ft): **106.7**  
Structural Grade: **0**  
O&M Grade: **0**  
Clock Start/From: **1**  
Clock To:  
1st Value: **4.000**  
2nd Value:  
Value Percent:  
Continuous Index:  
Within 8" of Joint:  
Remarks:

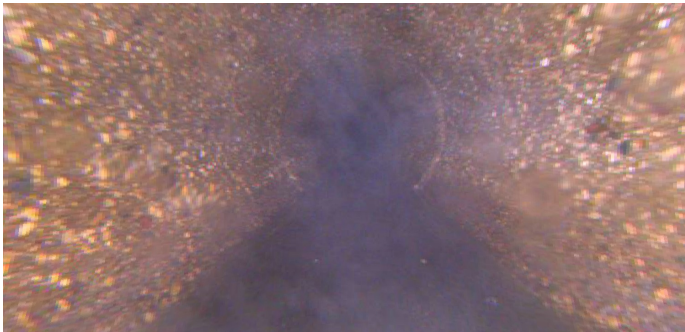
Code: **MGO**  
Description: **General Observation**

Distance (ft): **122.4**  
Structural Grade: **0**  
O&M Grade: **0**  
Clock Start/From:  
Clock To:  
1st Value:  
2nd Value:  
Value Percent:  
Continuous Index:  
Within 8" of Joint: **NO**  
Remarks: **steam in line**

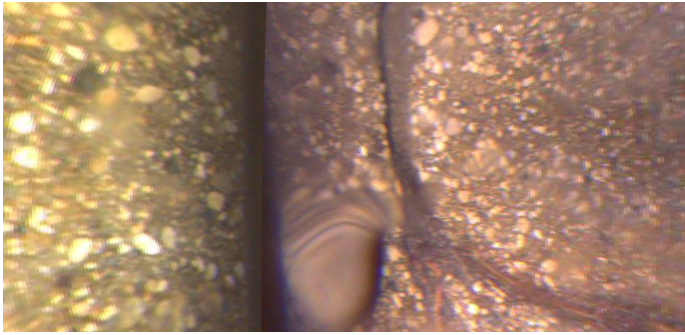
Code: **RFJ**  
Description: **Roots Fine Joint**

Distance (ft): **126.8**  
Structural Grade: **0**  
O&M Grade: **1**  
Clock Start/From: **7**  
Clock To: **5**  
1st Value:  
2nd Value:  
Value Percent:  
Continuous Index:  
Within 8" of Joint: **YES**  
Remarks:

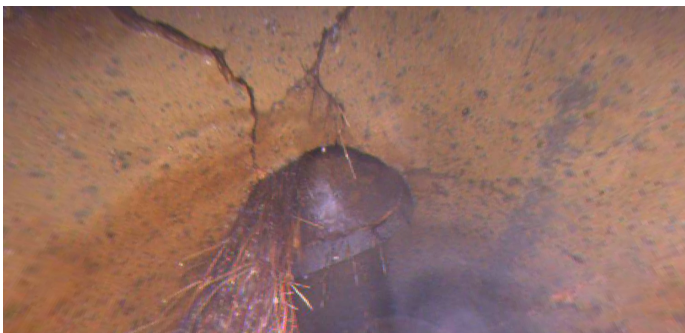
Code: **FM**  
Description: **Fracture Multiple**

Distance (ft): **130.1**  
Structural Grade: **4**  
O&M Grade: **0**  
Clock Start/From: **7**  
Clock To: **5**  
1st Value:  
2nd Value:  
Value Percent:  
Continuous Index:  
Within 8" of Joint: **YES**  
Remarks:

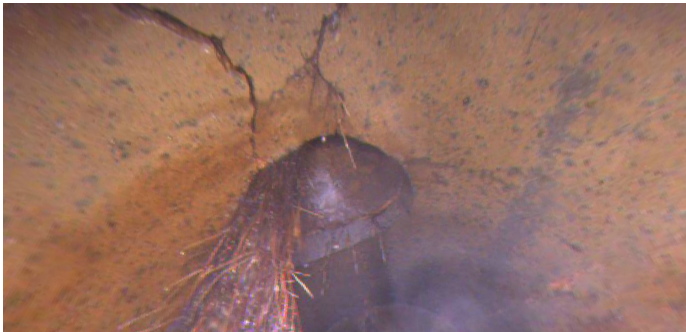
Code: **RML**  
Description: **Roots Medium Lateral**

Distance (ft): **130.1**  
Structural Grade: **0**  
O&M Grade: **3**  
Clock Start/From: **7**  
Clock To: **11**  
1st Value:  
2nd Value:  
Value Percent: **5.000**  
Continuous Index:  
Within 8" of Joint: **NO**  
Remarks:

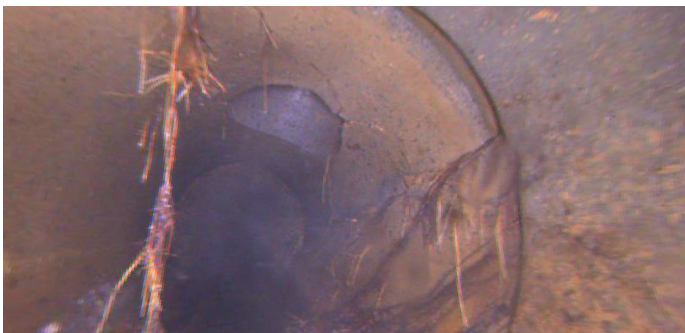
Code: **RFJ**  
Description: **Roots Fine Joint**

Distance (ft): **131.6**  
Structural Grade: **0**  
O&M Grade: **1**  
Clock Start/From: **7**  
Clock To: **5**  
1st Value:  
2nd Value:  
Value Percent:  
Continuous Index: **S03**  
Within 8" of Joint: **YES**  
Remarks:

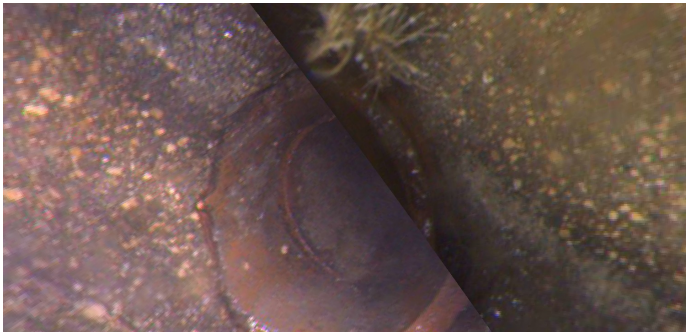
Code: **RFC**  
Description: **Roots Fine Connection**

Distance (ft): **151.1**  
Structural Grade: **0**  
O&M Grade: **1**  
Clock Start/From: **1**  
Clock To:  
1st Value:  
2nd Value:  
Value Percent:  
Continuous Index:  
Within 8" of Joint: **NO**  
Remarks:

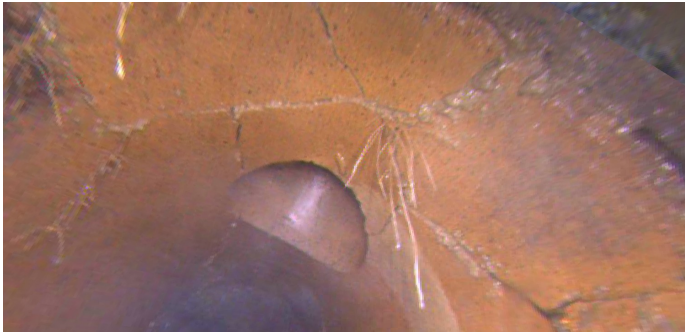
Code: **FM**  
Description: **Fracture Multiple**

Distance (ft): **168.6**  
Structural Grade: **4**  
O&M Grade: **0**  
Clock Start/From: **7**  
Clock To: **5**  
1st Value:  
2nd Value:  
Value Percent:  
Continuous Index:  
Within 8" of Joint: **YES**  
Remarks:

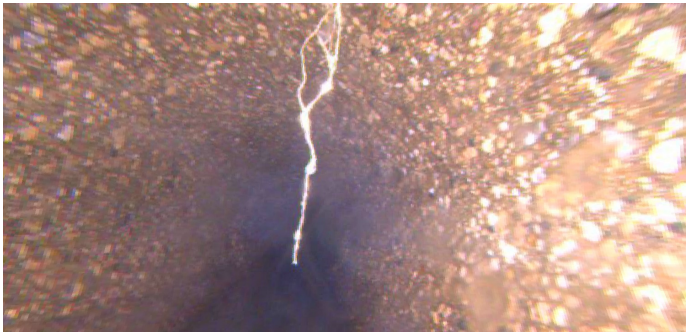
Code: **RFB**  
Description: **Roots Fine Barrel**

Distance (ft): **177.1**  
Structural Grade: **0**  
O&M Grade: **2**  
Clock Start/From: **12**  
Clock To:  
1st Value:  
2nd Value:  
Value Percent:  
Continuous Index:  
Within 8" of Joint: **NO**  
Remarks:

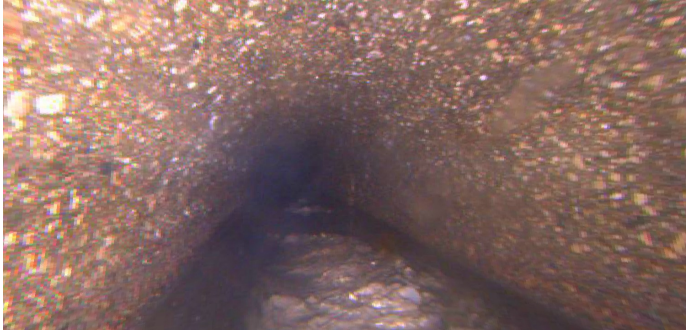
Code: **DSZ**  
Description: **Deposits Settled Other**

Distance (ft): **192.1**  
Structural Grade: **0**  
O&M Grade: **2**  
Clock Start/From: **6**  
Clock To:  
1st Value:  
2nd Value:  
Value Percent: **5.000**  
Continuous Index: **S05**  
Within 8" of Joint: **NO**  
Remarks: **tissue/debris**

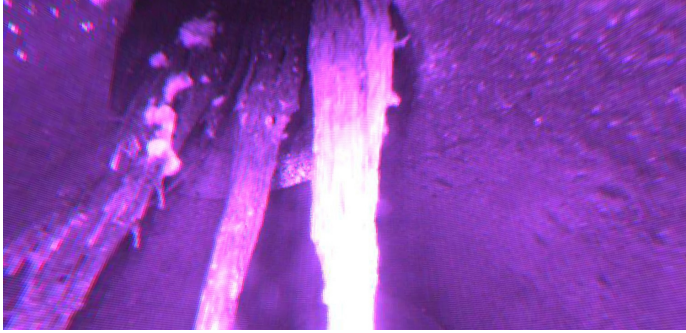
Code: **RML**  
Description: **Roots Medium Lateral**

Distance (ft): **280.5**  
Structural Grade: **0**  
O&M Grade: **3**  
Clock Start/From: **11**  
Clock To:  
1st Value:  
2nd Value:  
Value Percent: **5.000**  
Continuous Index:  
Within 8" of Joint: **NO**  
Remarks:

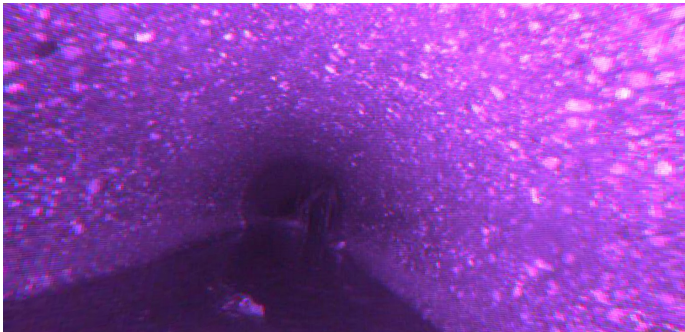
Code: **SAV**  
Description: **Surface Aggregate Visible**

Distance (ft): **299.1**  
Structural Grade: **3**  
O&M Grade: **0**  
Clock Start/From: **7**  
Clock To: **5**  
1st Value:  
2nd Value:  
Value Percent:  
Continuous Index: **F01**  
Within 8" of Joint: **NO**  
Remarks:

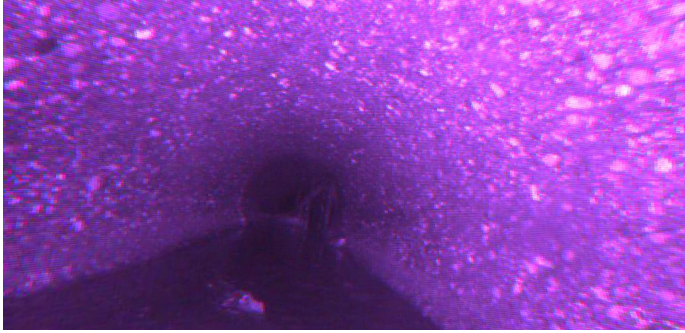
Code: **CC**  
Description: **Crack Circumferential**

Distance (ft): **299.1**  
Structural Grade: **1**  
O&M Grade: **0**  
Clock Start/From: **7**  
Clock To: **5**  
1st Value:  
2nd Value:  
Value Percent:  
Continuous Index: **F02**  
Within 8" of Joint:  
Remarks:

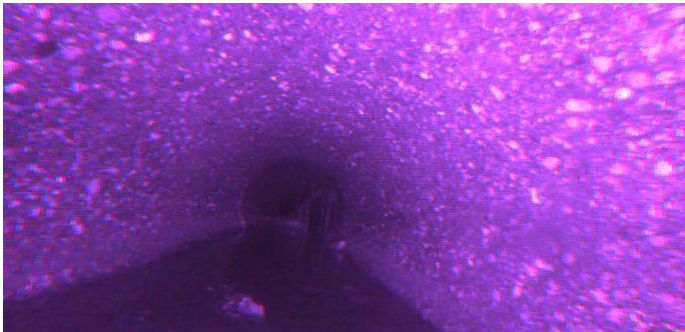
Code: **CM**  
Description: **Crack Multiple**

Distance (ft): **299.1**  
Structural Grade: **3**  
O&M Grade: **0**  
Clock Start/From: **7**  
Clock To: **5**  
1st Value:  
2nd Value:  
Value Percent:  
Continuous Index: **F04**  
Within 8" of Joint:  
Remarks: **wandering**

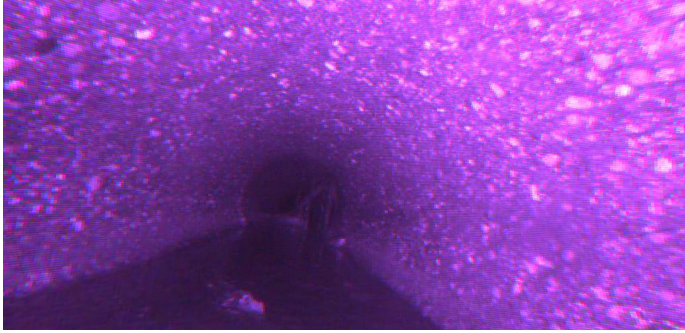
Code: **RFJ**  
Description: **Roots Fine Joint**

Distance (ft): **299.1**  
Structural Grade: **0**  
O&M Grade: **1**  
Clock Start/From: **7**  
Clock To: **5**  
1st Value:  
2nd Value:  
Value Percent:  
Continuous Index: **F03**  
Within 8" of Joint: **YES**  
Remarks:

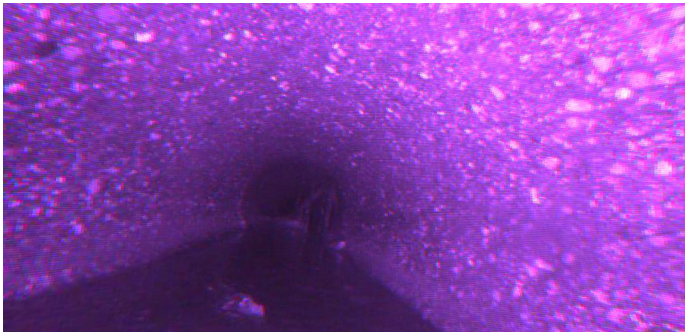
Code: **DSZ**  
Description: **Deposits Settled Other**

Distance (ft): **299.1**  
Structural Grade: **0**  
O&M Grade: **2**  
Clock Start/From: **6**  
Clock To:  
1st Value:  
2nd Value:  
Value Percent: **5.000**  
Continuous Index: **F05**  
Within 8" of Joint: **NO**  
Remarks: **tissue/debris**
