Profile/Photo Observation Report

Street:	W HOME AVE	Flow Control:	Not Controlled
City:	Hobart, IN	Year Renewed:	
Location:	Alley	Tape/Media #:	
Purpose:	Routine Assessment	Dia/Height:	12"
Use:	Sanitary	Material:	CP
Drain Area:	NA	Lining:	
Category:	NA		
Comment:	F_S_P_C at 3 ft debris flow direction wrong		
Location Details:		Direction of Survey:	Downstream
US MH:	M-504-052	DS MH:	M-504-053
		Total Length Surveyed (ft):	4.6

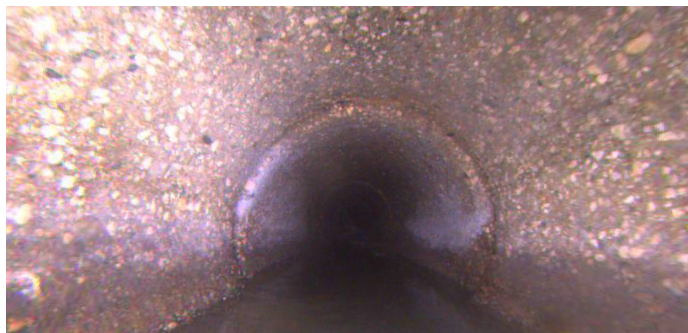
Code: **AMH**
 Description: **Manhole**

Distance (ft): **.0**
 Structural Grade: **0**
 O&M Grade: **0**
 Clock Start/From:
 Clock To:
 1st Value:
 2nd Value:
 Value Percent:
 Continuous Index:
 Within 8" of Joint: **NO**
 Remarks: **M-504-052**

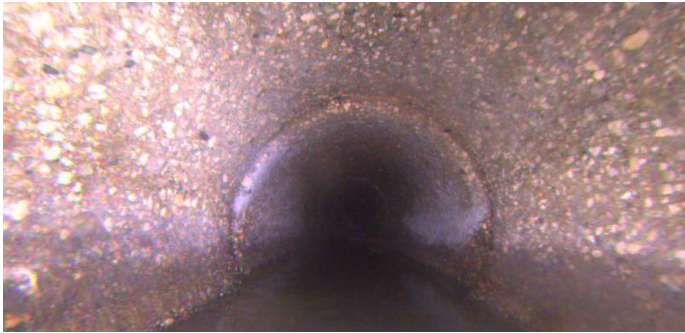
Code:	MWL
Description:	Water Level

Distance (ft):	.0
Structural Grade:	0
O&M Grade:	0
Clock Start/From:	
Clock To:	
1st Value:	
2nd Value:	
Value Percent:	10.000
Continuous Index:	
Within 8" of Joint:	NO
Remarks:

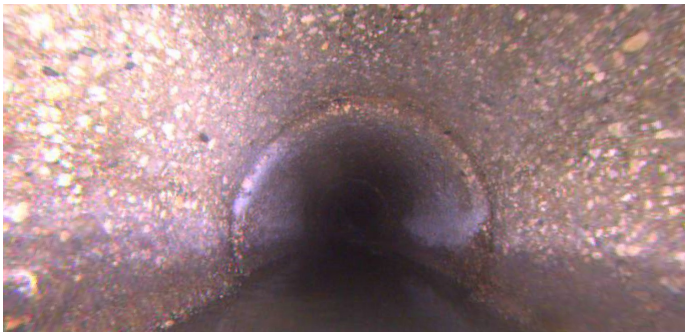
Code:	SAP
Description:	Surface Aggregate Projecting

Distance (ft):	.0
Structural Grade:	3
O&M Grade:	0
Clock Start/From:	8
Clock To:	4
1st Value:	
2nd Value:	
Value Percent:	
Continuous Index:	
Within 8" of Joint:	
Remarks:

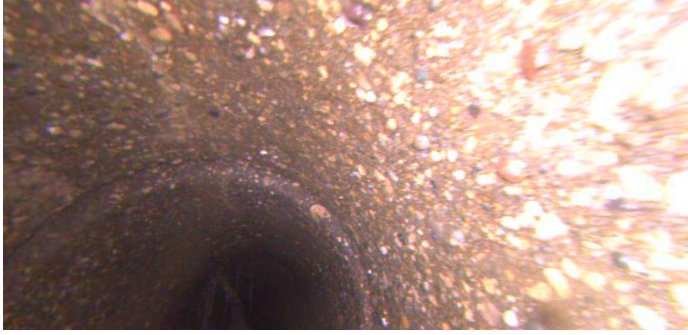
Code:	MSA
Description:	Abandoned Survey
Distance (ft):	4.6
Structural Grade:	0
O&M Grade:	0
Clock Start/From:	
Clock To:	
1st Value:	
2nd Value:	
Value Percent:	
Continuous Index:	
Within 8" of Joint:	NO
Remarks:	unknown
