Profile/Photo Observation Report

Date:	04/22/2018	Weather:		Coding:	PACP 6.0
Pipe Length (ft):	329.5	Owner:	NA	Pre Clean:	No Pre-Cleaning
P.O.#:		Surveyor:	Jen Costello	PSR:	P-504-053-052
Customer:		Clean Date:	01/01/1900	Shape:	C

Street:	FOXCROFT STREET	Flow Control:	Not Controlled
City:	Hobart, IN	Year Renewed:	
Location:	Alley	Tape/Media #:	
Purpose:	Routine Assessment	Dia/Height:	12"
Use:	Sanitary	Material:	CP
Drain Area:	NA	Lining:	
Category:	NA		
Comment:	F_S_P_C at 3 ft debris flow direction wrong		
Location Details:		Direction of Survey:	Downstream
US MH:	M-504-052	DS MH:	M-504-053
		Total Length Surveyed (ft):	4.6

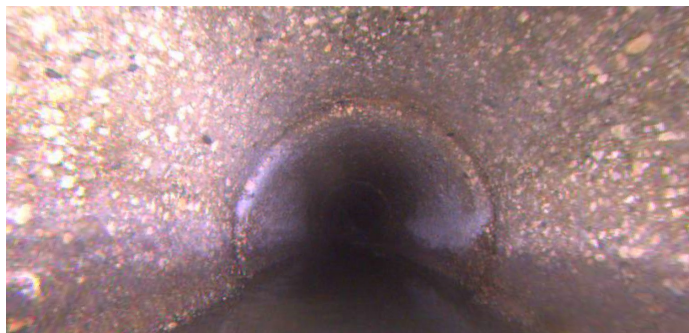
Code: **AMH**
 Description: **Manhole**
 Distance (ft): **.0**
 Structural Grade: **0**
 O&M Grade: **0**
 Clock Start/From:
 Clock To:
 1st Value:
 2nd Value:
 Value Percent:
 Continuous Index:
 Within 8" of Joint: **NO**
 Remarks: **M-504-052**

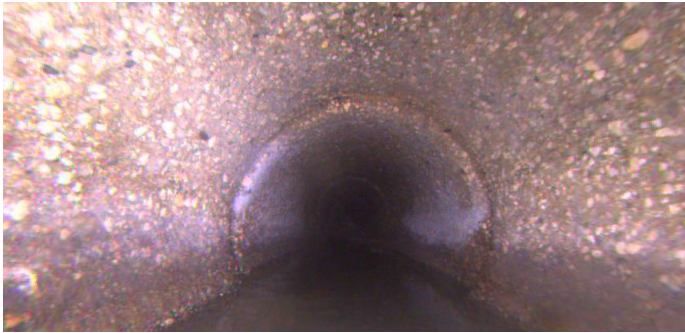
Code:	MWL
Description:	Water Level

Distance (ft):	.0
Structural Grade:	0
O&M Grade:	0
Clock Start/From:	
Clock To:	
1st Value:	
2nd Value:	
Value Percent:	10.000
Continuous Index:	
Within 8" of Joint:	NO
Remarks:

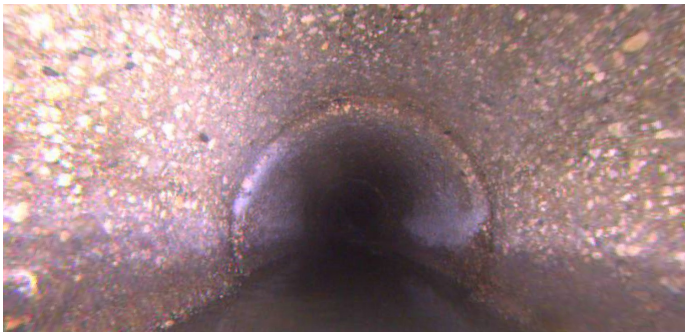
Code:	SAP
Description:	Surface Aggregate Projecting

Distance (ft):	.0
Structural Grade:	3
O&M Grade:	0
Clock Start/From:	8
Clock To:	4
1st Value:	
2nd Value:	
Value Percent:	
Continuous Index:	
Within 8" of Joint:	
Remarks:

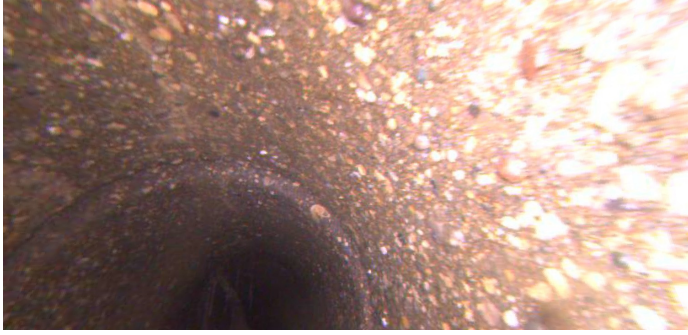
Code:	MSA
Description:	Abandoned Survey
Distance (ft):	4.6
Structural Grade:	0
O&M Grade:	0
Clock Start/From:	
Clock To:	
1st Value:	
2nd Value:	
Value Percent:	
Continuous Index:	
Within 8" of Joint:	NO
Remarks:	unknown
