Profile/Photo Observation Report

RUBUIICS
Date:	09/15/2021	Weather:		0	PACP 7.0
Pipe Length (ft)	: 318.3	Owner:	City of Hobart	Pre Clean:	Heavy Cleaning
P.O.#:	YES502259	Surveyor:	S. Bucklin	PSR:	P-504-053-052
Customer:	City of Hobart	Clean Date:	09/07/2021	Shape:	С
Street:	North Guyer Stree	t	Flow Control:	Not Controlled	
City:	Hobart, IN		Year Renewed:		
Location:	Local rural streets	with light traffic, t	Tape/Media #:		
Purpose:	Routine Assessme	nt	Dia/Height:	12"	
Use:	Sanitary Sewage P	ipe	Material:	СР	
Drain Area:			Lining:	None	
Category:	NA				
Comment:					
Location Details	5:		Direction of Survey:	Downstream	
US MH:	M-504-052	DS MH: M	-504-053	Total Length Surveyed (ft):	318.3
0&M Index:	2.09	O&M Quick:	372M	O&M Rating:	167.00
tructural Index:	3.00	Structural Quick	c: 4533	Structural Rating:	39.00
overall Index:	2.22	Overall Quick:	453A	Overall Rating:	206.00

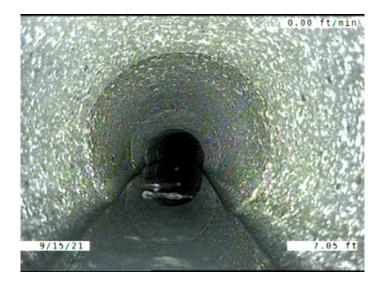
Code:	DSF
Description:	Deposits Settled Fine
Distance (ft):	7.0
Structural Grade:	0
O&M Grade:	2
Clock Start/From:	5
Clock To:	7
1st Value:	
2nd Value:	
Value Percent:	5.000
Continuous Index:	S02
Within 8" of Joint:	YES
Remarks:

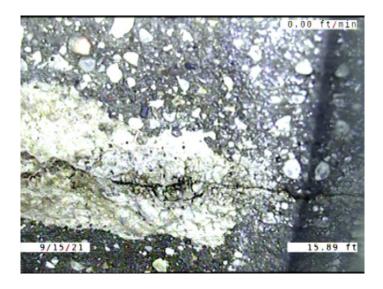
Code: Description:	CS Crack Spiral
Distance (ft): Structural Grade: O&M Grade: Clock Start/From: Clock To: 1st Value: 2nd Value: Value Percent: Continuous Index: Within 8" of Joint:	15.9 2 0 9 3 NO
Remarks:

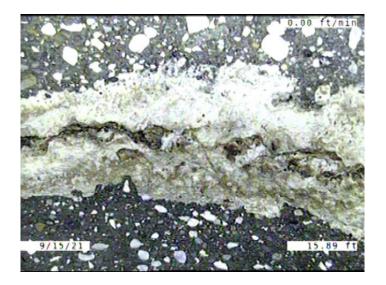
Code: Description:	DAE Deposits Attached Encrustation
Distance (ft):	15.9
Structural Grade:	0
O&M Grade:	2
Clock Start/From:	9
Clock To:	3
1st Value:	
2nd Value:	
Value Percent:	5.000
Continuous Index:	
Within 8" of Joint:	NO
Remarks:

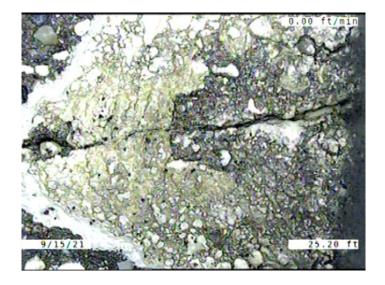
Code: Description:	CS Crack Spiral
Distance (ft):	25.2
Structural Grade:	2
O&M Grade:	0
Clock Start/From:	8
Clock To:	4
1st Value:	
2nd Value:	
Value Percent:	
Continuous Index:	
Within 8" of Joint:	YES
Remarks:

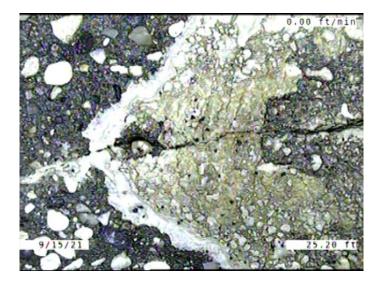
Code: Description:	DAE Deposits Attached Encrustation
Distance (ft):	25.2
Structural Grade:	0
O&M Grade:	2
Clock Start/From:	3
Clock To:	4
1st Value:	
2nd Value:	
Value Percent:	5.000
Continuous Index:	
Within 8" of Joint:	NO
Remarks:

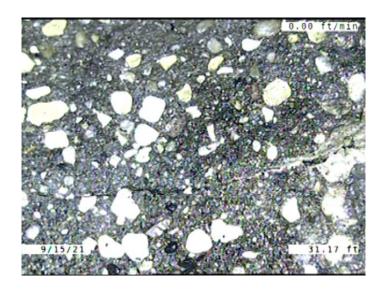
Code: Description:	CS Crack Spiral
Distance (ft):	31.2
Structural Grade:	2
O&M Grade:	0
Clock Start/From:	9
Clock To:	3
1st Value:	
2nd Value:	
Value Percent:	
Continuous Index:	
Within 8" of Joint:	YES
Remarks:

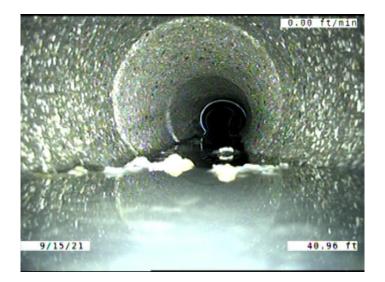
Code:	OBZ
Description:	Obstruction Other
Distance (ft):	41.0
Structural Grade:	0
O&M Grade:	2
Clock Start/From:	4
Clock To:	8
1st Value:	
2nd Value:	
Value Percent:	10.000
Continuous Index:	
Within 8" of Joint:	NO
Remarks:	UNKNOWN DEBRIS UNDER THE
	FLOW

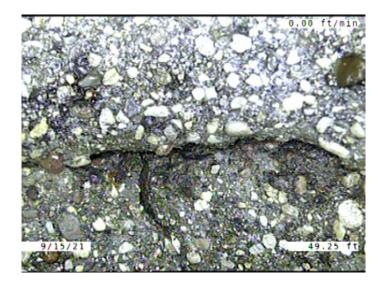
Code: Description:	FM Fracture Multiple
Distance (ft):	49.3
Structural Grade:	4
O&M Grade:	0
Clock Start/From:	7
Clock To:	5
1st Value:	
2nd Value:	
Value Percent:	
Continuous Index:	
Within 8" of Joint:	YES
Remarks:

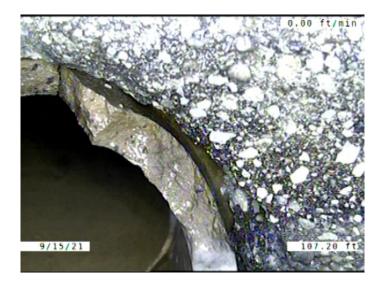
Code: Description:	B Broken
Distance (ft): Structural Grade: O&M Grade: Clock Start/From: Clock To: 1st Value: 2nd Value: Value Percent: Continuous Index: Within 8" of Joint:	107.2 4 0 12 2 YES
Remarks:

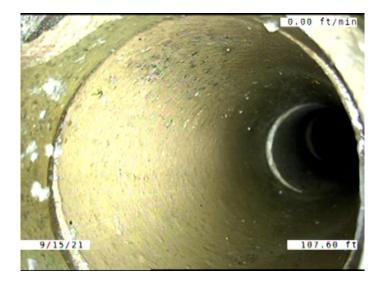
Code:	ТВІ
Description:	Tap Break-in Intruding
Distance (ft):	107.6
Structural Grade:	0
O&M Grade:	2
Clock Start/From:	1
Clock To:	
1st Value:	4.000
2nd Value:	1.000
Value Percent:	
Continuous Index:	
Within 8" of Joint:	NO
Remarks:	Broken near connection

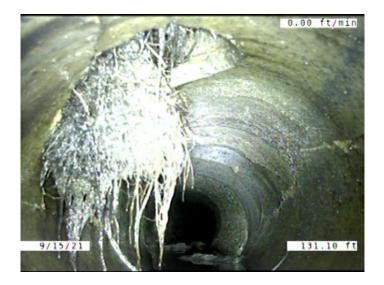
Code: Description:	RML Roots Medium Lateral
Distance (ft):	131.1
Structural Grade:	0
O&M Grade:	3
Clock Start/From:	9
Clock To:	11
1st Value:	
2nd Value:	
Value Percent:	10.000
Continuous Index:	
Within 8" of Joint:	NO
Remarks:

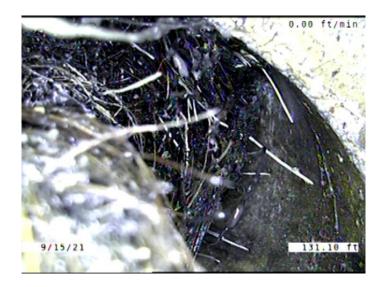
Code: Description:	TFD Tap Factory Defective
Distance (ft):	131.1
Structural Grade:	0
O&M Grade:	3
Clock Start/From:	11
Clock To:	
1st Value:	4.000
2nd Value:	
Value Percent:	
Continuous Index:	
Within 8" of Joint:	YES
Remarks:	100% PLUGGED WITH ROOTS

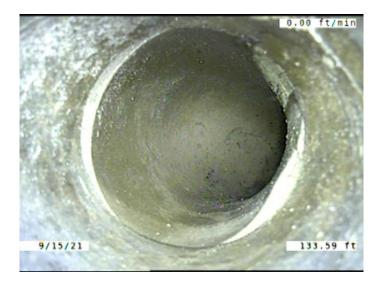
Code: Description:	TFD Tap Factory Defective
	122.0
Distance (ft):	133.6
Structural Grade:	0
O&M Grade:	3
Clock Start/From:	1
Clock To:	
1st Value:	4.000
2nd Value:	
Value Percent:	
Continuous Index:	
Within 8" of Joint:	YES
Remarks:	Defective

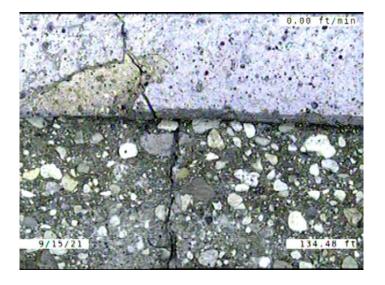
Code: Description:	FL Fracture Longitudinal
Distance (ft):	134.5
Structural Grade:	3
O&M Grade:	0
Clock Start/From:	12
Clock To:	
1st Value:	
2nd Value:	
Value Percent:	
Continuous Index:	
Within 8" of Joint:	YES
Remarks:

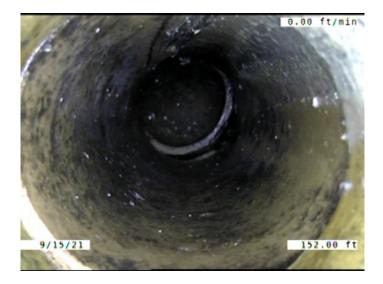
Code:	ТВІ
Description:	Tap Break-in Intruding
Distance (ft):	152.0
Structural Grade:	0
O&M Grade:	2
Clock Start/From:	12
Clock To:	
1st Value:	4.000
2nd Value:	1.000
Value Percent:	
Continuous Index:	
Within 8" of Joint:	NO
Remarks:

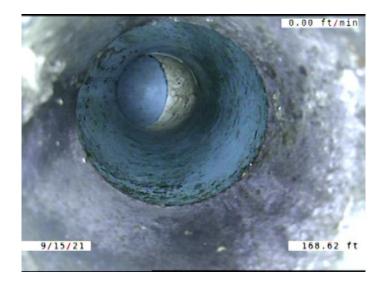
Code:	TFI
Description:	Tap Factory Intruding
Distance (ft):	168.6
Structural Grade:	0
O&M Grade:	2
Clock Start/From:	11
Clock To:	
1st Value:	4.000
2nd Value:	2.000
Value Percent:	
Continuous Index:	
Within 8" of Joint:	YES
Remarks:

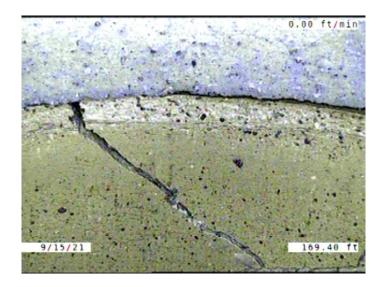
Code: Description:	B Broken
Distance (ft):	169.4
Structural Grade:	4
O&M Grade:	0
Clock Start/From:	10
Clock To:	5
1st Value:	
2nd Value:	
Value Percent:	
Continuous Index:	
Within 8" of Joint:	YES
Remarks:

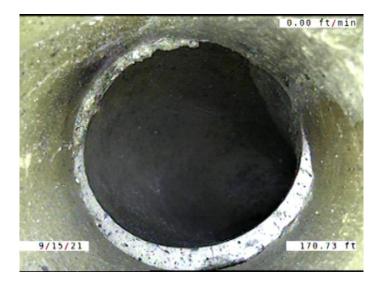
Code: Description:	TFD Tap Factory Defective
Distance (ft):	170.7
Structural Grade:	0
O&M Grade:	3
Clock Start/From:	1
Clock To:	
1st Value:	4.000
2nd Value:	
Value Percent:	
Continuous Index:	
Within 8" of Joint:	YES
Remarks:	Defective

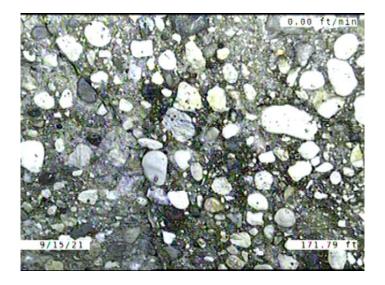
Code:	CS
Description:	Crack Spiral
Distance (ft):	171.8
Structural Grade:	
Structural Grade:	2
O&M Grade:	0
Clock Start/From:	2
Clock To:	4
1st Value:	
2nd Value:	
Value Percent:	
Continuous Index:	
Within 8" of Joint:	YES
Remarks:

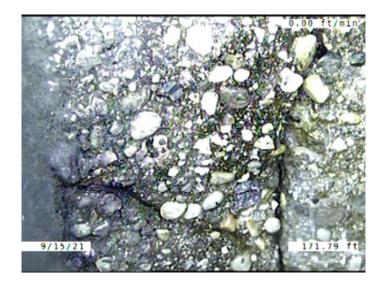
FM Fracture Multiple
171.8
4
0
7
9
YES

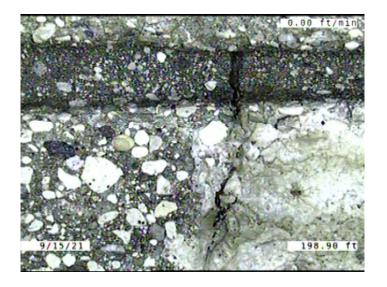
FM Fracture Multiple
198.9
4
0
10
3
YES

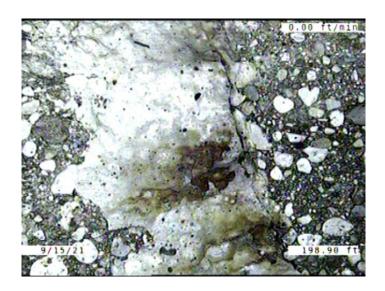
Code: Description:	DAE Deposits Attached Encrustation
Distance (ft): Structural Grade: O&M Grade: Clock Start/From: Clock To: 1st Value:	198.9 0 2 9 3
2nd Value: Value Percent: Continuous Index: Within 8" of Joint: Remarks:	5.000 YES

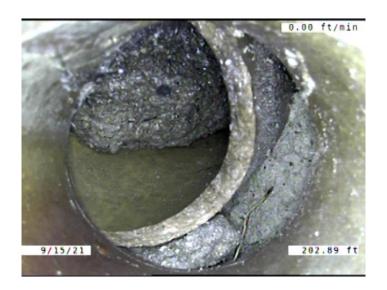
Code:	TFD
Description:	Tap Factory Defective
Distance (ft):	202.9
Structural Grade:	0
O&M Grade:	3
Clock Start/From:	11
Clock To:	
1st Value:	4.000
2nd Value:	
Value Percent:	
Continuous Index:	
Within 8" of Joint:	YES
Remarks:	SOIL VISIBLE. FIRST JOINT BACK HAS A LARGE OFFSET

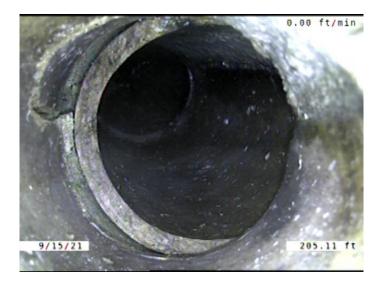
Code: Description:	TFD Tap Factory Defective
Distance (ft):	205.1
Structural Grade:	0
O&M Grade:	3
Clock Start/From:	1
Clock To:	
1st Value:	4.000
2nd Value:	
Value Percent:	
Continuous Index:	
Within 8" of Joint:	YES
Remarks:	Defective

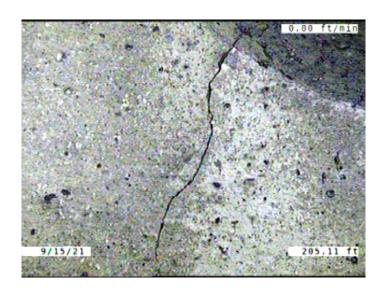
Code: Description:	CL Crack Longitudinal
Distance (ft): Structural Grade: O&M Grade: Clock Start/From: Clock To: 1st Value: 2nd Value: Value Percent: Continuous Index: Within 8" of Joint:	205.1 2 0 2
Remarks:

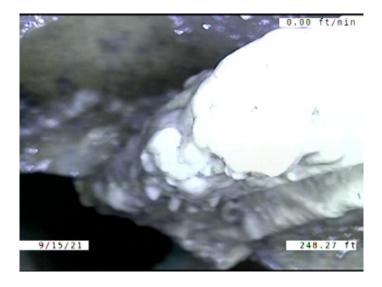
Code: Description:	DAE Deposits Attached Encrustation
Distance (ft): Structural Grade: O&M Grade: Clock Start/From: Clock To: 1st Value: 2nd Value:	248.3 0 2 1
Value Percent: Continuous Index:	5.000
Within 8" of Joint: Remarks:	YES

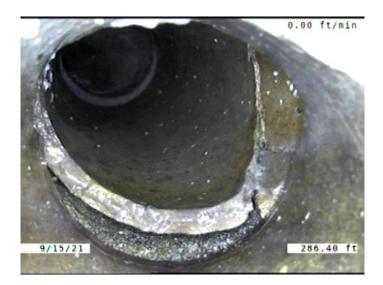
TFD Tap Factory Defective
286.4 0 3
11
4.000
YES Defective

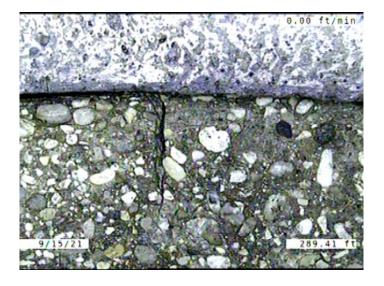
Code: Description:	FL Fracture Longitudinal
	200.4
Distance (ft):	289.4
Structural Grade:	3
O&M Grade:	0
Clock Start/From:	11
Clock To:	
1st Value:	
2nd Value:	
Value Percent:	
Continuous Index:	
Within 8" of Joint:	YES
Remarks:

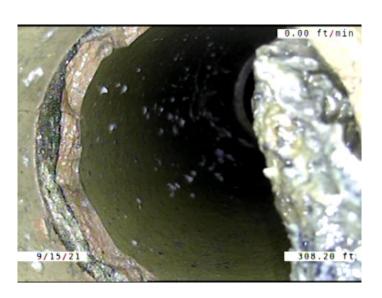
Code: Description:	TBI Tap Break-in Intruding
Distance (ft): Structural Grade: O&M Grade: Clock Start/From: Clock To: 1st Value: 2nd Value: Value Percent: Continuous Index: Within 8" of Joint:	308.2 0 2 1 4.000 1.000
Remarks:	Broken near connection

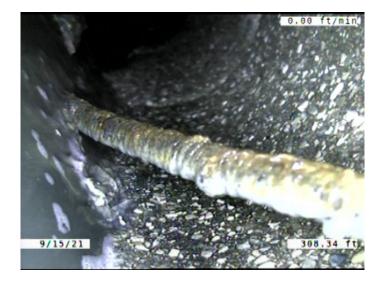
Code:	OBZ
Description:	Obstruction Other
Distance (ft):	308.3
Structural Grade:	0
O&M Grade:	2
Clock Start/From:	2
Clock To:	7
1st Value:	
2nd Value:	
Value Percent:	5.000
Continuous Index:	S01
Within 8" of Joint:	YES
Remarks:	STICK

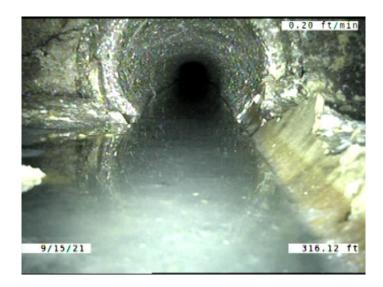
Code: Description:	OBZ Obstruction Other
Distance (ft):	316.1
Structural Grade:	0
O&M Grade:	2
Clock Start/From:	2
Clock To:	7
1st Value:	
2nd Value:	
Value Percent:	5.000
Continuous Index:	F01
Within 8" of Joint:	YES
Remarks:	STICK

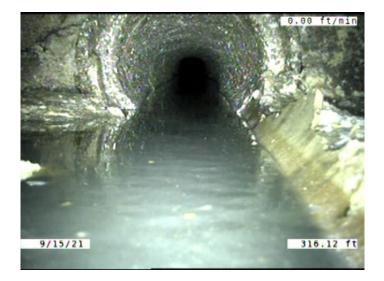
DSF
Deposits Settled Fine
316.1
310.1
0
2
5
7
5.000
F02
YES
